Appendix G2: Botanical Specialist Assessment Report

Botanical Impact Assessment for the proposed dualling of a section of the R43 from Vermont to Onrus, Overstrand Municipality, Western Cape Province

Report by Dr David J. McDonald
Bergwind Botanical Surveys & Tours CC.
14A Thomson Road, Claremont, 7708
Tel: 021-671-4056
Fax: 086-517-3806

March 2020; amended 20 January 2021

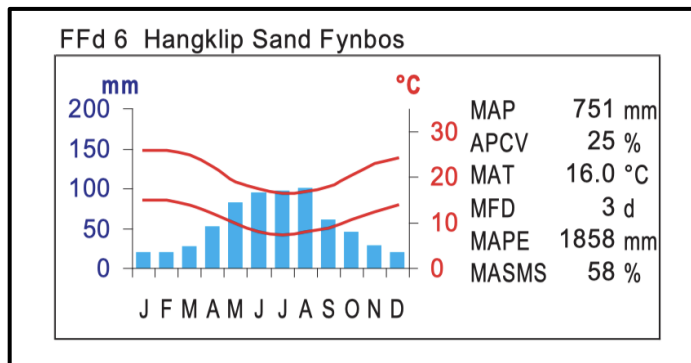
Figure 6a. Climate diagram for Hangklip Sand Fynbos and **6b.** Overberg Sandstone Fynbos (from Rebelo *et al.* 2006 in Rutherford & Mucina, 2006) showing MAP – Mean Annual Precipitation; APCV = Annual Precipitation Coefficient of Variance; MAT = Mean Annual Temperature; MFD = Mean Frost Days; MAPE = Mean Annual Potential Evaporation; MASMA = Mean Annual Soil Moisture Stress.

Mean annual precipitation (MAP) for Hangklip Sand Fynbos is 751 mm and for Overberg Sandstone Fynbos, 585 mm (Figure 6) (Rebello *et al.* 2006 in Mucina & Rutherford, 2006). The difference is attributed to the general closer proximity of Hangklip Sand Fynbos to the coast. The summers are generally hot and dry, and the winters cool to cold. Rain falls mainly in the winter hence the climate being classified as a Mediterranean-type climate. South-east

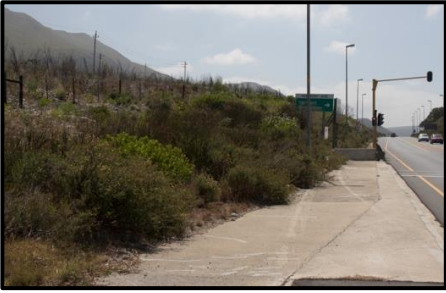
Waypoint	Descriptive Notes	Illustration
<p>VOD0001</p> <p>S 34° 24' 25.74" E 19° 09' 47.21"</p>	<p>This location is just before the intersection at Vermont Avenue, on the west side. A strip of natural vegetation about 4 m wide is present and then further upslope a firebreak has been cleared.</p> <p>The species listed below were recorded on the top of the road cutting in the road reserve. The cut-slope itself has revegetated but the vegetation is degraded and is dominated by <i>Acacia saligna</i>*, the grass <i>Tribolium uniolae</i> and <i>Metalasia densa</i>. The exotic grasses <i>Lagurus ovatus</i> and <i>Cortaderia selloana</i> (Pampas grass) were found on the cut-slope edge.</p> <p>Species present include:</p> <p><i>Acacia cyclops</i>*, <i>Anthospermum aethiopicum</i>, <i>Aspalathus</i> sp. (low & sprawling), <i>Athanasia trifurcata</i>, <i>Briza minor</i>, <i>Berkheya rigidus</i>, <i>Berzelia</i> sp., <i>Bobartia indica</i>, <i>Calobota</i> sp., <i>Centranthus ruber</i>*, <i>Cliffortia juniperifolia</i>, <i>Cullumia</i> sp., <i>Ehrharta</i> sp., <i>Elytropappus rhinocerotis</i>, <i>Eragrostis curvula</i>, <i>Erica brachialis</i>, <i>Ficinia filiformis</i>, <i>Ficinia</i> sp., <i>Gnidia squarrosa</i>, <i>Hyparrhenia hirta</i>, <i>Lanaria lanata</i>, <i>Leptospermum laevigatum</i>*, <i>Leucadendron xanthoconus</i>, <i>Lobelia coronopifolia</i>, <i>Lobelia pinifolia</i>, <i>Lobostemon</i> sp., <i>Metalasia erubescens</i>, <i>Mimetes cucullatus</i> and <i>Oedera capensis</i>, <i>Olea</i> sp., <i>Oncosiphon fruticosus</i>, <i>Osteospermum moniliferum</i>, <i>Osyris compressa</i>, <i>Passerina corymbosa</i>, <i>Pelargonium cucullatum</i>, <i>Pentameris macrocalycina</i>, <i>Phyllica</i> cf. <i>ericoides</i>, <i>Pinus radiata</i> (young sapling), <i>Plantago lanceolata</i>, <i>Protea repens</i>, <i>Psoralea pinnata</i>, <i>Pennisetum clandestinum</i>, <i>Searsia</i> cf. <i>lucida</i>, <i>Selago</i> sp. (white), <i>Senecio</i> sp., <i>Tetragonia fruticosa</i>, <i>Taraxacum officinale</i>*, <i>Thamnochortus insignis</i>, <i>Themeda triandra</i>, <i>Tribolium uniolae</i>, <i>Verbascum thaspus</i>* and <i>Willdenowia sulcata</i></p>

<p>View of the cutting at the Vermont Avenue intersection.</p>

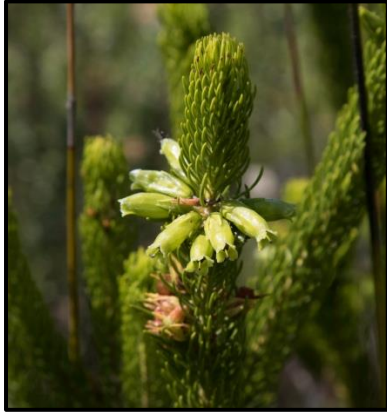
<p><i>Erica brachialis</i></p>

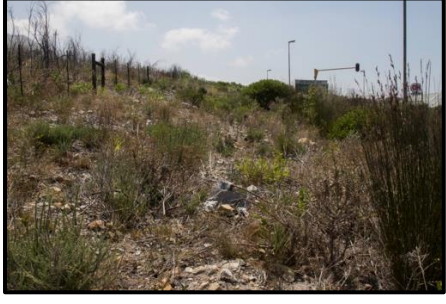
<p>The top of the cutting in the road reserve.</p>

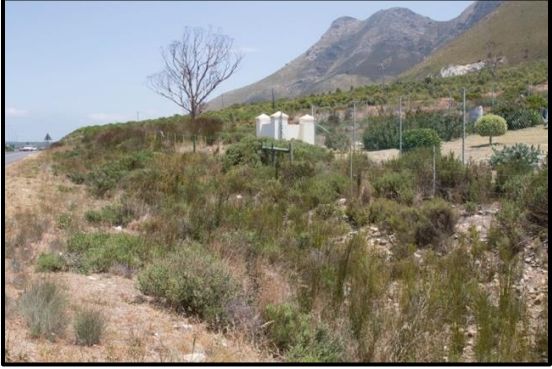
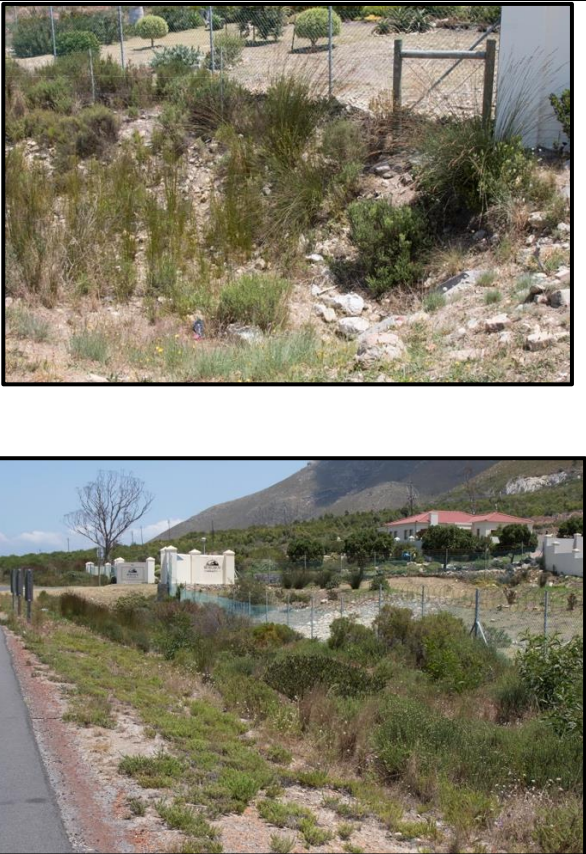
<p>VOD0003 S 34° 24' 26.05" E 19° 10' 12.95"</p>	<p>Alongside Berghof the vegetation is indigenous but with alien <i>Acacia saligna</i>* invading. The plant community is the same as that described above but with <i>Metalasia densa</i> dominant. Areas in the road reserve have been cleared at some point and now the <i>Thamnochortus insignis</i> seedlings are re-establishing.</p>

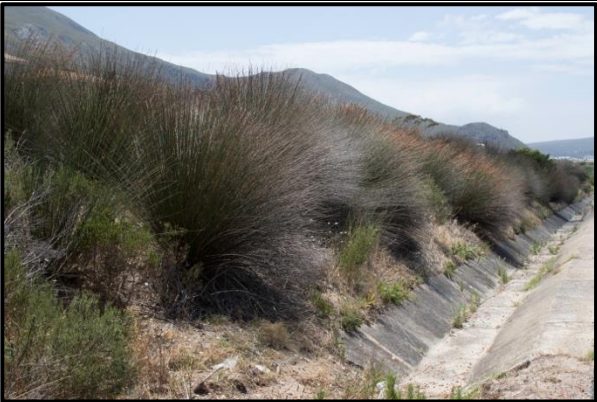
<p>VOD0004 S 34° 24' 26.53" E 19° 10' 16.77"</p>	<p>At this location outside Berghof, the dense stand of <i>Thamnochortus insignis</i> has ousted most other plants.</p>

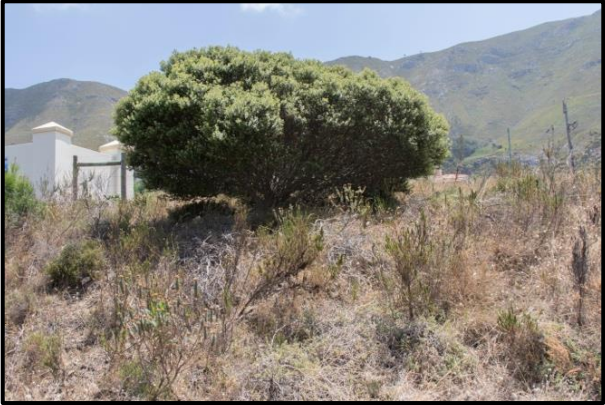
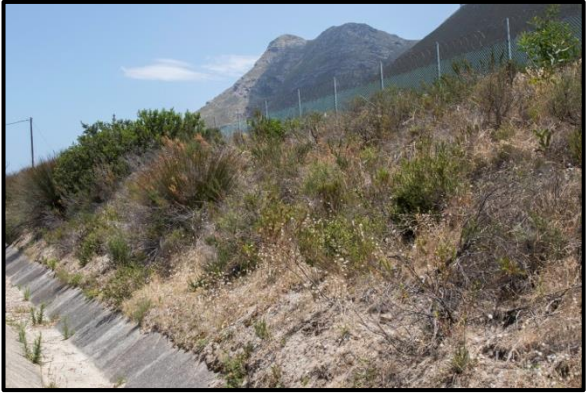
<p>VOD0005 S 34° 24' 26.47" E 19° 10' 19.44"</p>	<p>The same plant community as describe above is found here but with a few large shrubs of <i>Phyllica buxifolia</i>. <i>Searsia lucida</i> also occurs and young sapling of <i>Pinus radiata</i>* are present. The abundance of the shrub <i>Anthospermum aethiopicum</i> indicates a high level of disturbance and degradation of the plant community.</p>

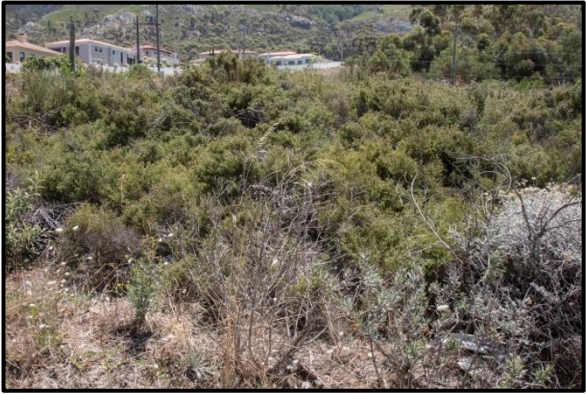
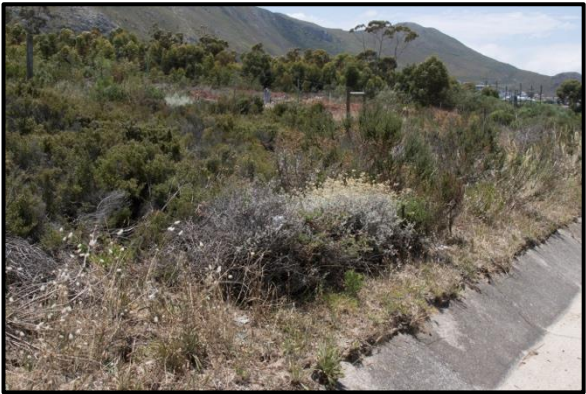
<p>VOD0006 S 34° 24' 26.71" E 19° 10' 21.58"</p>	<p>At this location is a dense stand of low to mid-high <i>Erica</i> sp. (not in flower and not identified) that is dominant. Companion species include, <i>Anthospermum aethiopicum</i>, <i>Carpobrotus edulis</i>, <i>Cliffortia juniperifolia</i>, <i>Ehrharta villosa</i>, <i>Eragrostis curvula</i>, <i>Geranium incanum</i>, <i>Helichrysum cymosum</i>, <i>Helichrysum pandurifolium</i>, <i>Hyparrhenia hirta</i>, <i>Lagurus ovatus</i>, <i>Passerina corymbosa</i>, <i>Pelargonium capitatum</i>, <i>Plantago lanceolata</i>*, <i>Searsia lucida</i>, <i>Stoebe plumosa</i>, <i>Struthiola myrsinites</i> and <i>Tarchonanthus littoralis</i>.</p>

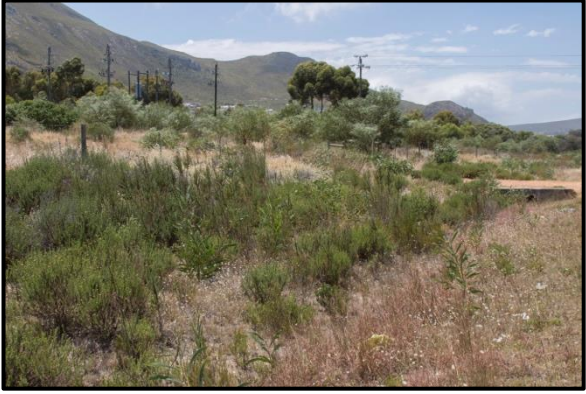
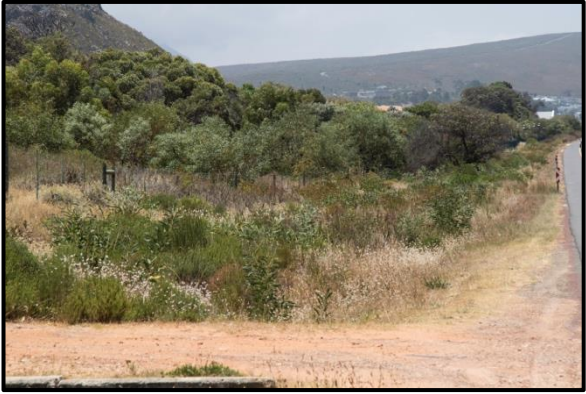
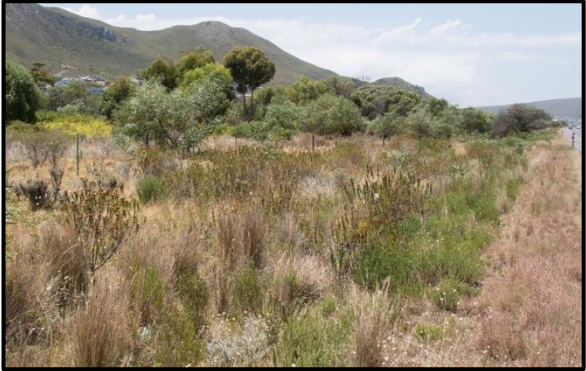
<p>VOD0007 S 34° 24' 26.85" E 19° 10' 26.45"</p>	<p>Degraded fynbos occurs at this location, dominated by <i>Metalasia densa</i>. Other species recorded include, <i>Anthospermum aethiopicum</i> (common), <i>Thamnochortus insignis</i> (only a few poorly developed individuals) <i>Acacia saligna</i>*, <i>Athanasia trifurcata</i>, <i>Helichrysum pandurifolium</i>, <i>Hyparrhenia hirta</i> (on edge of road verge), <i>Lagurus ovatus</i>, <i>Passerina corymbosa</i>, <i>Pelargonium capitatum</i> and <i>Senecio</i> cf. <i>rigidus</i>.</p>

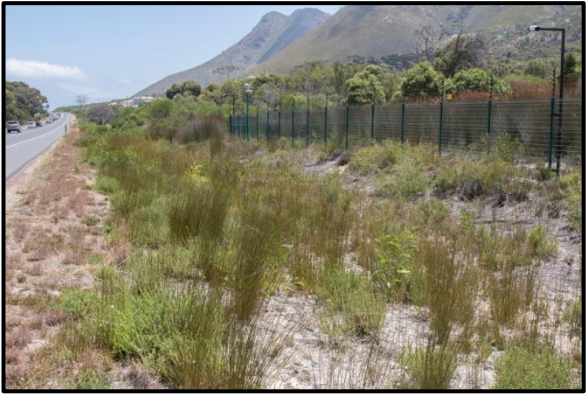
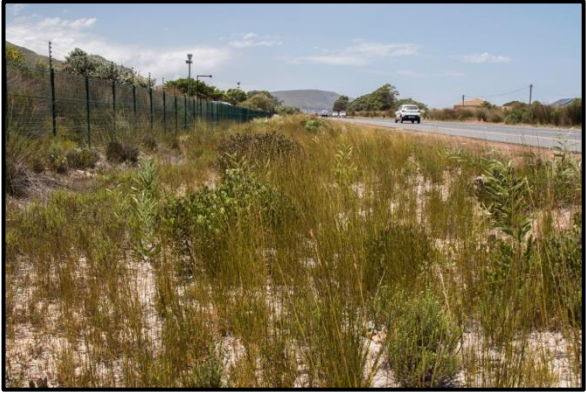
<p>VOD0008 S 34° 24' 28.26" E 19° 10' 10.13"</p>	<p>This waypoint was recorded outside Onrus Manor. The same plant community occurs here as that described above but it has been cleared. The <i>Thamnochortus insignis</i> has been brush-cut but is now resprouting. The result is that the veld is 'young' and species-poor. Species recorded include <i>Acacia saligna</i>*, <i>Anthospermum aethiopicum</i>, <i>Disparago ericoides</i>, <i>Leucadendron xanthoconus</i>, <i>Metalasia densa</i>, <i>Osteospermum moniliferum</i> and <i>Passerina corymbosa</i>.</p>

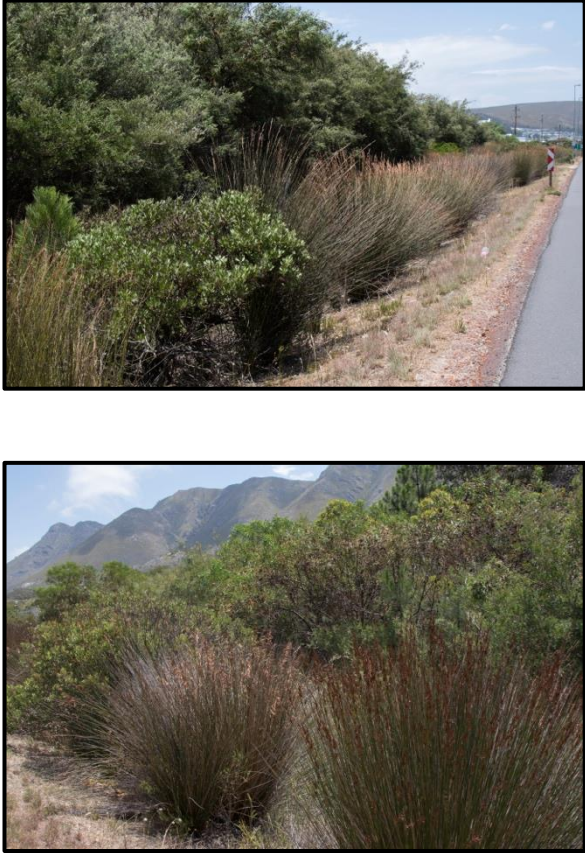
<p>VOD0009 S 34° 24' 29.24" E 19° 10' 55.36"</p>	<p>Tall, mature and dense <i>Thamnochortus insignis</i> is found in the road reserve here, with a few shrubs of <i>Osteospermum moniliferum</i>* and a few <i>Pinus radiata</i>* saplings. Over the fence (on private property) is a dense stand of woody invasive species comprising <i>Acacia saligna</i>*, <i>Eucalyptus conferuminata</i>* (spider-gum), <i>Leptospermum laevigatum</i>* (Australian myrtle) and <i>Pinus radiata</i>.</p>

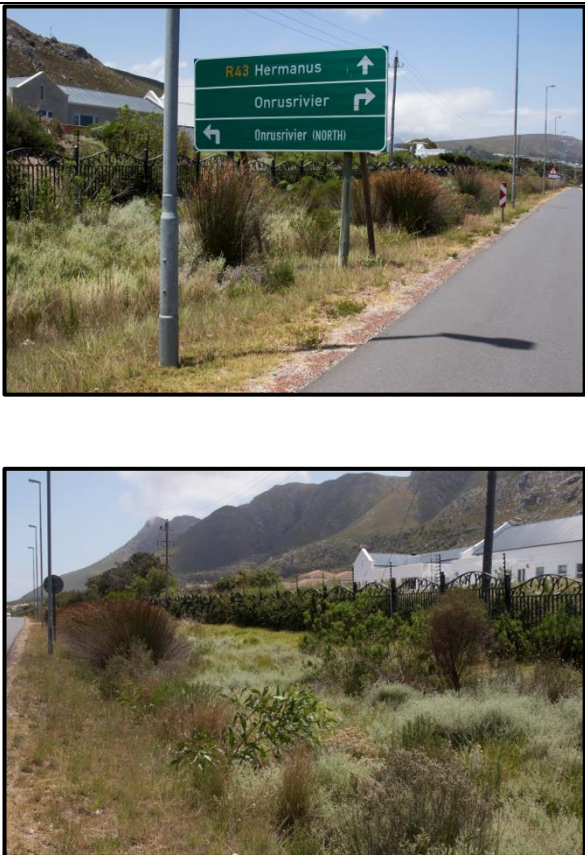
<p>VOD0010 S 34° 24' 31.08" E 19° 11' 04.96"</p>	<p>This waypoint is at the signboard to Onrusrivier and Onrusrivier North. <i>Thamnochortus insignis</i> occurs in a mature linear stand along the edge of the mowed road verge. The vegetation between the fence and the row of <i>T. insignis</i> is dominated by <i>Helichrysum</i> sp. Other species include, <i>Anthospermum aethiopicum</i>, <i>Berzelia lanuginosa</i>, <i>Leonotus leonurus</i>, <i>Passerina corymbosa</i> and a handful of sedge species (unidentified).</p>

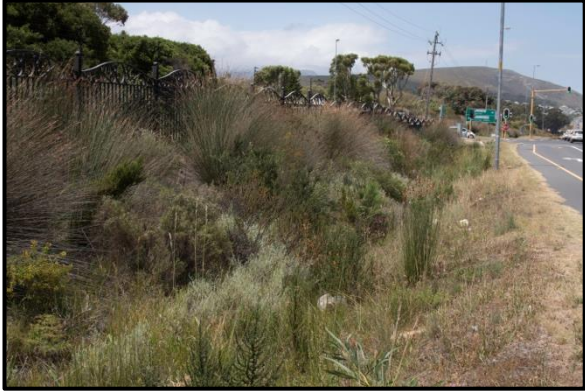
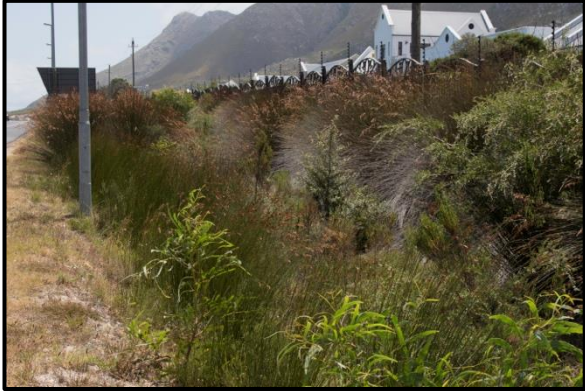
<p>VOD0011 S 34° 24' 32.05" E 19° 11' 11.53"</p>	<p>This location is near Chanteclair Avenue intersection. The vegetation consists of the same community with abundant <i>Thamnochortus insignis</i>. Invasive <i>Leptospermum laevigatum</i>* is common and <i>Acacia saligna</i>* is present. This area has a drainage ditch to a culvert at the intersection and <i>Cliffortia juniperifolia</i>, <i>Hypericum revolutum</i>* and <i>Stenotaphrum secundatum</i> (buffalo grass). <i>Erica</i></p>

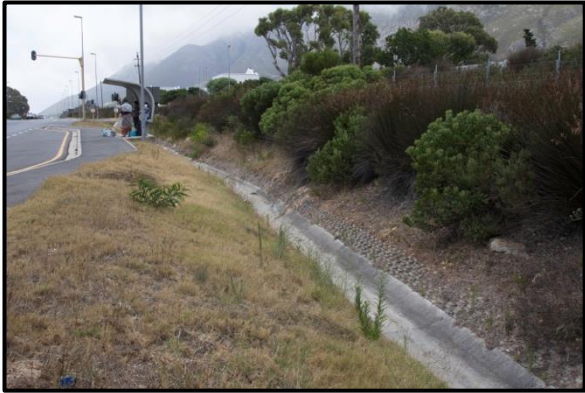
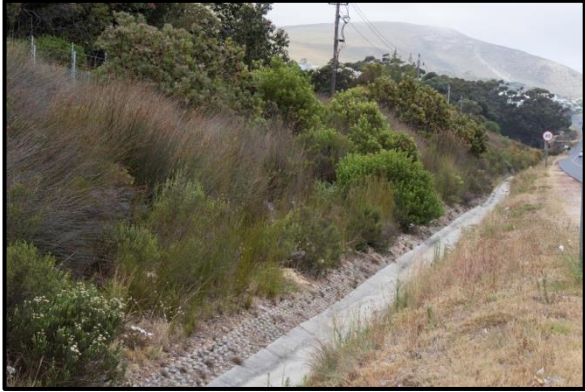
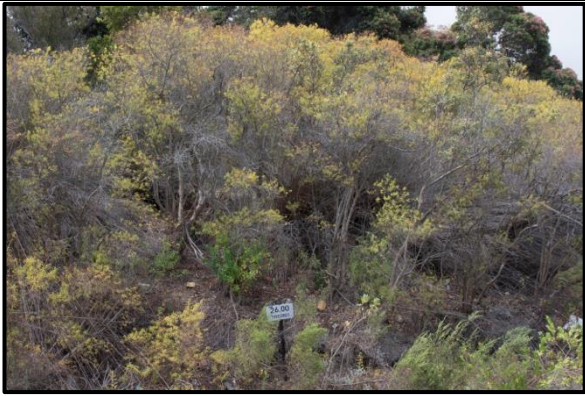
<p>VOD0012 S 34° 24' 33.99" E 19° 11' 19.99"</p>	<p>This waypoint was recorded outside Kidbrooke Place. Alongside the tarmac is a highly disturbed verge and then a concrete drainage ditch. On the estate side of the ditch is a moderately steep embankment with secondary fynbos vegetation.</p> <p>In the road reserve <i>Thamnochortus insignis</i> is dominant. The fynbos is very dense but with low sensitivity. Other species include <i>Acacia saligna</i>*, <i>Cliffortia juniperifolia</i>, <i>Gnidia squarrosa</i>, <i>Hypericum revolutum</i>*, <i>Lagurus ovatus</i>*, <i>Metalasia densa</i>, <i>Osteospermum moniliferum</i>, <i>Passerina corymbosa</i>, <i>Protea neriifolia</i>, <i>Protea repens</i> and <i>Struthiola</i> sp.</p> <p><i>Eucalyptus ficifolia</i>, <i>Pinus radiata</i> and <i>Leucadendron xanthoconus</i> form a dense stand on the private property adjacent to this waypoint.</p> <p>At the 26.0 km marker is a dense, mature stand of <i>Hypericum revolutum</i>*. This species is invasive and must be removed.</p>

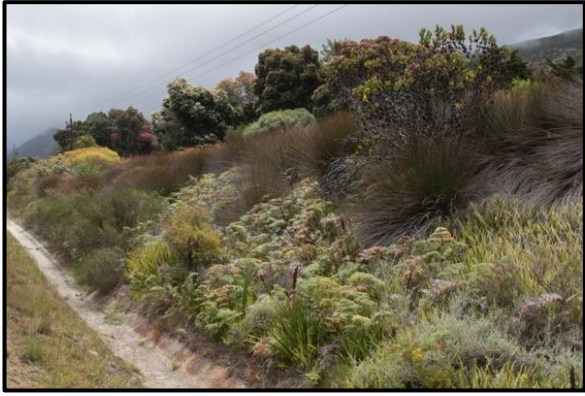
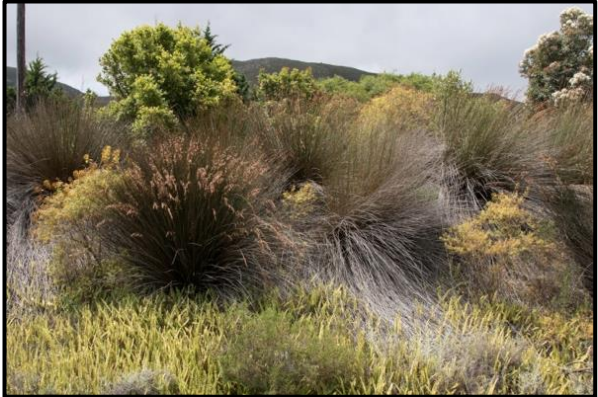
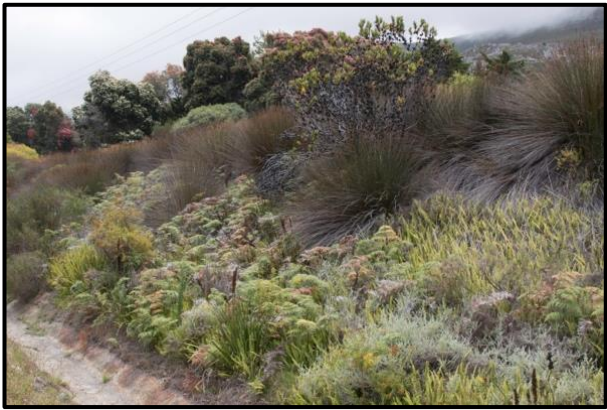
<p>VOD0013 S 34° 24' 34.87" E 19° 11' 25.03"</p>	<p>A patch of invasive <i>Nephrolepis cordifolia</i> subsp. <i>cordifolia</i>* is found on the embankment at this location.</p> <p><i>Thamnochortus insignis</i> forms a dense stand on the upper part of the slope along the fence. In addition, another stand of invasive <i>Hypericum revolutum</i> is located here and should be removed.</p> <p>Other species recorded here include <i>Aristea capitata</i>, <i>Helichrysum</i> sp., <i>Hypericum revolutum</i>*, <i>Kiggelaria africana</i>, <i>Leptospermum laevigatum</i>*, <i>Metrosideros excelsa</i>* (New Zealand Christmas Tree – invasive!), <i>Nephrolepis cordifolia</i>* and <i>Passerina corymbosa</i>.</p>

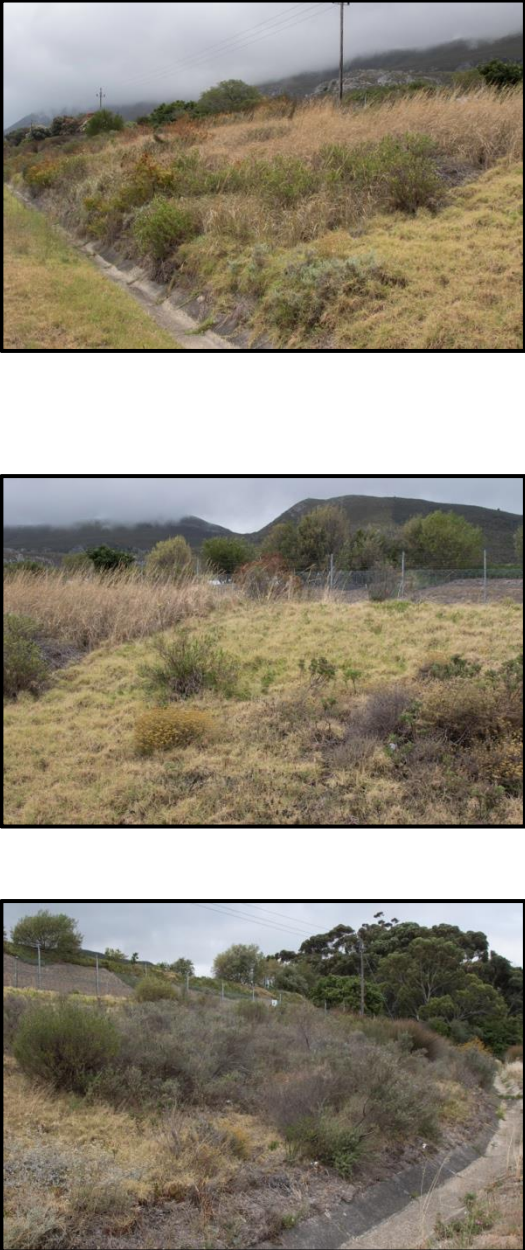
<p>VOD0014 S 34° 24' 36.31" E 19° 11' 31.28"</p>	<p>This waypoint is outside Kidbrooke Place. The embankment above the concrete drain has a stand of <i>Pennisetum macrourum</i> (riverbed grass) with <i>Conyza scabrida</i> and <i>Hypericum revolutum</i>*. Immediately adjacent is a dense stand of Kikuyu grass (<i>Pennisetum clandestinum</i>) with <i>Pelargonium cucullatum</i>, <i>Helichrysum cymosum</i>, <i>Helichrysum pandurifolium</i>, <i>Conyza scabrida</i> and <i>Carpobrotus edulis</i> amongst the Kikuyu grass.</p> <p>A stand of fynbos dominated by <i>Salvia africana-caerulea</i> is also found here.</p> <p>Towards the Onrus River bridge are small stands of <i>Thamnochortus insignis</i> interspersed with invasive Kikuyu grass. <i>Pelargonium cucullatum</i> and <i>Lagurus ovatus</i> occur in the vegetation matrix.</p>

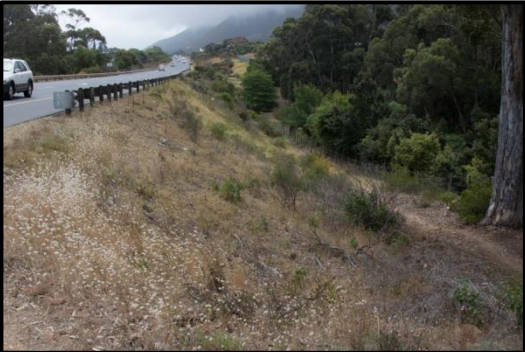
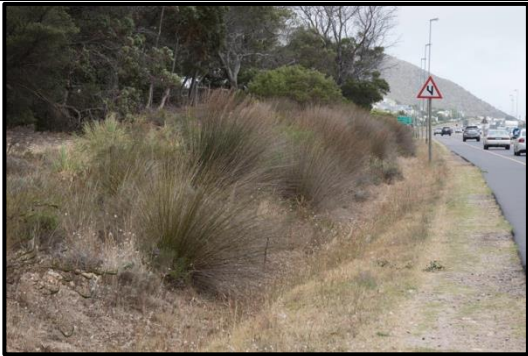
<p>VOD0015 S 34° 24' 38.78" E 19° 11' 41.94"</p>	<p>The east side of the Onrus River bridge is highly disturbed and invaded by alien invasive plants. From the bridge eastwards, the embankment is vegetated with dense <i>Thamnochortus insignis</i> with the same companion species as mentioned above but with invasive <i>Cortaderia selloana</i> (Pampas grass) present.</p>

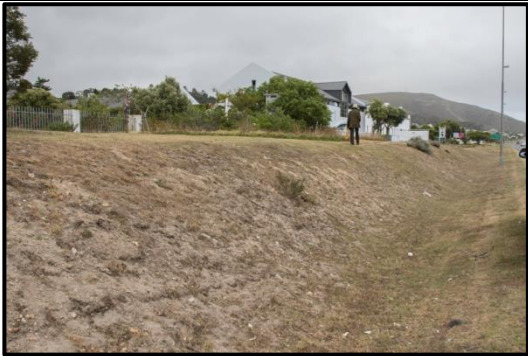
<p>VOD0016 S 34° 24' 40.37" E 19° 11' 48.20"</p>	<p>This waypoint is east of the Onrus River at the point from which there is no more natural or semi-natural vegetation as far as the intersection.</p>

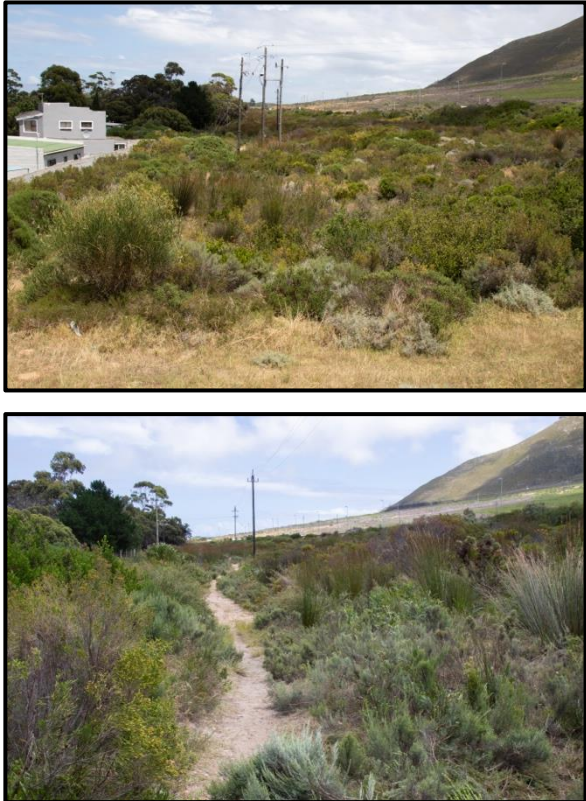
Waypoints	Descriptive Notes	Illustrations
<p>ONR1 S 34° 25' 33.87" E 19° 19' 11.9"</p>	<p>Only a single representative waypoint was recorded along the proposed Amana Road route. The vegetation is well-developed, dense, mid-high to tall fynbos shrubland on brown sandy soil. A footpath runs along the proposed route and there are traces of a previously tarred road. Below is a composite but not exhaustive list of the plant species recorded along the designated route.</p> <p><i>Acacia saligna*</i>, <i>Agapanthus africanus</i>, <i>Anthospermum aethiopicum</i>, <i>Aspalathus</i> sp. (no flowers), <i>Athanasia crithmifolia</i>, <i>Athanasia trifurcata</i>, <i>Avena fatua*</i>, <i>Berzelia lanuginosa</i>, <i>Briza minor*</i>, <i>Carpobrotus edulis</i>, <i>Cassytha ciliolata</i>, <i>Cliffortia juniperifolia</i>, <i>Cliffortia ruscifolia</i>, <i>Ehrharta</i> sp., <i>Elegia tectorum</i>, <i>Elytropappus rhinocerotis</i>, <i>Erepsia</i> sp., <i>Erica</i> sp. (no flowers), <i>Euryops virgineus</i>, <i>Gnidia juniperifolia</i>, <i>Helichrysum pandurifolium</i>, <i>Helichrysum cymosum</i>, <i>Hyparrhenia hirta</i>, <i>Lagurus ovatus*</i>, <i>Leonotus</i></p>

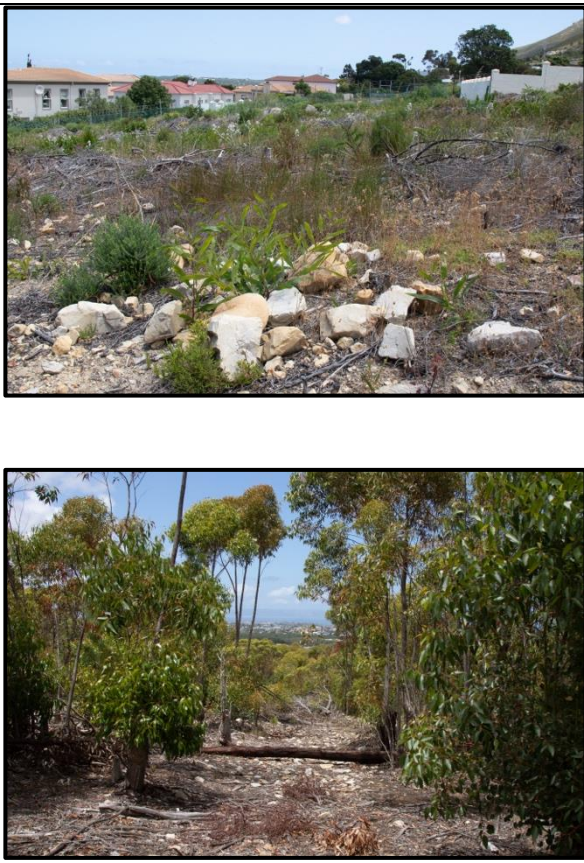
Waypoints	Notes	Illustrations
<p>ONR2 S34° 24' 18.15" E19° 10' 23.76"</p>	<p>The proposed link road between Berghof (Lobelia Street) and Kidbrooke Place (Chanteclair Avenue) would be aligned through the former landfill site. Immediately adjacent to Berghof, there is remnant fynbos that has been heavily degraded by trees having grown there and subsequently being felled. The physical effects of the invasive trees as well as the removal of the trees has resulted in vegetation with poor condition.</p> <p>Further east, the area is completely transformed and mostly vegetated with exotic <i>Eucalyptus cladocalyx</i> (sugar gum) and <i>Eucalyptus conferuminata</i> (spider gum) as well as other invasive plant species such as <i>Pinus halepensis</i> (Aleppo Pine), <i>Hakea drupacea</i> (sweet-scented hakea) and <i>Acacia</i> spp.</p> <p>Owing to its generally transformed state the terrain of the proposed link road route has very low botanical sensitivity.</p>

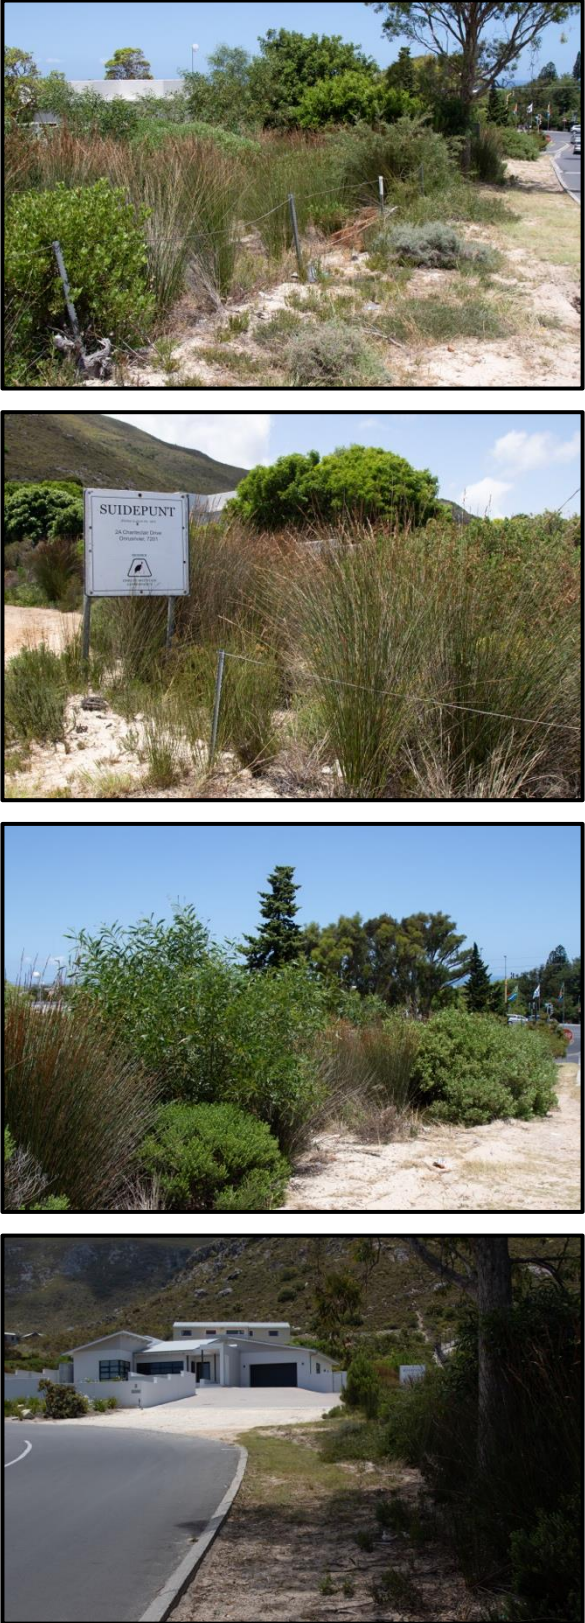
Waypoints	Notes	Illustrations
<p>ONR3 S34° 24' 18.15" E19° 10' 23.76"</p>	<p>This waypoint was recorded on Chanteclair Avenue where the new entrance to Kidbrooke Place is proposed. The vegetation is disturbed Hangklip Sand Fynbos on white sandy soil. Species recorded in the road reserve alongside Kidbrooke Place include <i>Acacia longifolia</i>*, <i>Acacia saligna</i>*, <i>Carpobrotus edulis</i>, <i>Ceratonia siliqua (carob)</i>*, <i>Cliffortia juniperifolia</i>, <i>Eucalyptus sp.</i>*, <i>Lampranthus aureus</i>, <i>Leptospermum laevigatum</i>*, <i>Metalasia densa</i>, <i>Osteospermum moniliferum</i>, <i>Pinus halepensis</i>*, <i>Stoebe plumosa</i> and <i>Thamnochortus insignis</i>.</p>
