# MITIGATION PLAN

## DEEP MEADOW MITIGATION PLAN

Union County, NC  
NCDEQ Contract No. 6887  
DMS ID No. 97131

Yadkin River Basin  
HUC 03040105

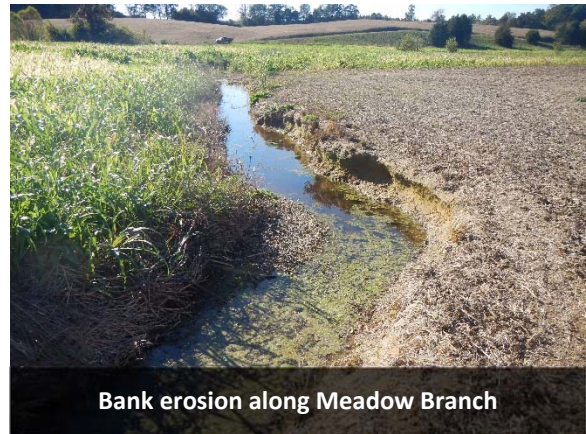
**Bank erosion along Meadow Branch**

Meadow Branch originates approximately 2.6 miles upstream of the Site near the Wingate University campus. In the section upstream of the existing ford crossing, the stream runs along the left valley wall and is influenced by several beaver dams, debris jams, and depositional bars. The channel makes a couple of meanders turns before reaching the ford crossing. The left bank just upstream of the ford crossing is up against the valley wall and is actively eroding in several locations. The valley slope upstream of the ford crossing is approximately 0.35%. Immediately downstream of the ford crossing, the channel width drastically narrows from an average of 20 ft to an

average of 9 ft. The right bank is nearly vertical and approximately 2.5 ft high. The left bank is lower and flatter and ties into a floodplain bench where several parallel ditches have formed in the left floodplain. These ditches can be attributed to more frequent inundation of the floodplain due to the smaller channel cross sectional area in this section. Approximately 350 ft downstream of the ford crossing, the channel widens back out to an average width of 28 ft. From this point to the downstream limits, the channel is dominated by long, sluggish pools formed by several debris jams. The valley downstream of the ford crossing is wide and flat with an average slope of 0.14%. Bed material is primarily coarse sand and fine gravel based on visual assessment. Vegetation along Meadow Branch consists of a single row of sporadic successional green ash boxelder, silky dogwood, and black elderberry, with the addition of a few older hardwoods on the right floodplain upstream of the ford crossing. Buffer vegetation and channel pattern has been kept to a minimum due to adjacent row crop operations.

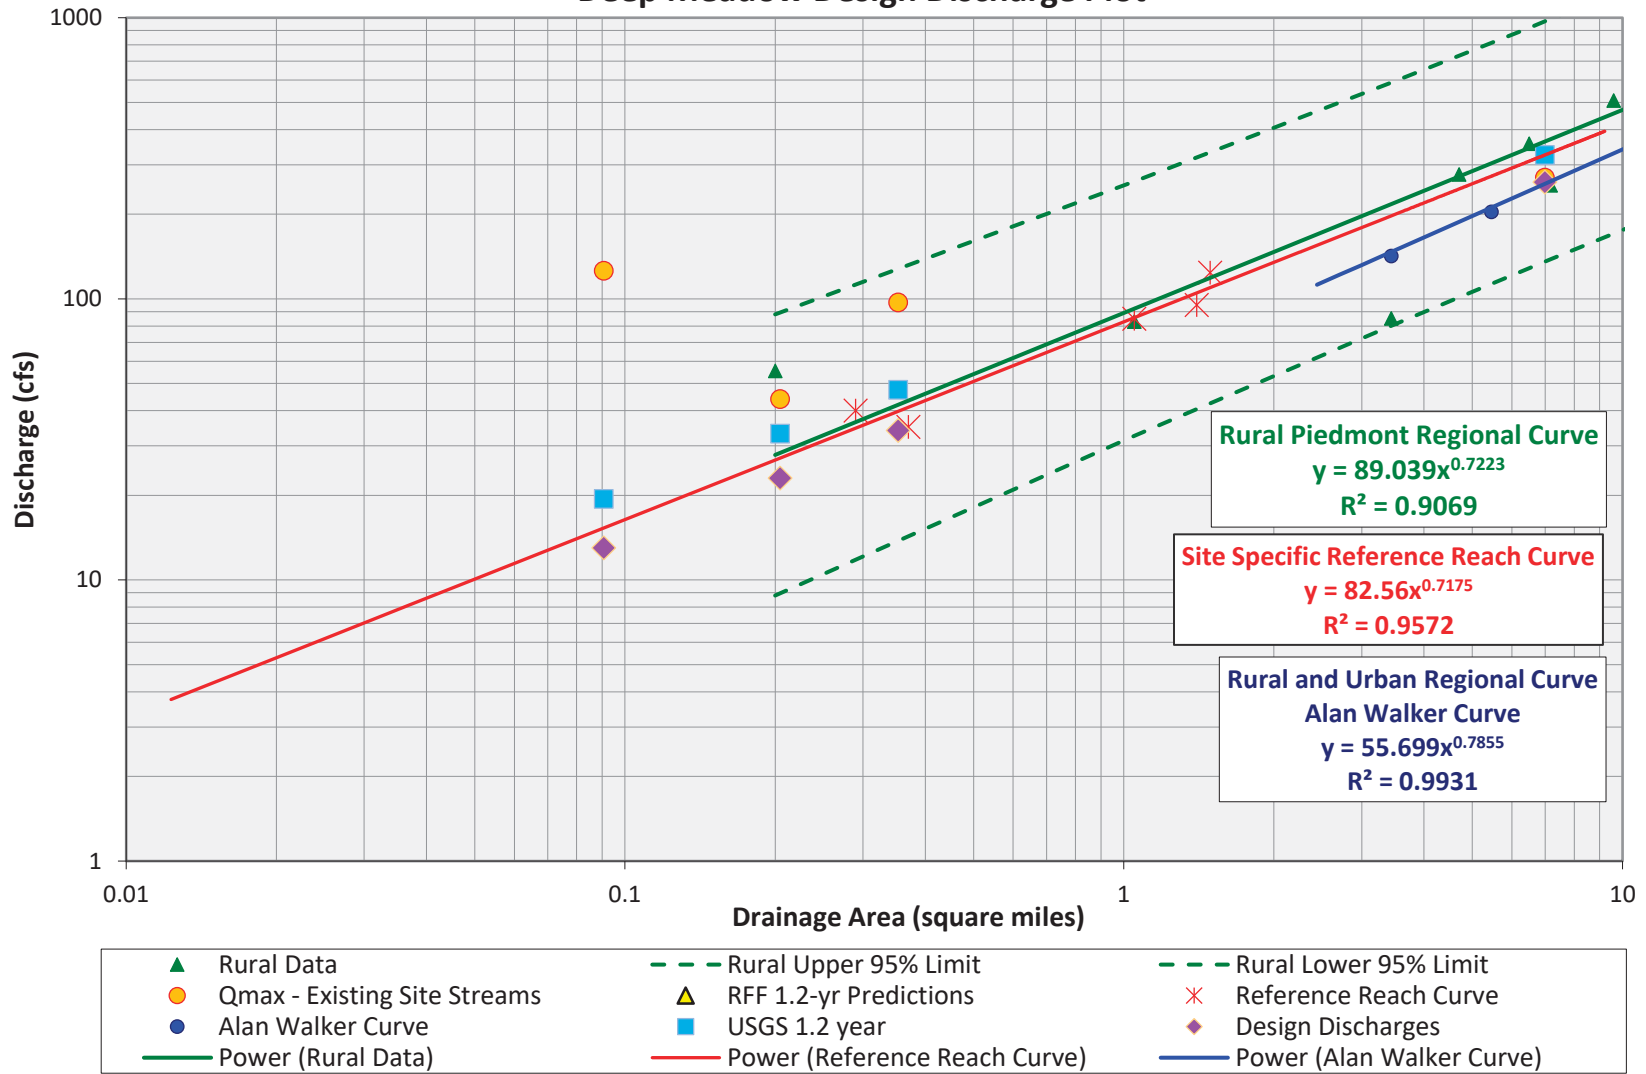
Figure 10 Discharge Analysis  
 Deep Meadow Mitigation Site  
 Yadkin River Basin (03040105)

### Deep Meadow Design Discharge Plot

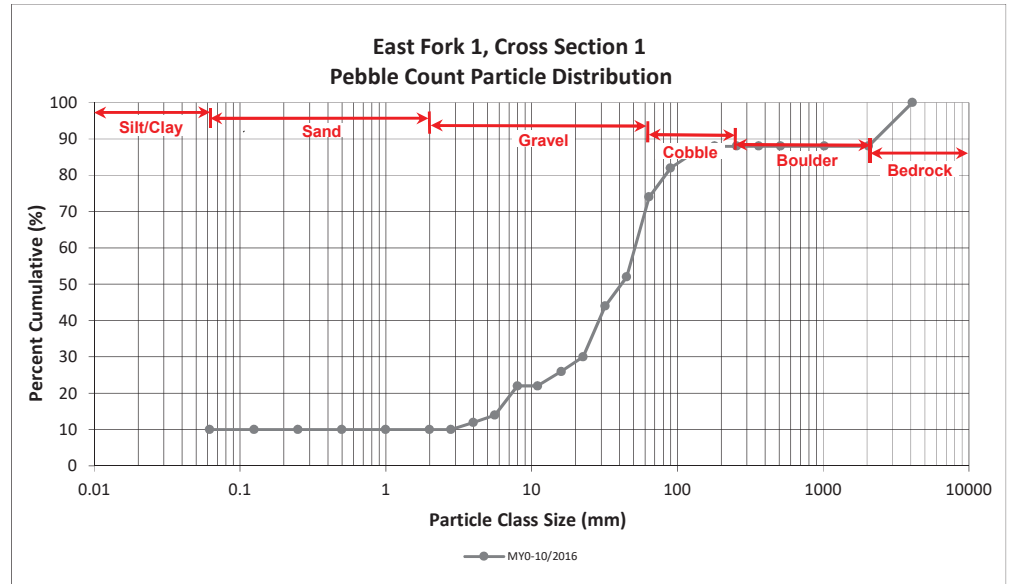
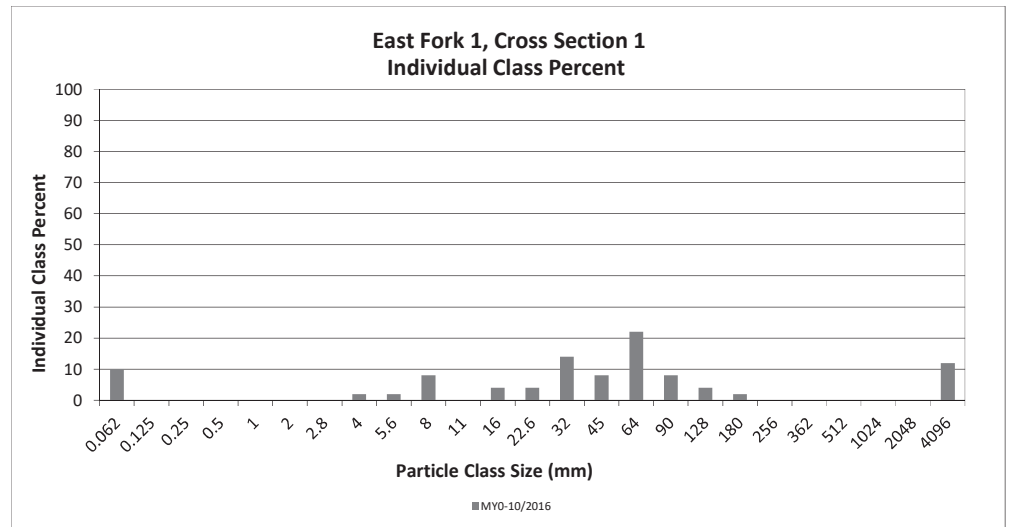
**Reachwide and Cross Section Pebble Count Plots**

Particle Class		Diameter (mm)		Riffle 100-Count	Summary	
		min	max		Class Percentage	Percent Cumulative
<i>SILT/CLAY</i>	Silt/Clay	0.000	0.062	5	10	10
<i>SAND</i>	Very fine	0.062	0.125			10
	Fine	0.125	0.250			10
	Medium	0.25	0.50			10
	Coarse	0.5	1.0			10
	Very Coarse	1.0	2.0			10
<i>GRAVEL</i>	Very Fine	2.0	2.8			10
	Very Fine	2.8	4.0	1	2	12
	Fine	4.0	5.6	1	2	14
	Fine	5.6	8.0	4	8	22
	Medium	8.0	11.0			22
	Medium	11.0	16.0	2	4	26
	Coarse	16.0	22.6	2	4	30
	Coarse	22.6	32	7	14	44
	Very Coarse	32	45	4	8	52
	Very Coarse	45	64	11	22	74
<i>COBBLE</i>	Small	64	90	4	8	82
	Small	90	128	2	4	86
	Large	128	180	1	2	88
	Large	180	256			88
<i>BOULDER</i>	Small	256	362			88
	Small	362	512			88
	Medium	512	1024			88
	Large/Very Large	1024	2048			88
<i>BEDROCK</i>	Bedrock	2048	>2048	6	12	100
		<b>Total</b>		<b>50</b>	<b>100</b>	<b>100</b>

Cross Section 1	
Channel materials (mm)	
D <sub>16</sub> =	6.12
D <sub>35</sub> =	25.59
D <sub>50</sub> =	41.3
D <sub>84</sub> =	107.3
D <sub>95</sub> =	3068.5
D <sub>100</sub> =	>2048

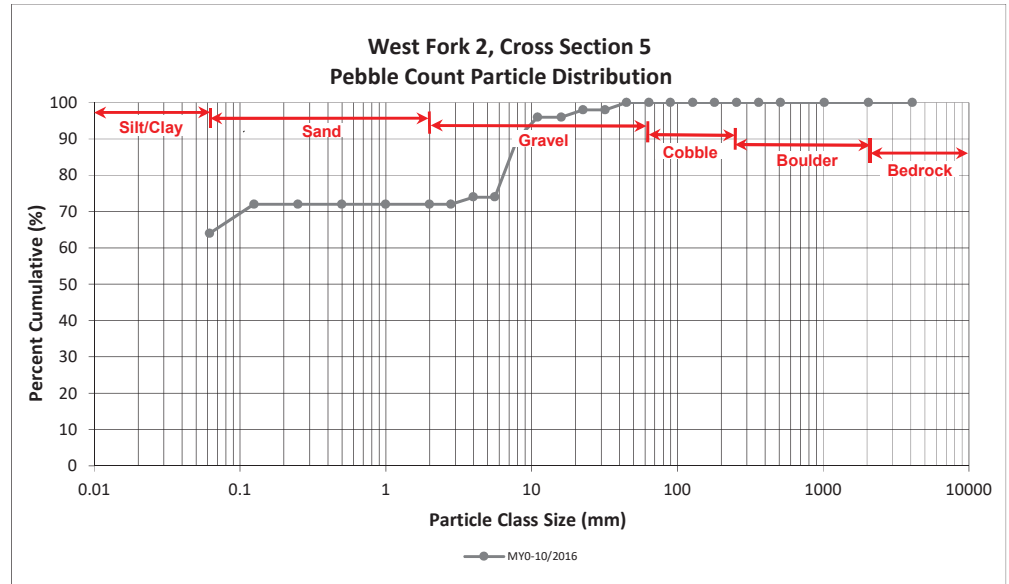
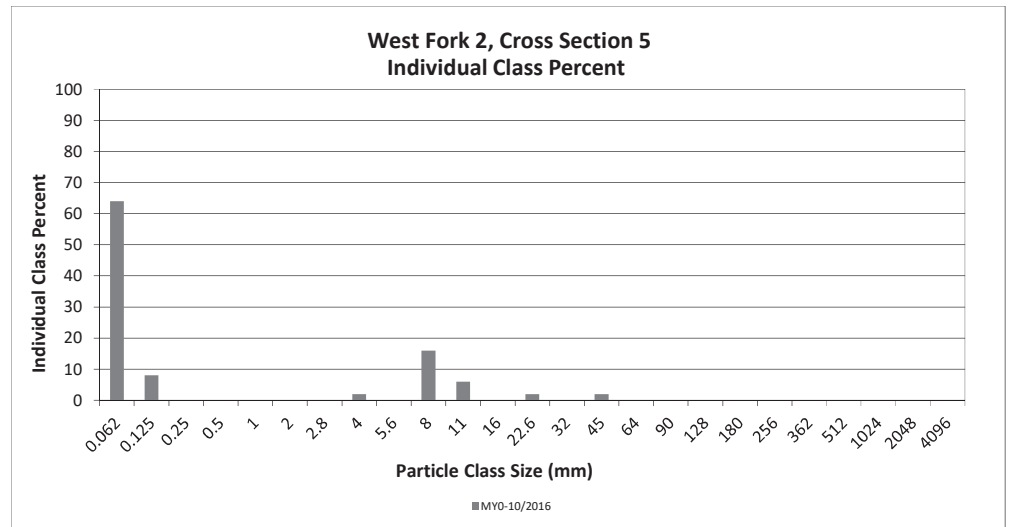
**Reachwide and Cross Section Pebble Count Plots**

Particle Class		Diameter (mm)		Riffle 100-Count	Summary	
		min	max		Class Percentage	Percent Cumulative
<i>SILT/CLAY</i>	Silt/Clay	0.000	0.062	32	64	64
<i>SAND</i>	Very fine	0.062	0.125	4	8	72
	Fine	0.125	0.250			72
	Medium	0.25	0.50			72
	Coarse	0.5	1.0			72
	Very Coarse	1.0	2.0			72
<i>GRAVEL</i>	Very Fine	2.0	2.8			72
	Very Fine	2.8	4.0	1	2	74
	Fine	4.0	5.6			74
	Fine	5.6	8.0	8	16	90
	Medium	8.0	11.0	3	6	96
	Medium	11.0	16.0			96
	Coarse	16.0	22.6	1	2	98
	Coarse	22.6	32			98
	Very Coarse	32	45	1	2	100
	Very Coarse	45	64			100
<i>COBBLE</i>	Small	64	90			100
	Small	90	128			100
	Large	128	180			100
	Large	180	256			100
<i>BOULDER</i>	Small	256	362			100
	Small	362	512			100
	Medium	512	1024			100
	Large/Very Large	1024	2048			100
<i>BEDROCK</i>	Bedrock	2048	>2048			100
<b>Total</b>				<b>50</b>	<b>100</b>	<b>100</b>

Cross Section 5 Channel materials (mm)	
D <sub>16</sub> =	Silt/Clay
D <sub>35</sub> =	Silt/Clay
D <sub>50</sub> =	Silt/Clay
D <sub>84</sub> =	7.0
D <sub>95</sub> =	10.4
D <sub>100</sub> =	45.0

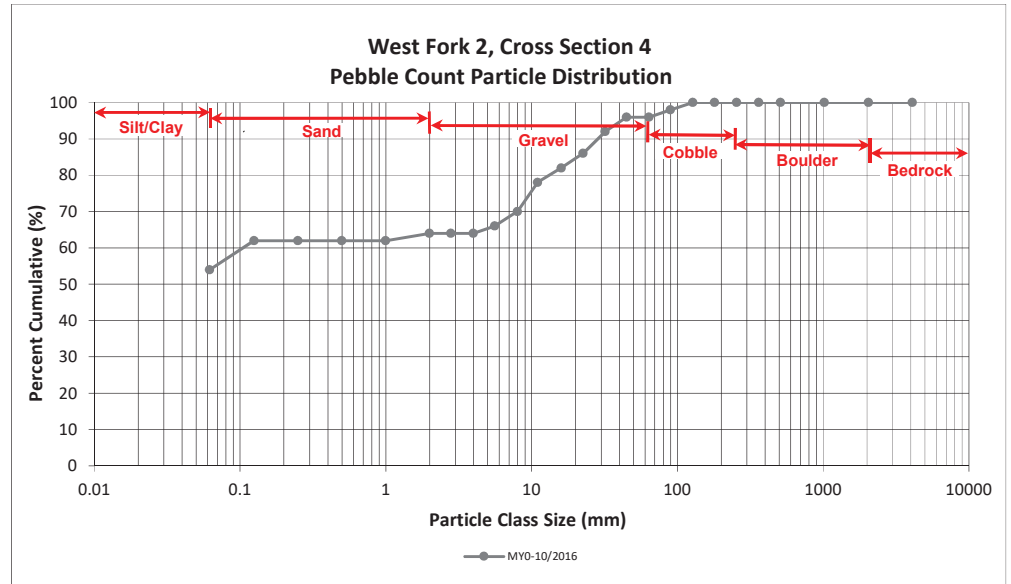
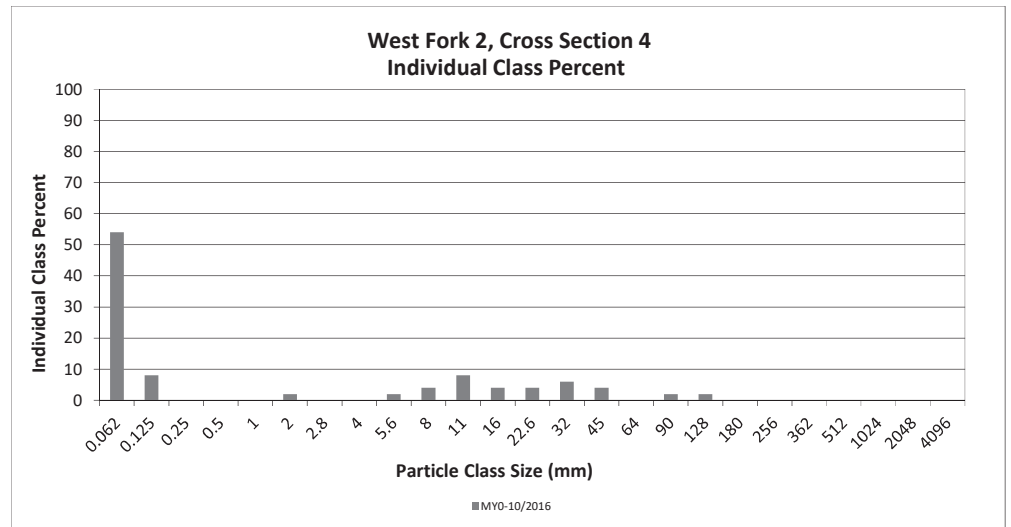
**Reachwide and Cross Section Pebble Count Plots**

Particle Class		Diameter (mm)		Riffle 100-Count	Summary	
		min	max		Class Percentage	Percent Cumulative
<i>SILT/CLAY</i>	Silt/Clay	0.000	0.062	27	54	54
<i>SAND</i>	Very fine	0.062	0.125	4	8	62
	Fine	0.125	0.250			62
	Medium	0.25	0.50			62
	Coarse	0.5	1.0			62
	Very Coarse	1.0	2.0	1	2	64
<i>GRAVEL</i>	Very Fine	2.0	2.8			64
	Very Fine	2.8	4.0			64
	Fine	4.0	5.6	1	2	66
	Fine	5.6	8.0	2	4	70
	Medium	8.0	11.0	4	8	78
	Medium	11.0	16.0	2	4	82
	Coarse	16.0	22.6	2	4	86
	Coarse	22.6	32	3	6	92
	Very Coarse	32	45	2	4	96
	Very Coarse	45	64			96
<i>COBBLE</i>	Small	64	90	1	2	98
	Small	90	128	1	2	100
	Large	128	180			100
	Large	180	256			100
<i>BOULDER</i>	Small	256	362			100
	Small	362	512			100
	Medium	512	1024			100
	Large/Very Large	1024	2048			100
<i>BEDROCK</i>	Bedrock	2048	>2048			100
		<b>Total</b>		<b>50</b>	<b>100</b>	<b>100</b>

Cross Section 4 Channel materials (mm)	
D <sub>16</sub> =	Silt/Clay
D <sub>35</sub> =	Silt/Clay
D <sub>50</sub> =	Silt/Clay
D <sub>84</sub> =	19.0
D <sub>95</sub> =	41.3
D <sub>100</sub> =	128.0

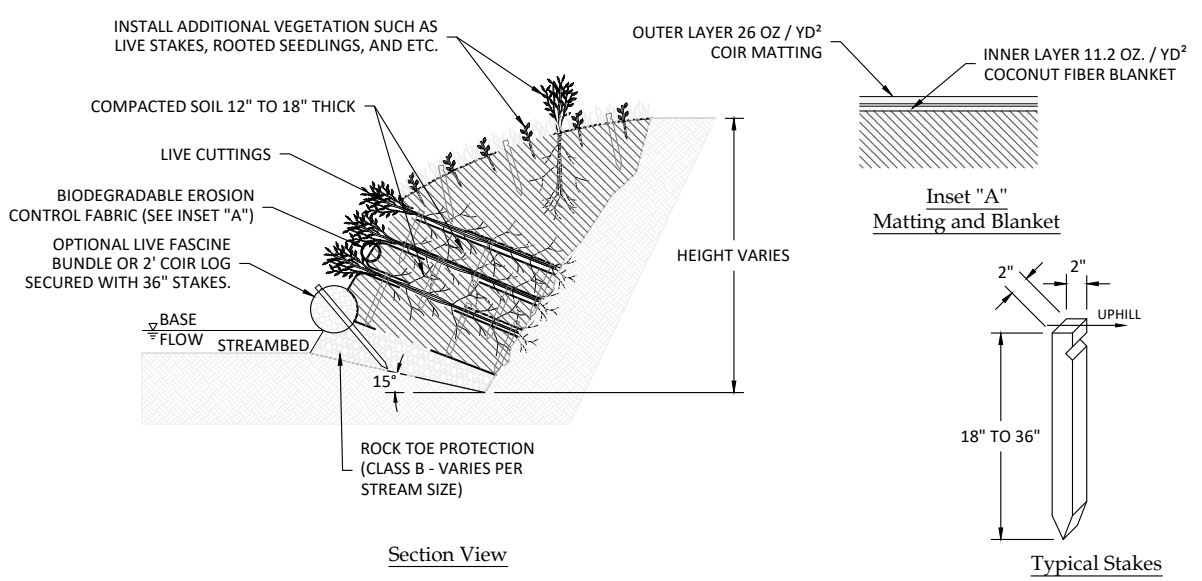
- NOTES:**
1. ROOTED/LEAFED CONDITION OF THE LIVING PLANT MATERIAL IS NOT REPRESENTATIVE OF THE TIME OF INSTALLATION.
  2. BOTTOM OF FIRST COMPACTED EARTH LIFT TO BE PLACED 6" ABOVE NORMAL BASEFLOW.
  3. NUMBER OF COMPACTED EARTH LIFTS TO VARY DEPENDING ON DESIGN TOP OF BANK HEIGHT.
- 3 Vegetated Soil Lift**  
6.5 Not to Scale

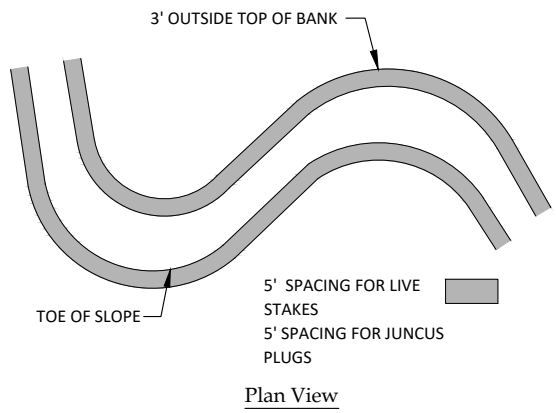
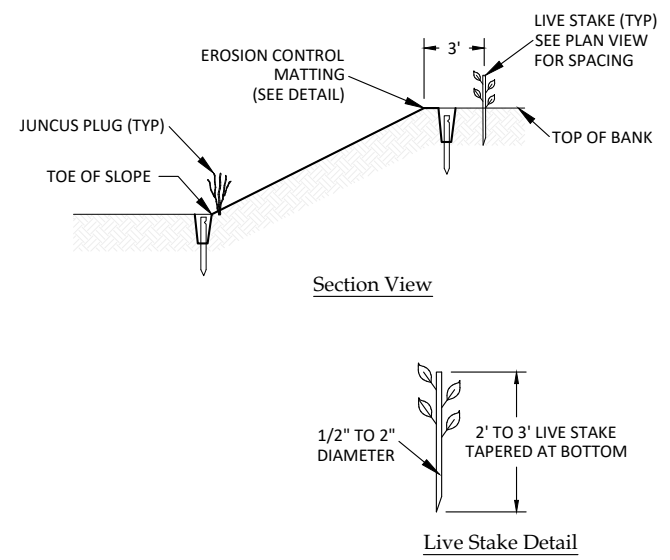
**4 Live Staking & Juncus Plugs**  
6.5 Not to Scale

- NOTES:**
- 1. LIVE STAKES TO BE PLANTED IN AREAS AS SHOWN ON PLANS AND DIRECTED BY THE ENGINEER.
