SOUTH BOCA RATON: ARTIFICIAL REEF RELIEF AND SAND MIGRATION CONUNDRUM

Erin A. Hague and Robert M. Baron
Marine Biologists, Coastal Planning and Engineering, Inc.
2481 NW Boca Raton Boulevard, Boca Raton, FL 33431
Phone: 561/391-8102 FAX: 561/391-9116
ehague@coastalplanning.net
rbaron@coastalplanning.net

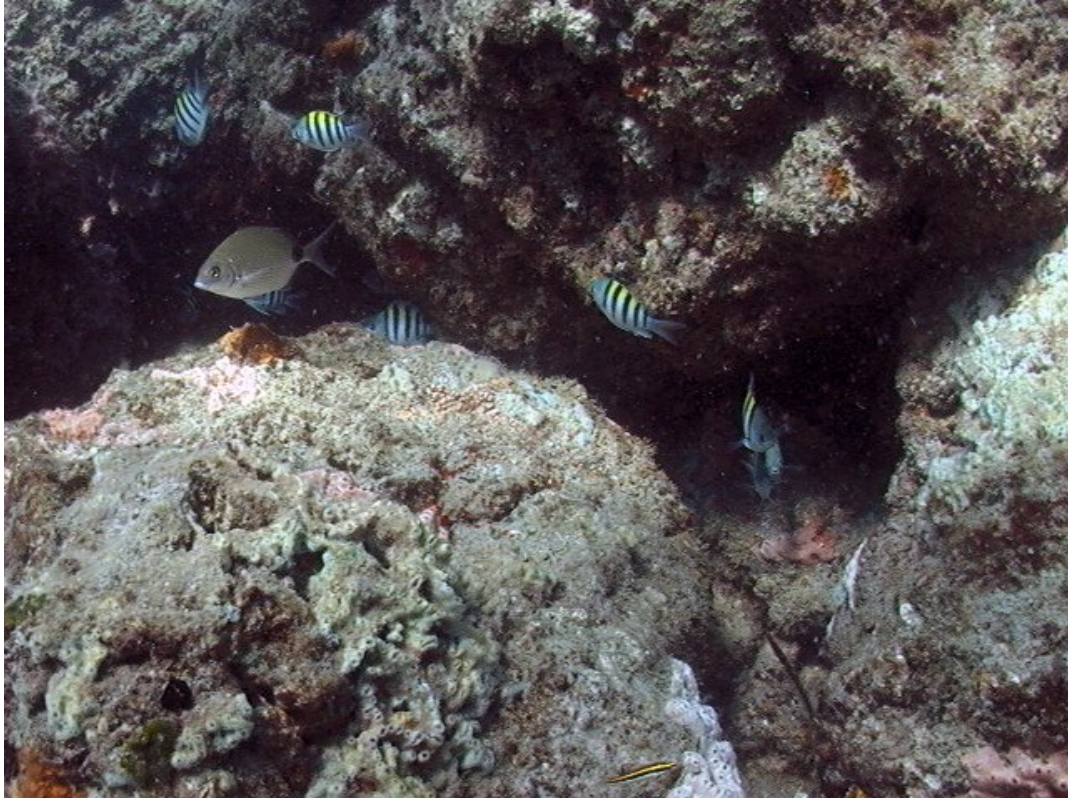
Photo 1. Sargent Majors (*Abudefduf saxatilis*) and Spottail Pinfish (*Diplodus holbrooki*) finding viable habitat and resources on the south mitigation reef.

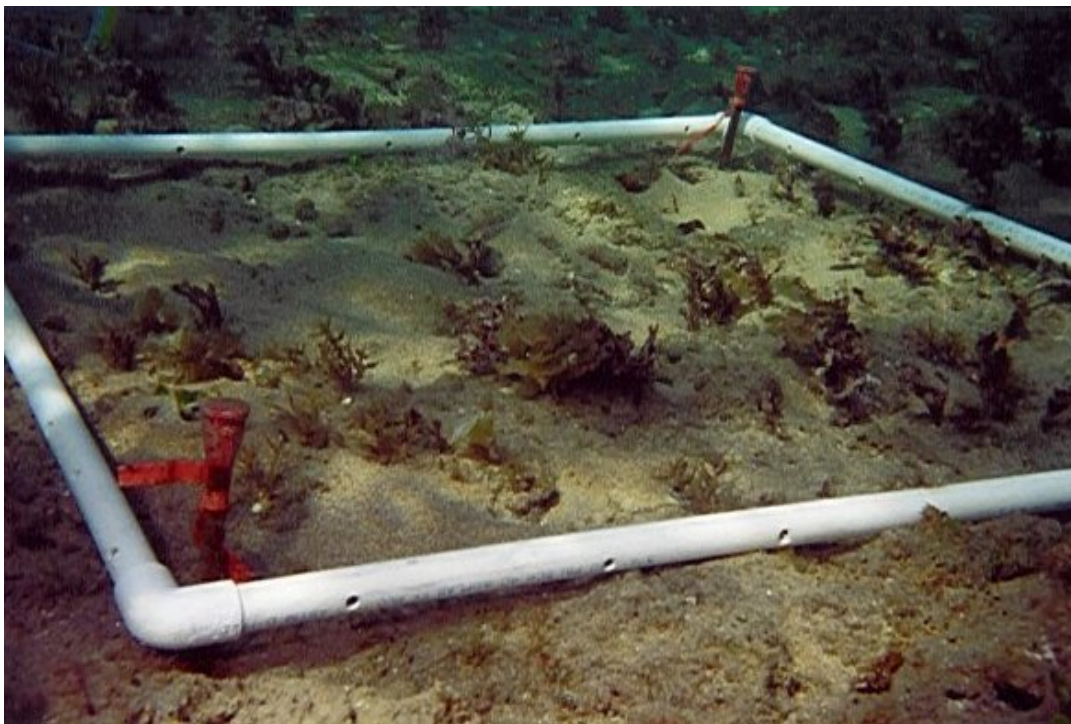
Photo 2. Low relief, nearshore hardbottom habitat (Station 5) dominated by Phaeophyta (brown algae) cover.

The biotic response to the uncovering of the exposed hardbottom was best observed at Compliance Stations 3 and 5. During the two-year monitoring event, Compliance Station 3 reported the entire transect and central monitoring station buried under 15-24 cm of sediment. The three-year post-construction monitoring event reported a 46-79% sediment cover at each of the sample stations along the shore parallel and shore perpendicular transects. Macroalgae cover dominated the center monitoring station with up to 46% cover.
