# NEW CAR ASSESSMENT PROGRAM CRASH IMMINENT BRAKING SYSTEM CONFIRMATION TEST NCAP-DRI-CIB-21-18

2021 Volkswagen ID.4 Pro S (Statement)

## DYNAMIC RESEARCH, INC.

## **Final Report**

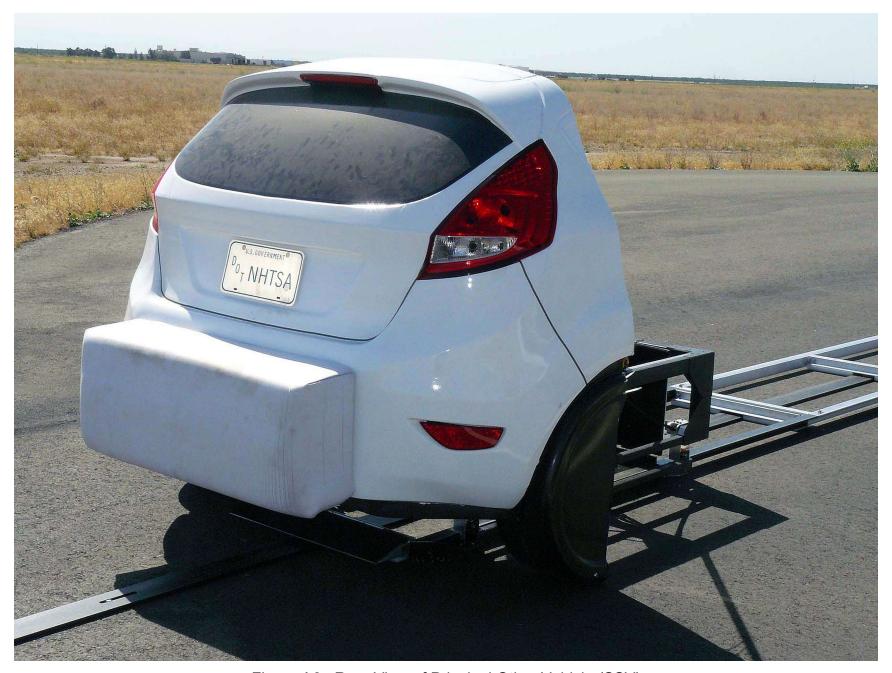
Figure A6. Rear View of Principal Other Vehicle (SSV)

CIB testing requires a POV that realistically represents typical vehicles, does not suffer damage or cause damage to a test vehicle in the event of collision, and can be accurately positioned and moved during the tests. The tests reported herein made use of the NHTSA developed Strikeable Surrogate Vehicle (SSV).

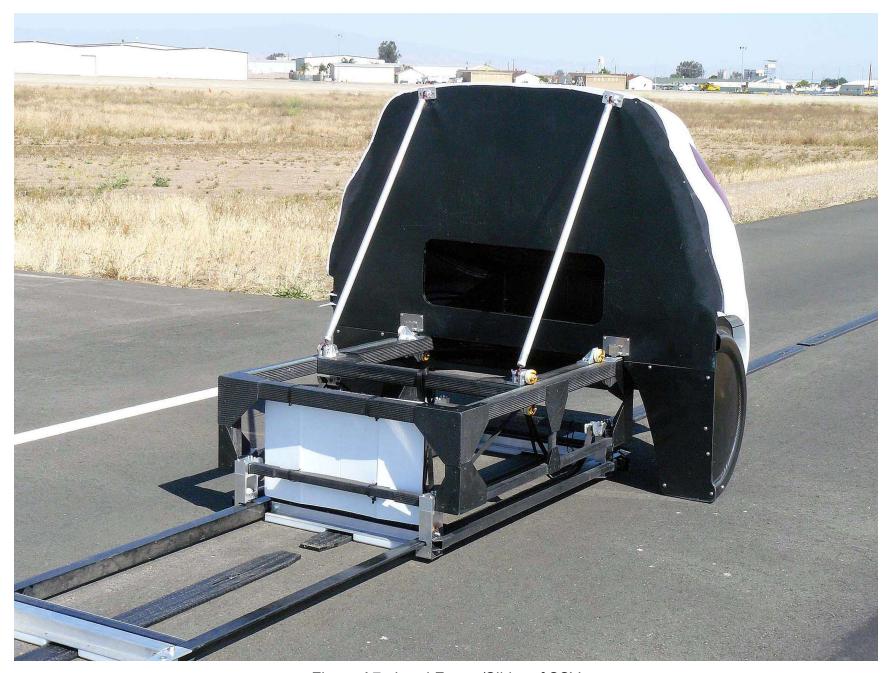
Figure A7. Load Frame/Slider of SSV

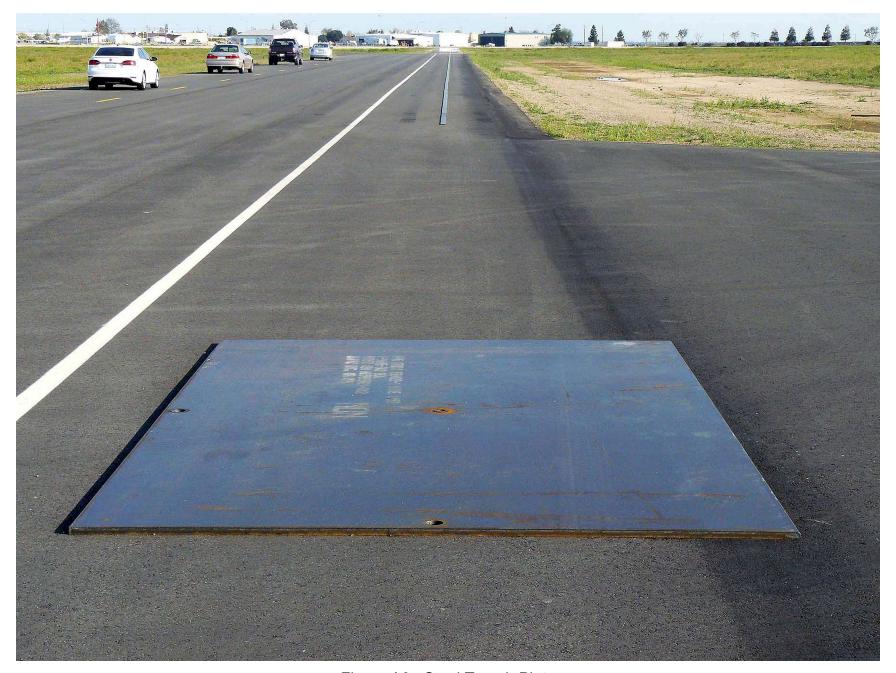
Figure A9. Steel Trench Plate

The false positive suppression test series evaluates the ability of a CIB system to differentiate a steel trench plate (STP) from an object presenting a genuine safety risk to the SV. Although the STP is large and metallic, it is designed to be driven over without risk of injury to the driver or damage to the SV. Therefore, in this scenario, the automatic braking available from CIB is not necessary and should be suppressed. The test condition is nearly equivalent to that previously defined for Test 1, the stopped POV condition, but with an STP in the SV forward path in lieu of a POV.

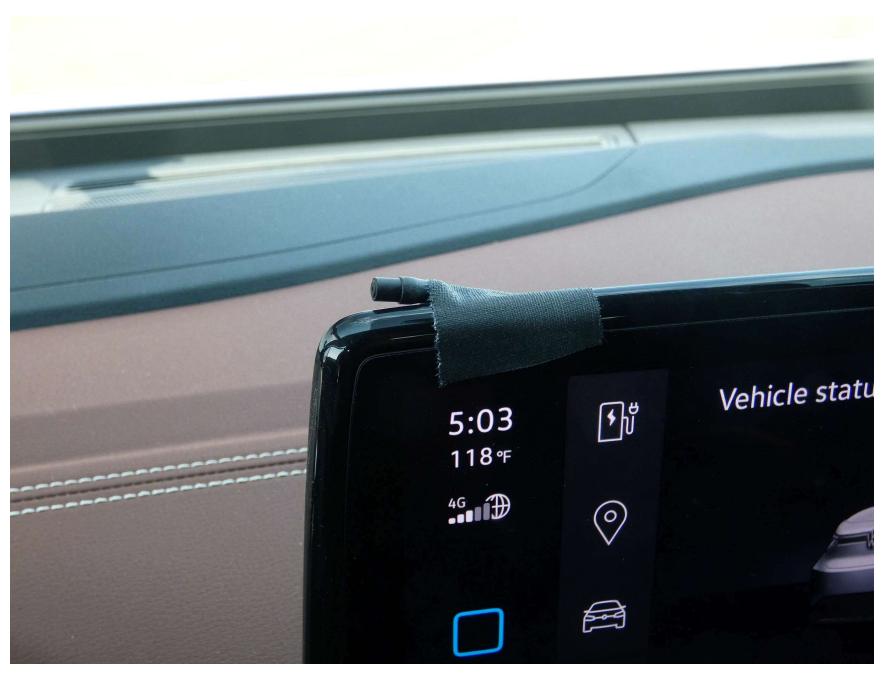
Figure A11. Sensor for Detecting Auditory Alert

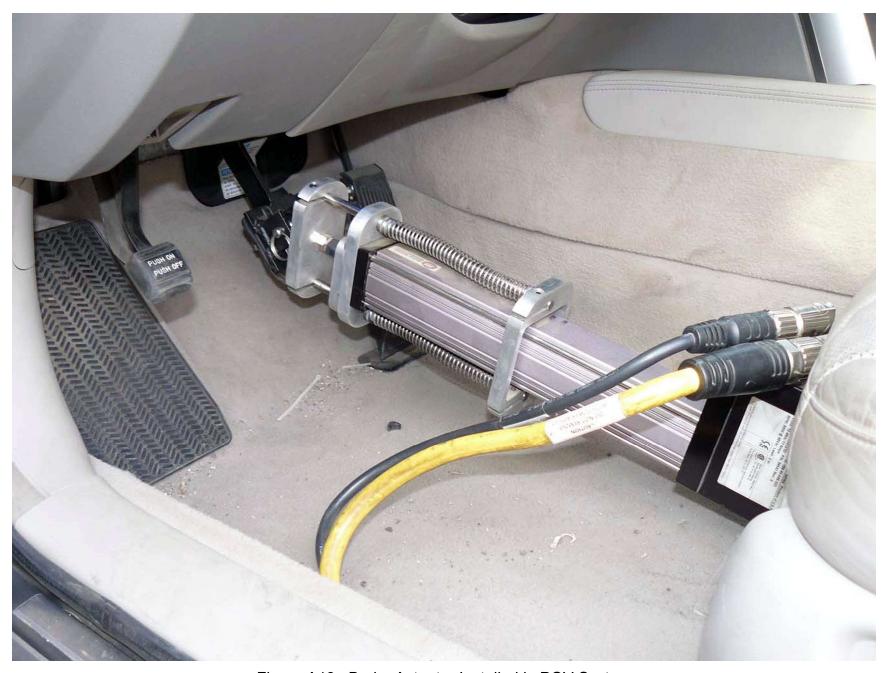
Figure A13. Brake Actuator Installed in POV System

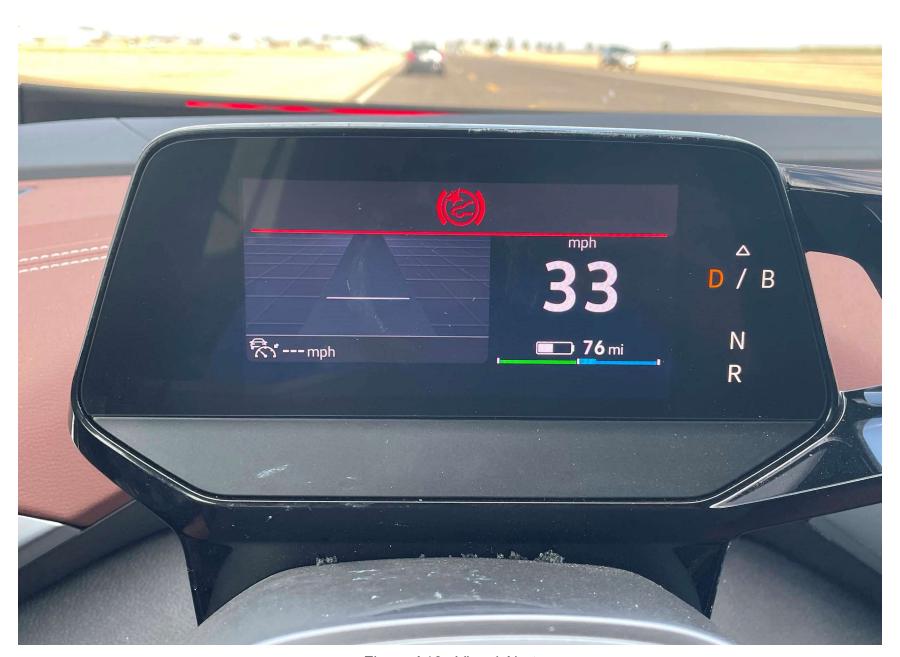
Figure A16. Visual Alert

The system detects a possible collision and prepares the vehicle for possible emergency braking. An auditory warning sounds and the red warning lamp lights up. See Appendix A. Figure A16.

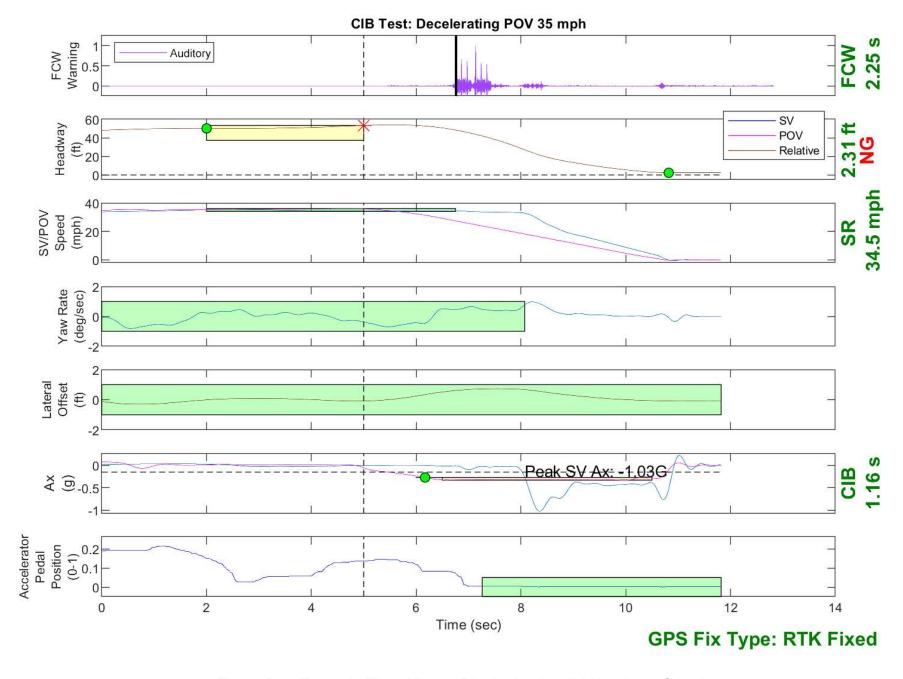
Figure D7. Example Time History Displaying Invalid Headway Criteria

Examples of time history plots for each test type (including passing, failing and invalid runs) are shown in Figure D1 through Figure D9. Figures D1 through D6 show passing runs for each of the 6 test types. Figures D7 and D8 show examples of invalid runs. Figure D9 shows an example of a valid test that failed the CIB requirements.

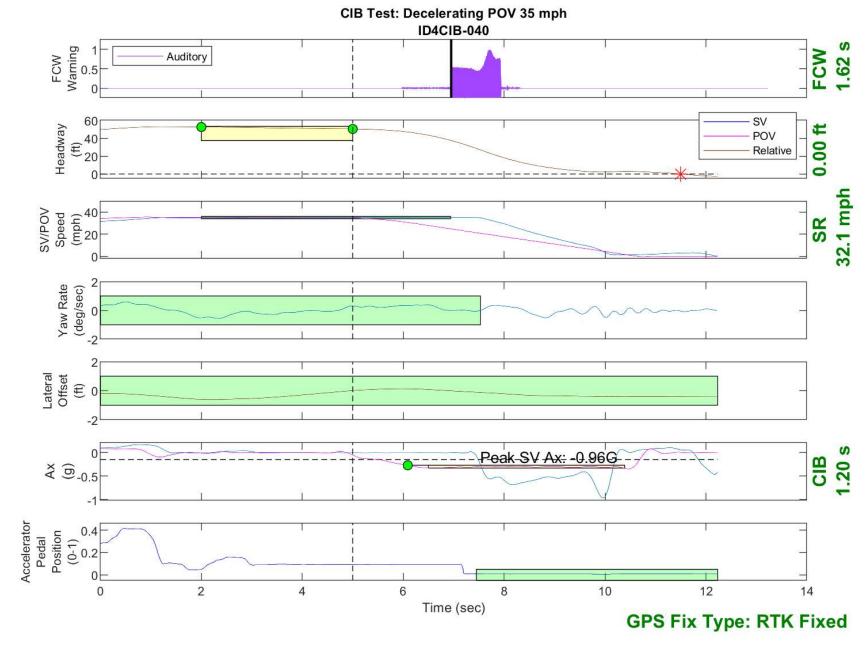
Figure D31. Time History for CIB Run 40, SV Encounters Decelerating POV, SV 35 mph, POV 35 mph
