AFWL-TR-87-101

# ISST STRUCTURE WITH SIFCON -- HFC-2 TEST

New Mexico Engineering Research Institute  
University of New Mexico  
Albuquerque, New Mexico 87131

Final Report

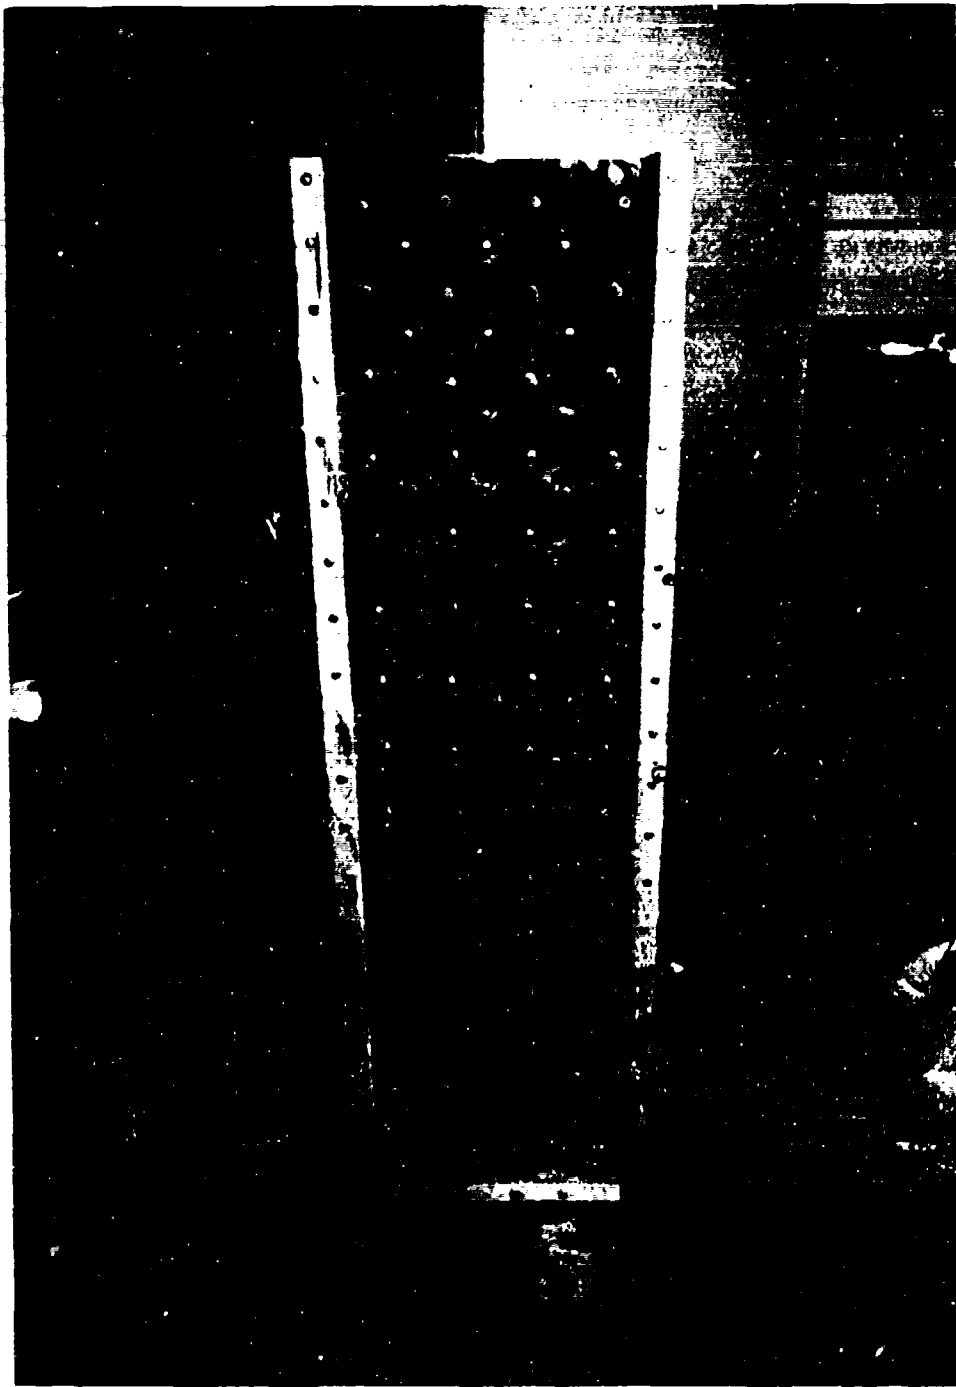
Figure 1. Wall mold for demonstration program.

In addition to the form simulating the wall of the model, three 204-mm (8-in) cubes of SIFCON were fabricated. These specimens were used to determine fiber densities as well as to produce core samples. The cored specimens, taken both horizontally and vertically from the cube, were used to study the effect of fiber orientation versus compressive strength. Standard 102-mm (4-in)-diam by 204-mm (8-in)-long cylindrical specimens of both SIFCON and the slurry were also prepared.

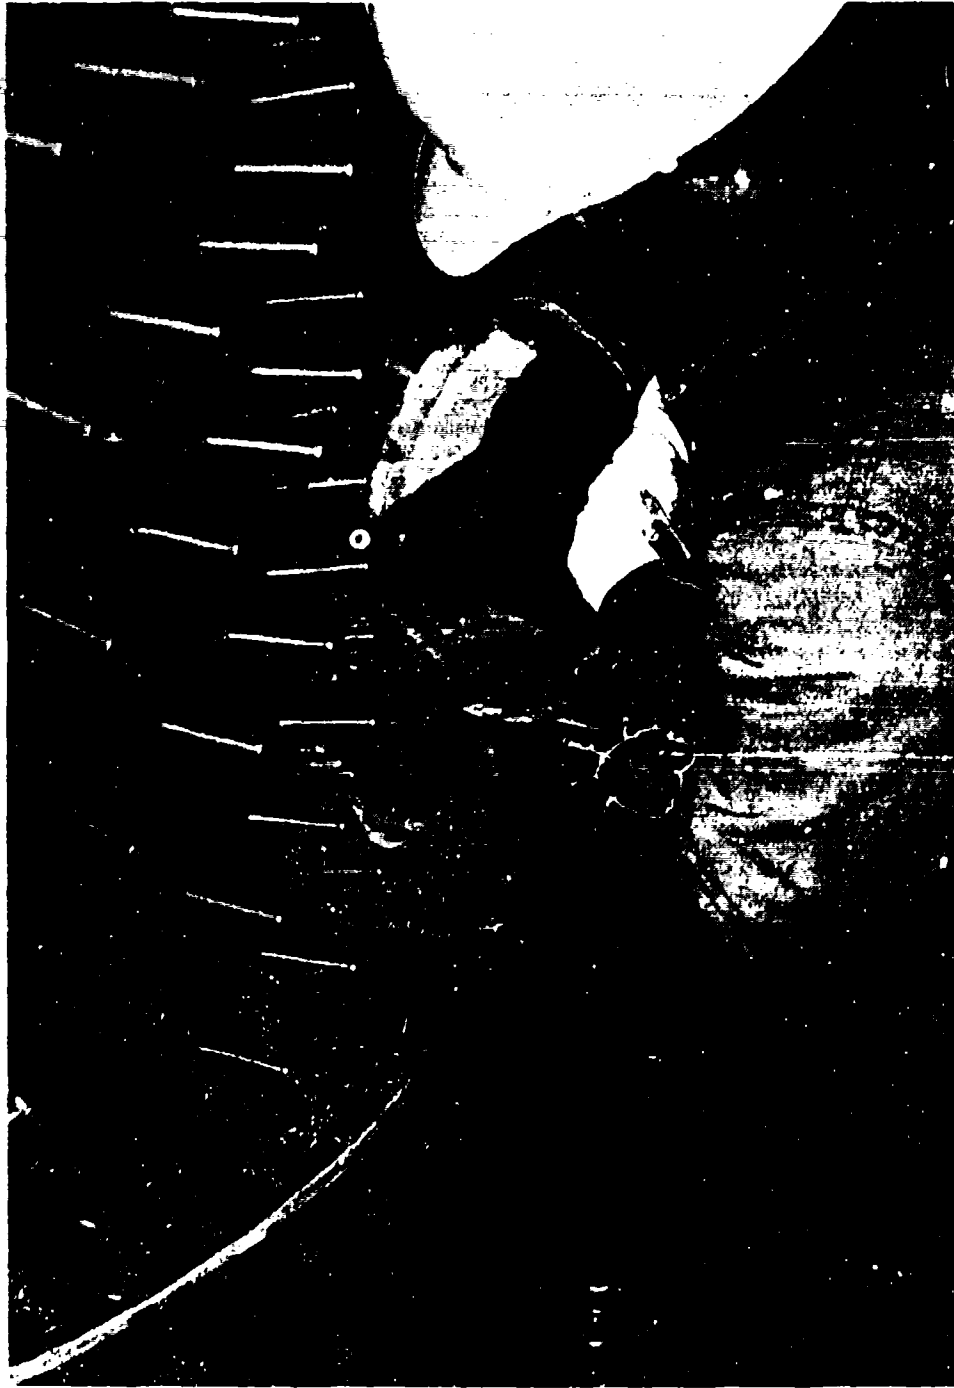
Figure 20. Slurry placement of silc walls.

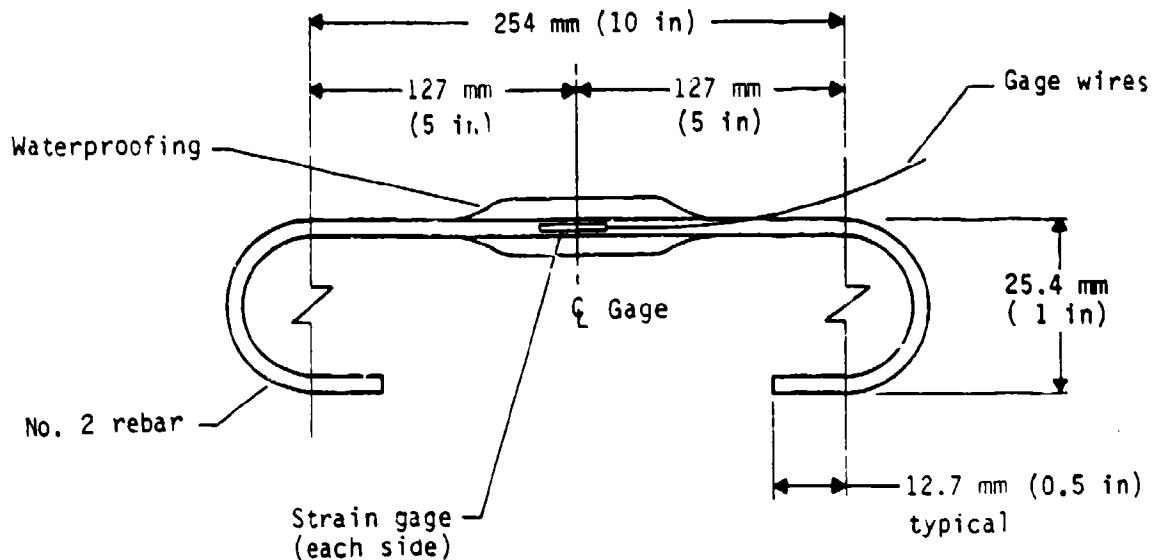
Figure 22. SIFCON strain transducer.

SIFCON strain--Micromeritics strain gages, type EA-06-500350, were used to measure strain in the SIFCON material of the test structure during loading. Manufacturer's specifications indicate that overall length could change by 5 percent without gage failure. This gage is a one-fourth bridge, 350- device with a gage factor of 2.05, mounted on a length of No. 2 deformed steel reinforcing bar. The bar was fabricated with hooks on each end to provide proper anchorage in the SIFCON.

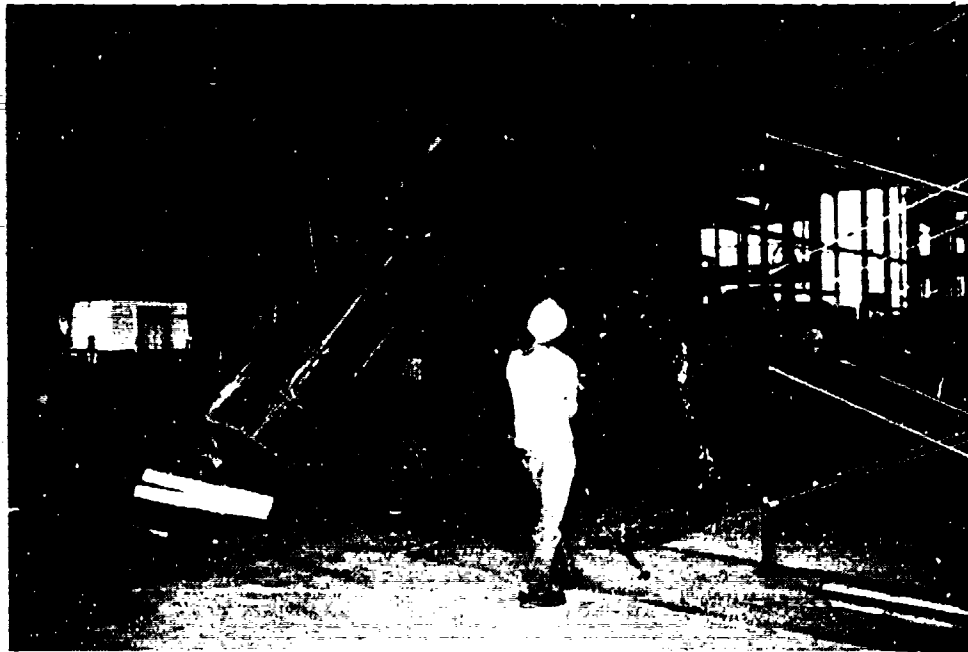
Figure 27. Setting silo in horizontal position.

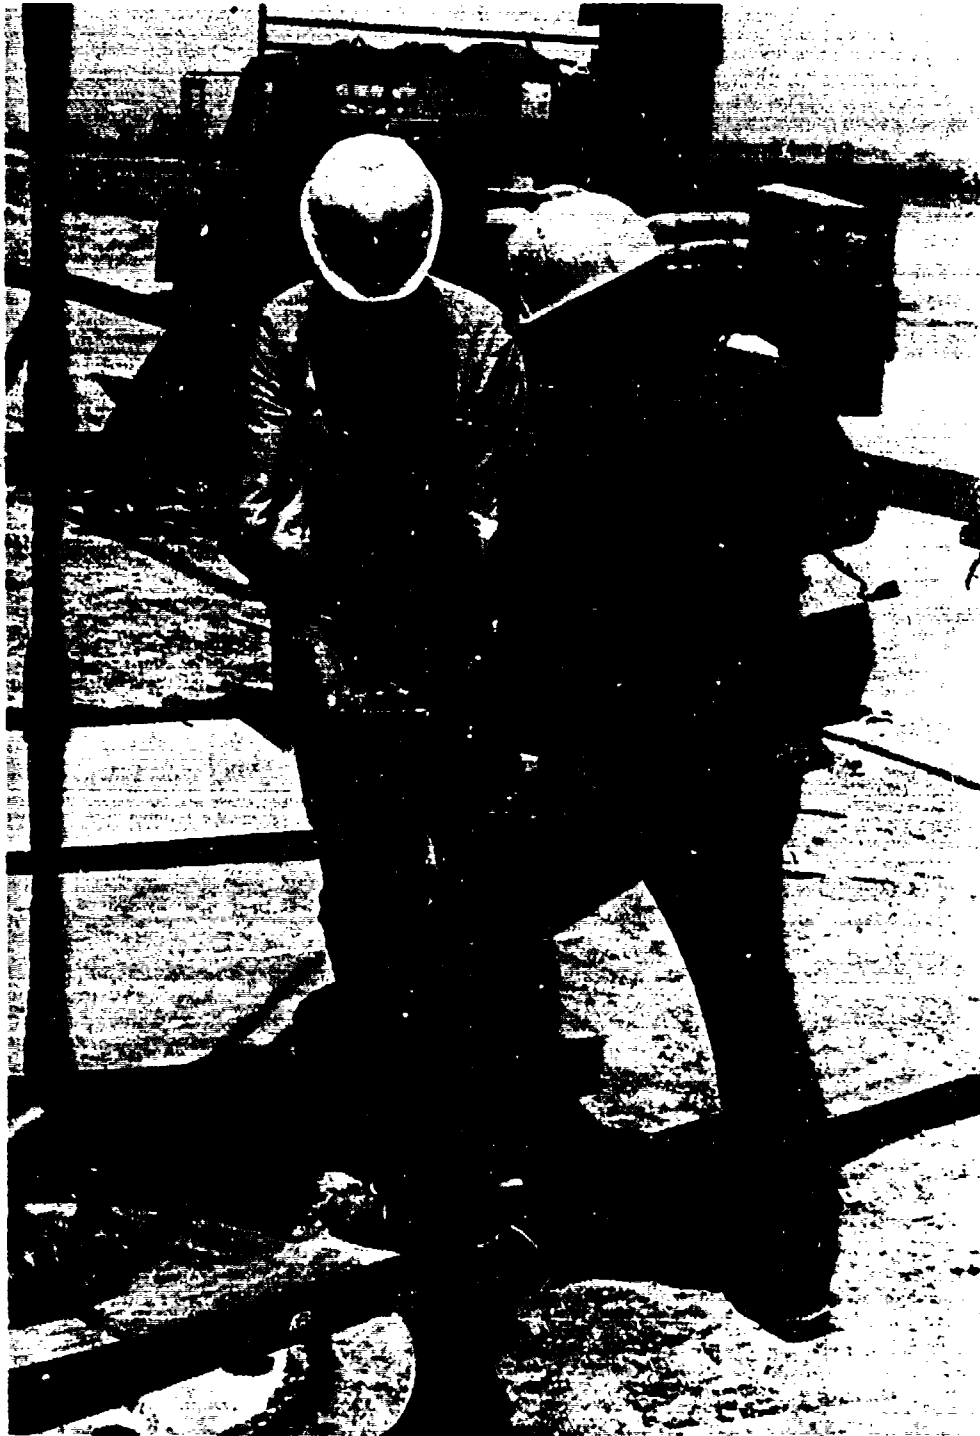
Figure 31. Grouting bottom of silo.

composed of masonry sand, cement, barite, Aqua Gel, and water was mixed on site (Table 5). The grout was poured into the drilled shaft using two 76-mm (3-in)-diameter pipes (Fig. 31). Grout was placed up to a level 585 mm (23 in) above the lowest point on the base of the model. The crane held the model in place for 24 hours, allowing the grout to set up thoroughly. After the grout had set up, a dry sand was rained into the drilled shaft around the sides of the model up to a level approximately 3 m (9.8 ft) from the bottom of the model. This elevation was the level of the existing instrumentation cable trenches (Fig. 32).

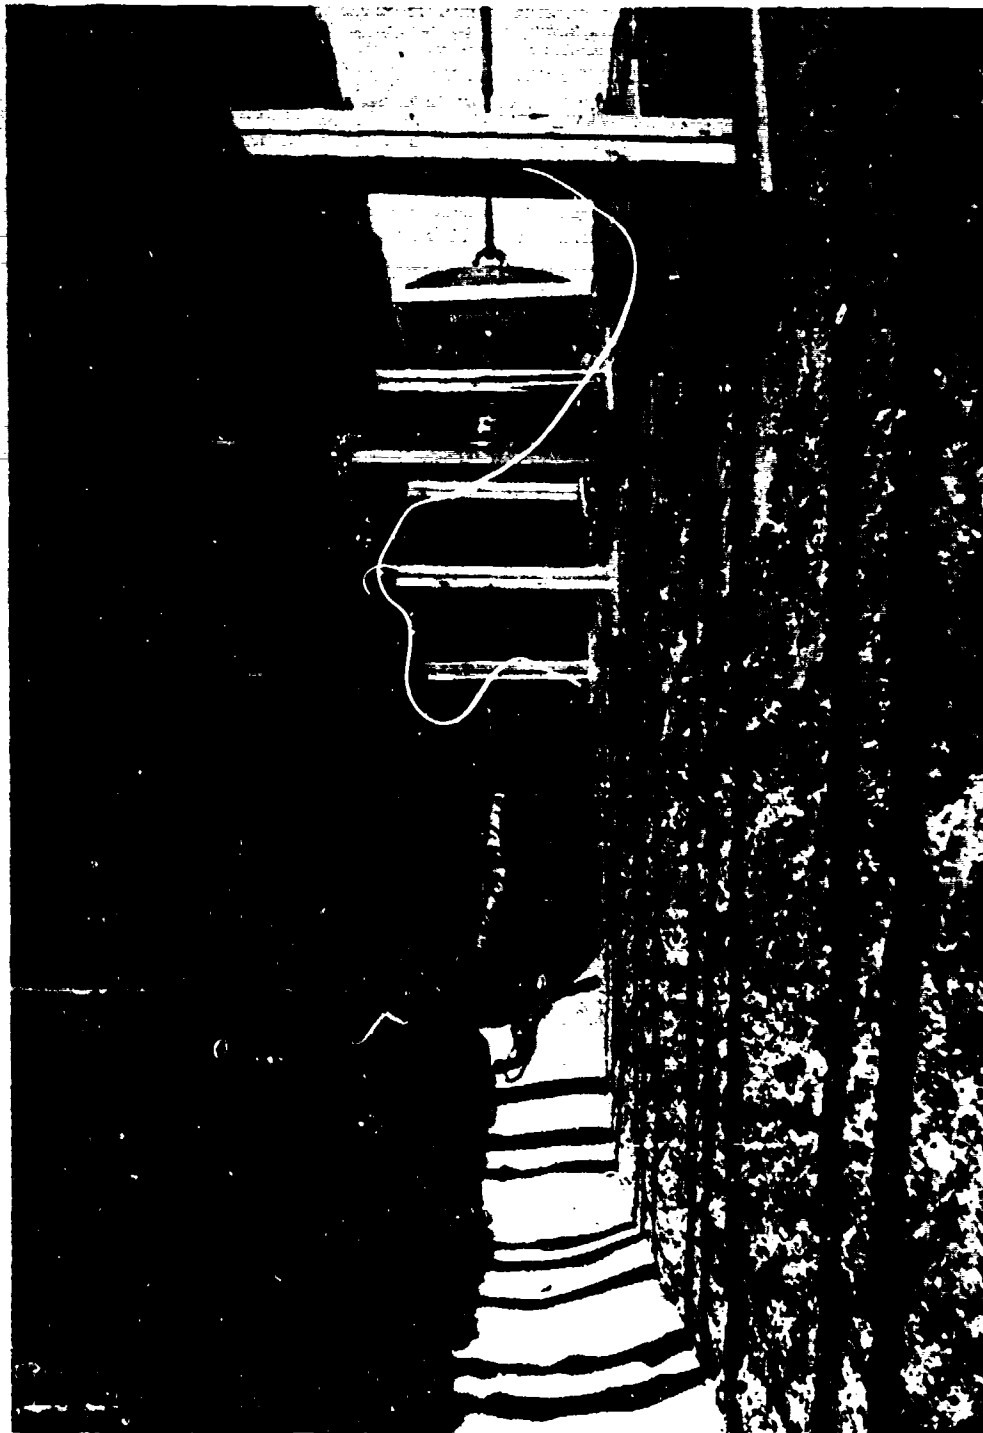
Figure 32. Instrumentation trenches for sifo.

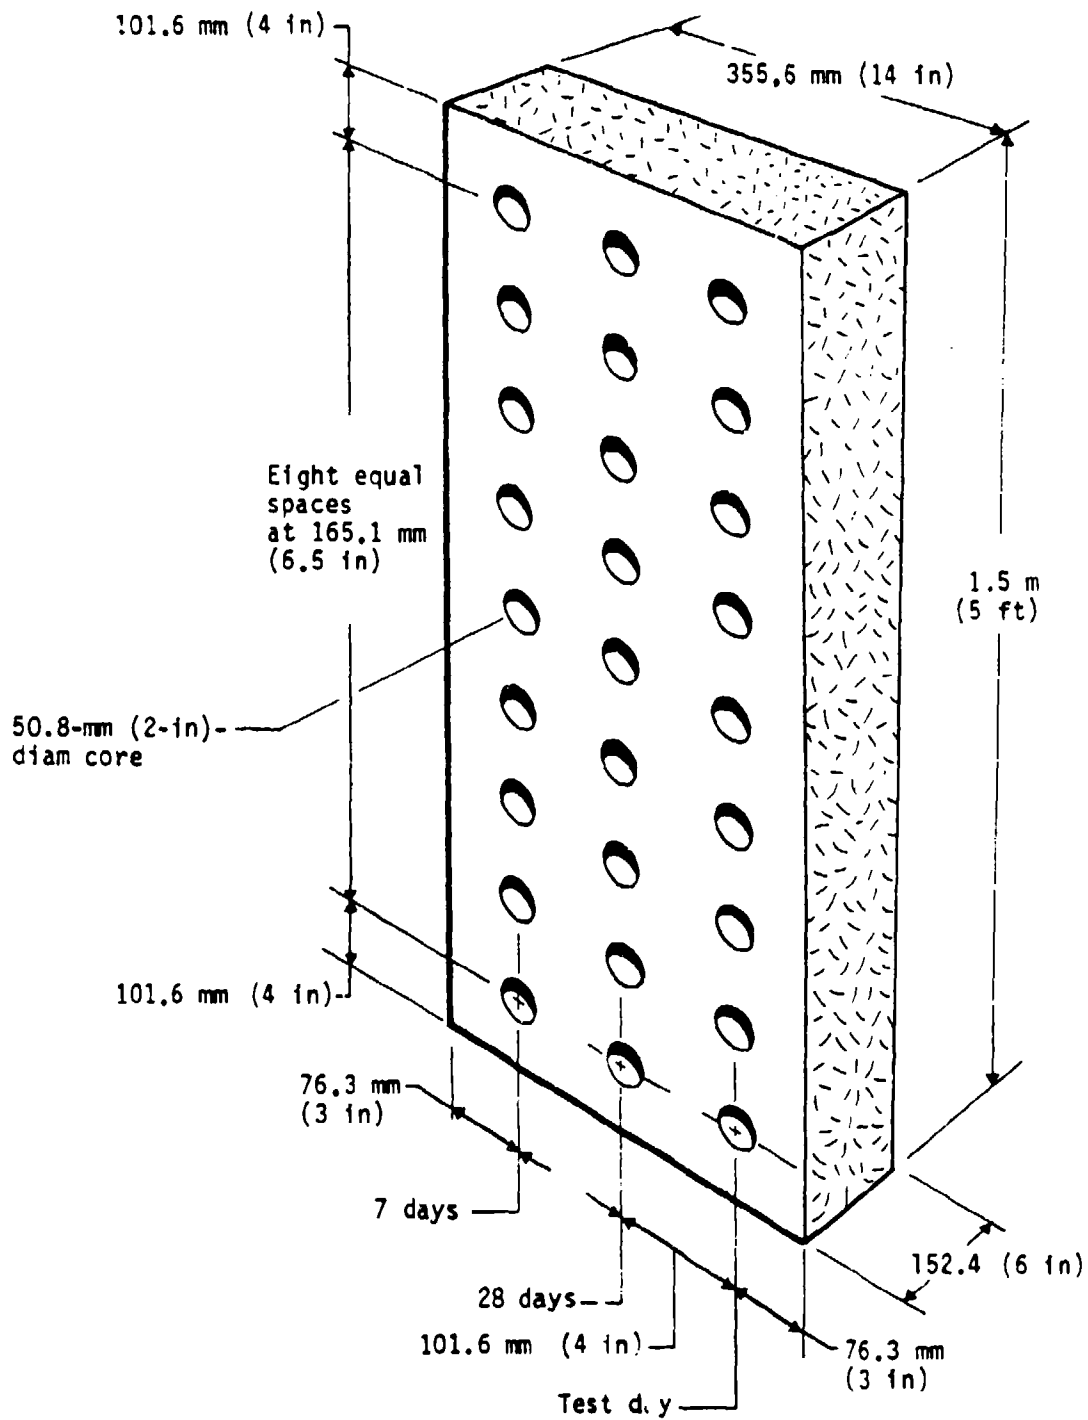
Figure 35. Core locations from wall slab.

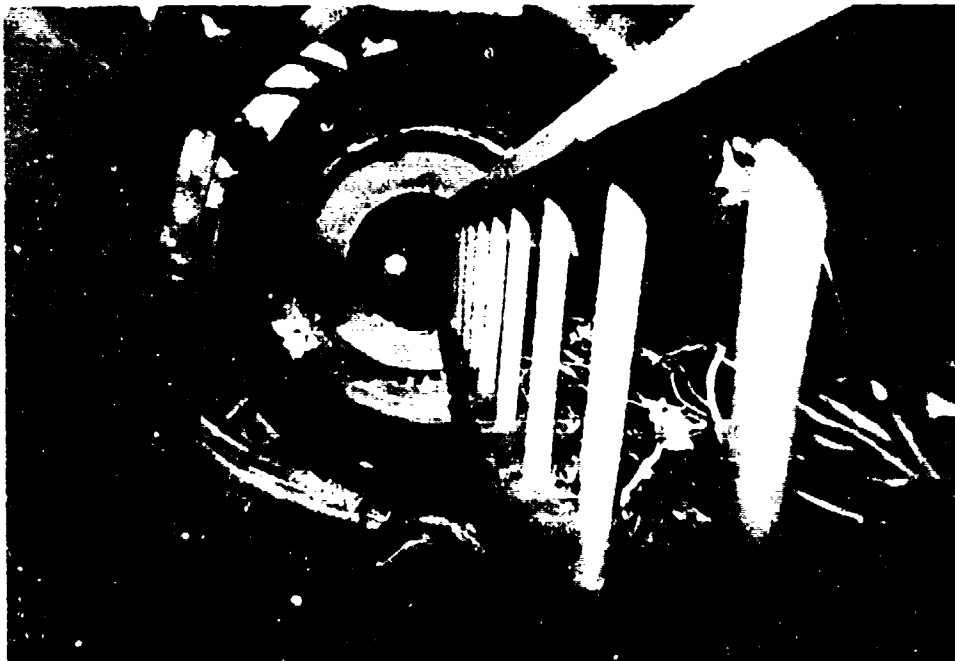
Figure 60. Buckle in liner plate at 3.0 m from top of model.
