## Design, Fabrication and Test of Graphite/Polyimide Composite Joints and Attachments

Data Report

J. B. Cushman, S. F. McCleskey and S. H. Ward

BOEING AEROSPACE COMPANY SEATTLE, WASHINGTON

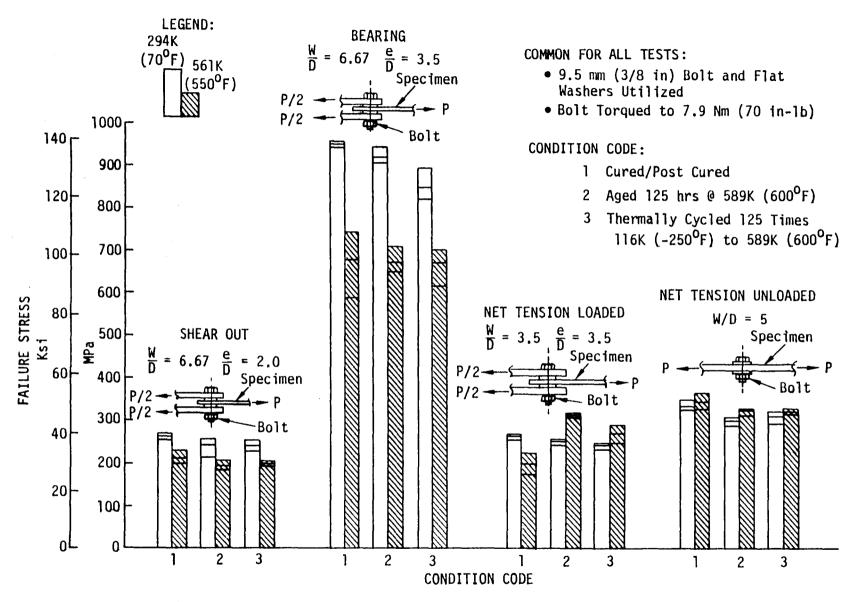
Figure 4-9: SUMMARY OF SMALL COMPONENT BOLTED JOINT TESTS CELION 3000/PMR-15 (0/+45/90)85

Test results for the shearout, bolt bearing, net tension loaded and net tension unloaded hole tests are shown in Figure 4-9. The data show a drop in strength at elevated temperatures, but no significant change due to the three environmental conditionings. The slight increase in failure stress at elevated temperature for the loaded and unloaded bolt hole test (see Figure 4-9) was caused by a softening of the matrix material. This reduced the severity of stress concentration at the hole edge. This slight increase in failure stress was not observed in the net tension loaded condition 1 tests. An explanation for this is that at elevated temperature the net tension failure mode was changing to a bearing mode. Since the glass transition temperature for condition 1 is lower than that for conditions 2 and 3, the bearing failure mode dominated causing the lower failure stress. Figures 4-10 through 4-13 show typical failed specimens for the shearout, bolt bearing, net tension loaded and net tension unloaded hole tests respectively. Raw data are given in Appendix A, Tables A-1 through A-4.

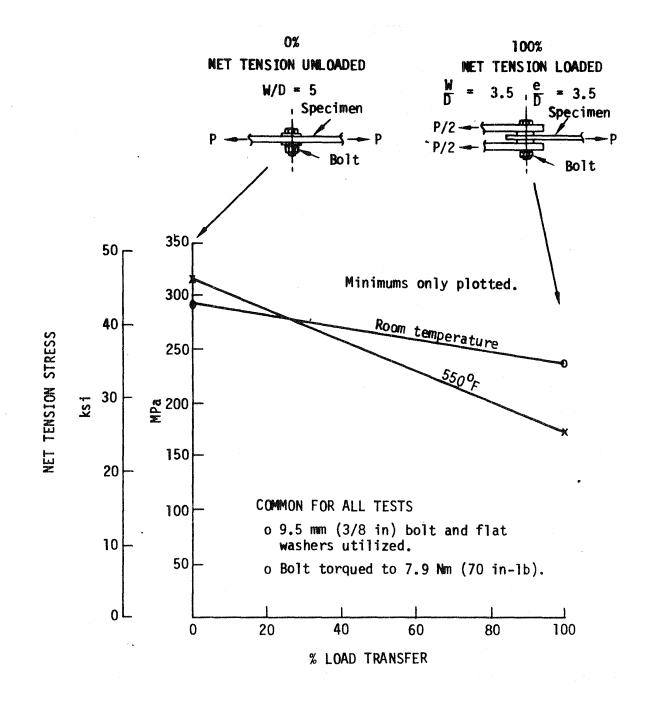
Figure 4-14: MINIMUM LOADED AND UNLOADED HOLE NET TENSION STRESSES (0,+45,90)<sub>85</sub> CELION 3000/PMR-15

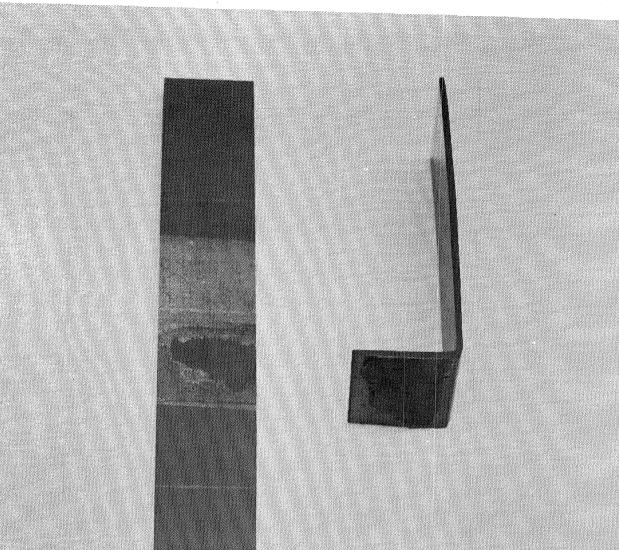
Figure 4-24: MATRIX 4C TEST 1A SINGLE ANGLE PULL-OFF TESTS - FAILED SPECIMEN

Tension test set-ups and results of the three bonded web attachment concepts are shown in Figure 4-23. Typical failed specimens for these configurations are shown in Figures 4-24 through 4-26. Raw data are given in Appendix A, Tables A-7 through A-9. Results for the room temperature single  $90^{\circ}$  angle were below the minimum design requirement; therefore, the elevated temperature tests were not conducted. The double angle attachment had average failure loads of 40.1 kN/m (229 lbs/in) and 46.9 kN/m (268 lbs/in) at 294K ( $70^{\circ}$ F) and 561K ( $550^{\circ}$ F) respectively. The "T" attachment averages were 55.3 kN/m (316 lbs/in) and 51.7 kN/m (295 lbs/in) respectively. Since the  $90^{\circ}$ angles are easier to fabricate than a "T" section and they exceed the maximum

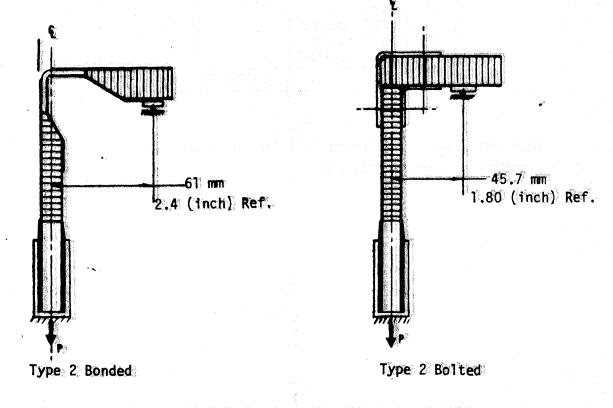
Figure 5-2: MATRIX 5 - TYPE 2 LOADING CONDITIONS

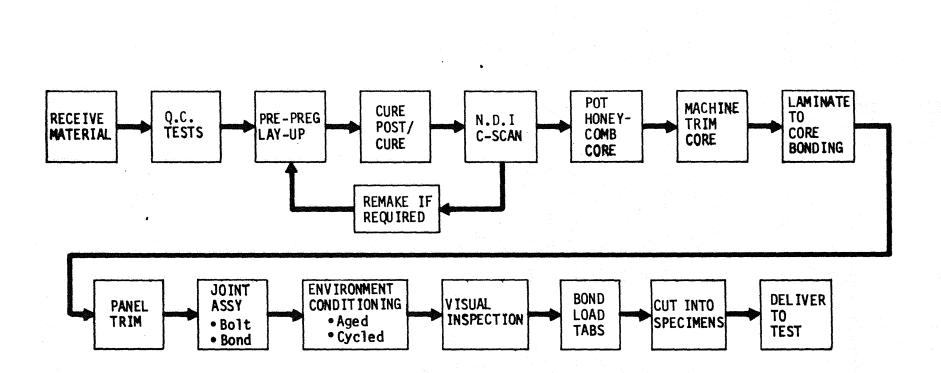
Figure 5-9: SPECIMEN FABRICATION FLOW DIAGRAM

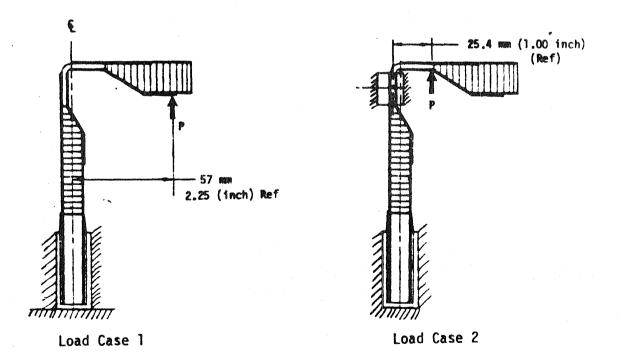
Figure 6-9: TASK 1.4 - TYPE 2 BONDED JOINT STATIC LOADING CONDITIONS

Room and elevated temperature fatigue tests (Matrix 7.3) were conducted on aged Type 2 Bonded joints using load case 2 (Figure 6-9). Specimen configuration was the same as for the static tests. Fatigue loads, determined from load case 2, are shown in Table 6-4. All three room temperature specimens went to  $10^6$  cycles without failure. Room temperature static strength tests were then conducted on these specimens to determine their residual strength after fatigue. Specimens were tested using load case 2. Test results are shown in Figure 6-33. A comparison of static strength before and after fatigue shows approximately a 14% drop in strength after fatigue cycling. Residual static strengths are still above the design load of 285 N-m/m (64 in-lb/in).

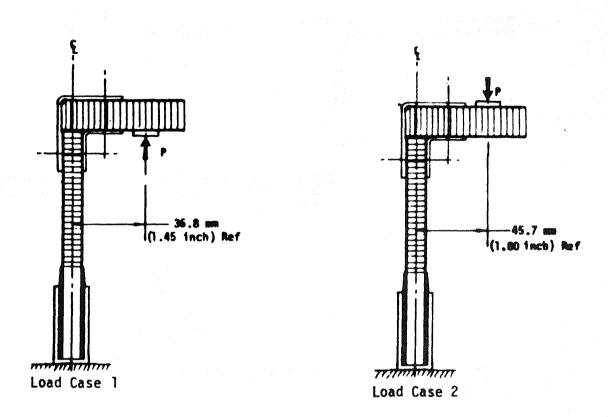
Figure 6-10: TYPE 2 BOLTED STATIC LOADING CONDITIONS

The static test specimen for the Type 2 Bolted joint is shown in Figure 6-61. Test results were conducted for two load cases as shown in Figure 6-10. Test results are presented in Figure 6-34 and are discussed below.

Room and elevated temperature fatigue tests of Type 2 bolted joints were conducted using load case 1 (Figure 6-10). Fatigue loadings are given in Table 6-4. All three room temperature specimens went  $10^6$  cycles without failure. The specimens were then tested statically to determine their residual strength after fatigue. A comparison of static strengths before and after fatigue is shown in Figure 6-34 and shows an average increase in joint strength of 39% due to fatigue. There is no apparent explanation for this phenomenon.

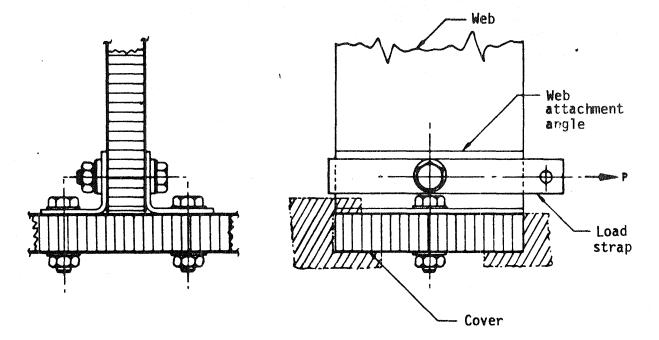
Figure 6-13: TYPE 4 BOLTED WEB ATTACHMENT SHEAR LOADING CONDITION

Static test specimens for Type 4 Bolted joints are shown in Figure 6-80. Specimens were loaded in bending and shear as shown in Figures 6-12 and 6-13. Test results are summarized in Figure 6-37 and are discussed below. Predicted loads for the bending tests are based on a compression failure in the upper cover skin using data from the design allowables testing (see Section 4.2). All specimens, except two, exceeded the design load of 11.2 kN/m (64 lbs/in); however, there were large variations in performance.

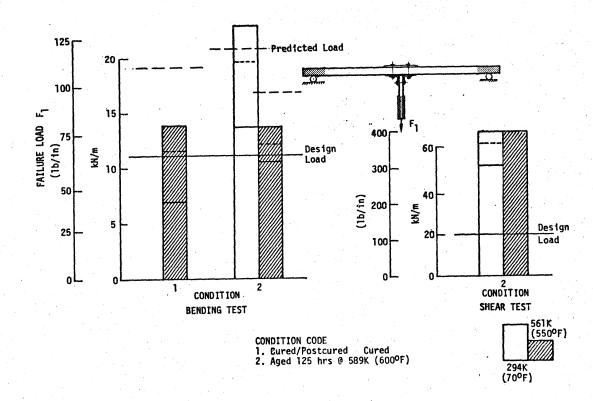
Figure 6-37: TYPE 4 BOLTED JOINT STATIC TEST RESULTS

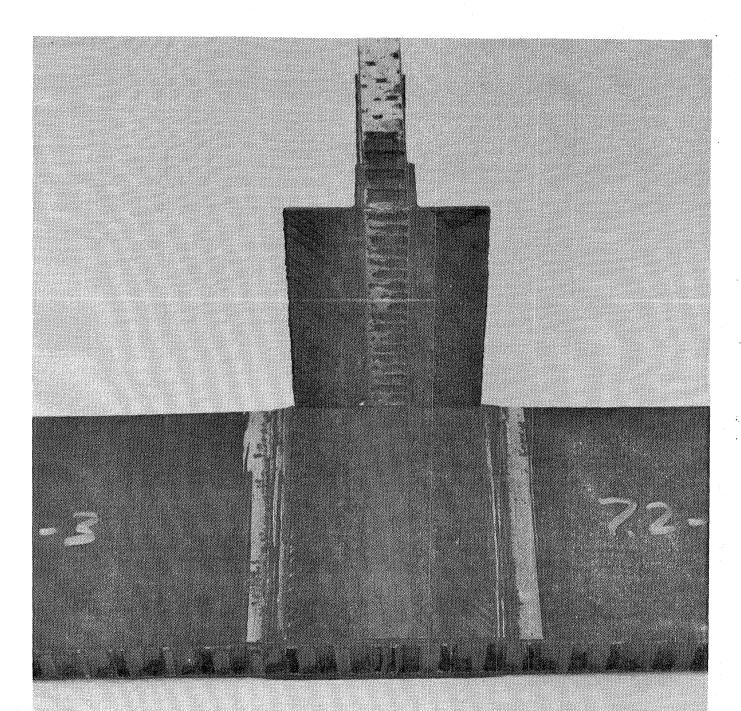
SPECIMEN 7.2-1A2-2-3 FAILURE LOAD 3.5 KN (776 LBS)

Figure 6-42: TYPE 1 BONDED - BENDING TEST, AGED, 294K (70°F)

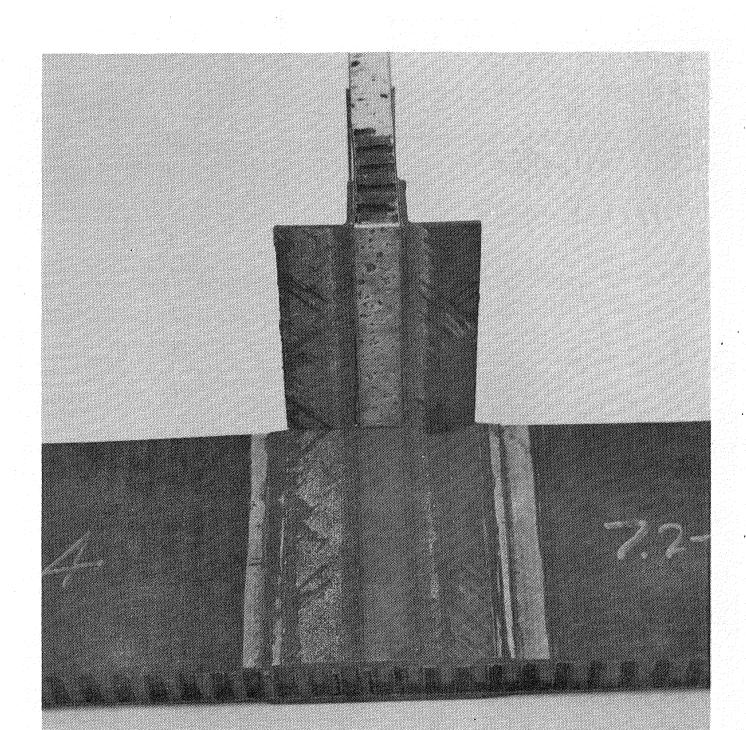
SPECIMEN 7.2-1A2-2-4 FAILURE LOAD 1.6 KN (362 LBS)

Figure 6-45: TYPE 1 BONDED - BENDING TEST, AGED, 561K (550°F)

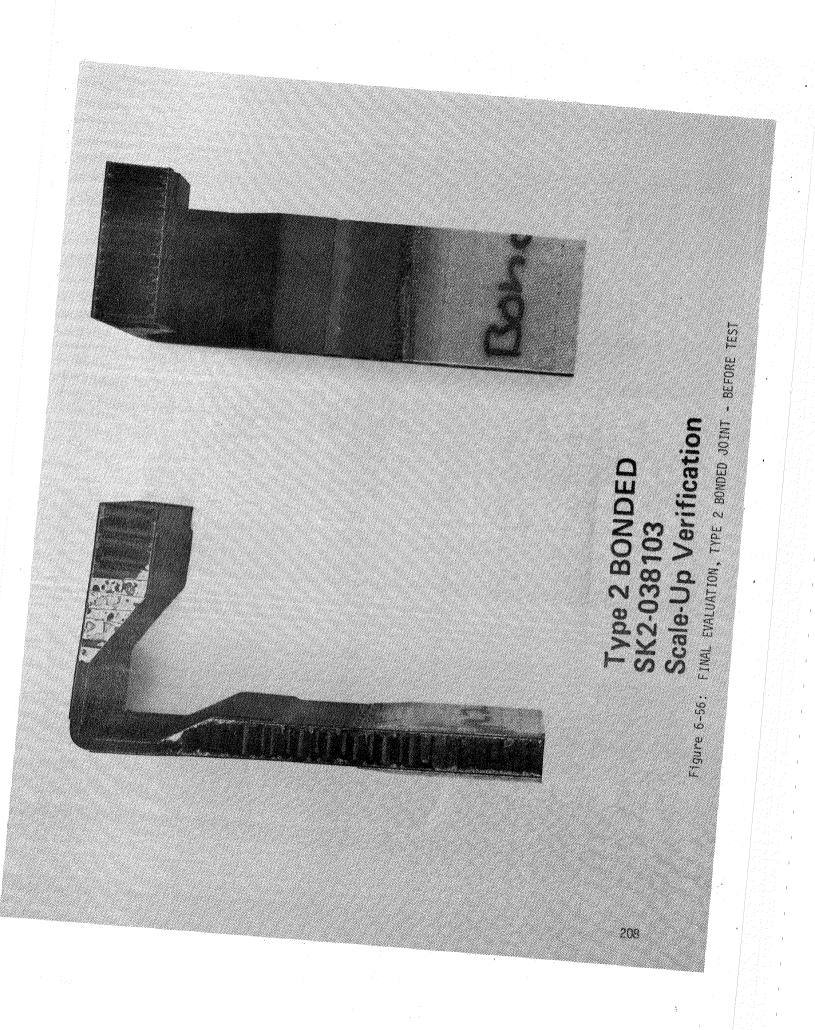
Figure 6-57: TYPE 2 BONDED JOINT LOAD CASE 1 FAILURE MODE

Scale-up Verification (Matrix 7.1) tests were performed at  $561K (550^{\circ}F)$  on cured/post-cured specimens using load case 1 (see Figure 6-9). In all cases the specimens failed prematurely due to peel in the honeycomb close out area (see Figures 6-57 and 6-59). Static Strength (Matrix 7.2) tests were performed at 294K ( $70^{\circ}F$ ) and  $561K (550^{\circ}F)$  on thermally aged specimens. The first load case was identical to that used for the Scale-up Verification tests. These specimens also failed prematurely due to peel in the honeycomb close-out area. The premature failures are attributed to poor bonds on the laminate to core in the honeycomb close-out area. This was caused by tolerance buildup and gaps during scale-up which did not allow adequate pressure during bonding.

Specimen originally tested under Load Case 1, retested under Load Case 2. Specimen retested. Residual strength test of fatigue specimen. See Figure 6-9 for load case diagrams. See Figures 6-57 and 6-58 for failure mode diagrams.

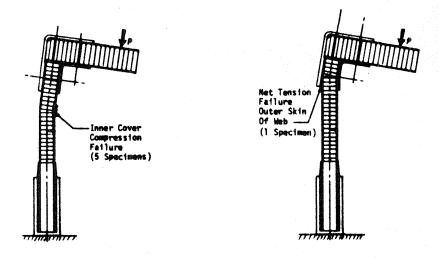
Figure 6-63: TYPE 2 BOLTED JOINT, FAILURE MODE - LOAD CASE 2

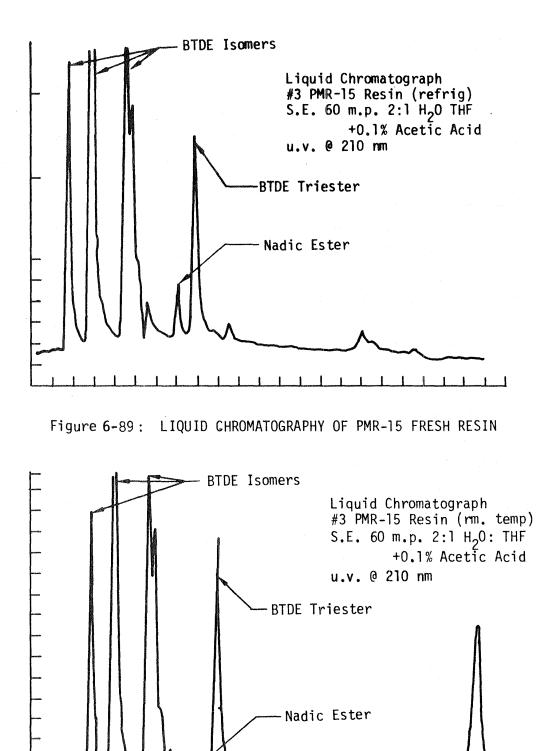
Figure 6-90: LIQUID CHROMATOGRAPHY OF PMR-15 AGED 45 DAYS

The degradation of the A7F adhesive has been attributed to overheating of the adhesive during the DMF solvent stripping process prior to coating onto the 112 E-glass scrim. The adhesive film for the "Final Evaluation" panels was prepared by US Polymeric. The DMF solvent was not used in the process used by the Boeing Materials Technology labs to prepare the previous batches of adhesive used in this program and thus the stripping difficulties were not encountered earlier. Only one of the two batches of A7F adhesive prepared by US Polymeric resulted in bad bonds. During the stripping of the DMF solvent from the second batch of adhesive the AI-1130 L amide-imide resin was advancing (partially curing) due to overheating. Therefore the properties of the adhesive were degraded, resulting in a loss of bond strength after thermal aging and cycling.
