District 3-0 Investigation of Fiber Wrap Technology for Bridge Repair and Rehabilitation (Phase III)

FINAL REPORT

January 14, 2010

By Julio F. Davalos, An Chen,
Indrajit Ray, Adam Justice
and Matthew Anderson
West Virginia University

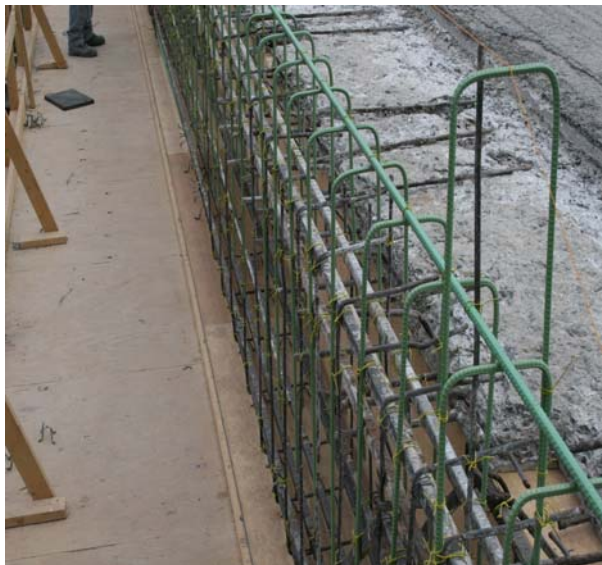
Figure 1: Complete Removal of Concrete from Beam 6, Exposing the Reinforcement

1. The contractors completed most of the demolition work of deteriorated and damaged concrete, as can be seen in Figures 1 and 2 below.

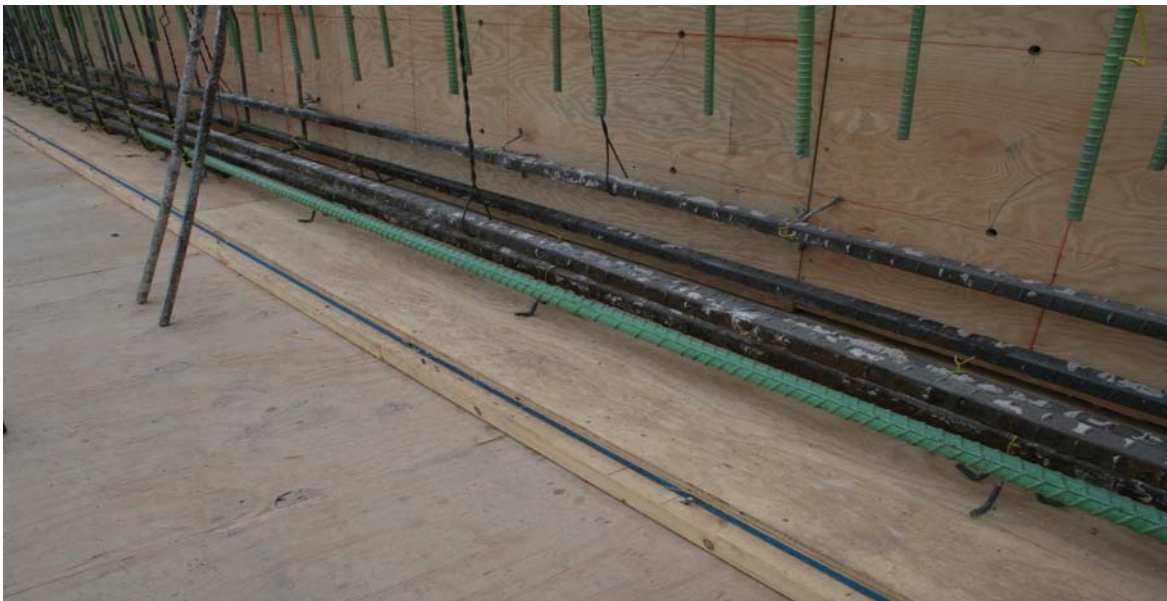
Figure 3: Central Portion of Beam 6 with Two Missing Bars in the Top Layer of Tension Steel

2. When the contractors removed the concrete from edge beams, they found tensile reinforcement missing of about 20% less than reported in the drawings. The rest of the beams not exposed were thought to have missing reinforcement as well. Also, some of the diagonal shear bars were missing. Moreover, the vertical stirrups within the central 15 feet were also missing. Figure 3 displays the central portion of Beam 6, where the two middle bars of the top layer of tension steel are missing, in contrast to what was specified in the original design plans. Also, complete absence of stirrups for the mid-section of the beam can be seen in this figure. Resulting discussions concerning this missing reinforcement are presented in Section 2.3.

3. One issue of concern was the need to possibly reevaluate the capacity of the bridge girders due to finding of less steel than in the original plan. It was decided that the FRP design would account for the missing steels (both in tension and shear).

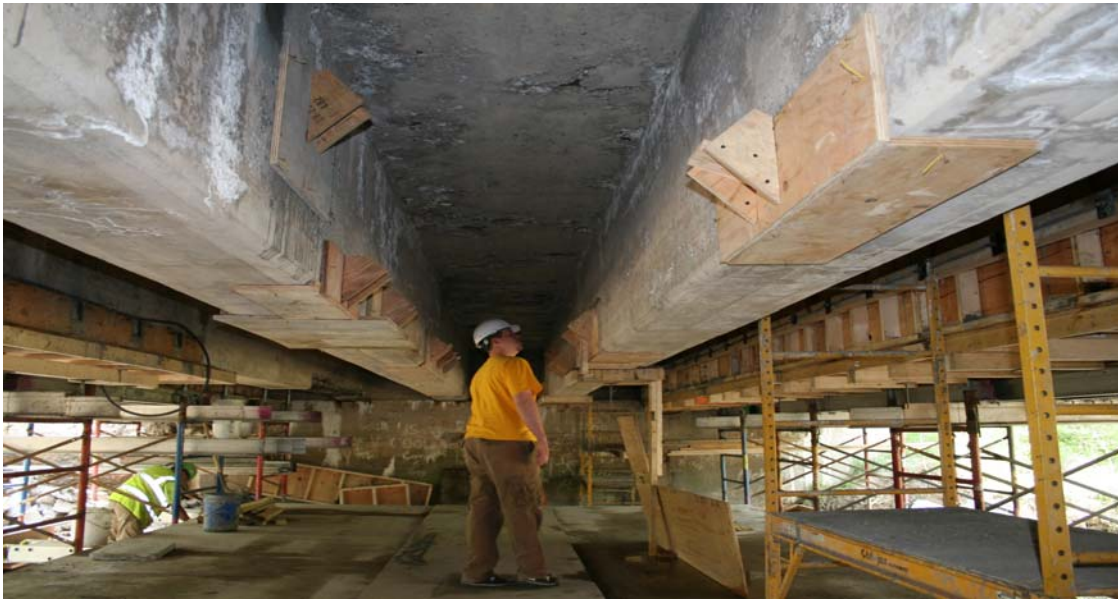
Figure 4: Formwork for Patch Repairs along Beams 3 and 4

2. Beams 2, 3, and 4 were patched using bag repairing materials.
3. The repairing was done following ACI 546R and ICRI no. 03730 guidelines. Form-and-pour techniques were used for bag repairing materials. The bag material is a BASF product, Emaco S66 CI “Flowable Structural-Repair Concrete with Integral Corrosion Inhibitors.” It’s a cement-based silica fume modified repair concrete with high durability and strength. It was mixed at the site and poured within forms using chutes attached to forms; the materials were properly compacted using rods and mallets only, as the patching method and form

construction did not provide vibrator access. Figures 4, 5, and 6 show the formwork for patch repairing and triple A mix application.

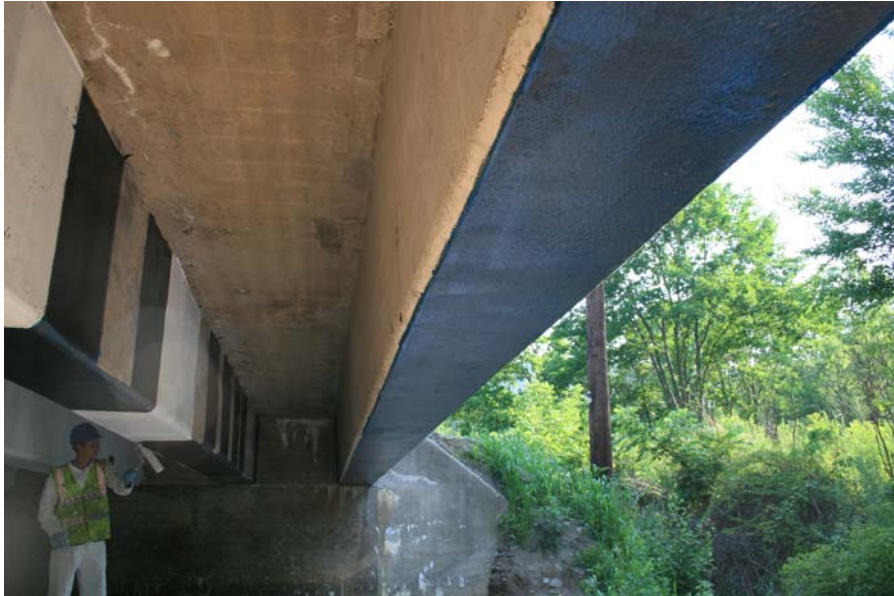
Figure 9: Flexural FRP Reinforcement along the Bottom of Beam 1

For 2-pplies, the process was simply repeated. Figures 9, 10, and 11 show different FRP layouts.

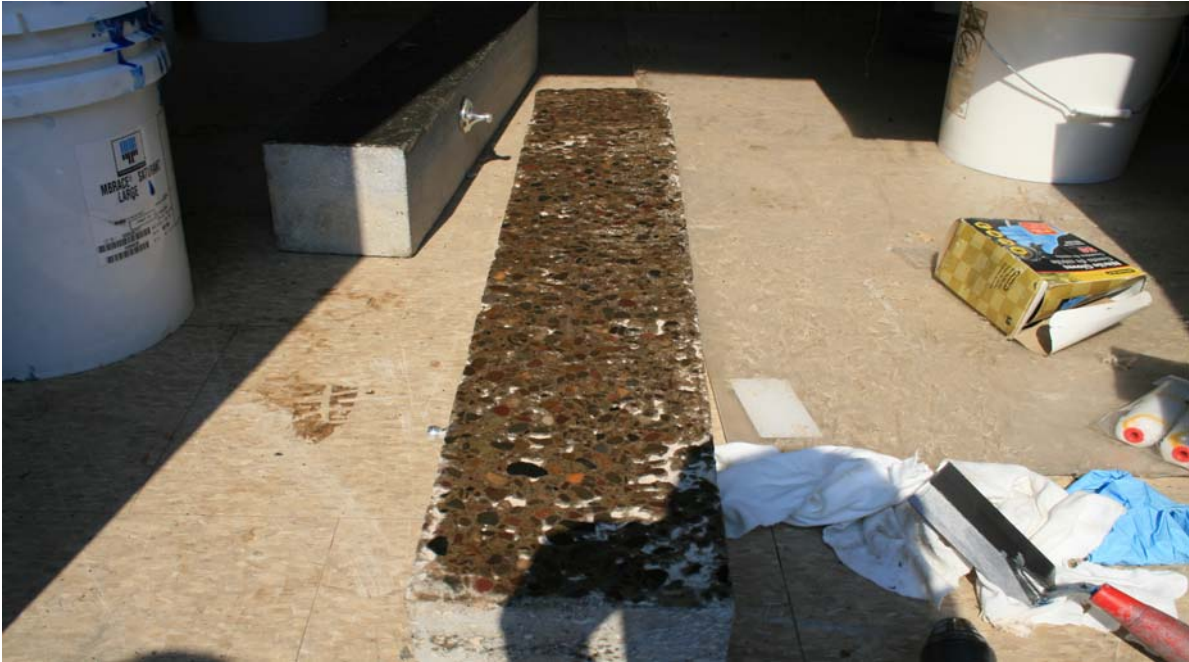
Figure 12: Test Prism Coated with Primer Prior to FRP Installation

- FRP was applied to three concrete test prisms. The procedures used as for dry lay-up in the real structure were followed for FRP bonding. Both one layer and two layers of FRP were bonded. These prisms would be used for pull-off testing per ASTM D 4541. Figures 12, 13, and 14 describe the procedures followed.

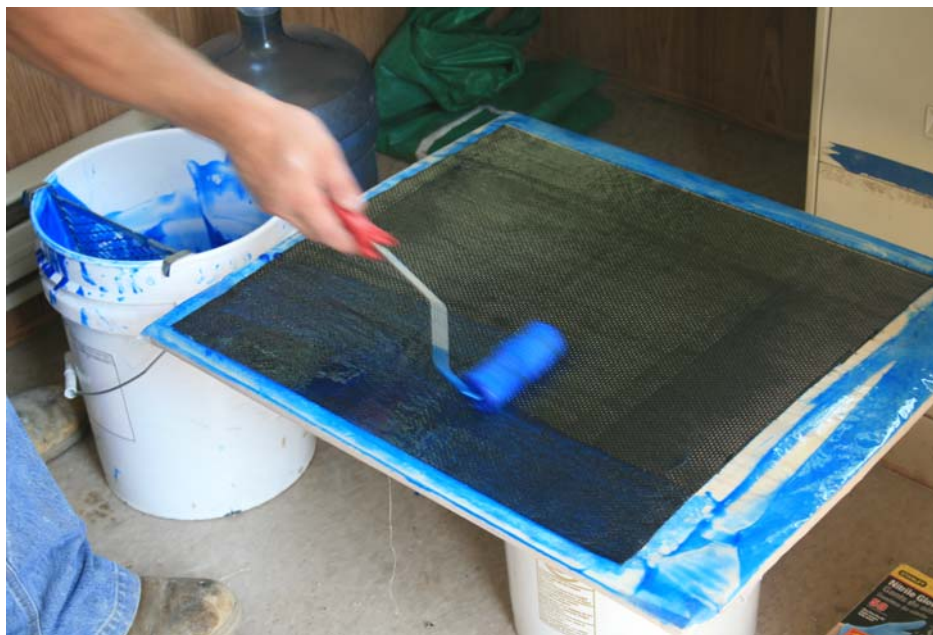
Figure 15: Fabrication of FRP Laminate to be used for Direct Tension Testing

- FRP laminates were produced using a plywood base (backed by plastic sheet) with the same fabric, primer, saturant, and application technique as in the bridge. Both one layer and two layer laminates were produced. Figure 15 displays the procedure of production of laminates.

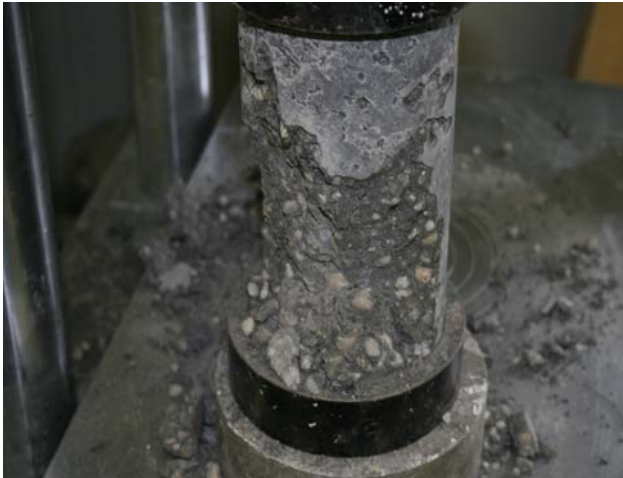
Figure 16: Cylinder after Compressive Strength test

patching materials. PennDOT specified the use of this repairing material. It is easily flowable, pourable, and durable cement-based concrete repair material having good bond with the old concrete surfaces. It has high freeze-thaw durability, sulfate and chloride resistance and corrosion resistance due to the corrosion inhibitor added. The compressive strength of bag material was about 46% higher than triple A mix at 90 days. Therefore, it is expected to be much higher than the strength of existing beams with old concrete. The 56-day mean (three specimens) splitting tensile strength (ASTM C 496) of bag material close to FRP installation day, was 595 psi (COV=0.05). Figures 16 and 17 display the compressive strength and splitting tensile strength of bag material.

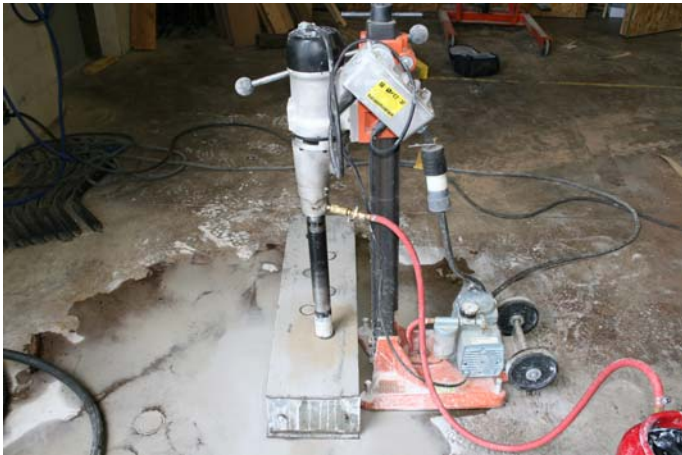
Figure 18: Core Drill Set-up used for Concrete

Core cutting tools with 2 in. diameter were used to cut cores of depths slightly more than 2 in. from the surface of both triple A and bag material, in order to reach barely within the substrate old concrete (Figure 18). After cutting the cores, aluminum discs of diameter 2 in. were bonded with epoxy, and the epoxy was cured for 48 hours. The pull-off test was conducted by pulling an attached disc until the concrete ruptured. The equipment used was a hydraulic type pull-off tester with digital recorder. For each concrete type about 8 locations were tested and the ultimate strength, location, and nature of failure were

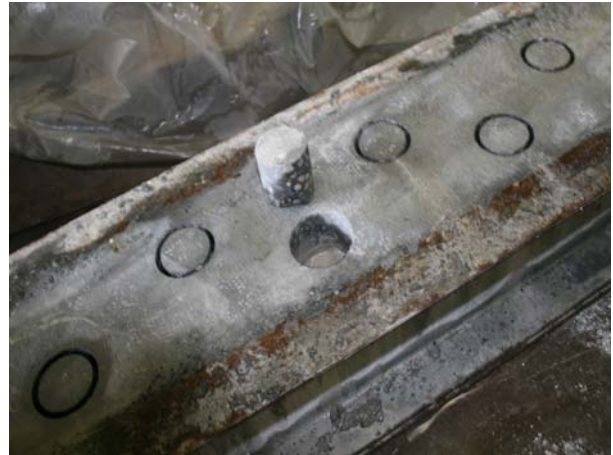
Figure 19: Cores Drilled for Pull-Off

recorded (Figure 19). The purpose of the test was to obtain the bond strength between old concrete and both triple A mix and bag material, according to ASTM C 1583 and ACI 503R Appendix A.

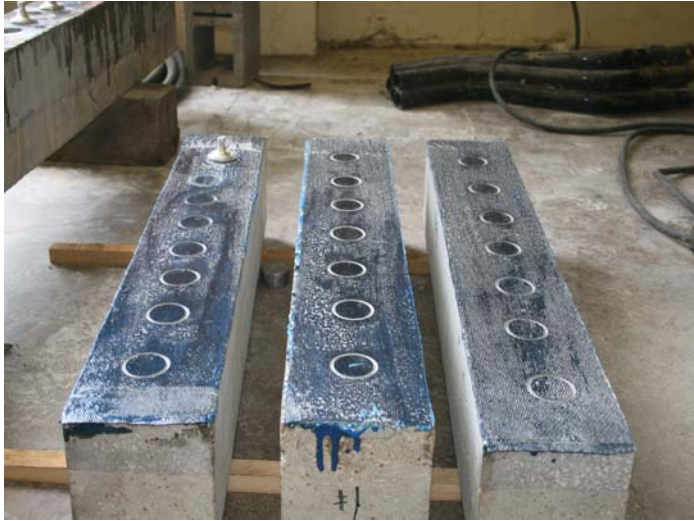
Figure 20: Field Prepared Prism Prepped for FRP Pull-Off Tests

The bond strength between FRP attached to both triple A and bag mixes were determined per ASTM D 4541. The FRP was attached both as single layer and double layer on the prism with bag material. The FRP disc was cut by drilling a 2 in. diameter core cutter that barely penetrated into the repaired material substrate (Figure 20). The aluminum discs were attached to the top surface using epoxy as before (Figure 21). The epoxy was allowed to cure for 48 hours in a curing room.

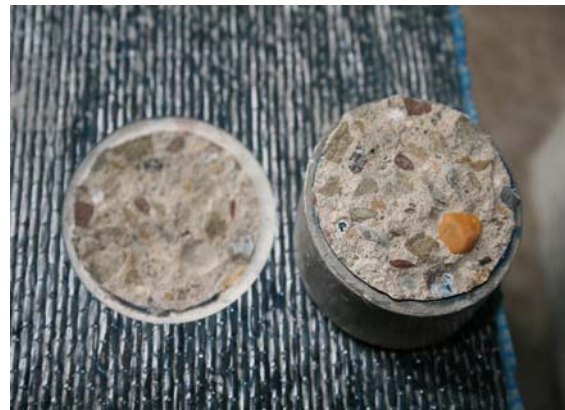
All the tests except one were successful with failure planes through concrete substrate in a cohesive fashion indicating a strong bond between FRP and concrete substrate (Figure 23).

Figure 22: Testing of One Disc is in Progress **Figure 23:** Pull-Off Test Showing Cohesive Failure

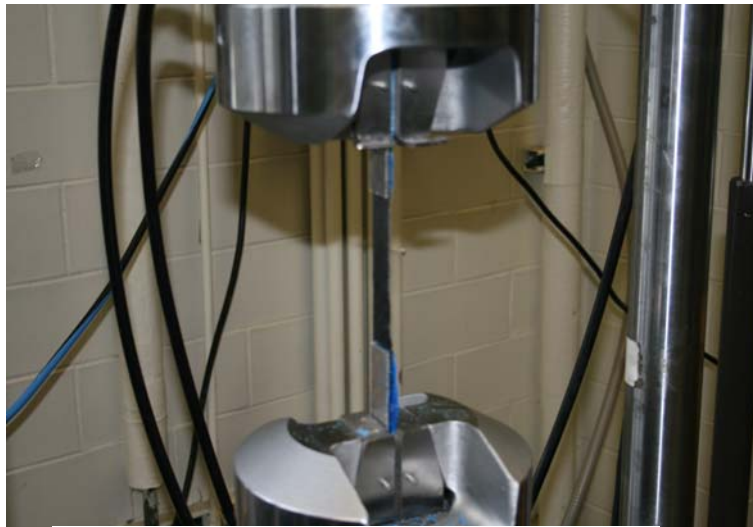
Figure 24: FRP Coupon Tension Test Setup

The gage length of each tension specimen was 4 in. Each specimen was tested in tension to failure at a constant load rate of 1,000 lbs/min using MTS 810 Material Testing System equipped with hydraulic wedge grips (Figure 24).

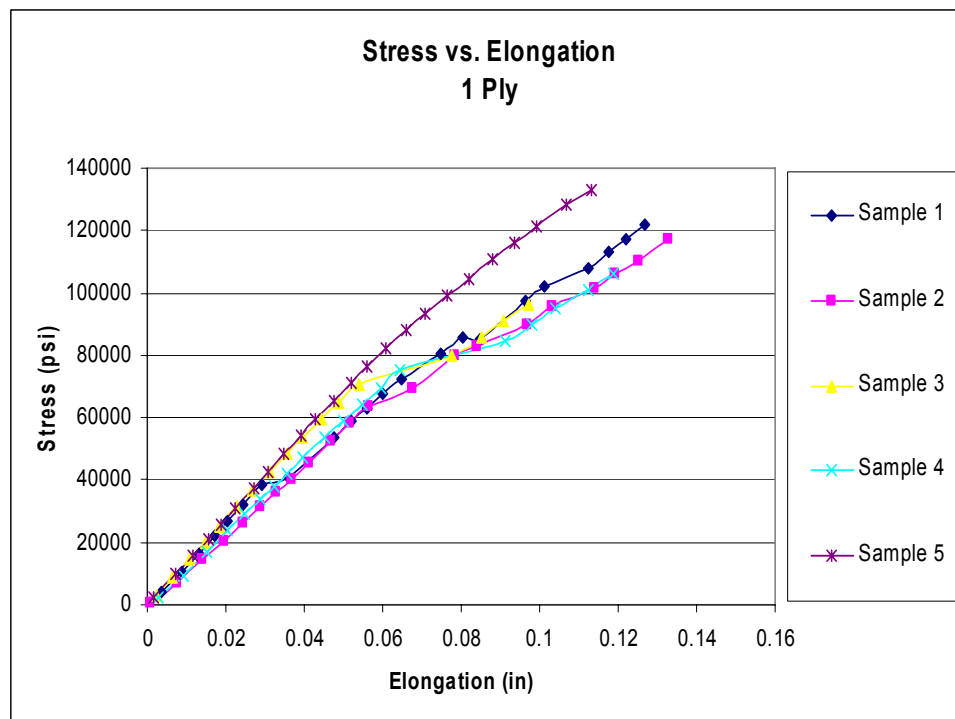
Figure 25: Five 1-Ply Samples

As could be expected, the ultimate tensile strength of 2-ply was much higher than 1-ply. The stress vs. elongation curves (Figures 25 and 26) for FRP direct tension tests show the nearly linear-elastic behavior and brittle failure for both cases. As a result of high ultimate tensile strength for the 2-ply system, the ultimate elongation is also higher, indicating no change in stiffness due to increase in thickness for up to 2-ply.

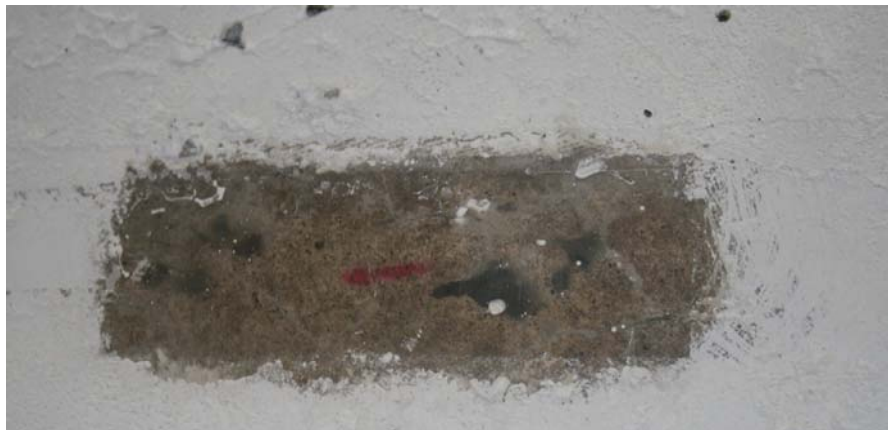
Figure 40: Surface Preparation

For the un-repaired bridge testing, the concrete surface preparation was attempted but was not successful because the 100% solid adhesive chosen at that time, Vishay M-Bond AE-10, could not cure at temperatures below 75°F. In an effort to solve this problem, under the advice of Vishay applications engineers, a different adhesive was chosen for the void filling process during this test. This adhesive, Vishay M-Bond 300, would allow for curing under a much broader range of temperatures. The curing requirements were: 24 hours at +40°F, 18 hours at +60°F, and 12 hours at +75°F. With this wide range of curing temperatures, the surface preparation was successfully performed. When the preparation was complete, each gage was bonded using Vishay M-Bond 200 and covered with Vishay Barrier E for protection. Figures 40, 41, and 42 illustrate some of these aspects with the strain gage application process.

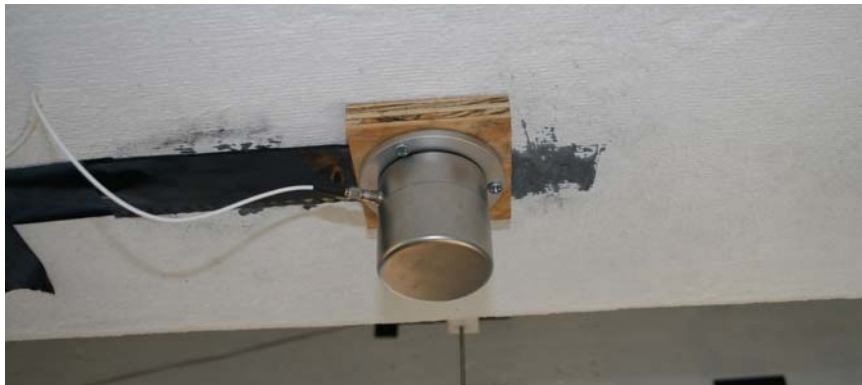
Figure 46: PCB 393C Accelerometer Mounted

A PCB Model 393C accelerometer was used to measure the vibration response of the bridge due to dynamic loading. The accelerometer was placed under the interior Girder #4 to closely reproduce the testing setup of the un-repaired bridge (see Figure 46). The data was collected using a Vishay System 6000 data acquisition system that allowed for using a data collection rate of 10,000 scans per second. Figure 47 illustrates the total instrumentation setup.

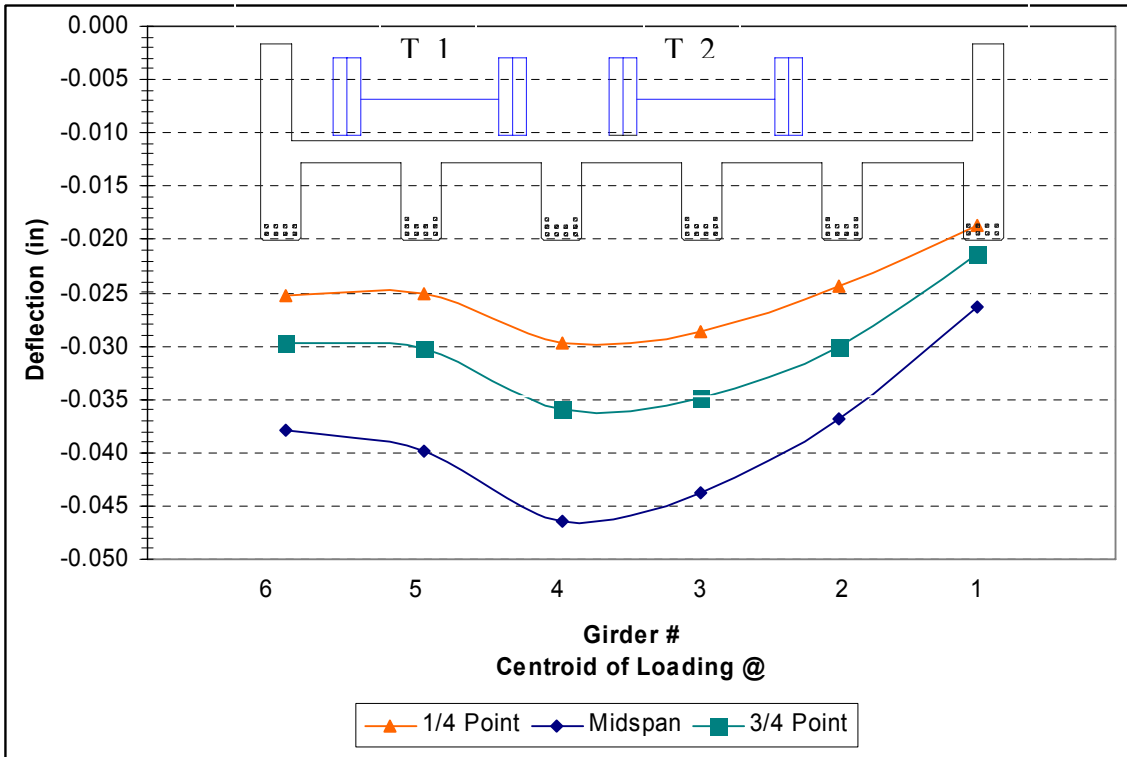
Figure 52: Load Case #1 – 2 Trucks

It is noted that this method of obtaining comparable values is reasonable for symmetric loading conditions only, since each wheel loads is different for the tandem trucks provided. A more accurate analysis can be performed using the FE model to verify the testing data since the FE analysis can include more accurately the individual axel loads and their corresponding locations on the bridge as shown in Section 4.1. As illustrated in the aforementioned deflection graphs, no significant changes are observed in the deflections of the un-repaired bridge and repaired bridge, indicating minor change of stiffness from externally bonded FRP strips. The deflection results for load case #1 – 2 trucks and load case #4 – 1 truck seem to indicate a possible malfunction in LVDT #1.

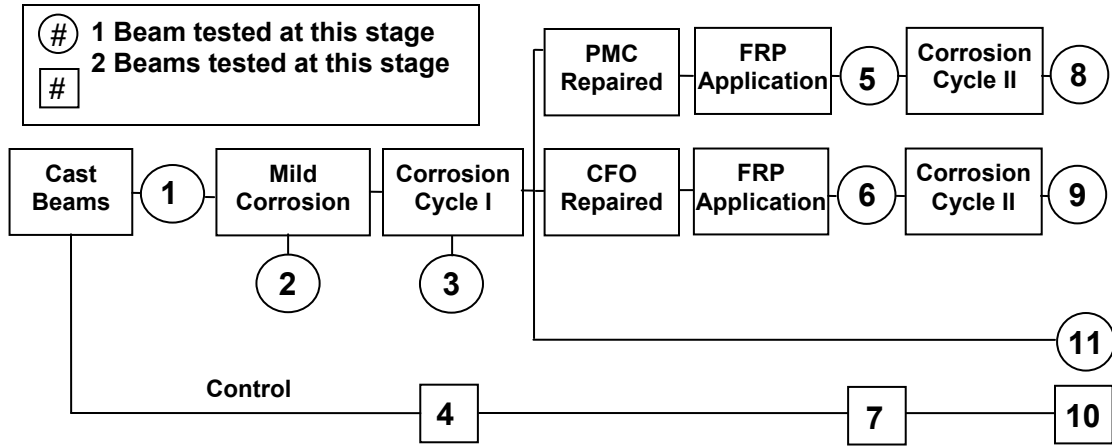
Figure 75: Schematic of experimental testing plan

The experimental program consisted of testing under 4-point bending load fifteen large-scale beams damaged by induced electric current. After repairing the concrete substrate using two different methods, and subsequent bonding of the CFRP flexural reinforcement and shear anchors after corrosion cycle I, some beam specimens were subjected to accelerated corrosion cycle II, and tested to failure in bending. The second-cycle corrosion-induced aging was used to indirectly evaluate long-term performance after CFRP retrofitting. As shown in Figure 75, the numerals indicate times at which static load tests were performed to failure. The numerals, which are lined up vertically in the figures, indicate control beams that were tested under flexure at the same age.

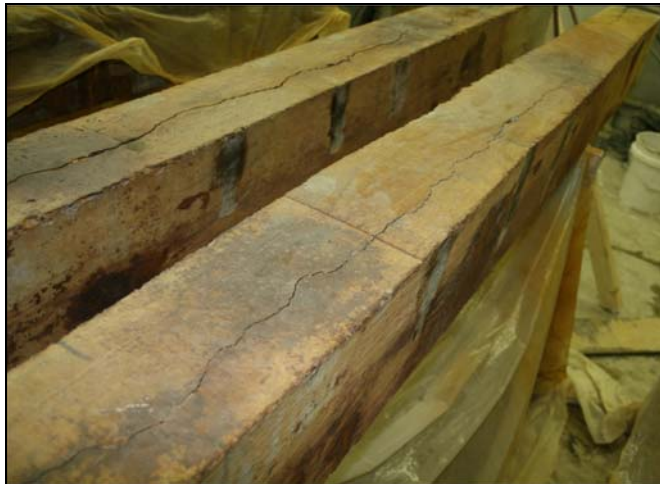
Figure 80: Typical extent of deterioration observed after initial corrosion

Figures 80 and 81 show the beams after corrosion cycles I and II, respectively, where severe material deterioration can be observed. After corrosion cycle II, it was observed that, for the PMC-repaired beam, cracks occurred within the old concrete running parallel above the patched concrete interface; and for the CFO-repaired beam, the cracks filled with epoxy were not visibly damaged, but new cracks formed above and parallel to the major filled cracks. This is because the epoxy-concrete interface was stronger than the deteriorated concrete itself. As shown in Figure 82, the corrosion resulted in deterioration of the laboratory specimens with similar characteristics to what was observed of bridges in the field. Table 11 lists the mass loss from different aging protocols, showing that longer corrosion period resulted in greater mass loss. When CFO-repaired beams were subjected to corrosion cycle II, a significant mass loss was observed. However, when PMC-repaired beams were subjected to the same corrosion cycle II, virtually no additional mass loss was observed.

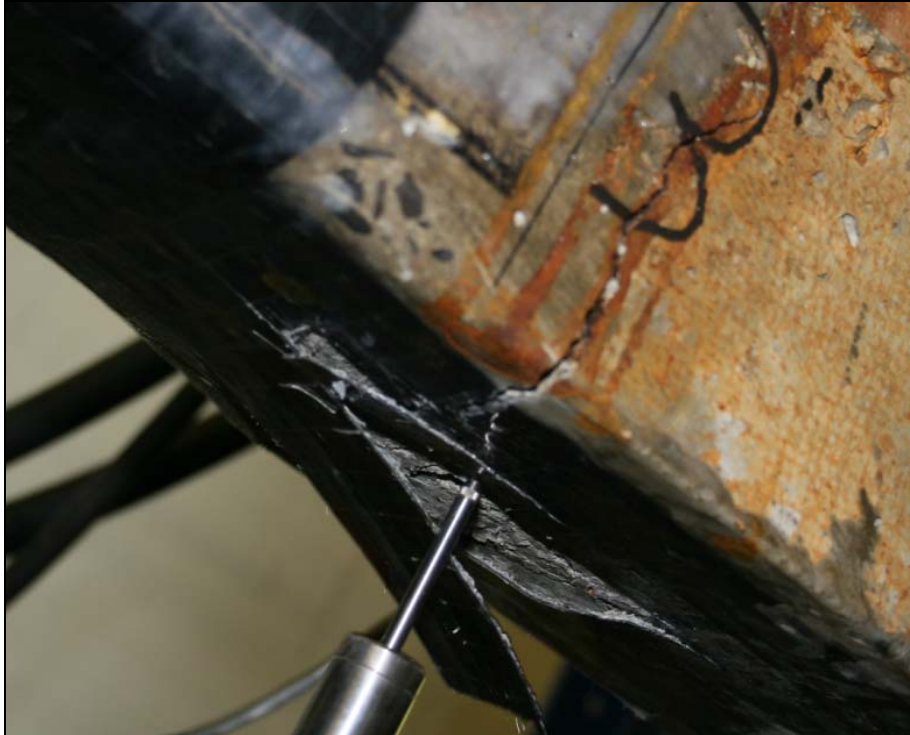
Figure 85: FRP rupture on PMC-repaired beam G-8

Photos of the FRP rupture of beams G-5 and G-8 (PMC-repaired), and G-6 and G-9 (CFO-repaired), are shown in Figures 84 through 87. Both PMC-repaired beams failed via crack-induced debonding and subsequent FRP rupture. Crack-induced debonding initiates at the location of a flexure crack where there is a high stress concentration at the FRP-concrete interface. When the stress level reaches a critical value, the crack instantly propagates along the FRP-concrete interface resulting in dramatic debonding of the FRP from the concrete. Due to the rapid redistribution of stress, the FRP ruptures at a location near the original concrete flexure crack. This debonding can be attributed to the high strength of the PMC-repaired concrete. The bond between the FRP and the concrete seemed to be sufficient.

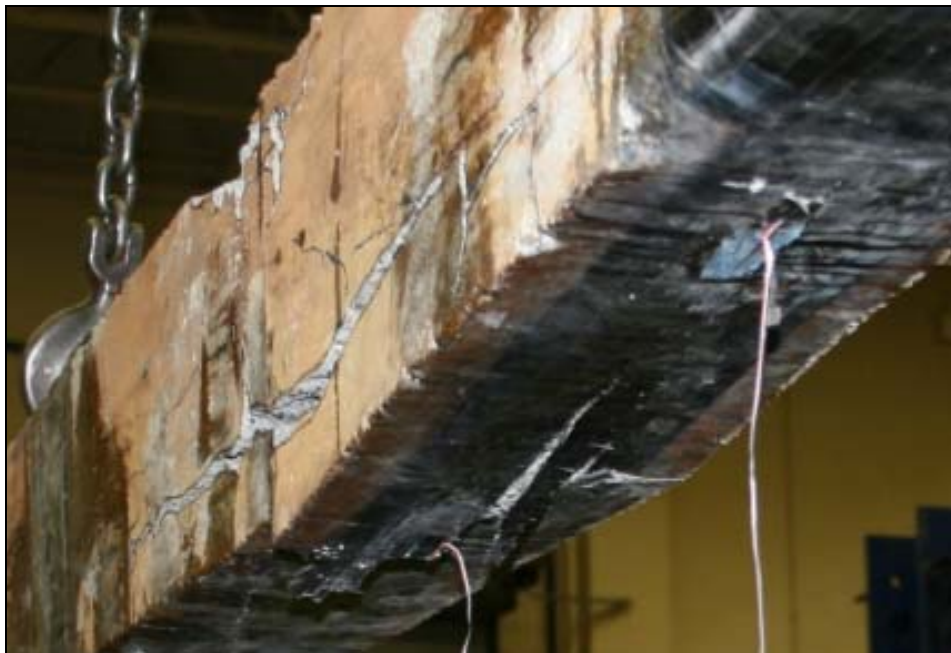
Figure 86: FRP rupture on CFO-repaired beam G-6

It was observed, however, that such sudden debonding did not occur for CFO-repaired beams. Instead, debonding occurred at the steel-concrete interface with subsequent cover delamination and FRP rupture. This behavior can be seen in Figures 86 and 87, which occurred probably because the steel-concrete bond was already weakened by corrosion cracking prior to static testing and the presence of corrosion products around the steel. It

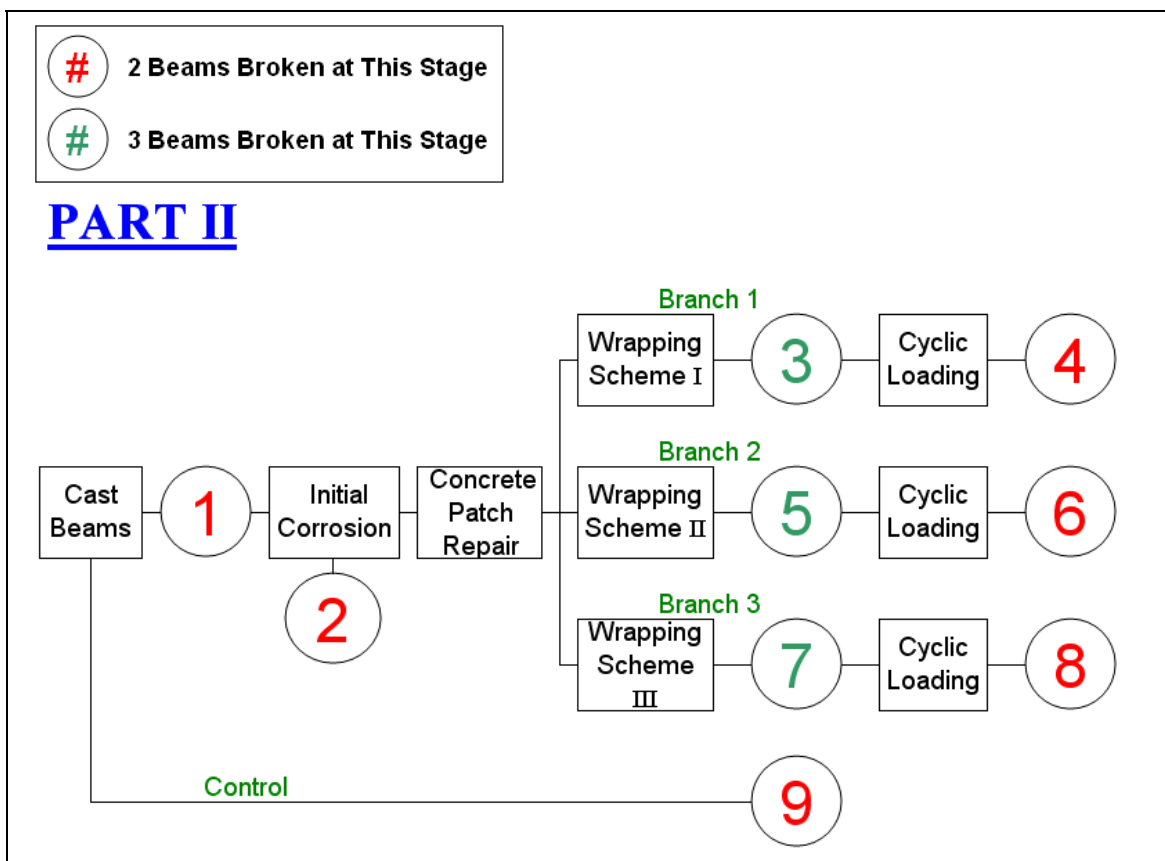
Figure 88: Schematic of experimental testing plan Part II

This study consisted of 21 large-scale reinforced concrete beam specimens which were cast using chloride contaminated, low-strength, highly porous concrete as described in Part I. The objective was to compare the performance of three unique FRP anchorage schemes under both static and cyclic loading. Scheme 1 consisted of flexural FRP only, scheme 2 consisted of flexural FRP plus two strategically placed anchor stirrups, and scheme 3 consisted of flexural FRP plus eight evenly spaced anchor stirrups.

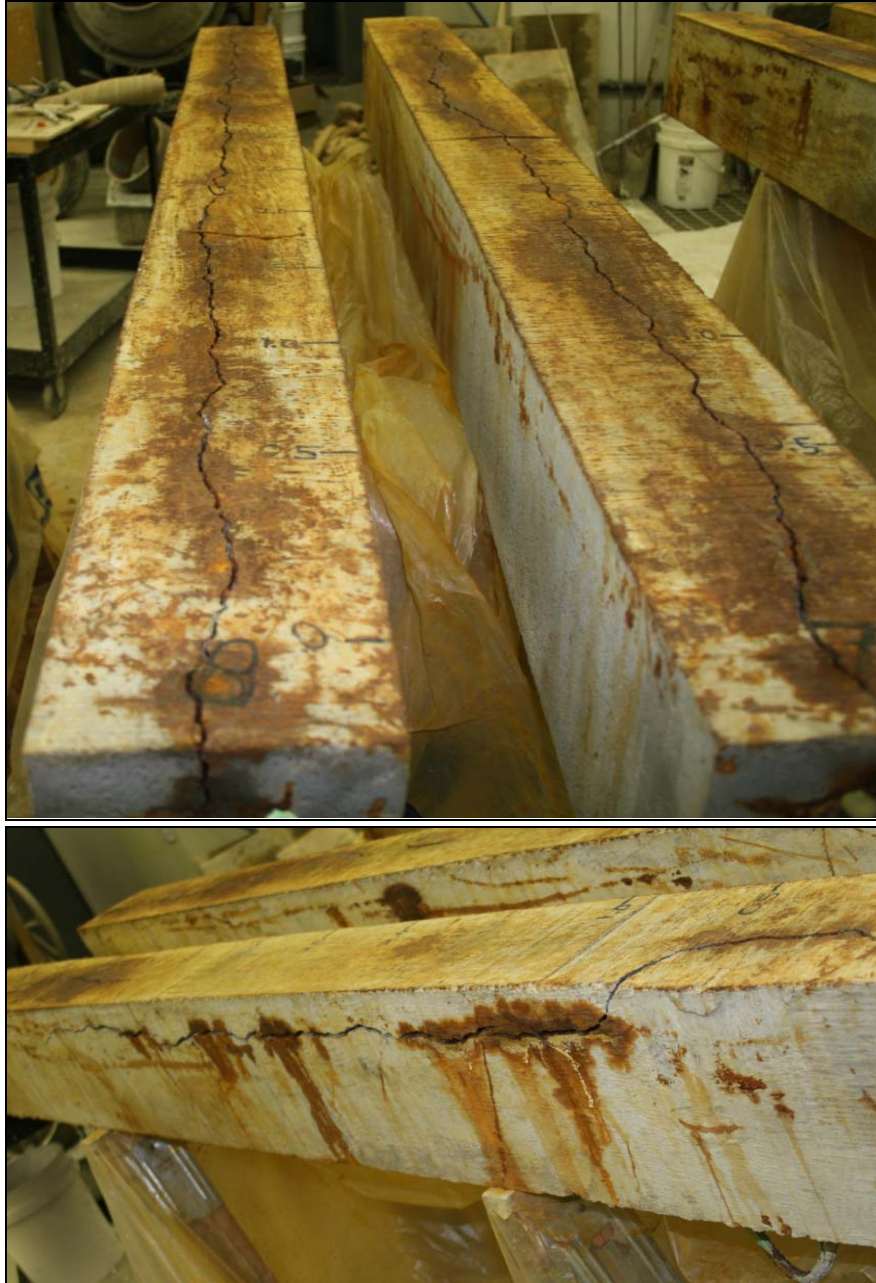
Figure 101: Typical deterioration of Part II beams prior to repair

The average percent mass loss for the FRP repaired beams subjected to $1,100\text{amp}\cdot\text{hours}$ (2,200 hours at a current of 500mA) was 22.5%. This magnitude of mass loss produced a substantial amount of concrete cover cracking and deterioration of steel-to-concrete bond. It should be noted that the average mass loss observed in the corroded unrepaired Beams II-3 and II-4 averaged a 1.7% greater mass loss than did the repaired beams. This difference is probably because these bars were encased in the chloride-contaminated concrete for a slightly longer amount of time than were the fifteen repaired beams. Typical deterioration of the beams are shown in Figures 101 and 102. A photo of Beam II-3 prior to concrete removal and steel extraction is provided in Figure 103. It should be noted that a natural mass loss of only 0.7% was observed in the long-term pristine beam at 34 weeks of age.

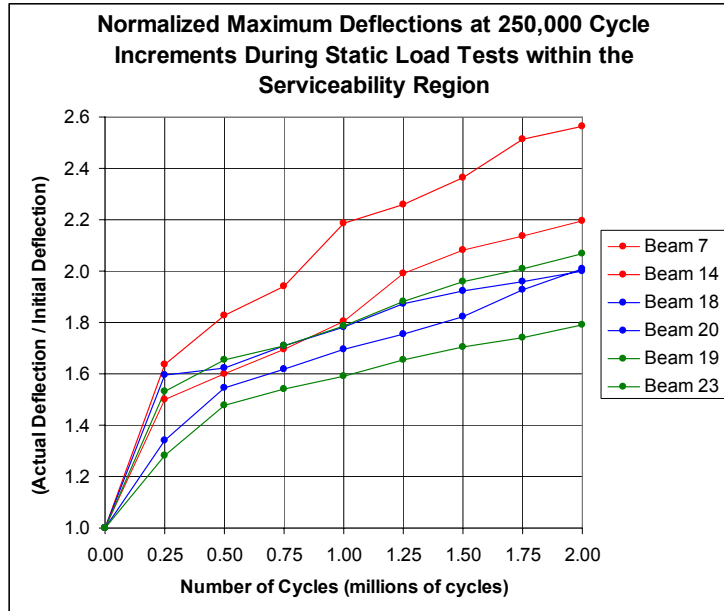
Figure 104: Decay of Part II fatigue-loaded beams as illustrated by normalized deflections at 250,000 cycle increments during static load tests within the serviceability region

The maximum deflection for beams repaired using Wrapping Scheme 1 was significantly higher than for beams repaired using Wrapping Schemes 2 or 3. The average normalized maximum deflection for Wrapping Scheme 1 beams was 2.38, while the average normalized maximum deflections for Wrapping Schemes 2 and 3 were 2.01 and 1.93, respectively. Therefore, when at least minimum anchorage was provided, deflections due to fatigue loading decreased significantly. More anchorage further reduced deflections, but only by a small amount. The range was largest for beams repaired with Scheme 1 and smallest for beams repaired with Scheme 3.

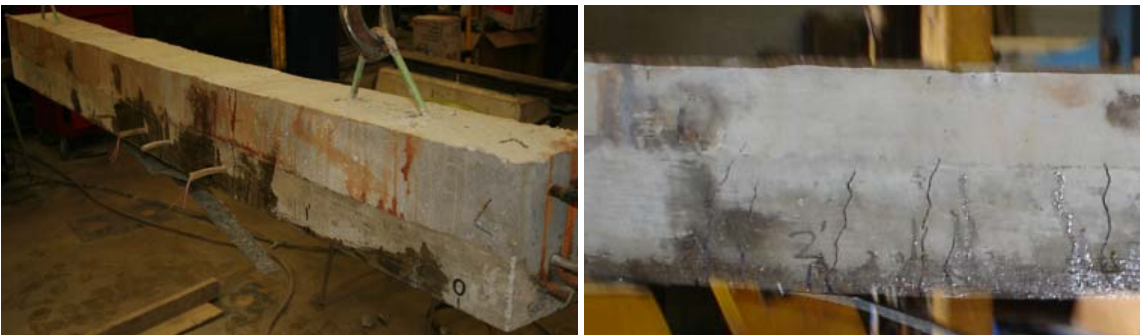
Figure 116: Photos of fatigued Part II beams repaired using Wrapping Scheme 1 after failure

Figure 116 presents photos of the statically-failed beams that were fatigued and beams that were repaired using Wrapping Scheme 1. The photo on the left is of Beam II-7 and the photo on the right is of Beam II-14. For the fatigued beams, vee-shaped cracking was not as prevalent (there were still very small v-shaped patches, but they were not nearly as pronounced as those observed on the non-fatigued beams). A possible reason for this was that either localized debonding or weakening of the epoxy-concrete interface occurred within the constant moment region during fatigue loading, which caused non-composite behavior. The strong bond closer to the beam ends may have held the FRP system in place, resembling the behavior of the prestressed beam. It should be noted that no visual observation could be made that suggested the weakening of the bond during fatigue loading or during static loading prior to failure.

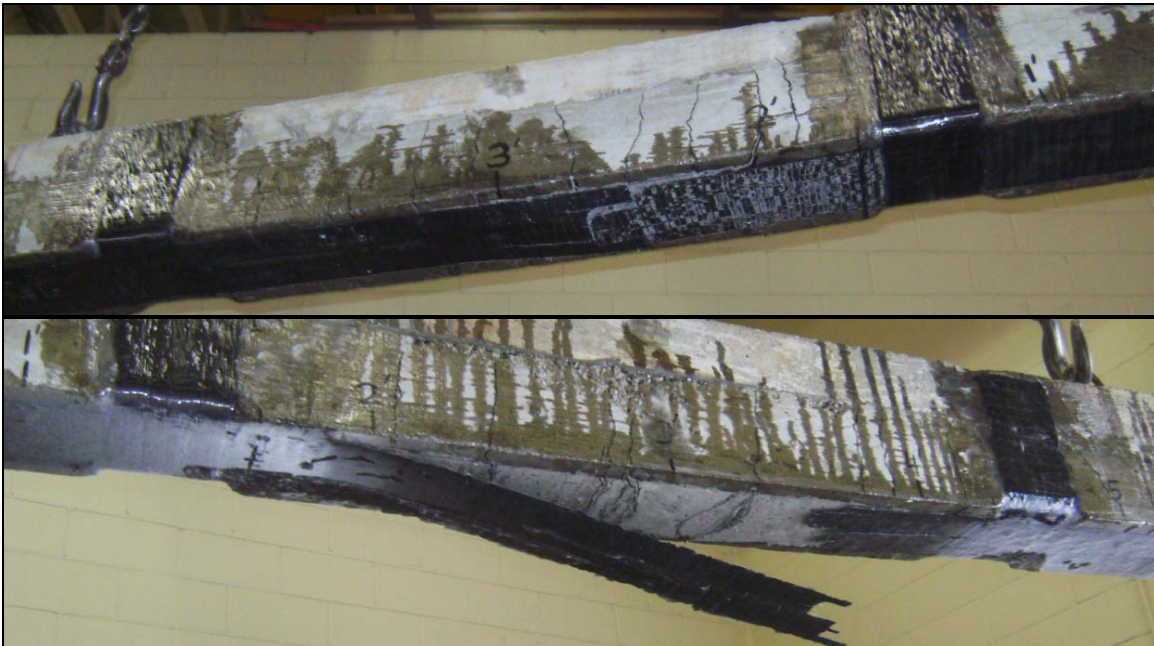
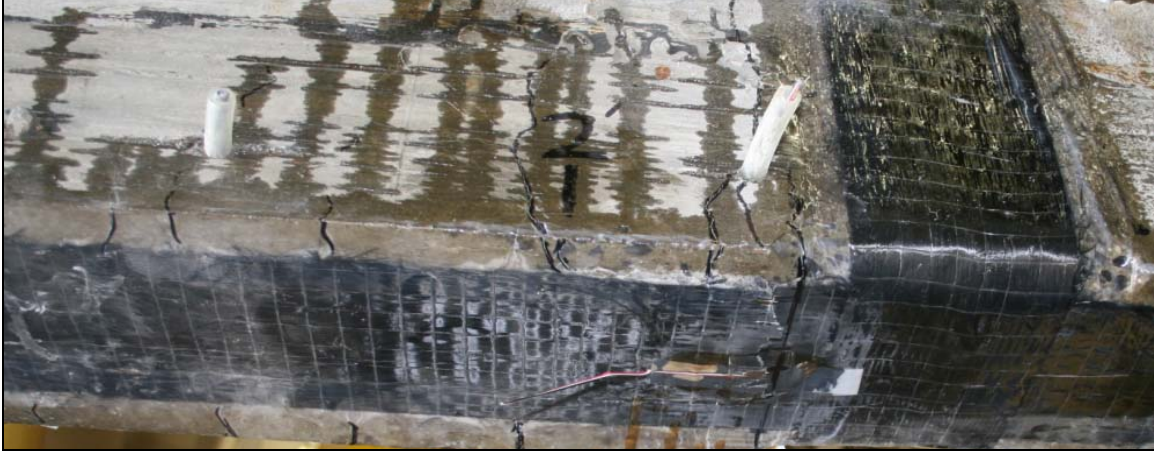
Figure 117: Photos of non-fatigued Part II beams repaired using Wrapping Scheme 2 after failure

Figure 117 shows photos of the statically-failed non-fatigued beams that were repaired using Wrapping Scheme 2. The top photo is of Beam II-13, the middle photo is of Beam II-15, and the bottom photo is of Beam II-17. Regions of dramatic delamination, as for

Scheme 1, were also observed to either side of the crack where crack-induced debonding occurred on Beams II-13 and 15. The anchors prevented the delamination from continuing beyond the stirrup locations. A very small area of delamination was observed adjacent to the rupture location on Beam II-17, which was near the anchor stirrup. Figure 118 displays photos of the statically-failed fatigued beams that were repaired using Wrapping Scheme 2. The photo on the left is of Beam II-18 and the photo on the right is of Beam II-20. The FRP rupture and delamination on these beams support the conjecture proposed for the fatigued Wrapping Scheme 1 beams. Notice how the FRP freely delaminated from Beams II-18 over almost the entire constant moment region and had multiple locations of partial rupture. Also, observe the lack of pronounced vee-shaped notches on the concrete tension face of Beam II-20.

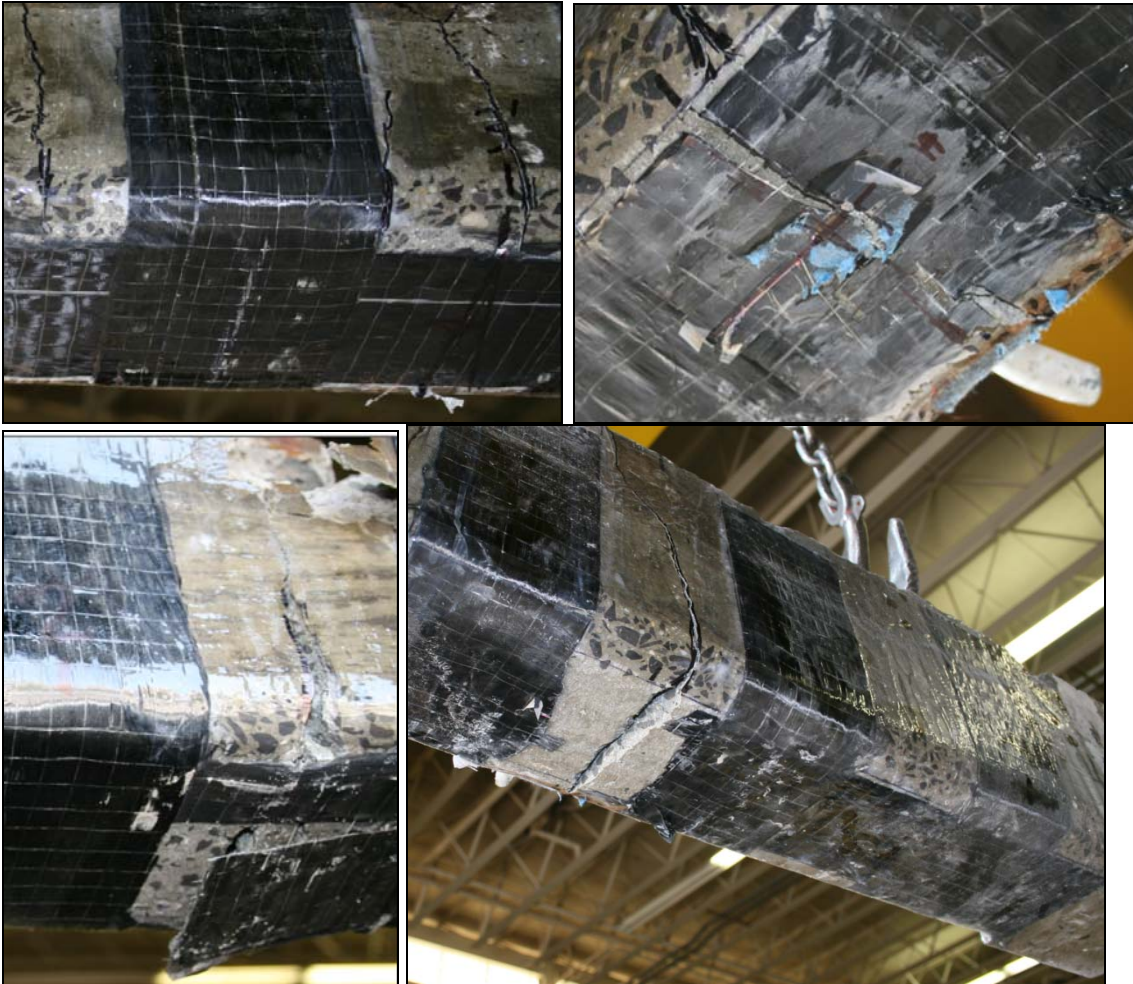
Figure 119: Photos of non-fatigued Part II beams repaired using Wrapping Scheme 3 after failure

Figure 119 presents photos of the statically-failed non-fatigued beams that were repaired using Wrapping Scheme 3. The top left photo is of Beam II-21, the top right photo is of Beam II-24, the bottom left photo is of Beam II-23, and the bottom right photo shows the pronounced vee-shaped crack on beam II-24 after the FRP was locally removed. The evenly spaced anchors greatly limited the size of FRP debonding areas at the time of failure. Failure in Beam II-21 occurred directly beneath the anchor stirrup, so no delamination was observed. The anchor stirrups confined the delamination on Beams II-22 and II-24 to within the 4in region between the transverse reinforcement.

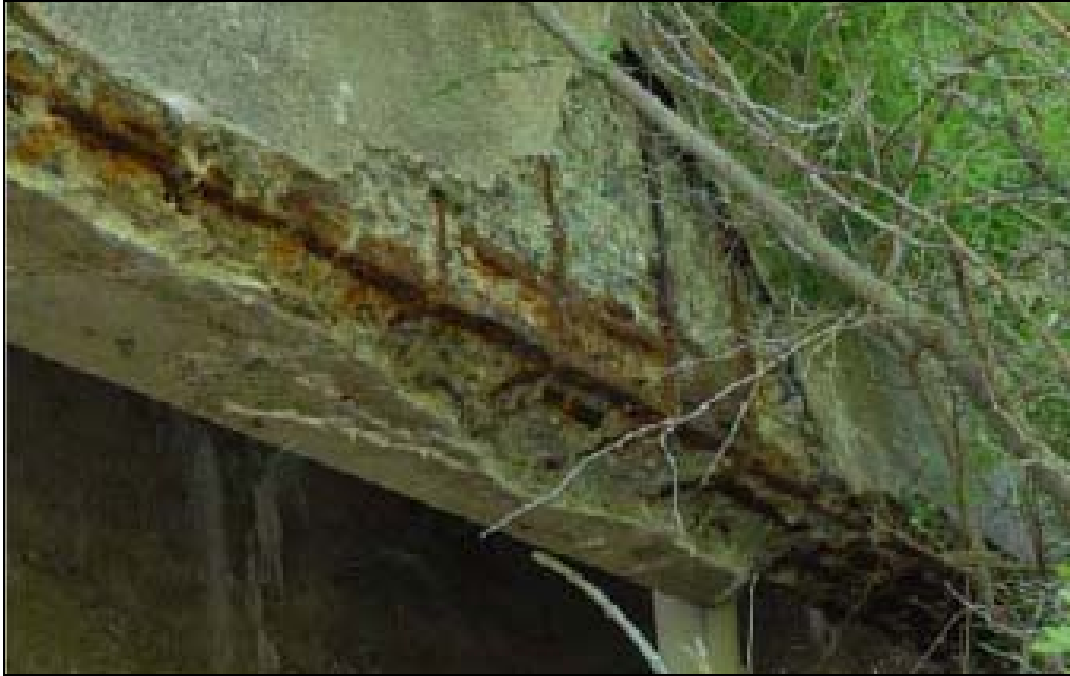
Observations of the corroded unrepaired beams during static flexure testing were very interesting since the deterioration closely resembled that typically seen in the field, as shown in Figure 122. Figure 122, which depicts what was observed on the severely-deteriorated exterior girder of #49-4012-0250-1032.

Figure 122 Figure Corroded exterior girder of PennDOT Bridge #49-4012-0250-1032

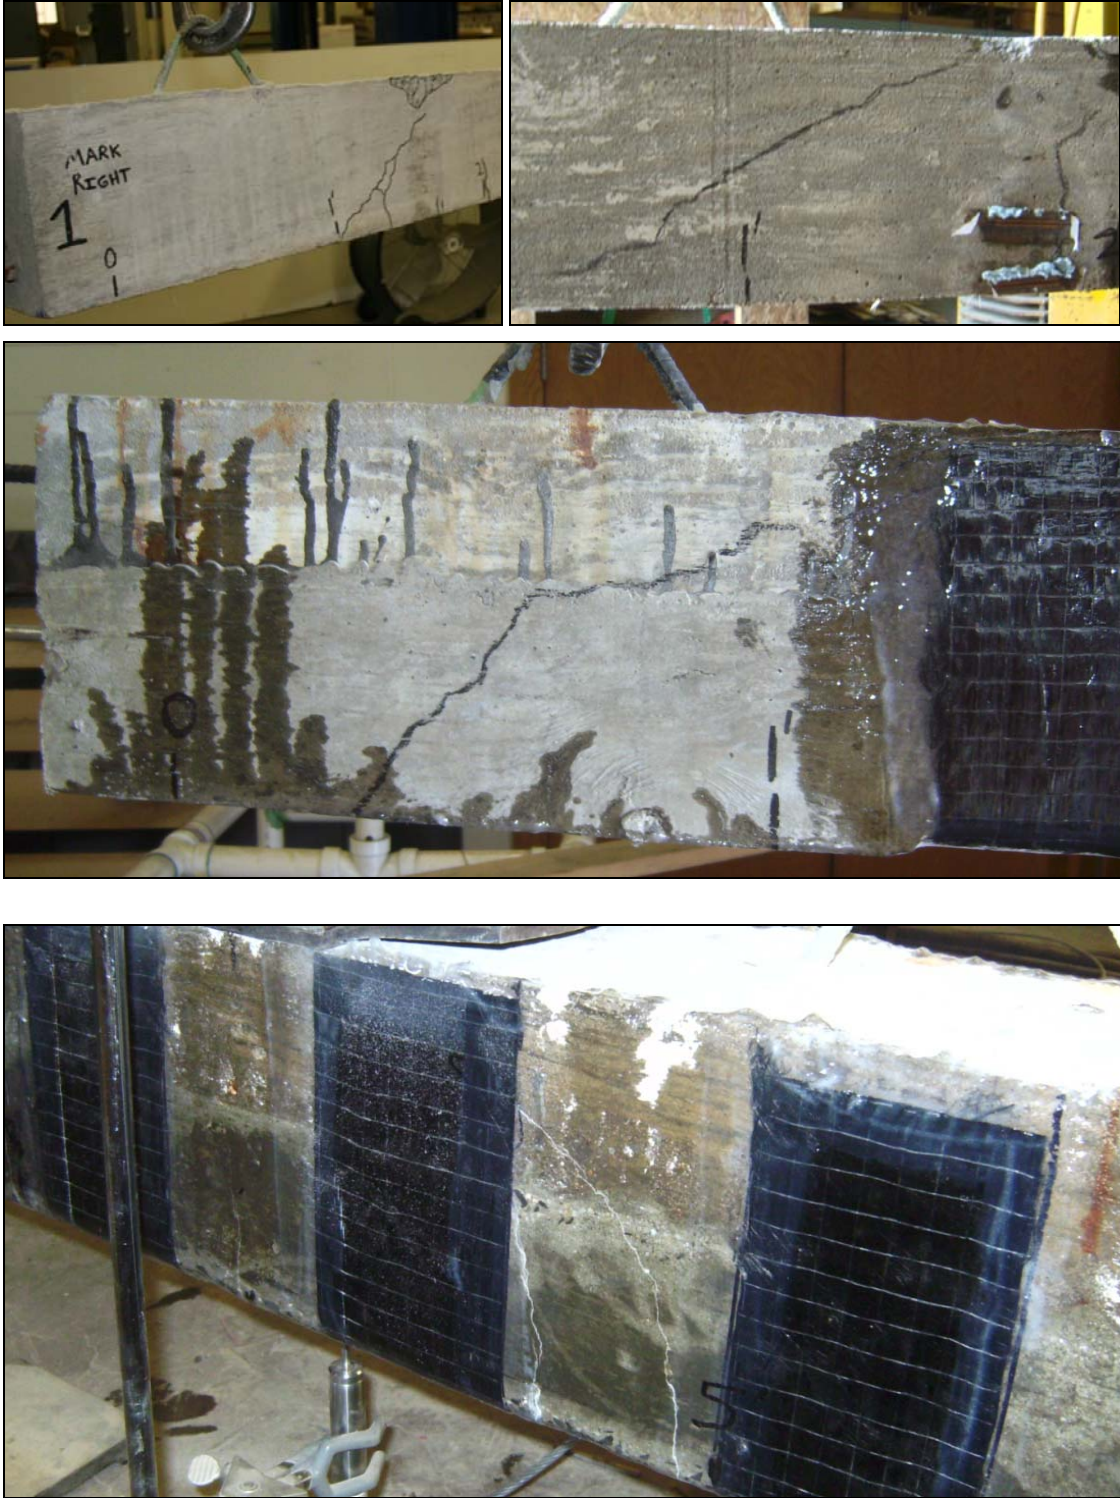
Figure 123: Typical shear flexure cracks observed on Part II beams

Another observation to note is the formation of a shear-flexure crack on most beams. This crack would begin on most beams as a flexure crack, and then begin to propagate at a 45° upward and toward the midspan as the load increased. Some examples of these shear-flexure cracks are displayed in Figure 123; from top to bottom are photos of Beams II-1, II-11, II-15, and II-21 respectively. Interestingly, these shear-flexure cracks were not observed in the corroded unrepaired specimens nor were they observed in the non-fatigued beams repaired with Wrapping Scheme 1 (they were observed on fatigued Scheme 1 beams). For beams repaired with Scheme 3, as in the bottom photo of Figure 123, multiple shear-flexure cracks were typically observed within the same region. The transverse FRP, however, appeared to terminate the growth of these cracks once they reached and propagated beneath the stirrups.
