District 3-0 Investigation of Fiber Wrap Technology for Bridge Repair and Rehabilitation (Phase III)

FINAL REPORT

January 14, 2010

By Julio F. Davalos, An Chen,
Indrajit Ray, Adam Justice
and Matthew Anderson
West Virginia University

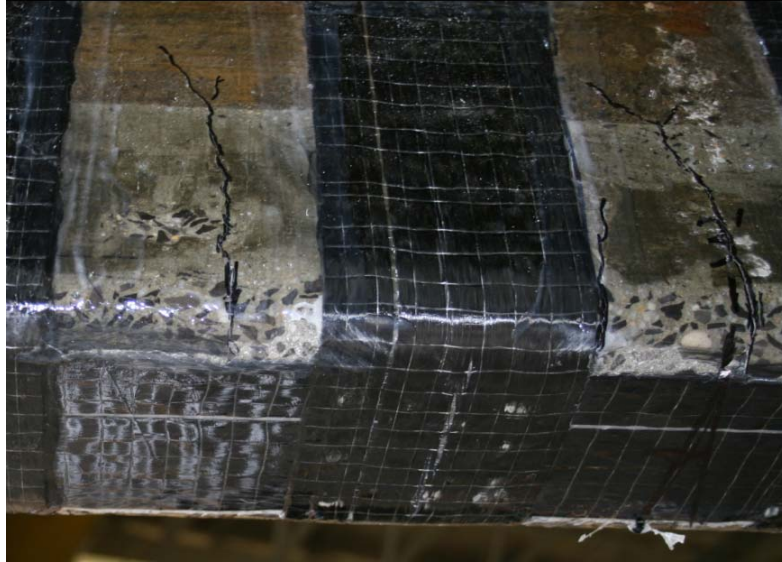
Figure 124: Composite action between old and new concrete on Part II beams as evidenced by cracking continuity across interface

After witnessing all the Part II static tests, it was determined that there was an excellent bond and composite action between old concrete and the polymer-modified repair-concrete. This is illustrated by the cracking seen in Figure 124. Cracks propagated across the interface of the two materials as if they were one material. Even in the shear spans where the patch material did not completely encase the steel, no horizontal cracking was observed along the interface and no debonding of the patch material was detected.

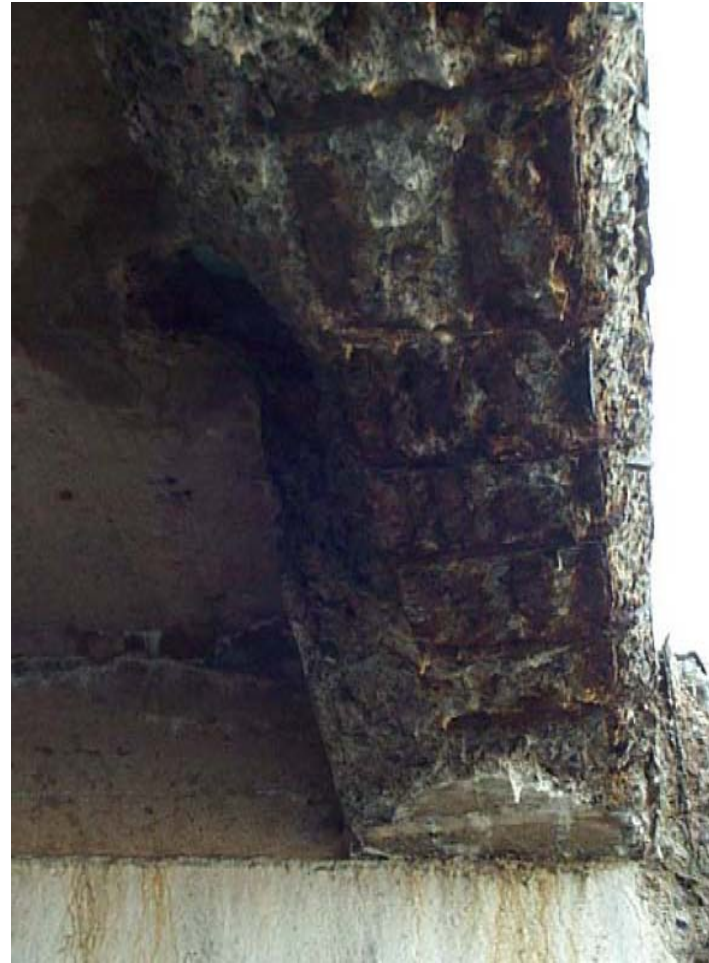
Photo on left: NCHRP Report 514, an example of a T-beam suitable for FRP-wrap technology

Photo on right: Provided by PennDOT for bridge #59-0045-0310-2011

Note: This is a likely candidate for repair. This bridge scored high because of its high traffic volume and similarities in damage to the NCHRP Report 514. This bridge ranked high even though it scored relatively low in the span and age categories.

Visual Damage:
Ranking: 10/10

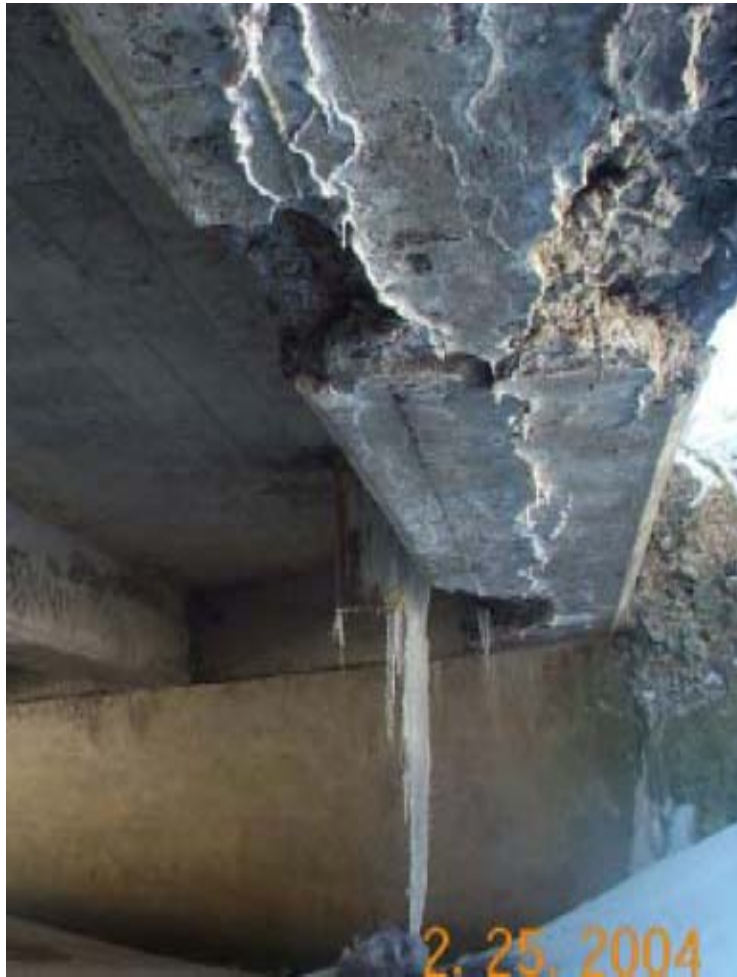
Photo on left: NCHRP Report 514, an example of a T-beam suitable for FRP-wrap technology

Photo on right: Provided by PennDOT for bridge #54-0522-0090-1932

Note: Though this bridge carries a lot of traffic, and ranked high in the span category, it is ranked into Class #2 because of the extent of the visual damage. This bridge would be suitable for repair by fiber-wrap technology.

Visual Damage:
Ranking: 6.67/10

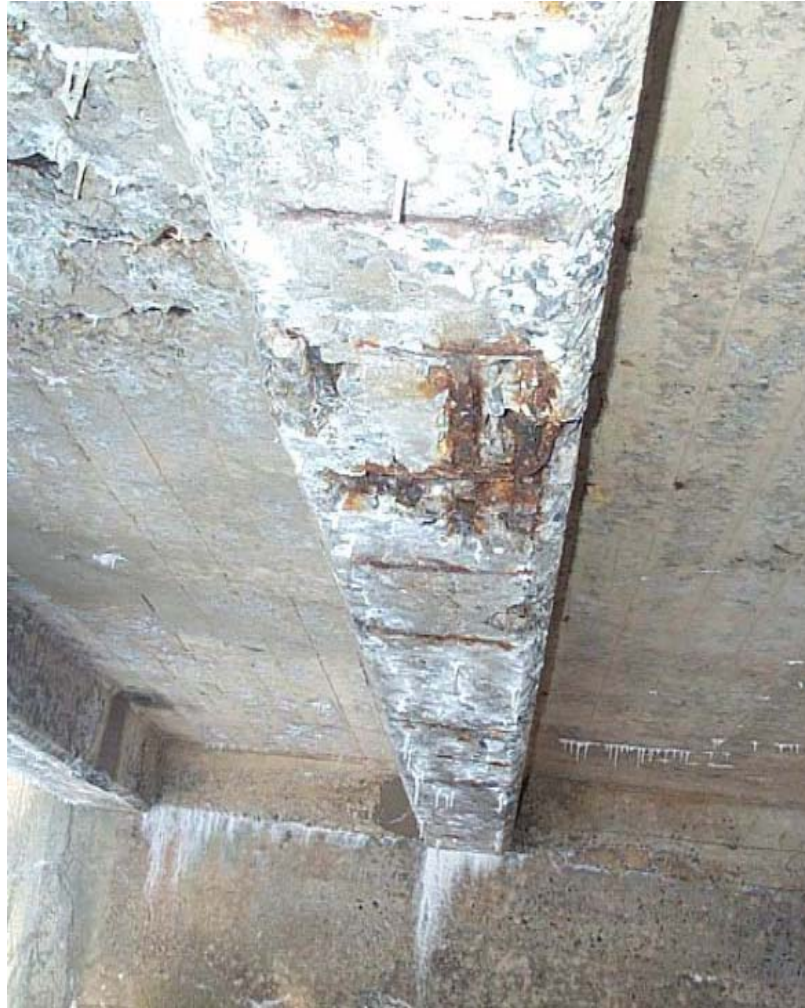
Photo on left: NCHRP Report 514, an example of a T-beam suitable for FRP-wrap technology

Photo on right: Provided by PennDOT for bridge #19-3008-0100-0039

Note: This bridge ranked low overall because of low traffic volume, short span, and old age. Also, the visual damage was not as severe as many of the other bridges. This is an example of a bridge which may not be a good candidate for FRP technology.

Visual Damage:
Ranking: 3.33/10
