**CERCLA
EXPANDED SITE INSPECTION**

**ST. LOUIS SMELTING AND REFINING
COLLINSVILLE, ILLINOIS
ILD980607006**

**PREPARED BY:
ILLINOIS ENVIRONMENTAL PROTECTION AGENCY
BUREAU OF LAND
DIVISION OF REMEDIATION MANAGEMENT
OFFICE OF SITE EVALUATION**

SEPTEMBER 19, 2003

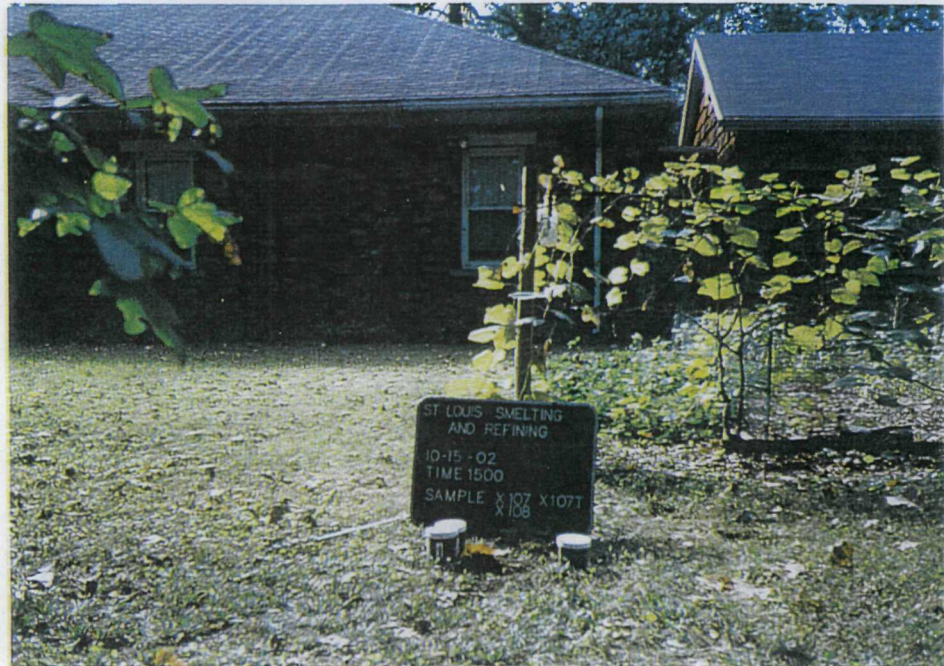
COMMENTS: Photo of soil sample location X107 and duplicate sample, X108. Also pictured is soil sample X107T. Address: 102 Pine Lake Drive

Soil sample X107 and a duplicate, X108 were taken from 3 to 6 inches below ground surface. Soil that was obtained for X107 and X108 was placed in a stainless steel pan, mixed thoroughly, then placed alternately into sample containers for both X107 and X108. Soil samples X107 and X108 were obtained from location R91 at 102 Pine Lake Road, five feet east of the garden and approximately 20 feet east of the northeast corner of the home. An additional sample, X107T was obtained from location R91 and was submitted for TCLP metals analysis.

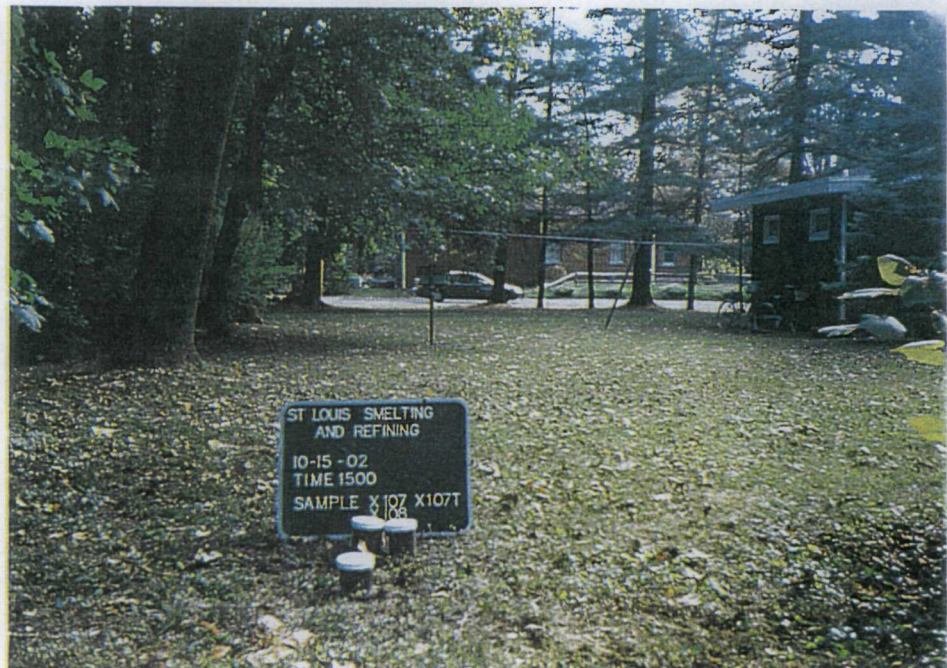
COMMENTS: Photo of soil sample location X107 and duplicate sample, X108. Also pictured is soil sample X107T. Address: 102 Pine Lake Drive

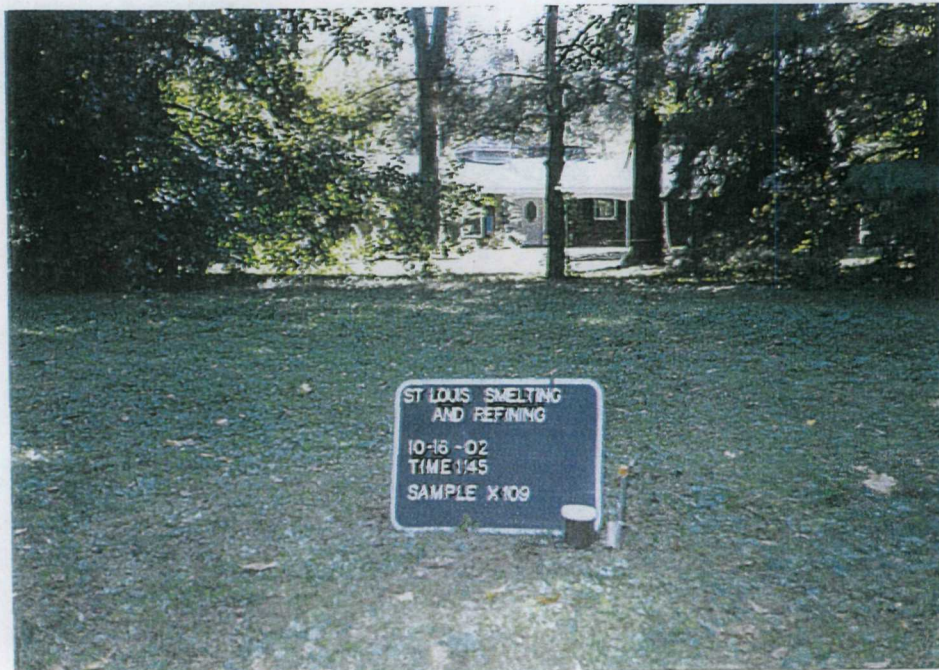
COMMENTS: Photo of soil sample location X109 at 210 Pine Lake Road

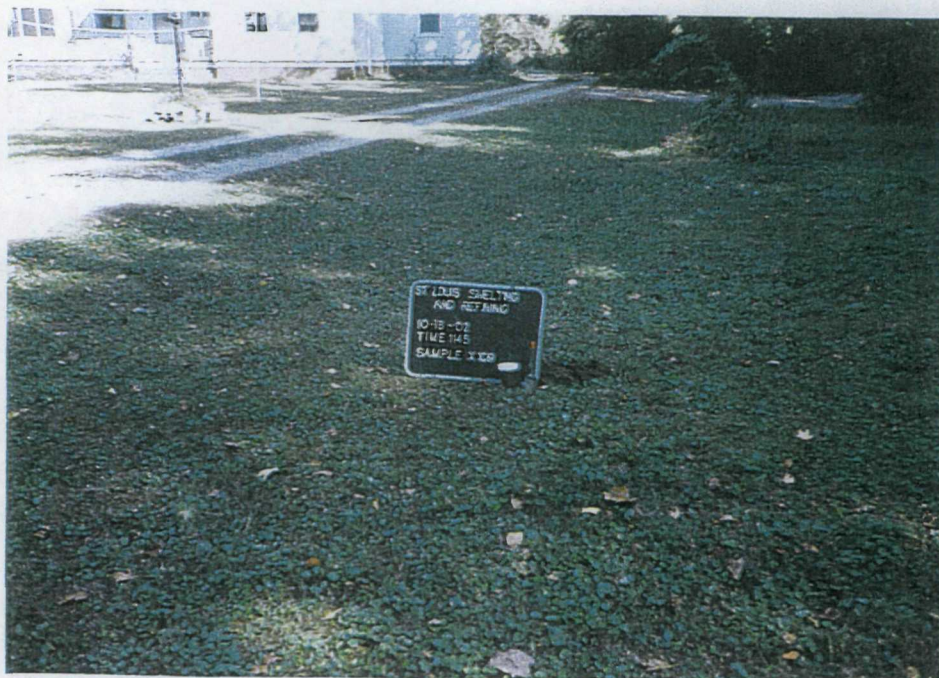
COMMENTS: Photo of soil sample location X109 at 210 Pine Lake Road

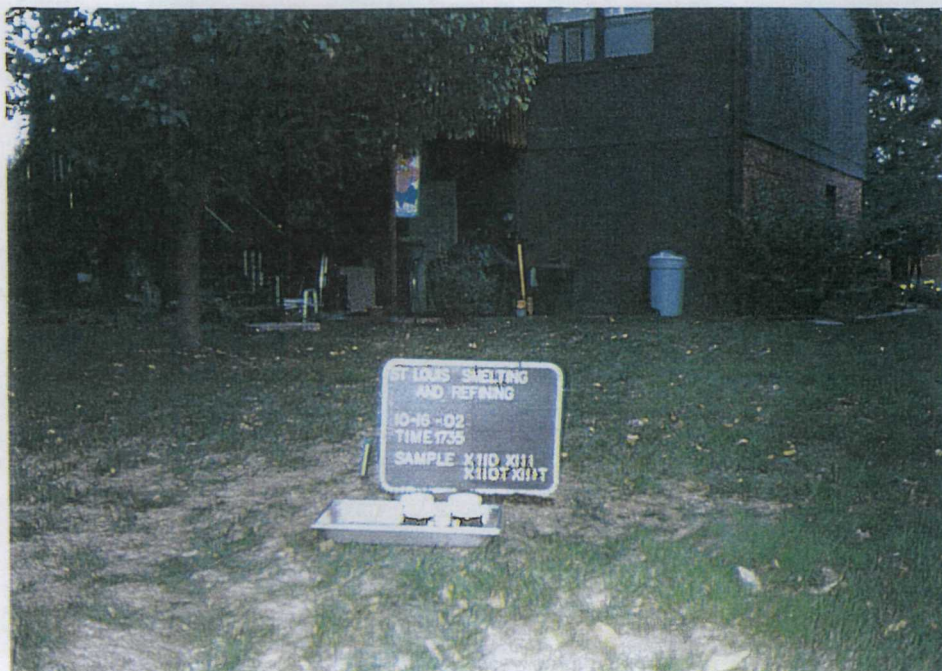
COMMENTS: Photo of soil sampling location for X110, X111, X110T and X111T. Sample location at 1973 Raintree Trail.

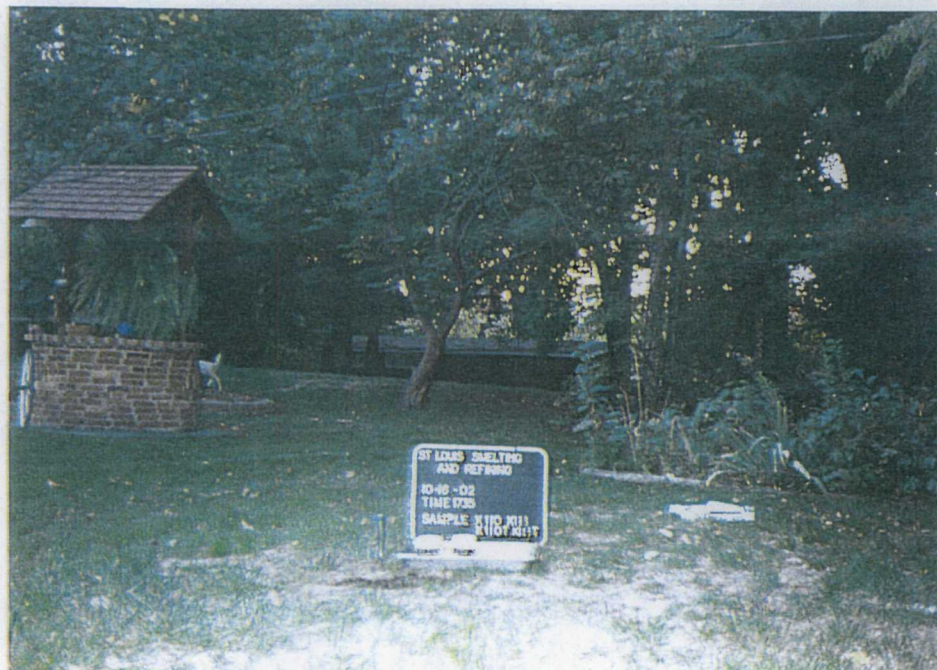
COMMENTS: Photo of soil sampling location for X110, X111, X110T and X111T. Sample location at 1973 Raintree Trail.

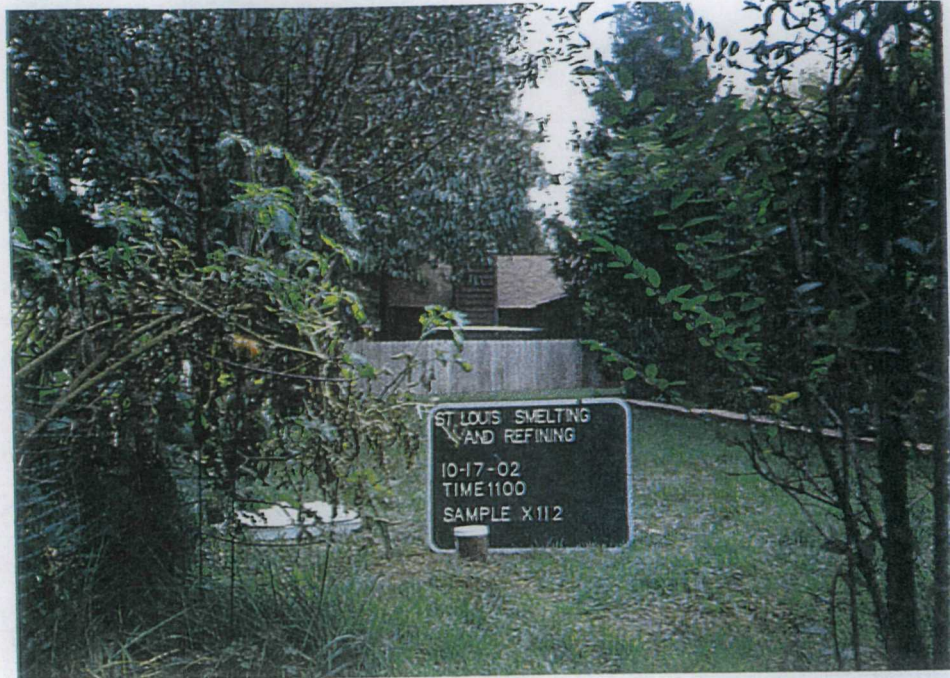
COMMENTS: Photo of soil sampling location X112 at 2001 Raintree Trail

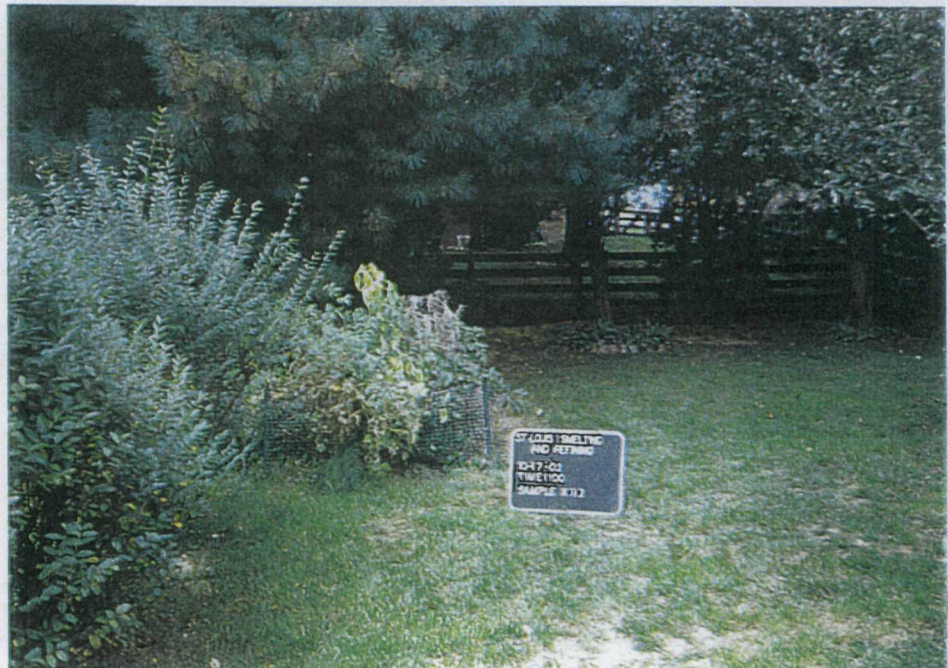
COMMENTS: Photo of soil sampling location X112 at 2001 Raintree Trail

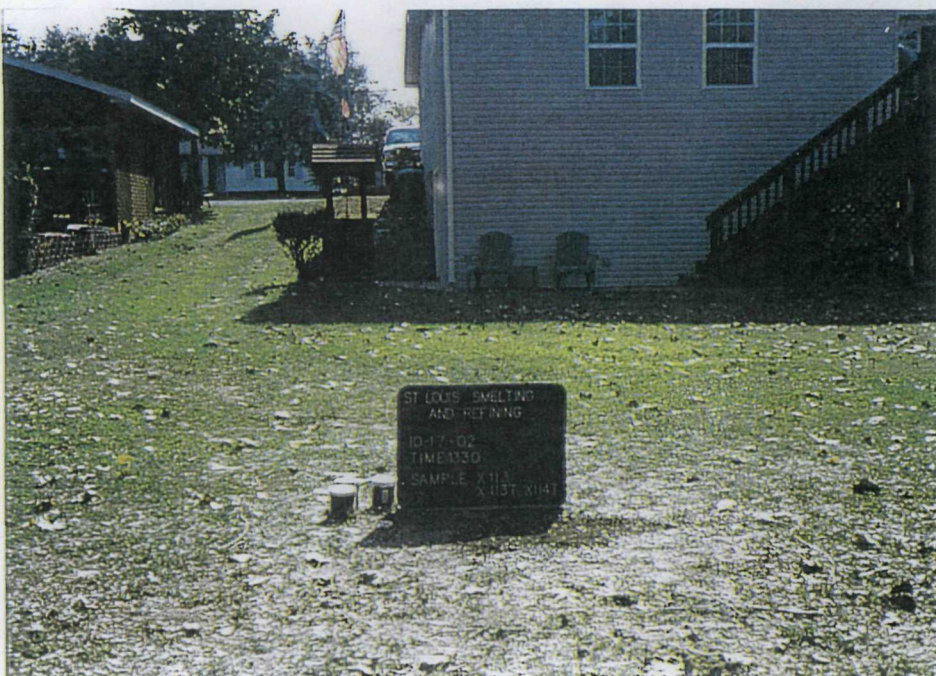
COMMENTS: Photo of soil sampling location X113, X113T and X114T. (X114T is a duplicate of X113T). Sample location at 1407 California Avenue

Soil sample X113 was taken from 12 inches bgs at location R123. Location R123 was obtained in the back yard of 1407 California Avenue, approximately 36 feet north of the house in a small spot with no grass. Samples X113T and X114T (duplicate of X113T) were also obtained from location R123, between 18 and 24 inches below ground surface. Soil that was obtained for X113T and X114T was placed in a stainless steel pan, mixed thoroughly, and then placed alternately into sample containers for both X113T and X114T. Samples X113T and X114T were collected and analyzed for TCLP metals.

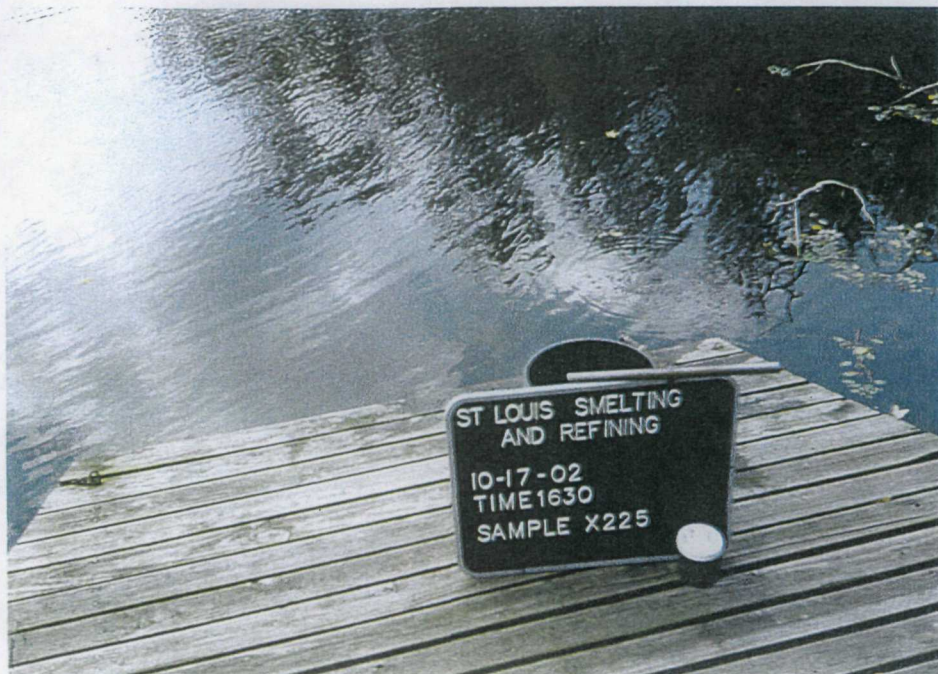
COMMENTS: Photo of sediment sampling location X225 from east side of Pine Lake. (Photo actually about 10 feet east of where sample obtained)

Sample X225 represents the probable point of entry (PPE) for Pine Lake and sample X227 is the PPE for the unnamed pond. Both samples had lead concentrations that met observed release criteria. Lead concentrations in X225 and X227 were 35,900 ppm and 5,840 ppm, respectively and can be attributed to the contaminated soil source.

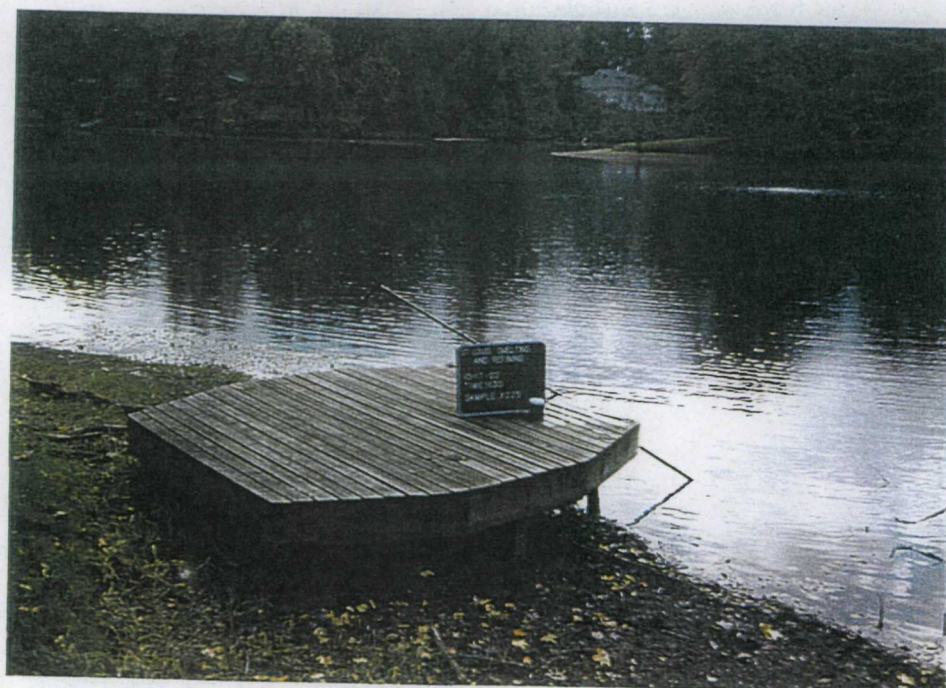
COMMENTS: Photo of sediment sampling location X225 from east side of Pine Lake. (Photo actually about 10 feet east of where sample obtained)

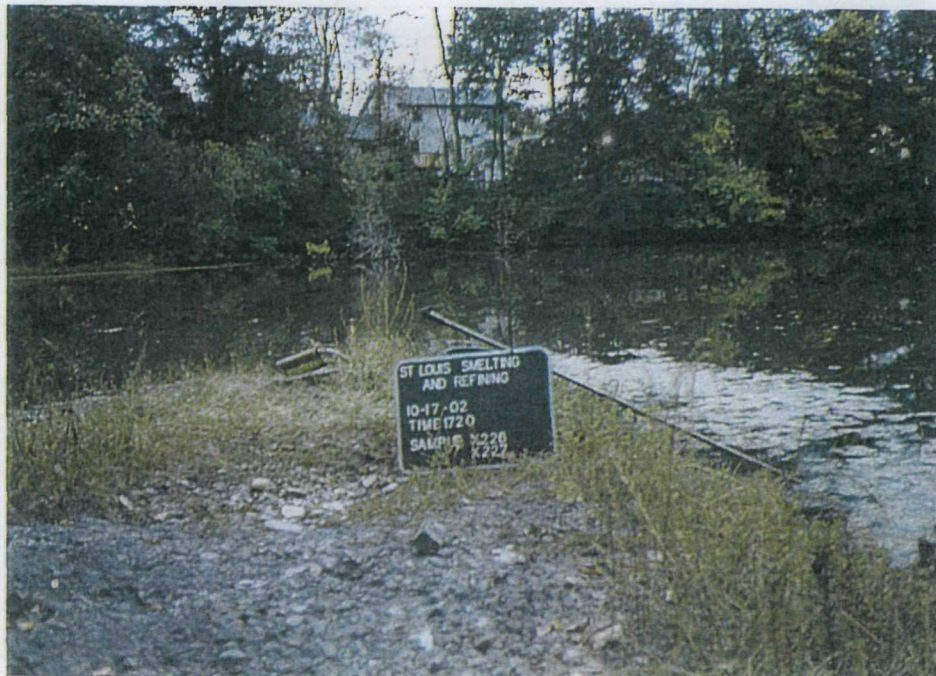
COMMENTS: Photo of sediment sampling location X226 and duplicate sample X227 from west side of Unnamed Pond. (Photo actually about 5 feet north of where sample obtained)

Samples X226 and X227 were taken from the northwest shore of the unnamed pond in an area where a significant portion of the shore is made up of slag, but at locations 2 – 3 feet out into the pond, most of the sediment is unconsolidated naturally occurring material. Sample X227 is a duplicate of X226. Sediment that was obtained for X226 and X227 was placed in a stainless steel pan, mixed thoroughly, and then placed alternately into sample containers for both X226 and X227. Samples X226 and X227 were obtained from 3 – 5 inches deep in the sediment, below several large chunks of slag. Samples X226 and X227 were intended to determine if runoff from both slag materials and the facility proper impacted sediments in the pond. (Although the area where the unnamed pond now exists has always been lower in elevation than surrounding land to the northwest, the pond was not constructed until after 1968.)

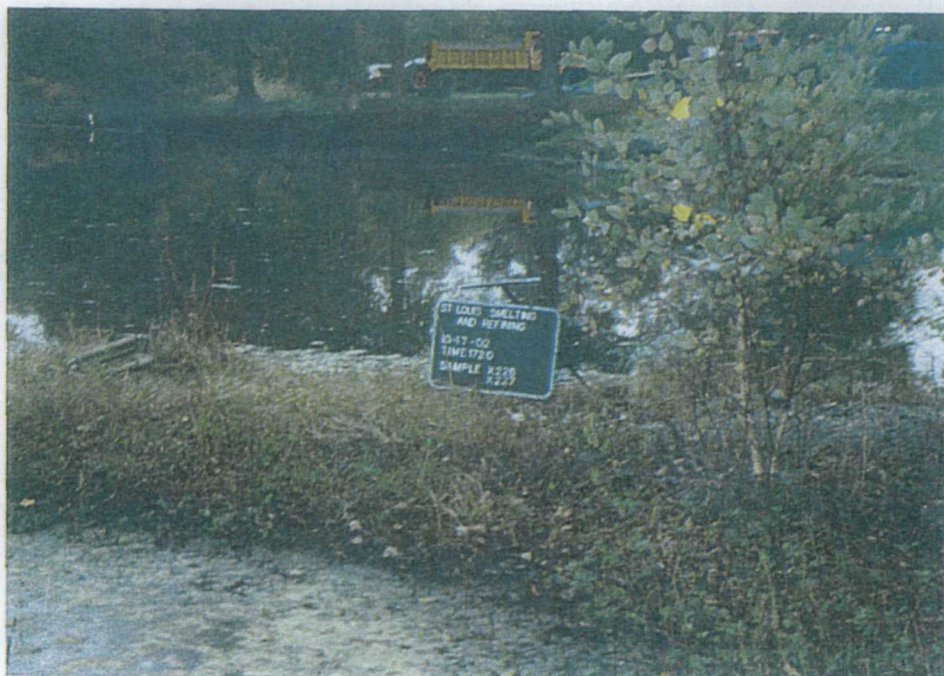
COMMENTS: Photo of sediment sampling location X226 and duplicate sample X227 from west side of Unnamed Pond. (Photo actually about 5 feet north of where sample obtained)

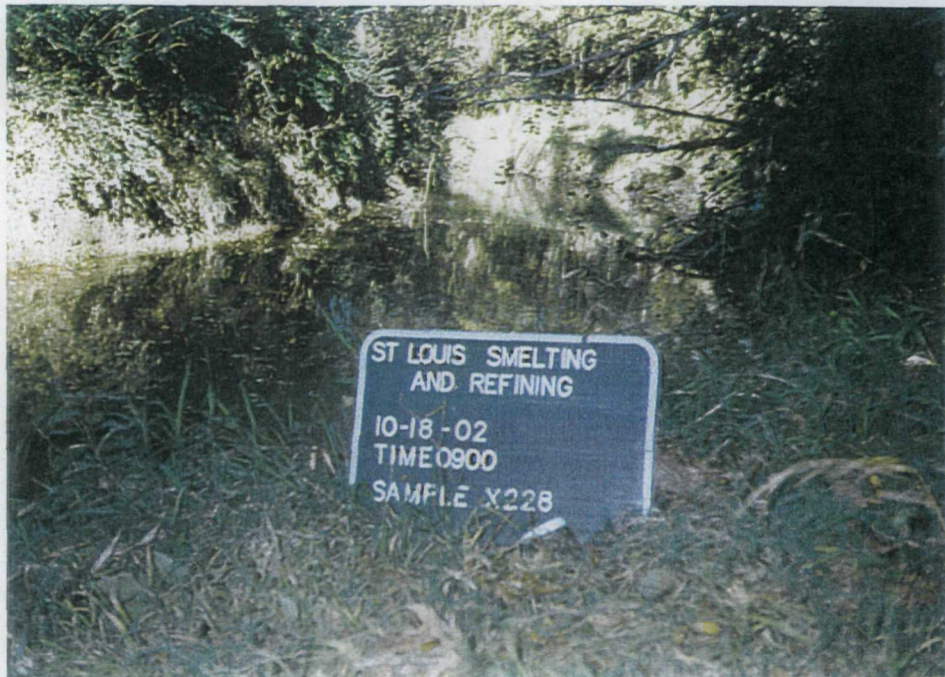
COMMENTS: Photo of sediment sampling location X228, downstream of facility and unnamed pond (Photo actually about 15 feet east of where sample obtained)

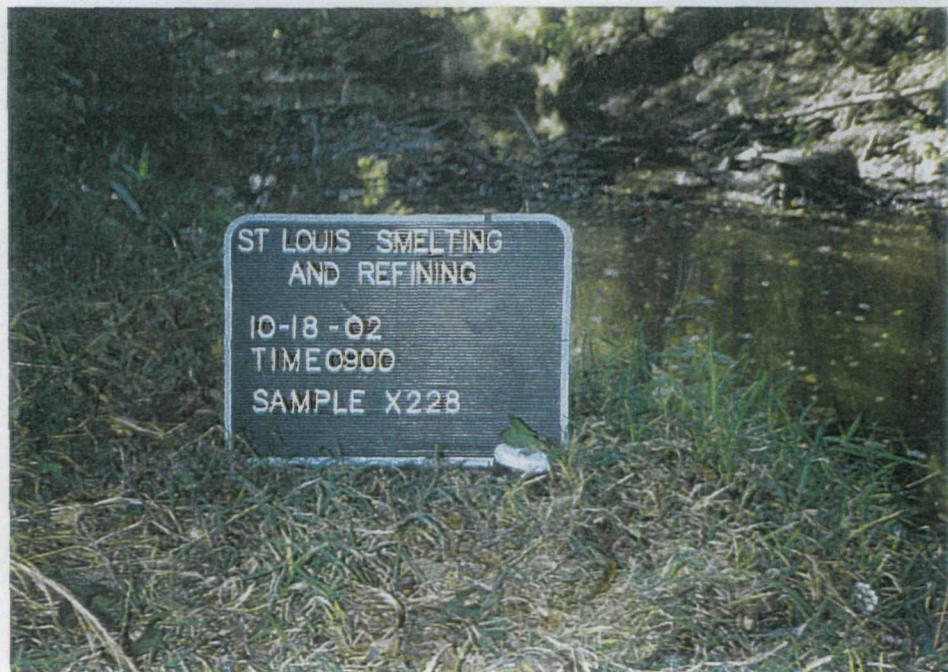
COMMENTS: Photo of sediment sampling location X228, downstream of facility and unnamed pond (Photo actually about 15 feet east of where sample obtained)

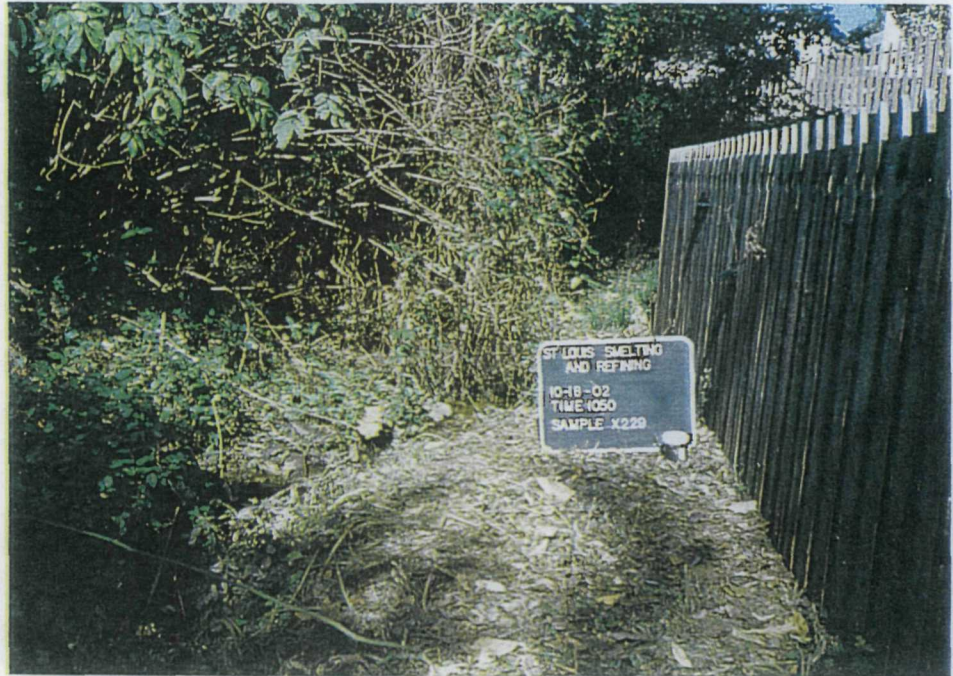
COMMENTS: Photo of
sediment sampling
location X229, drainage
way west of Pinehurst
Court

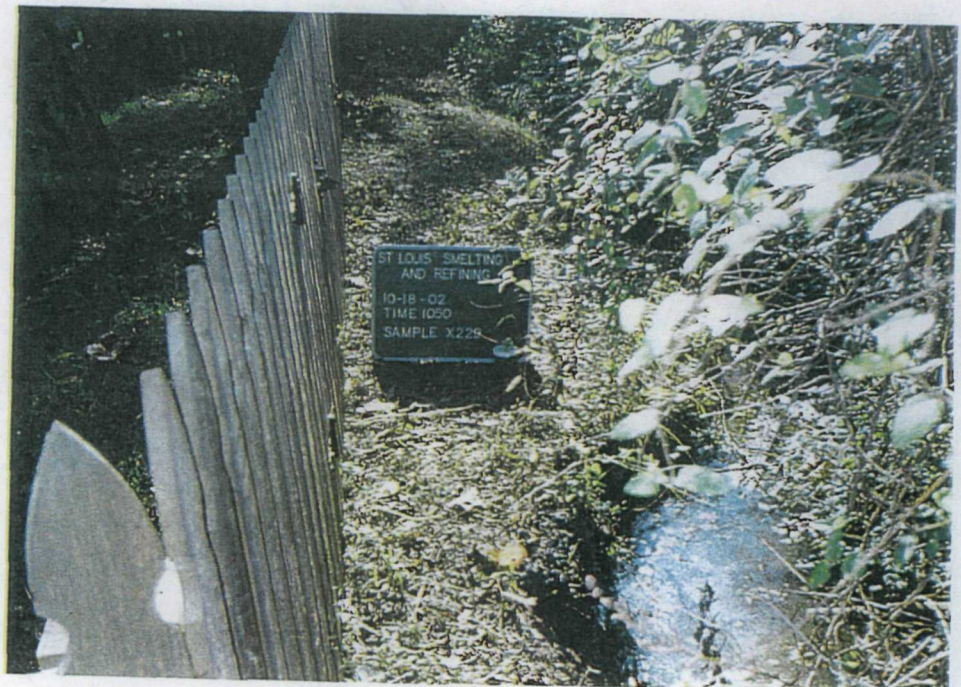
COMMENTS: Photo of
sediment sampling
location X229, drainage
way west of Pinehurst
Court

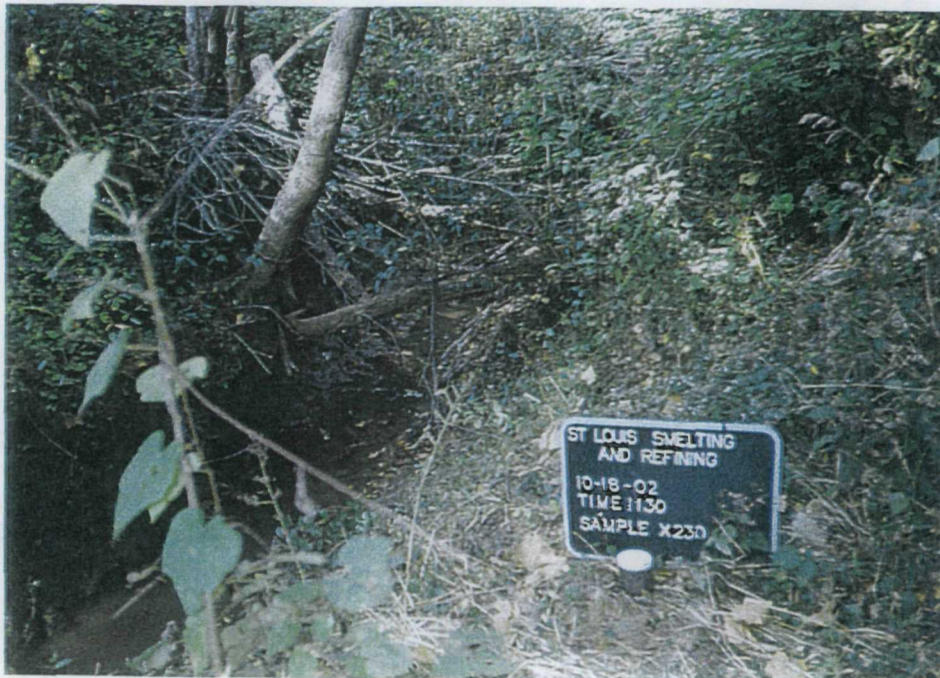
COMMENTS: Photo of
sediment sampling
location X230, drainage
way east of Pinehurst
Court

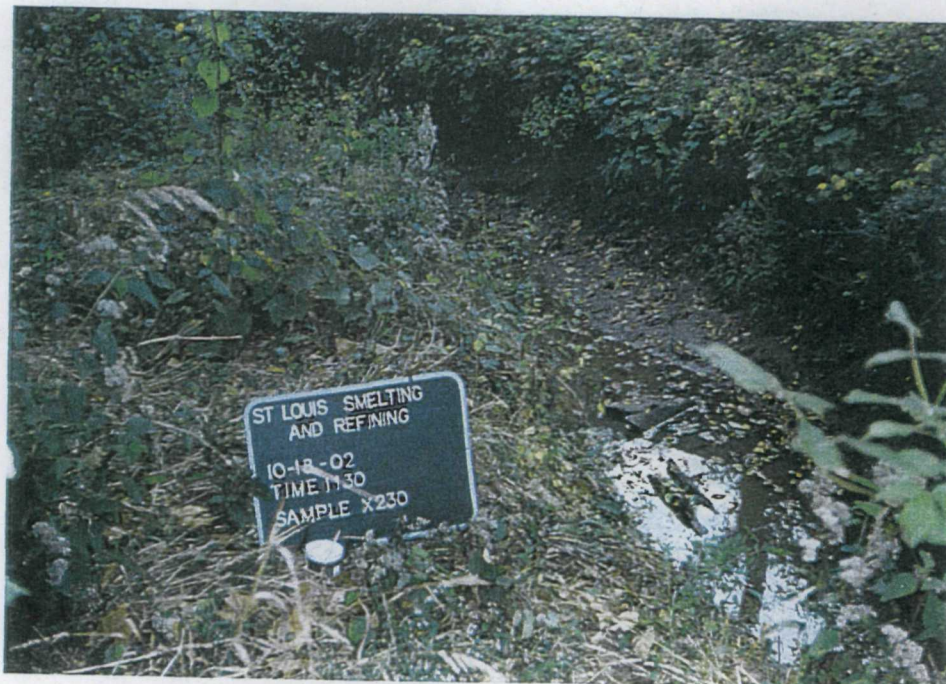
COMMENTS: Photo of
sediment sampling
location X230, drainage
way east of Pinehurst
Court

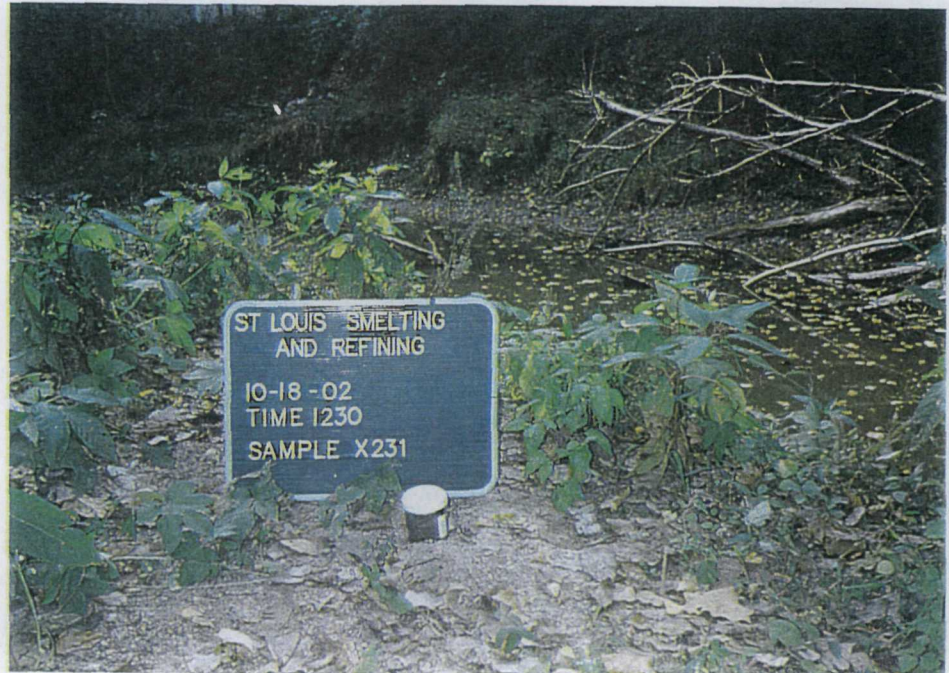
COMMENTS: Photo of
sediment sampling
location X231, Canteen
Creek (background
location).

Sample X231 is considered to be representative background conditions for waterways surrounding the site. Sample X231 was taken from Canteen Creek upgradient of the site. Sample X231 was obtained approximately 2000 feet northeast of the area where the facility was located during operation and appears not to impacted by facility operations. The sample was obtained from 0 – 2 inches below the sediment surface.

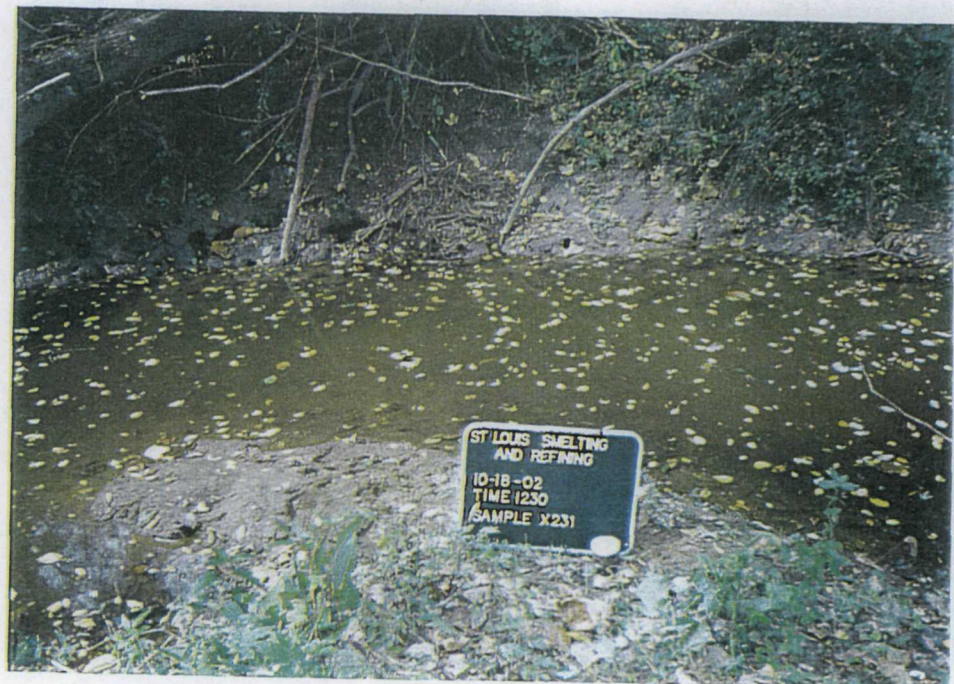
COMMENTS: Photo of
sediment sampling
location X231, Canteen
Creek (background
location).

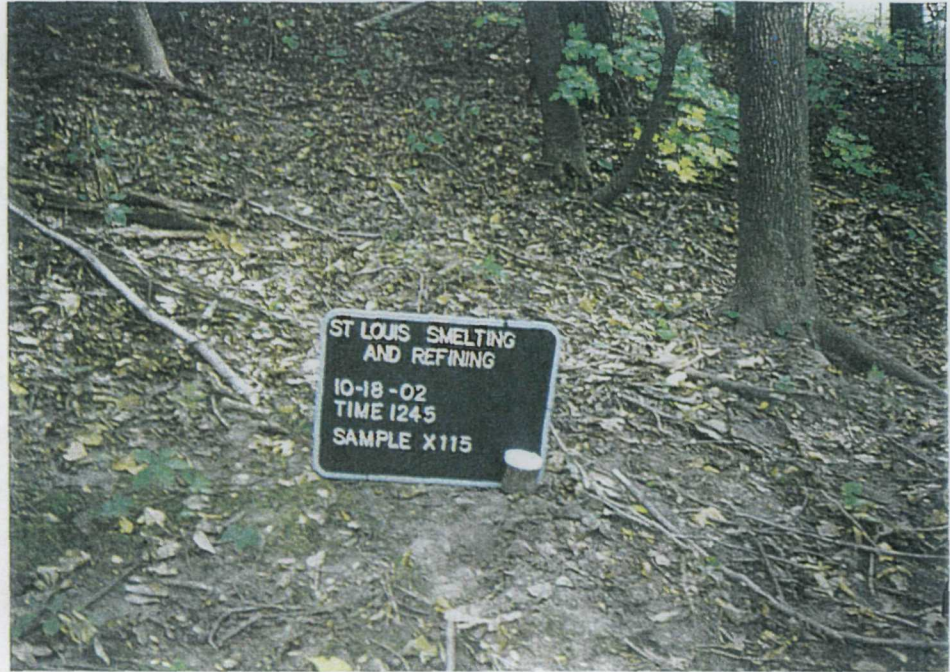
COMMENTS: Photo of
soil sampling location
X115, soil background
location

Soil sample X115 was obtained on private property approximately 1.5 miles east-northeast of the eastern boundary of facility as indicated on the 1926 fire insurance map as shown on Figure 2. More specifically, sample X115 was on a wooded hillside east of canteen creek in an area, that according to historical plat maps and current conditions, has been un-impacted forestland since the early 1900s. Sample location X115 was obtained from 0 - 2 inches bgs in a tan/brown silty loam and was not designated with an alphanumeric sample location identifier other than simply "X115". Tables 10 and 11 contain total inorganic analytical results and TCLP metals results for residential soil samples, respectively. Table 12 contains soil descriptions for all residential soil samples collected for laboratory analysis.

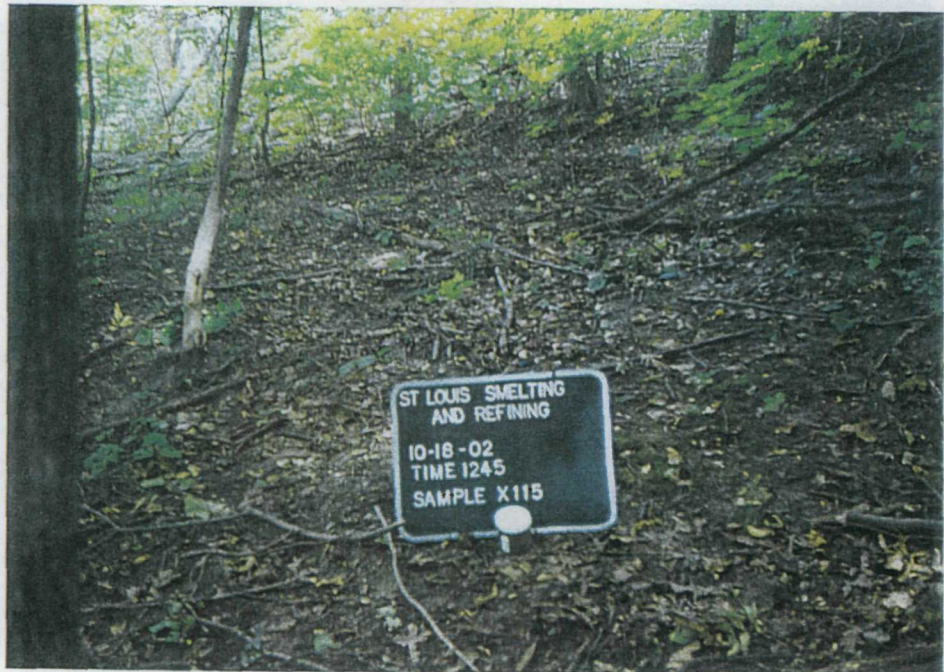
COMMENTS: Photo of
soil sampling location
X115, soil background
location
