NUMBER: 08-039-16

Harness Repair Or Replacement For No Start Or Stiff Steering

This bulletin involves inspecting the wire harness and installing mastic patch. If rub through is visible replace wire harness.

2014 - 2015 (KL) Jeep Cherokee

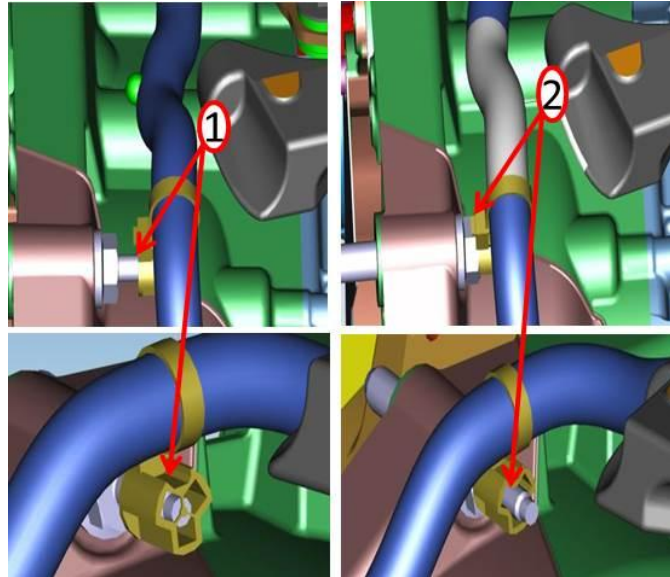
Fig. 1 Clip Location

- 1 - Present Position
 - 2 - Proper Position
-

1. Inspect the existing clip to be fully seated. The existing clip has a stop/cap that currently keeps clip at top of stud. This clip must be pushed in completely further onto the stud past the stop/cap. This can be attained by little force to break the stop/cap plastic stop (Fig. 1) & make sure the locking C clip is secured (Fig. 2).

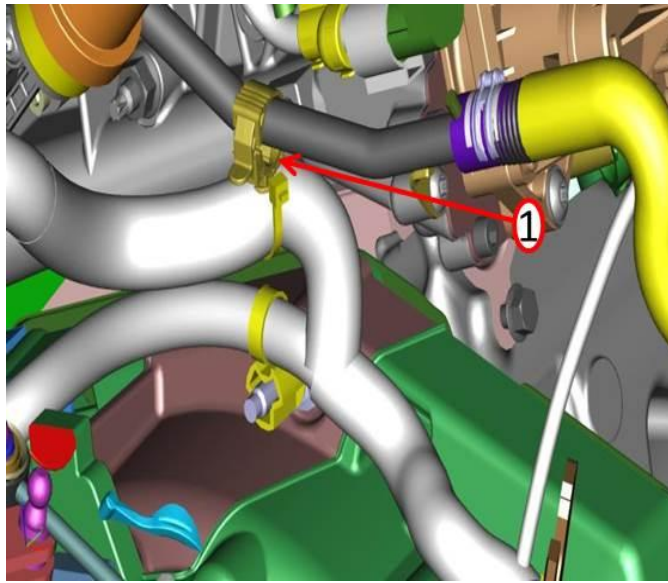
Fig. 2 Locking C clip

1 - Locking C-Clip

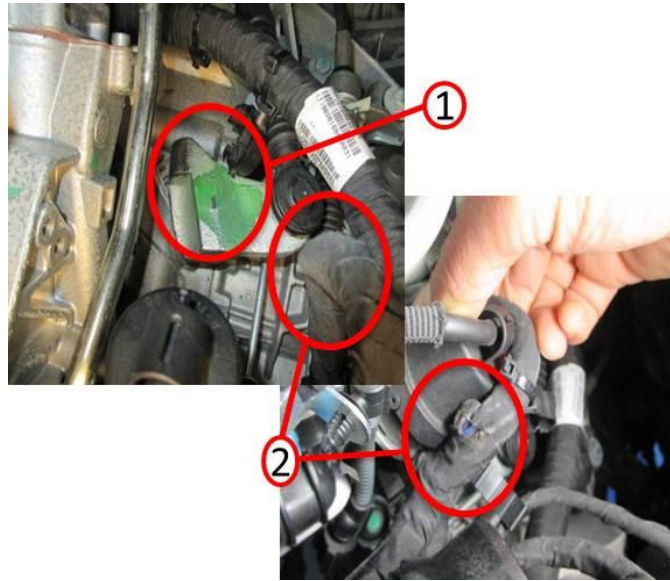
Fig. 3 Contact Areas

- 1 - Contact area 1 top side of engine transmission harness toward the rear cylinder head
 - 2 - Contact area 2 top side of engine transmission harness
-

2. Inspect the wiring harness at these locations for rub through or chaffing of the wires, (Fig. 3) & (Fig. 4).

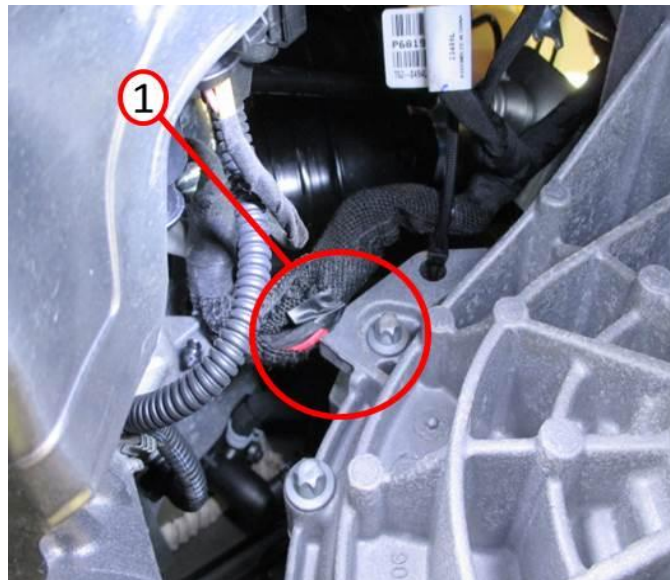
Fig. 4 Contact At Trans

- 1 - Contact At Trans
-

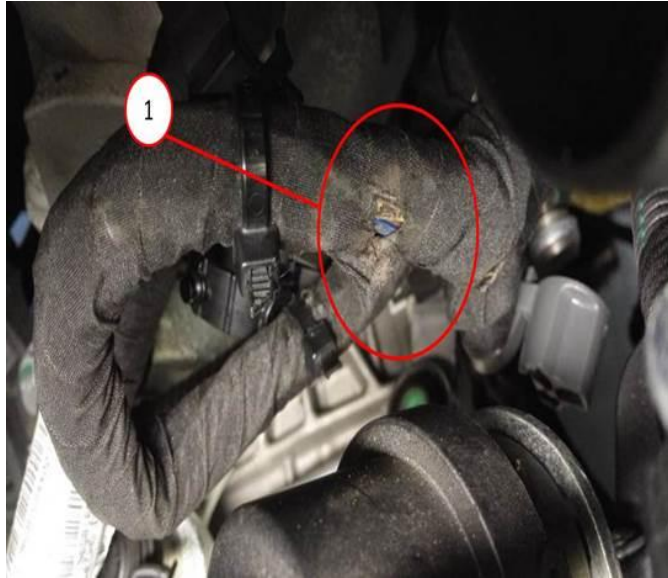
Fig. 5 Rub Area

3. Is there chaffing of the wires (Fig. 5)?

1 - Possible Rub Area

-
- a. YES>>> Replace wire harness proceed to [Step #4](#) and install mastic tape patch ([Fig. 6](#)) at the wear location ([Fig. 7](#)).
 - b. NO>> Install mastic tape patch ([Fig. 6](#)) at the wear location ([Fig. 7](#)). Proceed to [Step #24](#).

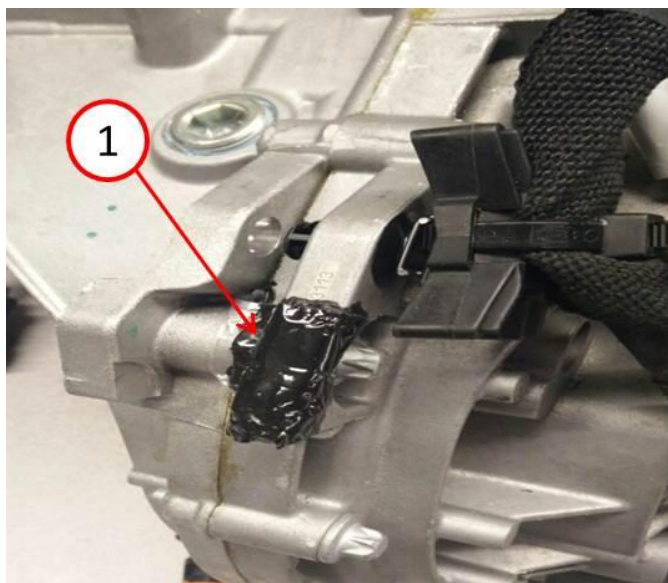
Fig. 6 Mastic

1 -Mastic Tape Repair

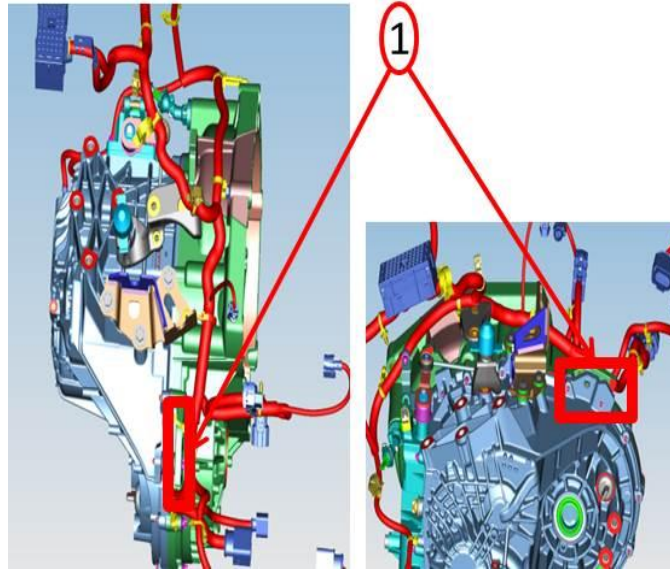
Fig. 7 Mastic Patch

1 - Mastic Patch Area

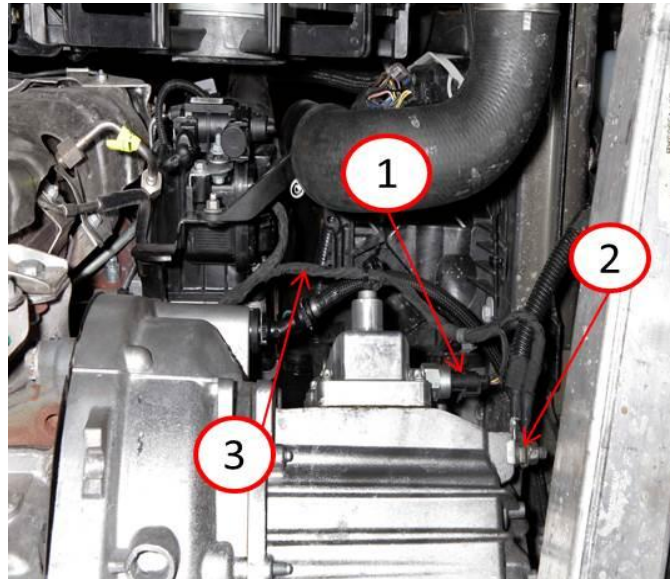
Fig. 9 Ground At Transmission

- 1 - Pressure Sensor
 - 2 - Ground Nut
 - 3 - Transmission Wire Harness
-

6. Remove the splash shield from underneath the vehicle.
7. Remove the ground nut from transmission to the wiring harness (Fig. 9).
8. Disconnect the pressure sensor electrical connector and the 3 wire retainers (Fig. 9).

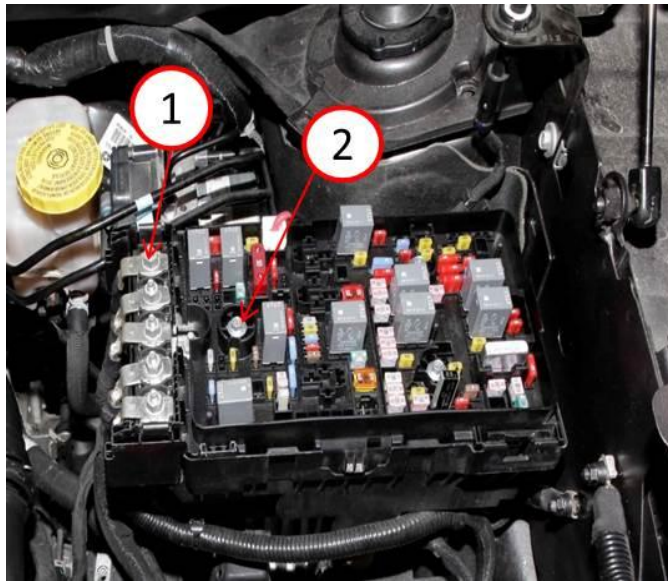
Fig. 12 PDC Wiring

- 1 - Fuse Wiring
 - 2 - Retainer For Transmission Wiring Under PDC
-

13. Remove the Power Distribution Cover (PDC).
14. Remove the fastener nut on #1 power wire in (PDC) (Fig. 12).
15. Loosen the bolt (Fig. 12) securing the transmission harness to the (PDC).
16. Remove the transmission wiring harness from under the PDC housing tray (Fig. 12).

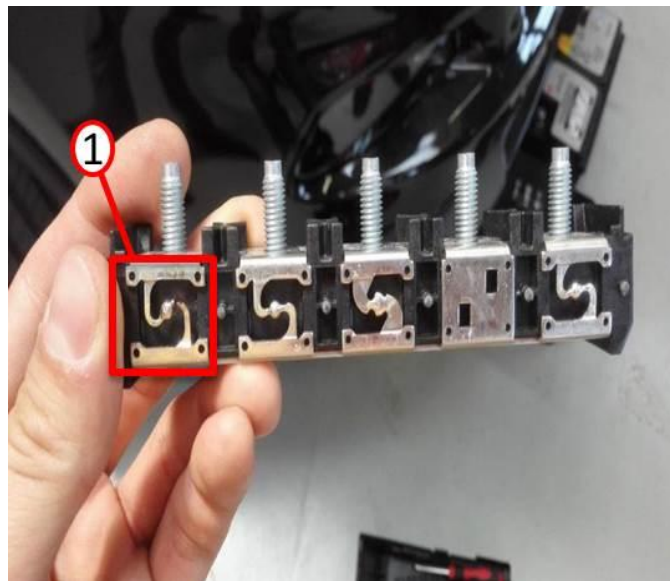
Fig. 14 Fuse

1 - Bad Fuse

- a. YES>> Replace the bad fuse(s) (Fig. 14) after the wiring harness has been replaced. Proceed to [Step #18](#).
- b. NO>> No further action needed with the fuses. Proceed to [Step #18](#).

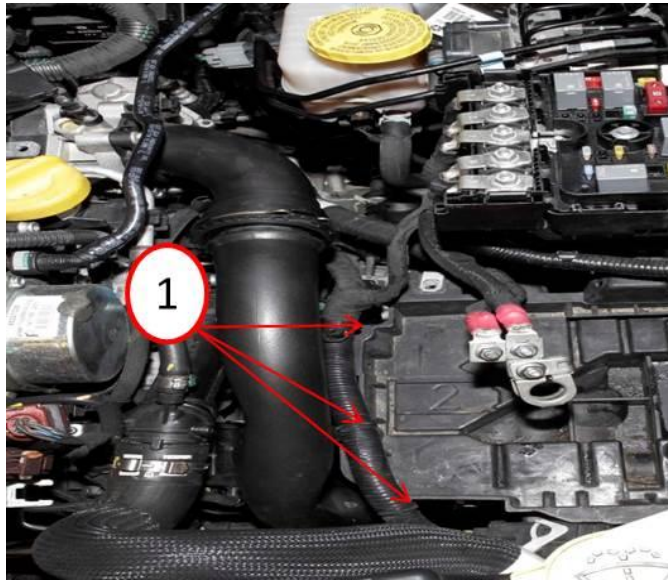
Fig. 15 Retainers At Battery Tray

1 - Retainers

18. Remove the electrical connector from the front side of the battery tray.
19. Remove the 4 push pins from the battery tray to the harness (Fig. 15).
