Standard Work Instruction No. SWI7.5-129	Rev. NR	Page 1 of 18
	Isuzu NPR XD Walkramp Interference With Fuel Hoses		
Identify Process Owner: Engineering, Josh Hunsberger	Document Control Administrator:

**Isuzu NPR XD Walkramp Interference With Fuel Hoses**

1.0	Application
	Applies to Isuzu NPR XD chassis, which were potentially built with an insufficient thickness of mounting wood. This document will identify potential interference (and, if necessary, retrofit) with the aft-axle mounted fuel tank hoses/fittings/fuel pick-up and the walkramp.
2.0	PPE (Special)
	N/A
3.0	Tools
	Varies, see individual sections.
4.0	Specific Tools
	Varies, see individual sections.
5.0	Fixtures (if required)
	N/A
6.0	Applicable Documents
	Varies, see individual sections.
CTS- Critical to Safety CTQ- Critical to Quality CTM- Critical to Manufacturing	
7.0	Inspection
7.1	Suggested Tool: <ul style="list-style-type: none">• Tape Measure• Flashlight• Pen• Inspection Report (provided, page 18)
7.2	CTS- Park the UNLOADED truck on a level surface with the transmission in PARK. Apply the EMERGENCY BRAKE and install a LOCK OUT TAG on the truck.

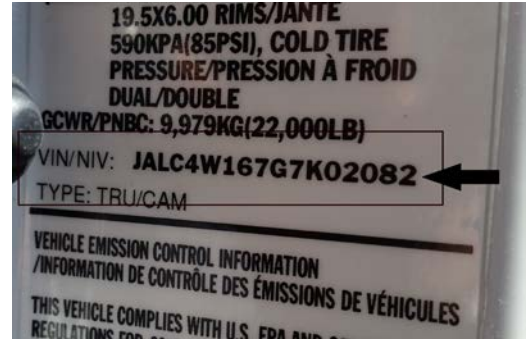
(Figure 1)

Locate and record the VIN located in the driver side cab door jamb (See Figure 1), and the Morgan Serial # located on the metal ID tag on the roadside, bottom, front of body (See Figure 2). Record these values on the *Inspection Report* (Page 18 of this document).

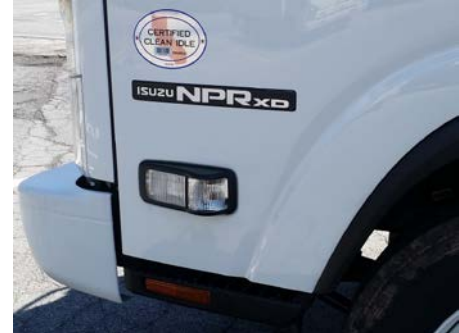
(Figure 3)

Verify that the chassis is an Isuzu NPR XD (See Figure 3) with an aft-axle mounted fuel tank (See Figure 4) and a walkramp installed between the frame rails (See Figure 5). [If chassis is NOT an Isuzu NPR XD with an aft-axle fuel tank with a walkramp installed between the frame rails, -STOP!- and proceed to the *Inspection Report* (Page 18 of this document) fill out lines 1-5 on the inspection report and submit the inspection report per the information in the *Report* section. No further action is required. Otherwise, continue with Inspection (and, if necessary, retrofit).]

**Note: Some chassis may not have the "Isuzu NPR XD" label as shown in Figure 3. If no Label, Identify via "K" value in the 12th VIN digit.*

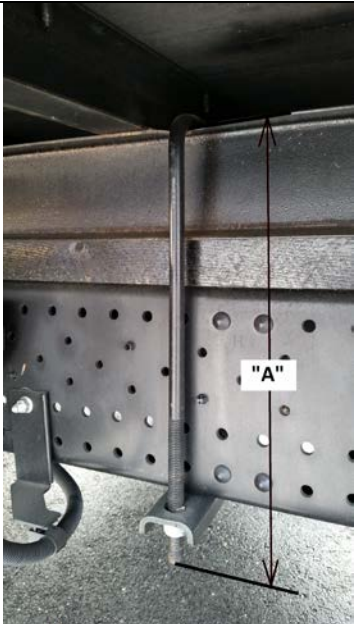
<p style="text-align: center;">(Figure 8)</p>

<p>8.3</p>	<p>Count and record the quantity of standard U-bolts (legs down) and quantity of inverted U-bolts (legs up). Measure the overall length of U-bolts from the inside of the “U” to the end of the U-bolt threads and record the overall length of the U-bolts (See Figure 8), also measure and record the amount of exposed threads past the nut (See Figure 9). Record these findings in the <i>Inspection Report</i> (Page 18 of this document).</p>

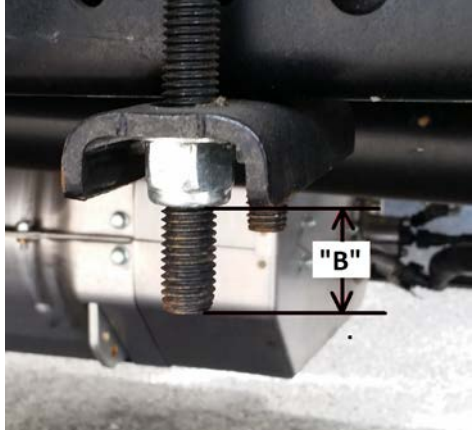
<p>(Figure 9)</p>
<p>8.4</p>	<p>If NO damage or fuel leak were noted in step 8.2, BUT the overall height of the longrail and mounting wood does <u>NOT</u> meet the minimum height requirement referenced in step 7.5 then proceed to step 9.0. Otherwise, continue to Step 8.5.</p>	
<p>8.5</p>	<p>Submit completed <i>Inspection Report</i> (Page 16 of this document) per the information in the Report section, and then wait for instruction from Morgan. Morgan will contact you with instructions and/or an authorization P.O. as well as a list of parts that Morgan will provide.</p> <p>After receiving authorization and parts from Morgan, continue to Retrofit section below.</p>

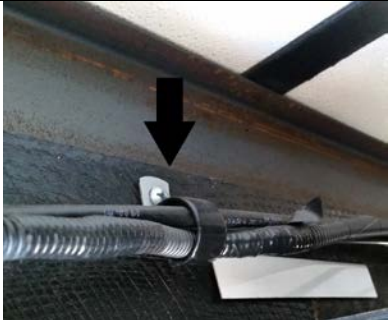
9.6	Mark exact position of each U-bolt on body longrail and on chassis frame rail (use grease pencil or similar marker).	
9.7	Disconnect any electrical harnesses or connections as required. Disconnect at connection/plugs rather than cutting wiring, if possible. Also disconnect refrigeration unit fuel hoses, and remove hose loop clamps or cable ties (as required).

9.8	Loosen and remove all U-bolt mounting nuts, washers and tie channels. Discard all U-bolt mounting nuts, they shall NOT be reused. Mark existing body location on chassis frame.

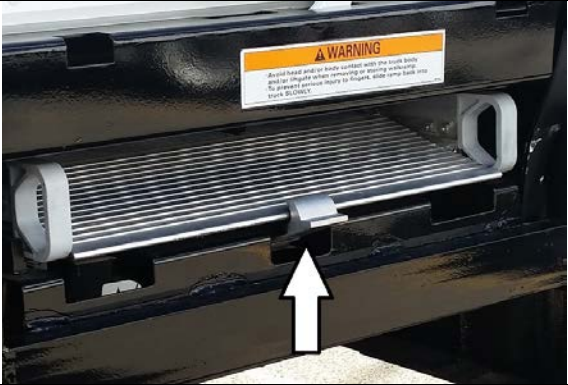
<p>9.13</p>	<p>Position and lower body back over chassis frame; ensure not to damage any chassis components, wires, hoses or other items when lowering body onto frame. Make sure to align U-bolts around mounting wood and chassis frame.</p>	
<p>9.14</p>	<p>Install U-bolt tie channels, washers and NEW nuts at positions marked in step 3 above, torque to 50 ft-lbs (± 10 ft-lbs).</p>	
<p>9.15</p>	<p>Re-connect all electrical harnesses or other disconnected accessories & clamps and re-secure as required. (refrigeration unit fuel hoses)</p>	
<p>9.16</p>	<p>Remount rear bumper or other as required. Ensure the walkramp latch and latch plate in rear bumper function properly. The rear bumper and/or latch plate must move with the body to maintain a proper working relationship.</p>

<p>9.17</p>	<p>Reinstall walkramp and carrier/trolley assembly, use new nuts (provided).</p>	
<p>9.18</p>	<p>Ensure all mounting hardware is properly torqued; all lights and accessories are working properly and refrigeration unit is working properly (if applicable).</p>

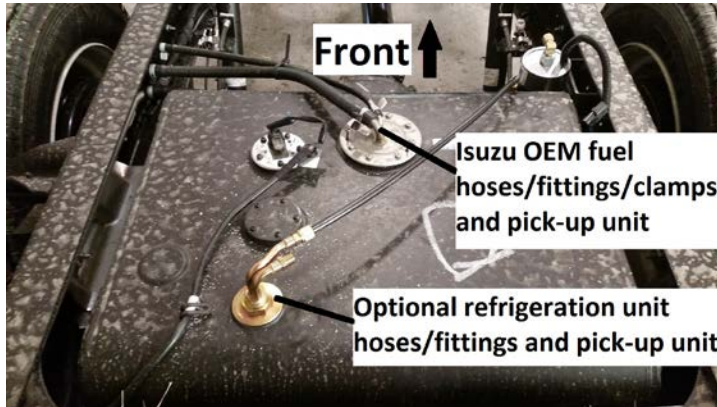
10.0 Retrofit - Replacing Isuzu OEM Hoses and Clamps (If Necessary)

<p>10.1</p>	<p>Suggested Tool:</p> <ul style="list-style-type: none"> • Adjustable pliers
<p>10.2</p>	<p>New Parts Required:</p> <ul style="list-style-type: none"> • Item 1: (1) Fuel hose, larger O.D. (Isuzu P/N: 8-98114-269-1) • Item 2: (1) Fuel hose, smaller O.D. (Isuzu P/N: 0-01558-300-0) • Item 3: (2) Hose clamps, larger O.D. (Isuzu P/N: 8-98150-356-0) • Item 4: (2) Hose clamps, smaller O.D. (Isuzu P/N: 8-98150-357-0) • Item 5: (1) Nylon zip-tie (Morgan P/N: 05540)
<p>10.3</p>	<p>Reference Documents:</p> <ul style="list-style-type: none"> • Isuzu Fuel Pick-Up Replacement
<p>10.4</p>	<p>Unmount body, reference steps 9.0 from above.</p>
<p>10.5</p>	<p>Squeeze and slide hose clamps off both ends of the (2) fuel hoses, (4) clamps total.</p>
<p>10.6</p>	<p>Remove the (2) fuel hoses and (4) clamps, do not damage metal fuel lines or fittings. Be careful of excess fuel in fuel lines & hoses.</p>
<p>10.7</p>	<p>Install new clamps and fuel hoses, secure to the fittings and fuel lines with the</p>

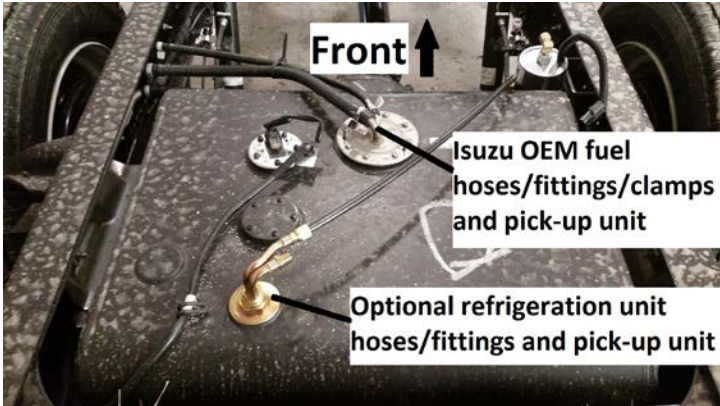
properly sized hose clamps.	
	10.8	Install zip-tie around the middle of the 2 hoses, and tighten without pinching hoses.	
	10.9	Ensure all fuel hoses and fittings are properly connected, clamped, secured and that there are no fuel leaks.	
	10.10	Remount body, reference steps 9.0 from above.	
11.0	<p>Retrofit – Replacing Isuzu OEM Fuel Pick-up Unit, Hoses & Clamps (If Necessary)</p> <p><i>* If fuel pick-up assembly is damaged, it's assumed the hoses and clamps are damaged as well, and all must be replaced.</i></p>

11.2	<p>New Parts Required:</p> <ul style="list-style-type: none"> • Item 1: (1) Fuel hose, larger O.D. (Isuzu P/N: 8-98114-269-1) • Item 2: (1) Fuel hose, smaller O.D. (Isuzu P/N: 0-01558-300-0) • Item 3: (2) Hose clamps, larger O.D. (Isuzu P/N: 8-98150-356-0) • Item 4: (2) Hose clamps, smaller O.D. (Isuzu P/N: 8-98150-357-0) • Item 5: (1) Black nylon zip-tie (Morgan P/N: 055401) • Item 6: (1) Fuel pick-up w/ gasket (Isuzu P/N: 8-98195-722-0)

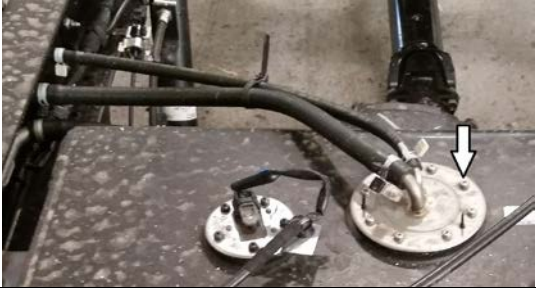
11.7	<p>Loosen and remove the fuel pick-up unit mounting screws around flange that secure the unit to the fuel tank.</p>

11.8	<p>Carefully remove fuel pick-up unit from fuel tank. Be careful of fuel dripping from the unit.</p>

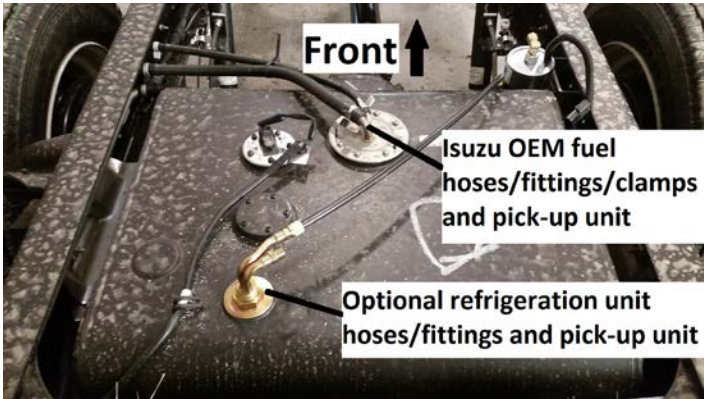
12.0	<p>Retrofit (<u>Refrigeration trucks only!</u>)– Replacing Refrigeration Unit Fuel Pick-up Unit, Hoses & Clamps (If Necessary)</p> <p><i>* Covers both Thermo-King and Carrier units.</i></p>

12.2	<p><u>Carrier</u>, New Parts Required:</p> <ul style="list-style-type: none"> Item 1: (1) Fuel pick-up assembly (Carrier P/N: 65-01091-00) Item 2: (1) Fuel hose, 3/8" O.D. X 25ft (Carrier P/N: 58-01391-00) Item 3: (1) Fuel hose, 1/4" O.D. X 25ft (Carrier P/N: 58-01390-00) Item 4: (2) Compression sleeve fitting kit, 3/8" O.D. hose (Carrier P/N: 40-01169-01) Item 5: (2) Compression hose sleeve, 1/4" O.D. hose (Carrier P/N: 40-00409-02) Item 6: (2) Compression hose eyelet, 1/4" O.D. hose (Carrier P/N: 40-00409-02) Item 7: (2) Compression hose nut, 1/4" O.D. hose (Carrier P/N: 40-00343-07)

12.3	<p><u>Thermo-King</u>, New Parts Required:</p> <ul style="list-style-type: none"> Item 2: (4) Compression sleeve & eyelet fitting kit, 3/8" O.D. hose (TK P/N: 10-242) Item 3: (4) Compression hose nut, 3/8" O.D. hose (TK P/N: 11-4941) Item 4: (1) Fuel hose, 3/8" O.D. (shorter supply hose), (TK P/N: 66-6856) Item 5: (1) Fuel hose, 3/8" O.D. x 35ft (return hose), (TK P/N: 11-4375) Item 31: (1) Fuel pick-up assembly (TK P/N: 11-9279)

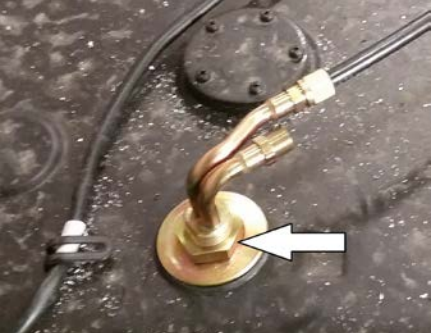
12.6	<p>Disconnect fuel hoses from fuel pick-up unit by unthreading the hose fittings. Be careful of excess fuel in fuel lines & hoses.</p>
12.7	<p>Loosen and fully unthread the fuel pick-up unit mounting nut.</p>

12.8	<p>Carefully angle fuel pick-up unit to remove</p>
