BULLETIN NUMBER:
SB18-N-001A

DTC U0106 LOST COMMUNICATION WITH GLOW PLUG CONTROL MODULE (GPCM)

- 2011-2018MY Isuzu N-Series Vehicles
Equipped with 5.2L 4HK1 Diesel Engines

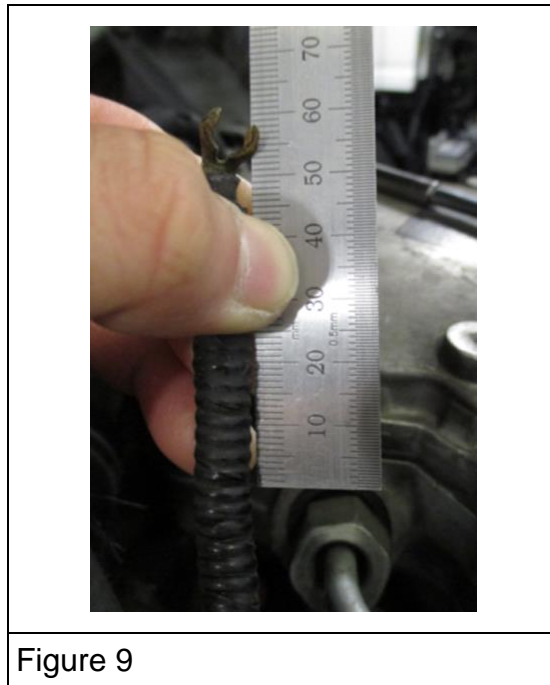
Figure 9

10. Cut off the original glow plug wire at approximately 60mm up from the glow plug connection eyelet. (See Figure 9.) Discard the removed wire with eyelet.
