SERVICE BULLETIN

APPLICABILITY: 2020-23MY Legacy & Outback
 2023MY Ascent

NUMBER: 07-213-22R

SUBJECT: Genuine Battery Replacement

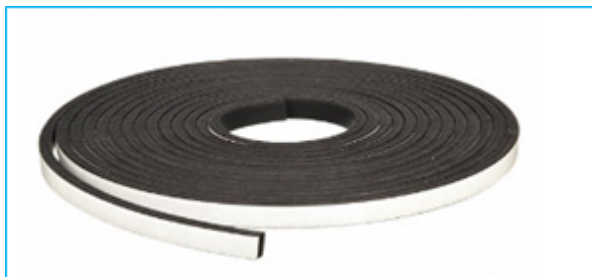
EPDM Neoprene SBR Strip

2 in x 50 ft, 1/16 Thick, Black, Closed Cell , Smooth Item # 6YHD7

(Self-adhesive EPDM foam taped for battery tray modification)

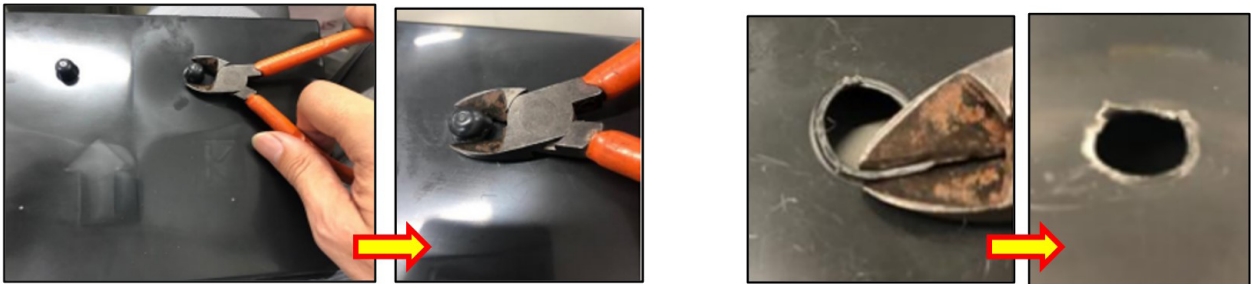
A. CAREFULLY cut off and trim the two protrusions on the bottom of the battery tray. This will allow a proper fit when installed. Try to make the cut as flush as possible.

CAUTION: Be sure the protrusions are trimmed flush. The remaining protrusion height **MUST** be less than 2mm to provide proper fitment.

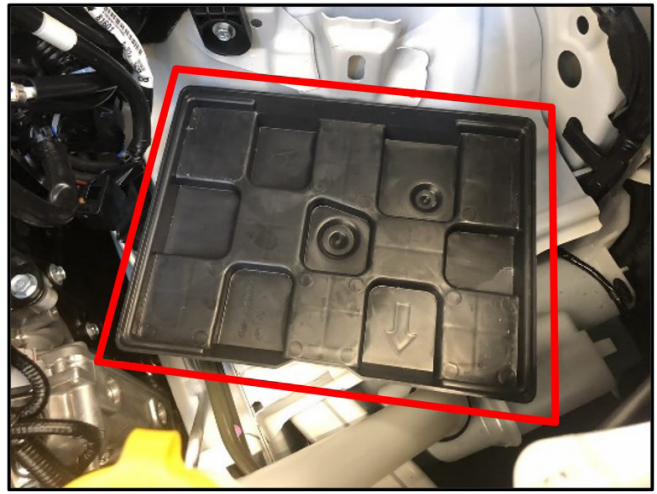
- B.** Remove and the original battery tray. **DO NOT** discard as this must be returned to the customer.

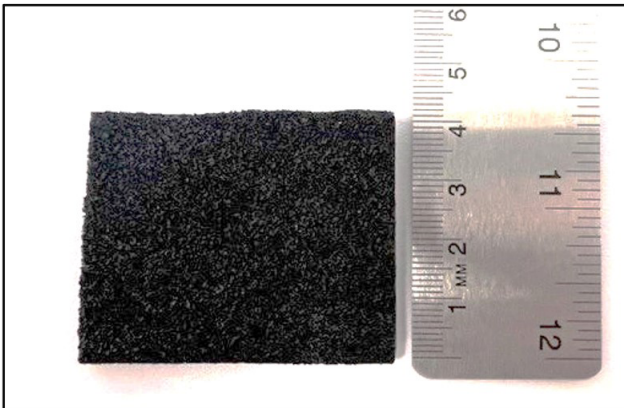
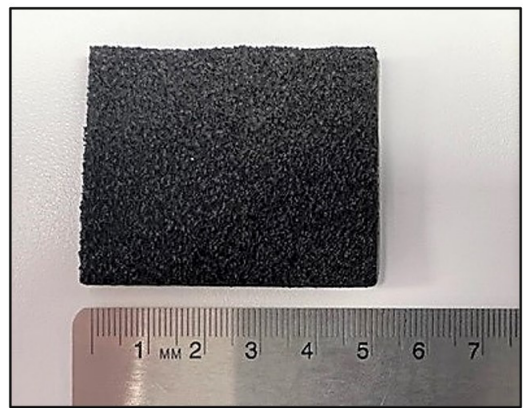
- C.** Prepare two pieces of EPDM neoprene sponge strip. Cut the sections approximately 40 mm tall and 50 mm wide. EPDM Neoprene SBR Strip (item # 6YHD7) supplied by Grainger was used in the example photos below.

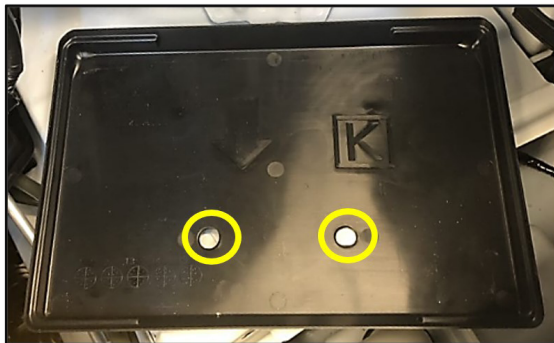
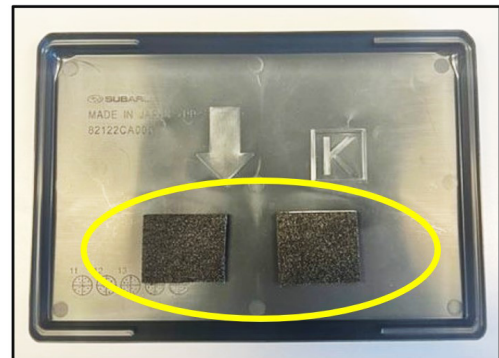
- D.** Cover the newly made holes with the two previously prepared EPDM neoprene sponge strip pieces.

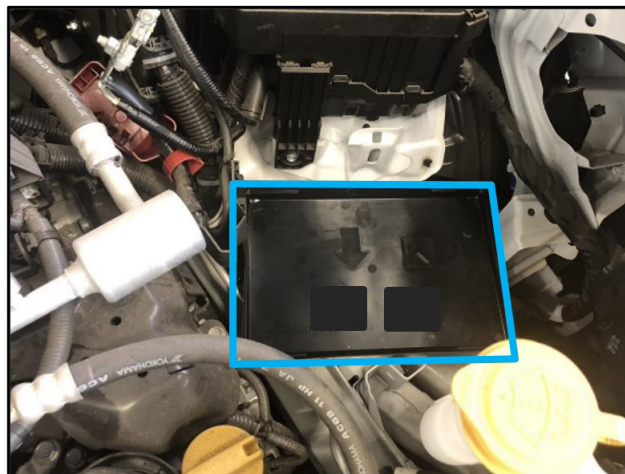
E. Install the battery tray.

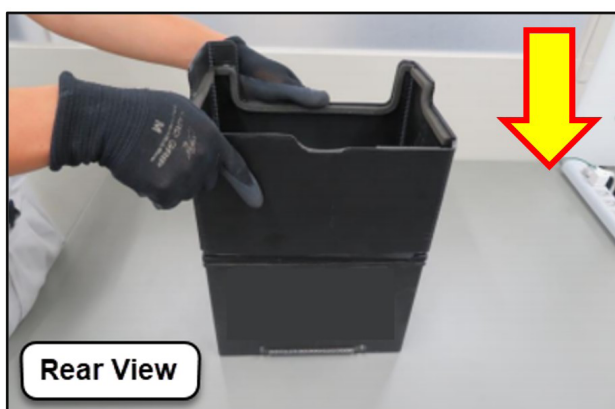
STEP 4: Install the original battery cover to the new replacement battery. Confirm the bottom of the cover is aligned flush with the bottom of the battery.

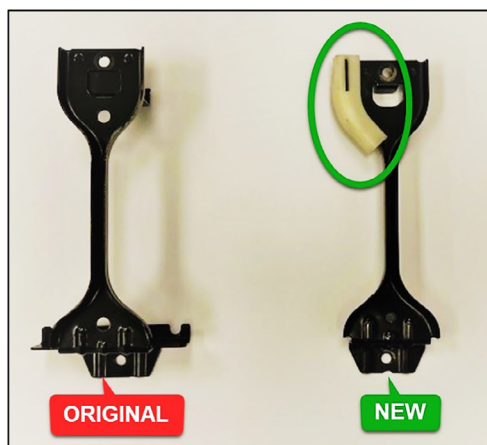
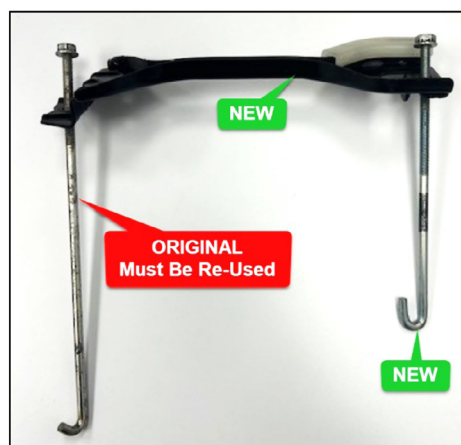
STEP 5: Assemble the new battery holder (p.n. 82184SG000), **NEW** rear holding rod (p.n. 82161SJ000), and the **ORIGINAL** front holding rod as shown below. The original rod nut can be transferred to the new rear holding rod.

IMPORTANT: DO NOT discard the original holder and rear rod. These parts are to be returned to the customer.

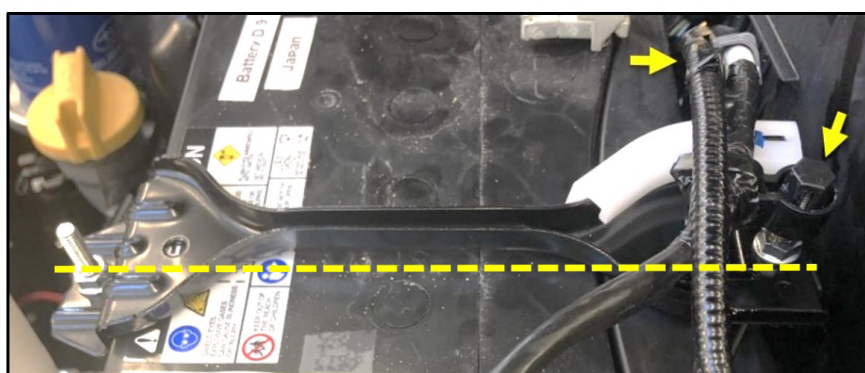
CRITICAL: Confirm the battery holder is center mounted with the battery cables secured and routed correctly.

- A. Torque the two holding rod mounting nuts to **3.5 N·m (2.6ft.-lbs. or 31inch.-lbs.)**.
- B. Torque the positive terminal to **6 N·m (4.4ft.-lbs. or 53inch.-lbs.)**.
- C. Torque the negative terminal to **7.5Nm (5.5ft.-lbs. or 66inch.-lbs.)**.
- D. If the battery sensor is removed or disconnected torque to 7.5Nm (5.5ft.-lbs. or 66inch.-lbs.) while supporting the sensor with the other hand as outlined in the applicable Service Manual under: STARTING/CHARGING SYSTEMS > Battery Sensor.
