***Investigations of Stress Corrosion  
Cracking of Spent Fuel Dry Storage  
Canisters Used for Long-Term Storage***

***IAEA International Conference on Management  
of Spent Fuel From Nuclear Power Reactors***

***S.J. Saltzstein, D.G. Enos, C.R. Bryan, K.B. Sorenson  
Sandia National Laboratories***

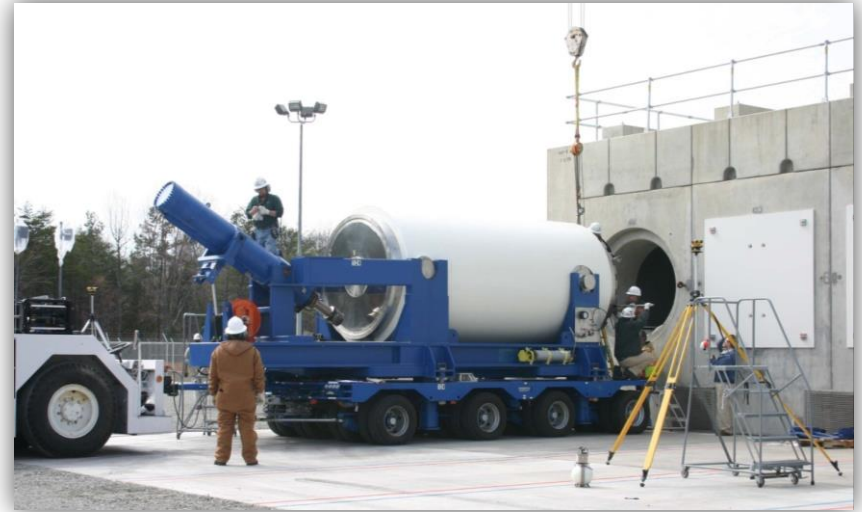
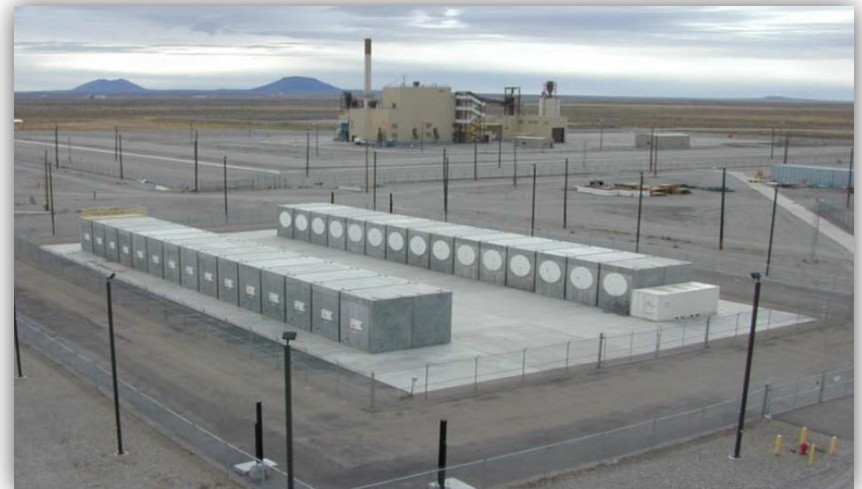
# Calvert Cliffs – Horizontal Storage System

- 30 minute leach with deionized water
- Cations:  $\text{Ca}_2^+ \gg \text{Na}^+, \text{Mg}_2^+, \text{K}^+$
- Anions:  $\text{SO}_4^{2-} \gg \text{NO}_3^- > \text{Cl}^-$

Salts do not appear to have a large marine component:

- Low  $\text{Na}^+, \text{Cl}^-$ , high  $\text{Ca}^{2+}, \text{SO}_4^{2-}$
- Conversion after deposition via particle-gas conversion reactions? Does not explain low Na.
- Preferential deposition of deliquesced Ca-Cl salts, followed by conversion to sulfates and chloride-loss?

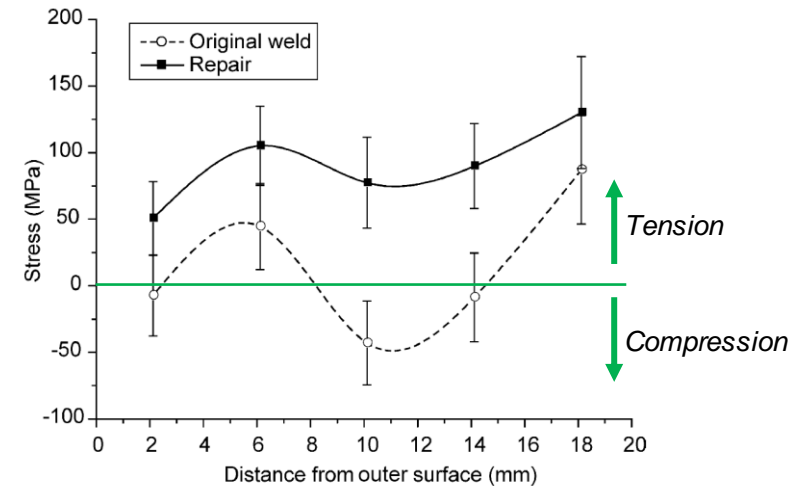
- Is there sufficient residual stress within the container wall to support propagation of a through-wall crack?
- Many complicating factors
  - Weld procedure (start/stop, technique, etc.)
  - Weld repairs

Fig. 14. Hydrostatic residual stress profile (17.5 mm from weld centre-line).
