To: Hospital Risk Managers and Surgeons
Subject: **URGENT MEDICAL DEVICE FIELD SAFETY NOTICE - CORRECTION**
Affected Product: ROSA One 3.1 Brain application

ROSA One 3.1 Brain Application

Affected Product: ROSA One 3.1 Brain application Field Action Reference: ZFA 2021-00198

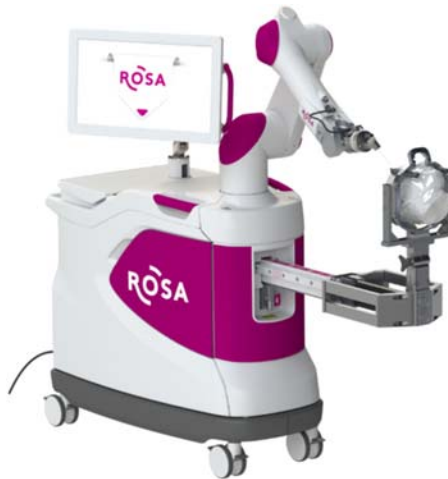
The ROSA One 3.1 Brain application system is intended for the spatial positioning and orientation of instruments holders or tool guides to be used by trained neurosurgeons to guide standard neurosurgical instruments (biopsy needle, stimulation or recording electrode, endoscope). The device is indicated for any neurosurgical procedure in which the use of stereotactic neurosurgery may be appropriate.

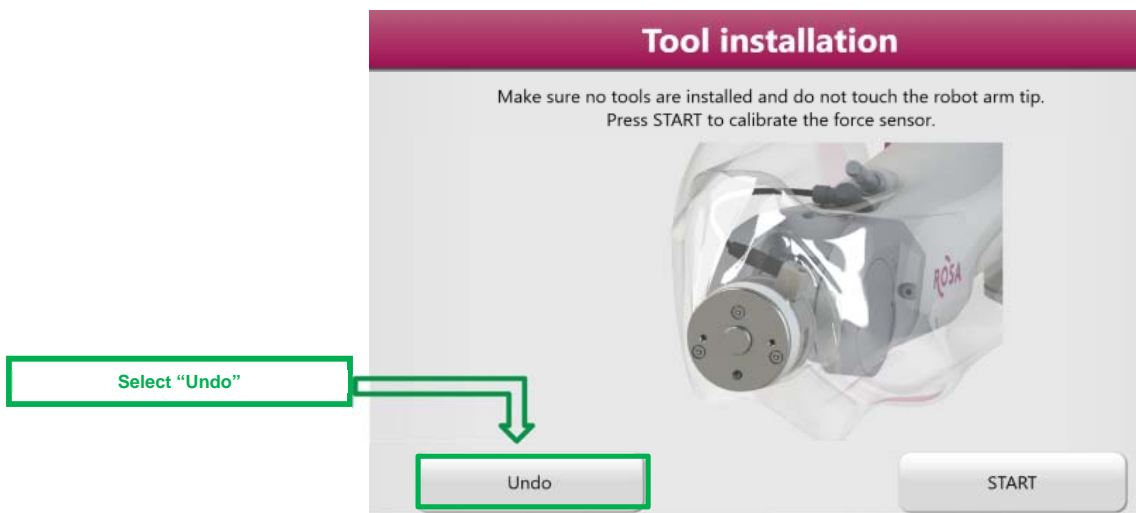
If a shutdown occurs during guidance mode, any empty calibration window that would subsequently appear during the session should be closed by pressing UNDO.

Required actions by users to prevent incorrect instrument configuration (Workaround):

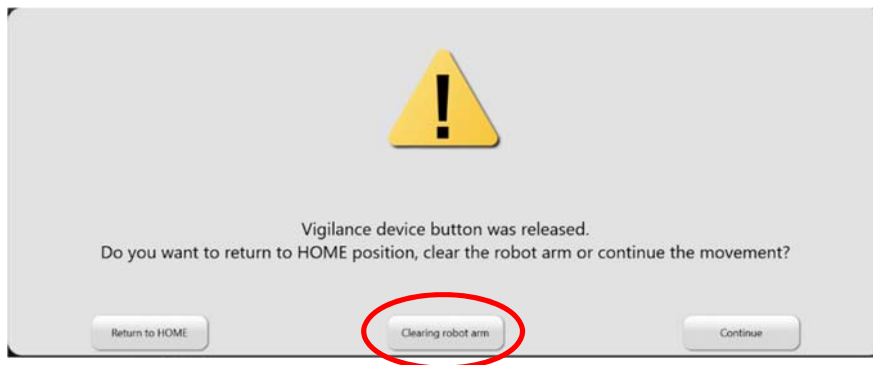
1. Launch ROSA One 3.1 Brain application.
2. Perform patient registration.
3. Go in guidance with a surgical tool mounted on the robot arm.
4. Shutdown the device while in guidance mode (the shutdown may occur unexpectedly or could be performed by the user).
5. Restart the device.
6. During movement of the robot arm, the vigilance device is released or a collision is detected by the software.
7. Select "Clearing robot arm".

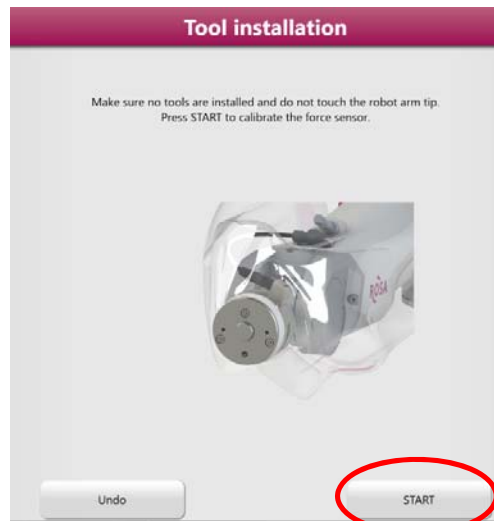
8. Software asks for an empty calibration of the force sensor.
9. Select "START" and perform the empty calibration.

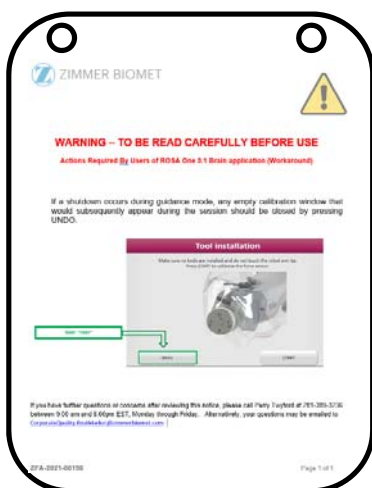
1. **Apply the Warning label on the robot: attach the label on the front handle of the robot using the cable fasteners provided.**
2. **Do not tighten the fasteners excessively so that the label is allowed to slide freely on the handle.**

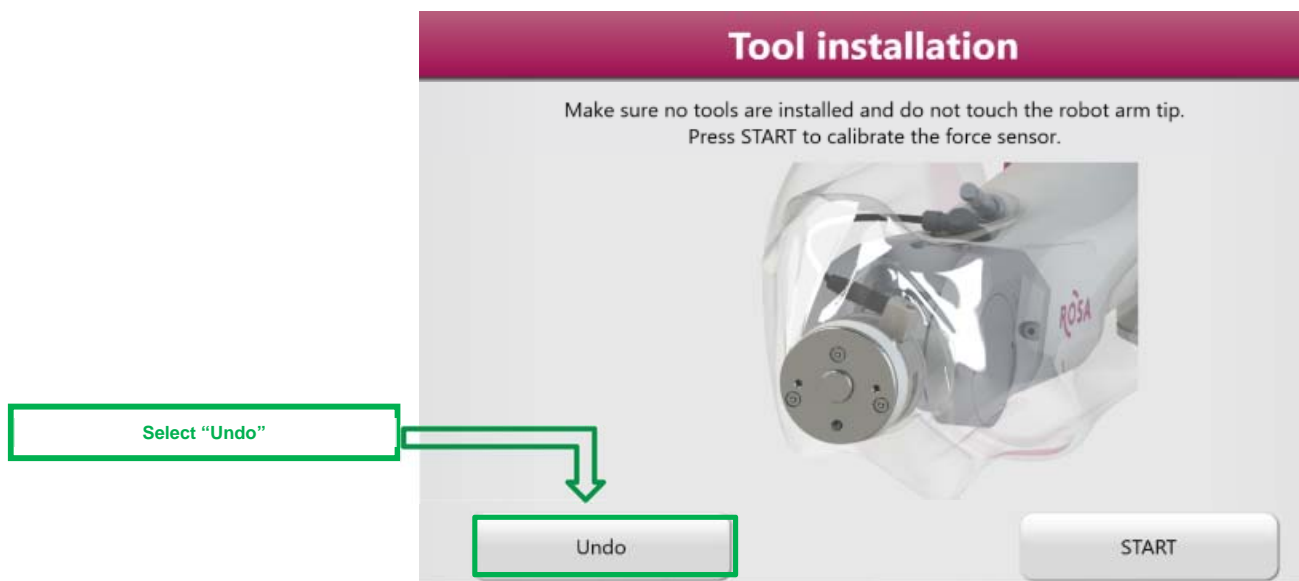
If a shutdown occurs during guidance mode, any empty calibration window that would subsequently appear during the session should be closed by pressing UNDO.
