STREET SMART

Toyota's U560E: First Things first

we'll cover problems plaguing the U660E valve body and solenoids.

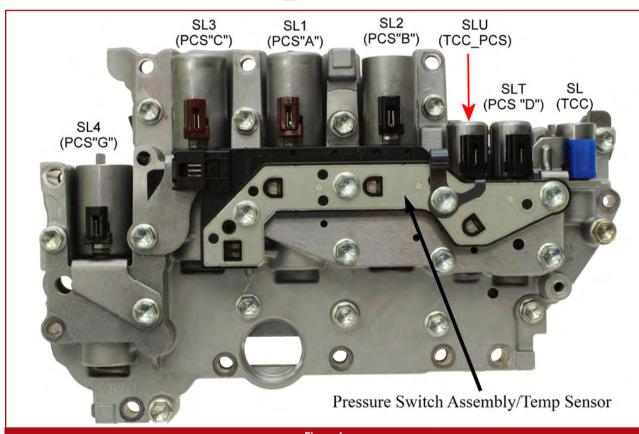
Figure 1

This transmission has six lineartype solenoids, one on/off solenoid (figure 1) and typical for Toyota solenoids, the SLT (line pressure control) is one to watch. It's the most common solenoid to fail, and when it does, you're likely to experience symptoms such as falling out of gear while coming to a stop, slamming back into gear, or a long slide-bump on the shift.

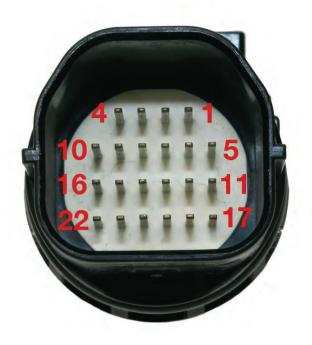
An easy way to check these solenoids is through a scan tool; but if you don't have a scan tool that can communicate with the Toyota computer system, you can still check them the old fashion way. Disconnect the TCM from the transmission. The transmission connector pin ID (figure 2) will help you isolate the failure.

TERMINAL	FUNCTION
1	Turbine Speed Sensor Ground
2	Turbine Speed Sensor Signal
3	Counter Gear Speed Sensor Ground
4	Counter Gear Speed Snesor Signal
5	"SLU" Ground
6	"SL" Positive (This solenoid is internally grounded)
7	"SLT" Ground
8	"SL2" Ground
9	"SL2" Positive
10	Pressure Switch Number 1
11	"SLU" Positive
12	"SLT" Positive
13	"SL1" Ground
14	"SL1" Positive
15	"SL3" Ground
16	"SL3" Positive
17	Transaxle Fluid Temperature Ground
18	Transaxle Fluid Temperature Signal
19	Pressure Switch Number 3
20	Pressure Switch Number 2
21	"SL4" Ground
22	"SL4" Positive

Measure the solenoid resistances: SLT, SLU, SL1, SL2, SL3, and SL4 should each be between 5.0–5.6 ohms; the SL should between 11–15 ohms. If the solenoids aren't within specs, replace them.

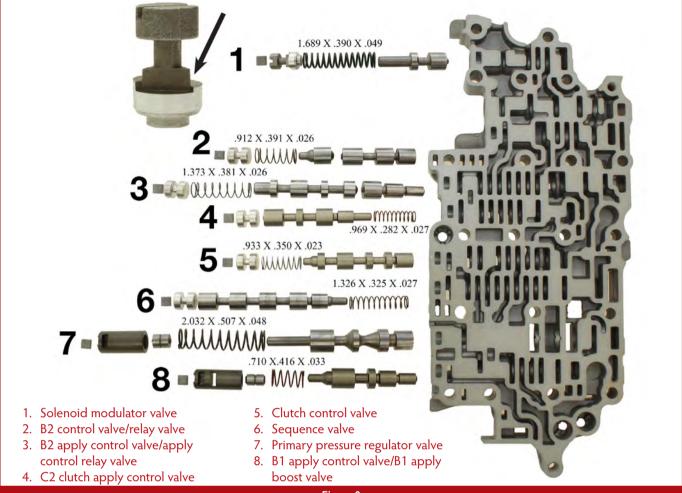
Middle Valve Body, Valve ID, and Spring Locations (figure 3, page 12)

- 1. Solenoid modulator valve
- 2. B2 control valve/relay valve
- 3. B2 apply control valve/apply control relay valve
- 4. C2 clutch apply control valve
- 5. Clutch control valve
- 6. Sequence valve
- 7. Primary pressure regulator valve
- 8. B1 apply control valve/B1 apply boost valve

Pay close attention to the settings on the solenoid modulator end plug #1 and mark it. It's adjustable; if you take it apart without marking its position, you have just a 1-in-3 chance of getting it back together properly. There are no factory settings from Toyota; each vehicle model is different, depending on engine and load.

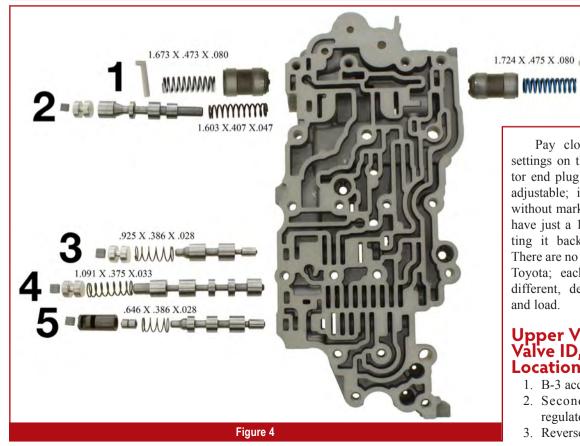
Upper Valve Body, Valve ID, and Spring **Locations** (figure 4)

- 1. B-3 accumulator
- 2. Secondary pressure regulator valve
- 3. Reverse sequence valve

- 4. Lockup relay valve
- 5. Lockup control valve and lockup control boost valve
- 6. C-2 accumulator

In this part of the valve body look closely at:

- #3 reverse sequence valve and bore #4 lockup relay valve and bore
- #5 lockup control and boost valve

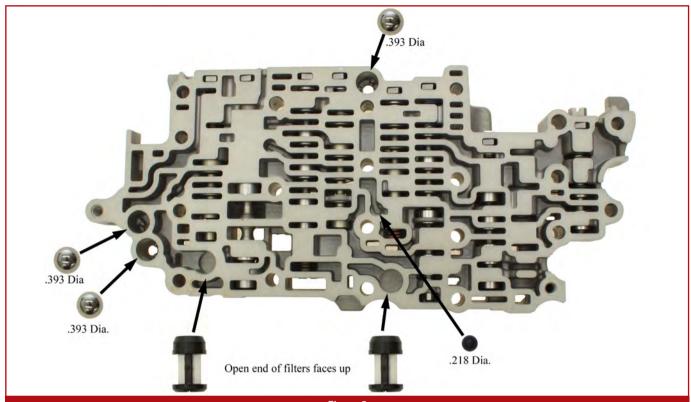
Figure 5

During your disassembly, make sure the filter open end faces up. Unlike the A340, these filters don't snap into the plate. They sit in the channel casting with the open end facing up (figure 5).

If these filters are installed incor-

rectly it will cut off oil that specific location.

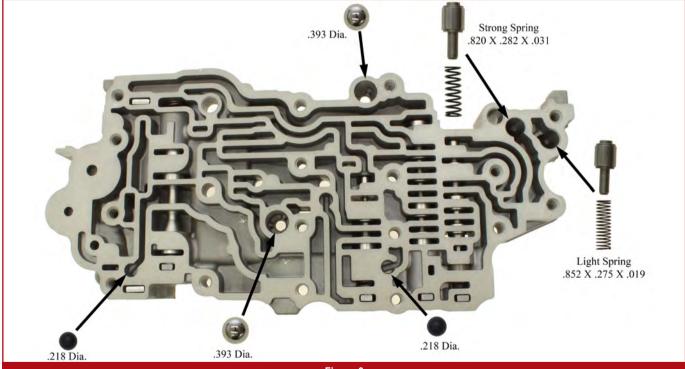
Figure 6

Upper Valve Body, Checkballs, and Check Valve Locations (figure 6)

Pay close attention to the separator plate and checkballs for wear (figure 6).

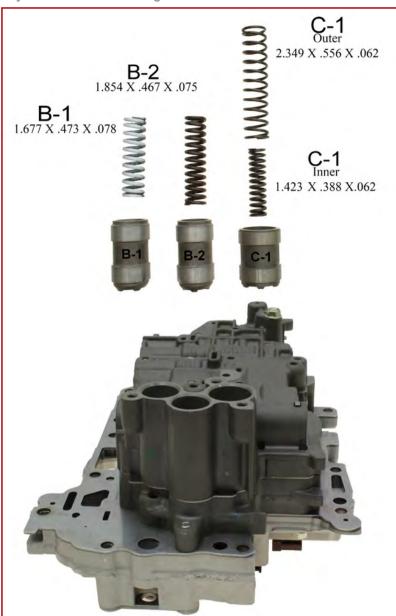
Figure 7

Like most Toyotas, this is a pretty normal failure. When you turn over the upper valve body you'll see the C-1, B-1, and B2 accumulator pistons and spring locations (figure 7).

This is also the location of the input and output speed sensor assembly.
