From: Kenagy, W David <KenagyWD@state.gov>
Sent: Friday, April 15, 2011 11:35 PM
To: Kenagy, W David; vince.mcclelland@nnsa.doe.gov; Rodriguez, Veronica; ann.heinrich@nnsa.doe.gov; HOO Hoc; HOO2 Hoc; Huffman, William; decair.sara@epamail.epa.gov; timothy.greten@dhs.gov; maria.marinissen@hhs.gov; (b)(6) doehqeoc@oem.doe.gov; hhs.soc@hhs.gov; james.kish@dhs.gov; HOO Hoc; Smith, Brooke; Zubarev, Jill E; Shaffer, Mark R; nitops@nnsa.doe.gov; Skypek, Thomas M; (b)(6) clark.ray@epamail.epa.gov; Stern, Warren; DeLaBarre, Robin; Burkart, Alex R; Metz, Patricia J; Fladeboe, Jan P; Withers, Anne M; Lowe, Thomas J; Lewis, Brian M; SES-O_OS; EAP-J-Office-DL; O'Brien, Thomas P; Lane, Charles D; Conlon, John N; Foughty, Michael A; Mahaffey, Charles T; (b)(6) Jih, Rongsong; (b)(6) (b)(6) Cutler, Kirsten B
Subject: RE: IAEA distributed documents
Attachments: Folow-up_until_15_april[1].pdf; ENAC - Downloaded Message 8.txt

Radiological follow-up in Spain of the nuclear accident in Fukushima (Japan)

Seismic Damage Information (the 95th Release)
(As of 15:00 April 15th, 2011)

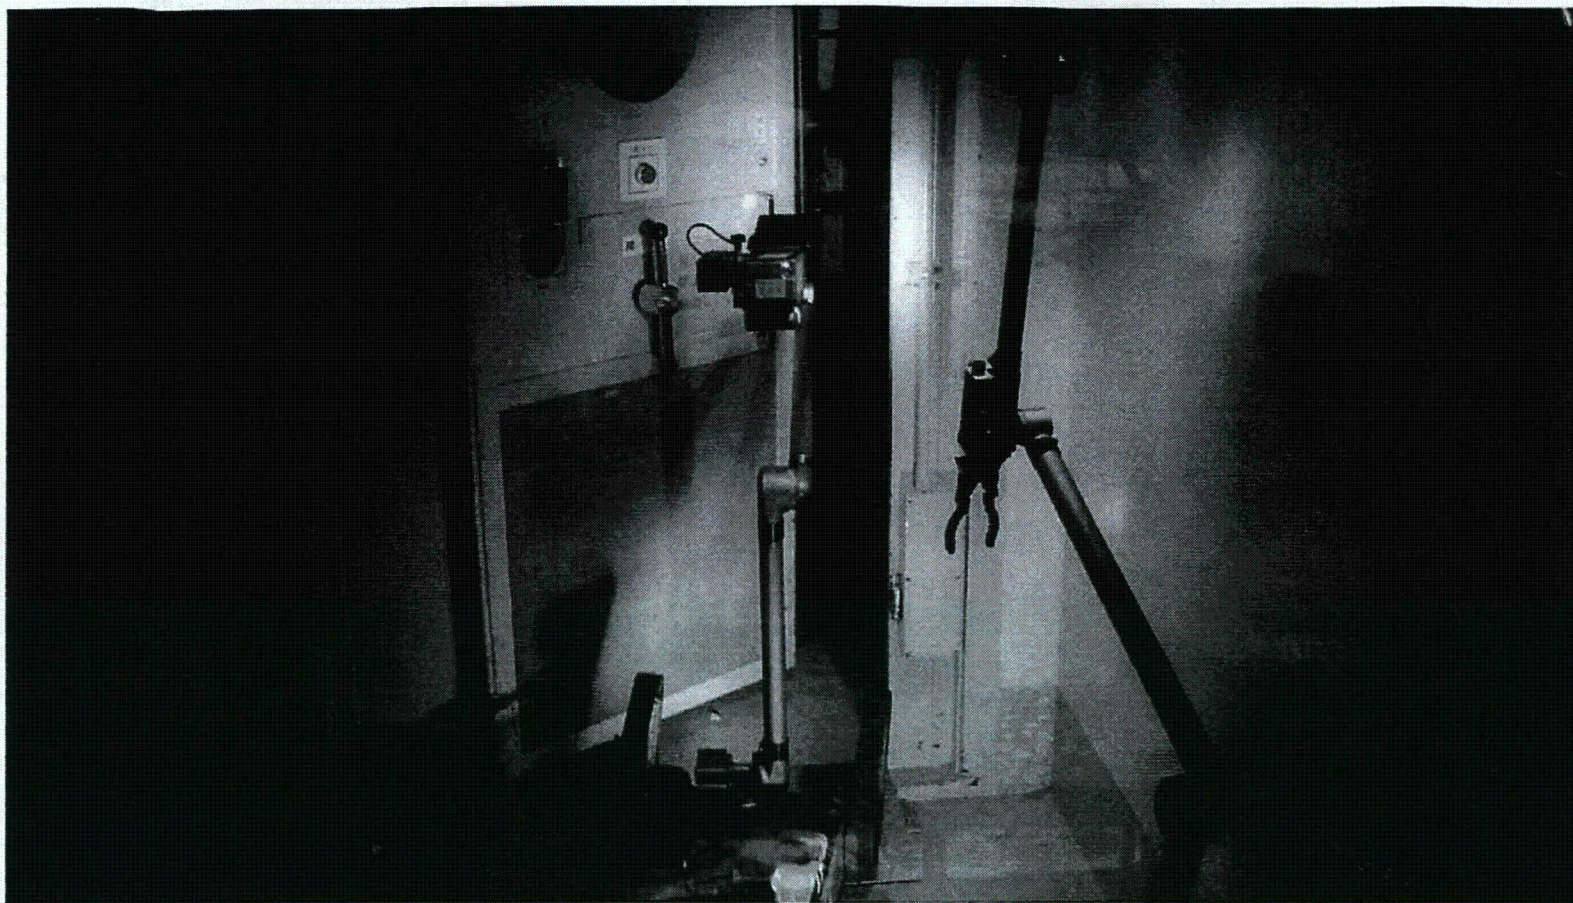
パックボットが二重扉を開ける様子①

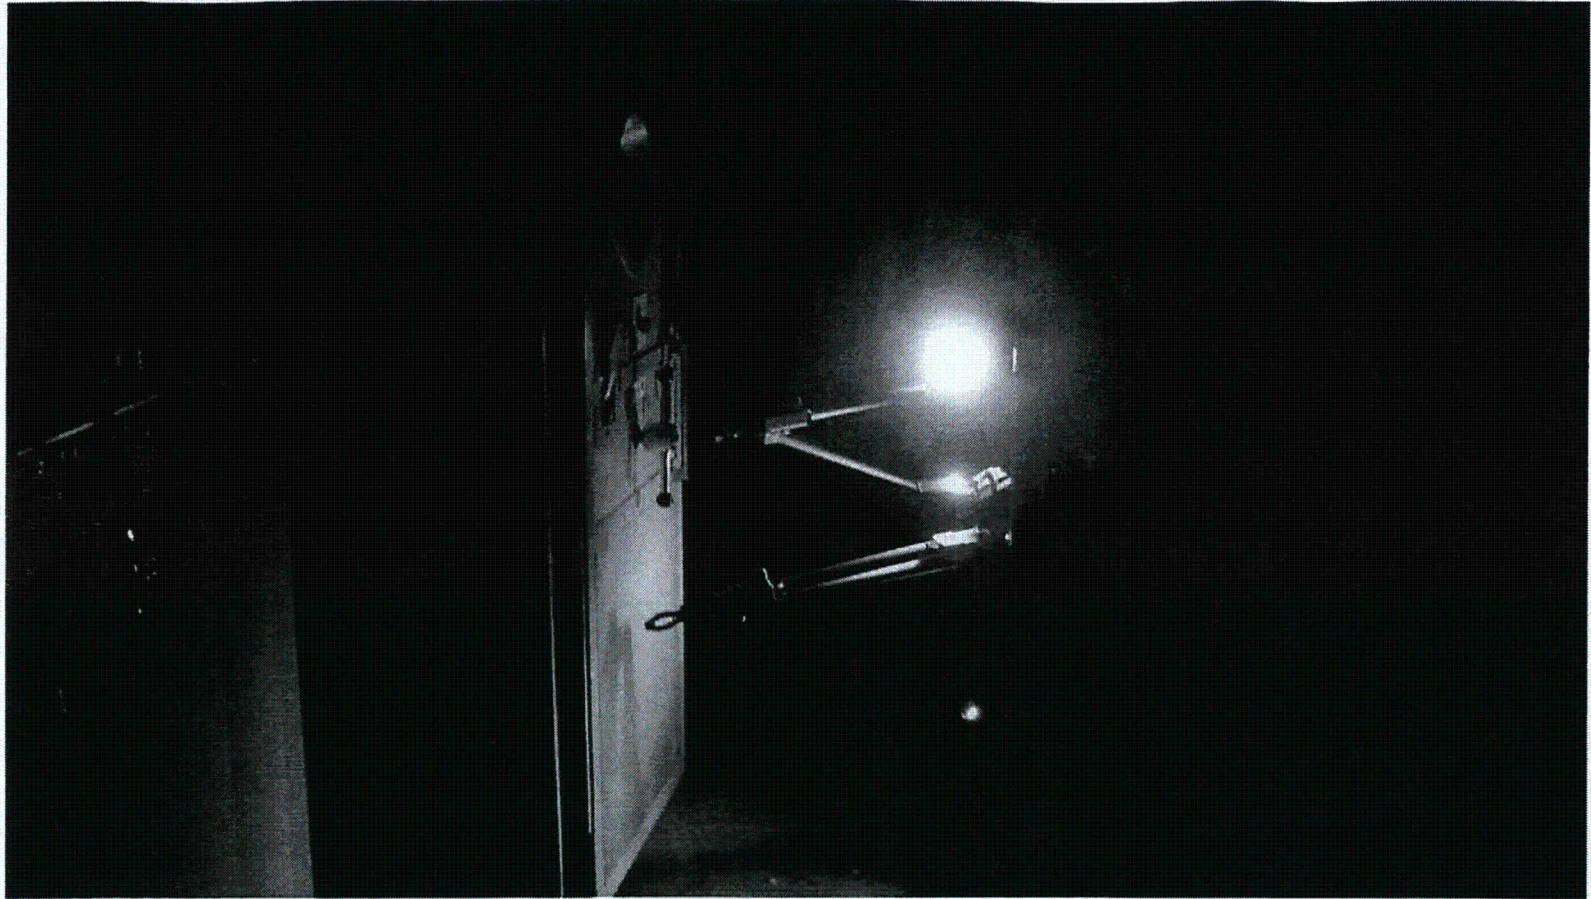
パックボットが二重扉を開ける様子③

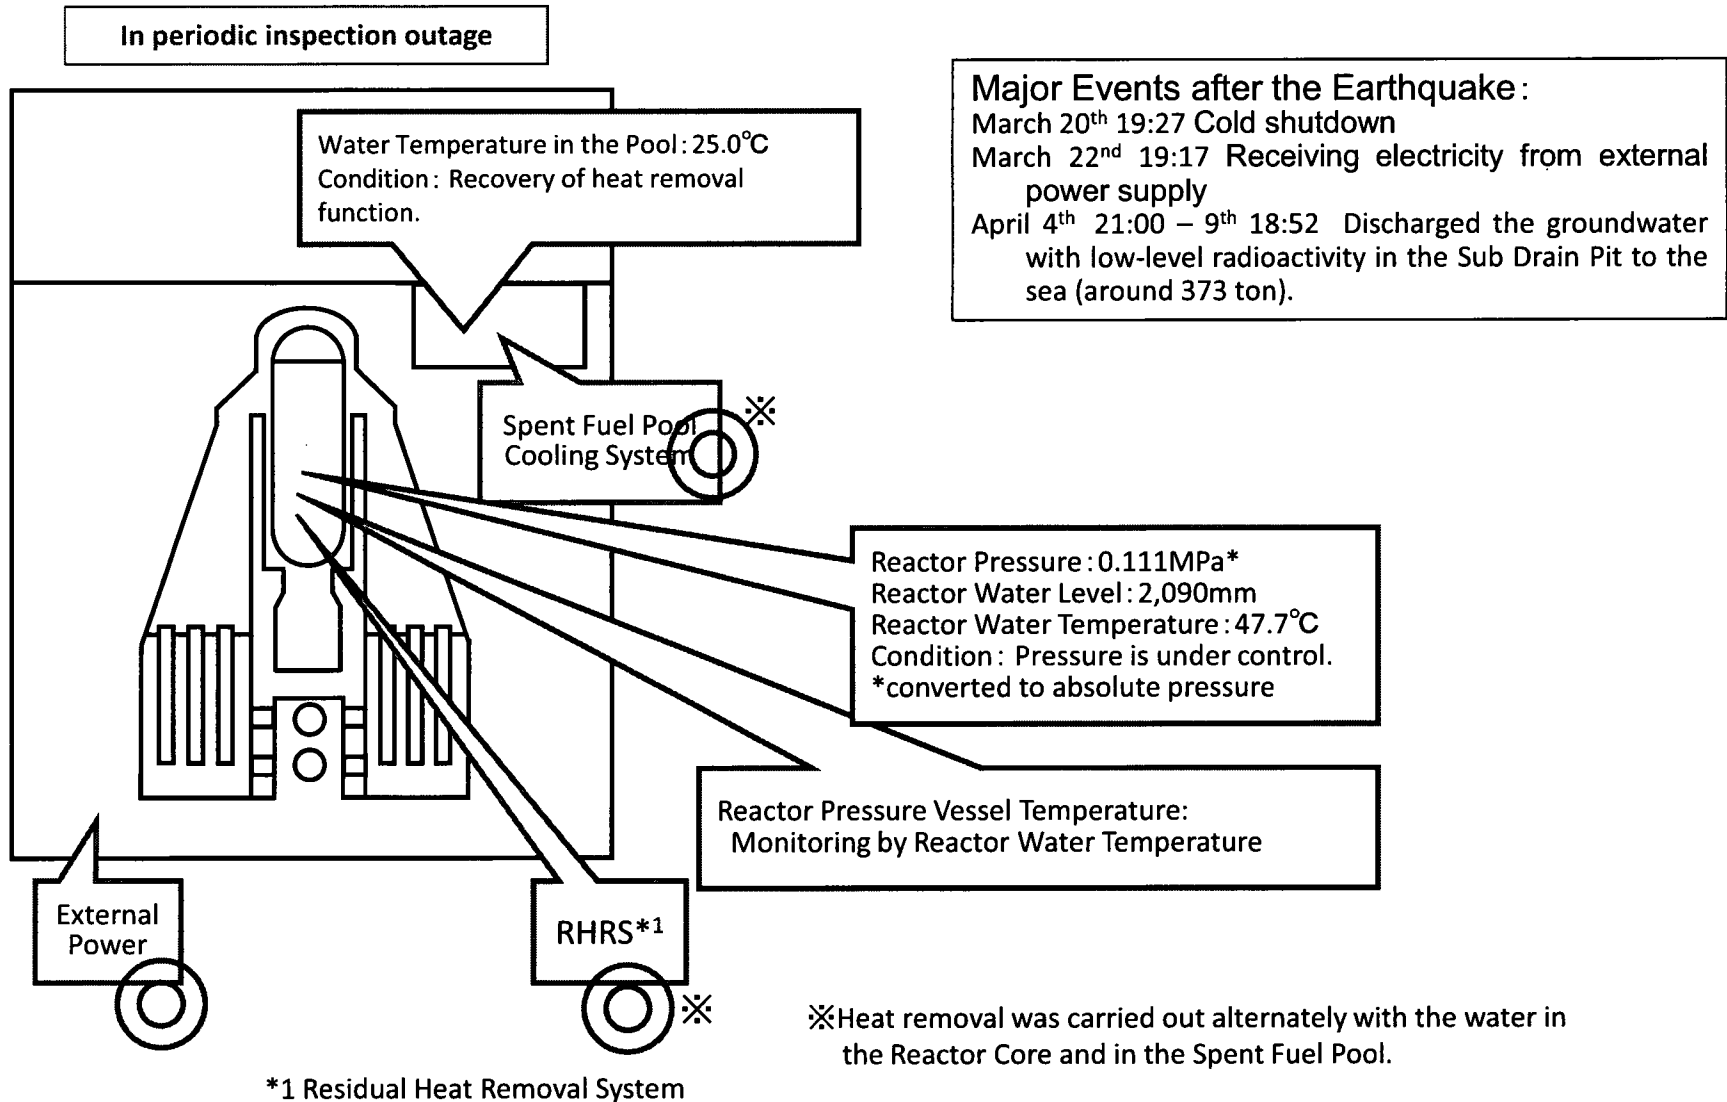
Conditions of Fukushima Dai-ichi Nuclear Power Station Unit 6 (As of 7:00 April 19th, 2011)

Major Events after the Earthquake:
 March 20th 19:27 Cold shutdown
 March 22nd 19:17 Receiving electricity from external power supply
 April 4th 21:00 – 9th 18:52 Discharged the groundwater with low-level radioactivity in the Sub Drain Pit to the sea (around 373 ton).
