Intersecciones en Antropología, vol. 15, núm. 1, 2014, pp. 55-69

Post-depositional processes studies of wooden artifacts from the 18th century *Swift* shipwreck site (Patagonia, Argentina)

Mónica Grosso

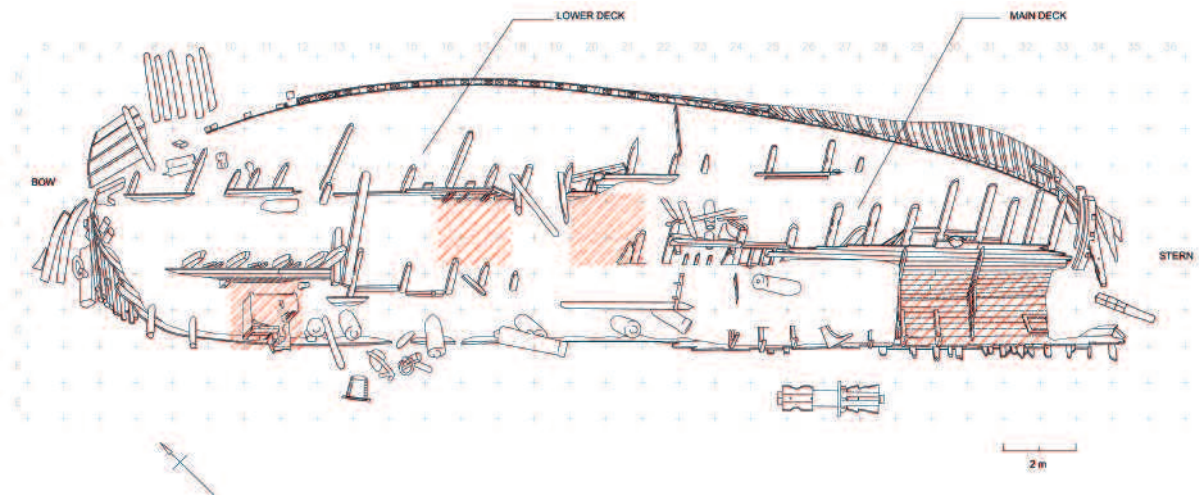
Figure 2. Site plan with the excavated areas highlighted (Drawing: C. Murray).

Excavated areas allowed the examination of wooden elements that had been covered by sediments. As shown in Figure 2, 20 m² were excavated, distributed as follows: on the main deck near the galley (bow-port side) and the Captain’s quarters (stern-port side); on the lower deck, in a possible block storeroom, and forward of the main mast. In the two first areas listed, internal planking was reached while the others were just partially excavated.

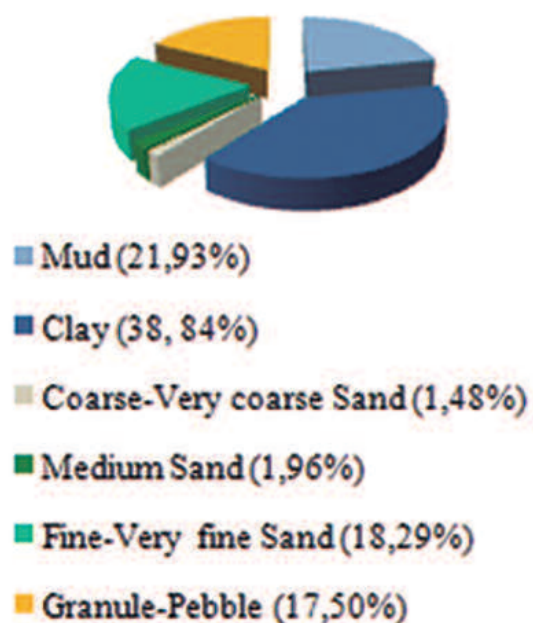
Figure 4. Granulometric composition of the *Swift* site. Sizes classification follows Udden-Wentworth scale (Bastida *et al.* 2011).

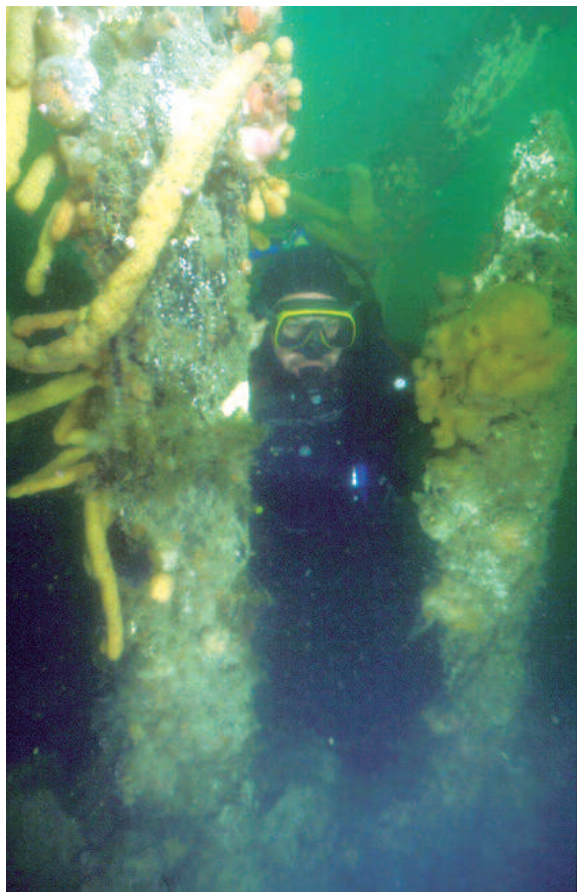
Figure 5. Deck beams colonized by tunicates of solitary and colonial species (Photo: S. Massaro).

Among the fouling organisms colonizing the shipwreck, tunicates ("sea squirts") are the most notorious, due to their size and distribution over the whole site on various types of substrata. Tunicates are able to develop communities of considerable size even from very small areas, chiefly in zones of good water flow, as in the case of frames and beams that are nearly vertical due to the ship list (Figure 5).

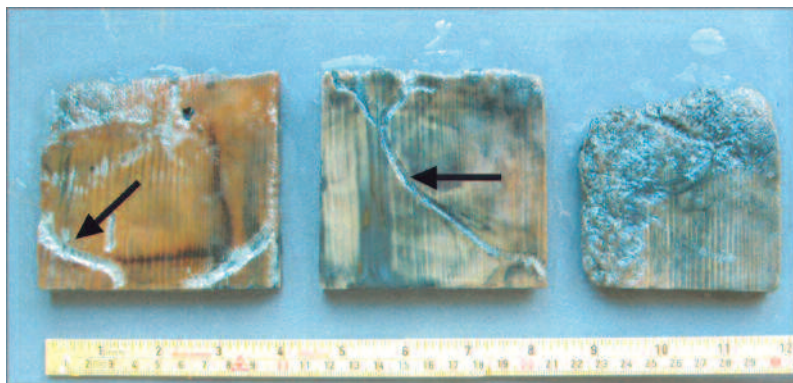
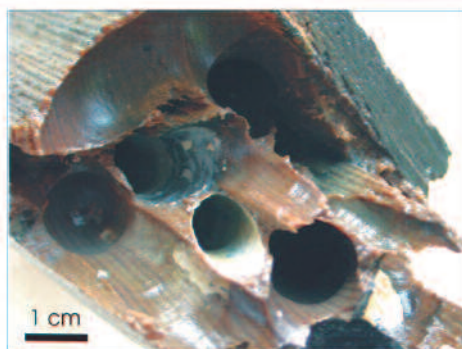
Figure 6. a) Impressions left by soft tube polychaetes in chest components. b) Timber broken as a consequence of teredid activity. One of the tunnels still retains its calcium carbonate lining.

In situ observations reveal that colonization has spread over structural elements and objects of varied forms and sizes, which supports arguments that different wood species and their hardness are not determining factors for wood-borer settlement (*e.g.*, Nair and Saraswathy 1971; Bastida and Torti 1972a). It is interesting to note also that artifact size has no apparent relation to the intensity of colonization (Figure 6b).

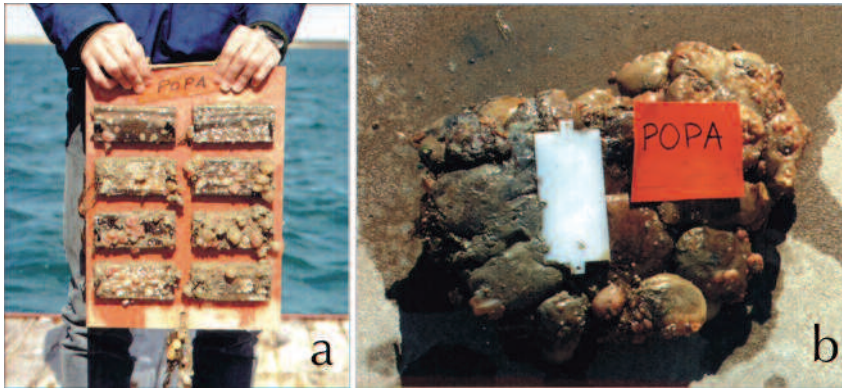
Figure 7. a) Wooden panels after one year of immersion. b) Significant growth of biofouling form one of the acrylic panels after two years of immersion.

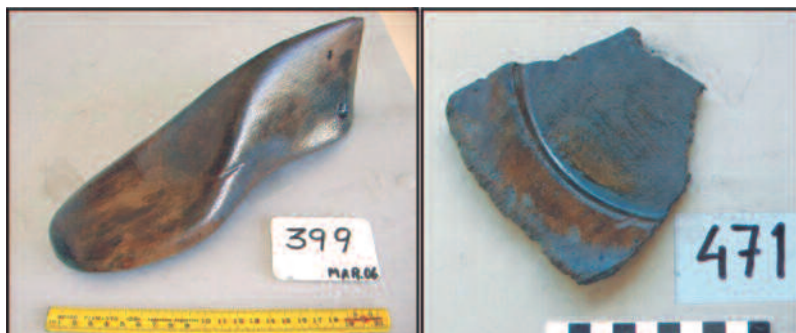
Figure 8. A shoe last (INA 399) and a plate fragment (INA 471), both made from *Fagus* sp., exhibit differential preservation as a consequence of their particular post-depositional history.

The particular physical and chemical properties of different wood species are also relevant factors when considering the degradation and water-saturation processes in the marine environment. In this respect, it has been stated that porous woods like *Betula* sp. (birch), *Fagus* sp. (beech) and *Fraxinus* sp. (ash) become completely saturated within a few hours of being submerged and scarcely survive in the water. However, several artifacts manufactured with some of these species (*i.e.*, *Fagus* sp. and *Fraxinus* sp.) were found at the *Swift* site. Additionally, objects made from *Fagus* sp exhibit clear differences in their preservation, likely due to differences in their depositional histories. For example, the most degraded artifacts (tableware pieces) were found in the galley area, a location more exposed than the stern, where well preserved objects (such as a shoe last) were found completely covered by sediments (Figure 8).

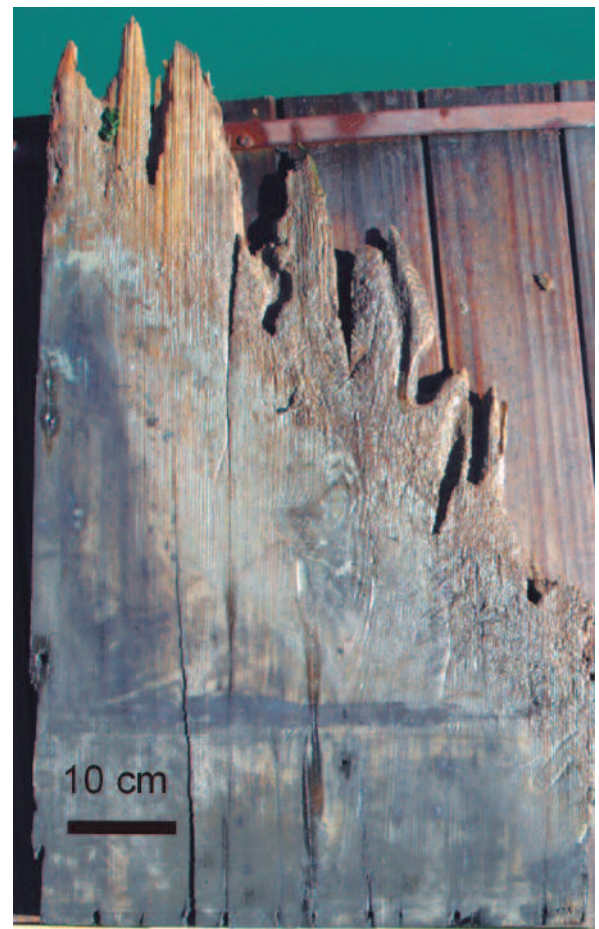
Figure 9. Part of this sea chest component was seriously deteriorated because of wood-borers activity and erosion processes. A well preserved area due to sediment coverage can clearly be observed (Photo: C. Murray).

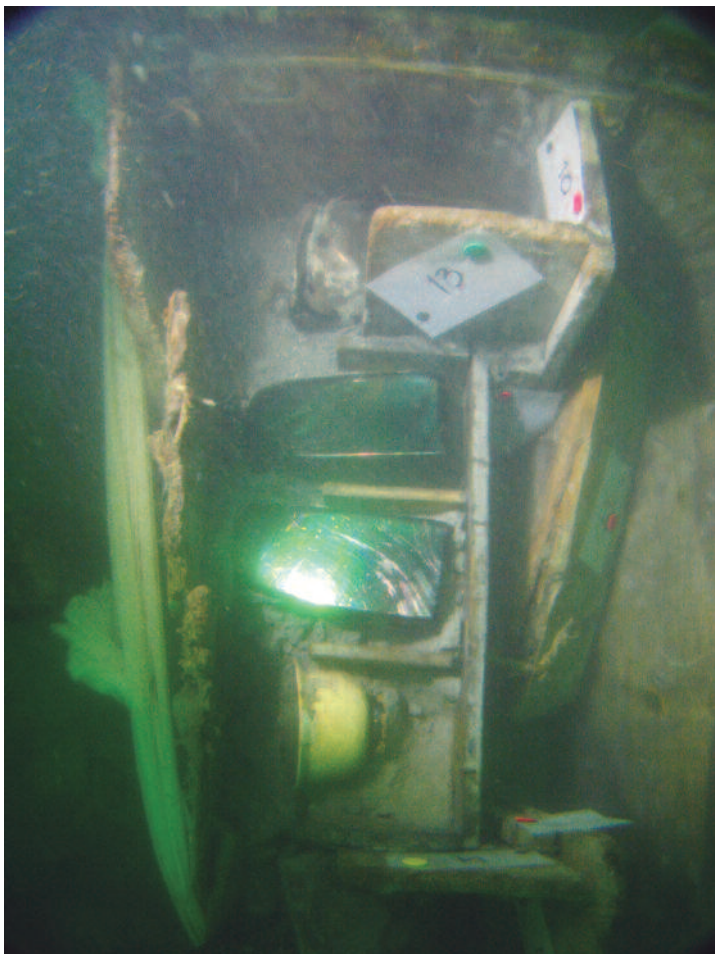
Figure 10. Medicine chest found on the superficial level in the amidship area with a very well preserved content (Photo: C. Murray).

and permitted the distinction between the Captain's cabin and his chamber. The spatial location and the integrity of the objects there seemed more clearly defined. Some examples of this are furniture (e.g., folding stools) found in what it seems to be its original storage location, and a cupboard and its content that have maintained their contextual relations. Sediment accumulated inside boxes and chests before nails and ironwork corroded, preventing the collapse of wood components and preserving the original content. This pattern has also been observed in other areas of the site where sedimentation was rapid, even in levels close to the surface (Figure 10).
