Final Report

MASH TL4 Evaluation of MassDOT's Curb-Mounted
and Sidewalk-Mounted S3-TL4 Steel Bridge Railing
Using Finite Element Analysis

Prepared for: **Gill Engineering and the Massachusetts Department of
Transportation**

Project No: **X129053P11 - PHASE II**

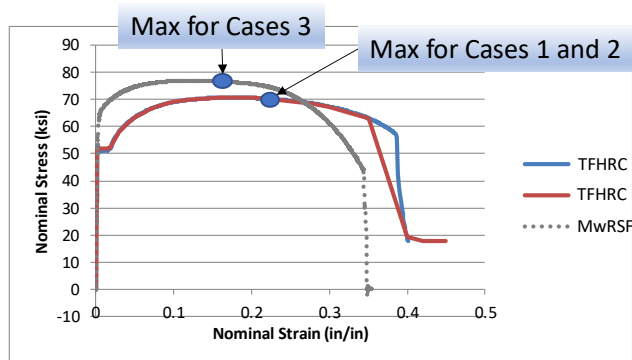
Figure 110. Maximum strain results in relation to material stress-strain curve.

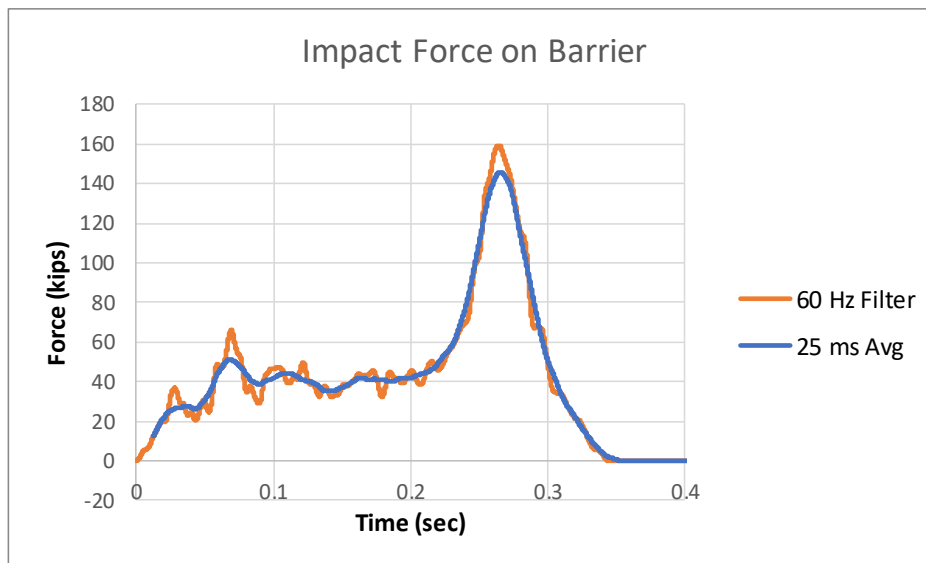
Figure 112. Lateral force-time history between vehicle and barrier for curb-mounted bridge rail.

The impact force between the vehicle and the barrier was computed to determine the peak loading on the barrier which could then be compared to the design strength of the bridge rail. The lateral force-time history results are shown in Figure 112 for the 25-millisecond moving average force and the force data filtered with cutoff frequency of 60 Hz. The maximum impact force occurred when the rear tandem wheel set impacted against the bridge rail. The maximum 25-ms moving average force was 146 kips. The lateral strength of the bridge rail should be greater than 145 kips to prevent failure for this impact case.

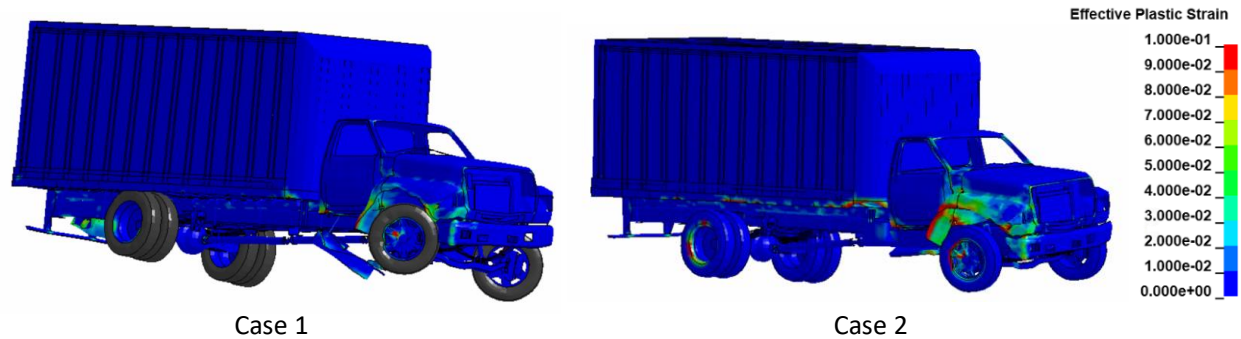
Figure 113. Damages to vehicle in Test 4-12 analysis of curb-mounted bridge rail for Cases 1 and 2.

Figure 113 shows contour plots of effective plastic strain for the vehicle, which were used to identify areas of the vehicle that suffered damage during the simulated impact event. The most severe damages were to the front bumper, the front fender, the front impact-side suspension, the front axle, the front impact-side corner of the cargo box, the cargo-box floor beams, and the cargo box main rail.
