PETALUMA RIVER WATERSHED

CONTEMPORARY RIPARIAN CONDITION ASSESSMENT

January 2024

SFEI | San Francisco
Estuary Institute

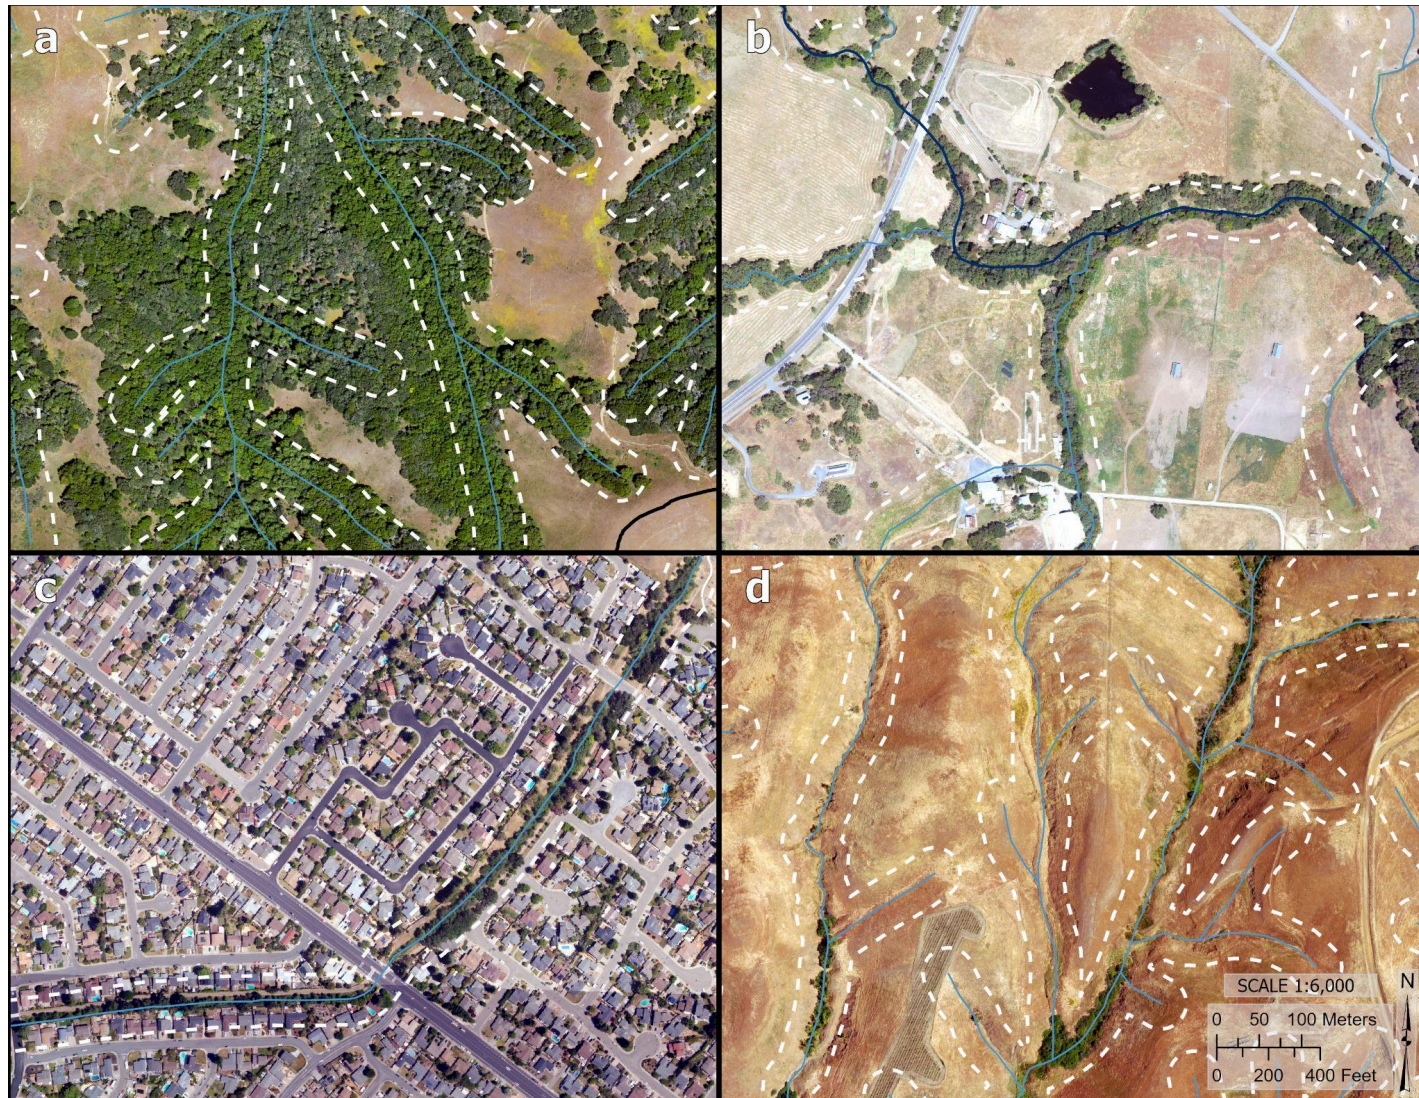
Figure 2. Aerial imagery (U.S. Geological Survey, 2022) showing examples of the riparian zone (dashed white lines) from various locations across the watershed. The riparian zone is 100 ft wide on either side of mapped streams (blue lines; SFEI-ASC, 2017). Images are A) forested headwaters of San Antonio Creek, B) the main stem San Antonio Creek, indicated by the darker blue streamline, C) East Washington Creek in the City of Petaluma, and D) gullied streams dominated by grassland vegetation in the southeast part of the watershed.

The riparian zone assessed in this document was defined as a standard 100 ft width on either side of mapped streamlines (Figure 2). Based on measurements taken from aerial photography, this width captures the majority of riparian forest vegetation in this watershed. As Table 1 suggests, a single riparian width can be chosen when evaluating multiple functions, and because our evaluation of riparian functions relies primarily on vegetation mapping (as discussed below), we chose to use riparian forest width as a guide; along streams in much of the watershed, riparian forest was easily distinguishable by a distinct shift from forest to grassland vegetation, usually within 100 ft of the stream (Figure 2b). This 100 ft buffer area also encompasses many riparian functions related to flooding, bank stability, and runoff filtration, which are present even in the non-forested, open, grassland areas of the watershed. In some headwater areas, forests are wider than the riparian zone, but with a brief evaluation of a digital elevation model hillshade and local knowledge of the study area, we assume that beyond 100 ft, the forest transitions to upland ecosystems, more reliant on hillslope drainage than streamflow (Figure 2a). In the Petaluma Valley, riparian ecosystems may have historically been much wider, however the 100 ft buffer captures current riparian width in urban areas fairly well (Figure 2c). The buffer was applied to all mapped streams in the watershed.

Within the riparian zone across the watershed, land cover consists of 60% grassland, 30% forest, 4% developed, 3% cropland, 1% shrub, 1% wetland, and 1% other categories (Table 2). The riparian zone generally has higher tree cover than the rest of the watershed; 41% of all forested areas in the watershed are found within the 100 ft riparian zone buffer, despite this area accounting for only 11.5% of total land area. Within the riparian zone, trees generally grow directly adjacent to streams. Although grassland comprises a majority of the riparian zone, a significant portion of the grassland within the 100 ft buffer is not stream-adjacent, seen on the Figure 5 inset and Figure 2b. Grassland is, however, directly adjacent to 52% of streams, most commonly in arid, south-facing drainages in the southeastern part of the watershed and north side of the San Antonio Creek drainage where little to no tree cover exists (Figure 2d).

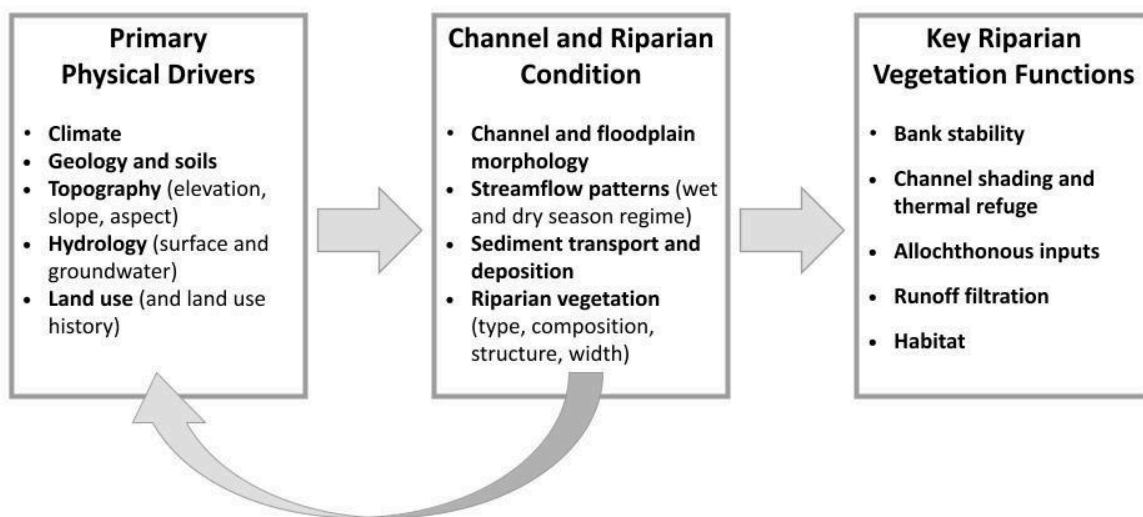
Figure 3. Conceptual diagram of the relationship between physical drivers, channel and riparian condition, and riparian vegetation functions. The five primary physical drivers determine channel and riparian condition, which includes riparian vegetation type, composition, structure, and width. Vegetation can influence both the physical drivers and channel and riparian condition, a complex feedback mechanism simplified here. Ecological functions of riparian vegetation are determined by the channel and riparian condition.

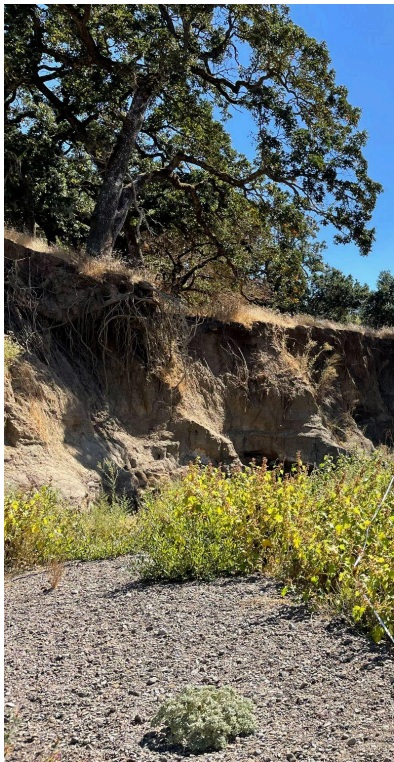
Figure 9. Riparian Valley Oak (*Quercus lobata*) at a large bank erosion feature in an incised reach of San Antonio Creek.

Erosion and incision impact the riparian area in a few ways. First, accelerated erosion of cutbanks and encroachment on historical riparian forests are causing long-established trees to fall into the channel. In a 2023 field visit, we observed estimated 100+-year-old valley oaks and coast live oaks being lost to bank erosion (Figure 9). Lowered baseflow and water table elevations stress the existing riparian vegetation along the mainstem of San Antonio Creek and hinder the reestablishment of riparian forests along incised reaches. Although smaller tributaries of San Antonio Creek are also incised, riparian vegetation along these streams typically have access to water and nutrients from hillslopes. According to a preliminary study conducted in 2000, increased rates of bank erosion and stream incision along San Antonio Creek, coupled with drawdown of the adjacent water table, have led to the loss of riparian vegetation along terrace banks (Collins et al., 2000). These factors, alongside channel straightening, have sped up the erosion process significantly. Human activities in the watershed have increased sediment production by estimates greater than 50%, and have sharply reduced base flow and increased peak flows (Collins et al., 2000).
