**KNOXVILLE/KNOX COUNTY METROPOLITAN PLANNING COMMISSION  
 USE ON REVIEW REPORT**

▶ **FILE #:** 12-E-18-UR

**12-E-18-UR  
USE ON REVIEW**

Pages from GEOS Study re Lot 15 6-25-06  
& GEOS Study re Lot 16 6-28-06

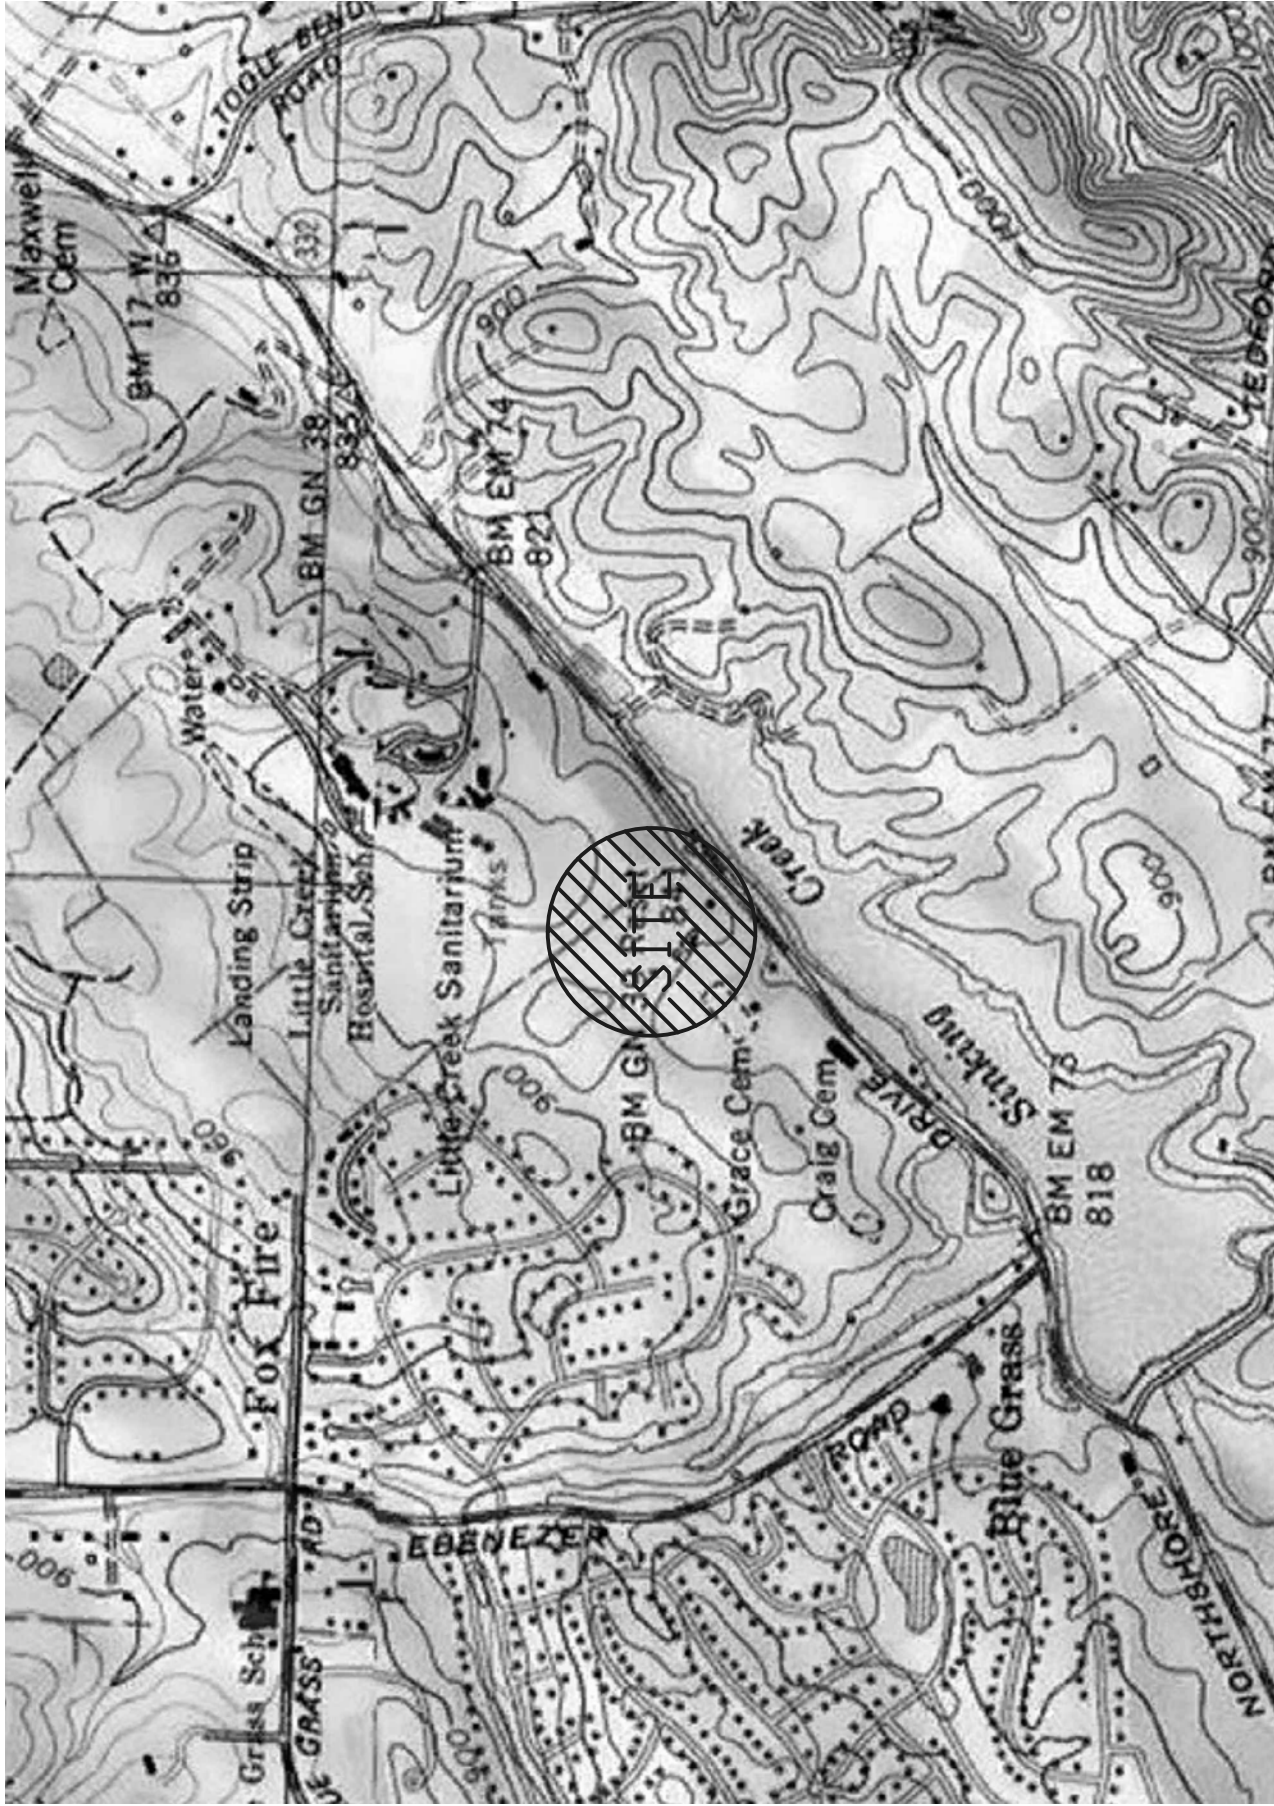
Attachments: Site Vicinity Map, Boring Location Plan, Boring Legend, and Boring Logs

The site subsurface conditions were explored with five (5) soil test borings spread across the site. The boring locations were marked in the field by GEOServices personnel. All depths in this report reference the ground surface that existed at the time of this exploration. Drilling was performed on July 20 and 21, 2018. The borings were advanced using 3.5-inch inside diameter hollow stem augers (HSA) with a Diedrich D-120 track-mounted drill rig. Within each boring, standard penetration test (SPT) and split-spoon sampling were performed at 2.5 foot intervals in the upper 10 feet, and 5 foot intervals thereafter. The drill crew worked in general accordance with ASTM International (ASTM) D 6151 method for HSA drilling. Sampling of overburden soil was performed in general accordance with ASTM D 1586, per the SPT procedure. The borings were backfilled with soil cuttings. Detailed information pertaining to each boring location can be found on the boring logs provided as an attachment to this report.

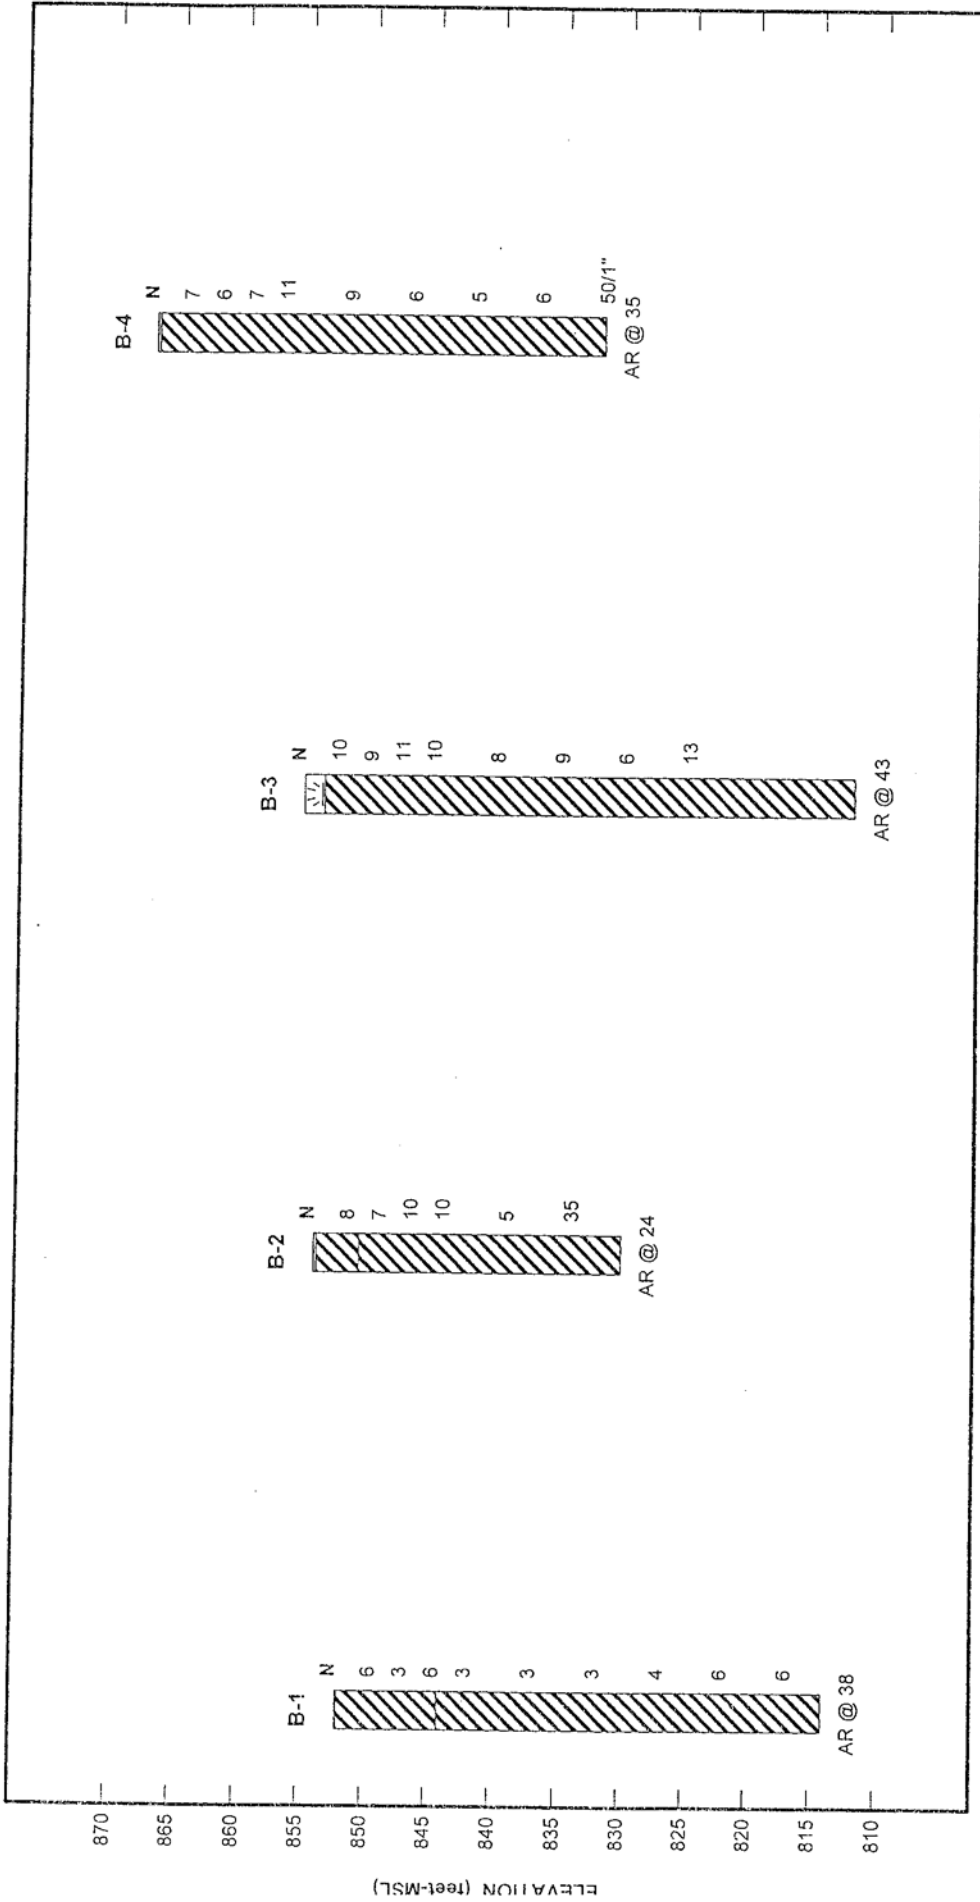
N = Standard Penetration Test resistance value (blows per foot). The depicted stratigraphy is shown for illustrative purposes only. The actual subsurface conditions will vary between boring locations.
