PHASE I ENVIRONMENTAL SITE ASSESSMENT

**WEST END COMMUNITY CENTER, INC.
705 KENT STREET
DURHAM, DURHAM COUNTY, NORTH CAROLINA**

July 31, 2012

Terraquest Project No. 03112

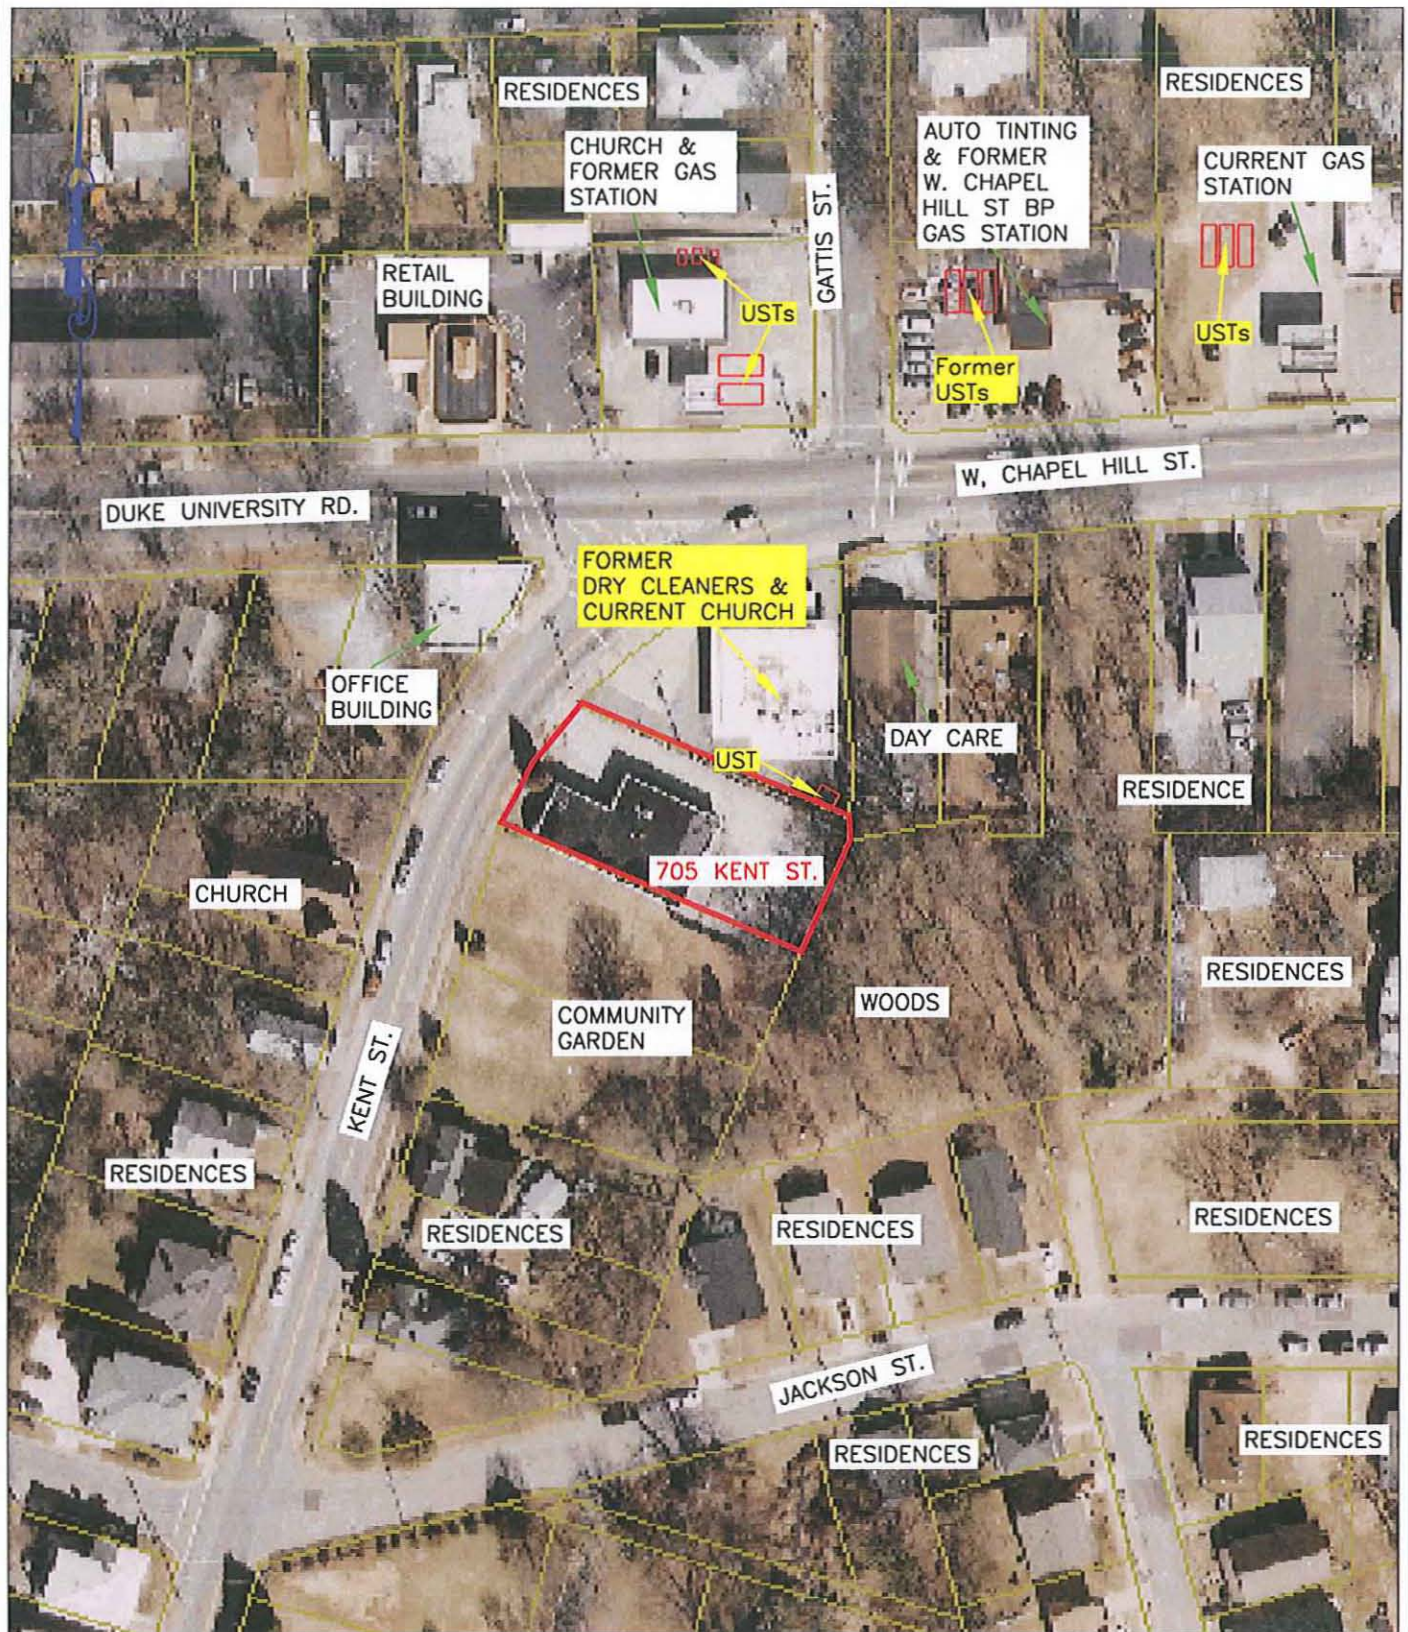
FIGURE NO. 1

SUBJECT PROPERTIES OUTLINED IN RED

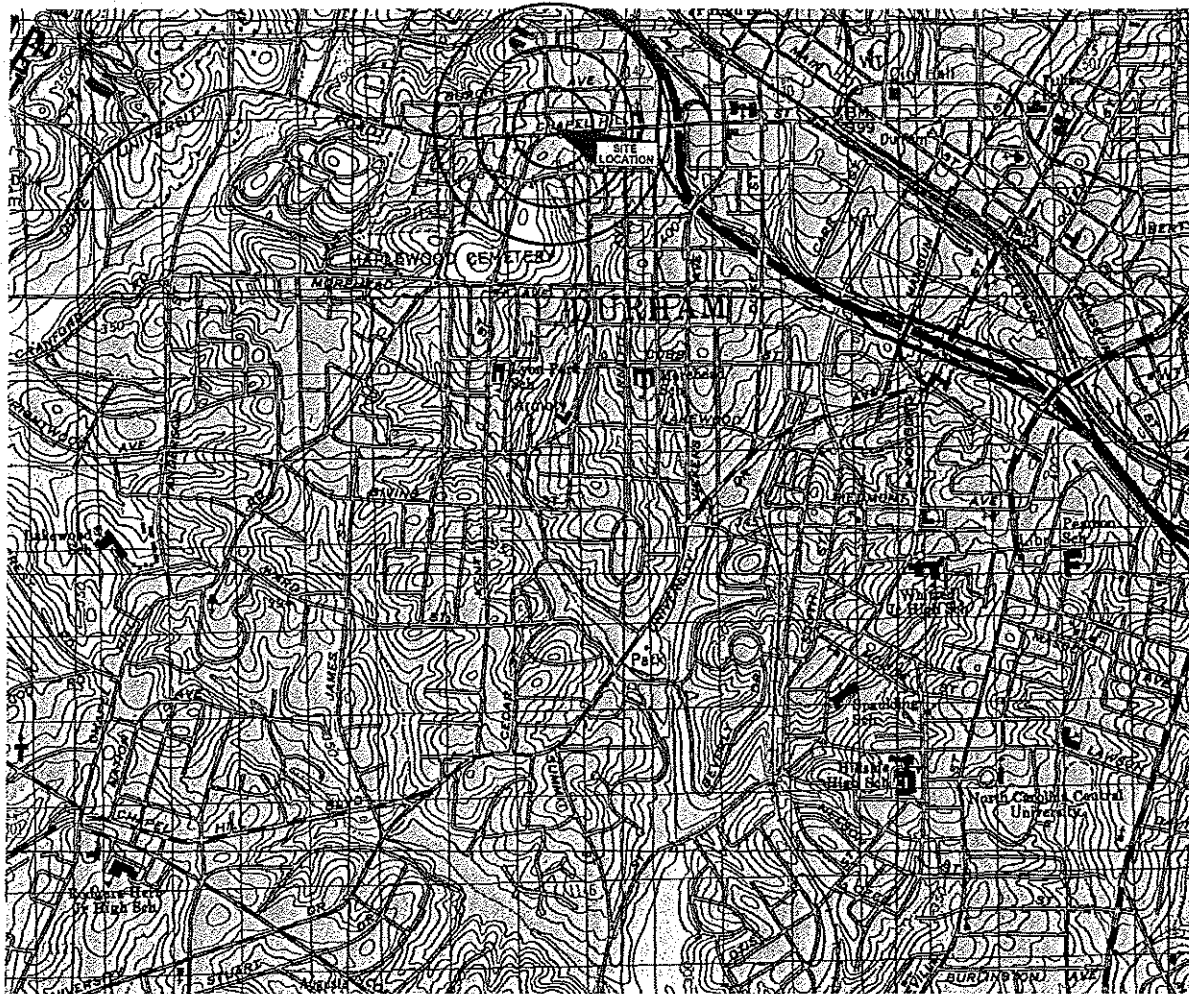
FIGURE 1:
SITE AND VICINITY TOPO MAP
1118 W. CHAPEL HILL STREET
DURHAM, NORTH CAROLINA

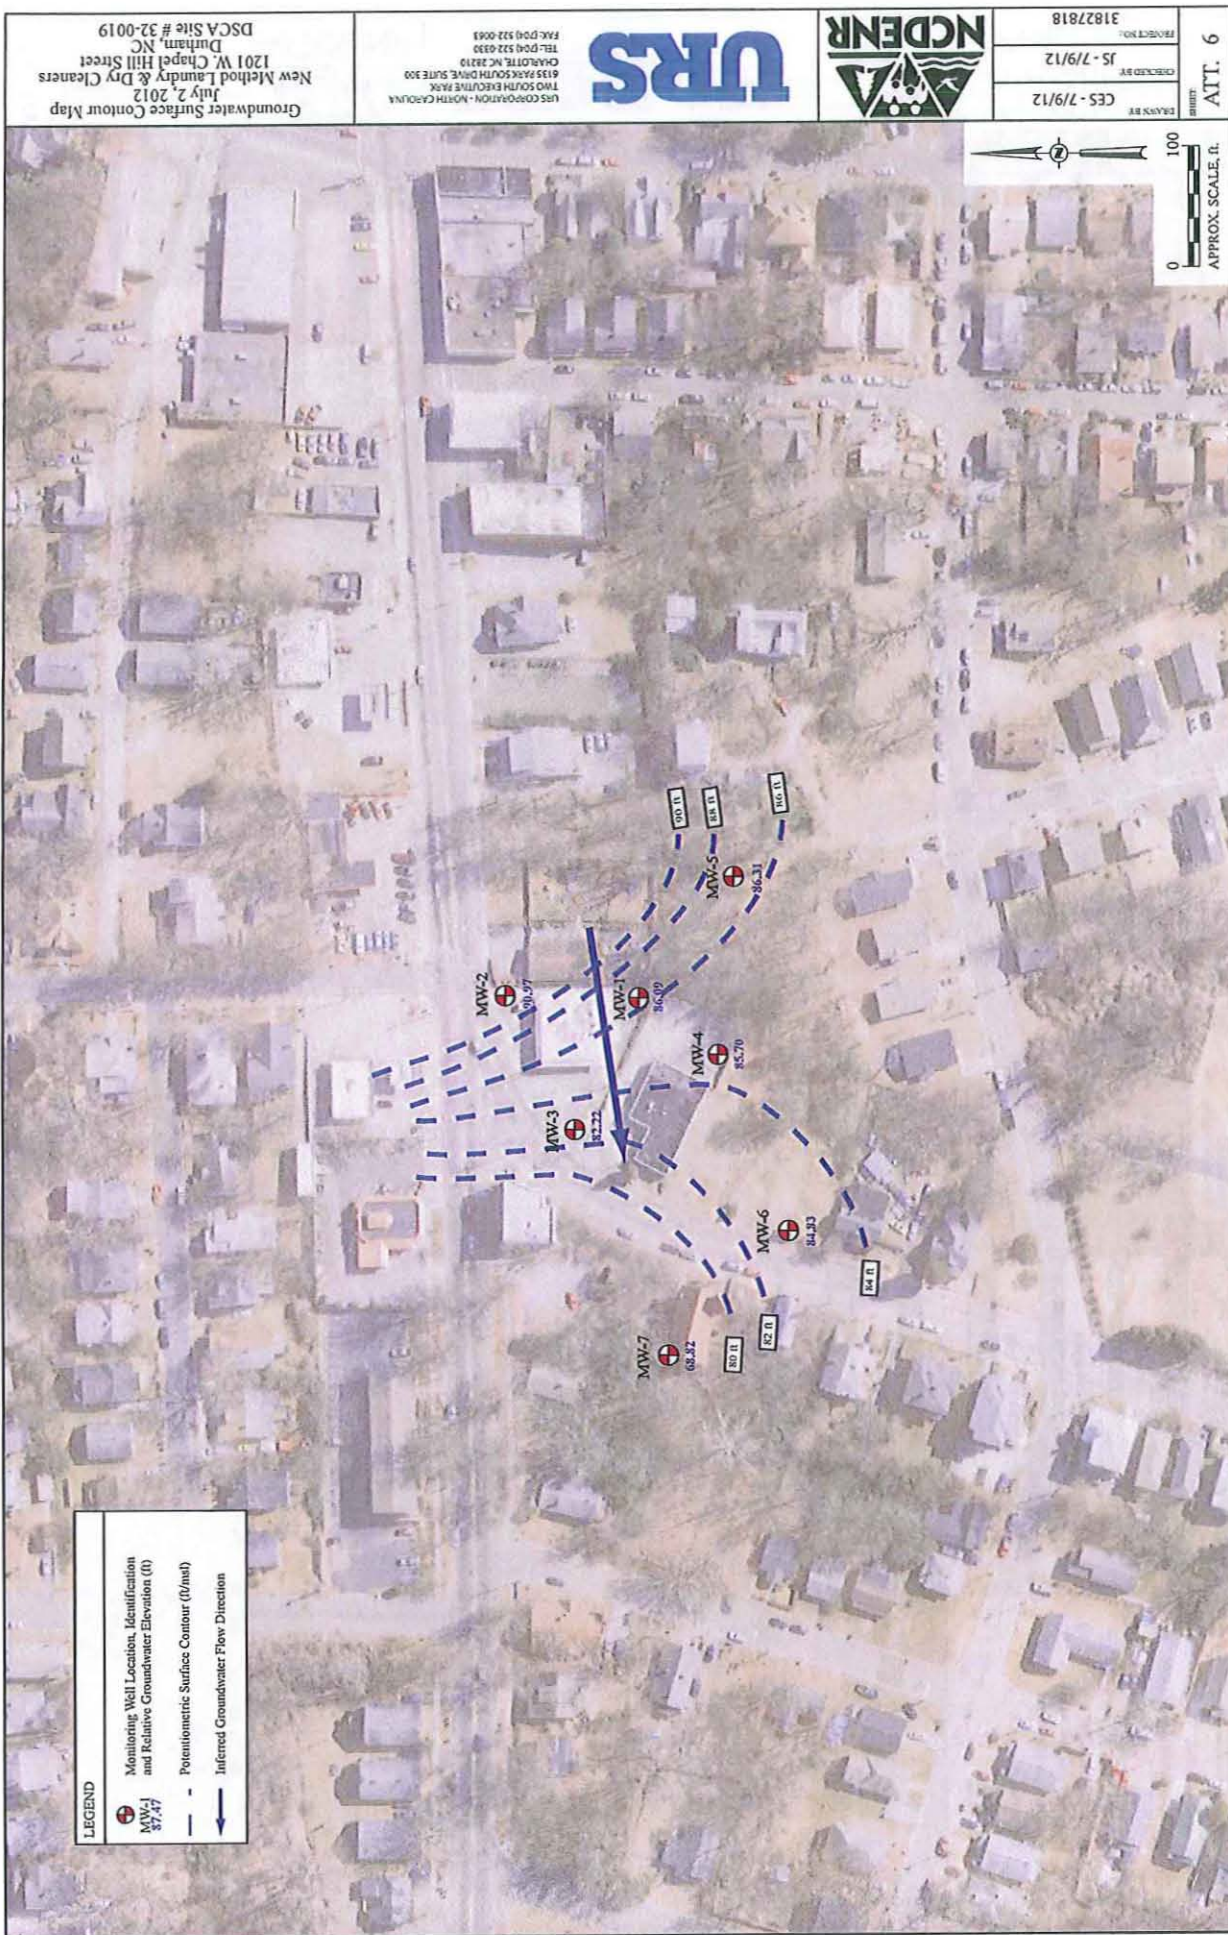
Groundwater Surface Contour Map
 July 2, 2012
 New Method Laundry & Dry Cleaners
 1201 W. Chapel Hill Street
 Durham, NC
 DSCA Site # 32-0019

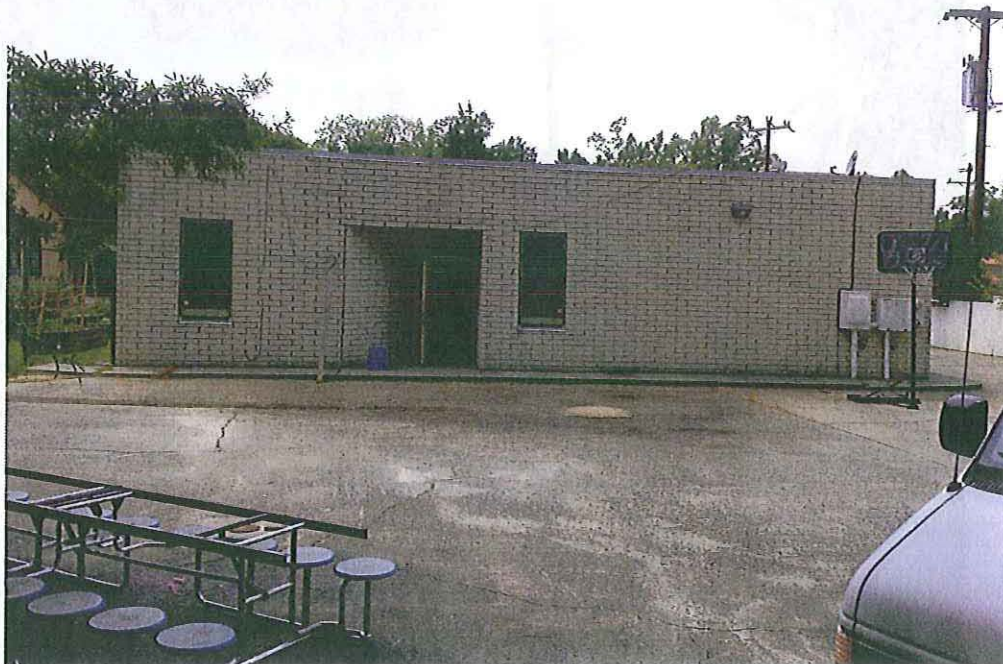
Rear of Main Building on Subject Property; Looking West From Southern End of Subject Property

Terraquest observed no indications of air discharges at the West End property during the site visit. A storm water drain was noted off the southwest corner of the building. This drain is supplied by the roof drains. Water is removed from the drain via an electric sump pump and discharged to grass area and public sidewalk west of the building. The West End property building is connected to the City of Durham for sanitary sewage disposal.

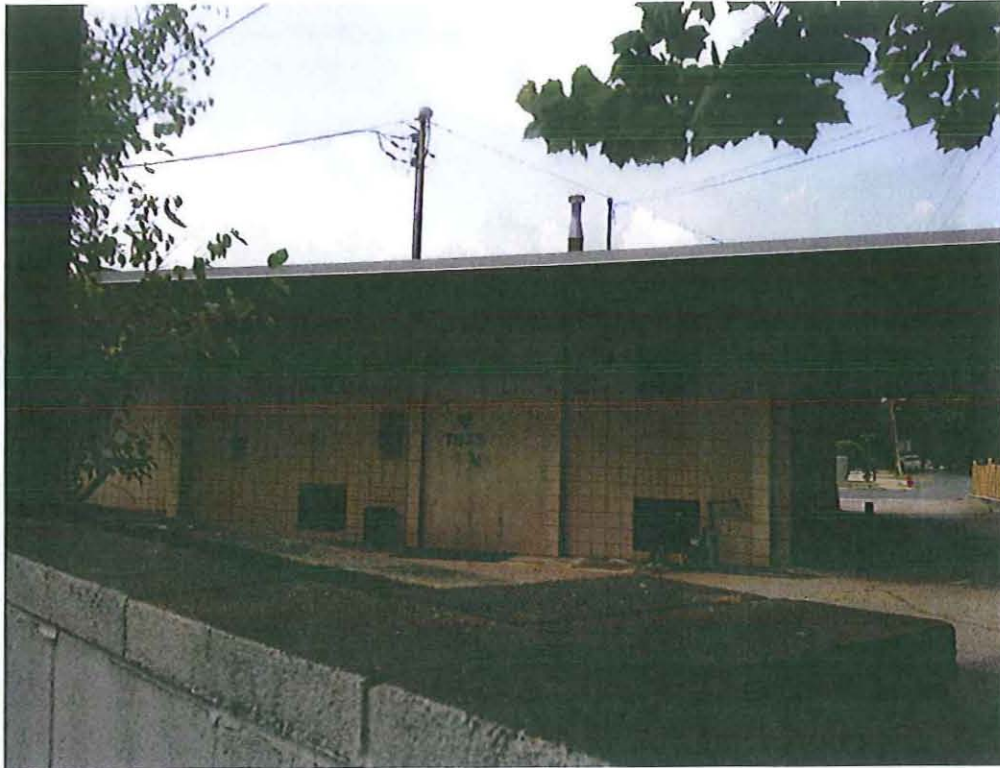
Former Dry Cleaners, Suspected PCE Source; Looking North

The other environmental concern identified during the site visit and records review was the aforementioned chlorinated solvent release discovered on the adjacent 1201 W. Chapel Hill property and concentrations of PCE soil contamination that was found on the West End property. Current assessment and future cleanup of the chlorinated solvent release are being addressed by the DSCA program and are not the current responsibility of the West End property owner. Future assessment and cleanup completed by DSCA may occur on the West End property. Furthermore, future institutional/engineering controls may be required for future development of the West End property given the presence of PCE soil and/or groundwater contamination.

Due to presence of chlorinated solvents on the adjacent 1201 W. Chapel Hill St. property and the West End property, Terraquest recommends a Brownfields Agreement be completed for the West End property to provide a covenant-not-to-sue from the state and federal regulatory agencies prior to purchasing the property. Furthermore, a dialogue with the NCDWM DSCA program should be maintained to monitor and verify ongoing assessment, cleanup, and closure of the incident due to the presence of PCE contamination on the West End property.

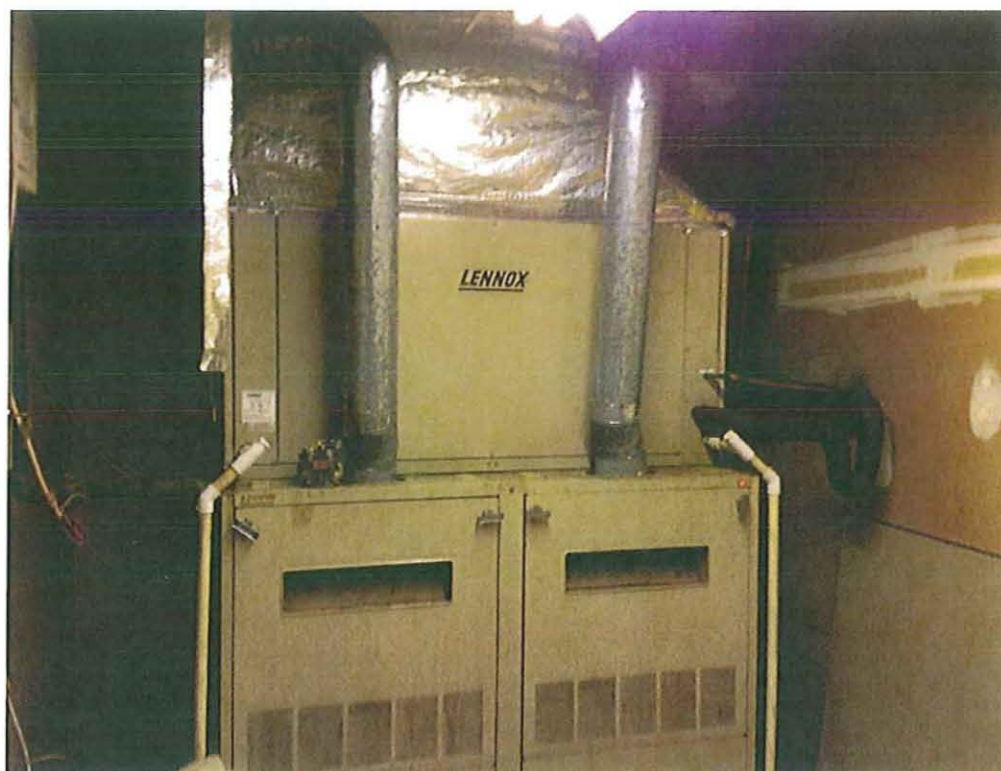
Natural Gas HVAC Unit in Building Interior
