Williams Creek Restoration Project: Alternatives Analysis

FINAL REPORT for CDFW Grant Agreements P1596013 & P1796009

March 2020

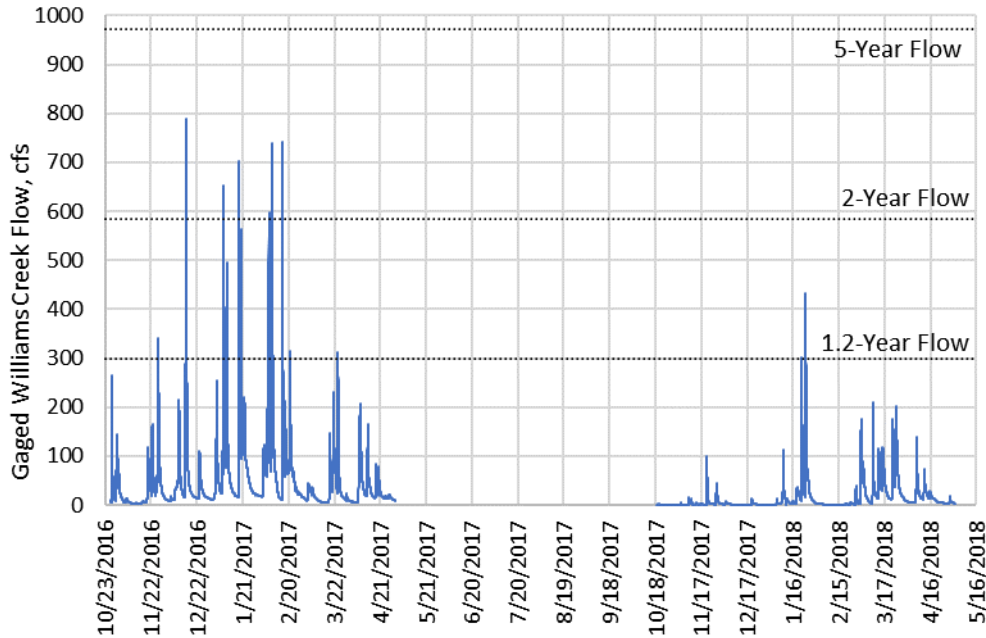
Figure 2-2. Gaged flows in Williams Creek during the 2017 and 2018 water years, with return periods indicated for reference.

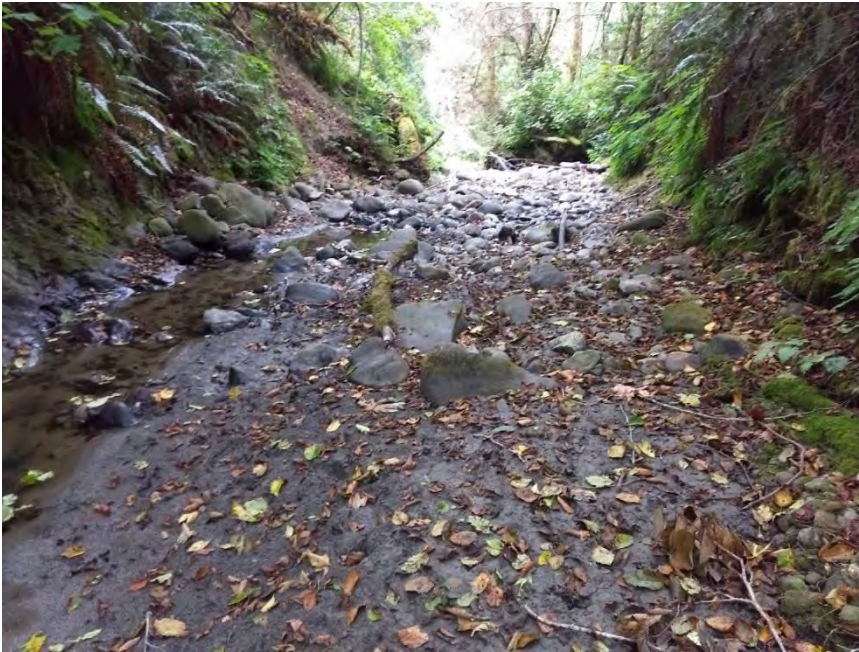
Figure 2-7. Confined channel in the upper reaches of Williams Creek. Thick silt deposition overlays coarse alluvial materials formed of sandstone (Photo 2018).

The upper reaches of Williams Creek, upstream of Tributary 2 on Figure 2-6 are comprised of a mix of bedrock and alluvial materials ranging in size from silts to small boulders. In most locations, the valley walls are comprised of bands of competent sandstones layered with thick deposits of highly erosive mudstones. Typically, the sandstones are relatively stable and the mudstones friable and very erosive. Areas of more competent sandstone appear to be the sources of the streambed material. The eroding mudstones in the upper reaches of Williams Creek deliver a substantial amount of sediment to the channel, primarily as finer grained materials. Sand and silt deposits are evident throughout the channel, and are thick in localized areas. A photograph of the upper reaches is show on Figure 2-7.

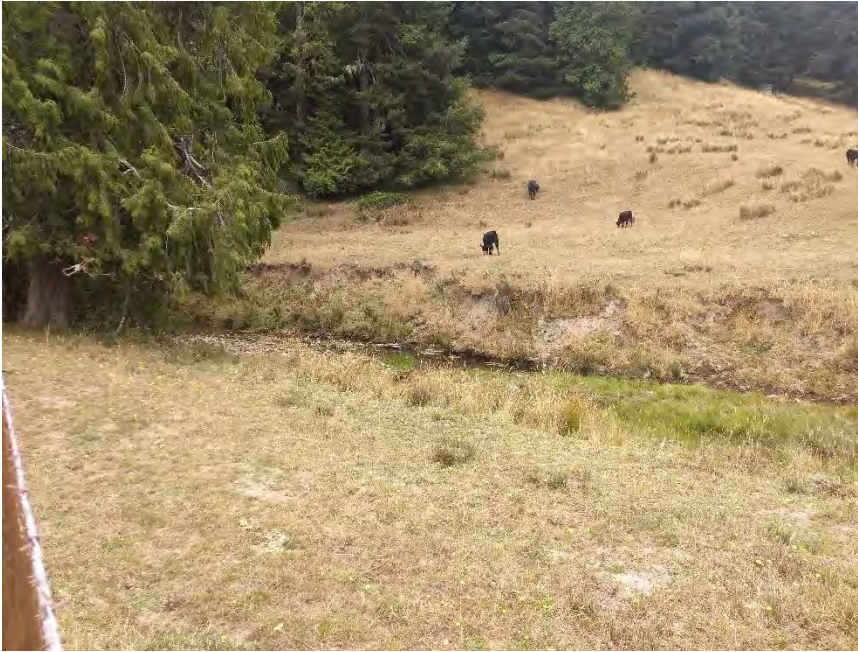
Figure 2-8. Unconfined channel in the middle reaches of Williams Creek where the valley is less confined. Streambed materials are smaller than upstream, but silt deposition remains pervasive and bank erosion is common (Photo 2018).

The middle reaches of Williams Creek are located between Tributary 2 and Grizzly Bluff Road. In these reaches, the channel slope decreases, the stream valley widens and the channel is typified by unconfined meanders with alluvial floodplains on one or both sides of the channel. The sediment sizes in the channel decrease gradually in the downstream direction. In general, it appeared that the middle reach is a sink for larger size particles, while delivering to the lower reaches finer materials. Silt deposition on the channel margins and upstream of channel

obstructions is pervasive. The channel banks along this reach are typically unstable resulting from livestock access and minimal riparian vegetation. Streambank erosion contributes silts to gravel-size sediment to the channel.

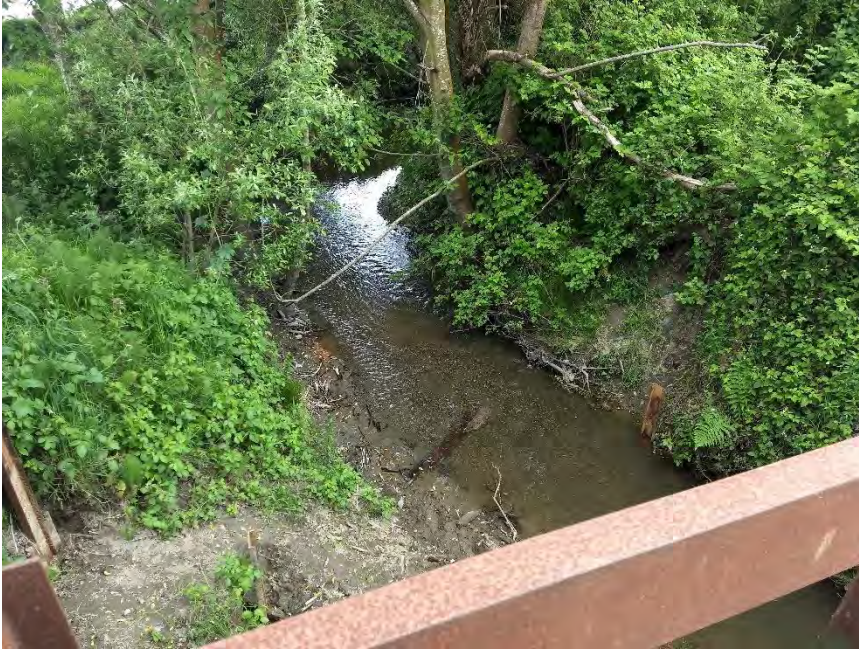
Figure 2-11. Williams Creek in the upper alluvial fan reach. The channel is generally trapezoidal in shape and over 6 feet deep (Photo 2018).

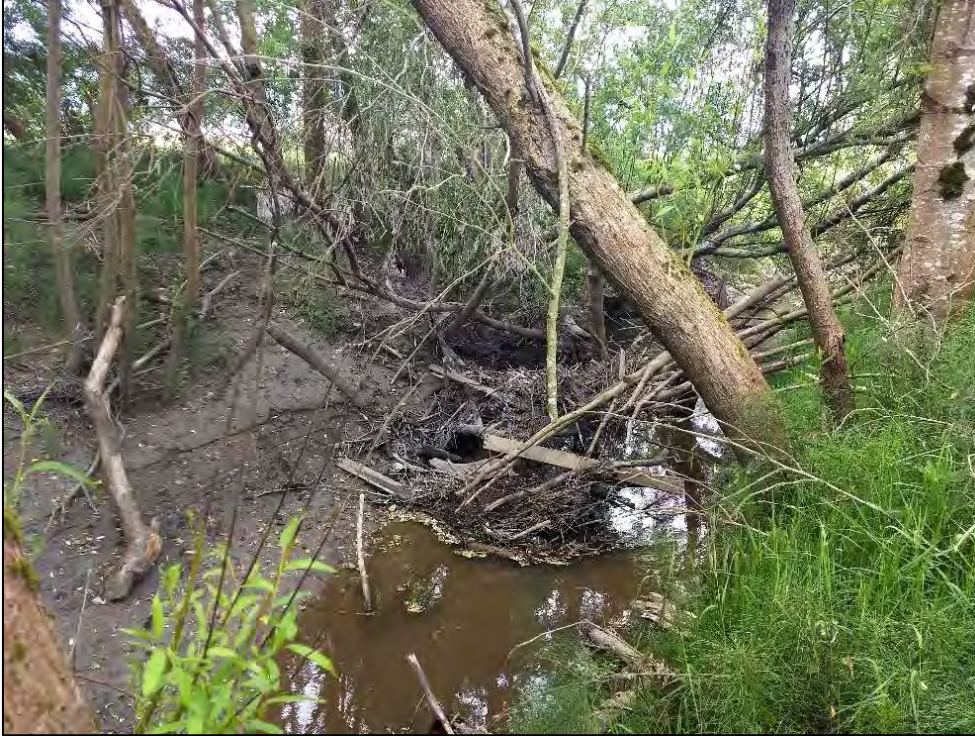
Figure 2-12. Overhanging trees and debris jam between Bridge 1 and Bridge 2 on Williams Creek causing sedimentation on the channel bed, banks, and overbanks (Photo 2018).

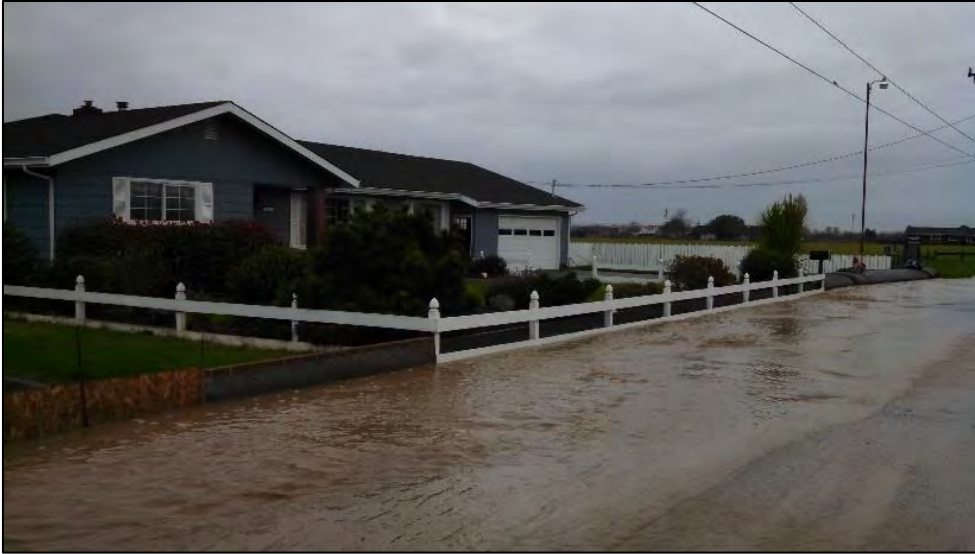
Figure 2-13. Overbank flows from Williams Creek flowing northward along Ambrosini Lane. Residents have installed various measures for flood protection (J. Svehla, December 2015).

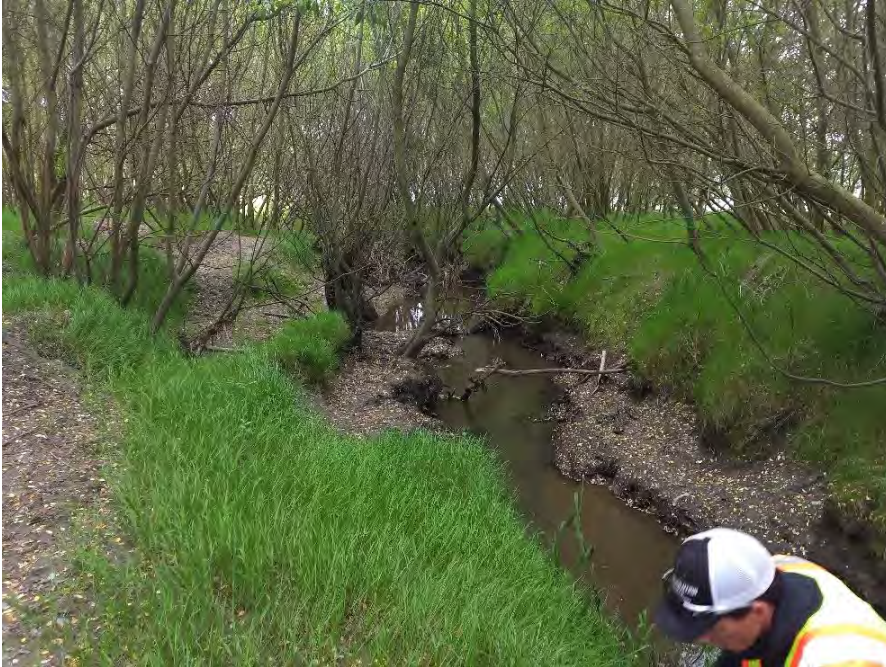
Figure 2-15. Incision through recent in-channel sediment deposited associated with breaching of the berm that diverted Williams Creek into the upper Salt River from 1998 through 2015 (Photo 2018).

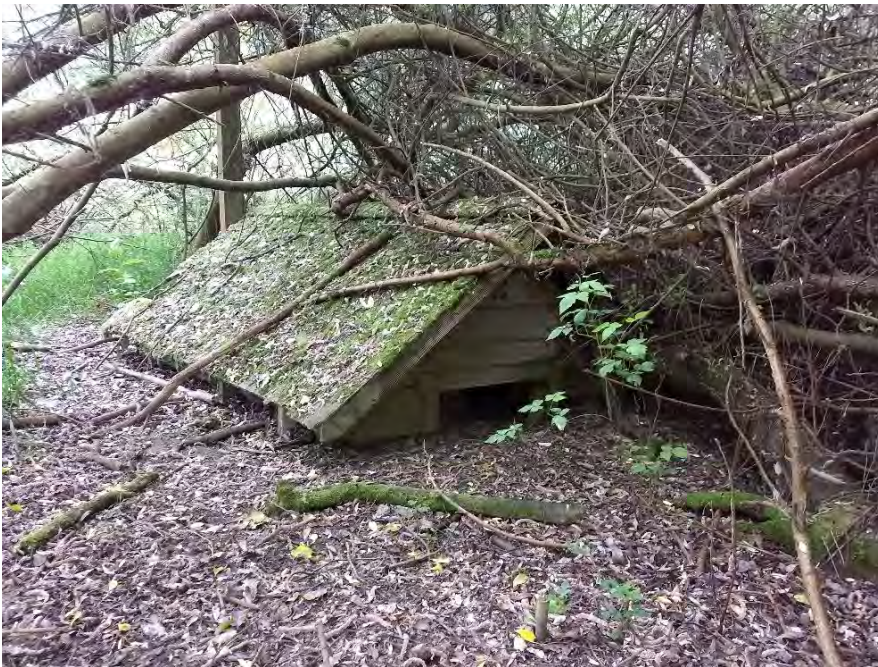
Figure 2-16. Buried outbuilding on south side of Williams Creek upstream of WCG-1 (Photo 2018).

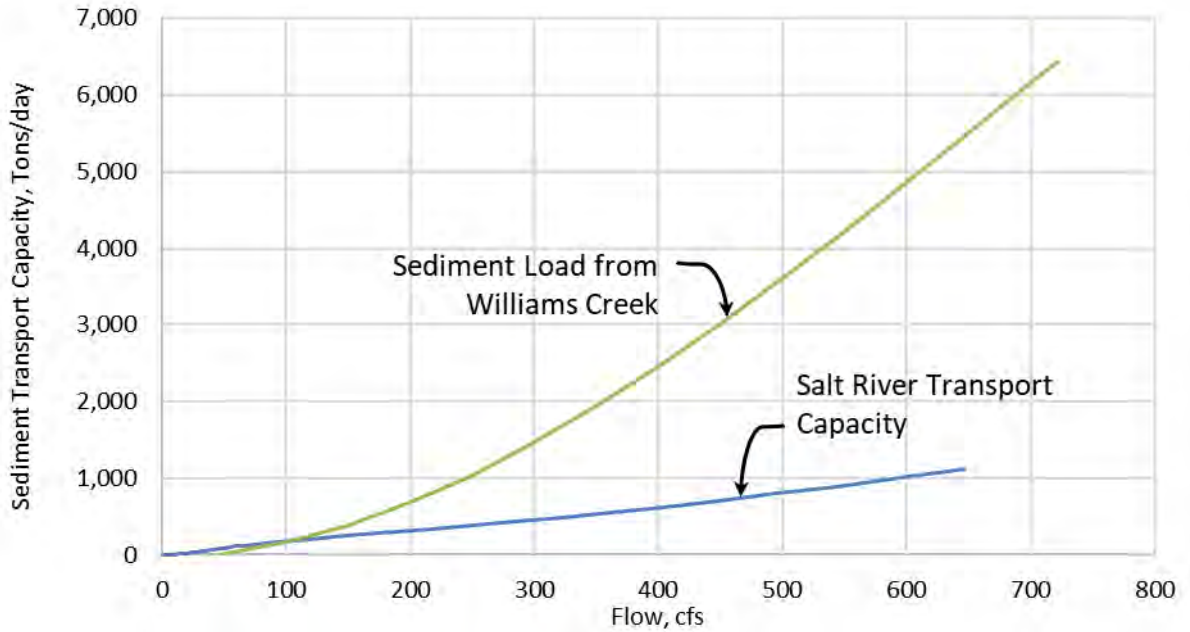
Figure 2-22. Comparison of the sediment load in Williams Creek at Bridge 3 with median grain size (D_{50}) of 0.18 mm to the sediment transport capacity of the Salt River for the same median grain size.

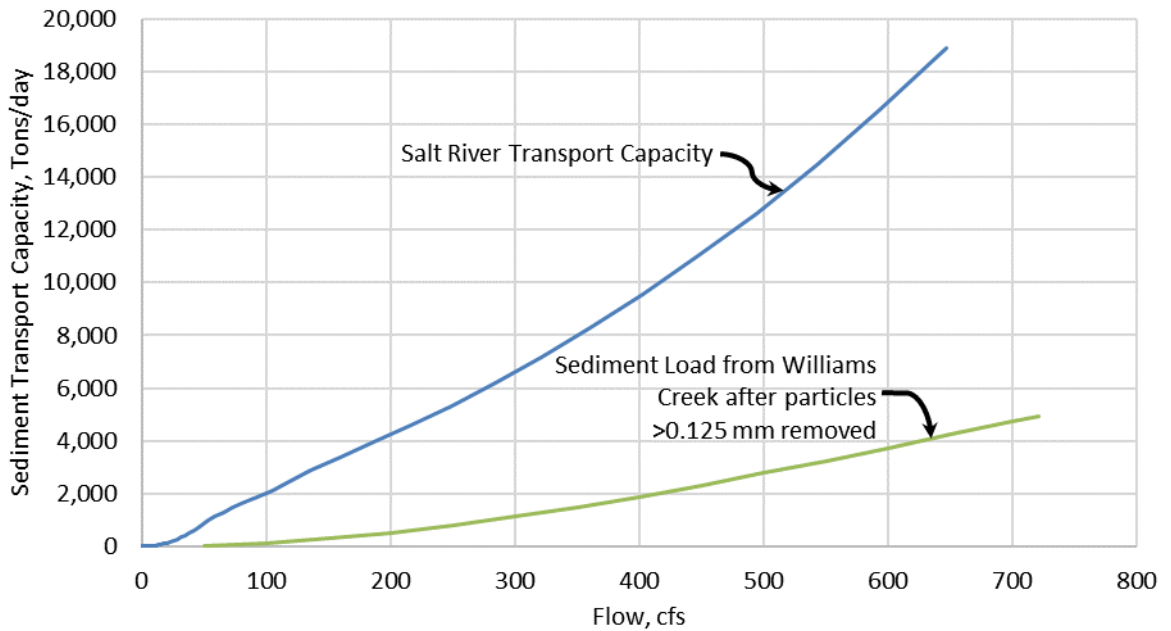
Figure 2-23. Comparison of Salt River sediment transport capacity to the Williams Creek sediment load, assuming all particles >0.125 mm are trapped and prevented from entering the Salt River (delivered sediment D_{50} = 0.09 mm).

The analysis also found that the transport capacity of the Salt River is highly dependent on the size and proportion of material delivered from Williams Creek. Figure 2-23 shows the predicted sediment load from Williams Creek and the Salt River sediment transport capacity if the coarser grain sizes (> 0.125 mm) in Williams Creek were trapped rather than being delivered to the Salt River. This analysis indicates that it is necessary to prevent coarser sands and gravels from being delivered to the Salt River from Williams Creek, and any rehabilitation alternative considered for Williams Creek must provide a mechanism to accomplish this.

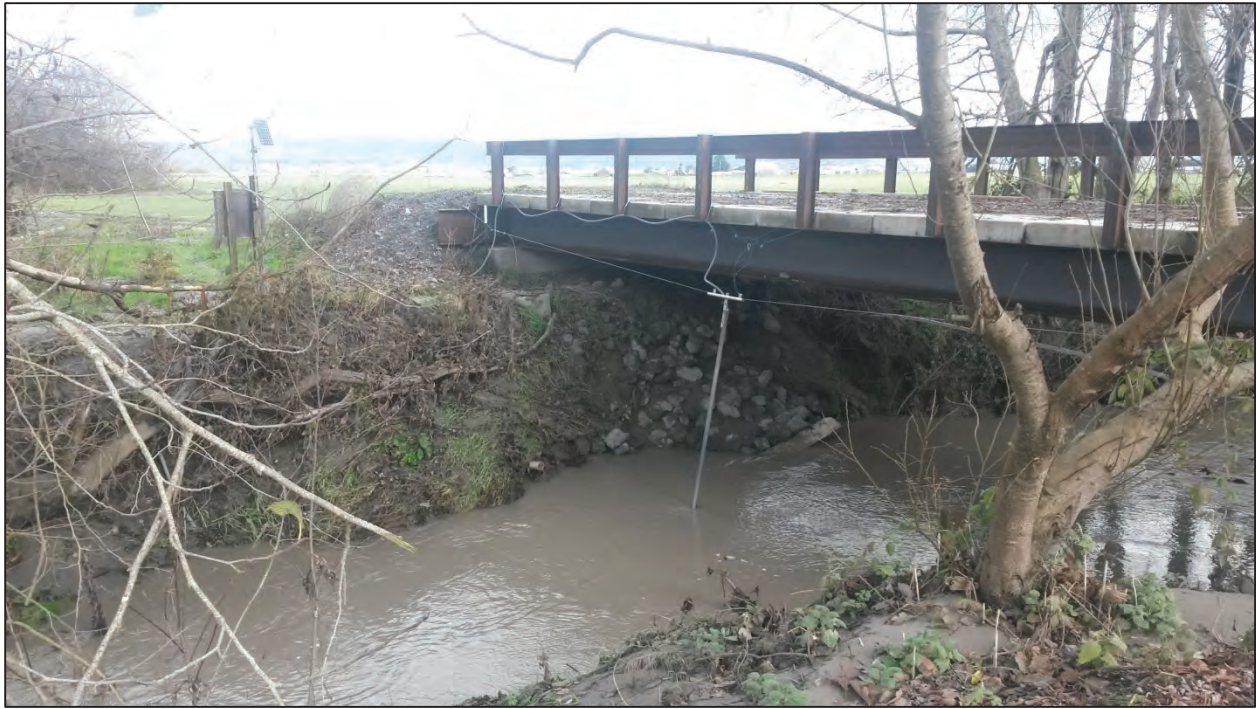
Figure 2. Upstream view of sampling section, turbidimeter boom on cable, gage house and solar panel.

The gage at Williams Creek was originally installed on October 26, 2016. Gaging equipment included 3 staff plates, a Campbell 850 data collection platform, a DTS-12 turbidimeter, and an H-310 pressure transducer (Figure 2). These devices are powered by a common 12 volt solar supported system. On October 27, 2016 during the first storm event following gage installation, it was determined that the DTS-12 turbidimeter would not have a high enough range (1600 FNU) to capture high flow turbidities on Williams Creek. At that time an OBS3+ turbidimeter was ordered. The OBS3+ turbidimeter (1-4,000 FBU) was installed on December 5, 2016. Additionally, on November 18, 2016 a telemetry modem was installed at the site. Due to troubleshooting issues with US Cellular, the modem did not become fully operational until December 7, 2016. The gage was downloaded monthly and checked for drift periodically.

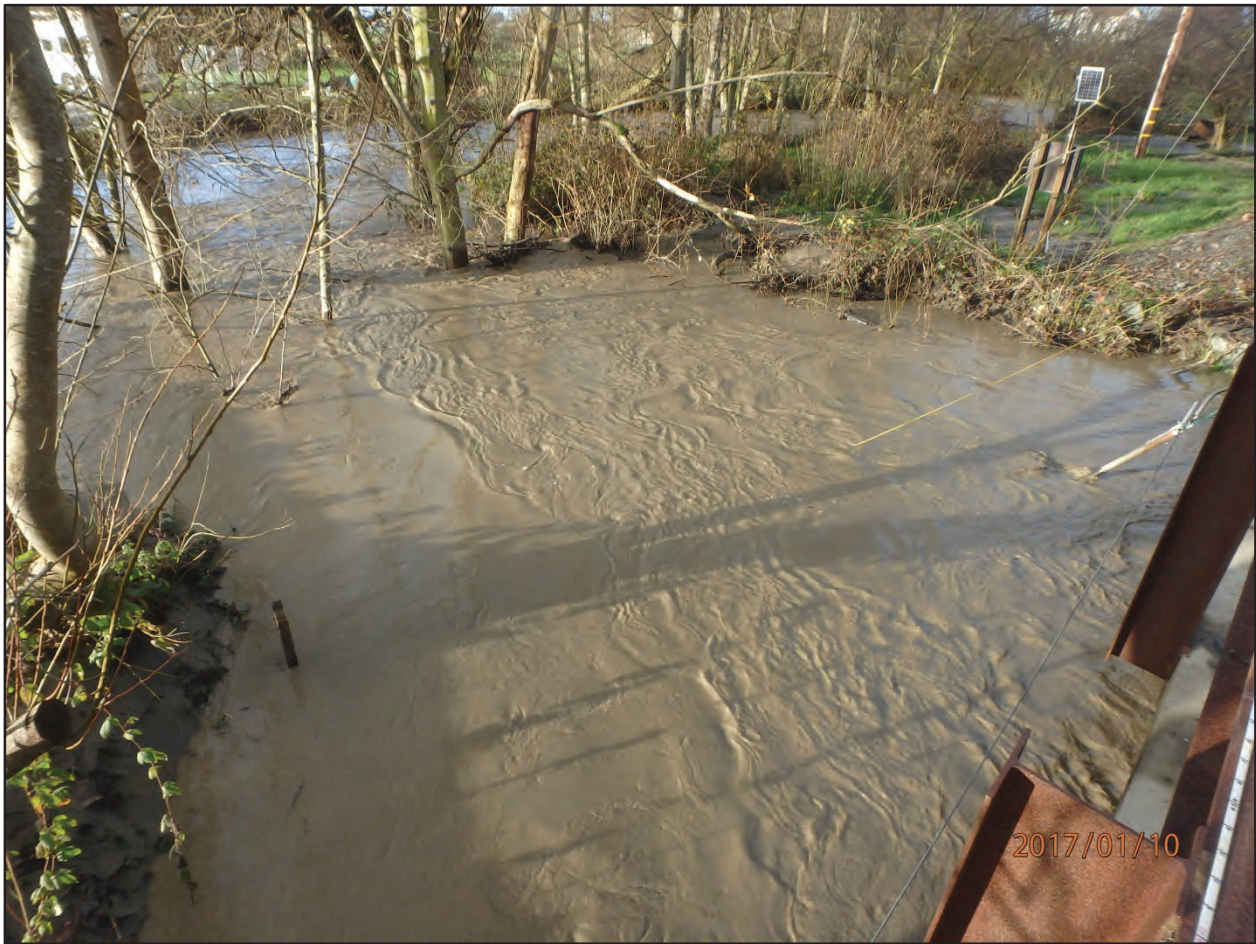
Figure 3. Downstream view of sampling section during a high flow in February 2017.

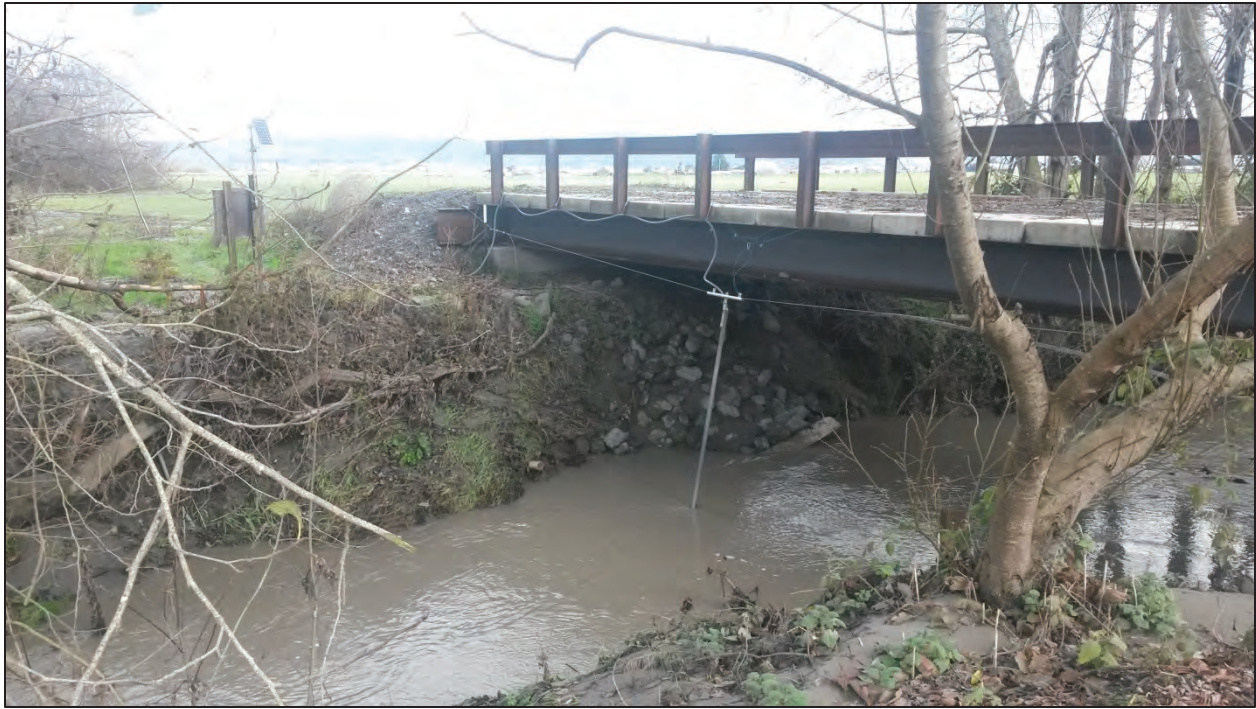
Figure 2. Upstream view of sampling section, turbidimeter boom on cable, gage house and solar panel.

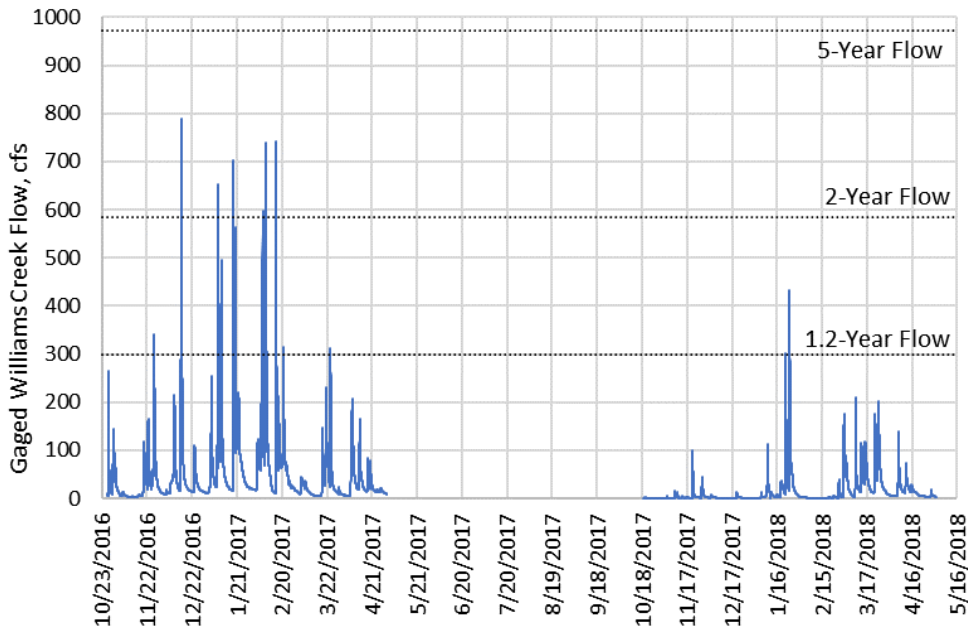
Figure 2. Gaged flows in Williams Creek during the 2017 and 2018 water years, with return periods indicated for reference.

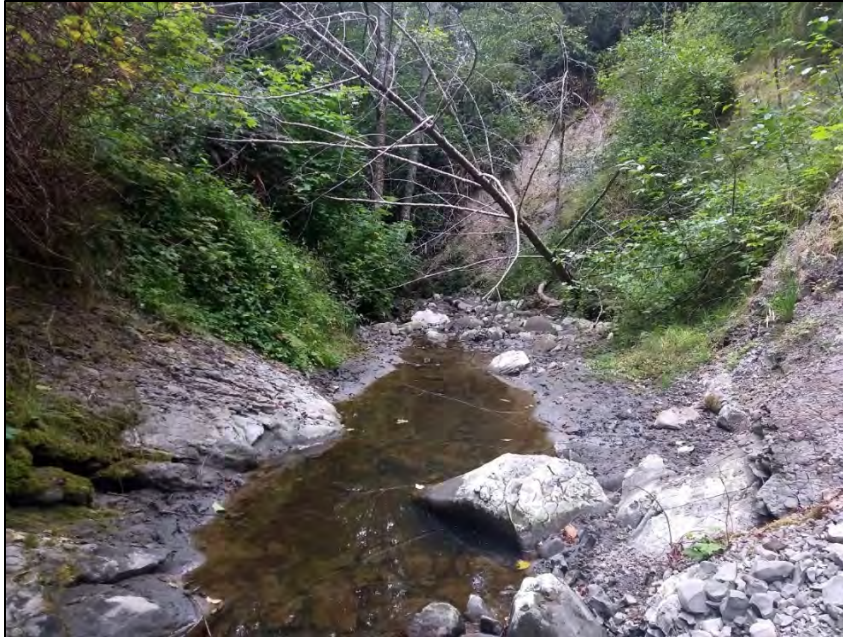
Figure 7. Confined upper reaches of the Williams Creek channel where the valley walls and some of the stream bottom are formed of sandstone and highly erosion mudstone. The channel margins and pools are filled with silt deposition from erosion of the surrounding bedrock.

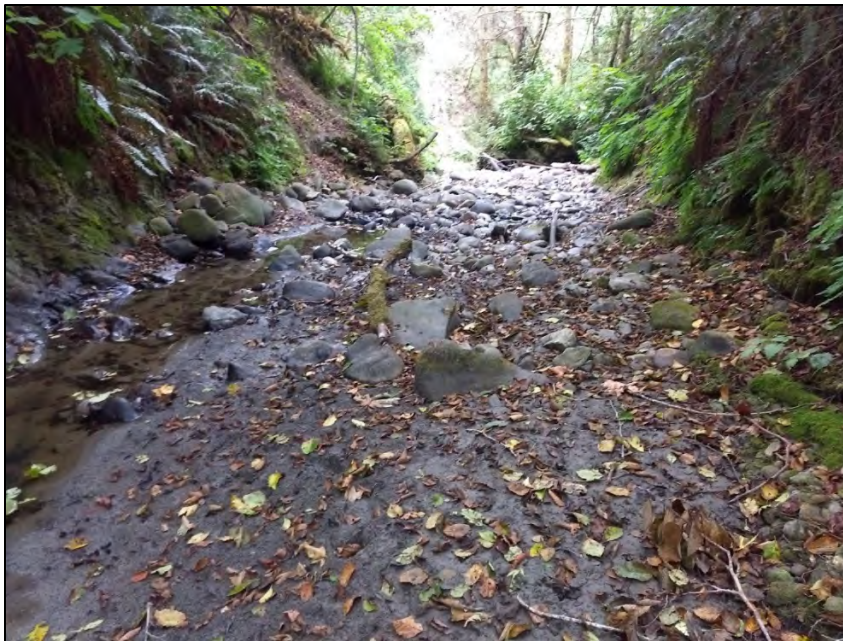
Figure 8. Confined channel in the upper reaches of Williams Creek. Thick silt deposition overlays coarse alluvial materials formed of sandstone.

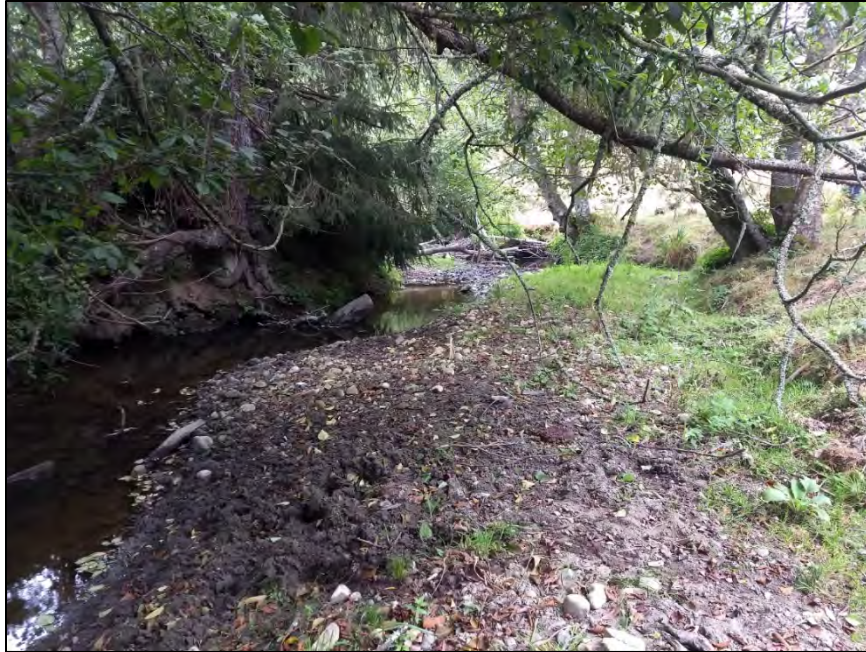
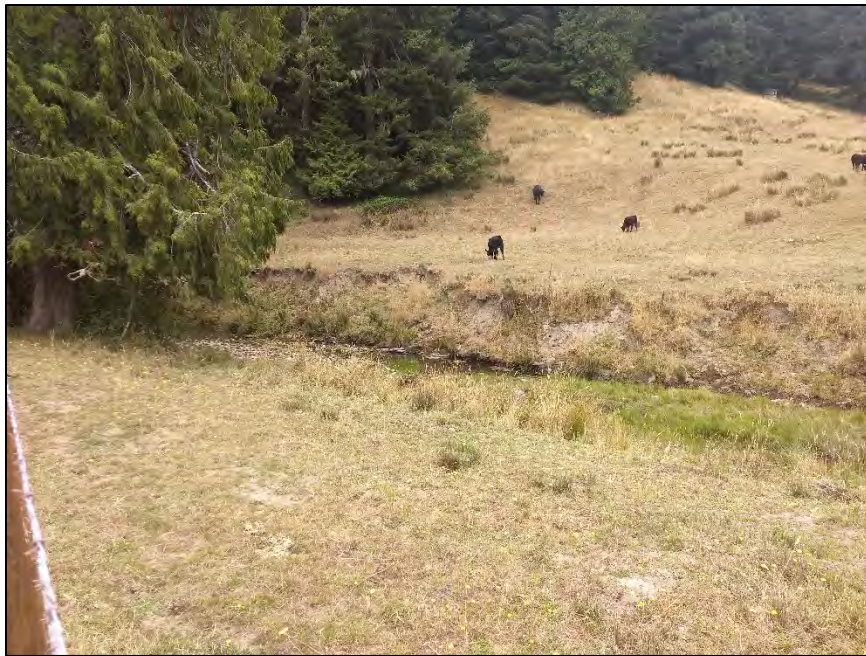
Figure 9. Unconfined channel in the middle reaches of Williams Creek where the valley is less confined. Streambed materials are smaller than upstream, but silt deposition remains pervasive and bank erosion is common.

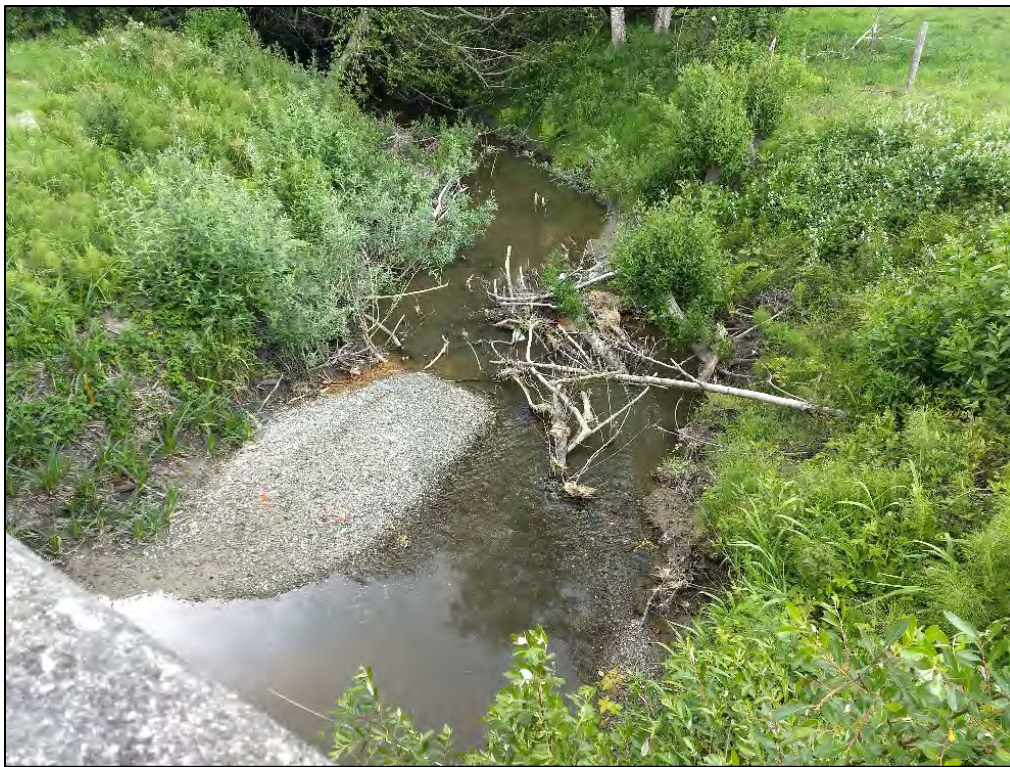
Figure 11. Williams Creek looking upstream from the Grizzly Bluff Road Bridge.

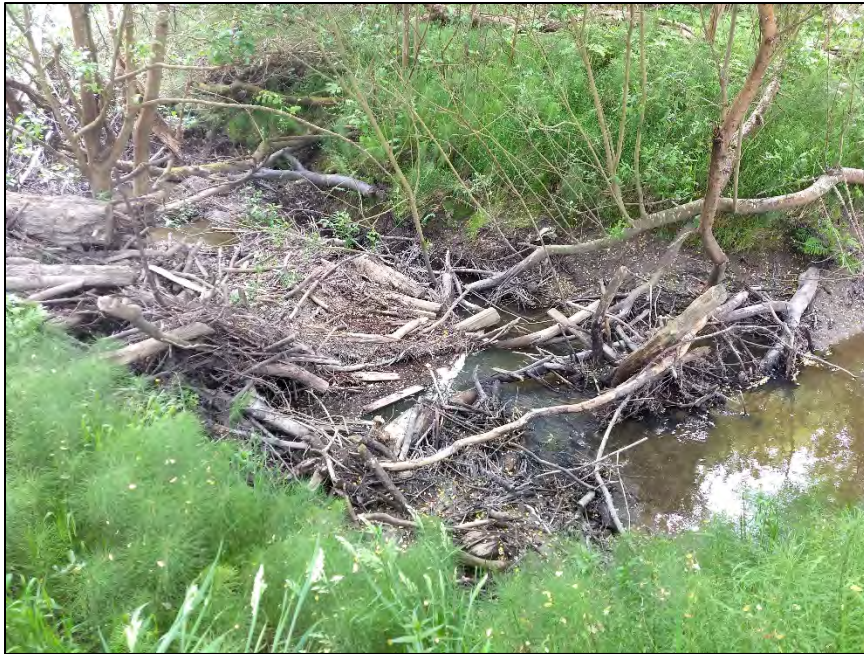
Figure 12. The reaches of Williams Creek between Grizzly Bluff Road and the WCG-5 monitoring location are choked with debris jams. Bank slopes are gentler in this portion of the reach.

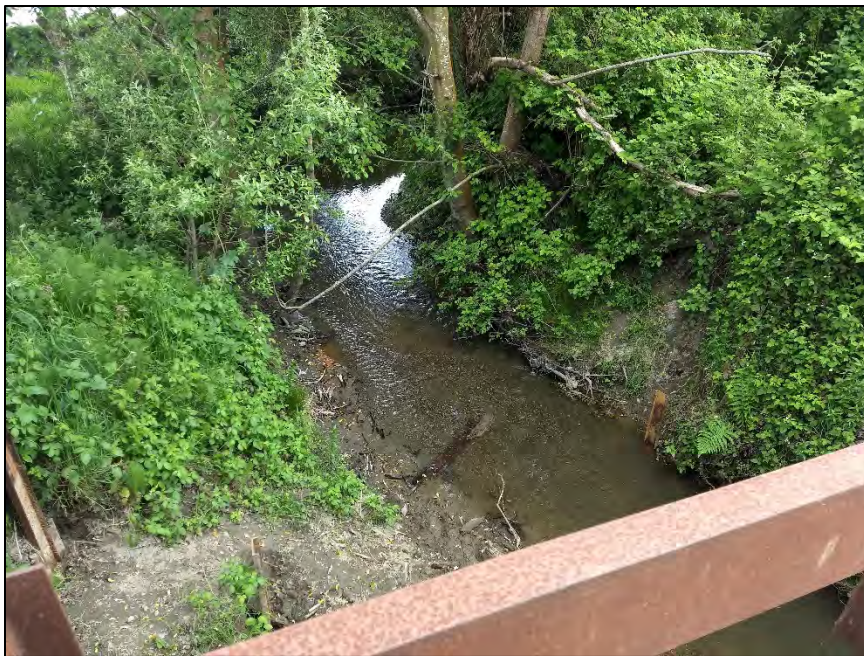
Figure 13. Williams Creek from Bridge 3. The channel shape becomes more trapezoidal in this portion of the reach.

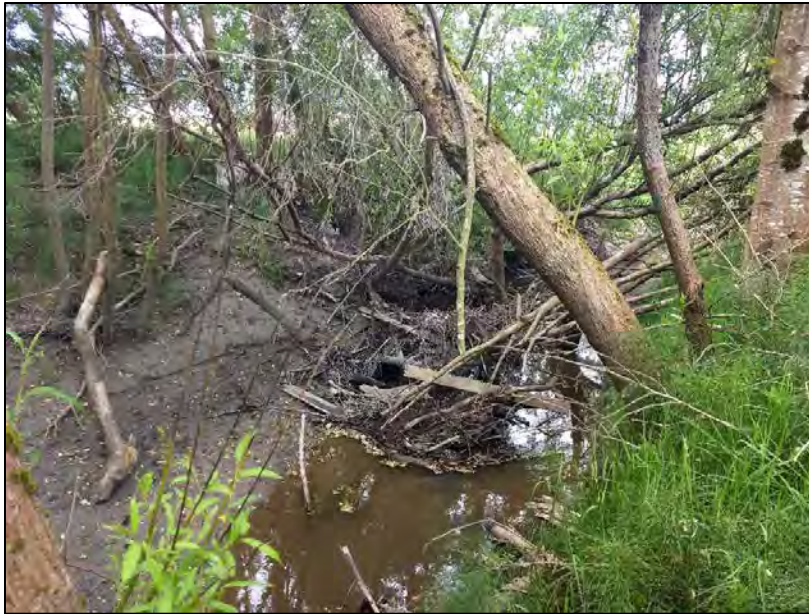
Figure 15. Overhanging trees and debris jam between Bridge 2 and Bridge 1 on Williams Creek causing sedimentation on the channel bed, banks, and overbanks.

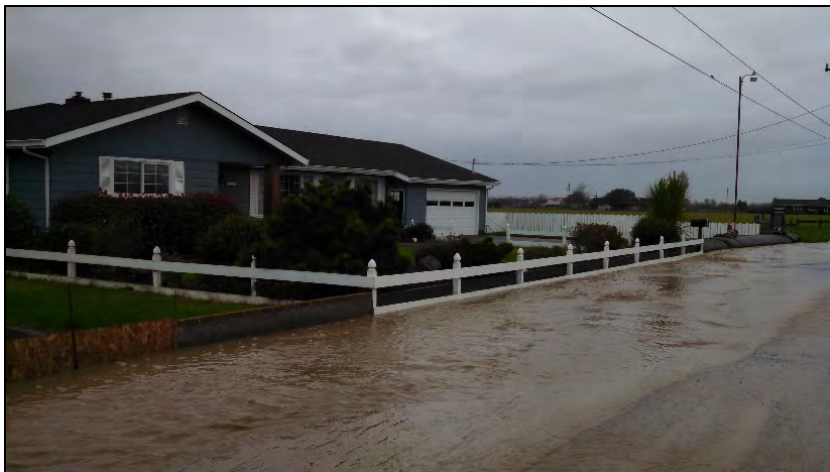
Figure 16. Overbank flows from Williams Creek flowing northward along Ambrosini Lane. Residents have installed various measures for flood protection (Svelha, December, 2015).

Overbank flows occur to both the east and west of the channel. Where overbank flows spill to the west and northwest, they inundate the roadway, residences and outbuildings on Ambrosini Lane, as well as pastures to the northwest. Figure 16 shows a photograph of Ambrosini Lane, where overbank flows from Williams Creek flowed northward down the lane. Due to removal of deposited sediments around houses and on the road following flood events, the ground along Ambrosini Lane has not aggraded, while the eastern banks have

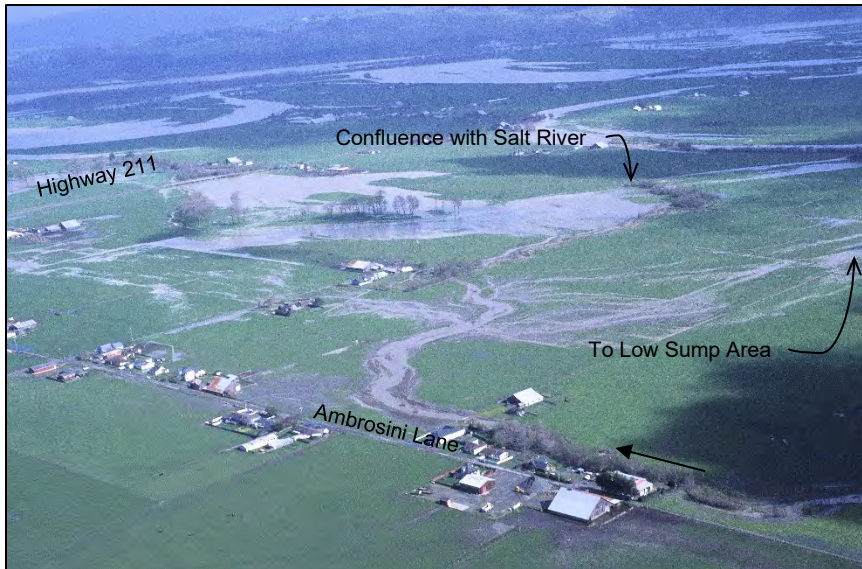
Figure 17. April 8, 2011 aerial view of Lower Williams Creek overbank flooding looking northeast (Photo by D. Tuttle).

Where overbank flows spill to the east, they flow down the gently-sloped fields between the lobes of the alluvial fan, and become trapped in a low sump south of the upper Salt River, between Williams Creek and Coffee Creek. Sedimentation and natural alluvial levees along the Salt River prevent the ponded surface water from flowing into the Salt River or returning to Williams Creek. Figure 17 shows flooding patterns in April 2011.

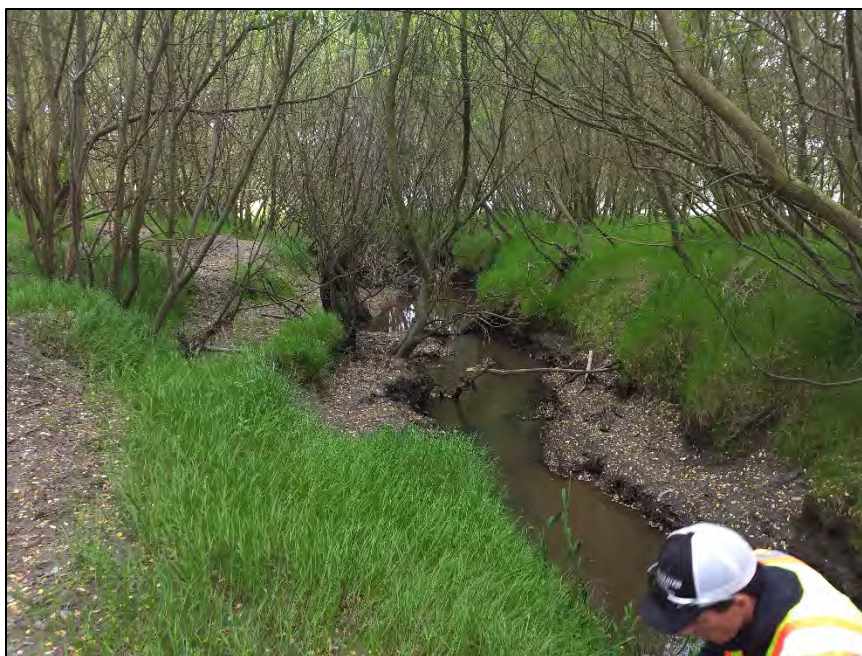
Figure 18. Incision through recent in-channel sediment deposited associated with breaching of the berm that diverted Williams Creek into Old Salt River between 1998 and 2015.

The downstream-most reaches of Williams Creek, just upstream of the confluence with the Salt River, show evidence of substantial aggradation associated with the period when Williams Creek was diverted into the upper Salt River. Following the breach of the berm at the Salt River confluence circa 2016 and forming the Williams Creek Sediment Splay (Figure 1), the channel has since down-cut through some of these deposited sediments, as evident in the reach immediately downstream of Bridge 1 (Figure 18).

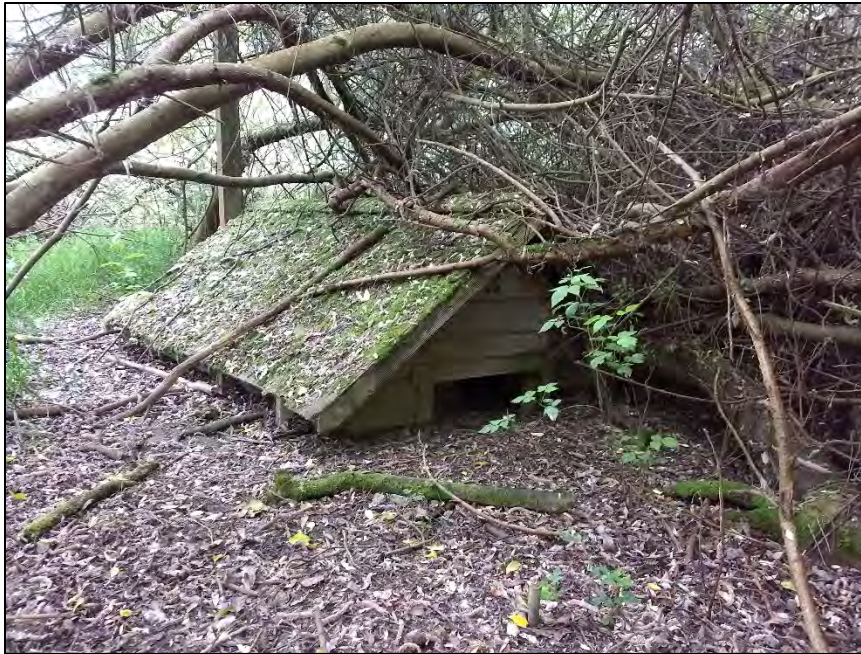
Figure 19. Buried outbuilding on south side of Williams Creek upstream of WCG-1.

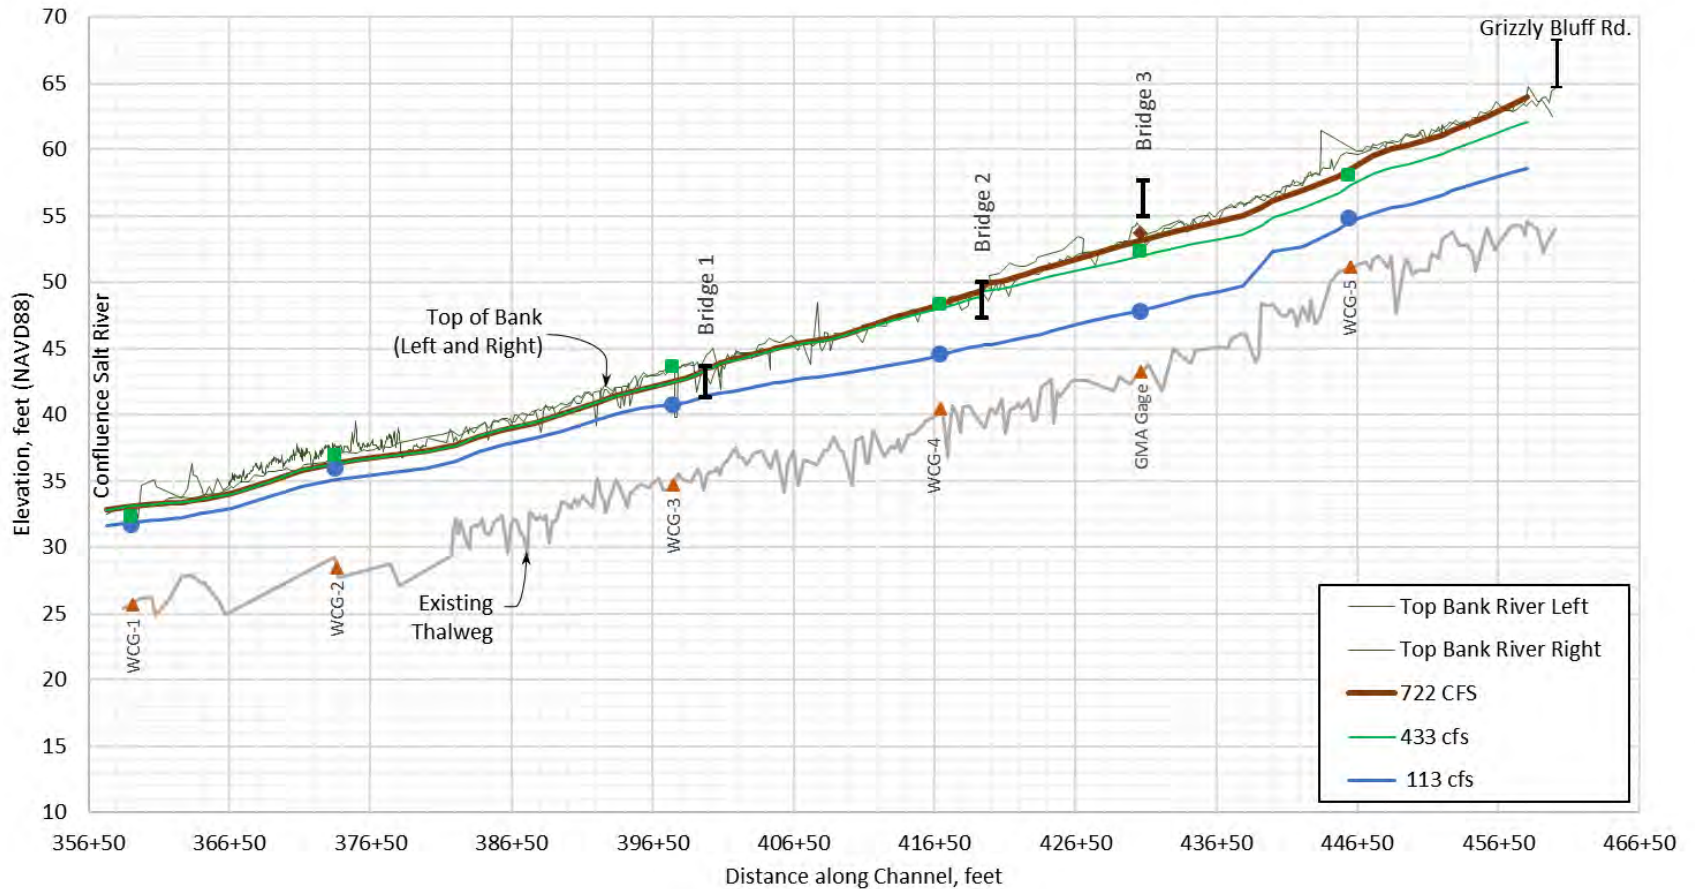
Figure 20. Williams Creek HEC-RAS model-predicted water surface profiles for 113 cfs (1.01-year return period), 433 cfs (1.5-year return period) and 722 cfs (3-year return period). The circle, triangles, and squares represent measured water levels. The lighter weight red and green lines represent the top of channel banks where flows begin to spill out-of-bank.

A flow of 147 cfs has a return period between 1.01- and 1.1-years. Therefore, out-of-bank flows can be expected to occur a minimum of once per year, and typically more frequently under existing conditions. This overbank flooding frequency is similar to what residents living adjacent to the channel have observed.

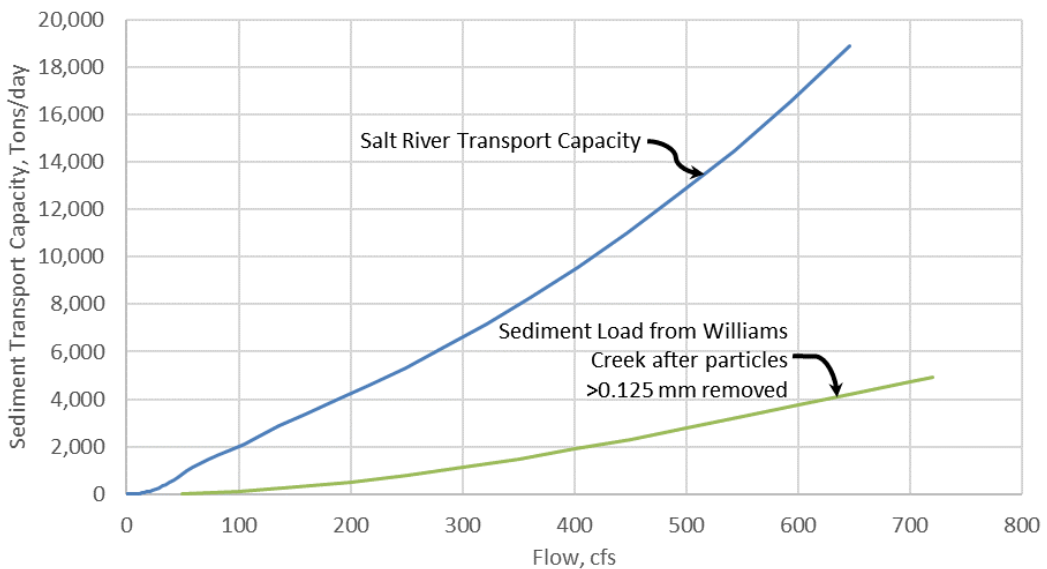
Figure 29. Comparison of Salt River and Williams Creek sediment transport capacities if the larger particles (>0.125 mm) in the Williams Creek sediment load were not delivered to the Salt River, resulting in a $D_{50} = 0.09$ mm of the sediment load.

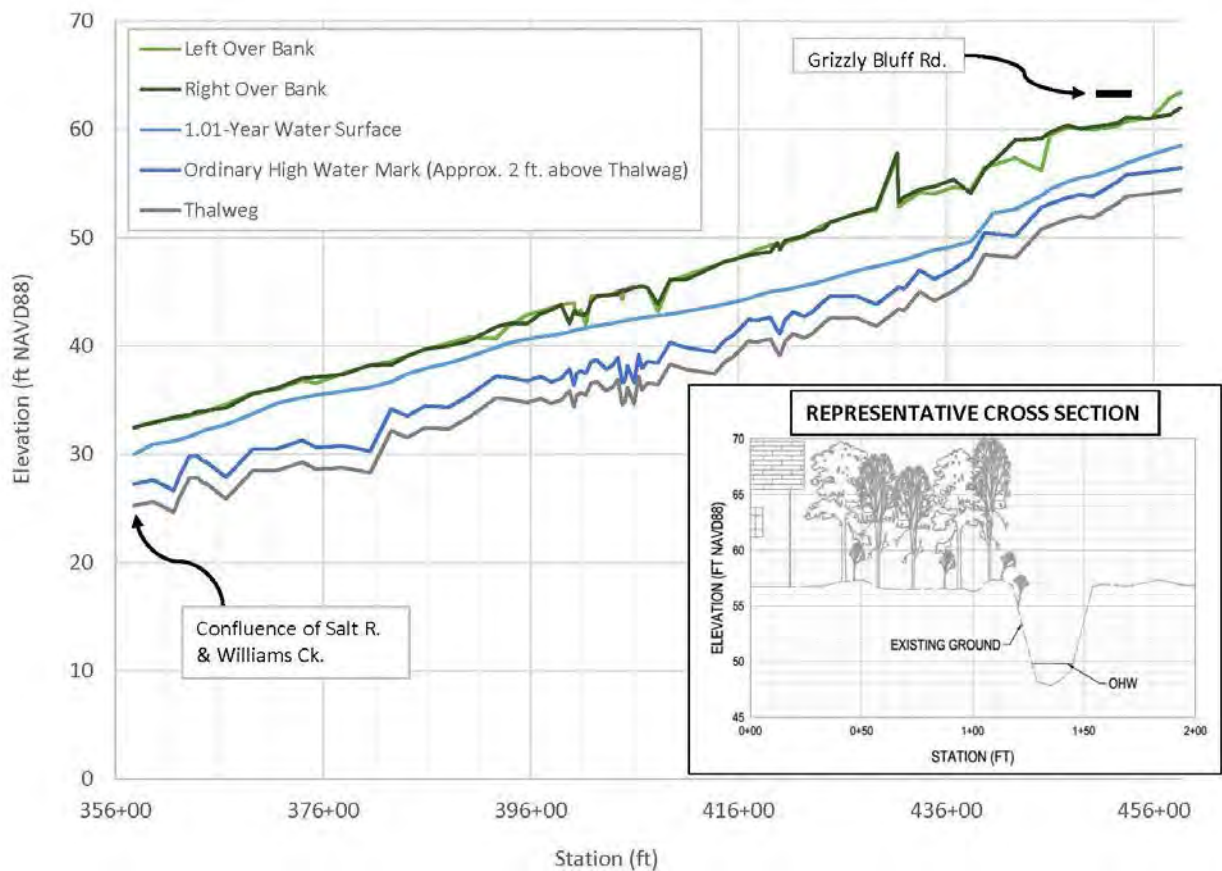
Figure 4. Williams Creek Ordinary High Water.

As a comparative approach and based on field observations, a depth of 2 feet was added to the measured channel thalweg and found to be lower than the 1.01-year return period WSE and more consistent with observed geomorphic indicators of scour and erosion of channel banks and change in riparian vegetation type. Given the consistency with observed field conditions, adding 2 feet to the channel thalweg was thus selected as the preferred approach to determining the OHW boundary for the Williams Creek throughout the project corridor (Figure 4).
