HYDROLOGIC AND HYDRAULIC REPORT

S.R. 0051, SECTION A60
(HUTCHINSON HILL ROAD)
STATION 155+11.00
OVER
FALLEN TIMBER RUN

VOLUME 1

TOWNSHIPS OF ELIZABETH AND FORWARD
ALLEGHENY COUNTY

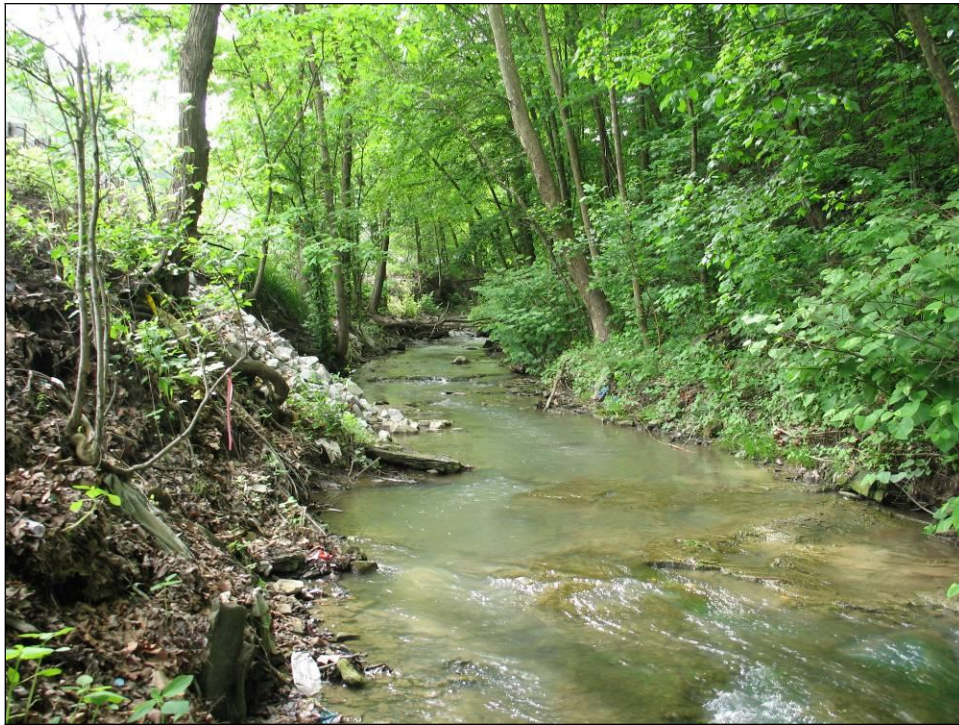
PHOTO NO. 4: Upstream Channel Seen from End of Right Wingwall of Hutchinson Hill Bridge Over Fallen Timber Run – Note Bedrock in Channel.

the gravelly sediments and rocks described above (see Photos 4, 23 and 24). The original FEMA model utilizes channel roughness coefficients of 0.04 and 0.045, and though somewhat conservative, they were retained in the existing conditions model without modification.

The banks and overbank areas typically exhibit moderate to thick vegetation density (see Photos 4 to 6, 9 to 11 and 18 to 20). In these areas, the FEMA model utilizes roughness values that range from 0.07 to 0.10, which are fair representations of the channel overbanks (though somewhat conservative at some locations) and they were retained in the existing model. Left and right bank stations in the FEMA model were also reviewed and most of them were revised to better reflect site conditions with most of the bank areas being covered with vegetation to the edge of the stream or even encroaching upon the waterway. A summary of revisions to the FEMA model is included in Appendix Section B, Pages AP-11 and AP-12.

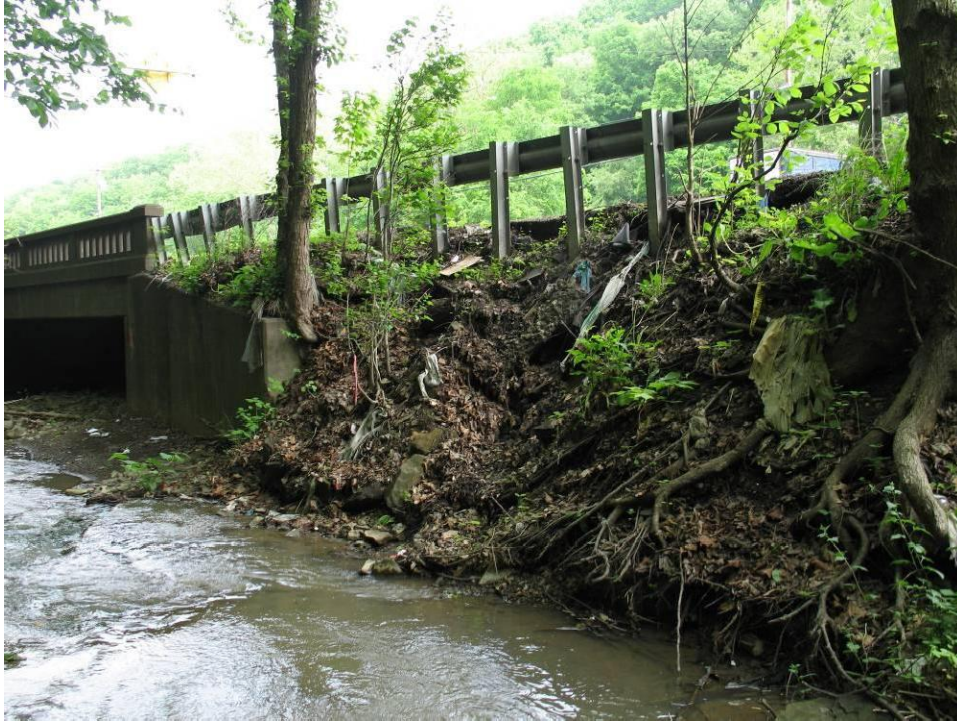
PHOTO NO. 7: Eroded Stream Bank/Roadway Embankment
Just Upstream of Hutchinson Hill Bridge

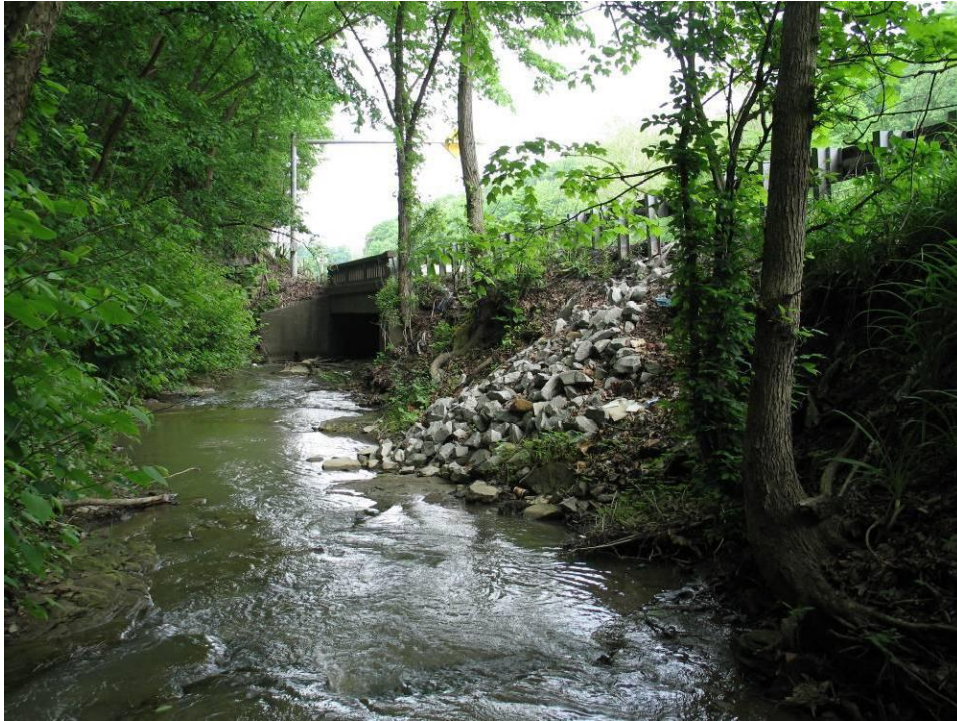
PHOTO NO. 8: Channel Approx. 150 ft. Upstream of
Hutchinson Hill Bridge – Note Rock Protection
on Stream Bank/Roadway Embankment.

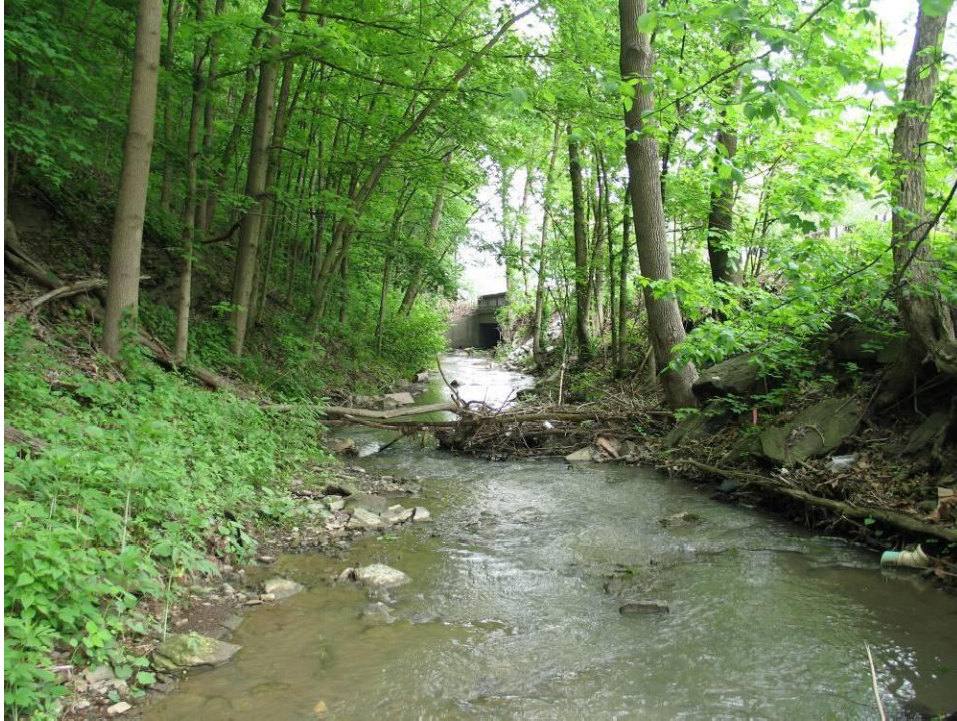
PHOTO NO. 9: Channel Approximately 300 ft. Upstream of Hutchinson Hill Bridge – Looking Downstream (Note Flood Debris in Channel)

Because of thickly vegetated and steep banks, there is potential for significant amounts of debris and drift masses to move through Fallen Timber Run during high flow events including large tree limbs. In addition, telephone poles have been observed floating in channel during one or more high water events by locals (see Item 2(b) on Page A-5). Some flood debris was noted and photographed in the channel during the H&H Field View (Photo 9).

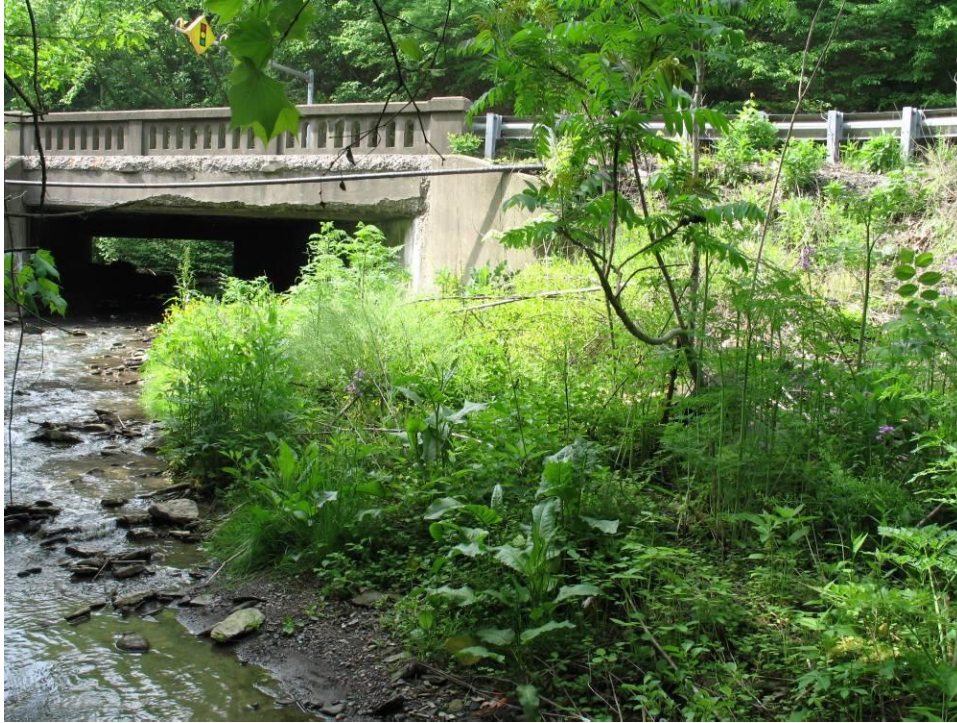
PHOTO NO. 17: Vegetated Sediment Accumulation at Left Side of Channel Just Downstream of Hutchinson Hill Bridge

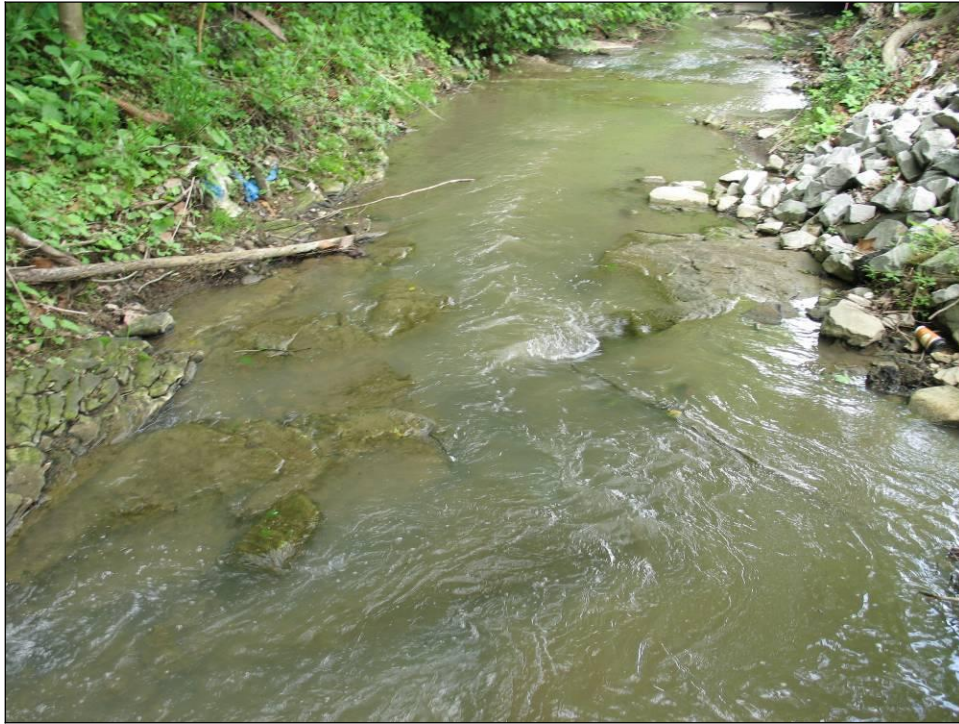
PHOTO NO. 23: Bedrock Channel Bottom Approximately 100 Feet Upstream of Hutchinson Hill Bridge

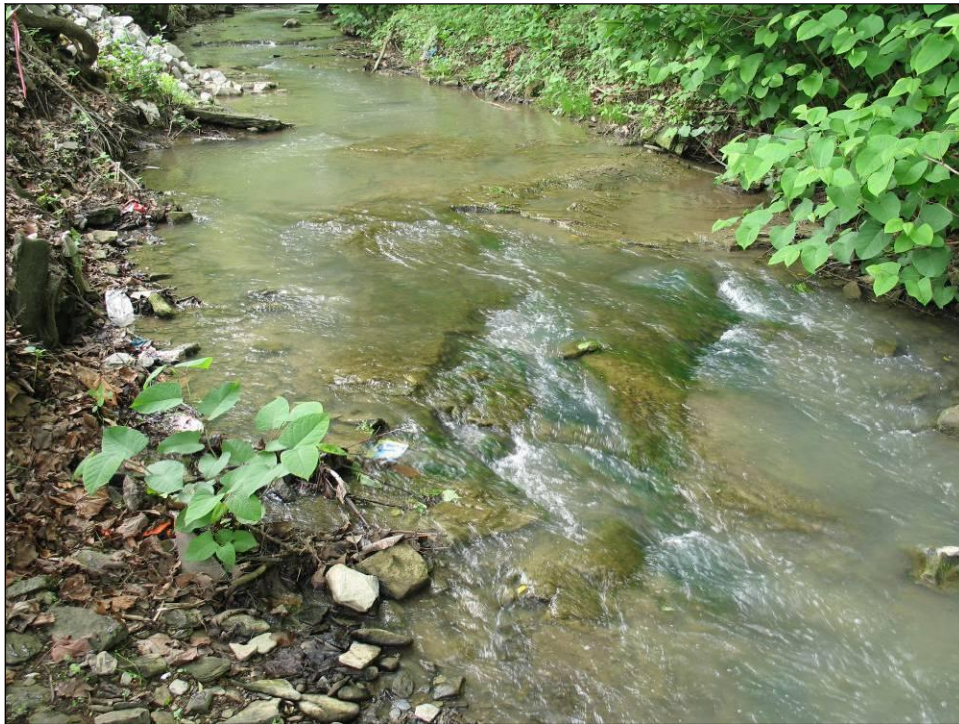
PHOTO NO. 24: Bedrock Channel Bottom Just Upstream of Hutchinson Hill Bridge

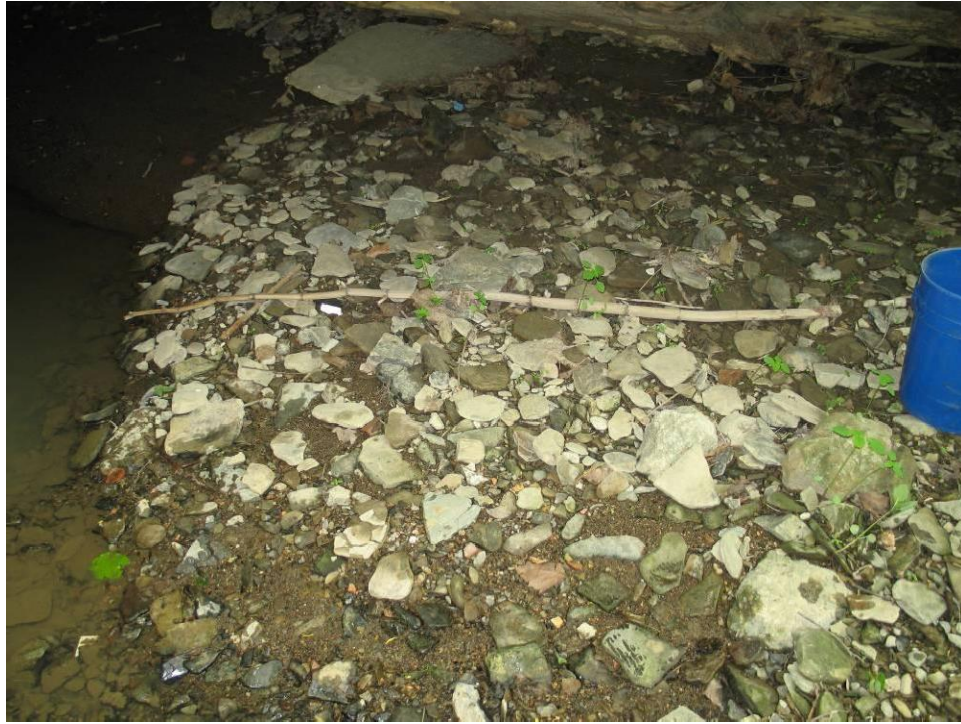
PHOTO NO. 25: Sediment Under Hutchinson Hill Bridge at Upstream End with Sand, Gravel, Flat Stones and Cobbles

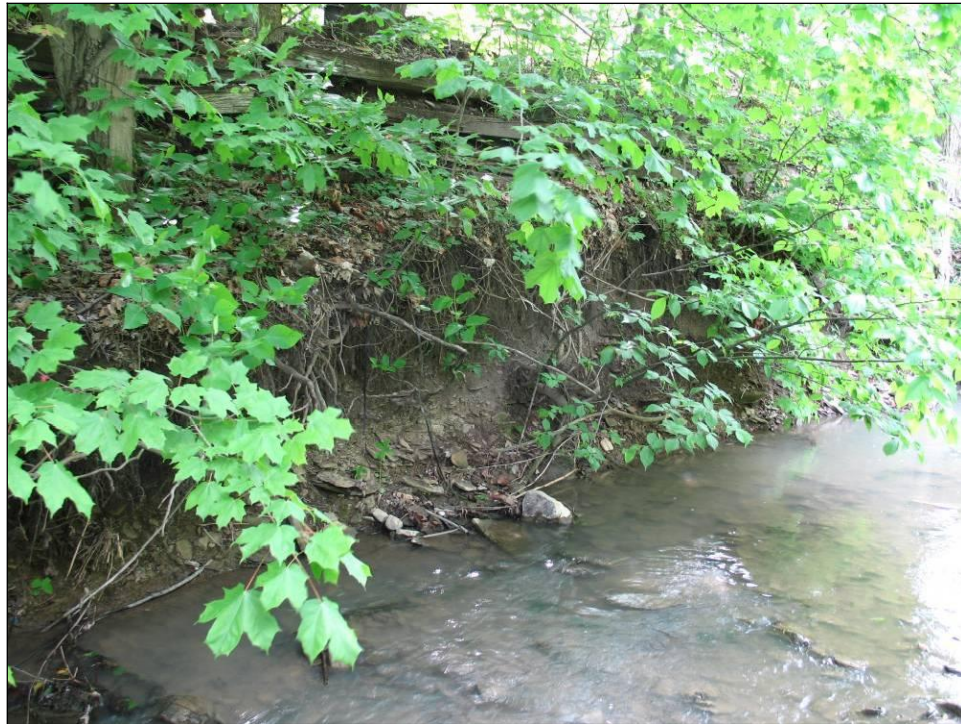
PHOTO NO. 26: Right Bank Scour Approximately 100 ft. Downstream of Hutchinson Hill Bridge; Timber Crib Wall Above.

During the H&H Field View some bank erosion up to approximately 3 or 4 feet above stream elevation was noted (Photos 26 and 27). No other indications of high water were observed. See accounts of past flooding history under Items 2(a) through 2(c) above. Upstream of the subject bridge the insurable structures that are present are located across Route 51 from Fallen Timber Run and are above the 100-year flood elevation. Downstream of the bridge, there is a two story frame dwelling situated at the right overbank with the base of its foundation at approximate Elevation 772 where it meets ground level (Photo 29). This would place the structure within the 100-year floodplain; however, the inhabited floor appears to be elevated above the 100-year flood.

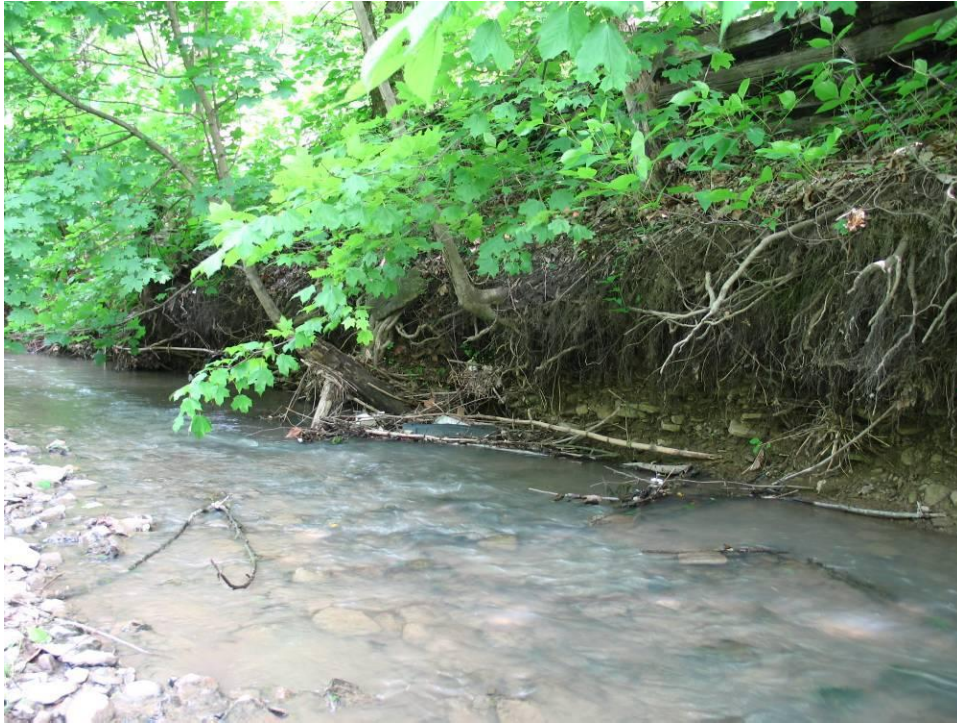
PHOTO NO. 27: Right Bank Scour Approximately 120 ft.
Downstream of Hutchinson Hill Bridge

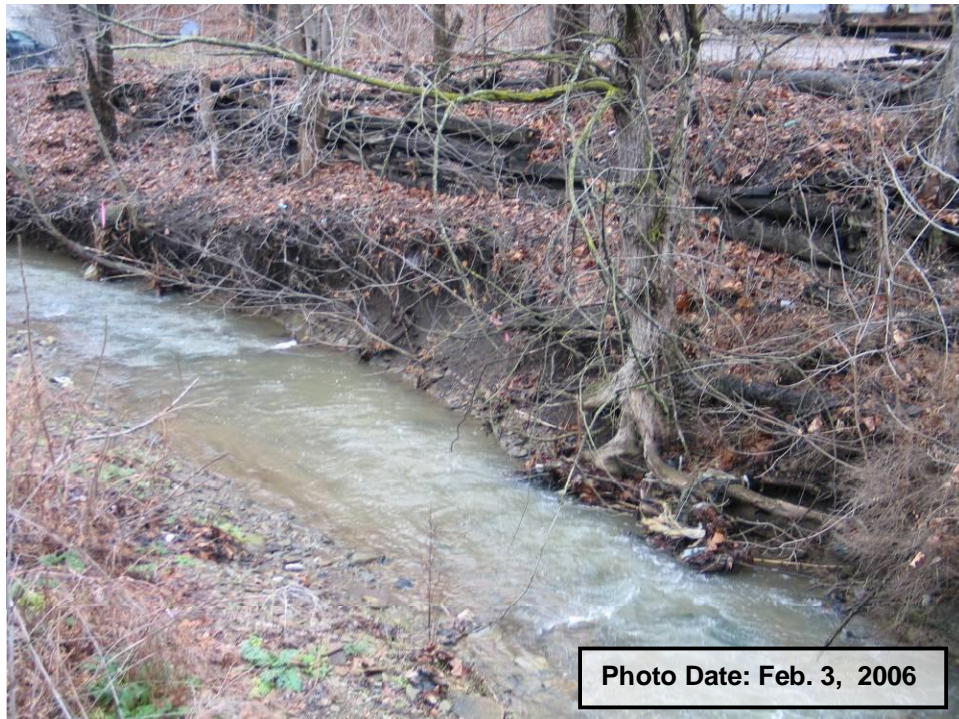
PHOTO NO. 30: Channel with Bank Scour and Timber Crib Wall Above it at Two Story Frame House Location (Photo 29).

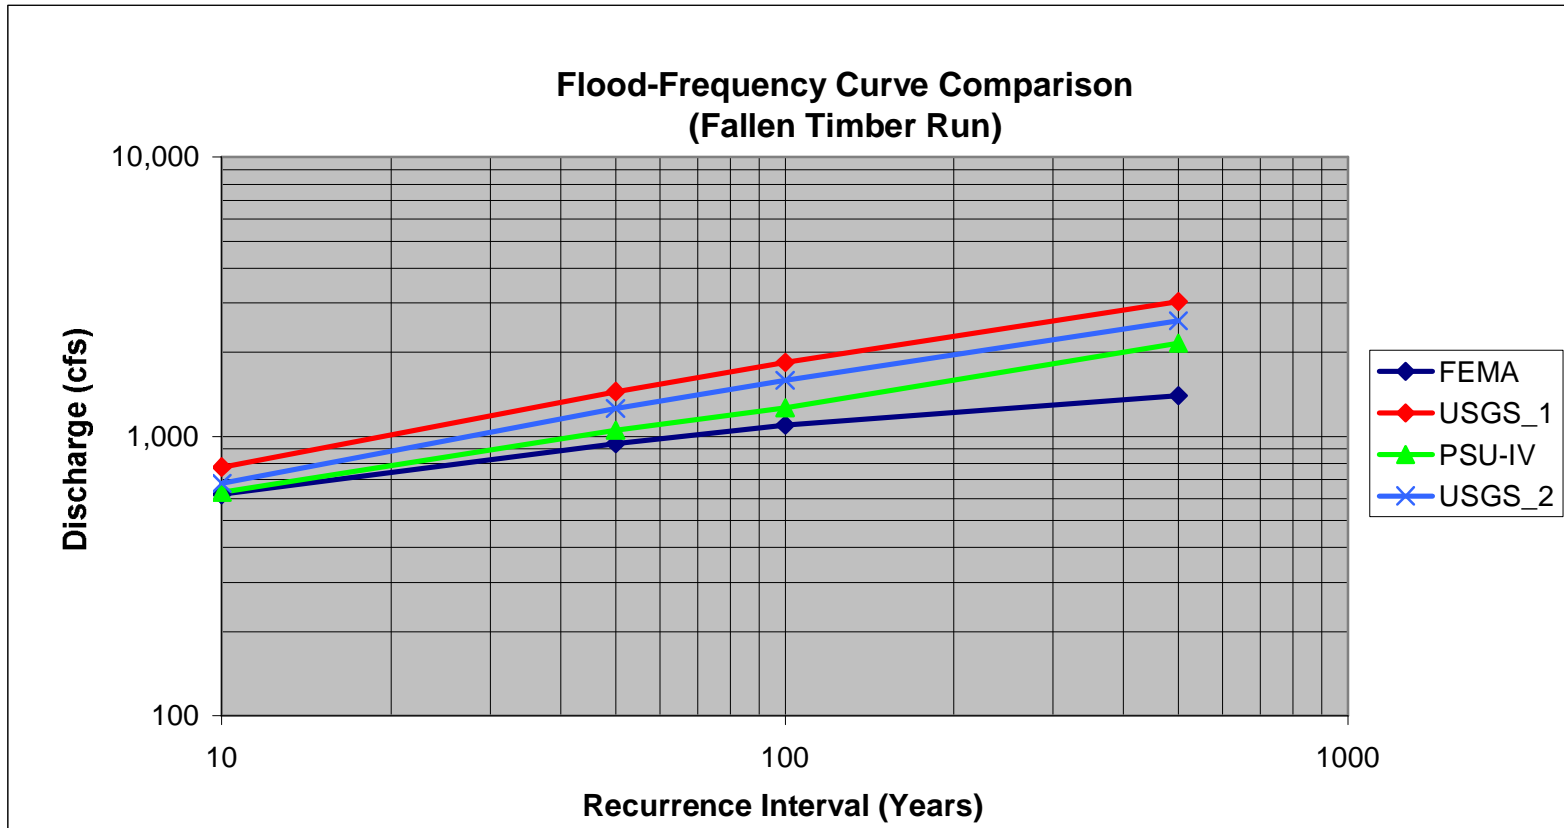
Frequency, n	Discharge (cfs)				Drainage Area
	10	50	100	500	
FEMA Flows	620	940	1,100	1,400	4.5 sq. mi.
USGS Method 1	777	1,450	1,840	3,040	4.5 sq. mi.
PSU-IV Method	632	1,052	1,268	2,155	4.26 sq. mi.
USGS Method 2	679	1,260	1,590	2,600	4.26 sq. mi.

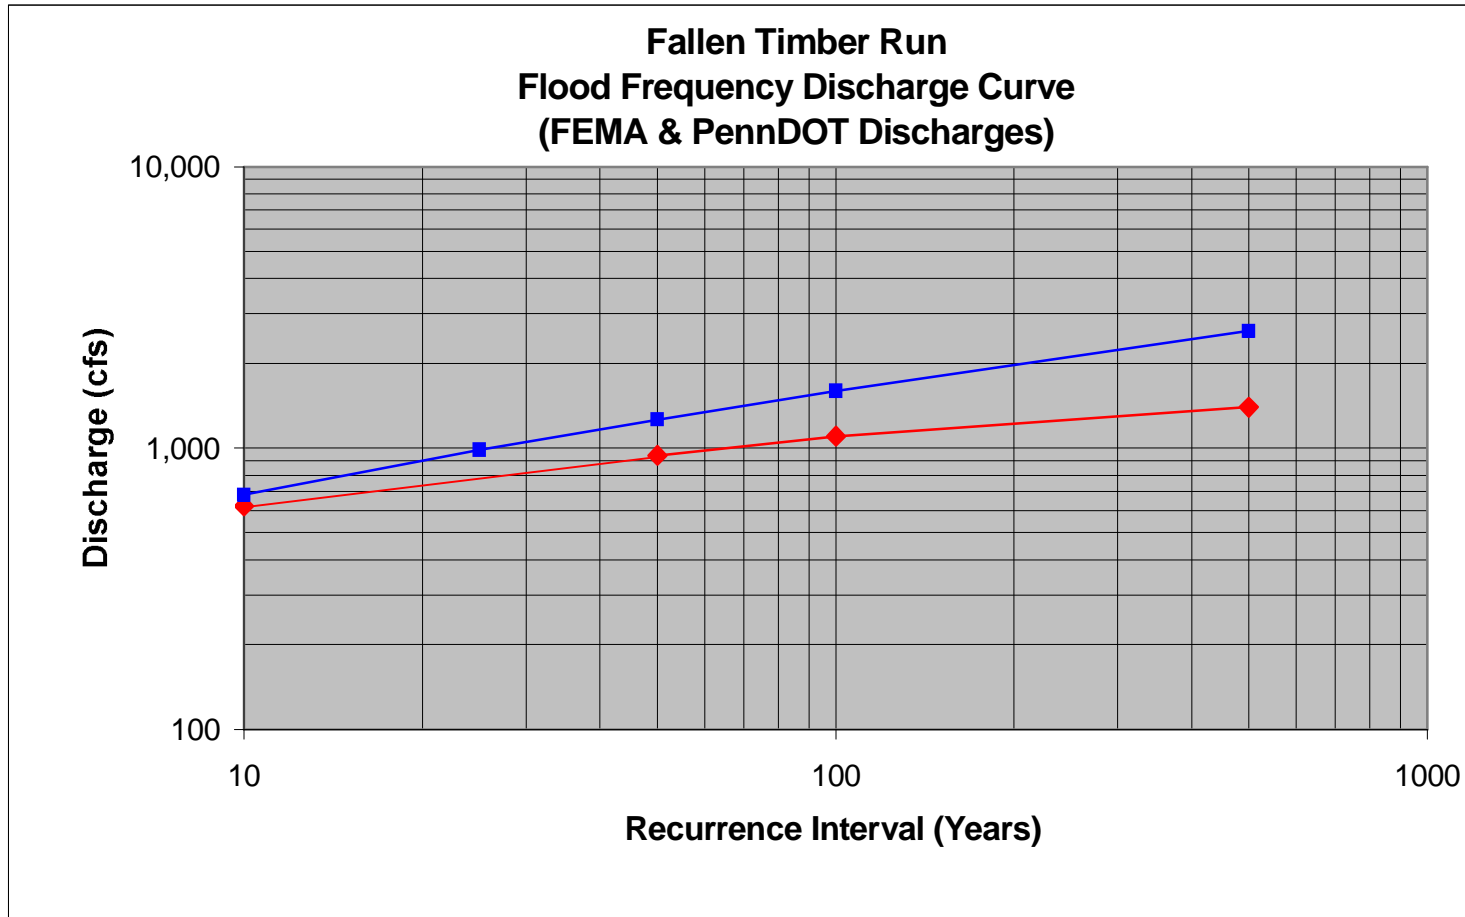
Storm Frequency	Discharge (cfs)				
	10	25	50	100	500
FEMA Flood Discharges	620	—	940	1,100	1,400
PennDOT Flood Discharges	679	983	1,260	1,590	2,600

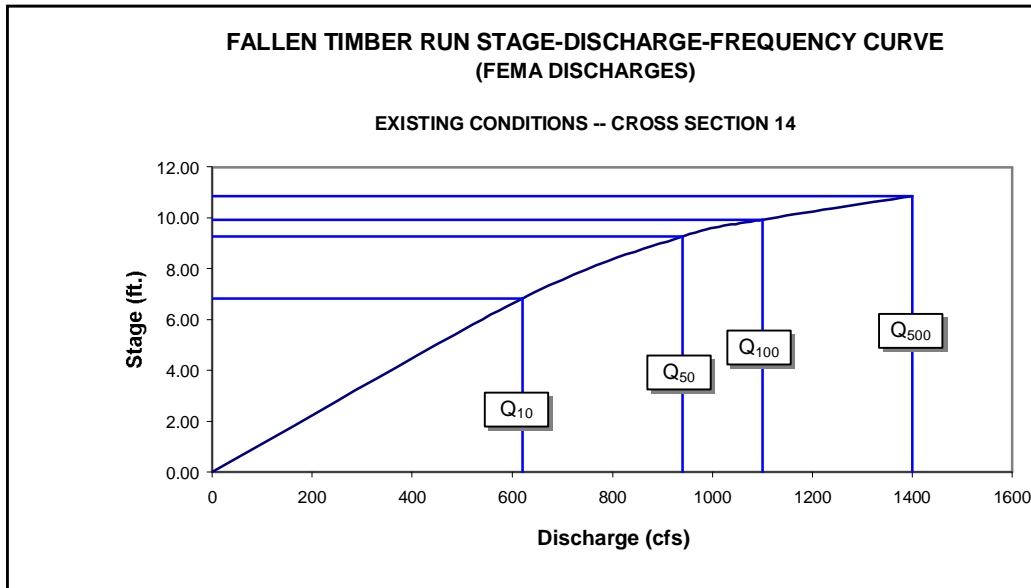
Frequency (Yrs)	Discharge (cfs)	Stage (ft)
0	0	0.00
10	620	6.83
50	940	9.27
100	1,100	9.93
500	1,400	10.86

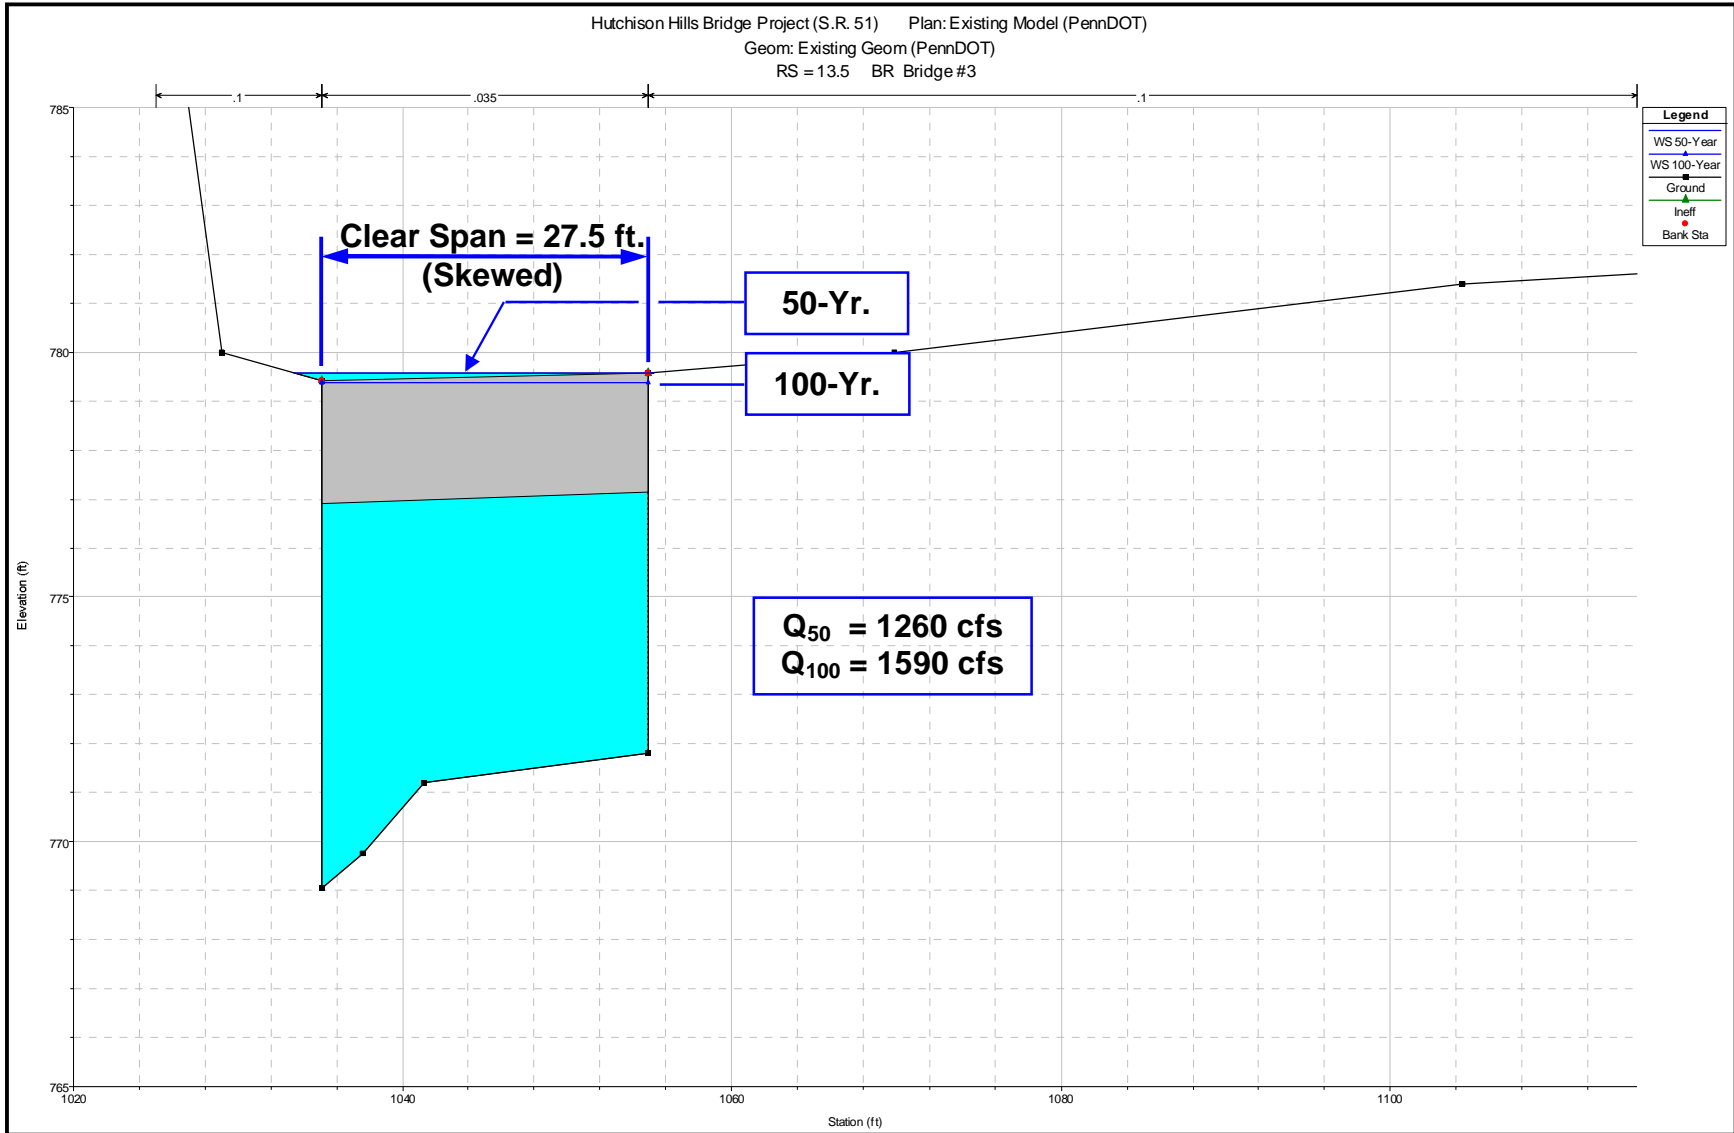
50 & 100-Year Flood Flow Distribution Bridge Section 13.5 U/S (Existing Conditions – PennDOT Flows)

Flow distribution plots follow on Pages C-22 through C-25.
