EeziBleed

Dual Brake Masters

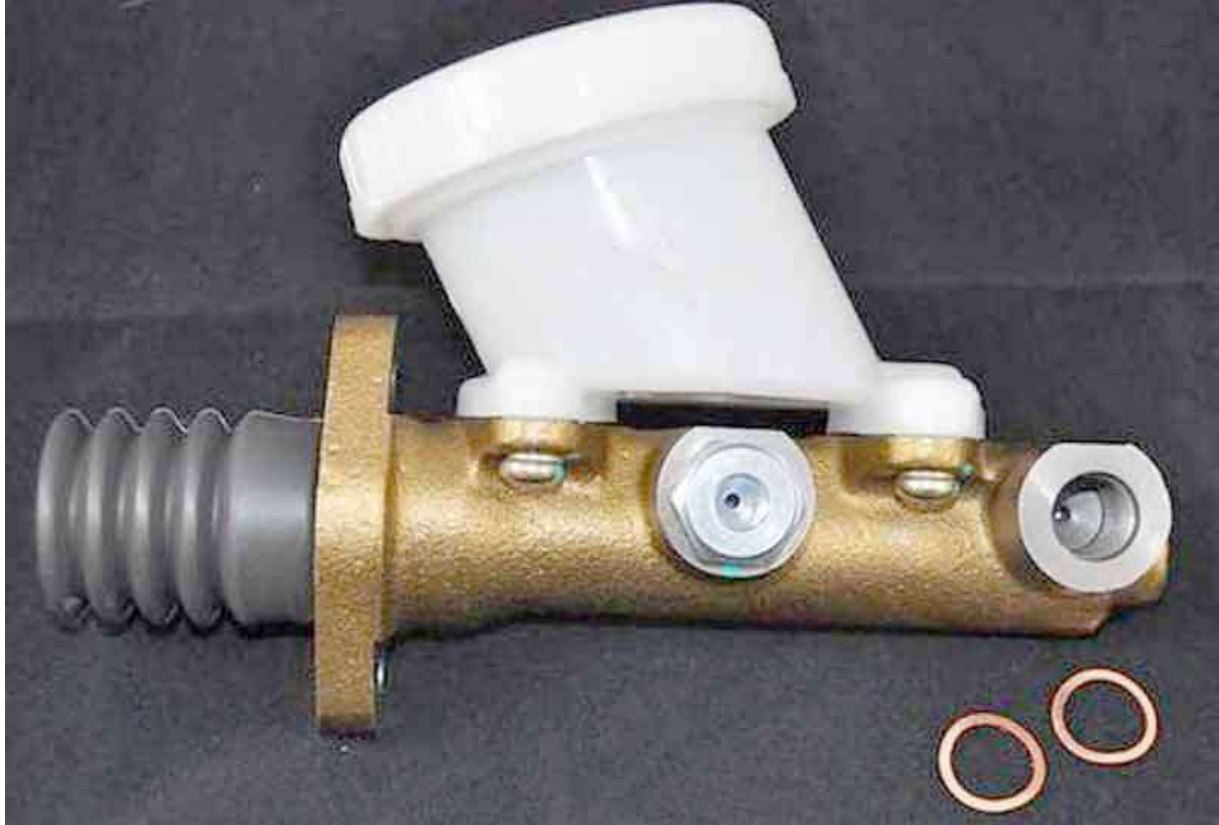
1968 to 74 North American unboosted dual master 37H2780, two outputs to a separate manifold unit that contains the pressure failure switch:

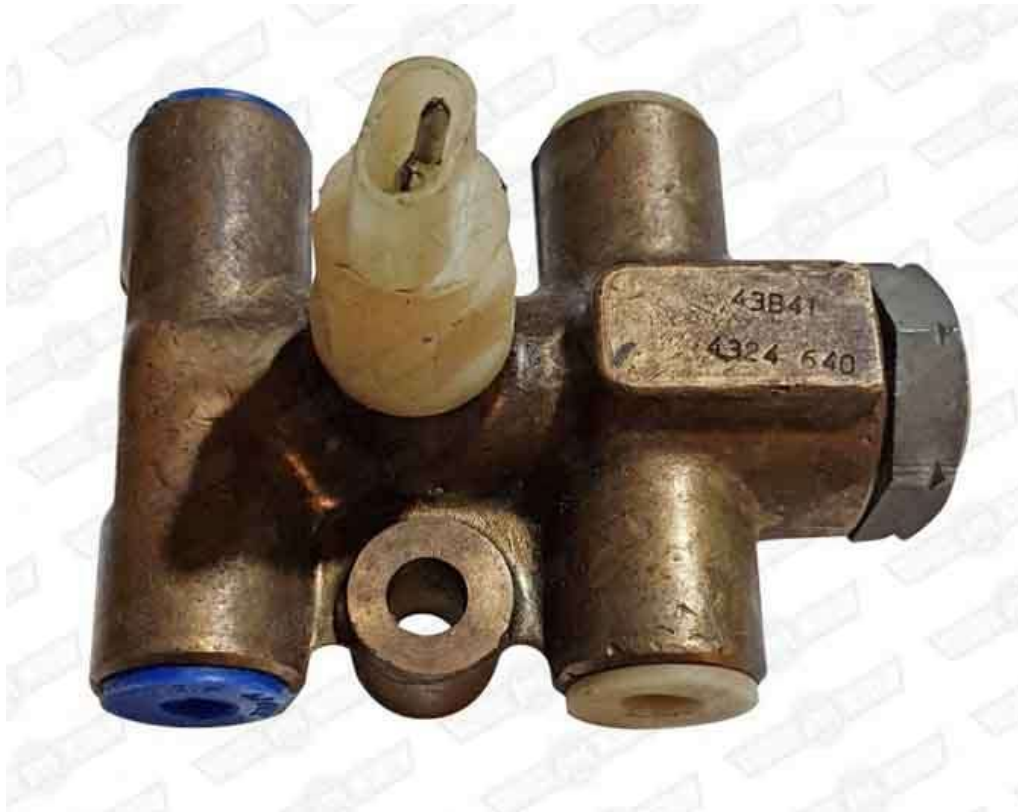
The remote pressure failure switch assembly 13H5905: ([Somerset Mini](#))

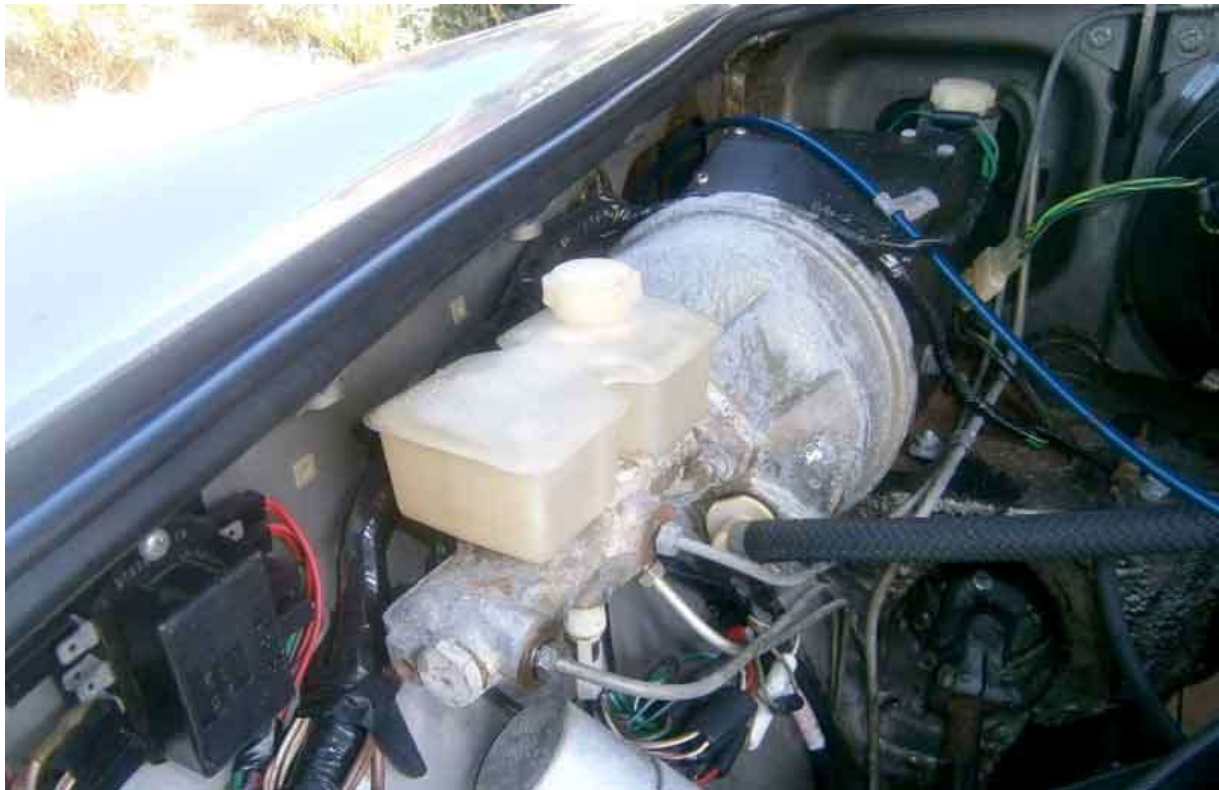
1974-on North America and 1977-on RHD dual brake master with integral servo:

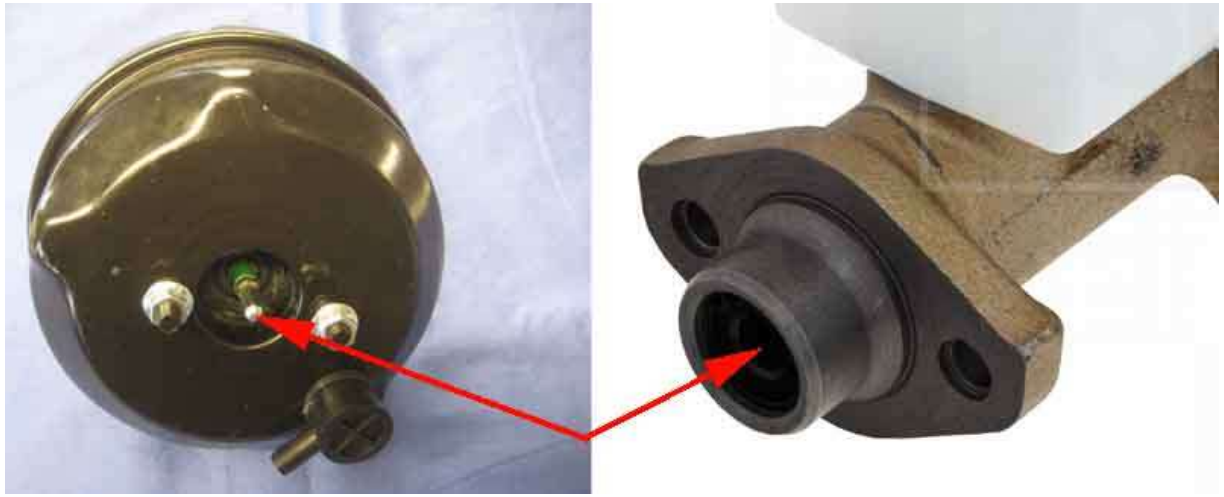
The push-rod from the servo acts directly on the master cylinder piston:

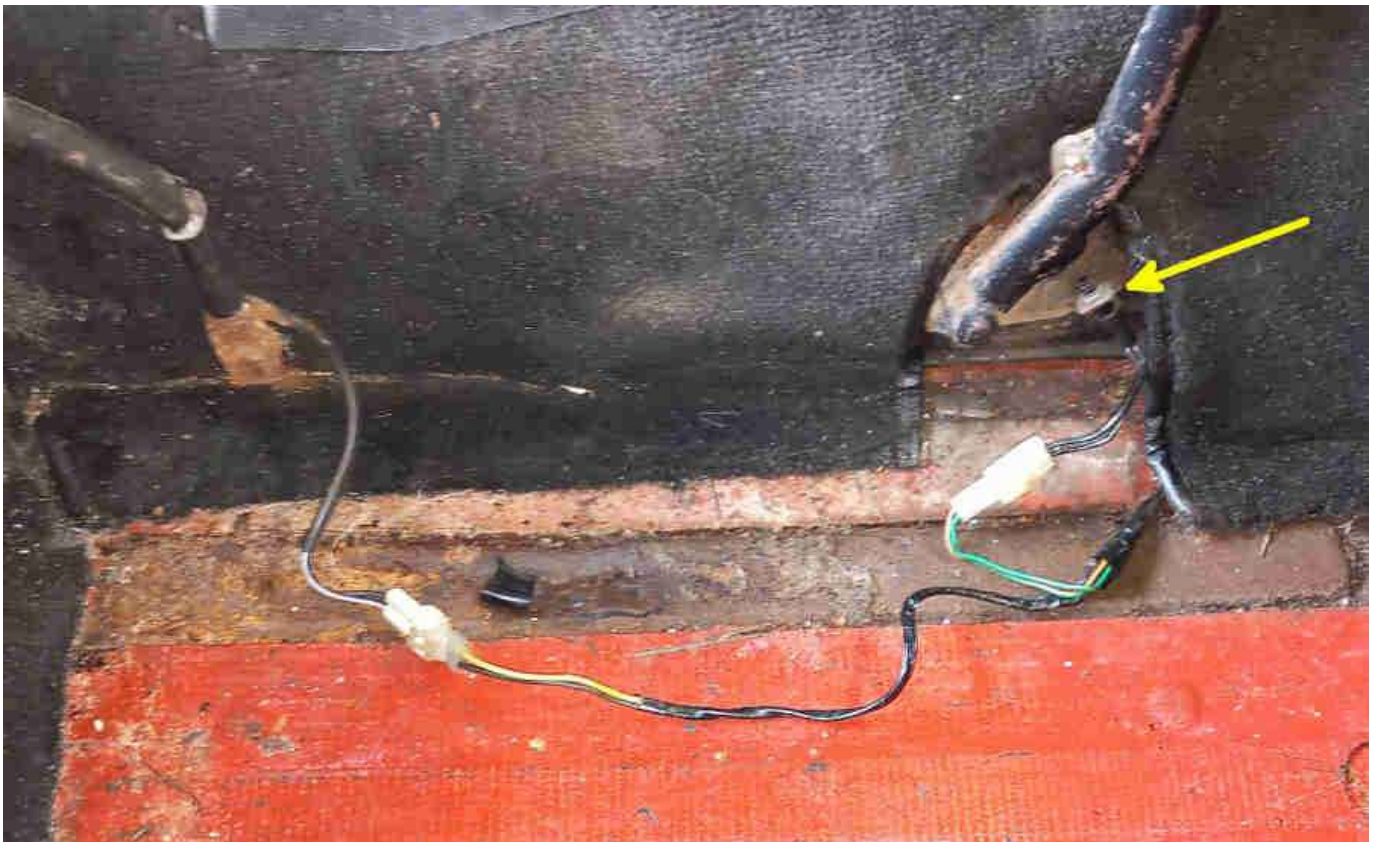
The UK seat-belt and handbrake switch wiring:

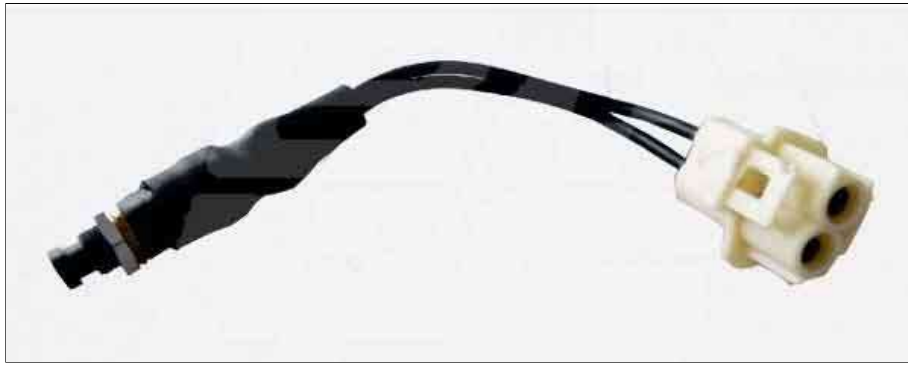
The handbrake switch used is AAU2492: (*Brown & Gammons*)

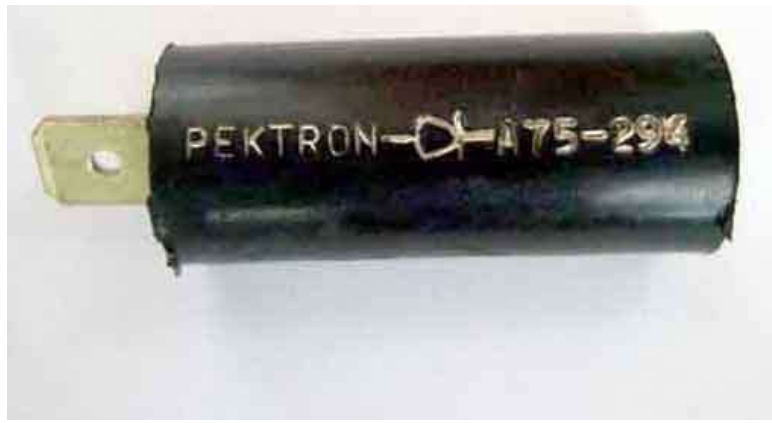
Warning light test diode showing the male connector for the white/red wire ...

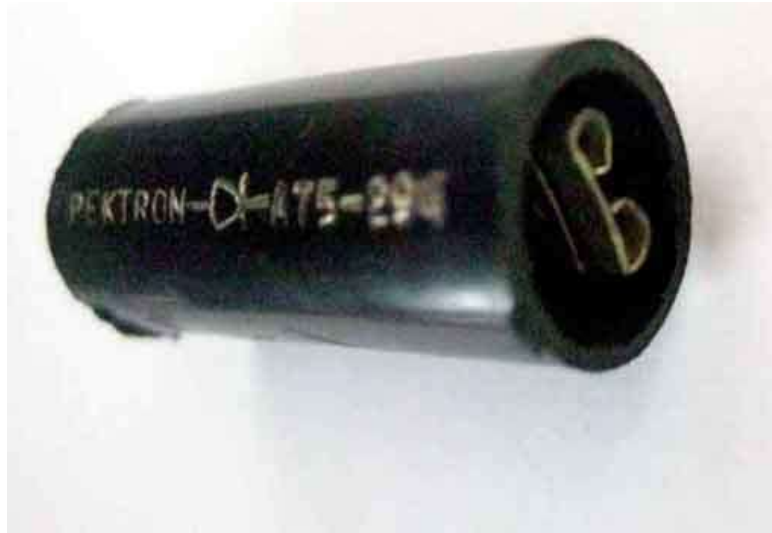
... and the recessed female connector for the green/orange wires:

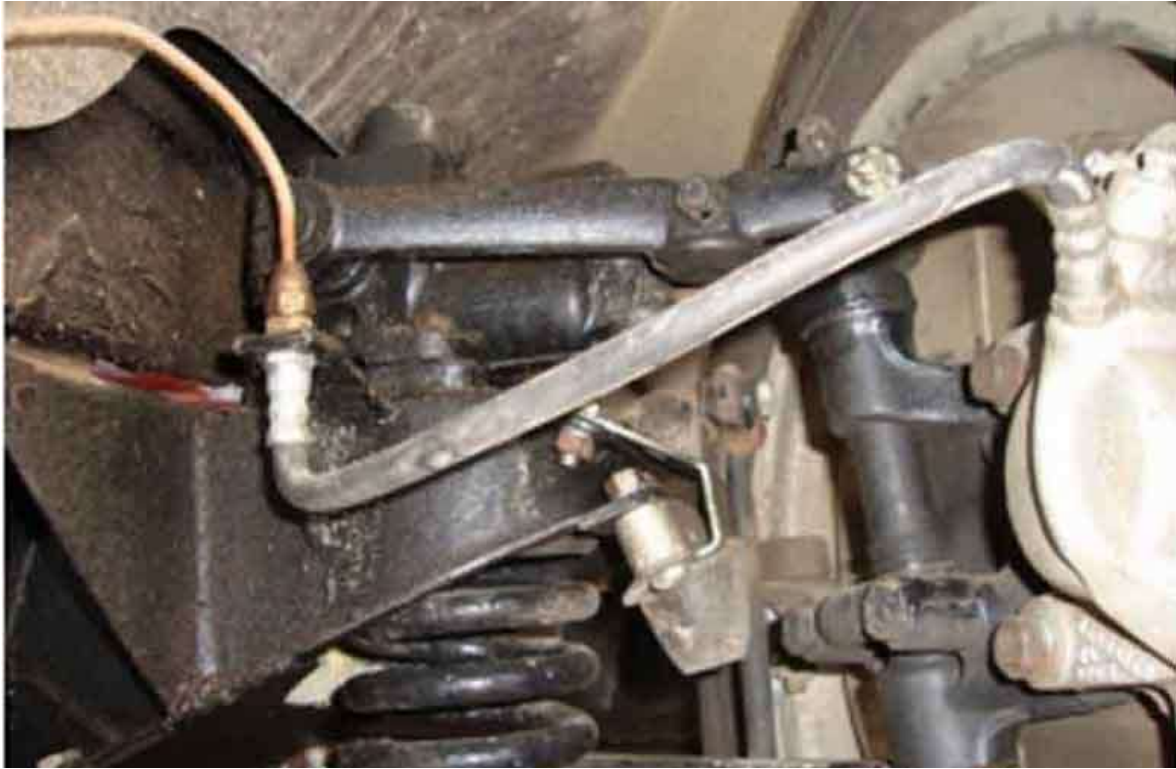
The hose pictured in this [V8 Register document](#) - pretty tight:

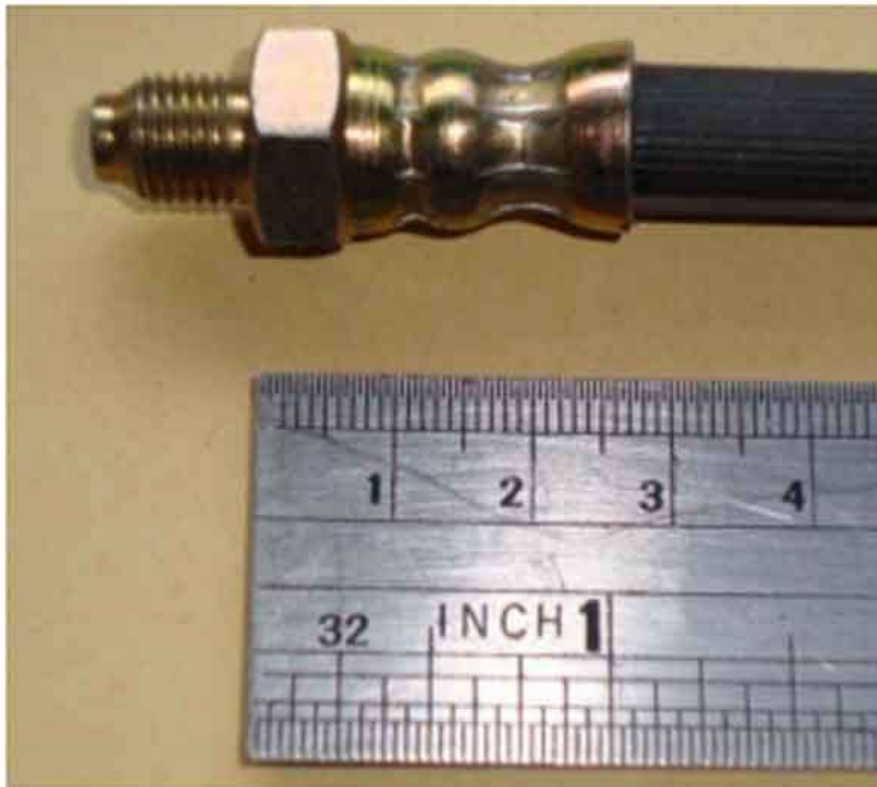
Measuring the length of the metal ends - minus threads:

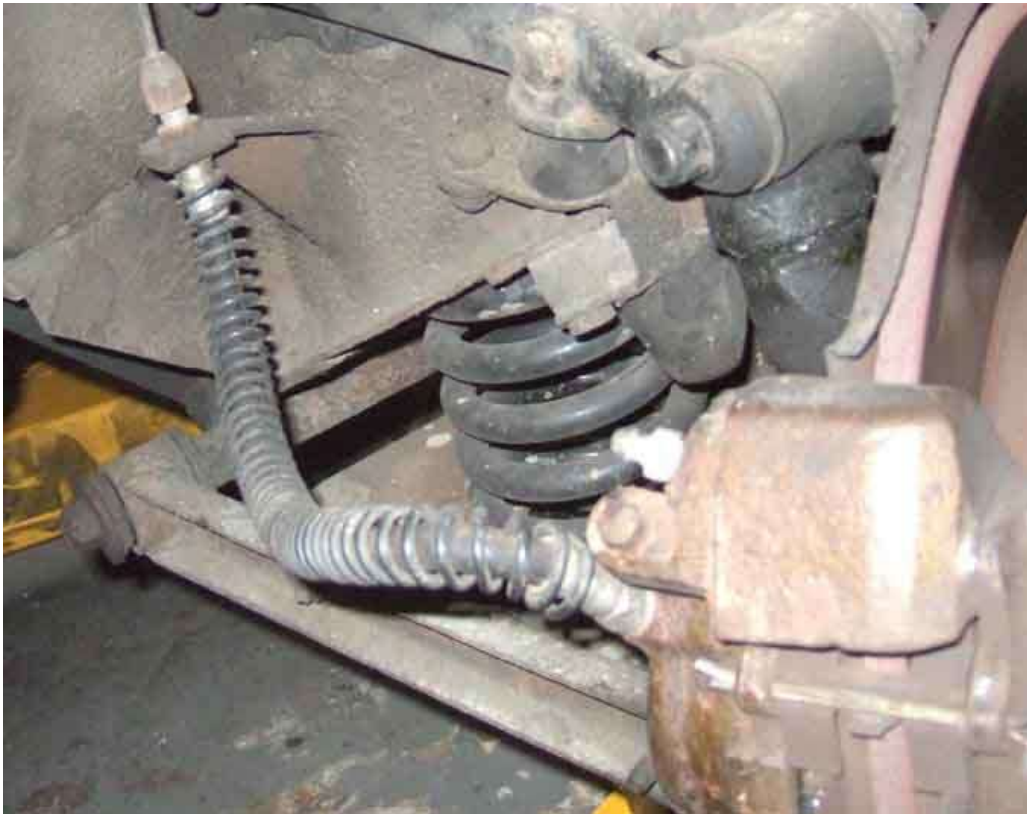
Bee's, with 321mm as far as I can judge from hex face to hex face, and metal ends 22mm at the bracket and 25mm at the caliper:

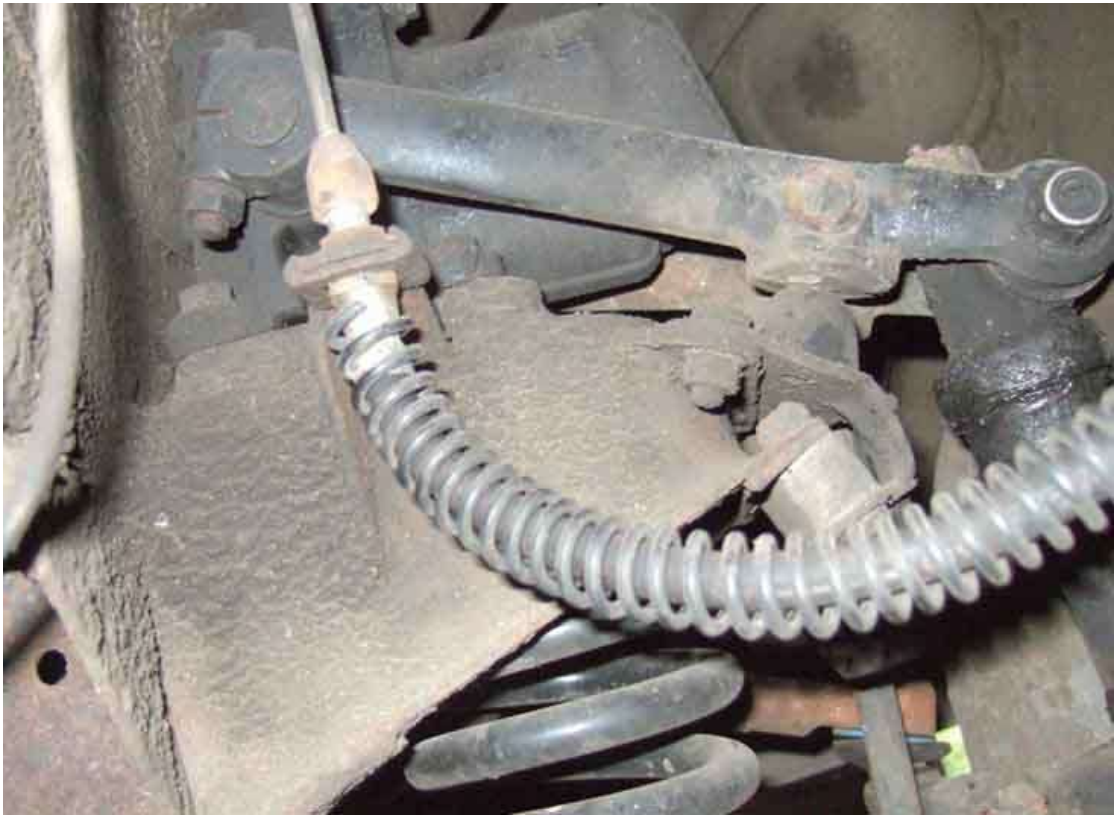
Alignment of bracket to damper:

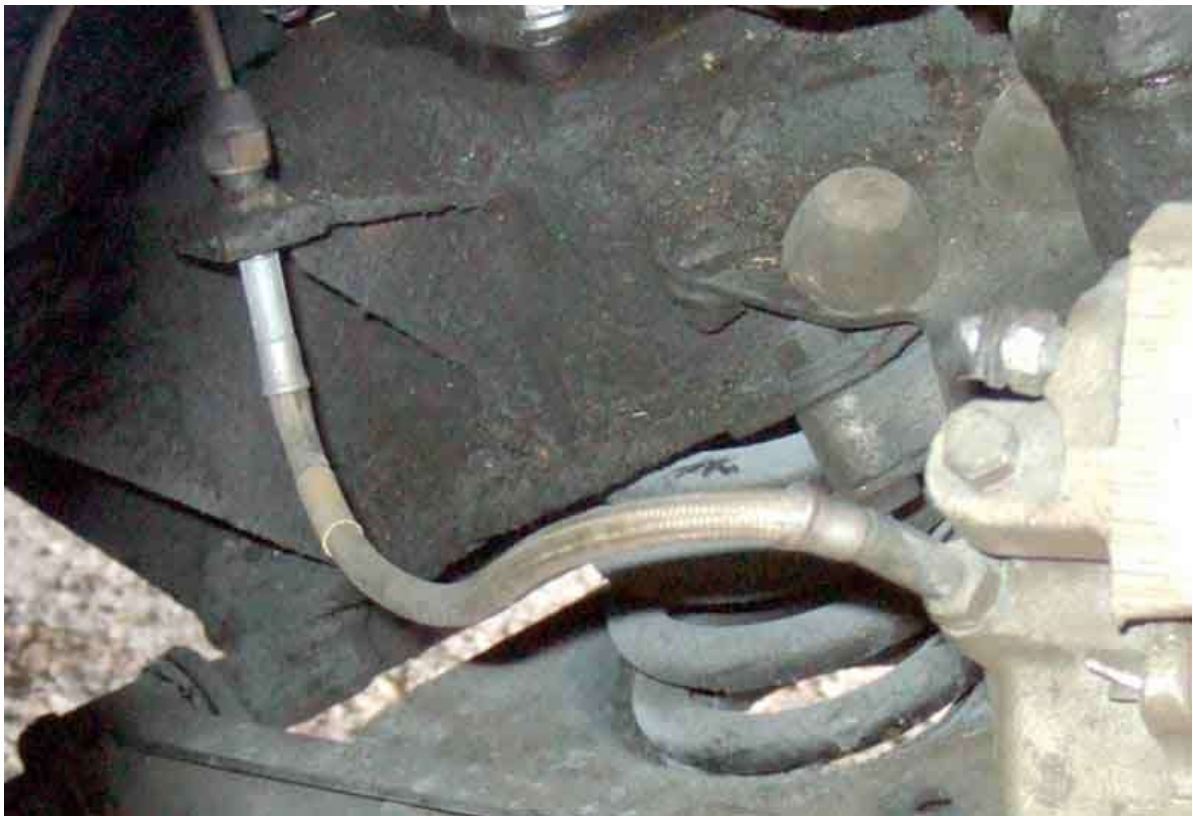
Vee's, with 330mm from hex face to hex face, but with 33mm metal ends:

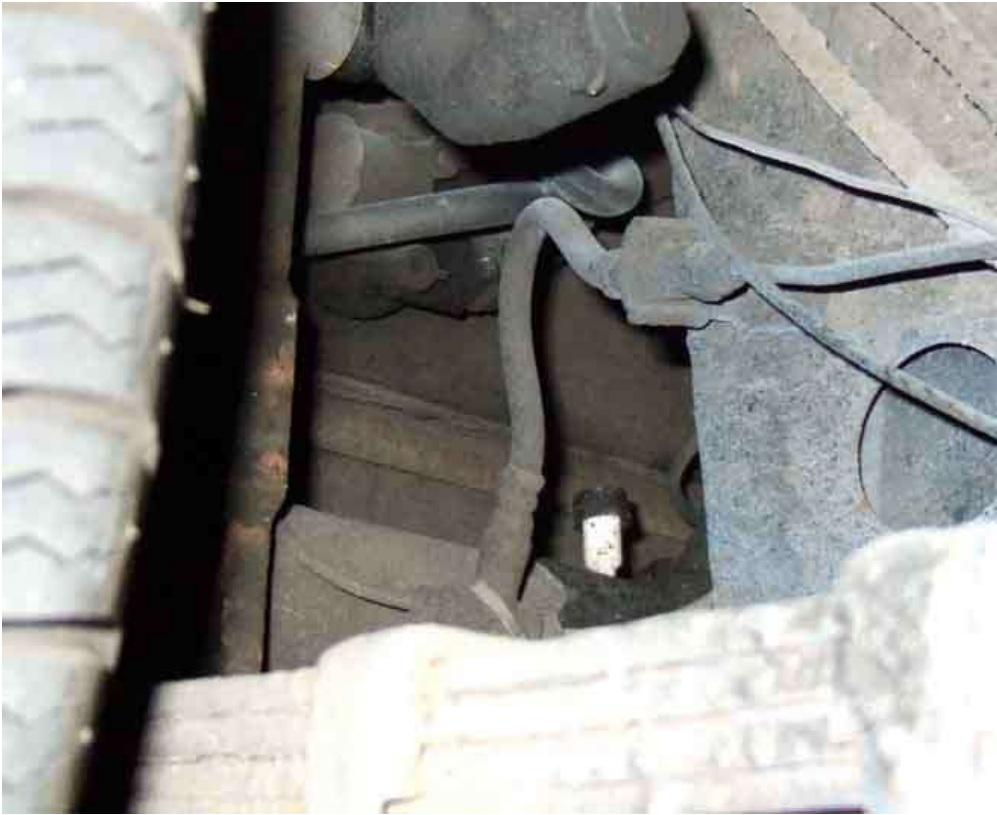
Originally the pipe points more-or-less straight back to the hose, which is secured to a bracket welded to the side of the battery box, and the hose attaches to the top of the 3-way union on the axle, this from my 75 V8:

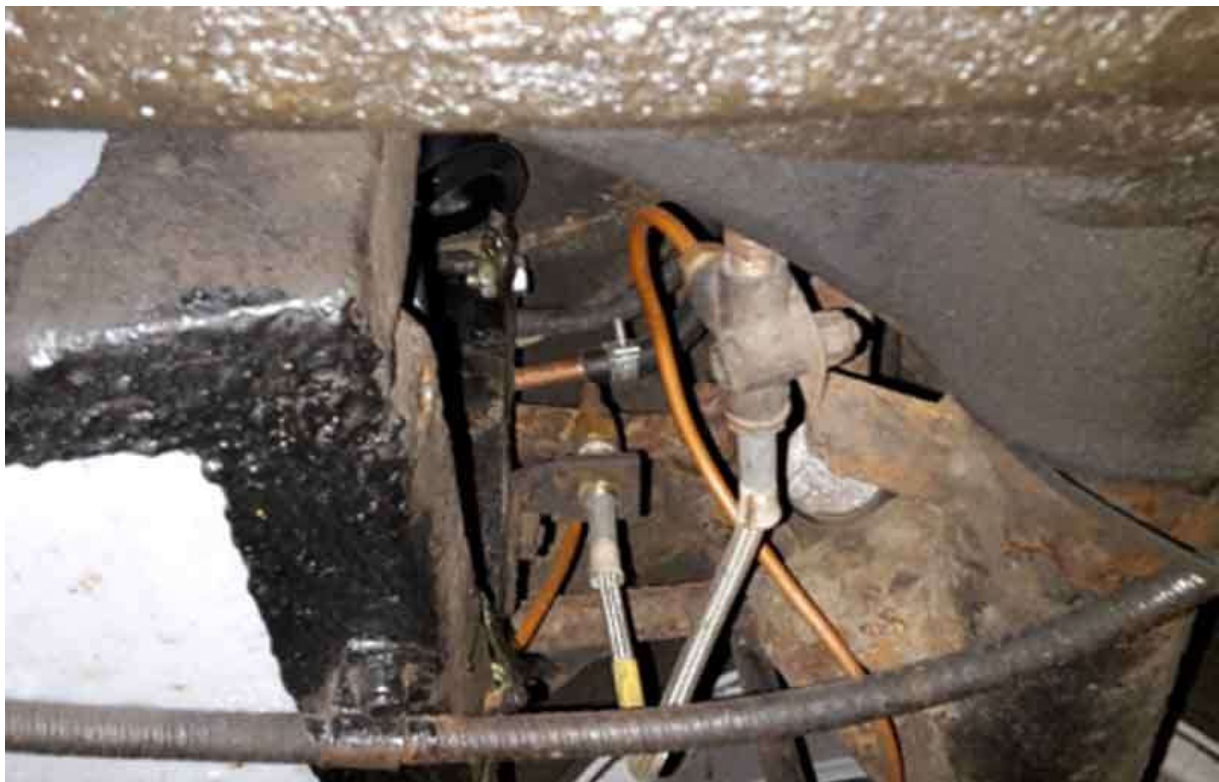
But for UK 77 and later at least the bracket changed to one bolted to a welded nut on the rear of the battery box, and the pipe now connects to the hose pointing downwards. Also the hose now attaches to the off-side of the union on the axle, and the off-side pipe comes off the top. This is probably because the union had to move closer to the diff because of the ARB brackets. Image from Charles9 UK on the [MG Enthusiasts BBS](#).

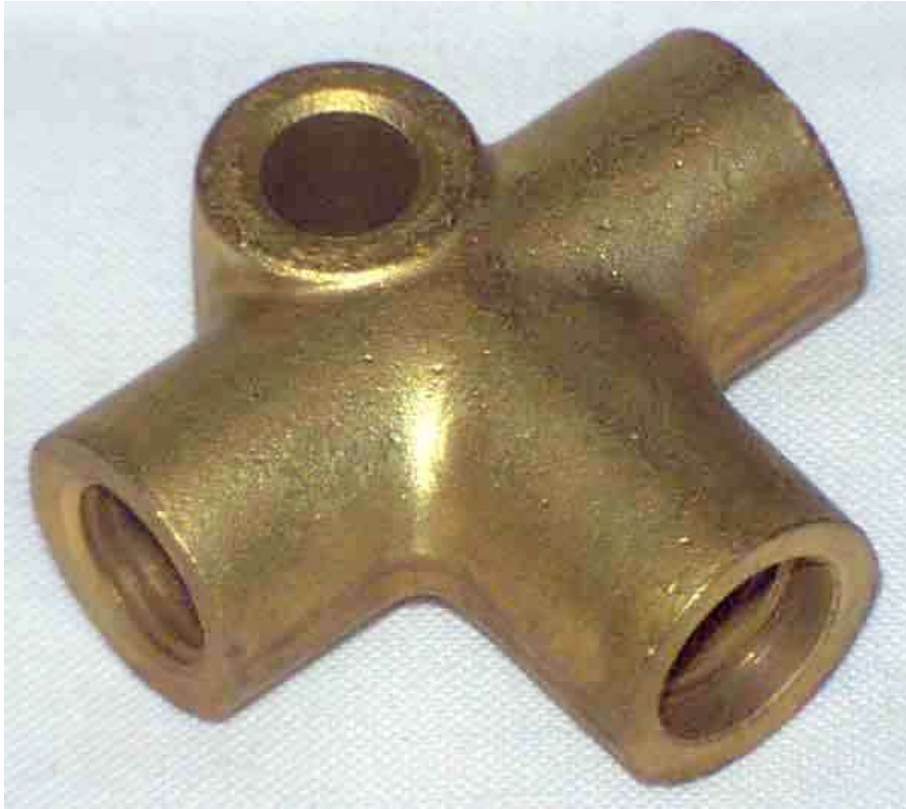
3H2424 from Motaclan/Leacy at £7.50 - what would be the top port for the hose pre-77 definitely different to the other visible port.

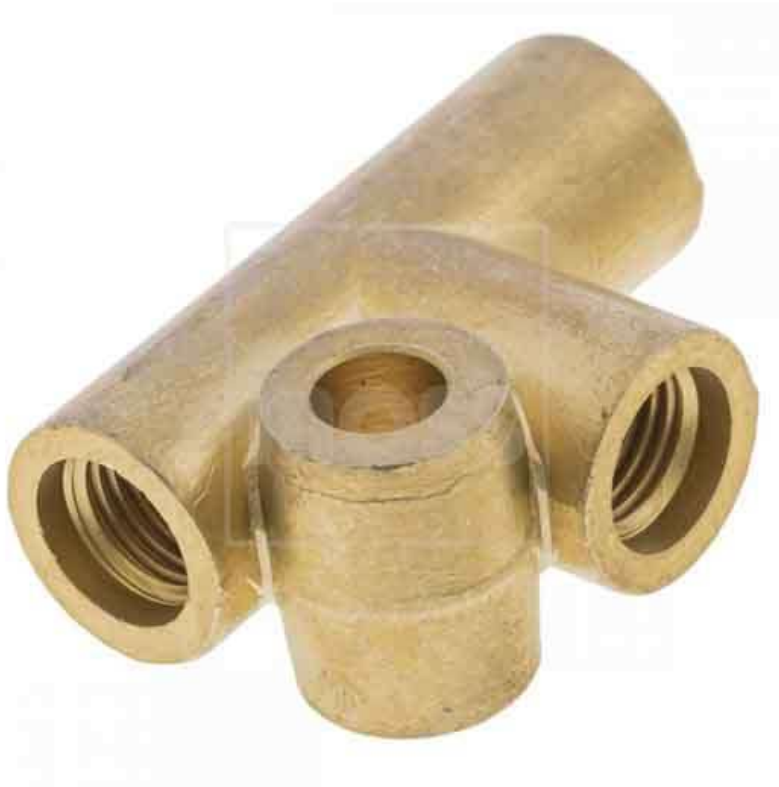
[BTB657 for Triumph models from Moss Europe](#) at £17.10 - the two visible ports with the same recessed thread, although the mounting boss is in a significantly different position.

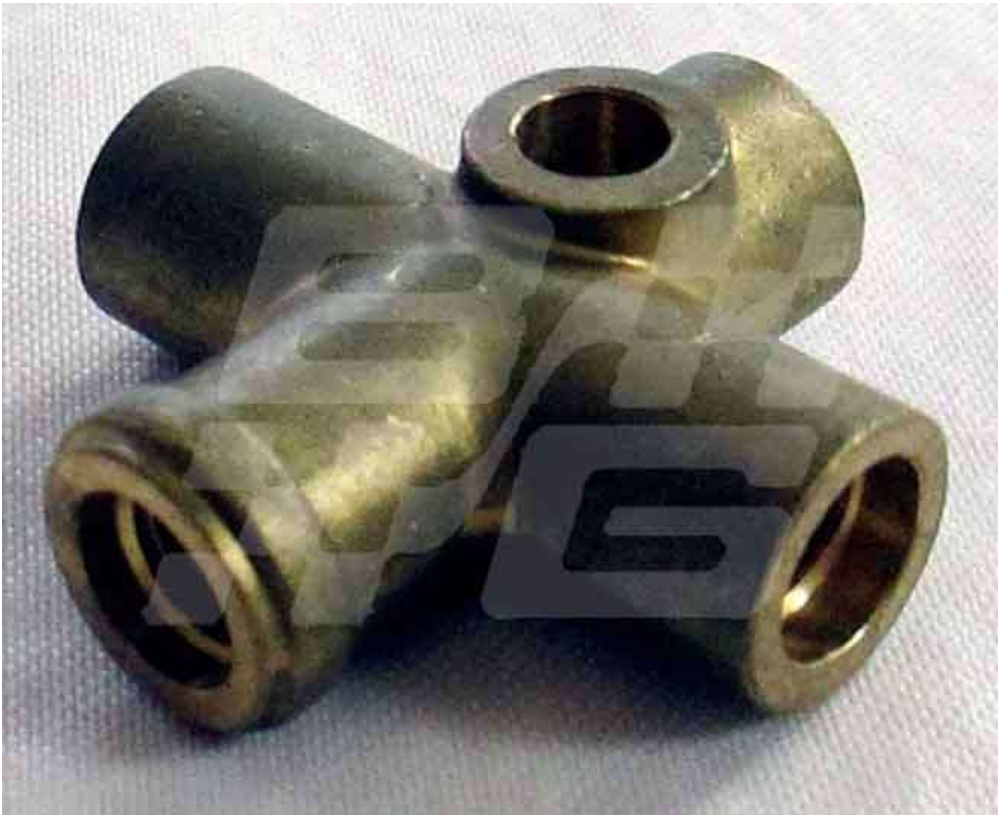
[AJA5028 for the MGA from Brown & Gammons](#) at £16.07 - possibly four ports although one could be blanked off, the lower right (in this image) port looking correct although the lower left is completely different.

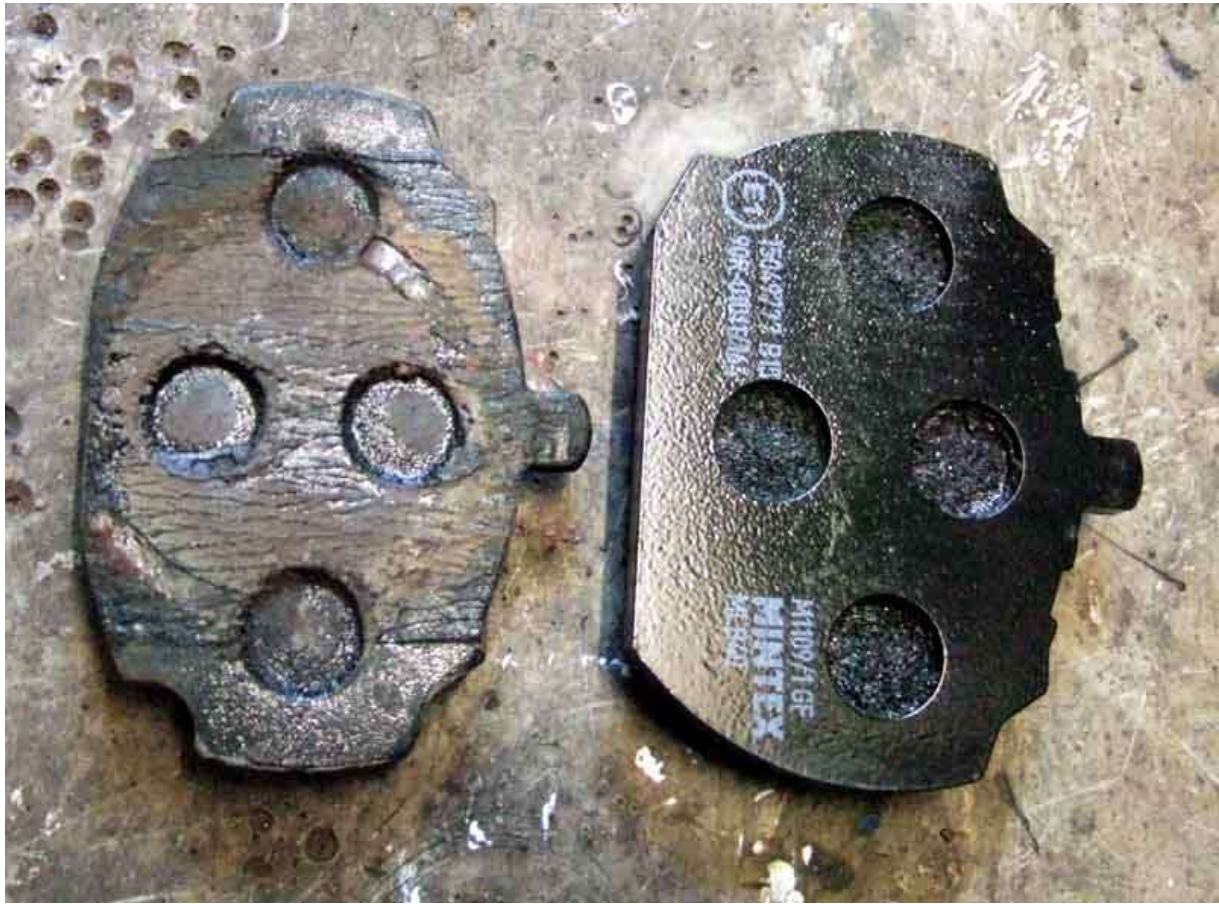
Comparison of 4-cylinder (left) to V8 (right). Rubberised coating on the back of the 4-cylinder with no shim. And despite shims being included with the above set none with this set, even though they did come with retaining springs and split-pins, which isn't always the case.

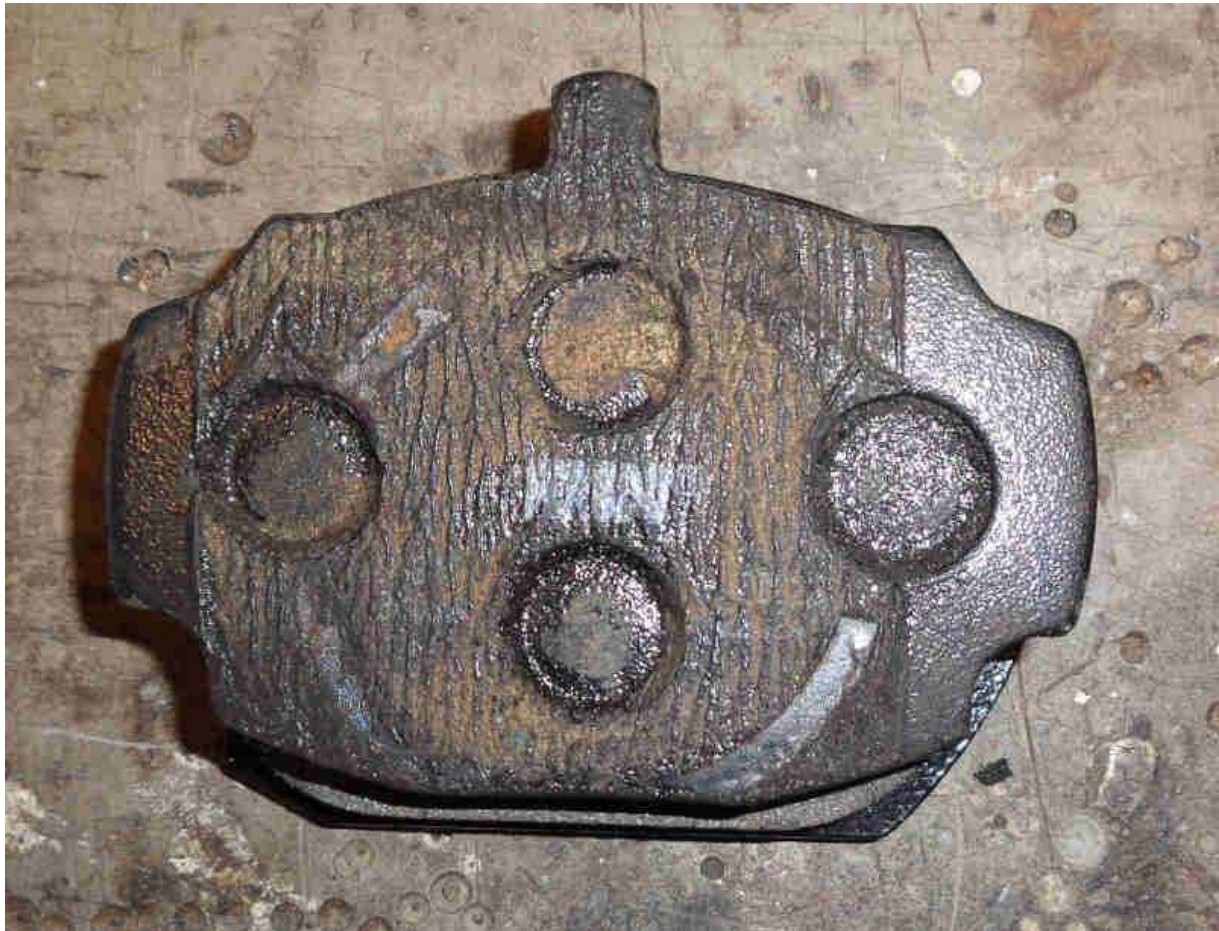
V8 pads in 4-cylinder calipers: With the 'tops' aligned the 'bottoms' of the V8 pads extend a bit further:

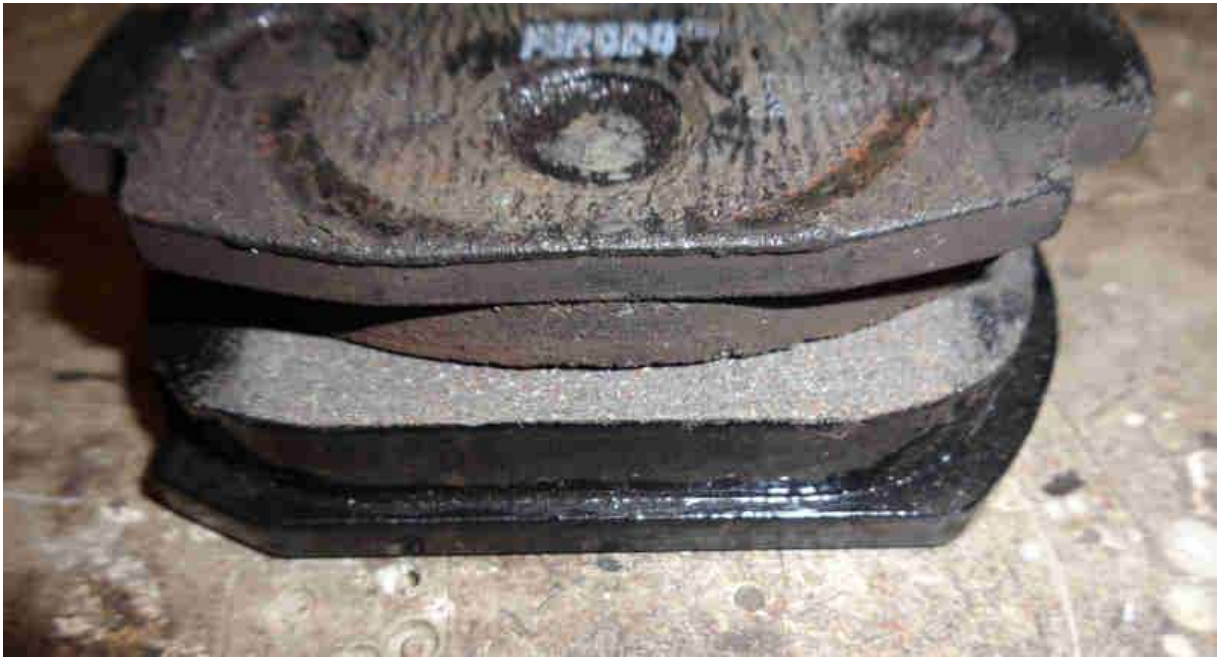
There is noticeably more friction material closer to the stub-axle:

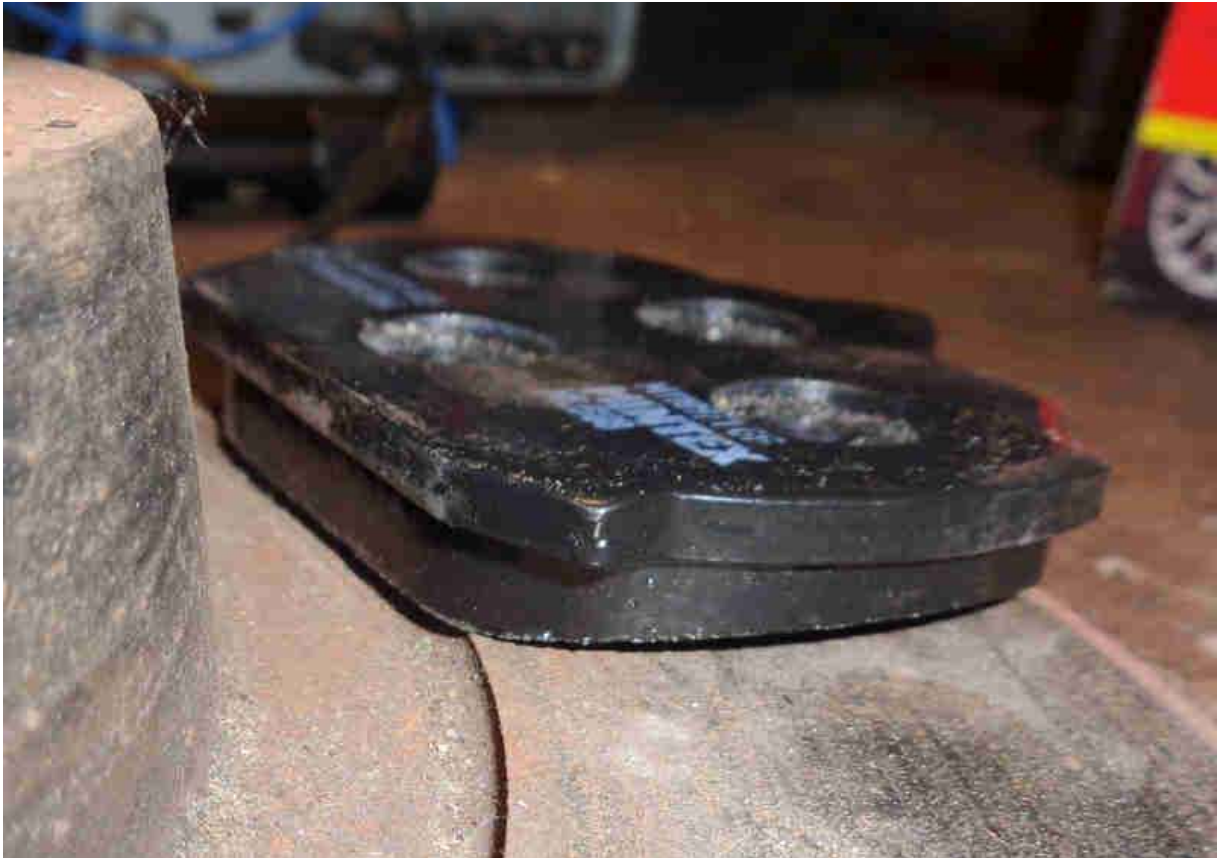
V8 pad on 4-cylinder disc: On the outer face of the disc some of that extra material is not doing anything and as the pads wear that unused part will lodge in the recess in the disc meaning the piston will have to be retracted more than usual to remove them:

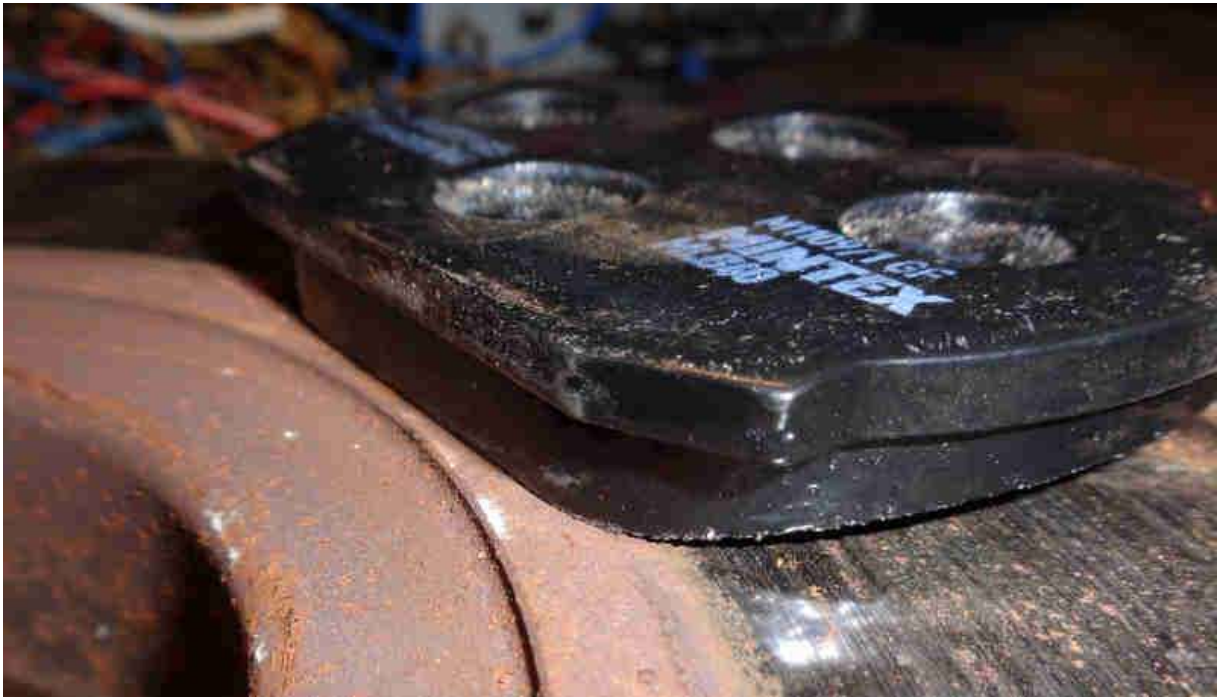
Whereas on the inner face all the friction surface is used. Some dismantling will be required to clean up that additional area on the disc when fitting V8 pads to 4-cylinder calipers for the first time - or new or skimmed discs, but it will result in imbalance between the two faces of the disc, which may have unwanted effects including warping:

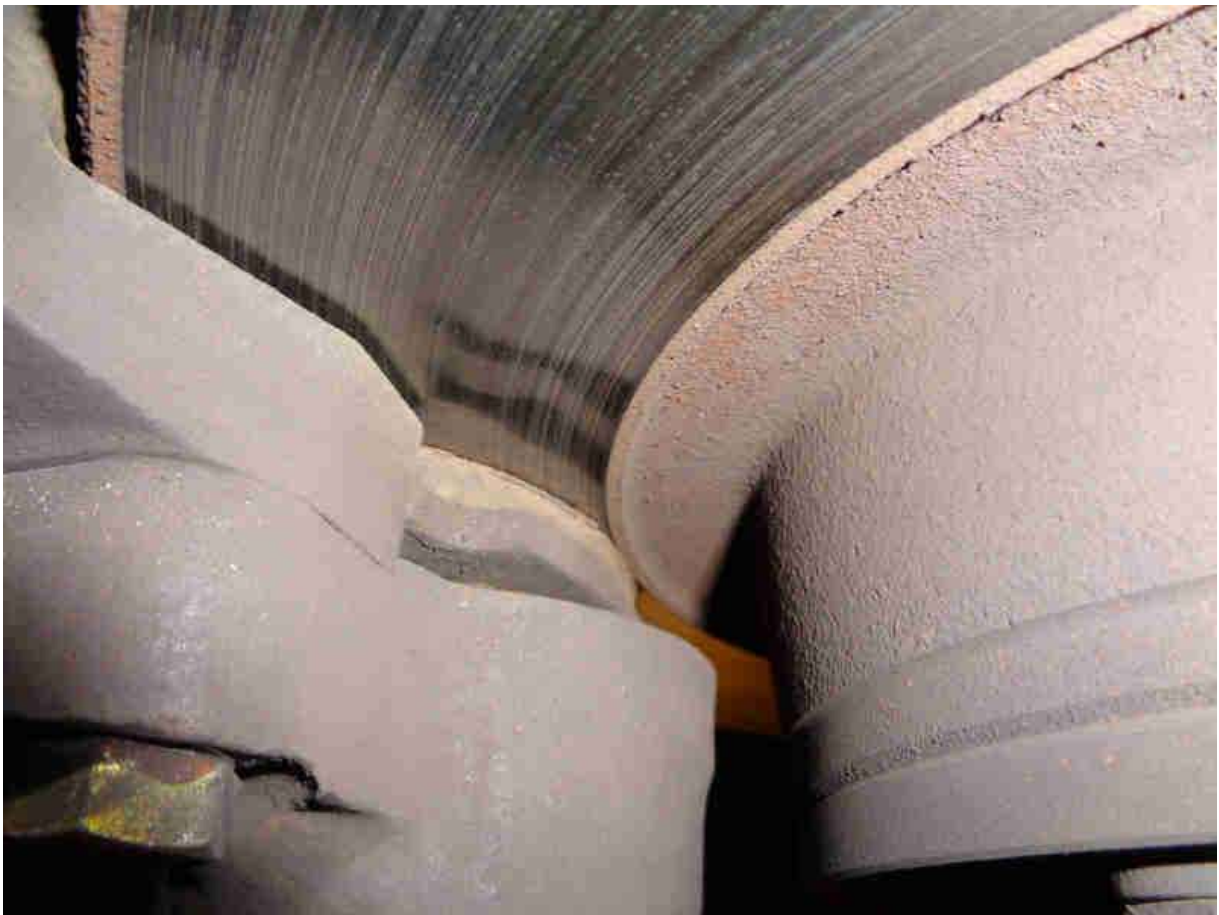
Confirmed in the caliper - 4-cylinder pad with 4-cylinder caliper and disc:

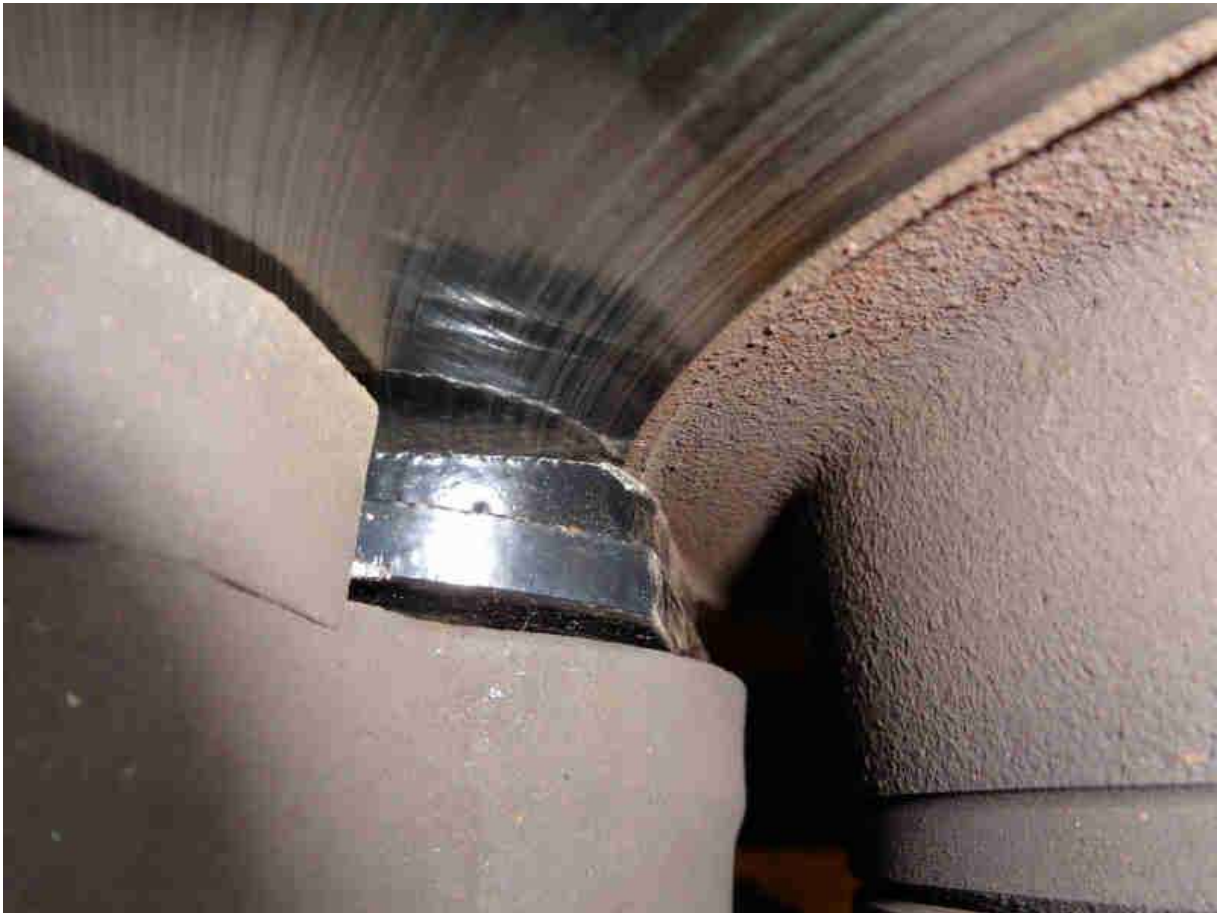
V8 pad with 4-cylinder caliper and disc:

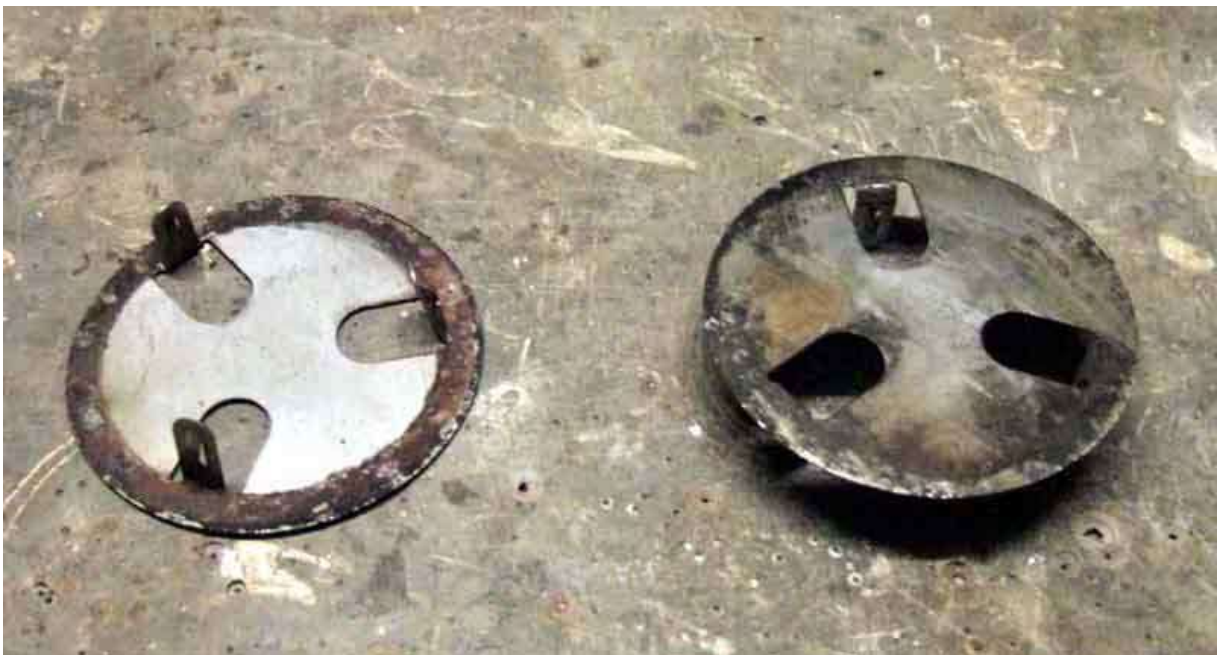
MG ZS shims with prongs that project into the pistons, similar to Peugeot shims which some have said have cured their MGB squeal. Only one per side on the ZS, whereas I need two for each MGB, or three more ZS pad changes ...
