EeziBleed

Dual Brake Masters

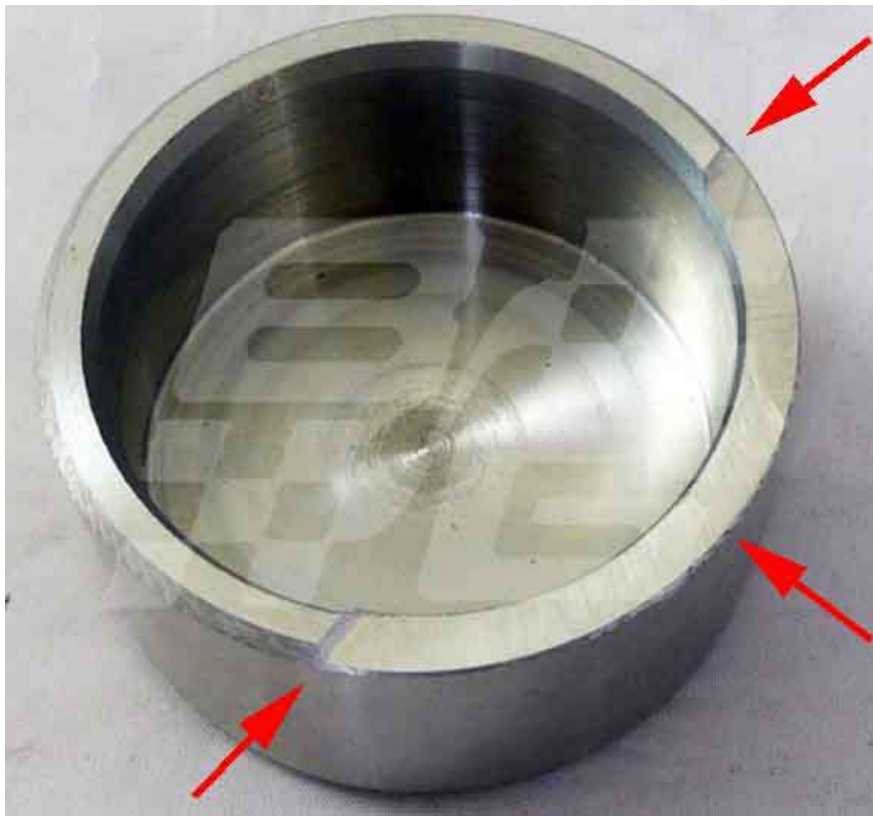
Caliper piston showing the cut-out (Brown & Gammons)

The cut-away portion of the piston (arrowed) must be located at the inner edge of the calliper, i.e. towards the hub

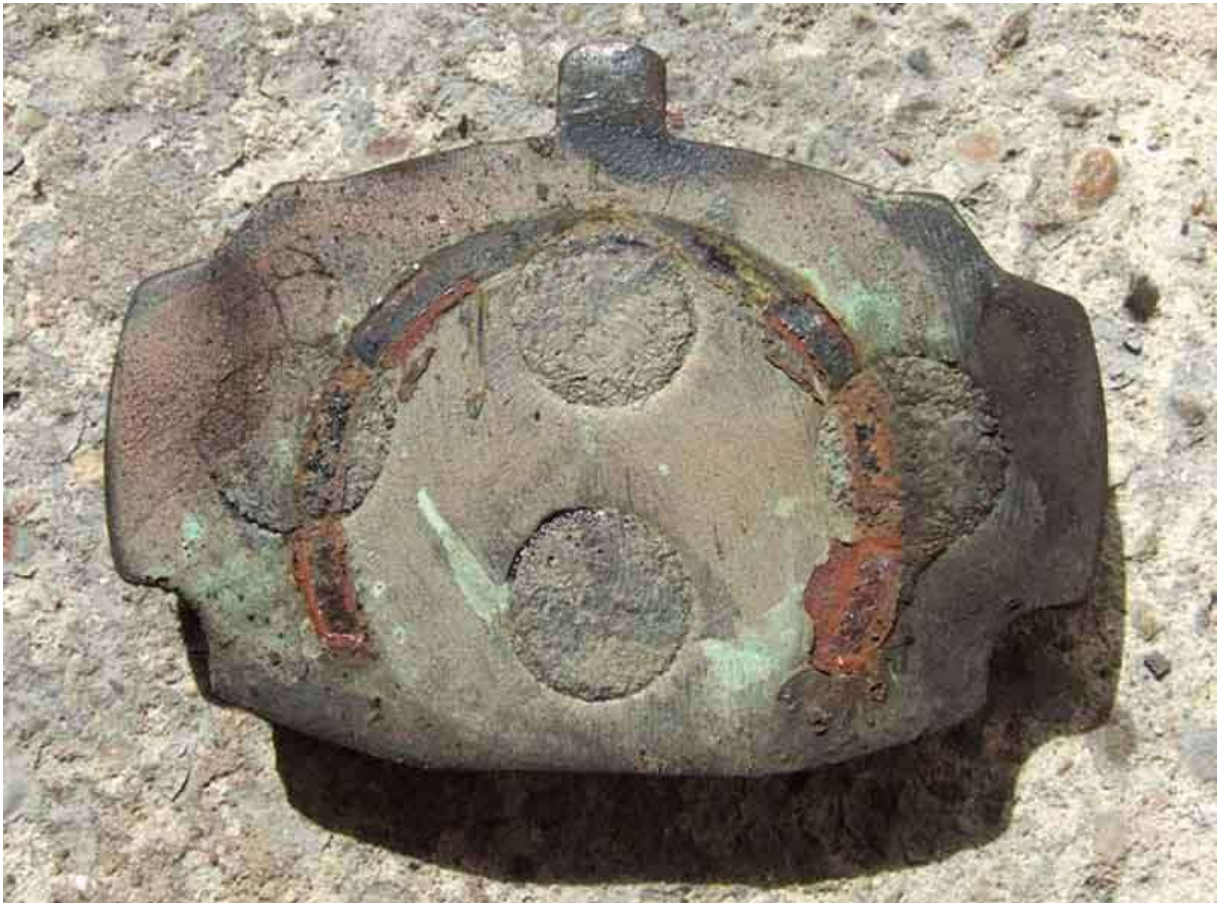
MGB pad with piston witness marks ...

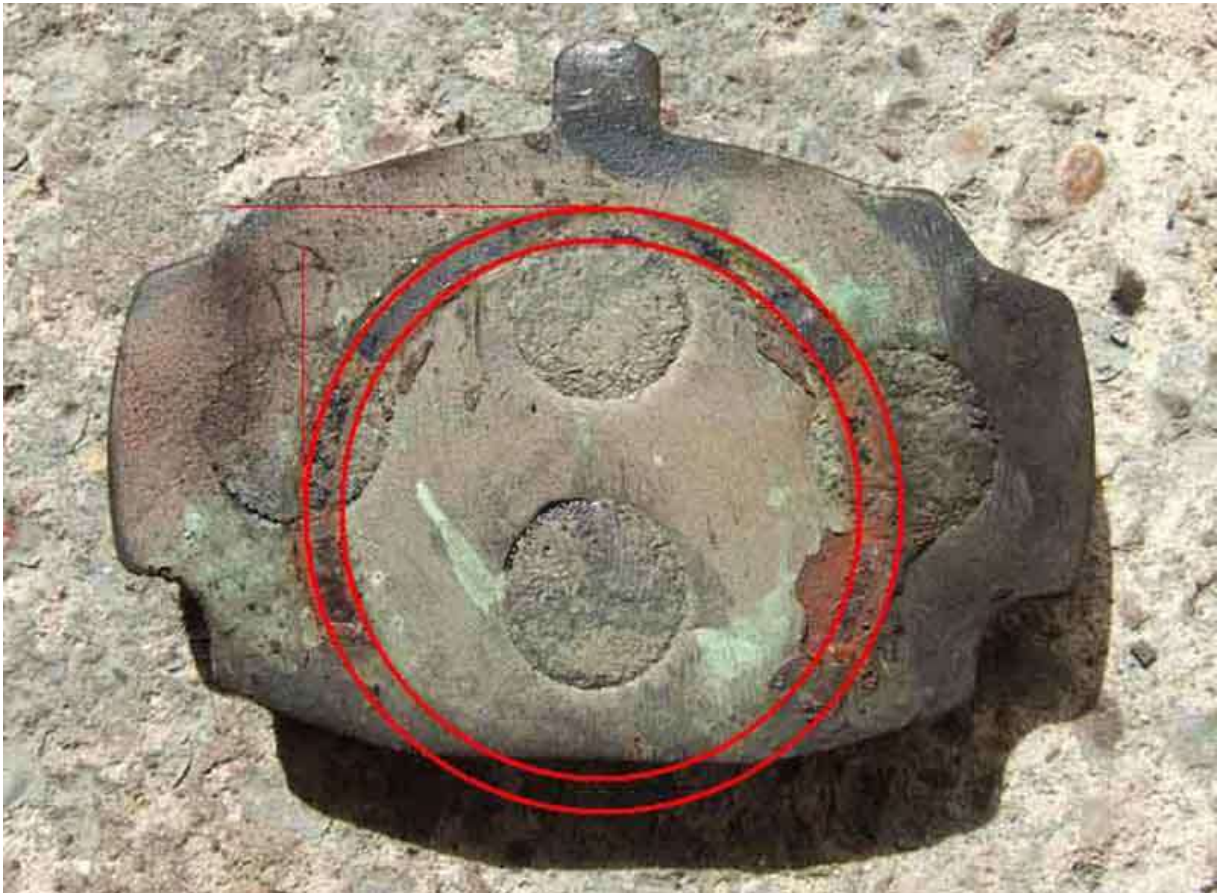
... showing that without the cut-out the lower edge of the piston would be off the pad ...

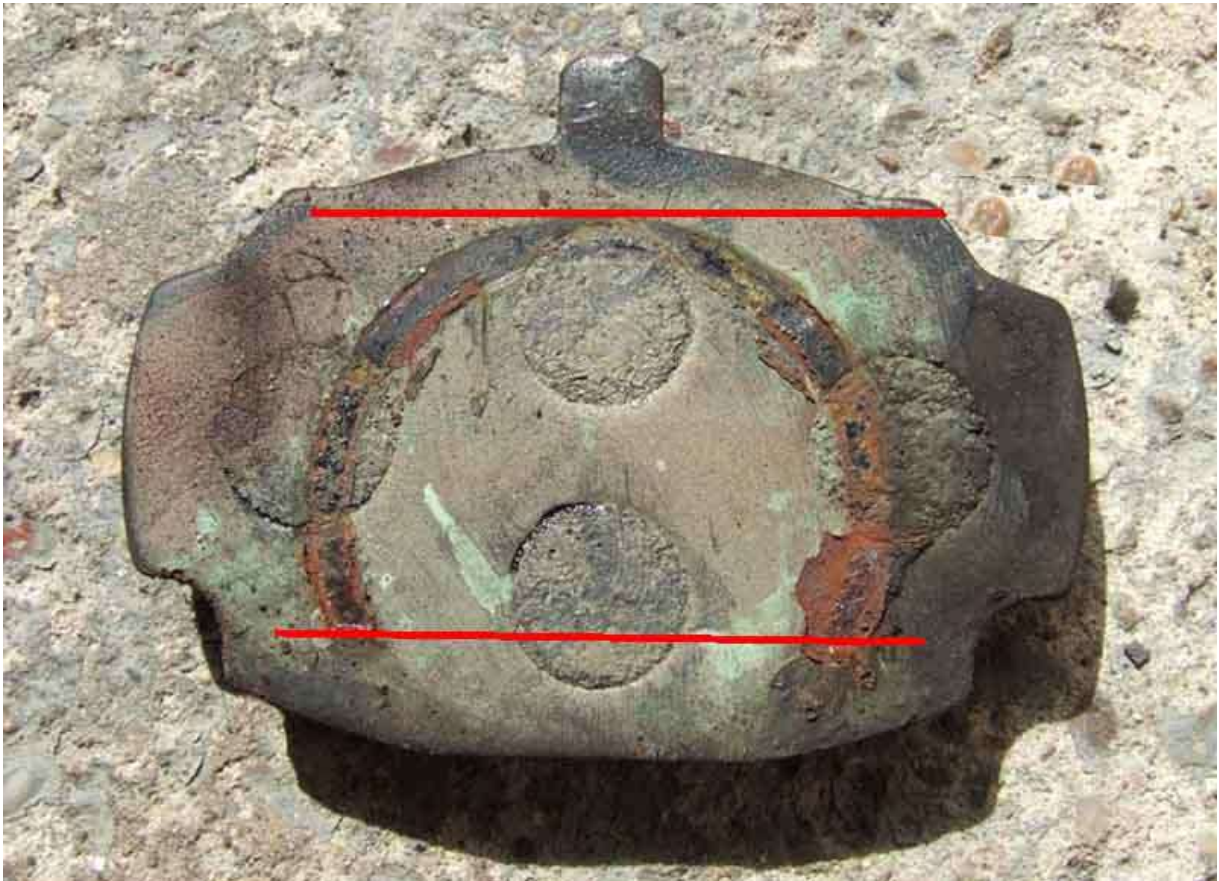
... but with the cut-out it is effectively in the middle and will apply even pressure of pad to disc.

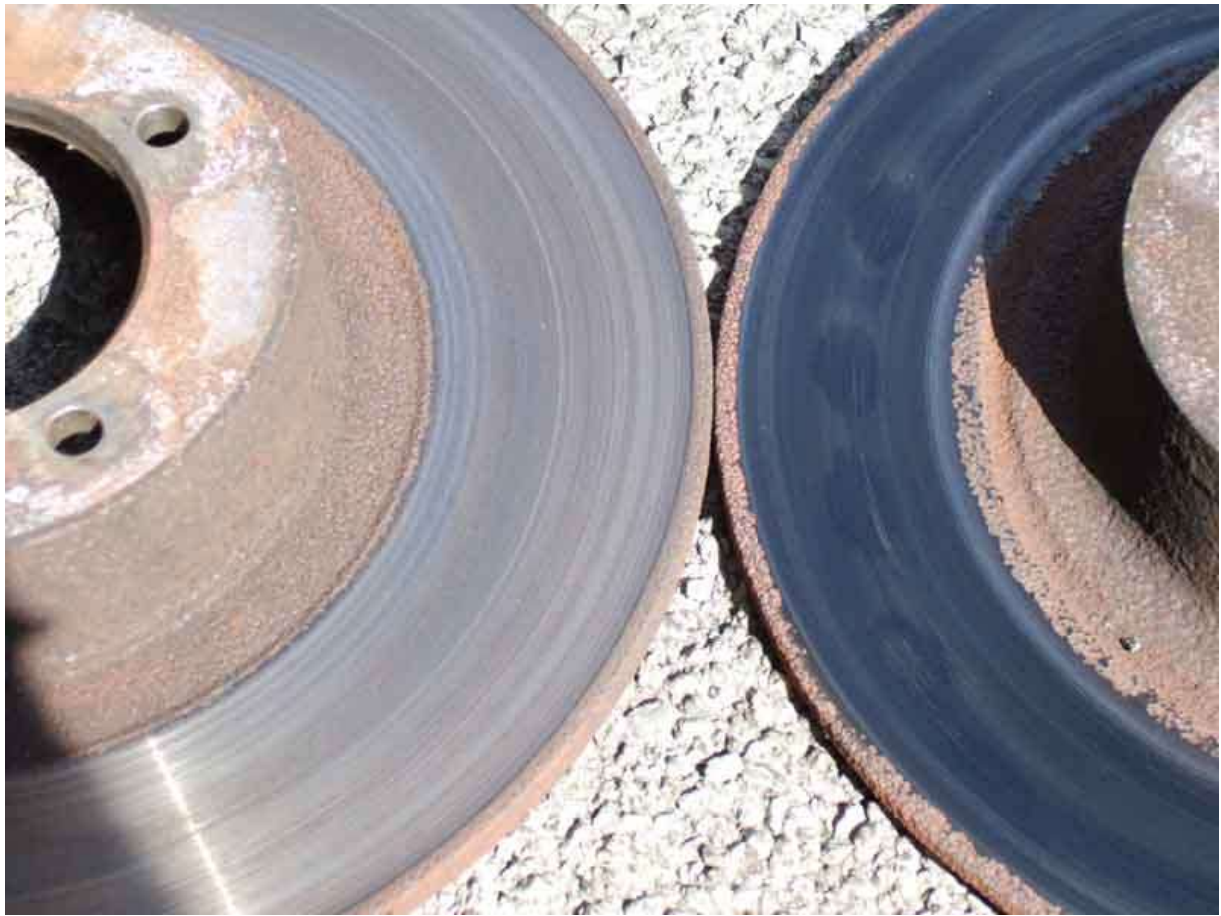
Blued disc. Swept depth also seems to be noticeably smaller than the other disc. This is the very thin disc, but I opt for replacing both.

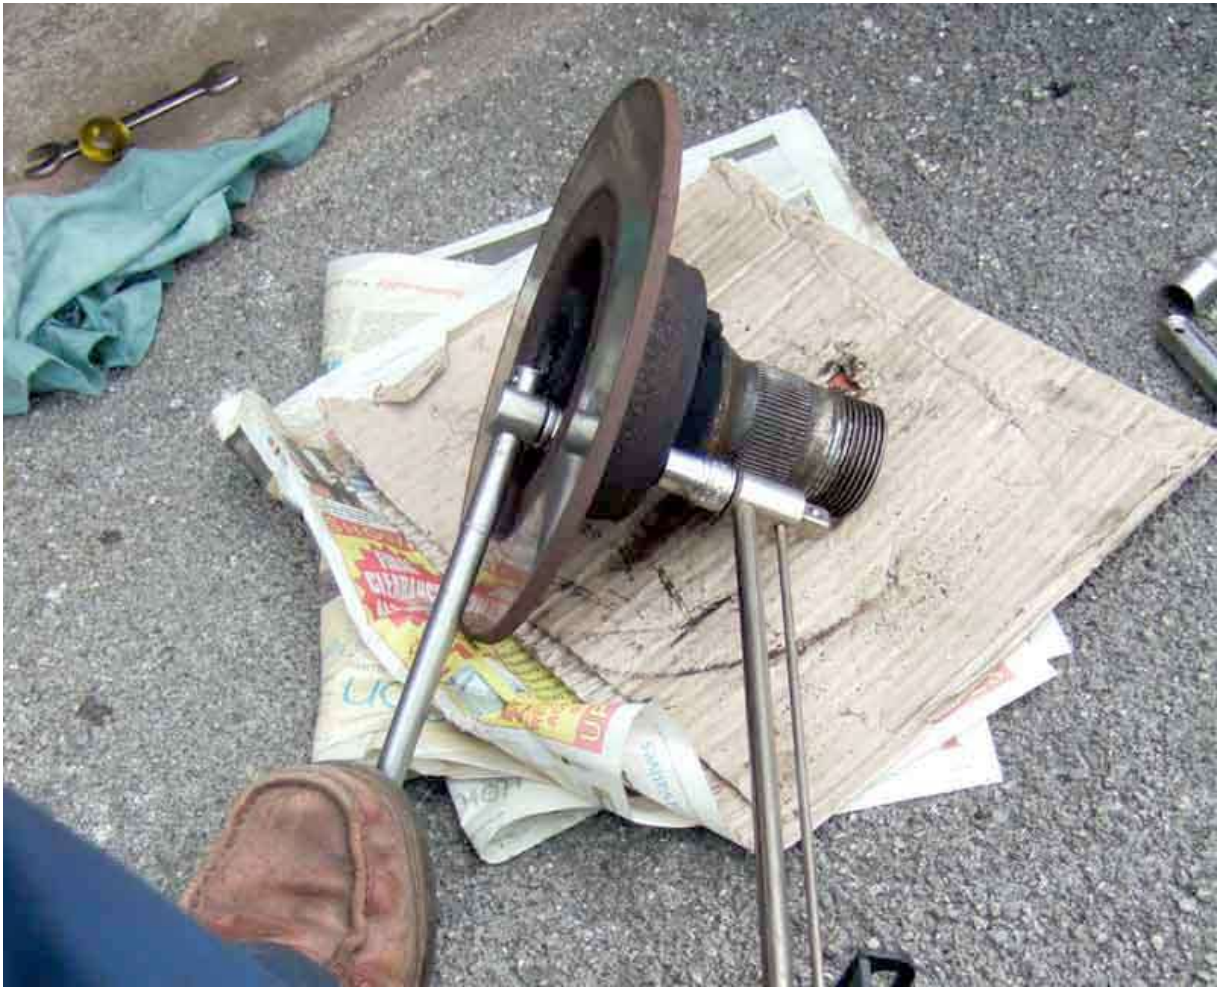
Using 'ground effect' to assist in undoing the nuts and bolts. All the bolts turned before the nuts cracked loose so I had to have a socket either side. That on the bolt head needs to be kept as square as possible and pushed onto the head as much as possible as the socket only fits on about half-way due to a step on the disc flange. When I knew I was going to do the same job on a pals car I got hold of a large bench vice which I was able to use to grip the disc while my pal pushed the socket/box-spanner (see below) onto the bolt head while I used a breaker bar on the socket.

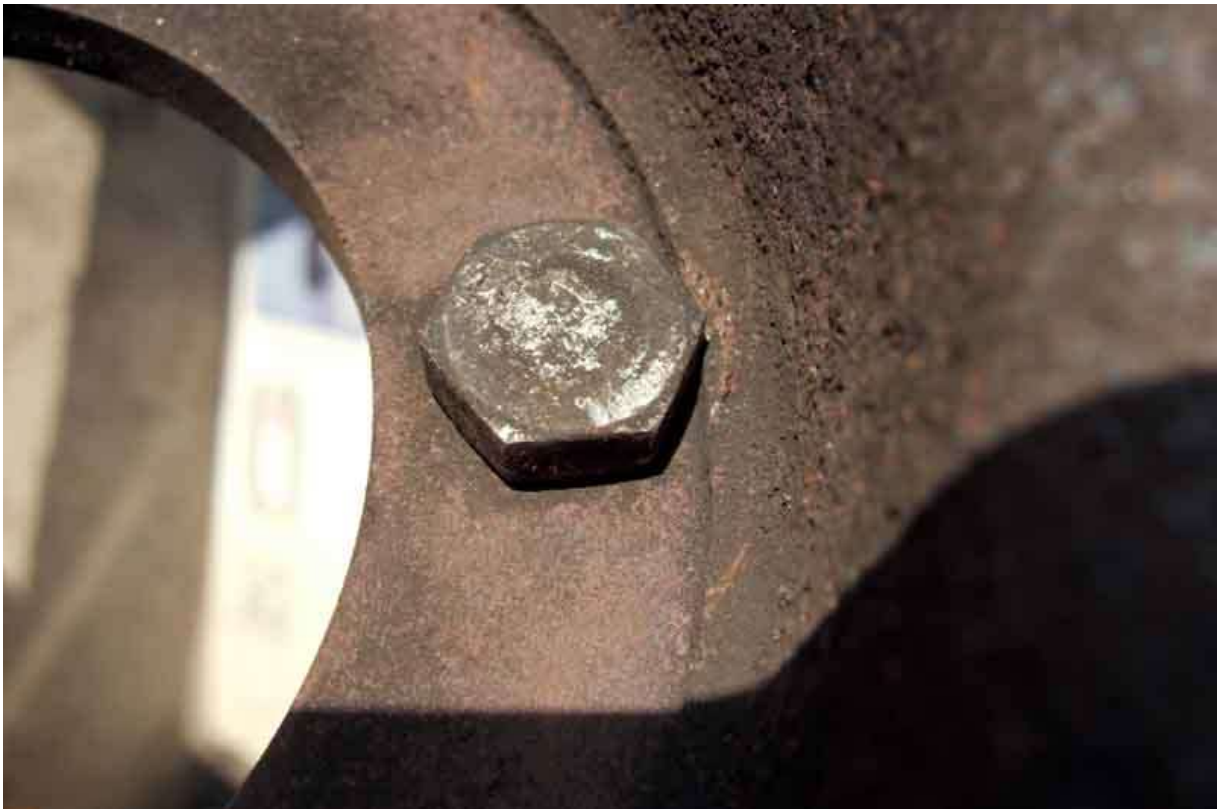
One of Bee's discs showing no clearance at all between the angle on the bolt head and the raised portion at the bottom of the well. This is a result of the flange being cast much thicker than it needs to be, so quite a lot of metal has been machined off, but not out to the wall of the well. This leaves a step on the flange which significantly reduces how far a socket can go on the head and also puts it an angle, making it very likely to slip off damaging the head in the process.

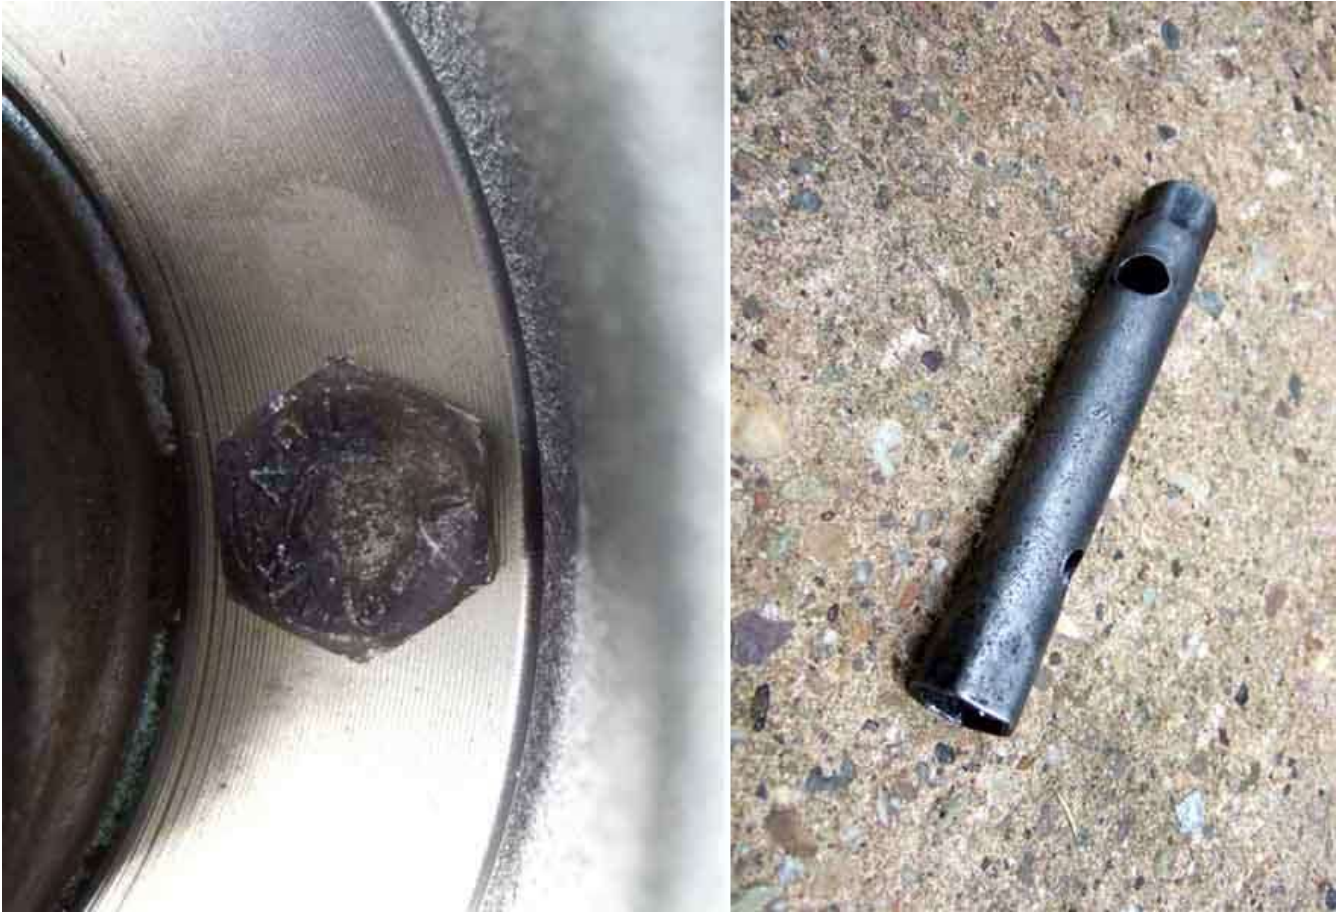
The new disc has a larger clearance, but still isn't enough for a socket to fully seat. However a box-spanner (inherited from my Dad, been in my toolbox unused for probably 40 years) did when the bolt head flat was aligned as shown, as the box-spanner is

only 0.747" across the flats externally whereas my sockets are 0.809" OD.

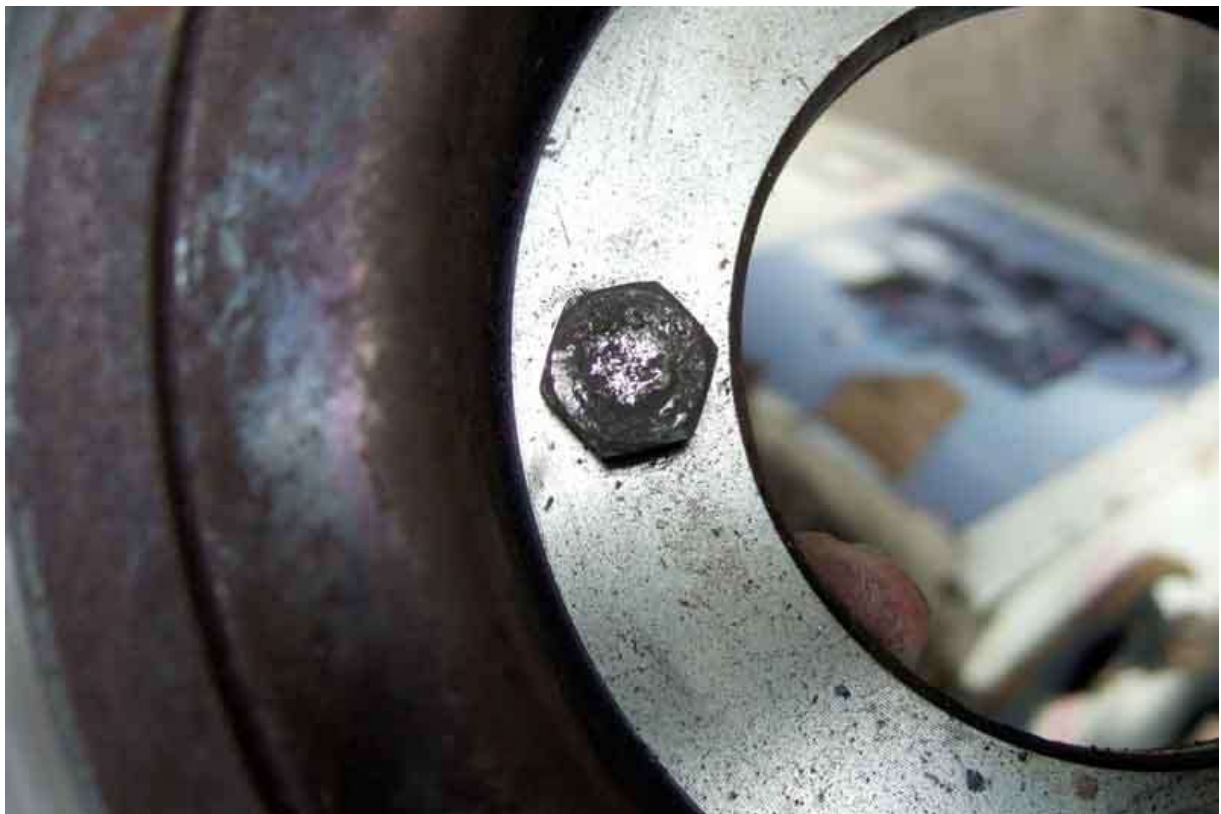
One of the old discs not much more than half the thickness of the new, the other is not so thin so probably has been replaced in the past.

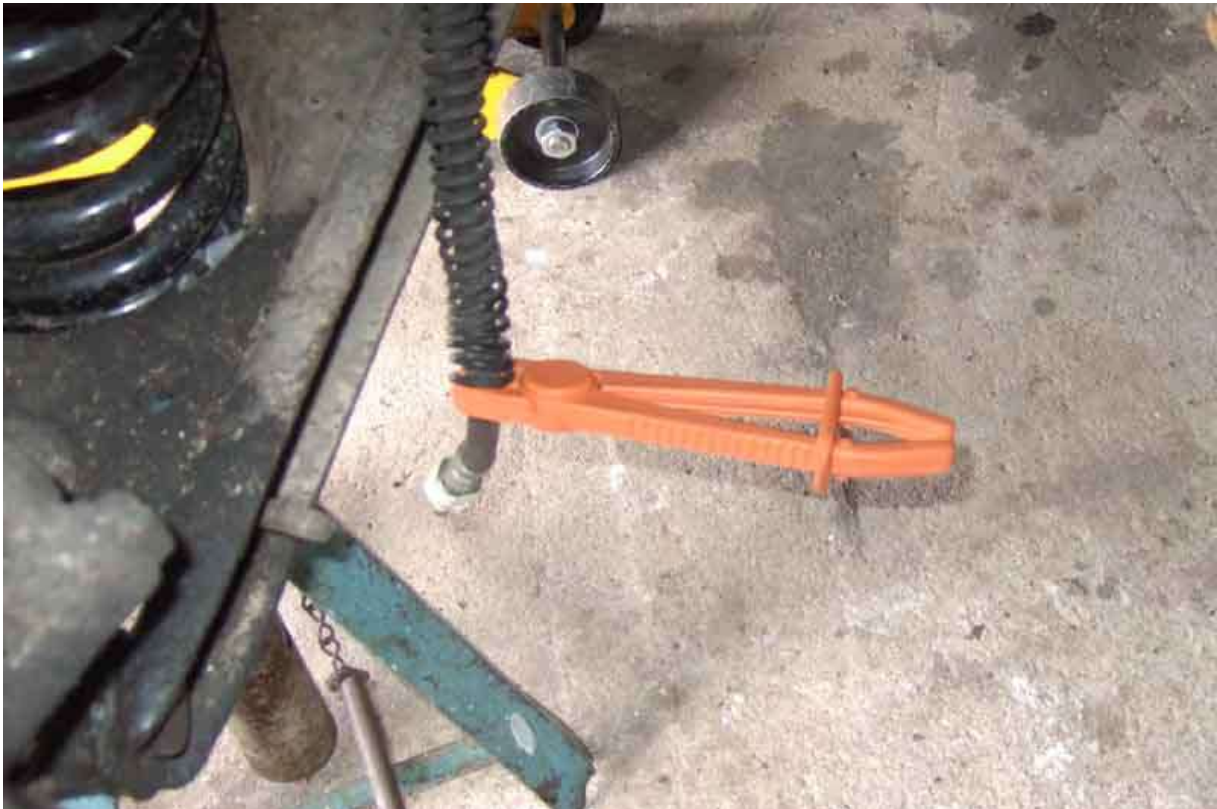
Hose clamp. Halfords had two, this was about a pound cheaper than the other, so got my vote. However they are only plastic whereas the others are steel. If they get brittle and break then they will have been poorer value. Also the part that grips the hose is 'V' shaped on these plastic clamps whereas it is 3/16" or so round bar on the metal ones which is probably less harmful to the hose.

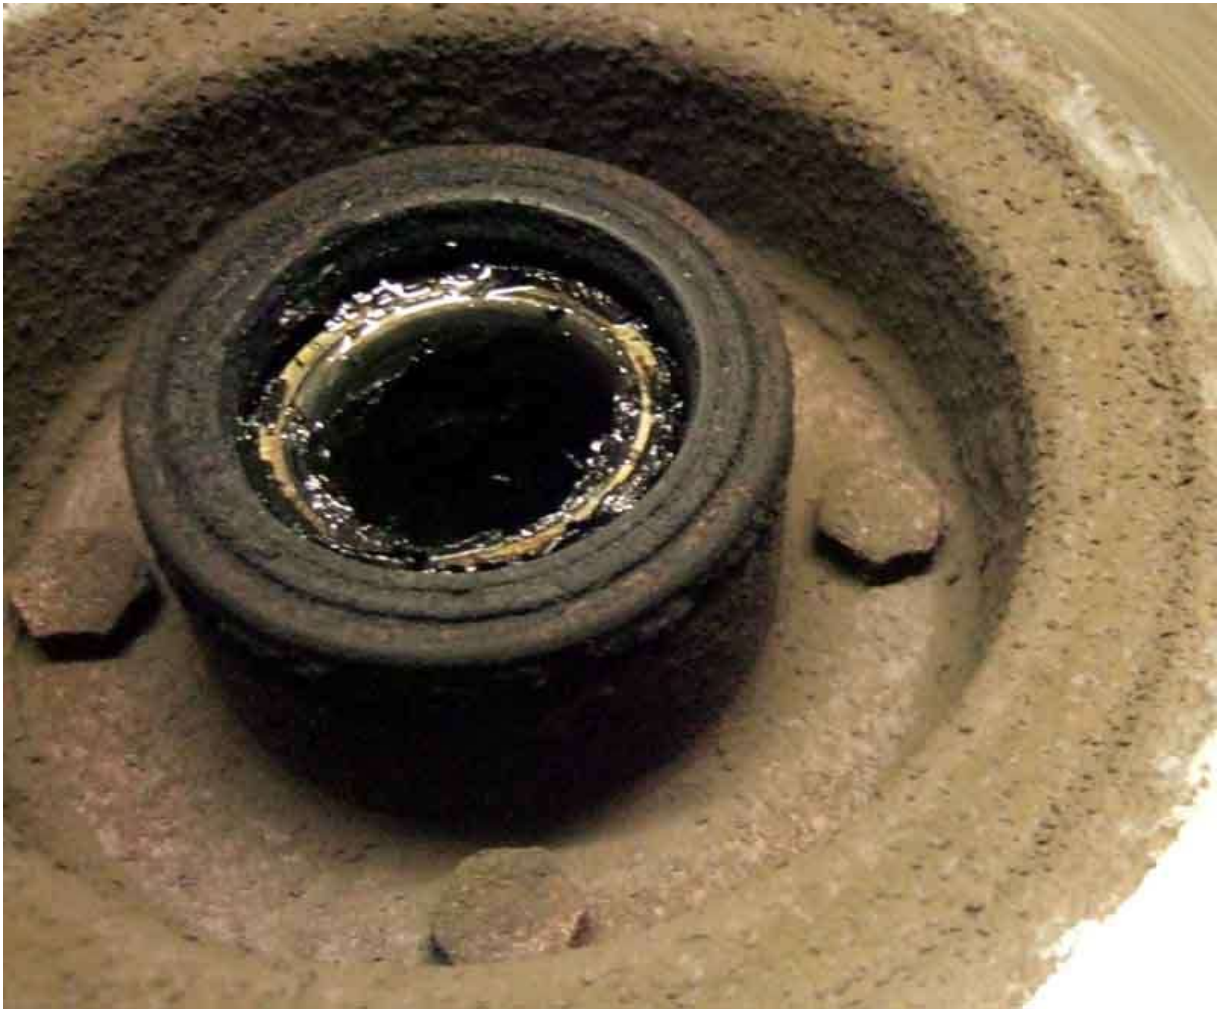
Vee's disc change. Old discs with very shallow machining and a good distance to the wall so a standard socket grips the head for removal.

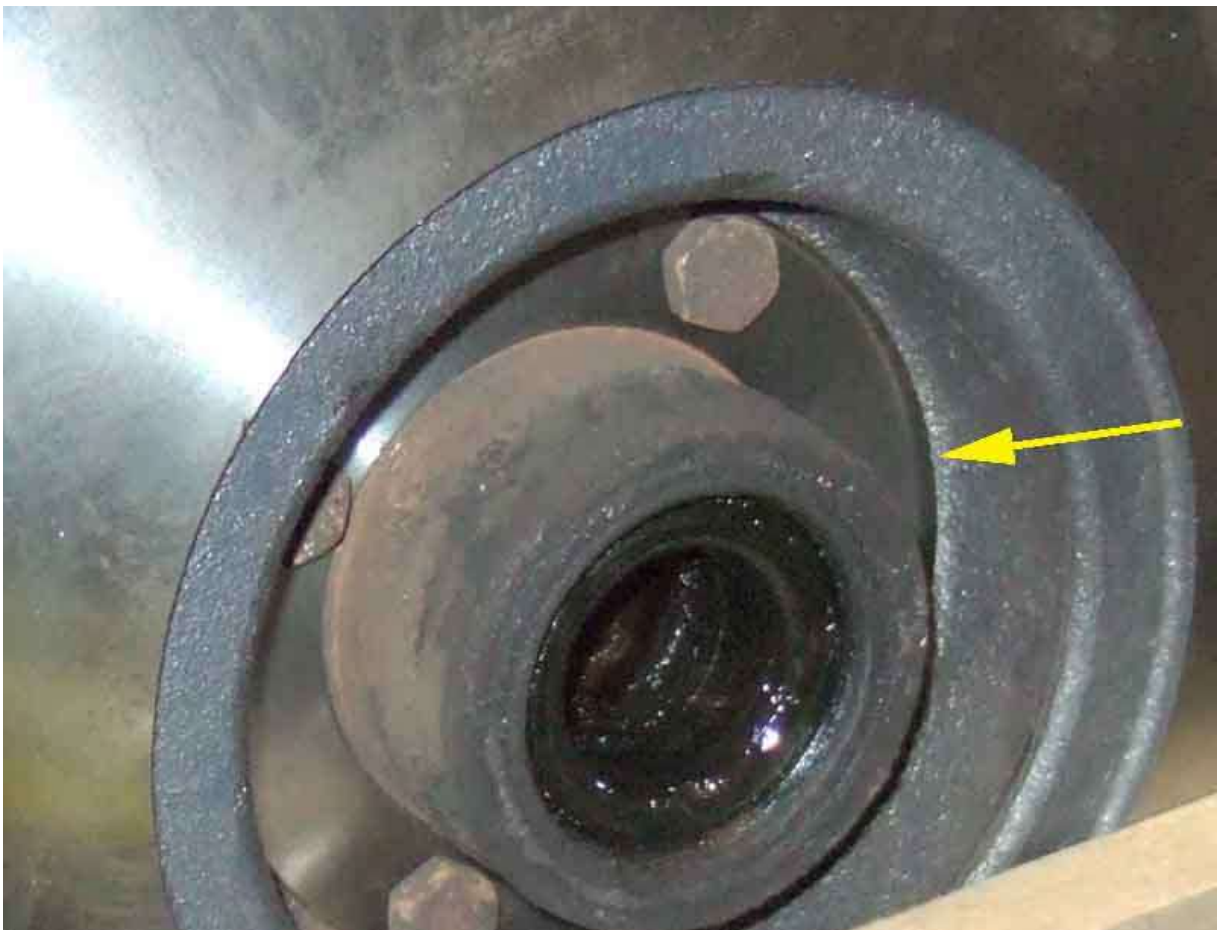
But the new discs have very deep machining, almost as deep as the head, with negligible clearance to the side of the bolt head so not even the box-spanner will go on, let alone a socket.

In the end I had to wedge the flat blade of a screwdriver in between a flat and the side of the machining. That gap was even narrower on the second disc, not enough space to grip the screwdriver as with the first one. The second one I tried was fractionally too thin and went round with the head, but finally an in-between size locked the head. A thick washer would raise the head enough to get a socket on, but would need a longer bolt to get the same number of threads protruding.

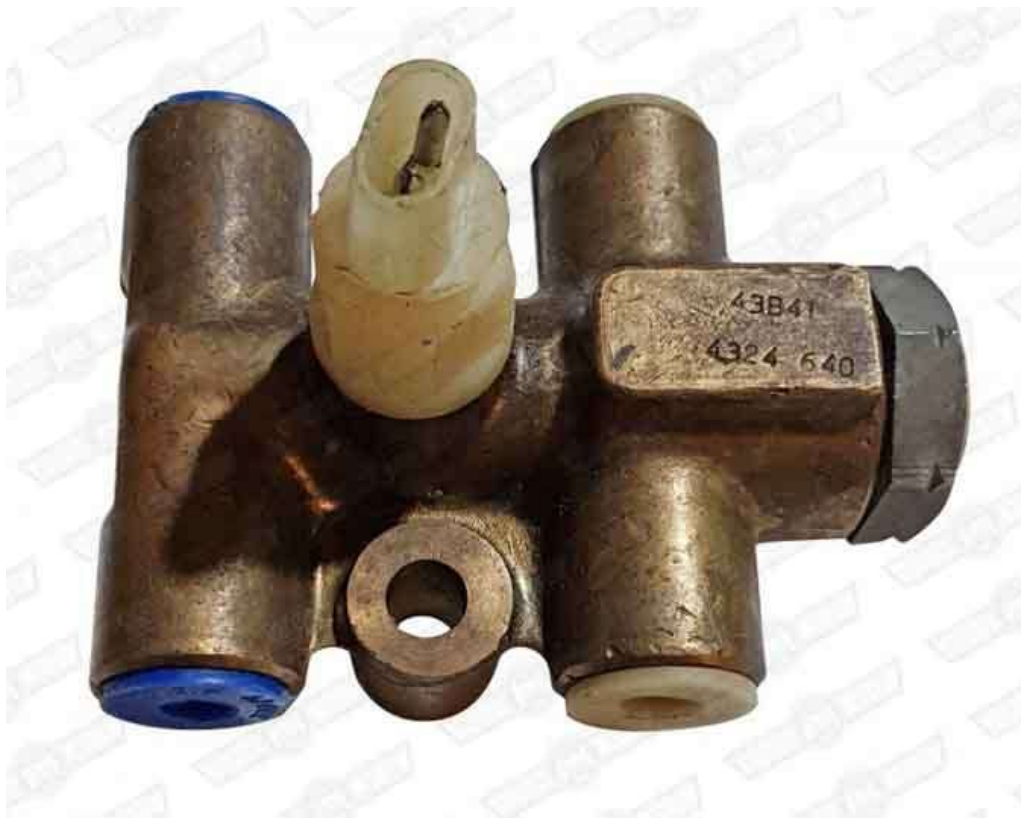
The remote pressure failure switch assembly 13H5905: ([Somerset Mini](#))

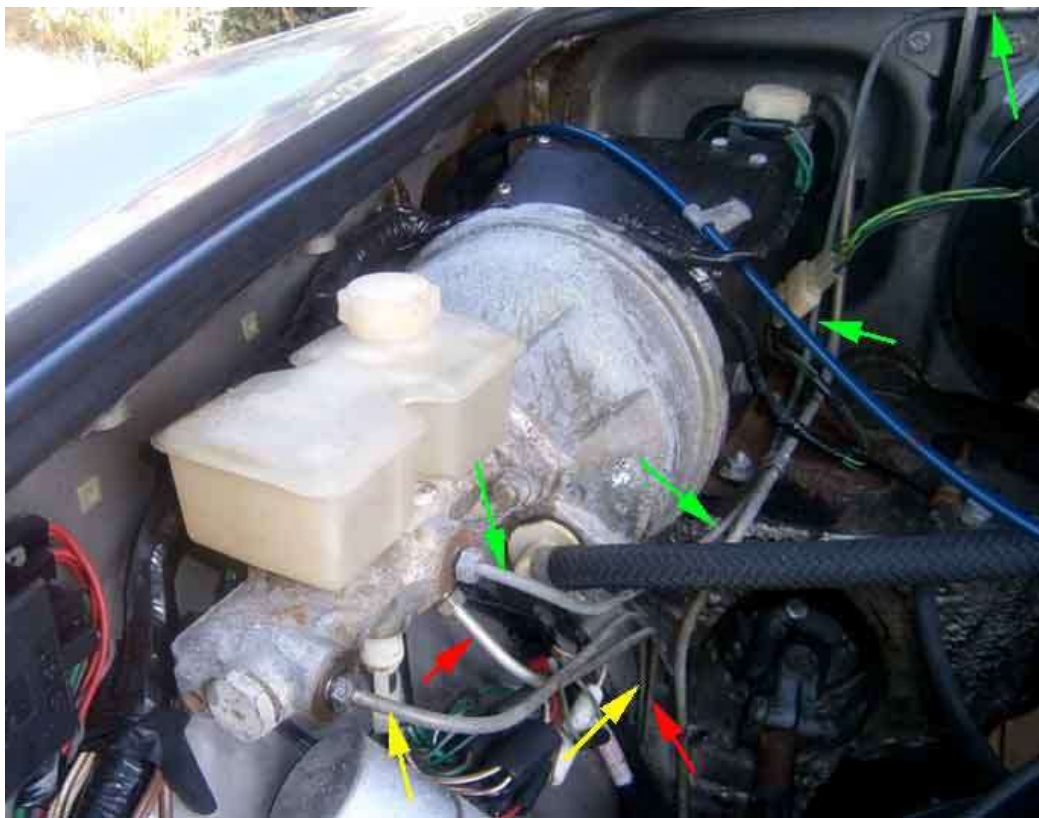
I subsequently obtained copies of both the 1978 Repair Operation Manual AKM4070 and the 1977 LHD Workshop Manual AKD3524 section on master cylinder removal which has the same drawing and description. These drawings indicate two of the pipes going up and one down. Indications such as this can't be taken as gospel, although one should be able to believe the words and the labelling are correct. Clausager shows an RHD with this braking system with one pipe going up and two down, which would be logical, with the one going across to the left-hand caliper and the other two going down to the right-hand caliper and the rear, without being able to tell which is which. Clausager doesn't show how the left-hand caliper pipe goes across but this picture does - over the heater (which is how rubber bumper remote servo pipes were routed):

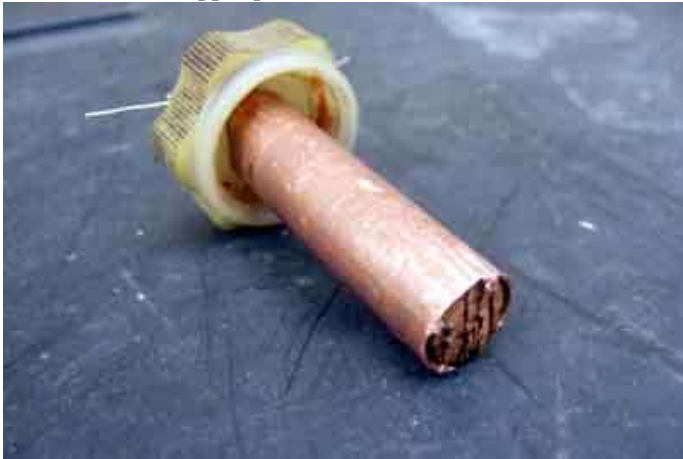
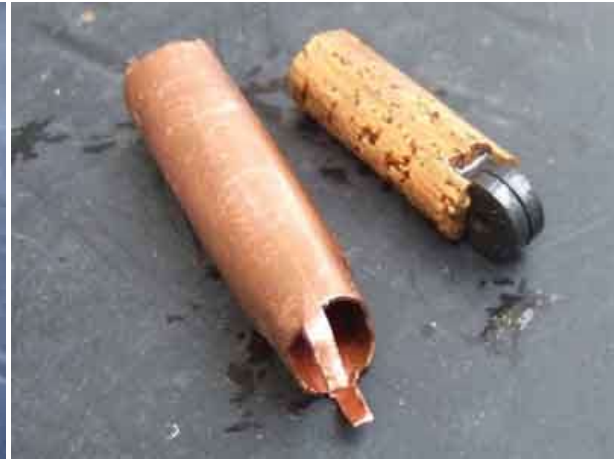
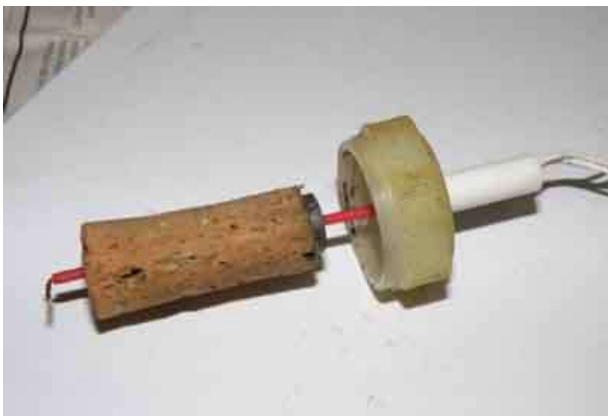
But researching magnets I came across very small ring magnets, which were worth a punt. However with the reed contact lying across the underside of the cap, the magnet rings had to be on their sides to operate the contact, which meant I couldn't have a hole up the middle and a spindle. I tried them inside a copper guide tube attached to the cap, but it stuck even more, and I didn't like the idea of copper parts in the fluid.

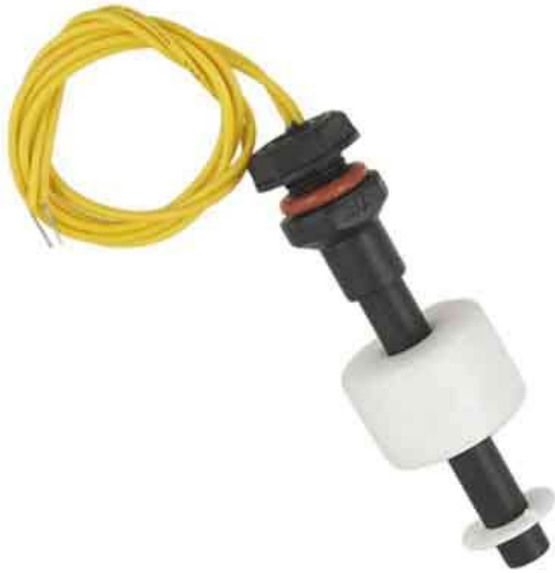
More research into float switches came up with a commercial product that looked to solve both problems. These have a polypropylene foam float containing a ring magnet, that slides on a spindle that contains a reed contact. Furthermore by turning the float over, you can arrange for the contact to close when the float drops, or to open when the float drops - this latter being just what I wanted. If that wasn't enough they have a thread, sealing ring and plastic nut at the top end where the wires come out which will be ideal for securing it to the master cap. There were various offerings from a couple of suppliers, with different dimensions, the most important being the float diameter, as it has to fit through the filler neck. Float diameters were either 15mm or 19mm, and checking my masters they varied between 17 and 19mm. The length is also a factor, there is 56mm available from the top of the neck to the metal plate over the cylinder inside the reservoir. But for the items on sale only overall lengths were given at 72mm and 44mm respectively. And although the overall length included the mounting flange and thread, I couldn't be sure if the longer one (which had the narrower float) would fit. So I ordered the shorter one, very cheap and free P&P even though it comes from China, but it does mean a wait for them.

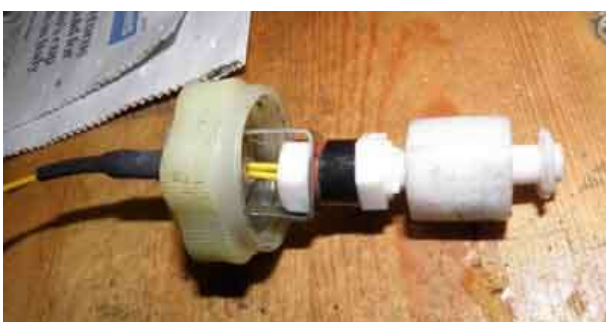
I've got two choices - I can either fit the threaded part of the spindle up through the main part of the cap and have the nut under the top cap, or I can fit the spindle down through the main part of the cap, and have the threaded part going through the top cap and the nut above that. Unfortunately not so easy, having set the float correctly so that it opens the reed contact when fluid level falls, I find that not even the lower position i.e. with the nut inside the two halves of the cap, does the float rise high enough to close the contact.

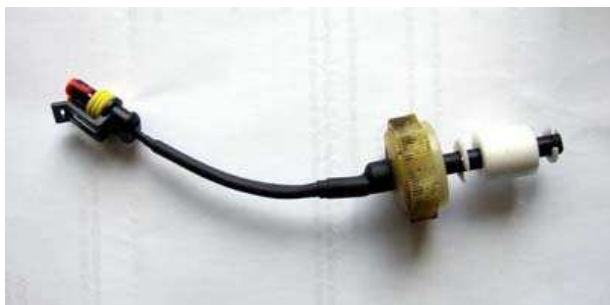
I pondered spacers and brackets to position this short switch lower down, and a pal did opt for that method. However it does mean that as you unscrew the cap the switch and the wiring from it twists as well.

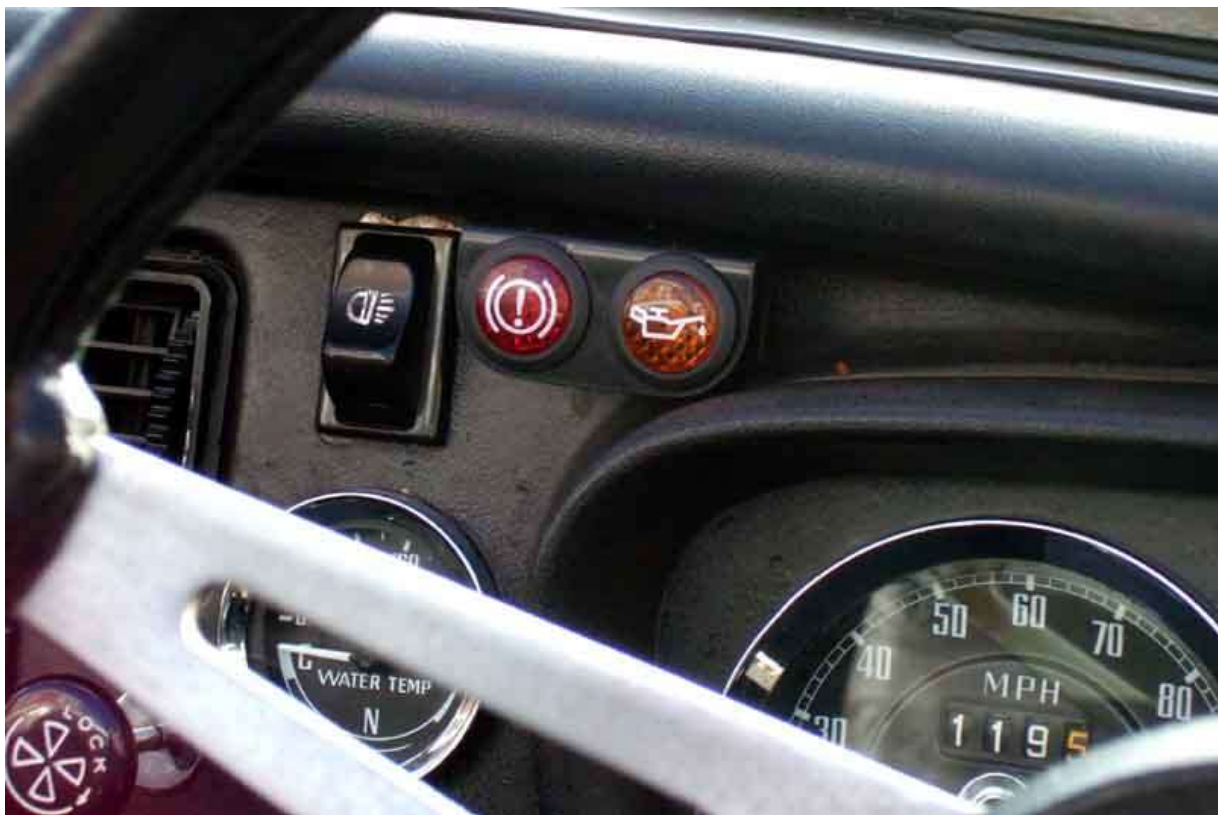
After-market warning lights modified with superbright LEDs: Visible from the driving seat, off ...

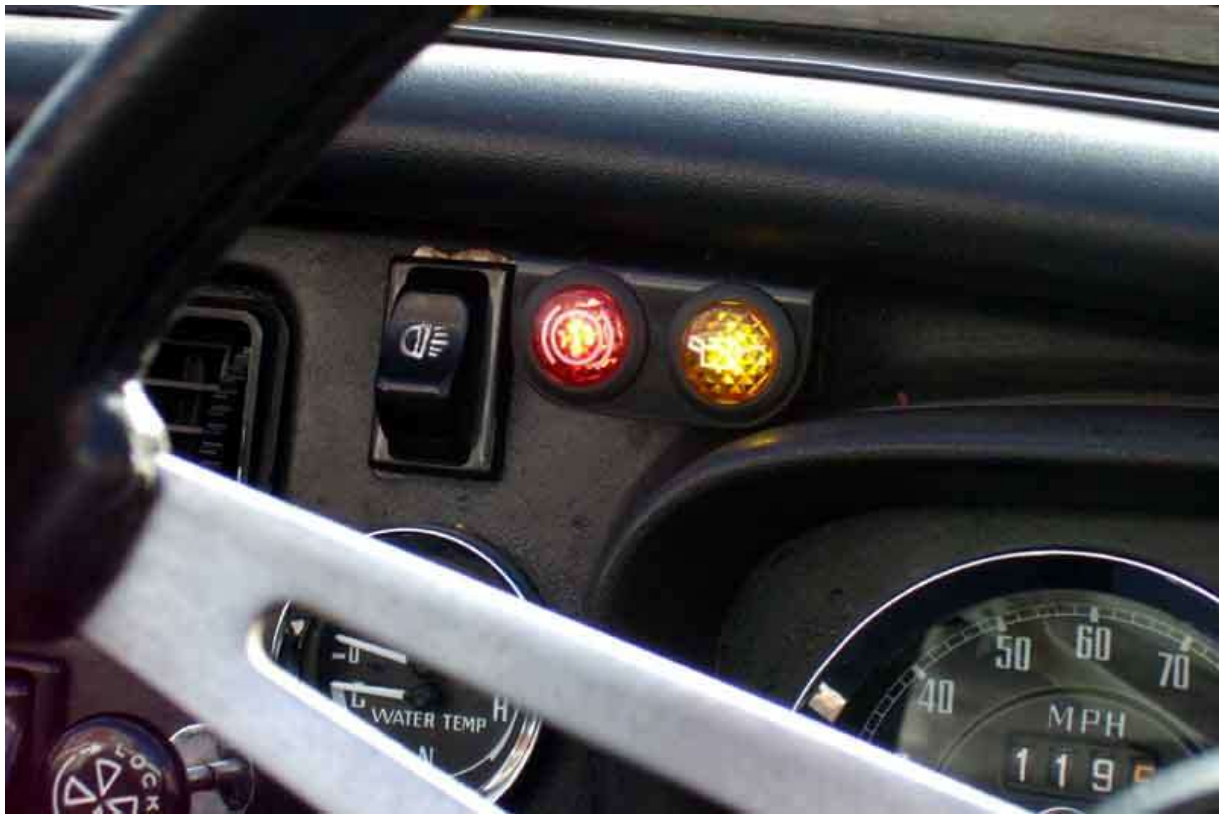
... and on in bright but not direct sunlight.

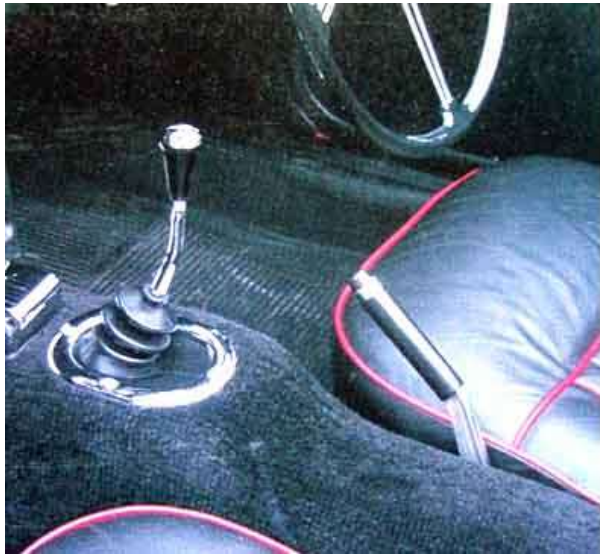
'Short' on a 64 (Mk1) and 'long' on a 68 (Mk2), changing at chassis number 115596 in March 67: (Clausager)

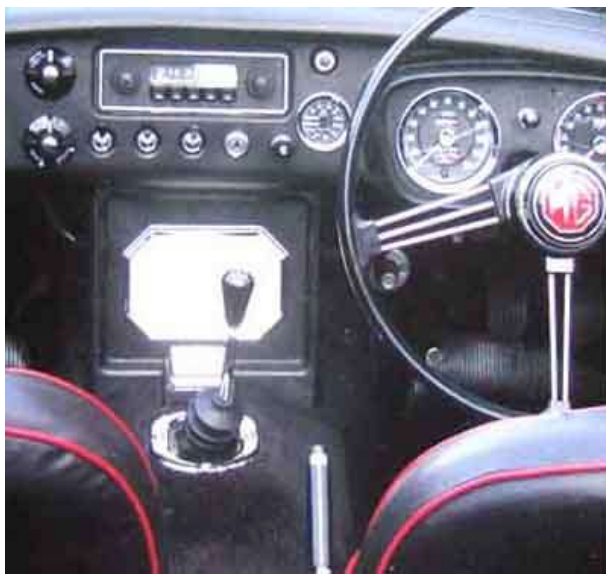
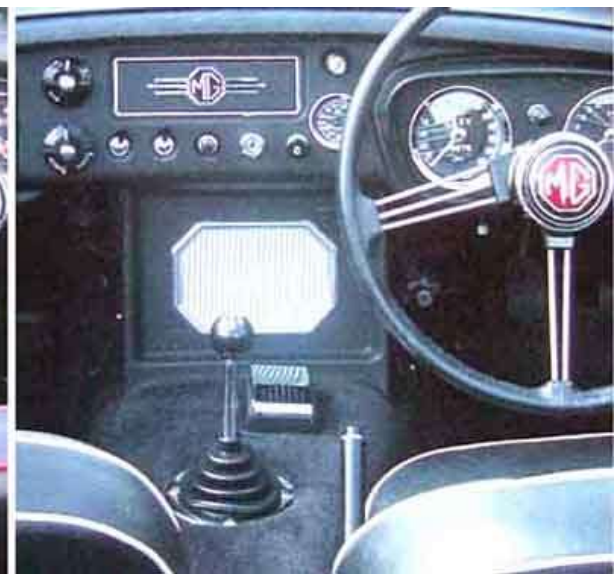
A 64 (Mk1) and a 68 (Mk2) both pointing pretty-well straight forward: (Clausager)

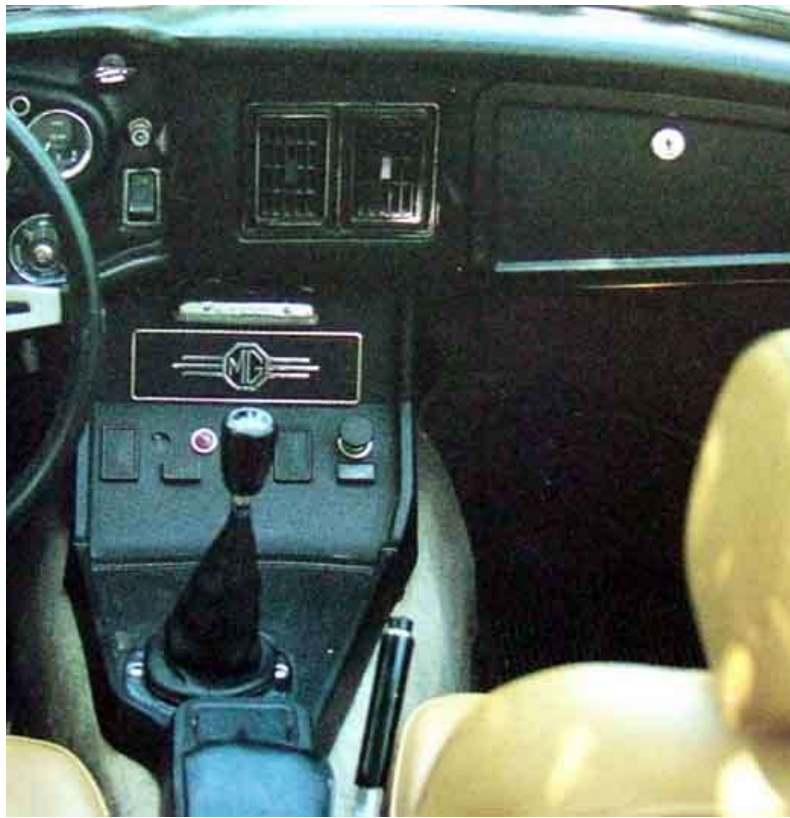
A 73 cranked to the right to clear the tunnel console, changing at chassis number 258001 for the 1972 model year, albeit on an LHD: (Clausager)

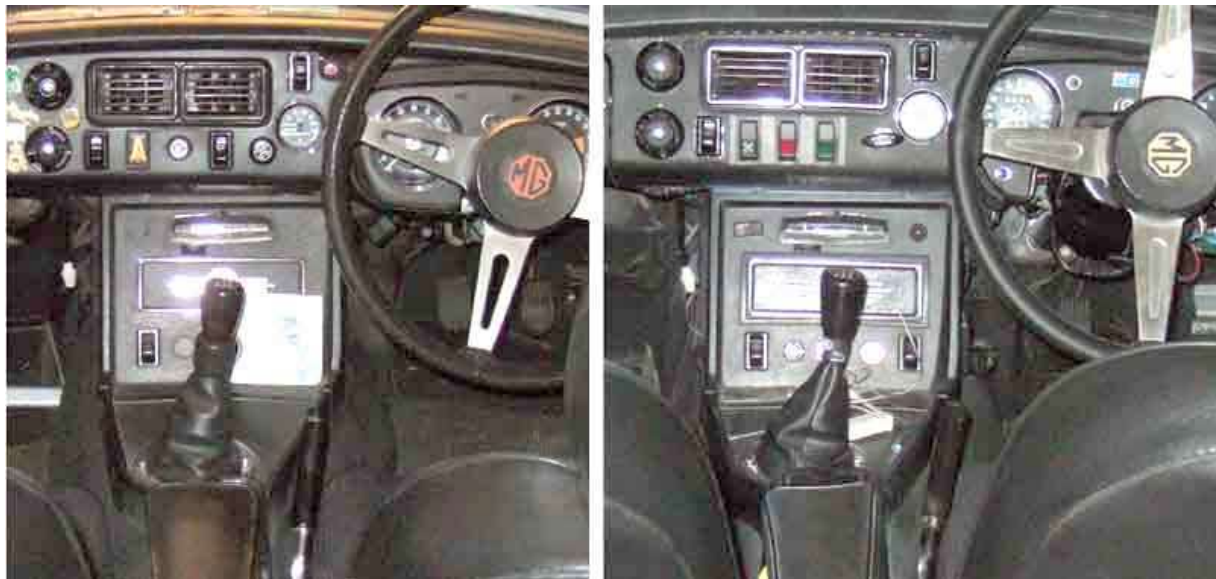
Bee (73) and Vee (75) both cranked to the right, albeit Vee's more noticeable:
