EeziBleed

Dual Brake Masters

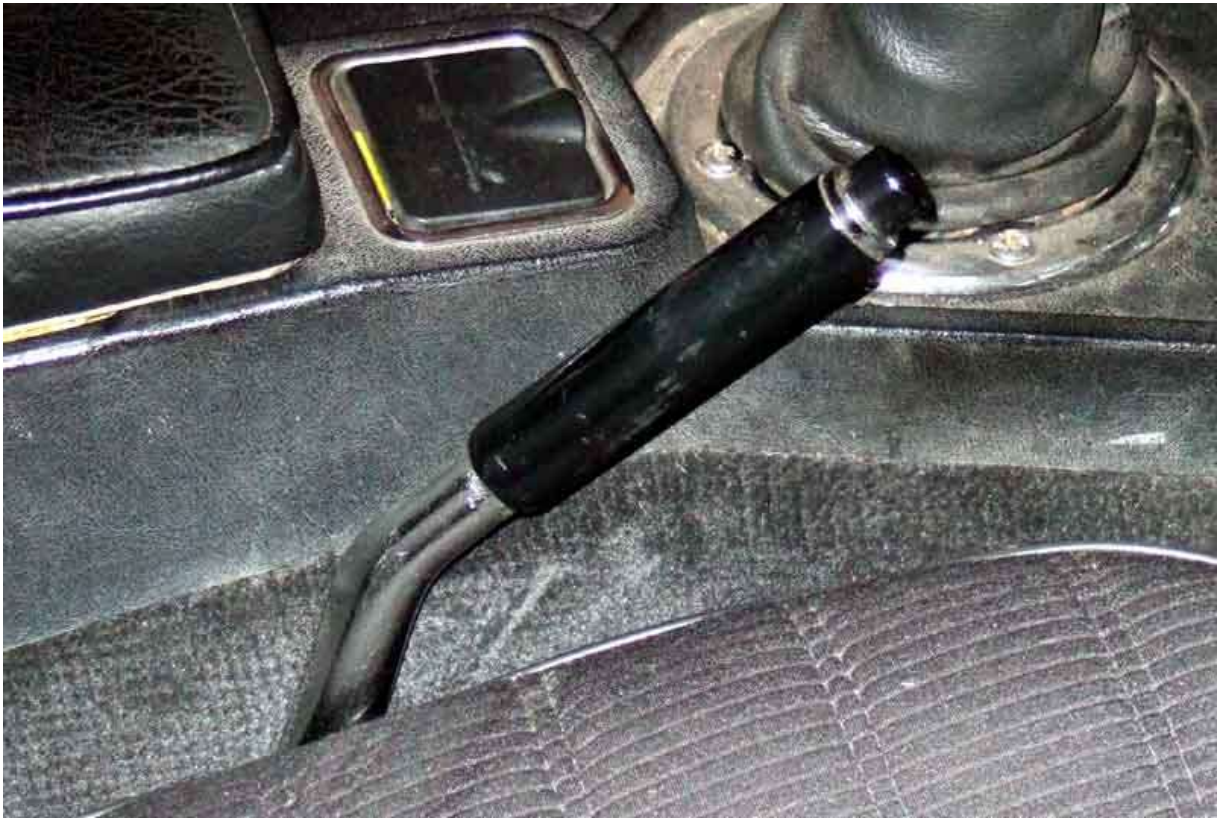
Bee's CB 'long' chrome lever measuring about 13.75":

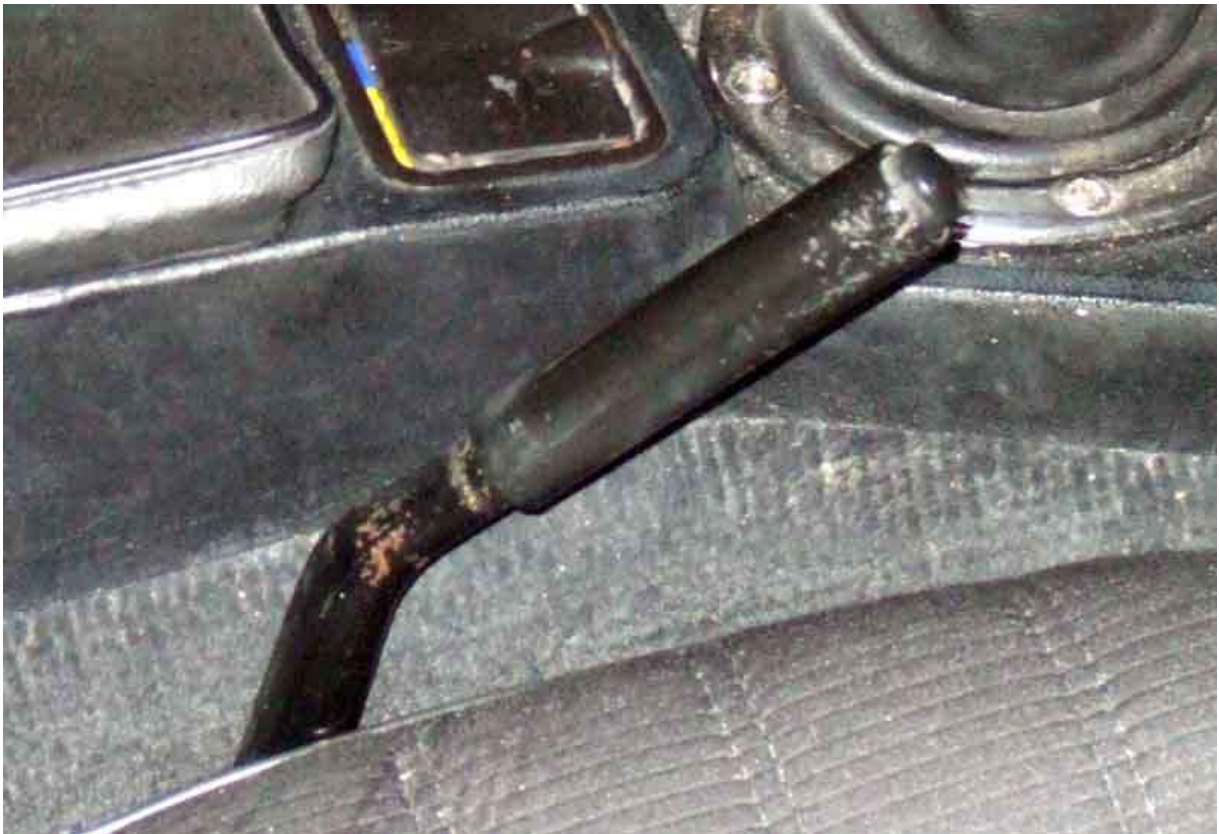
Vee's RB 'long' lever painted black instead of chrome-plated. It appears the grip is longer covering what was the chrome trim ring just under the button of Bee's. Maybe the grip has slid up the tube a bit, but it doesn't interfere with the button:

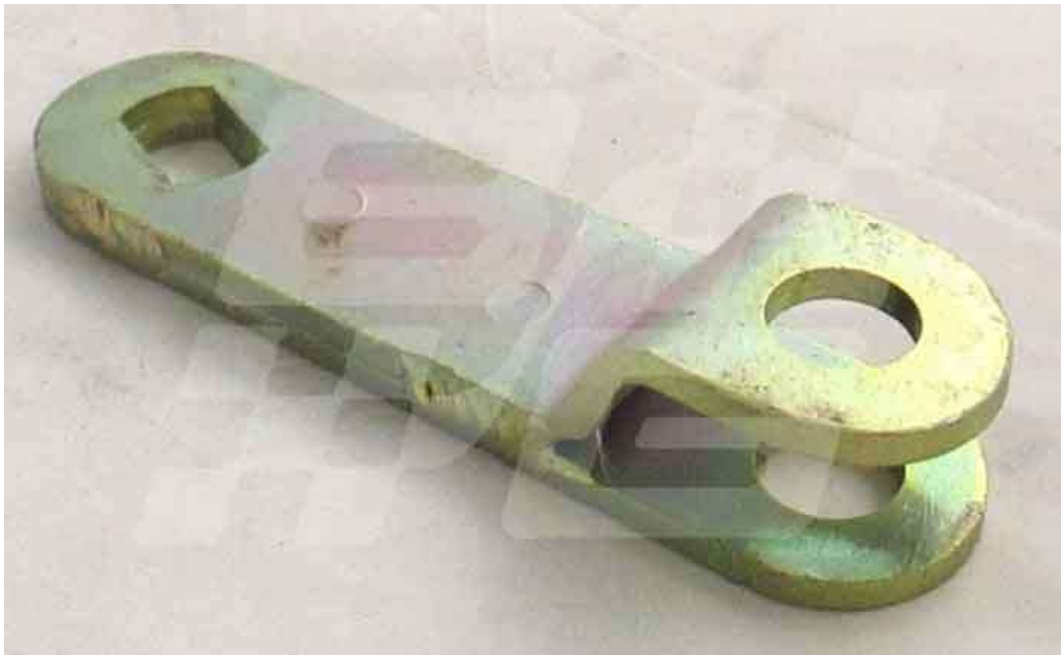
The handbrake assembly has a lever (BHH1469) in the tunnel that is similar to the compensation lever on the diff casing, but the two halves are welded together: ([Brown & Gammons](#))

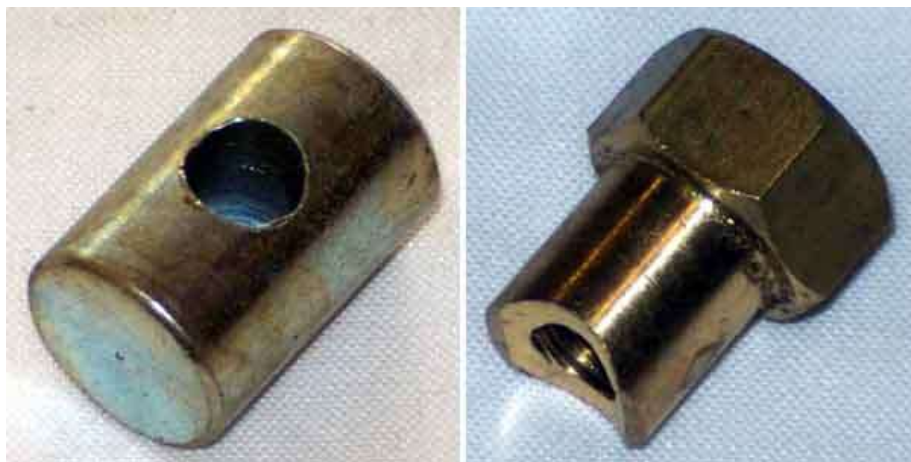
Trunnion AHH5322 (left) and brass adjuster nut ACH5104: ([Motaclan/Leacy](#))

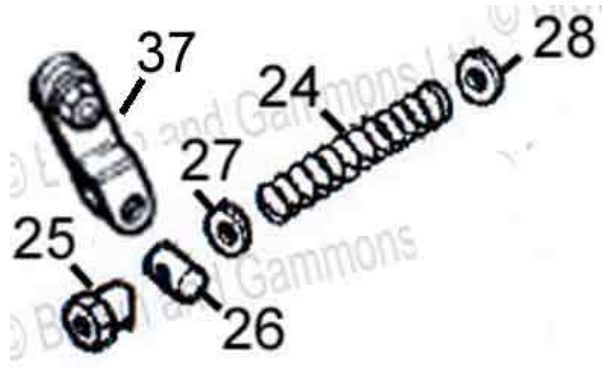
The trunnion (26) fits in the two holes of the handbrake lever (37) (it can fall out when removing or refitting the cable and roll some distance!), the threaded section of the cable fitted with a 1/4" x 3/4" washer (28), an expanded spring (24) and another washer (27) is passed through the fitted trunnion, and finally the adjuster nut (25) is screwed on: ([Brown & Gammons](#))

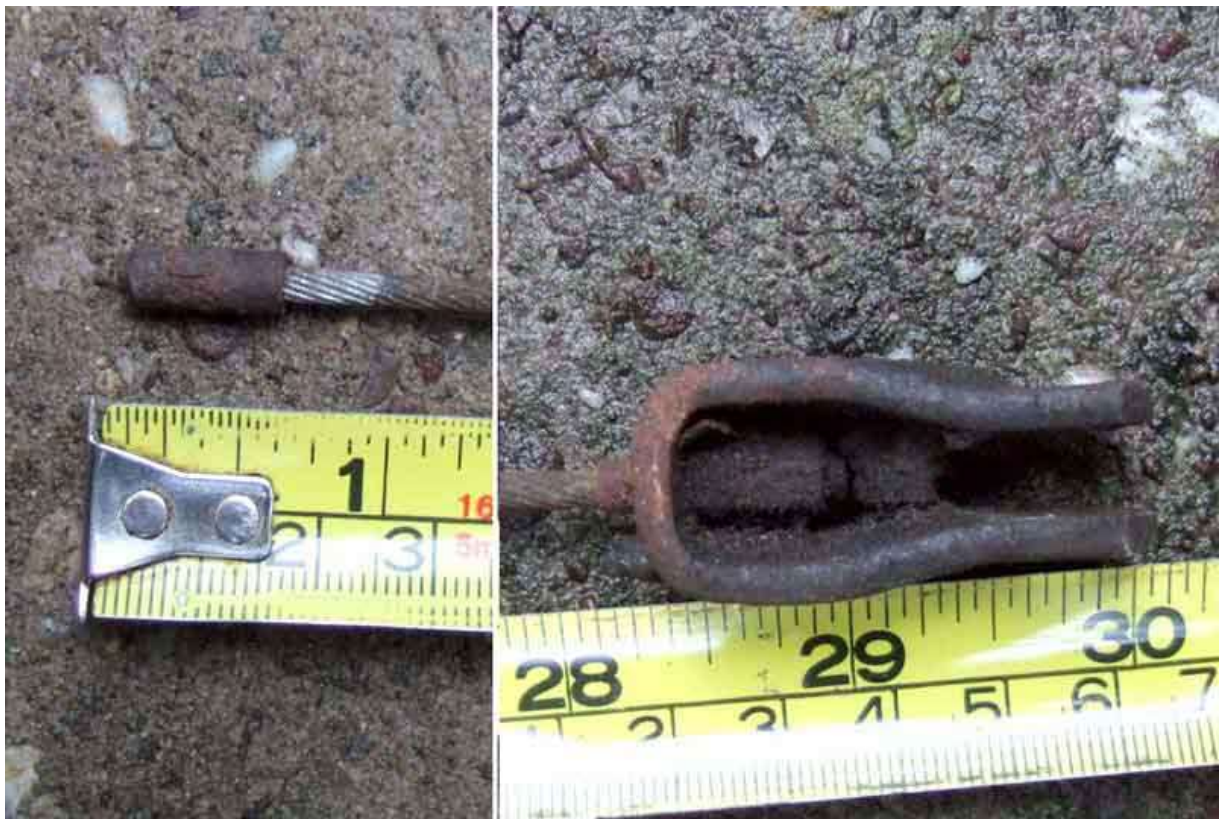
An old stud-wheel cable measuring 30" from the tip of the nipple in the short cable at the compensation lever end, to the tip of the U-clip that attaches to the lever sticking out from the back-plate. A new, almost certainly wire-wheel axle cable measures 28.5" here.

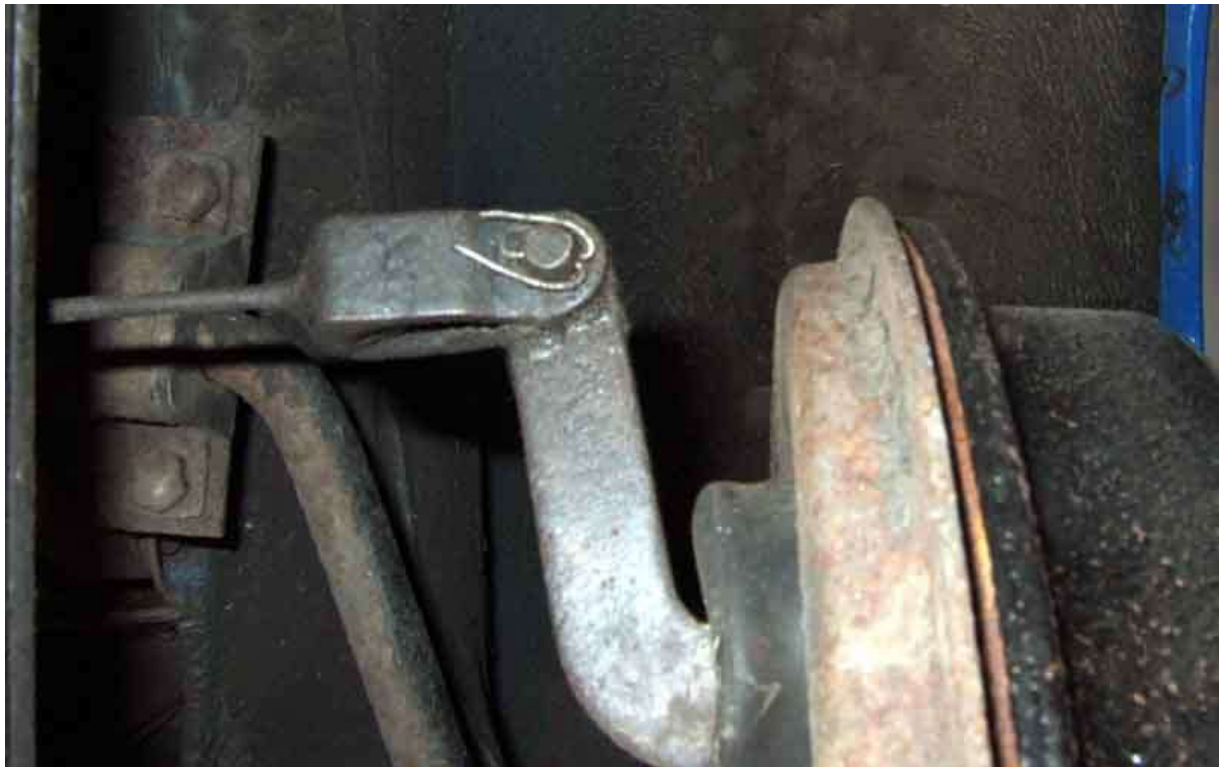
Clearance to wheel weights: The cable and lever should not project past the edge of the brake drum:

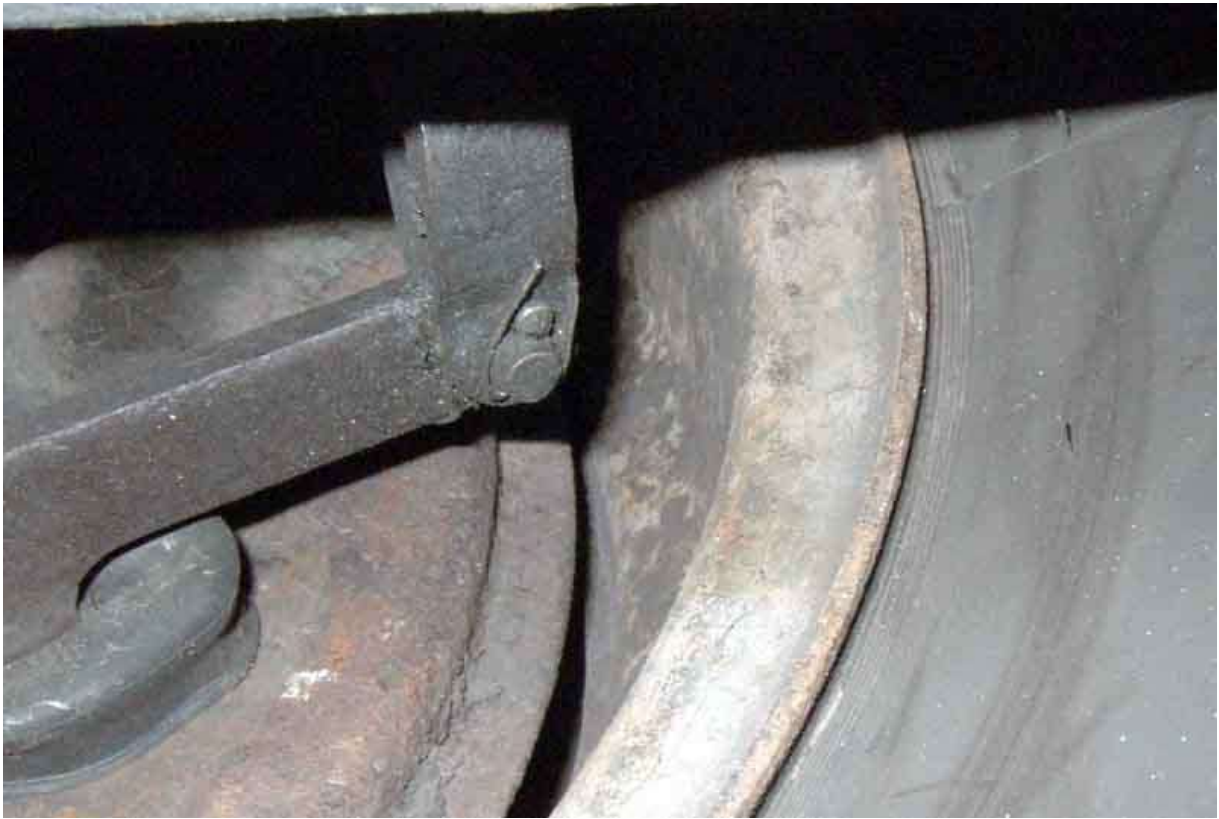
Leaving plenty of clearance - at least 1/2" - for stick-on wheel weights:

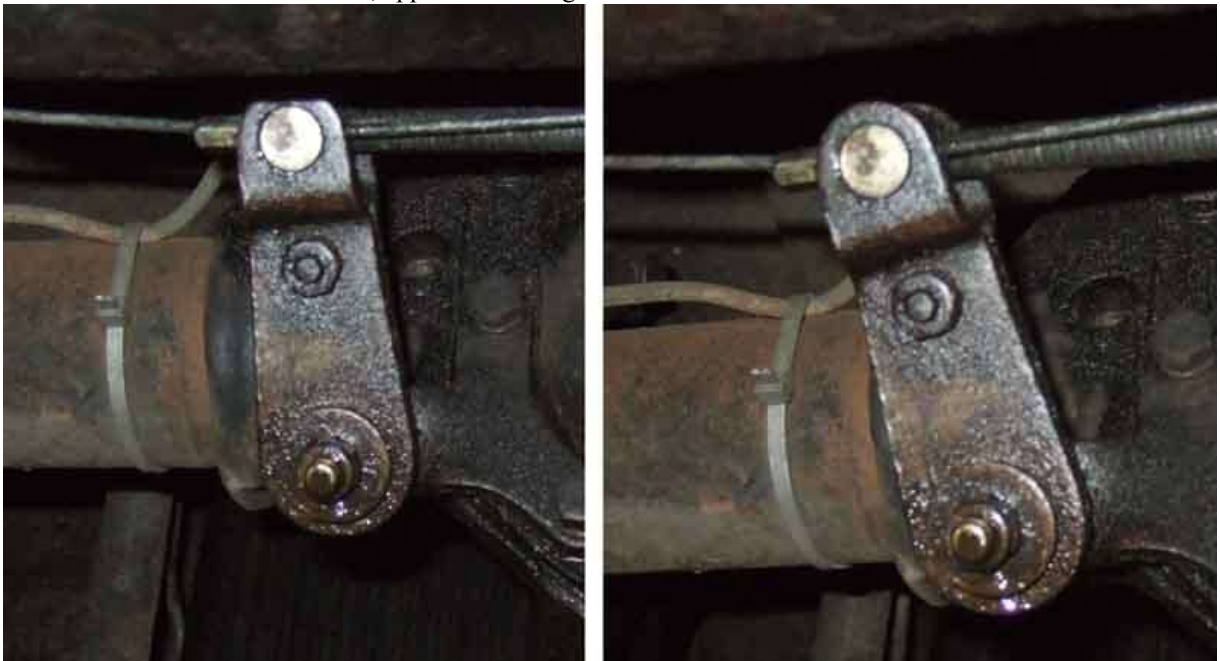
Compensator prior to 1977:

Orientation on Bee - released on the left, applied on the right:

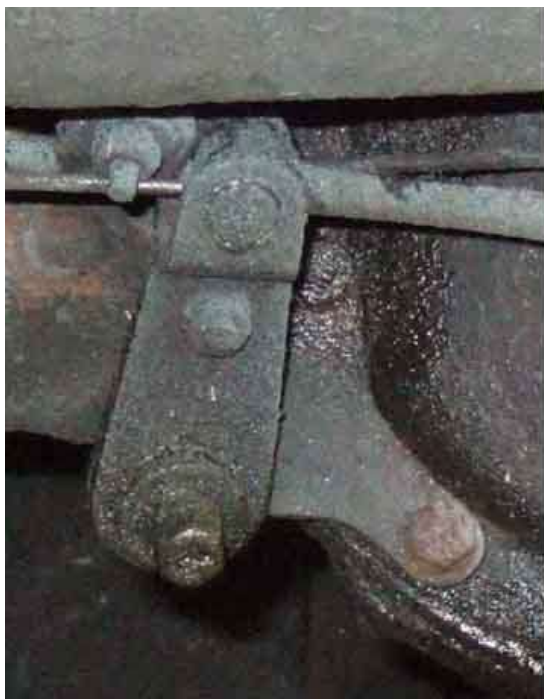
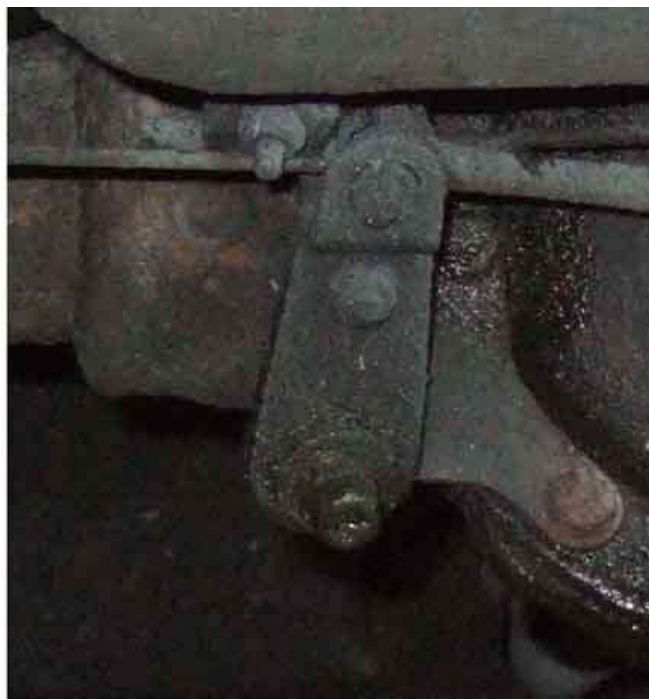
See ditto, with shortener hence the compensator points more towards the off-side ... somewhat muckier than when first fitted:

Decades later and I've just noticed that Vee's cable trunion is the other way round to Bee's, putting the end of the outer away from the viewer on Bee and towards the viewer on Vee - I've changed both at various times. Pictures elsewhere show it both ways, but as Vee it allows the outer to drop away from the short cable as it goes under axle, whereas the other way round they can rub together.

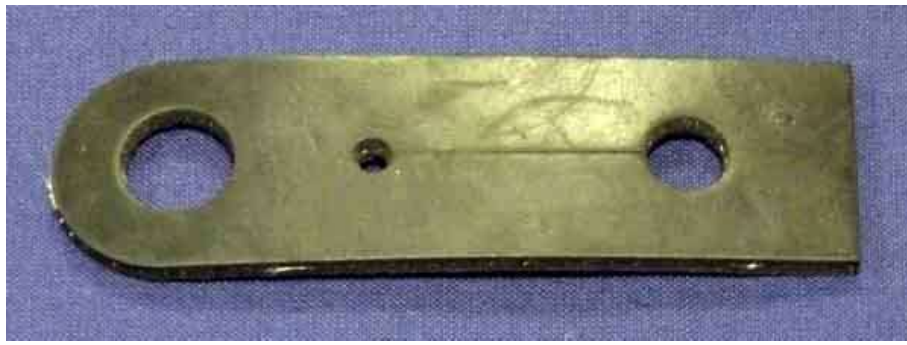
The strap has a cut from the middle-sized hole for the cable towards the large hole for the fixing bolt, ending at a small hole, and this slot should enable the cabin lever end of the cable with the tunnel stud on the outer to be passed through for retrospective fitting. However that does need the cable to be disconnected from the cabin lever and tunnel, and the support under the battery box, to fit from that end: *Motaclan/Leacy*

November 2016: It was only when someone asked a question about an additional support for this cable that I realised something is missing from my pal's car. There should be a rubber strap (BHH2136) through which the cable passes, attached to the diff cover bolt to the right of the level/filler plug in the above image, and indeed there does seem to be the spacer and remains of the strap under the bolt (arrowed). The [Moss Europe image](#) below shows how it is used (item 59). This strap deteriorates rapidly and apart from the bit under the bolt and washer may well vanish. Lack of it does not affect handbrake operation, but may allow the cable to rattle against the axle.

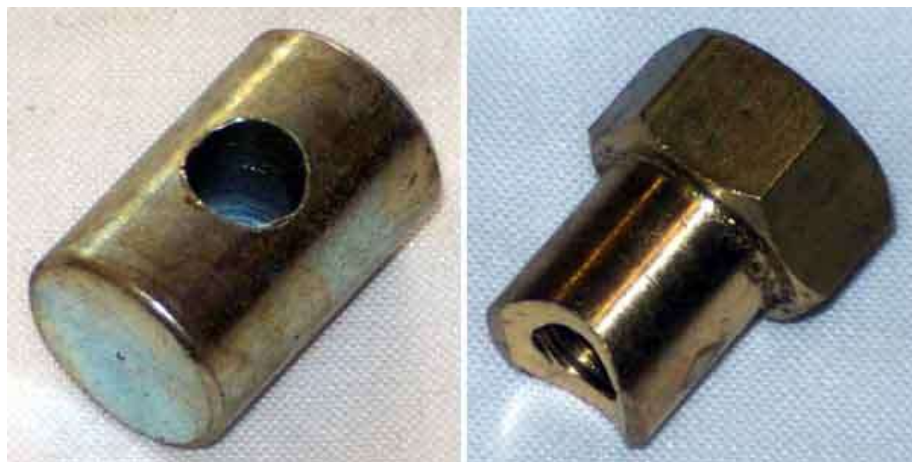
Trunnion AHH5322 (left) and brass adjuster nut ACH5104: ([Motaclan/Leacy](#))

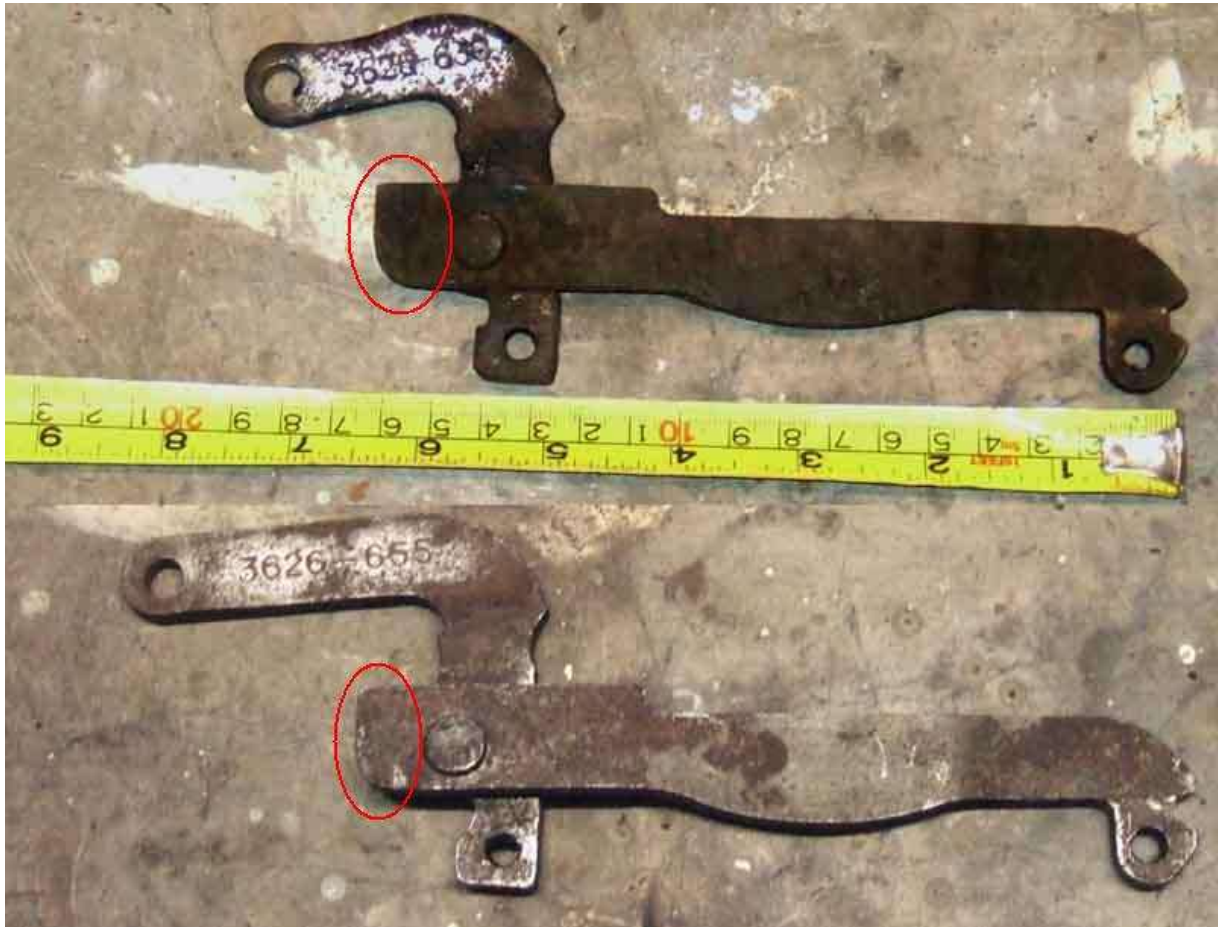
Early lever (top) with the short lever with a curved profile, and about 1" shorter than the later lever. Other than that the long lever has exactly the same profile on both types (note extension circled) ...

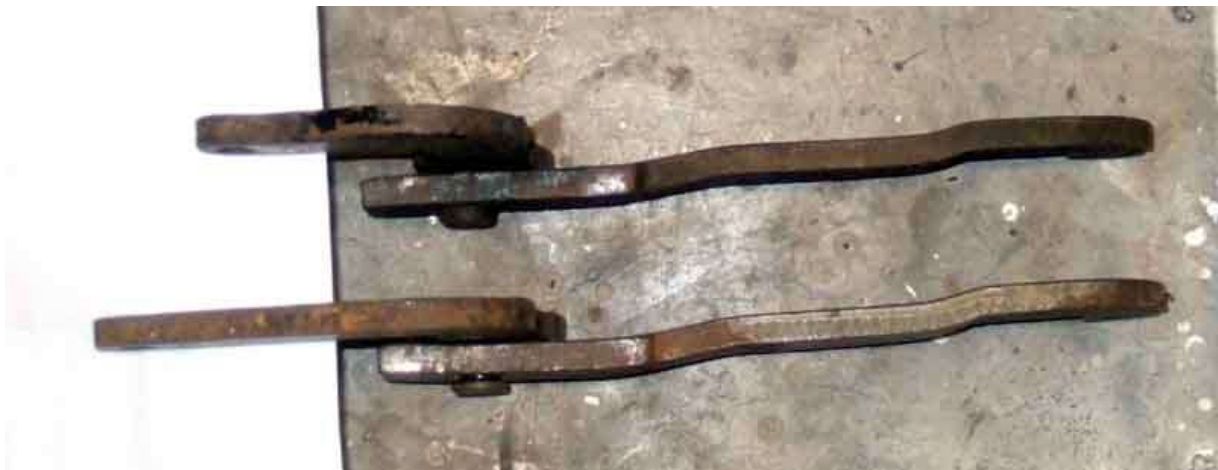
... and the same bends.

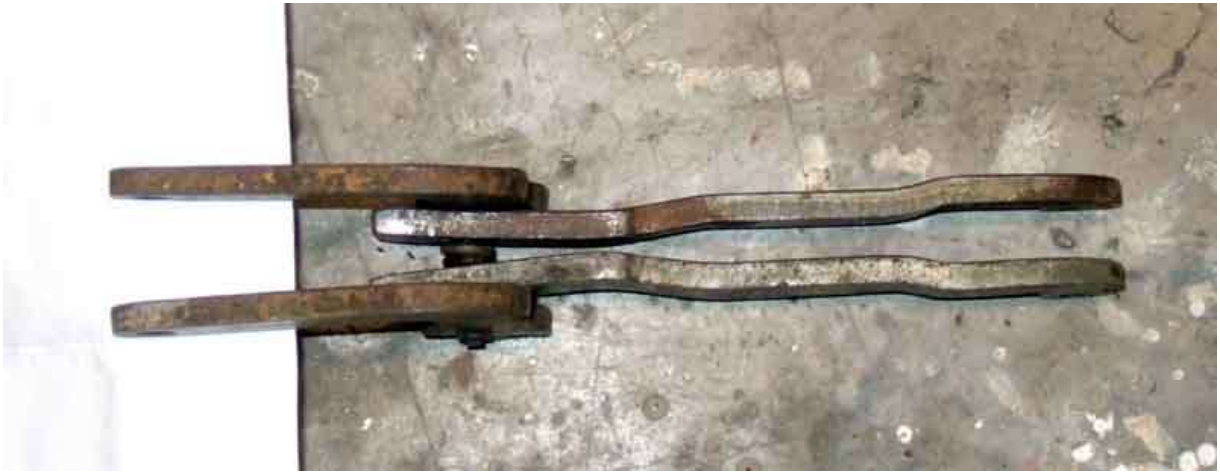
A pair of the same type have mirror-image bending of the long levers ...

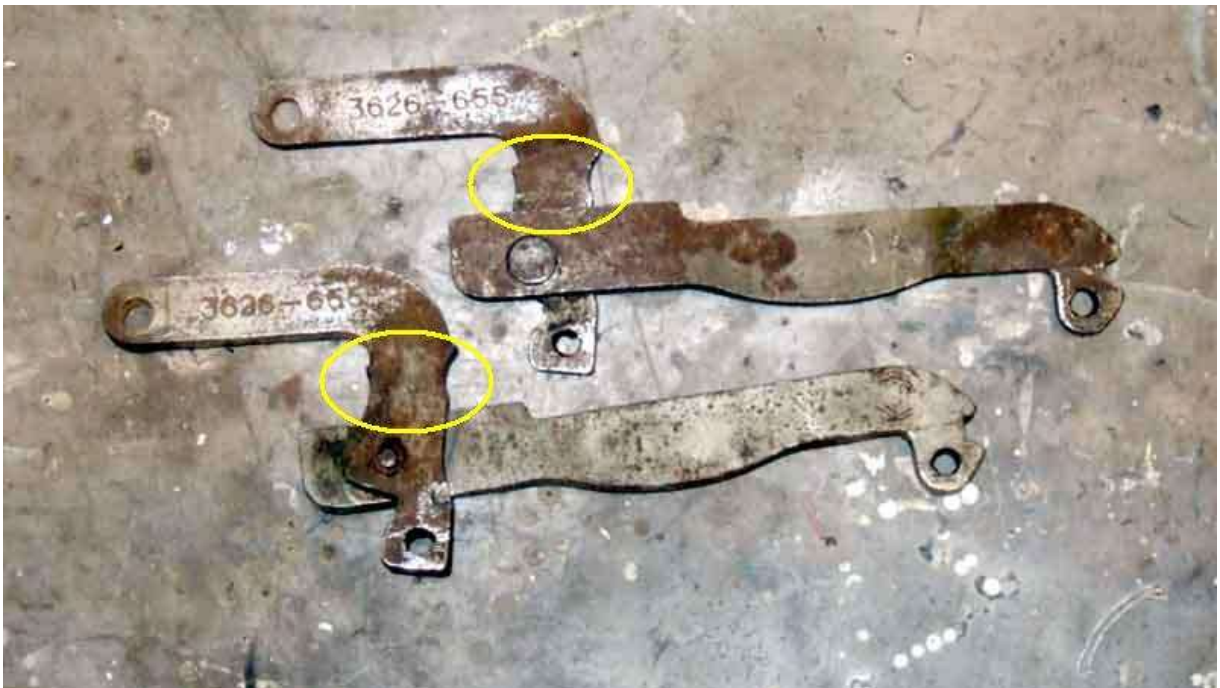
... but identical short levers, they are just fitted to the other side of the long lever. That is why the numbers stamped into the short levers are the same for both sides, and when installed one faces up and the other down. (Circled is the waisted section where the slot in the rubber boot is pushed down to when fitted).

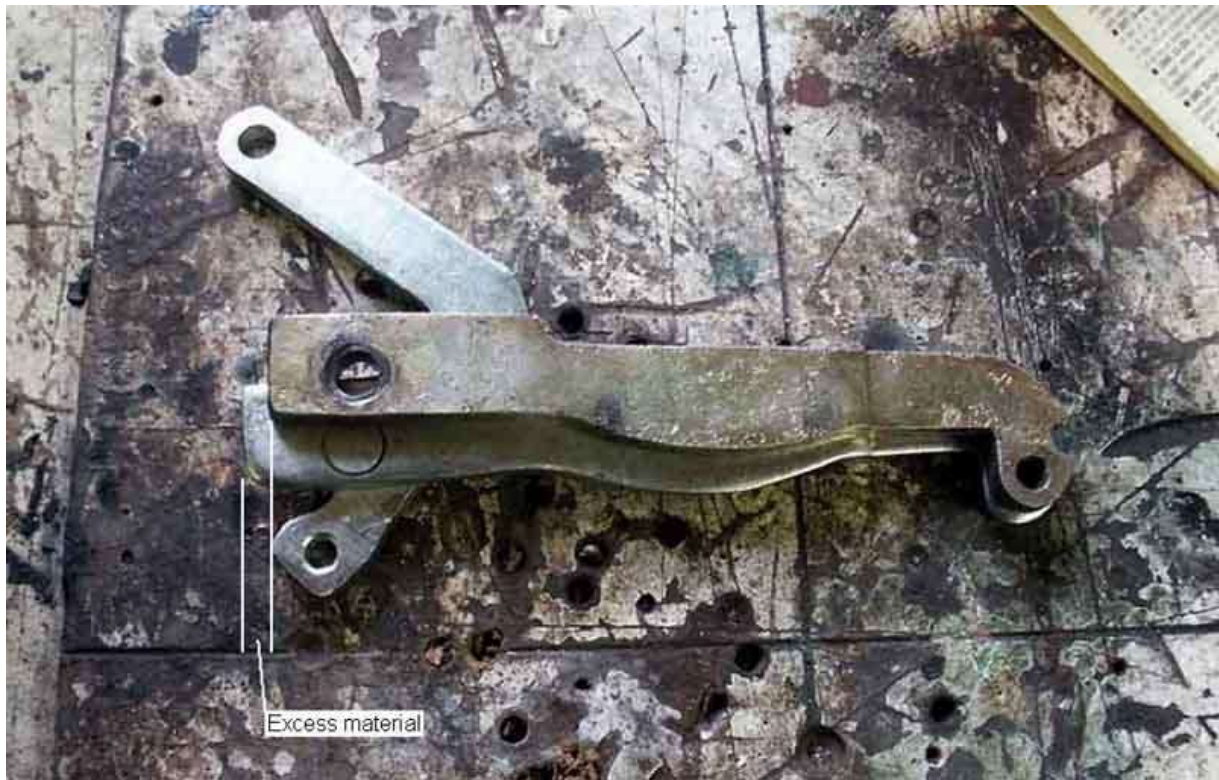
Toni Kavcic's original (short lever detached) on top, new one below, both being for the right-hand side. The excess material on the long lever of the new item was fouling the back of the rear shoe and holding it further out such that the drum could not be refitted, even when the levers were installed the correct way up i.e. long lever above short lever.

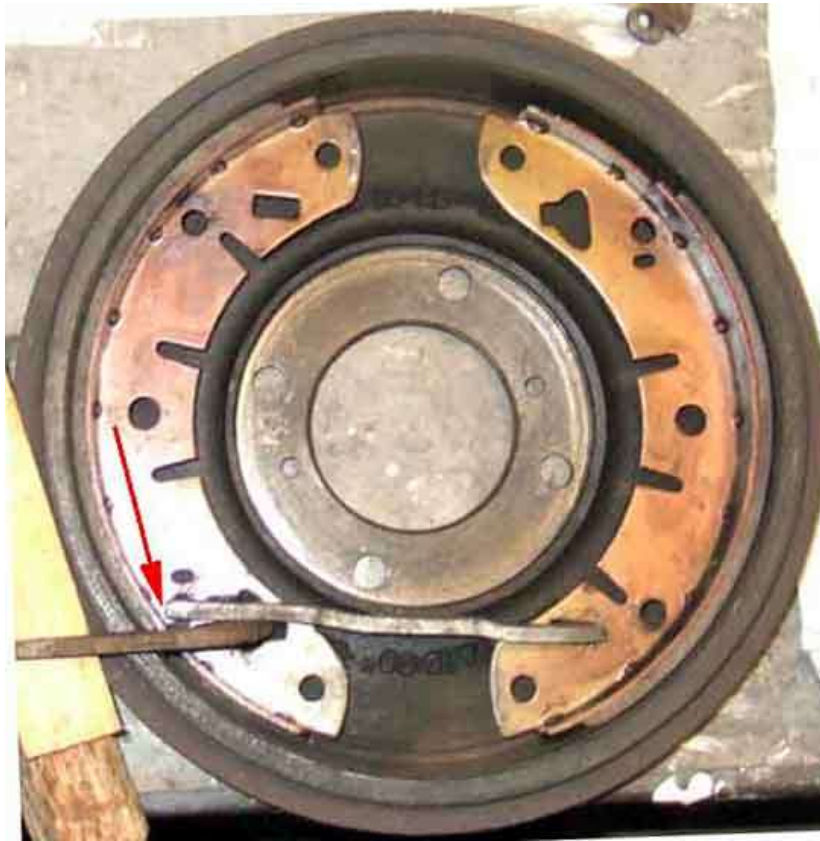
Looking from the backplate side (placed in a drum), installed correctly the projection at the pivot end of the long lever just clears the back of the shoe (arrow) and the ends of the shoes are about the same distance apart.

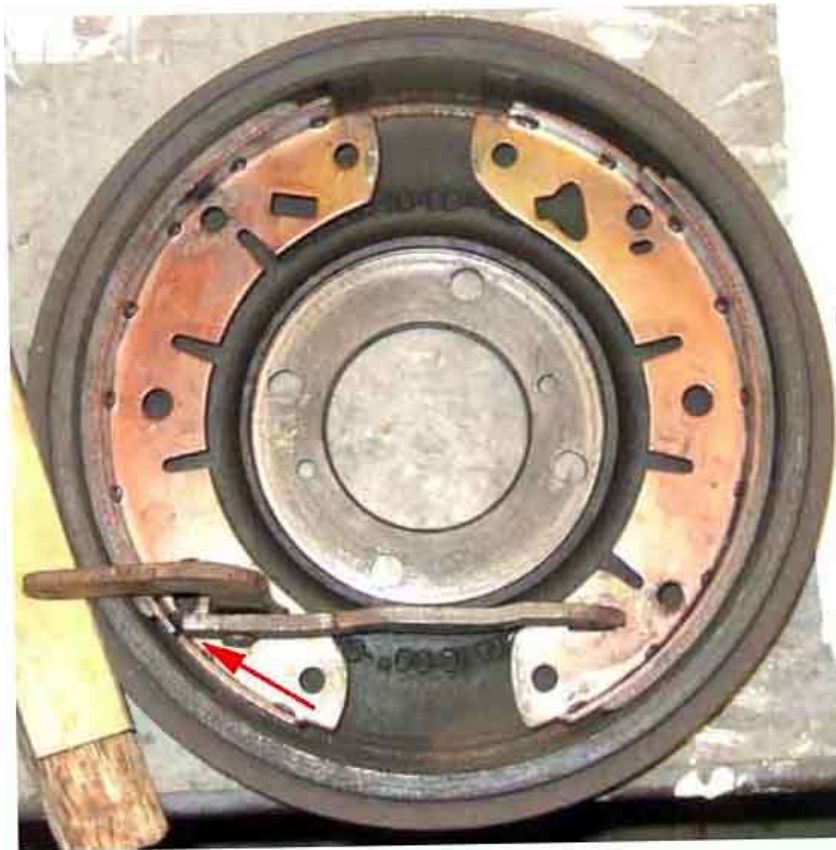
Installed incorrectly the projection at the pivot end of the long lever fouls the back of the shoe (arrow), pushing the tops of the shoes closer together and the bottoms further apart, and pushing the rear shoe away from the short lever.

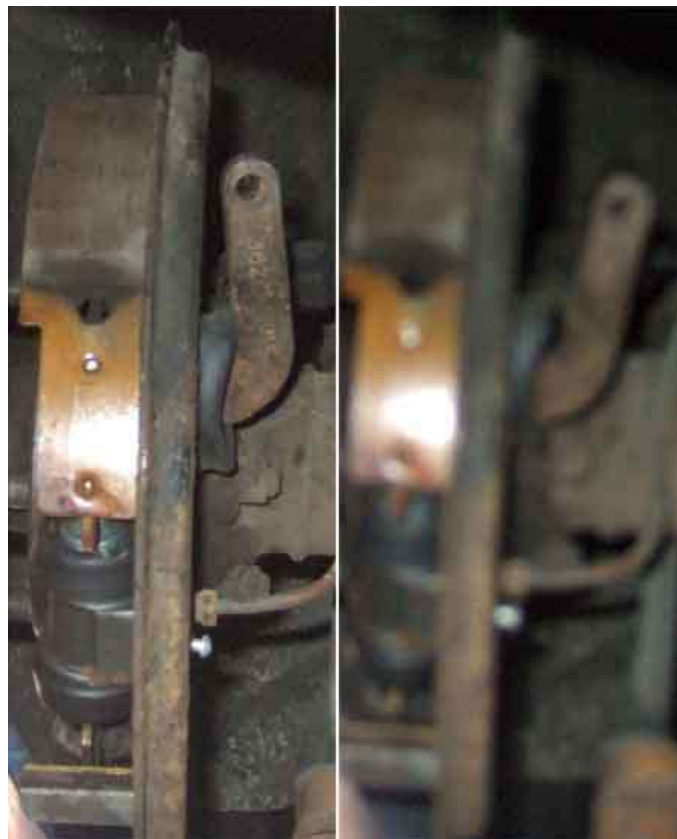
Installed incorrectly because the pivot end of the long lever is pushing the rear shoe away from the short lever, there is a huge amount of free play in the short lever (unfortunately I didn't notice the poor focus until after everything was back together on the correct sides). All of these issues are exactly the same with both the early and the later levers, when the levers are incorrectly installed with the short lever above the long lever. All of these aspects are exactly the same no matter which lever type is fitted to the axle, which is a Salisbury in this case:

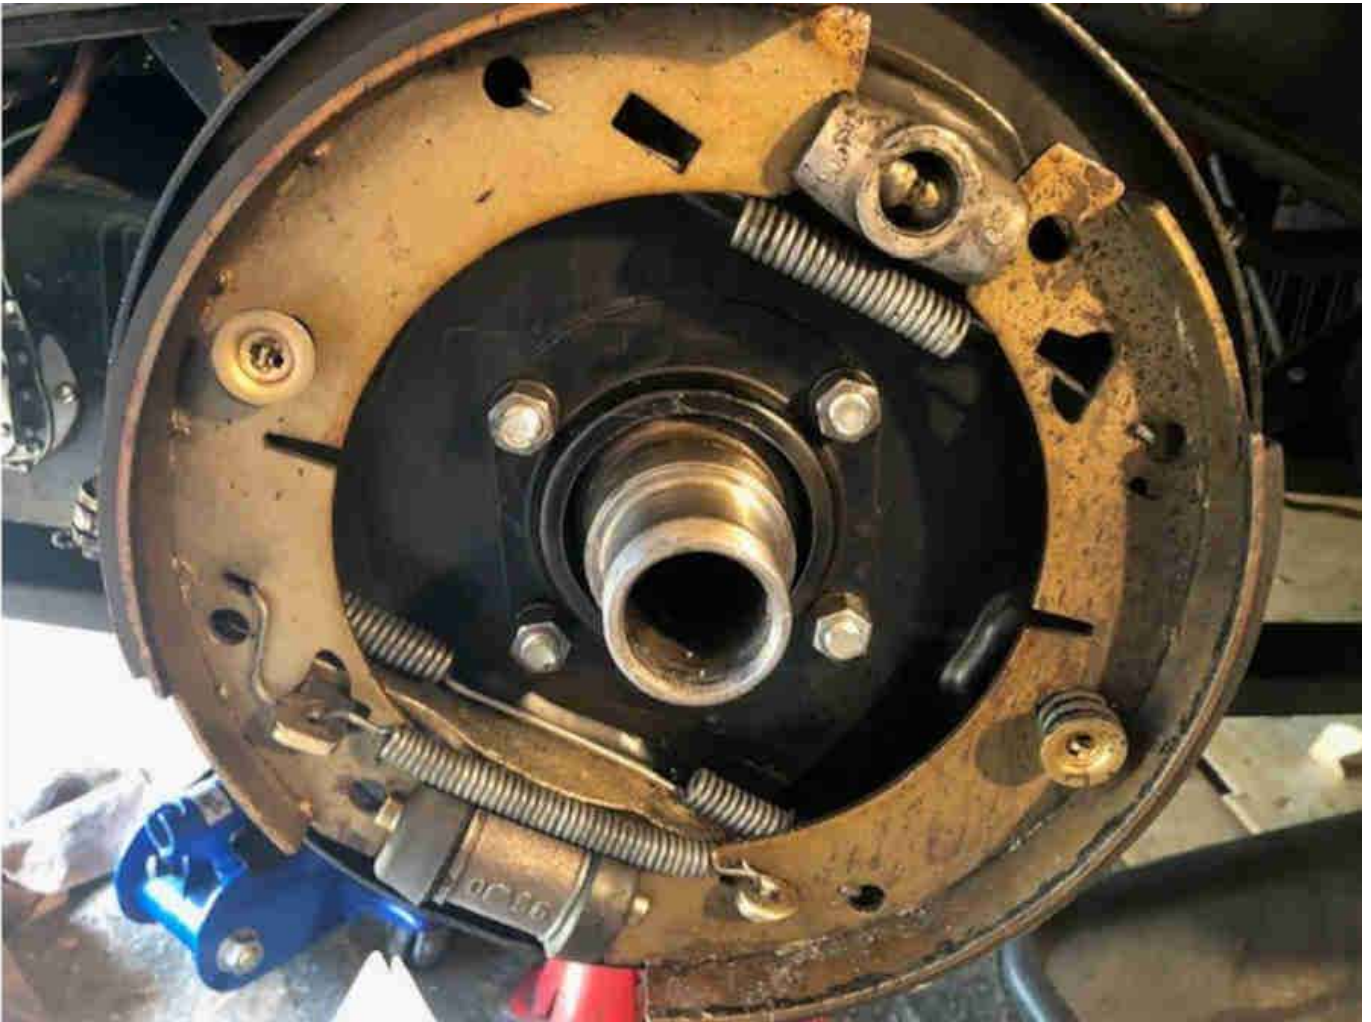
But what about the banjo axle? John Eklof has done the same tests with the earlier levers on the banjo axle and found the same thing, but several sources are incorrect. Drawings from the Leyland Workshop Manual, Parts Catalogue, and Moss Europe at least all show the banjo lever to be the other way round to the Salisbury/tube axle lever i.e. long lever **below** the short lever. But [this MGOC page](#) (about sleeving a banjo axle to cure a hub oil leak) has pictures that clearly show the long lever above the short:

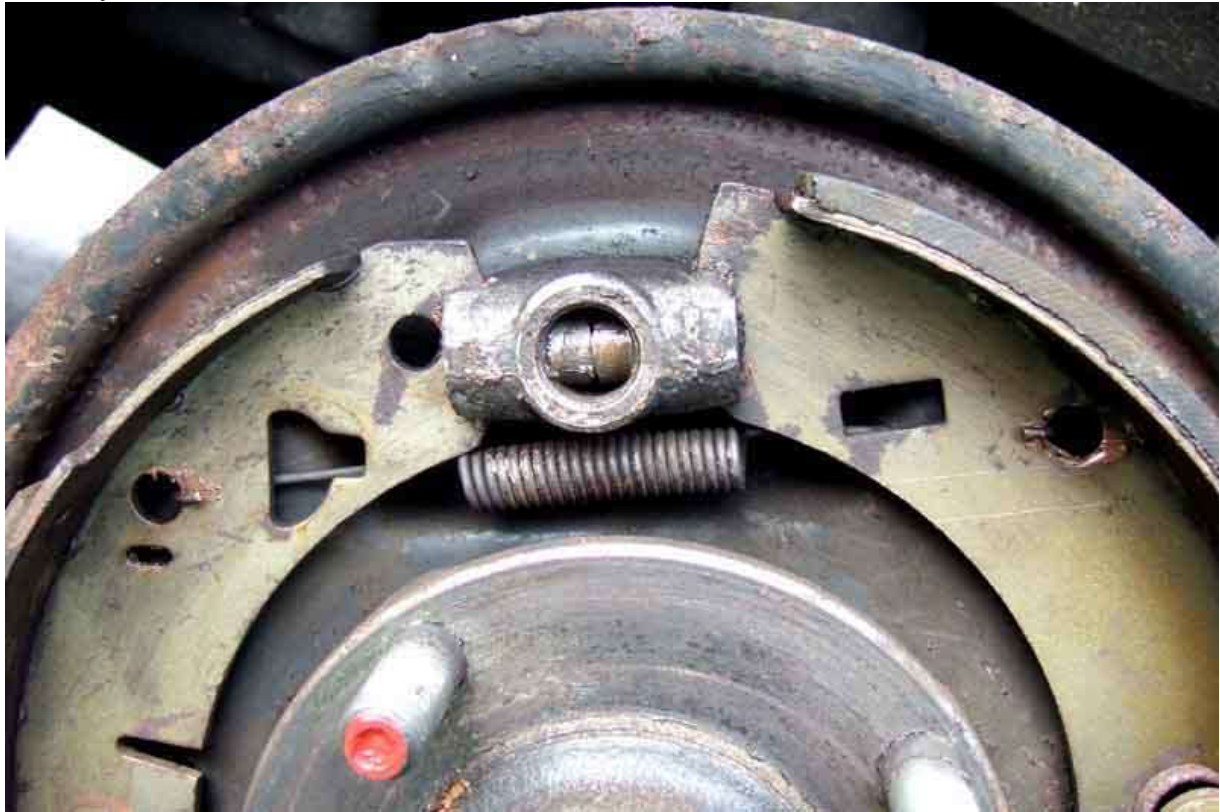
The top spring is fitted to the holes in the shoes and not the slots, and is orientated such that the coil is below the line of the arms of the spring where it sits in a depression in the backplate. Haynes shows the slot being used on one side instead of the hole, and the coil is above the line of the ends so it fouls the bottom of the adjuster. The spring shouldn't foul either backplate or adjuster:

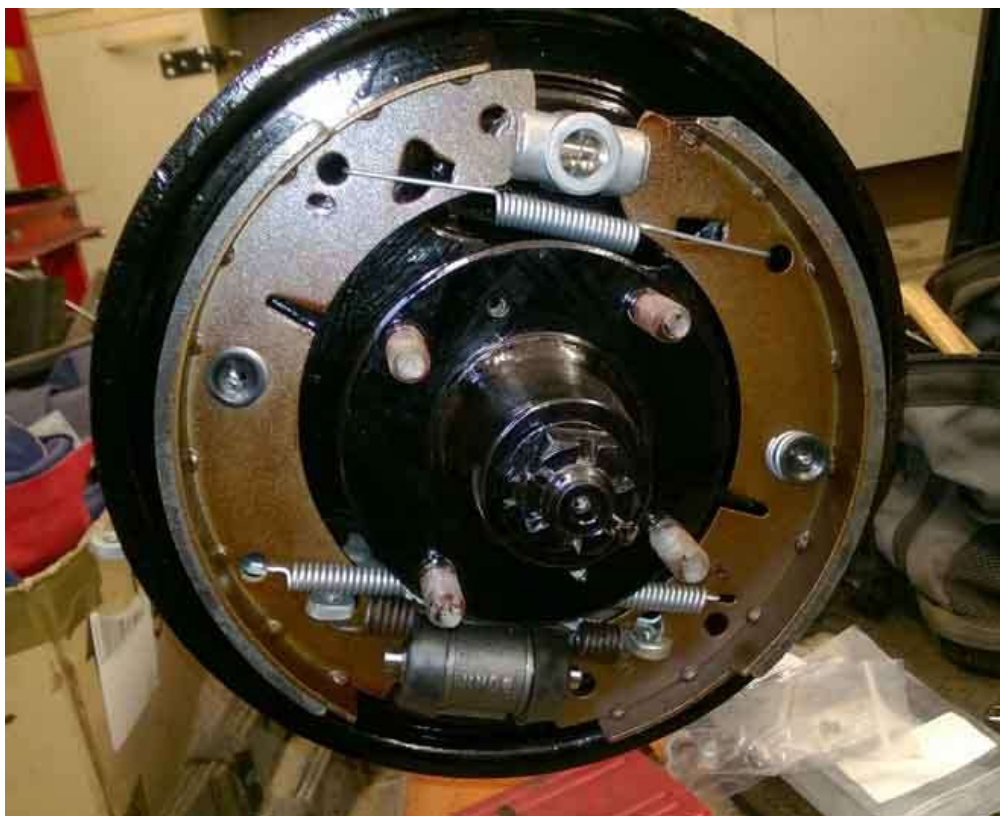
It's always been a fiddle fitting the top spring behind the shoes, I wondered if it could go on the outside, and out of many images showing it behind I came across this one with it like that. I've asked the site owner how that came about and he said that is probably how he found them to begin with. As part of stripping one wheel to replace the handbrake lever boots I refitted that spring on the outside and it was way easier. Drives fine, MOT next month so I'll be able to see if there is any difference between sides. This also shows the lower shoe inner spring on the outside as well (and using one hole and one slot instead of two holes). I don't think I'd do that as that's the one I put in the shoes before offering them up to the brake lever and wheel cylinder as a pair, and that is relatively easy:

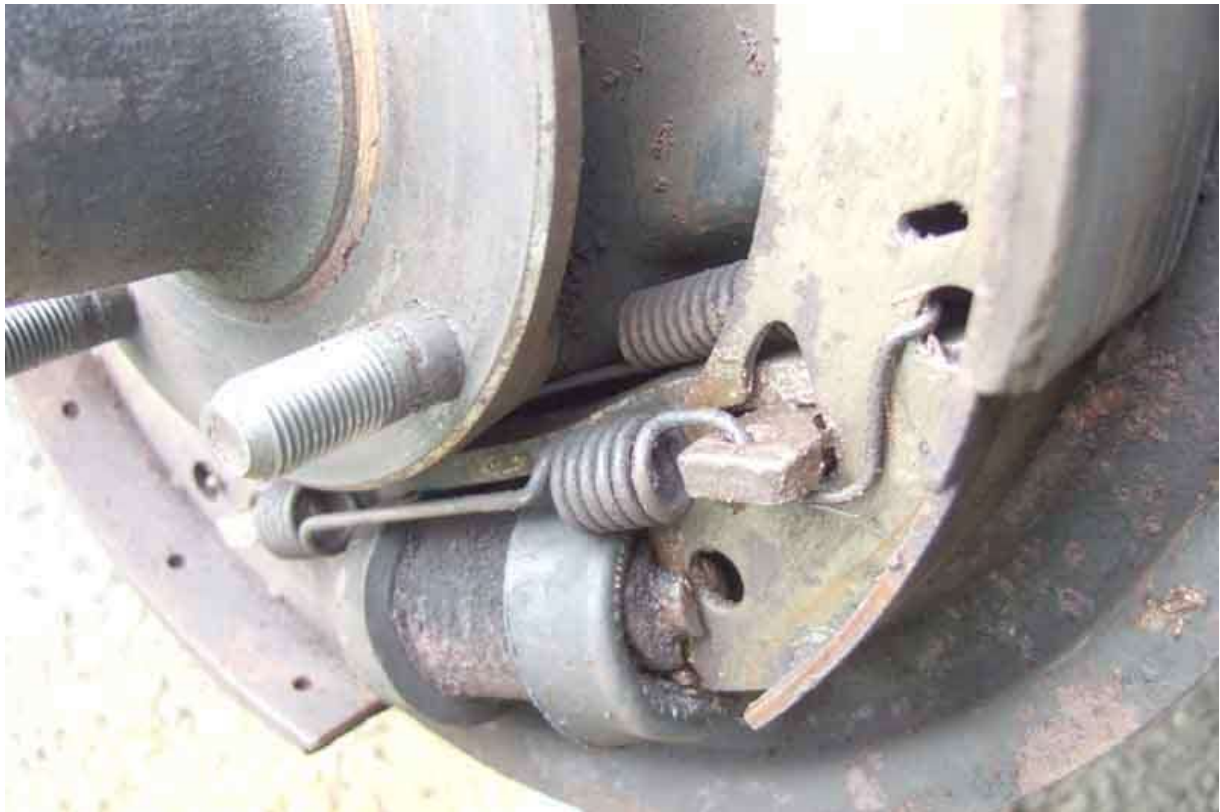
Detail of bottom springs showing the inner spring also mounted in the holes and not the slots. The outer handbrake spring goes through holes in the ends of the handbrake lever, with the wire between the coils positioned away from the long lever. Haynes incorrectly shows this in the inner position, where it rubs on the long lever. This is the later spring, the earlier version has a single long coil. The change point seems to have been with the levers, not with the axles as implied by the drawings. Maybe the orientation of the inner spring i.e. whether the long wire end came through the front shoe or the rear, also changed with the levers and not the axle:

I'd never understood why the inner spring has the long extension coming through the rear shoe as in the above picture (Salisbury axle, drawings show it in the front shoe for banjo axles, which may be an error - there are many of them). Haynes shows this correctly using the hole in the shoe and not the slot, but resting on top of the handbrake lever. I've always felt that was wrong as it was easier to fit underneath - until I saw a drawing for Sprites/Midgets that described it as an anti-rattle measure for the handbrake lever, also curled round the lever as I fit it, and [John Twist specifically states it goes like this at 5:05:](#)

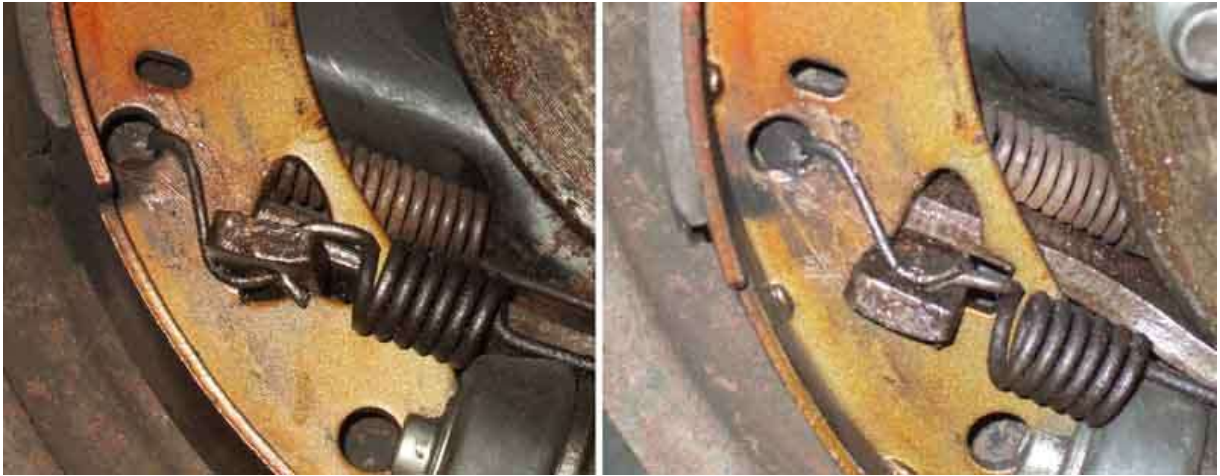
If it **is** an anti-rattle measure then it probably should be above as Haynes shows it for two reasons: One is that underneath the lever is only resting on the spring and there is plenty of free-play in the slot in the shoe above the lever for it to move around. The other is that when underneath the lever is resting on the cut end of the spring, which for moving parts seems poor mechanical practice, and having it above with the smooth loop of the spring pressing against the lever would be preferable, as well as being more effective as an anti-rattle measure. It can be positioned either below or above, although to position it above takes more effort. However with it below there is no tendency of the levers to rattle in the shoes given the third spring on the levers, so there is no point in struggling to get it on top, and no drawbacks to having it below:

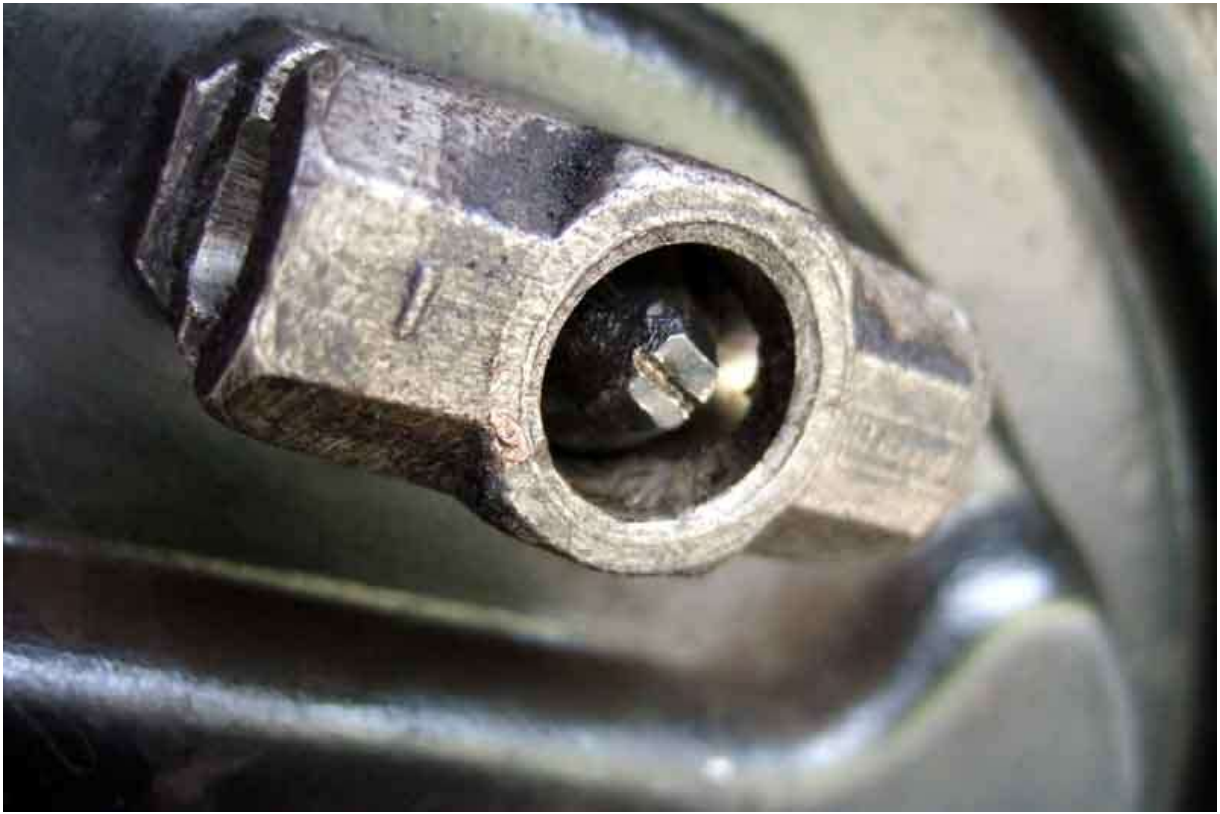
Slot cut in end of adjuster so it can be removed and refitted with a screwdriver. Note this is not for adjustment of the shoes!:
