EeziBleed

Dual Brake Masters

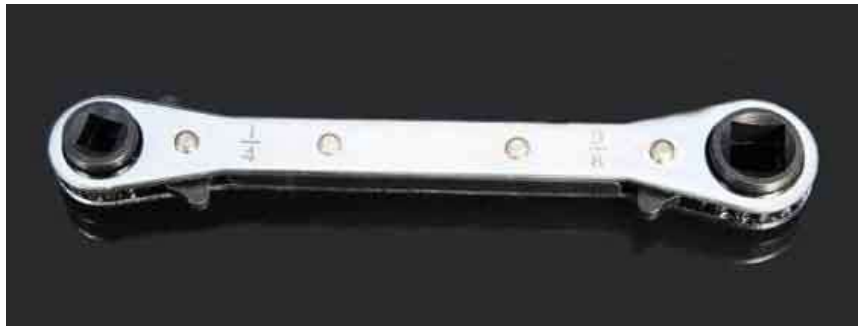
When looking at a couple of John Twist videos while investigating the 'anti-rattle' feature mentioned above I noticed he was using a ratchet spanner with a 1/4" square hole which directly fits the adjuster, and he happened to mention it was a refrigeration spanner. Various Googles later I come up with this, with [four square-drive sockets including 1/4"](#) - select CT122, which is a bargain at £4. OK I may not use the other three very often if at all, but seeing as how a single 1/4" from Sealey is £14, it's no contest. Makes winding the adjuster out from all the way in with the shoes refitted a doddle, although to be fair having the plain adjuster spanner as well for the final adjustments back and fore is slightly easier than flipping the ratchet to change direction each time:

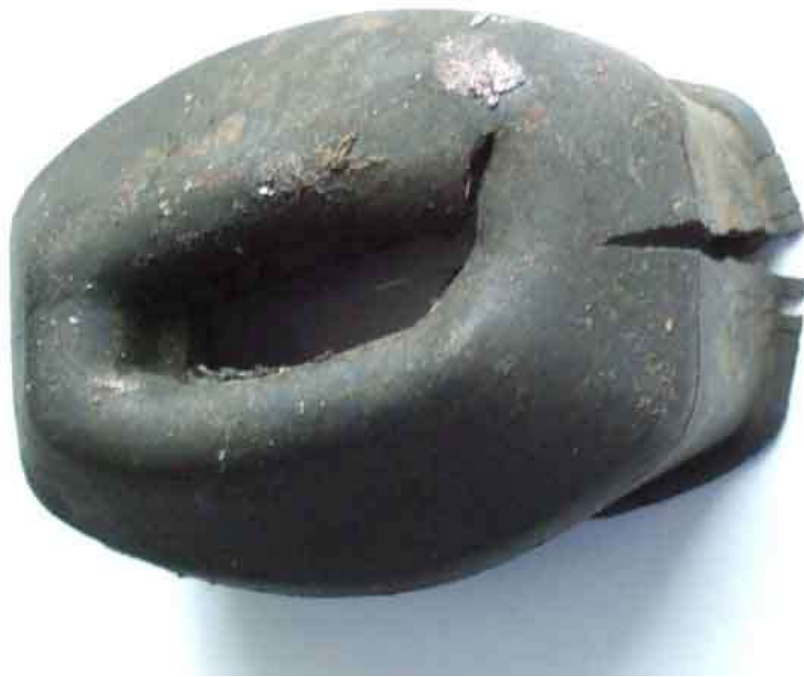
Vee's split and hanging off, after just three years.

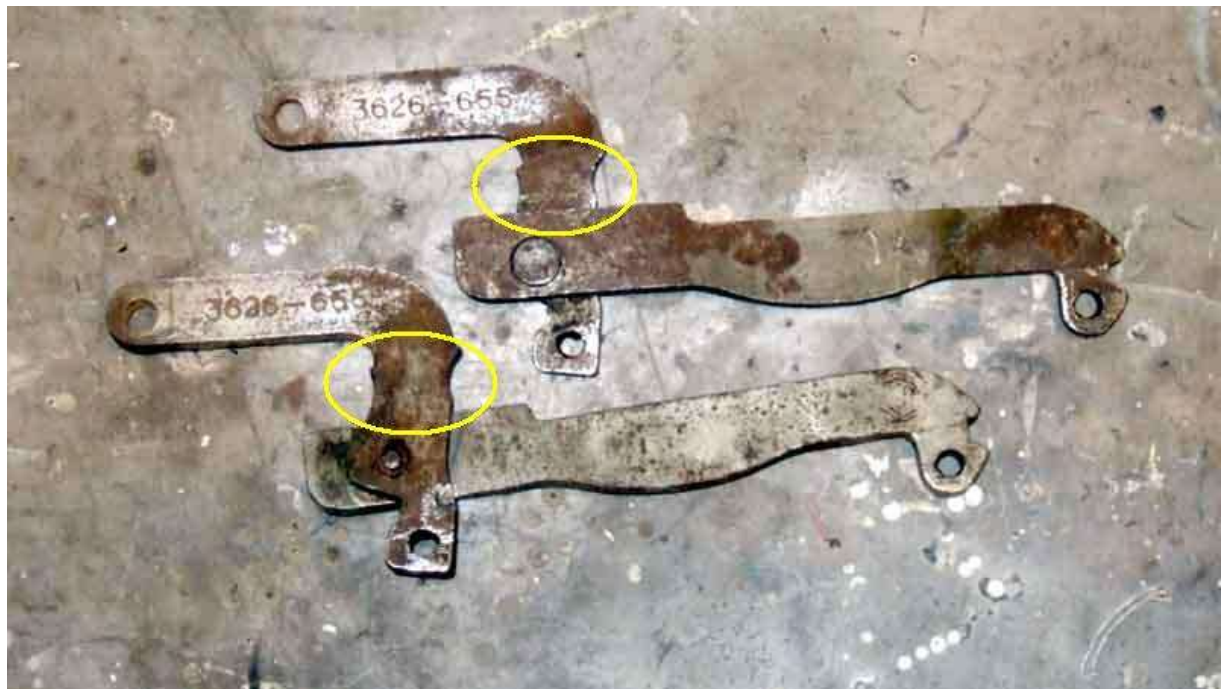
Circled is the 'waisted' section that the slot in the boot should be pushed onto, which helps prevent it getting pushed off the back-plate tabs

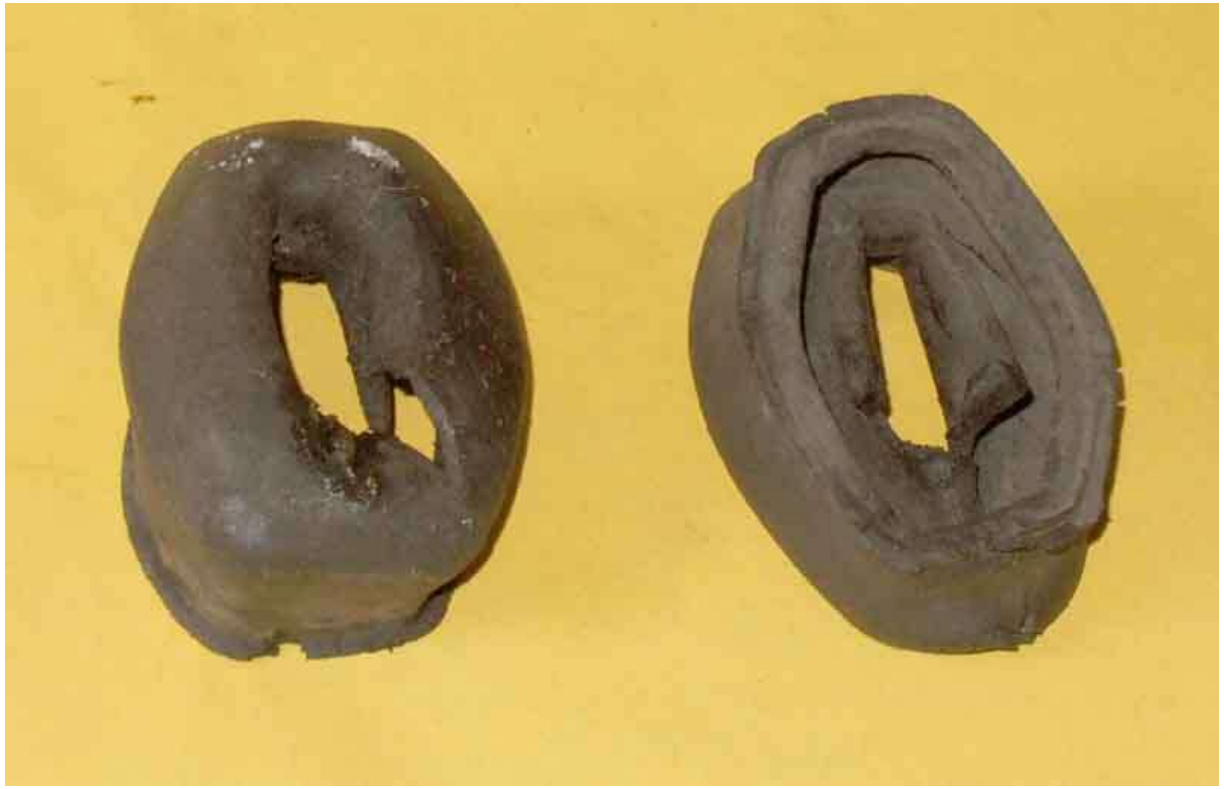
Bee's after six years and 10k. Vees having been replaced three years ago showed no signs of deterioration.

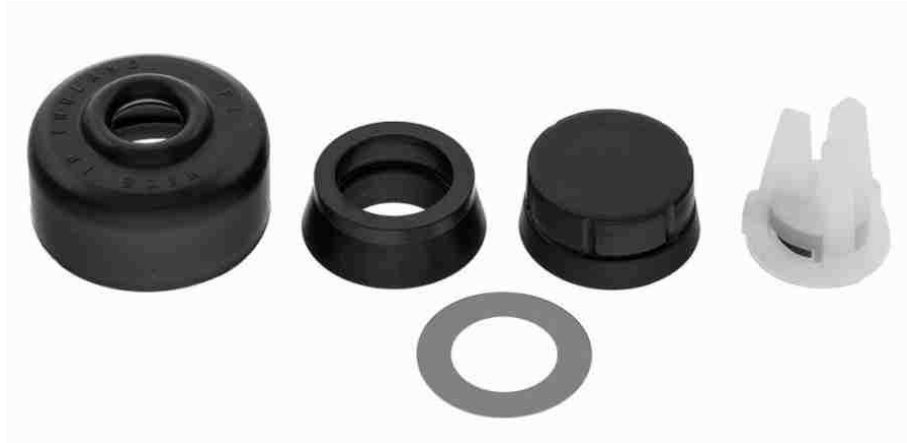
GRK1026 for the early brake master with cup seal and [restrictor](#), the washer goes between the piston and the back of the cup seal:

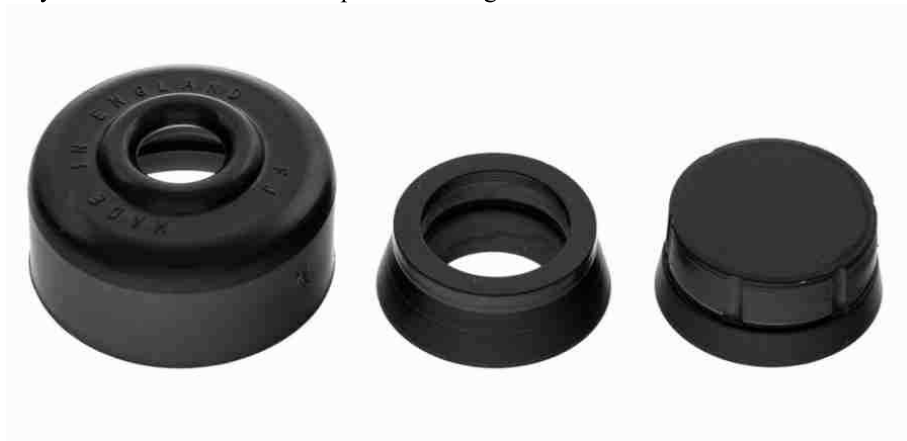
GRK3007Z for the early clutch master with one cup and one ring seal:

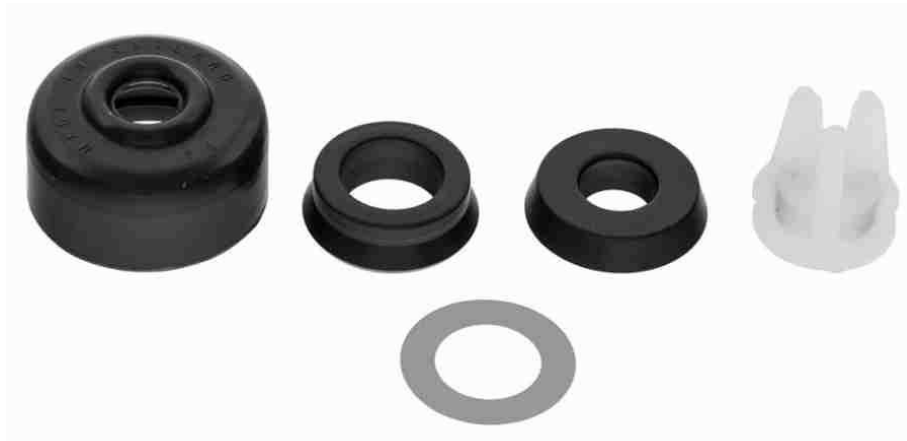
GRK3004Z for later brake **and** clutch masters with two ring seals. This includes a restrictor valve which **MUST** be fitted to the brake master, and must **NOT** be fitted to the clutch master:

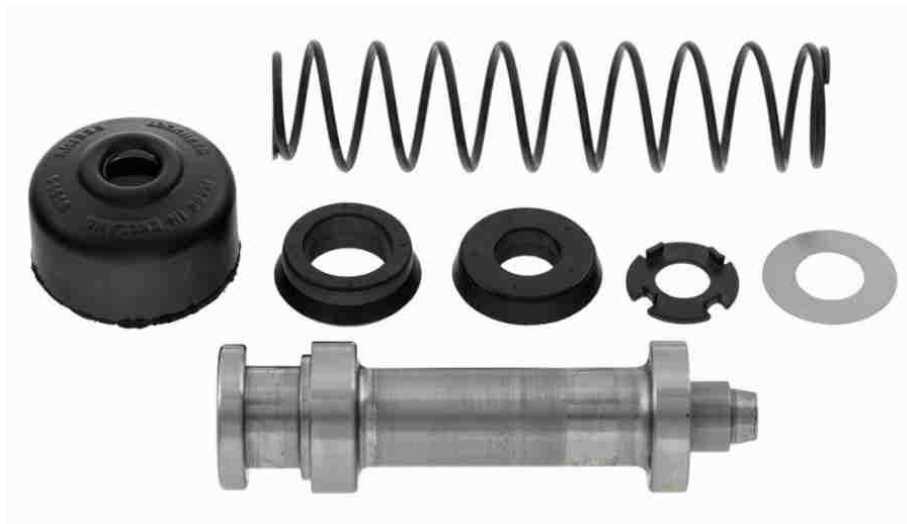
GRK3007 converts the earlier clutch internals to the later type and uses two ring-type seals, at about three times the price:

Not all suppliers show all four kits and some show GRK3007 i.e. without the 'Z' suffix as being the basic cup-type repair kit **not** the conversion kit to ring-type seal that most suppliers show.

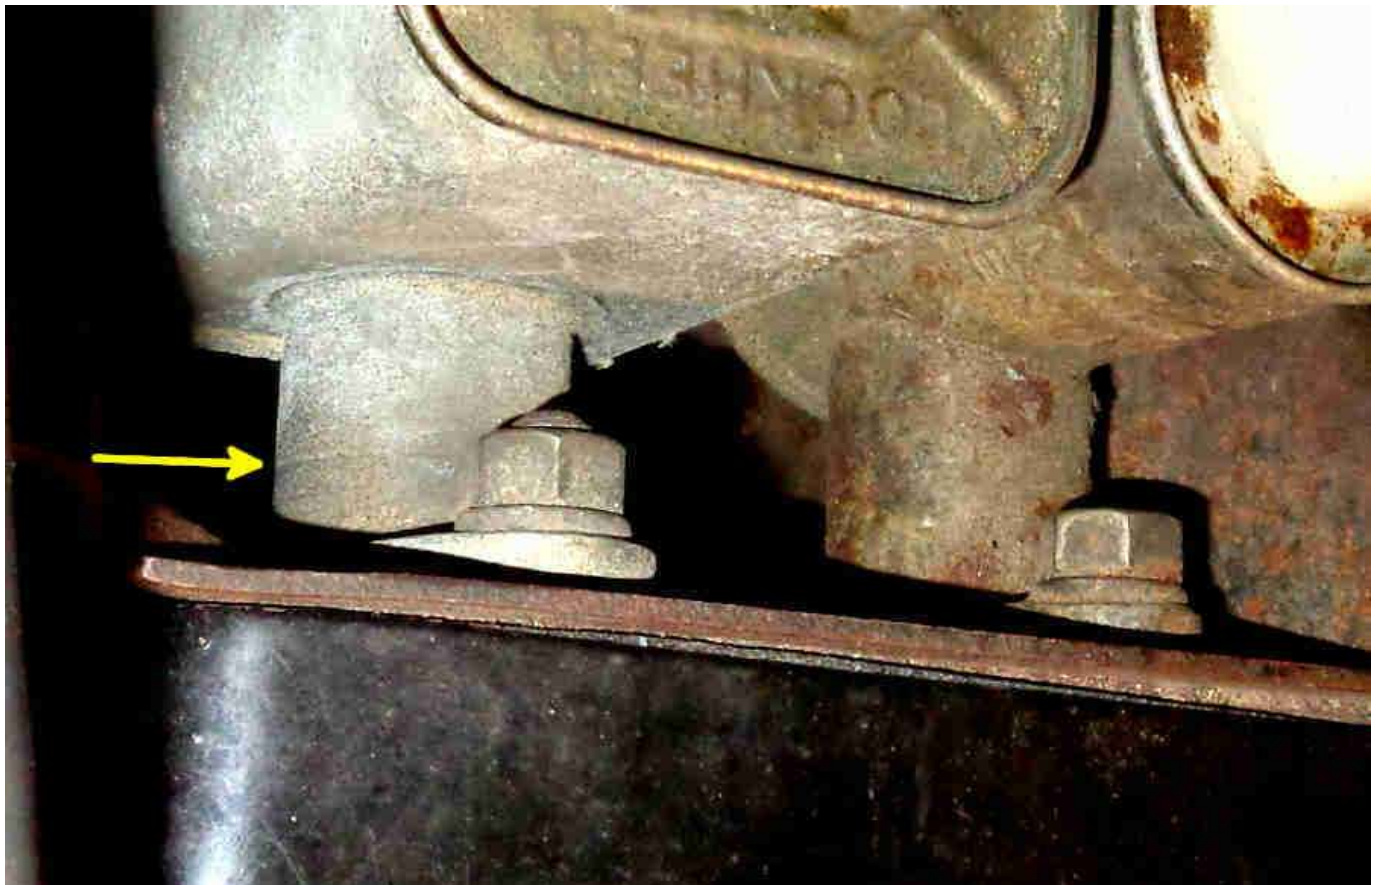
Groove barely visible on the replaced brake master on my 73, the clutch master is the earlier cup-seal type so no markings:

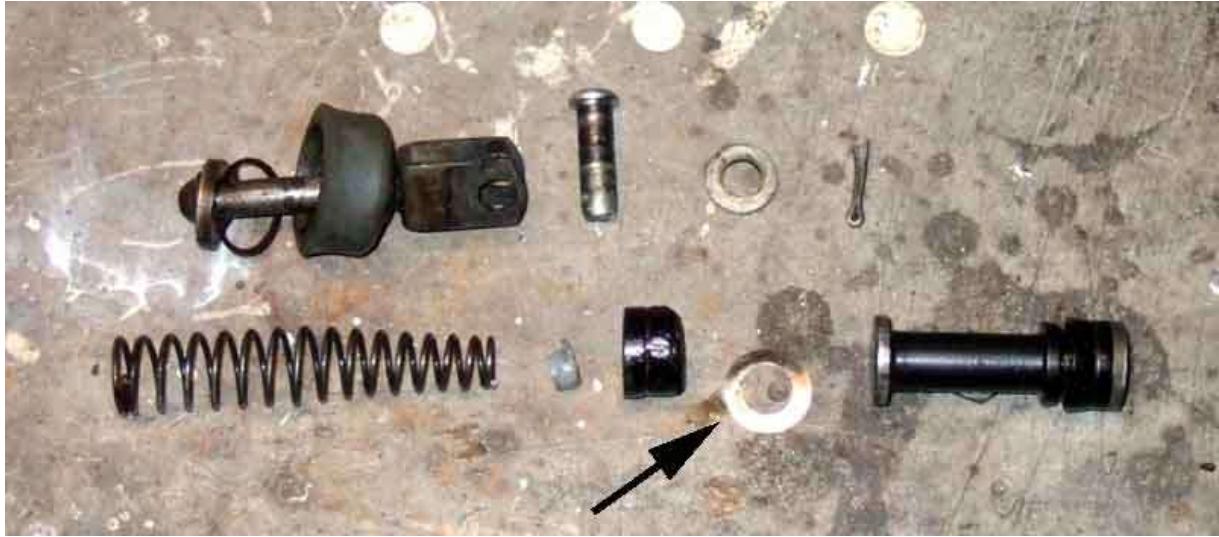
Cup-type seal internals: The shim (arrowed) goes between the seal and the piston, and on all pistons both primary and secondary seals face forwards. When fitting the dust cover to the push-rod do so from the piston end before assembly to the master

cylinder, the sharp edges and large size of the clevis pin fork can rip the seal:

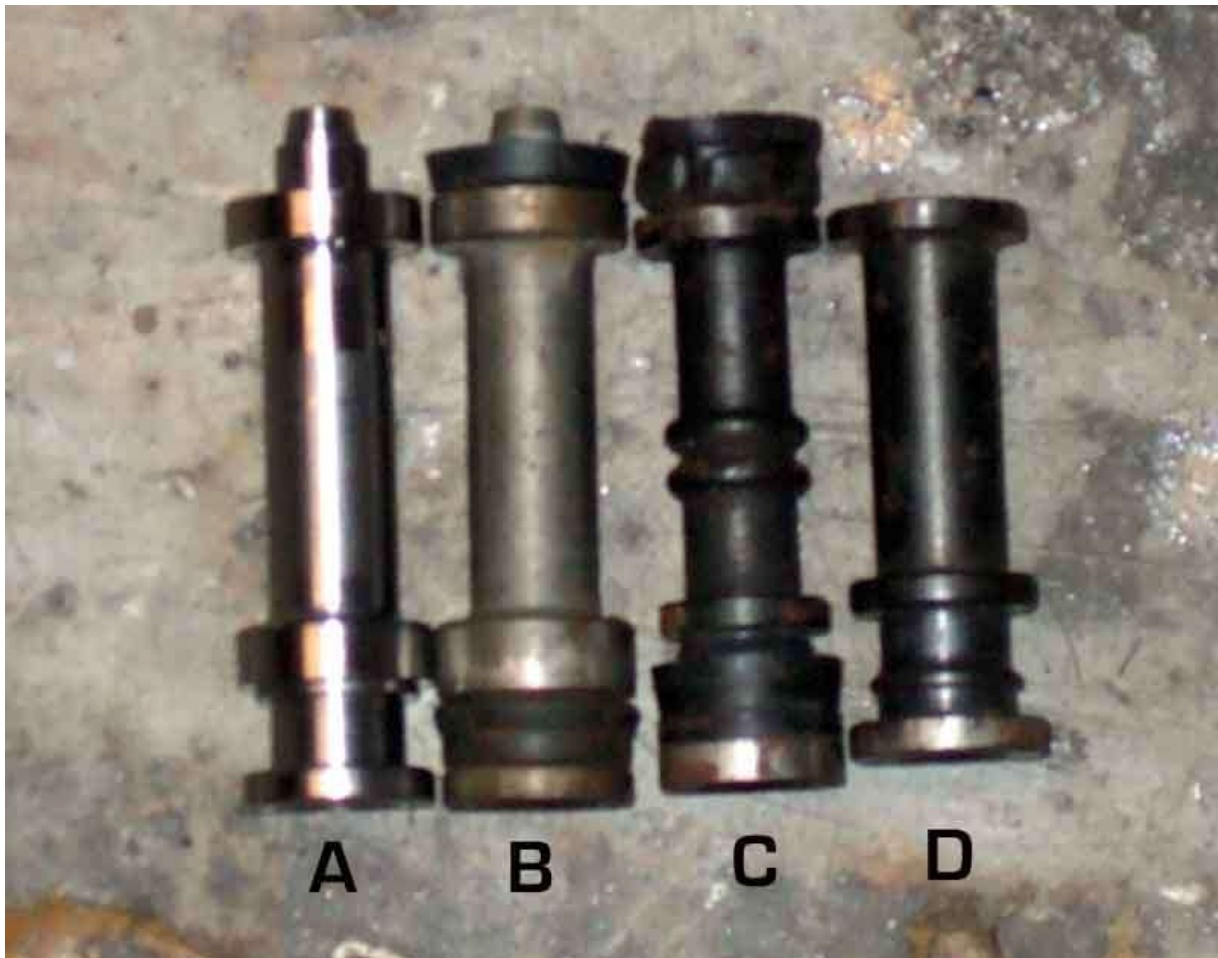
A selection of pistons and seals: A is the new piston from the conversion kit, B an identical item from a previously changed cylinder. C is from the V8 clutch and has two parallel rings! D is probably from the roadster brake master and identical to the one from the clutch master:

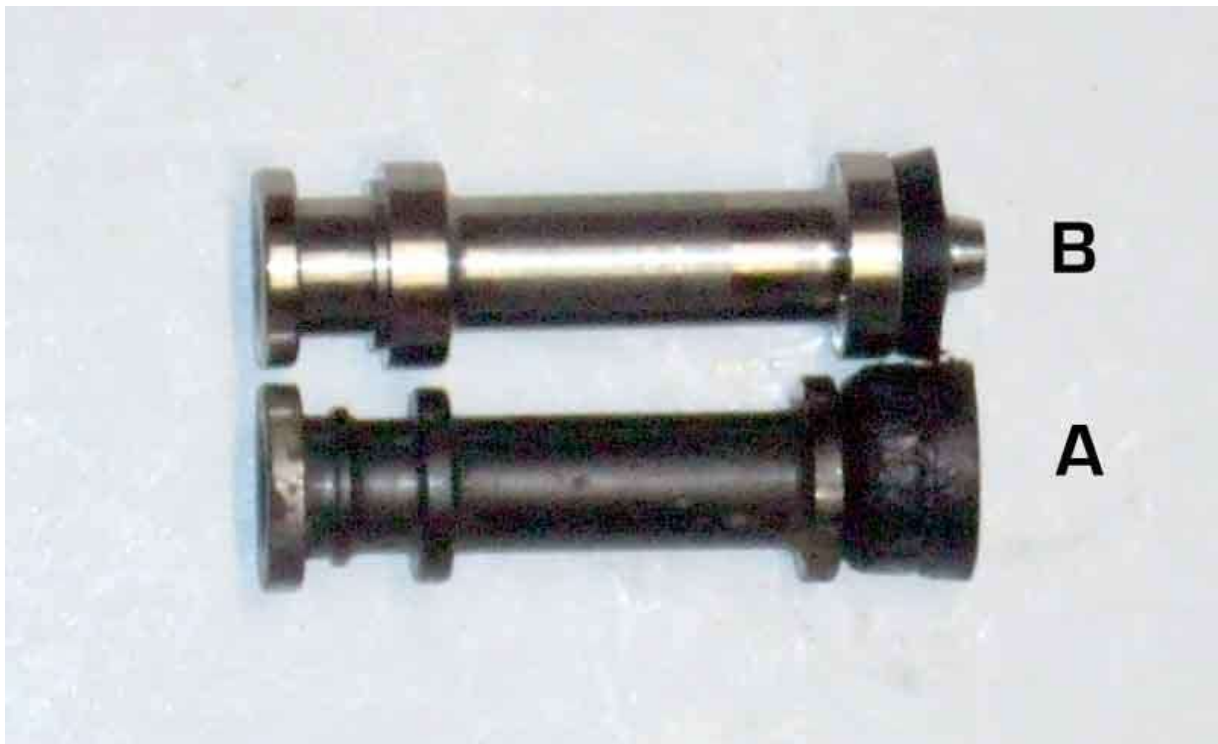
Piston and cup-type seal from Bee's clutch (A) significantly longer than the piston and ring-type seal of the conversion kit:

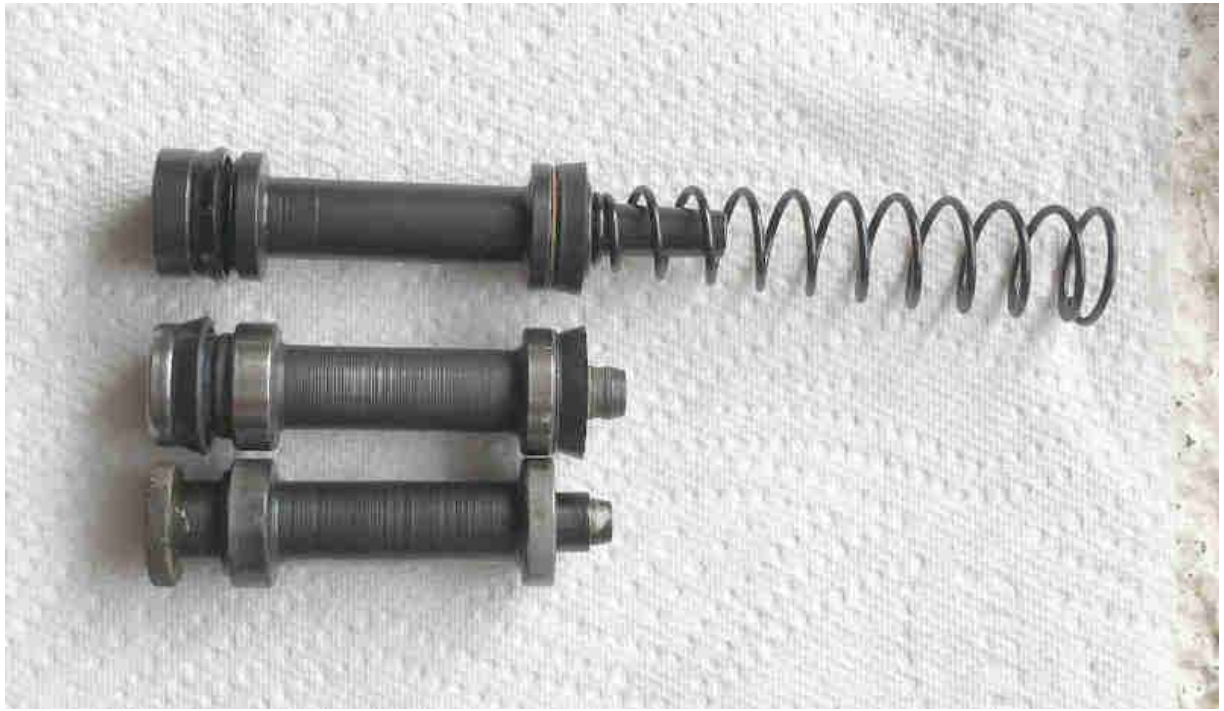
Three from Richard Massey on the MGOC forum - top from a 100 mile no-name plastic-bodied replacement that started leaking, middle from an older TRW plastic, bottom from a metal can. Slight differences in thickness of the flanges either side of the seals which is irrelevant as long as the seals are in the same position. Also slight differences in diameter of the flanges but only 3 thou max between any of them. Speculation that it was deliberate to give greater clearance to the bore, but I can't see that after all these decades, and it would allow for more lateral movement of the piston in the bore which could impact the sealing. Whilst my old pistons do show some polishing on the sides of the flanges there was no scratching or scoring in the bore which the 100 miler shows. What (to me) is more interesting is the long extension inside the spring of the no-name plastic. It shows how much free space there is at the bottom of the cylinder, and I can see it being needed in some applications to prevent the piston going too far and tangling up the spring, which then may not push the piston back as it should when the pedal is released. Neither do you want to push the secondary seal past the inlet port which will cause fluid to leak out:

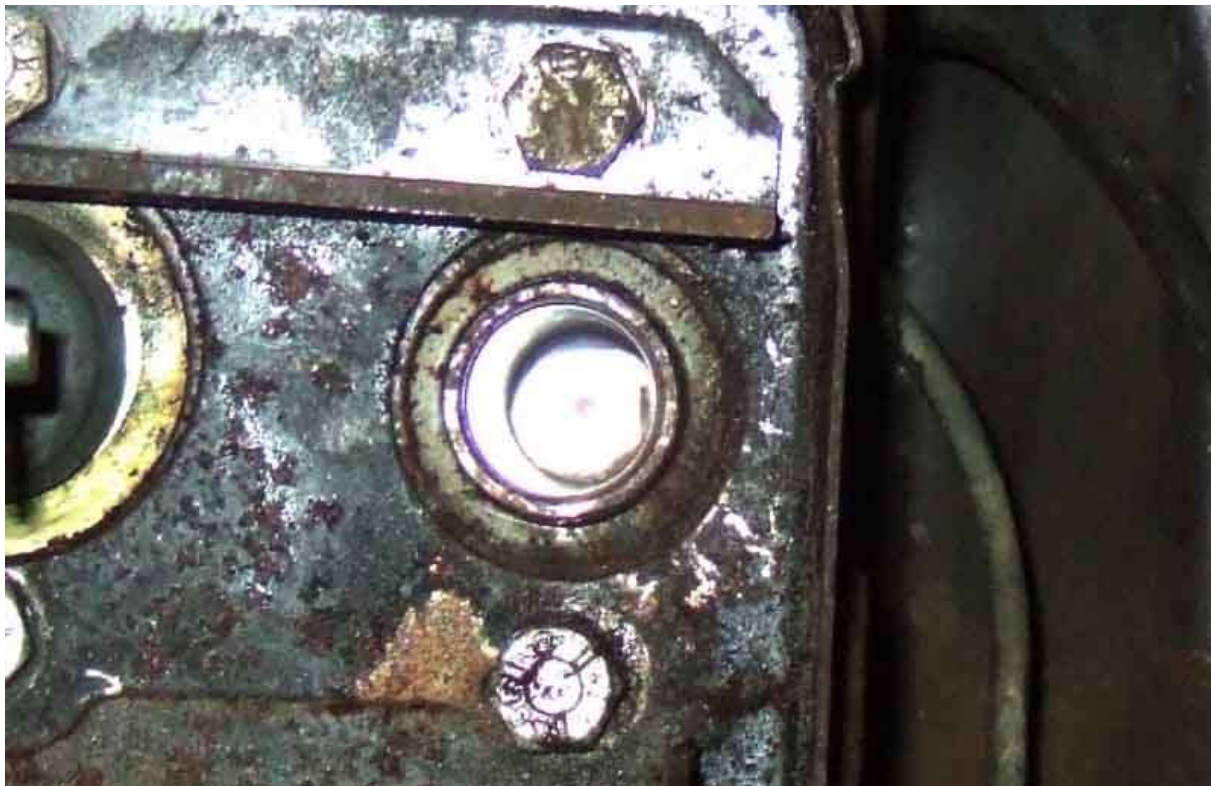
Shiny bore full length and all the way round:

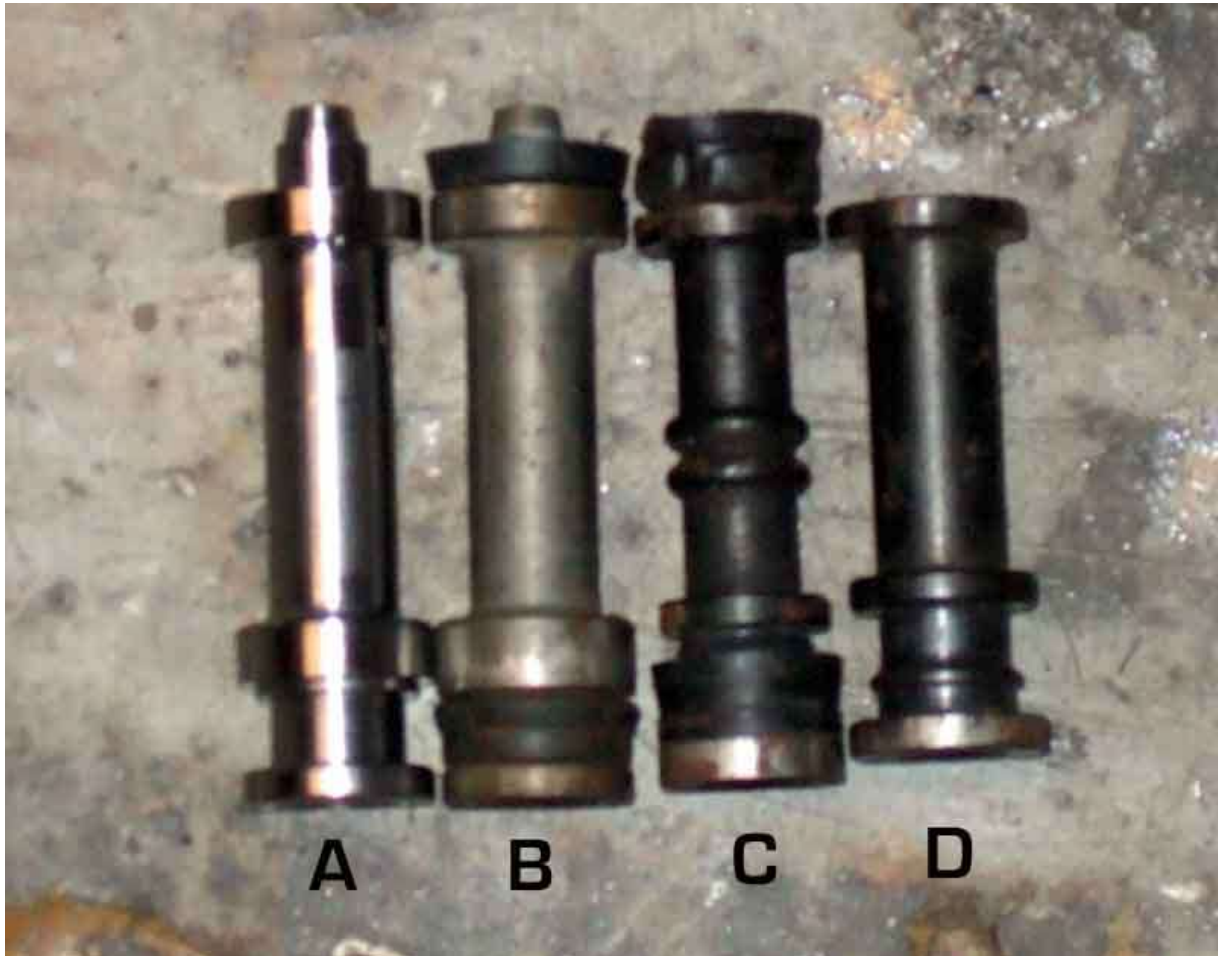
A selection of pistons and seals: A is the new piston from the conversion kit; B an identical item from a previously changed cylinder; C is from the V8 clutch; D is probably from the roadster brake master and identical to the one from the clutch master:

Parts arrived from Moss next morning, and with the low biting point in mind and wondering if I would be able to improve it, I compared the lengths of the five pistons I now had - three previous replacements one with ring seals and the other two with cup, Bee's clutch with cup seal, and the new conversion kit with ring seal. They vary in length quite a bit, except that the new conversion piston is the exactly the same length as the previous replacement that has a ring seal, and Bee's piston is exactly the same as one of the old cup seal pistons. The remaining cup seal piston is slightly longer, and is my first thought to fit, but when I check the diameter it is fractionally smaller than Bee's. That must be from the V8 clutch, which has a slightly smaller bore than the 4-cylinder, so not a good idea to use. All the secondary seals are ring-type, but do vary in size.

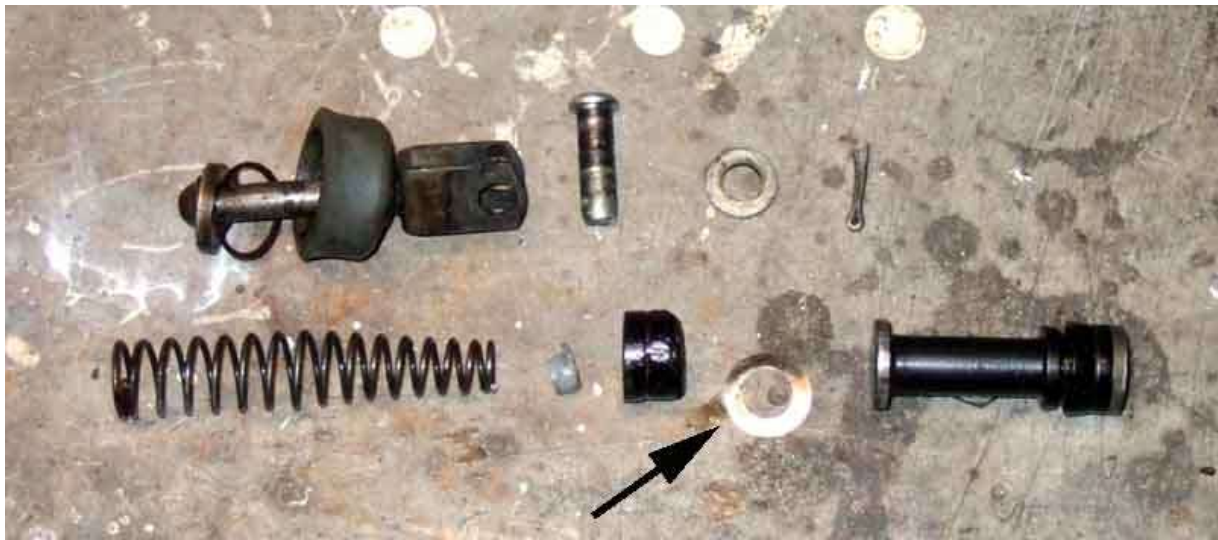
The shim (arrowed) that fits between the seal and the piston, on both cup and ring-type seals.

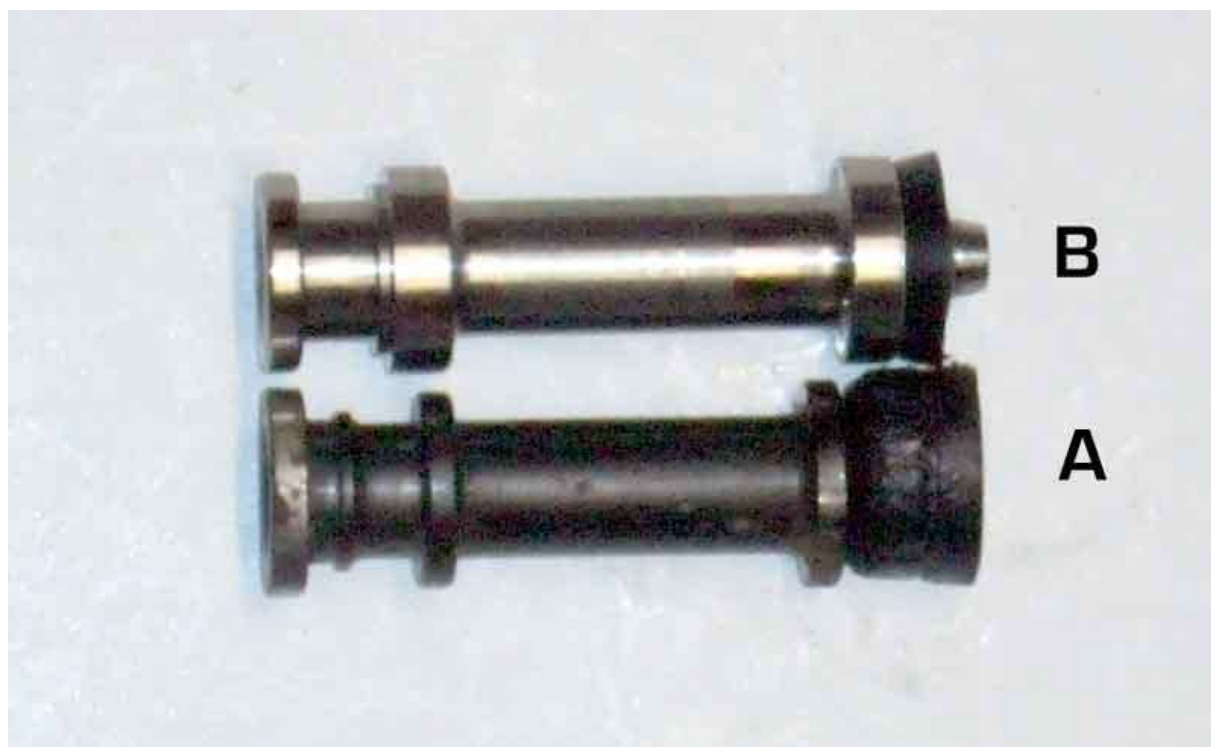
Piston and cup-type seal from Bee's clutch (A) significantly longer than the piston and ring-type seal of the conversion kit.

I could take the piston and seals out again, and perhaps fit the conversion kit, but that is also about 1/8" shorter than a piston with the original seal so isn't going to be any better. And after the problems with bleeding I'm not keen on having to go through it all over again. If I could put a spacer between the push-rod and the piston, then with the pedal fully released the piston would

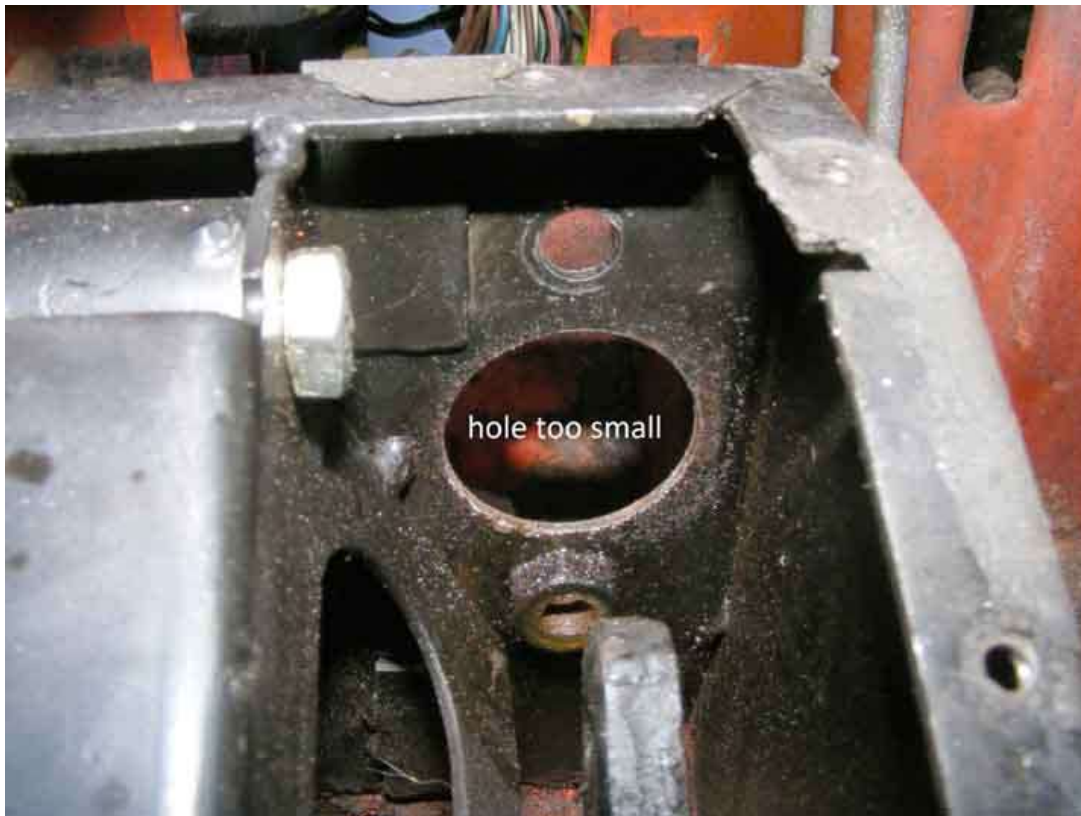
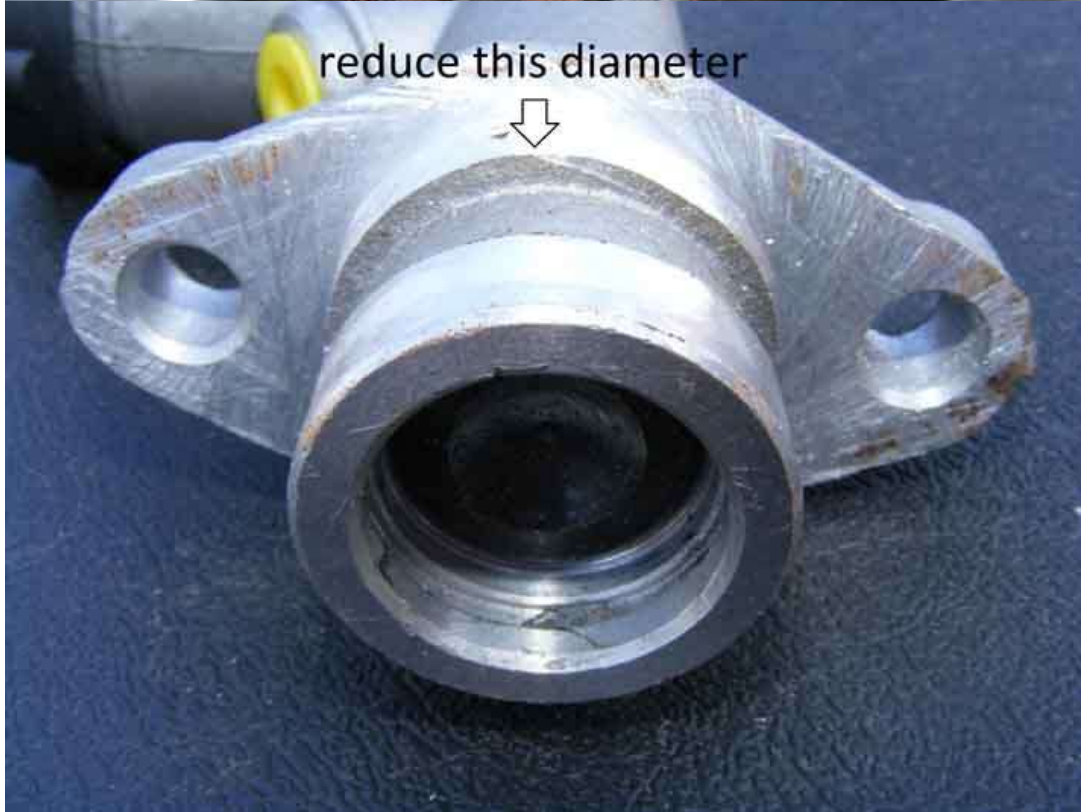
The Girling master cylinder was installed in most Triumphs, Land Rovers and the MGC. There are various bores available including 3/4inch (0.75") the same bore as the MGB. The pedal box mounting bolt holes match up perfectly, but unfortunately the centre hole is a few mm too small, but a few minutes with a hand file on the master cylinder solves this:

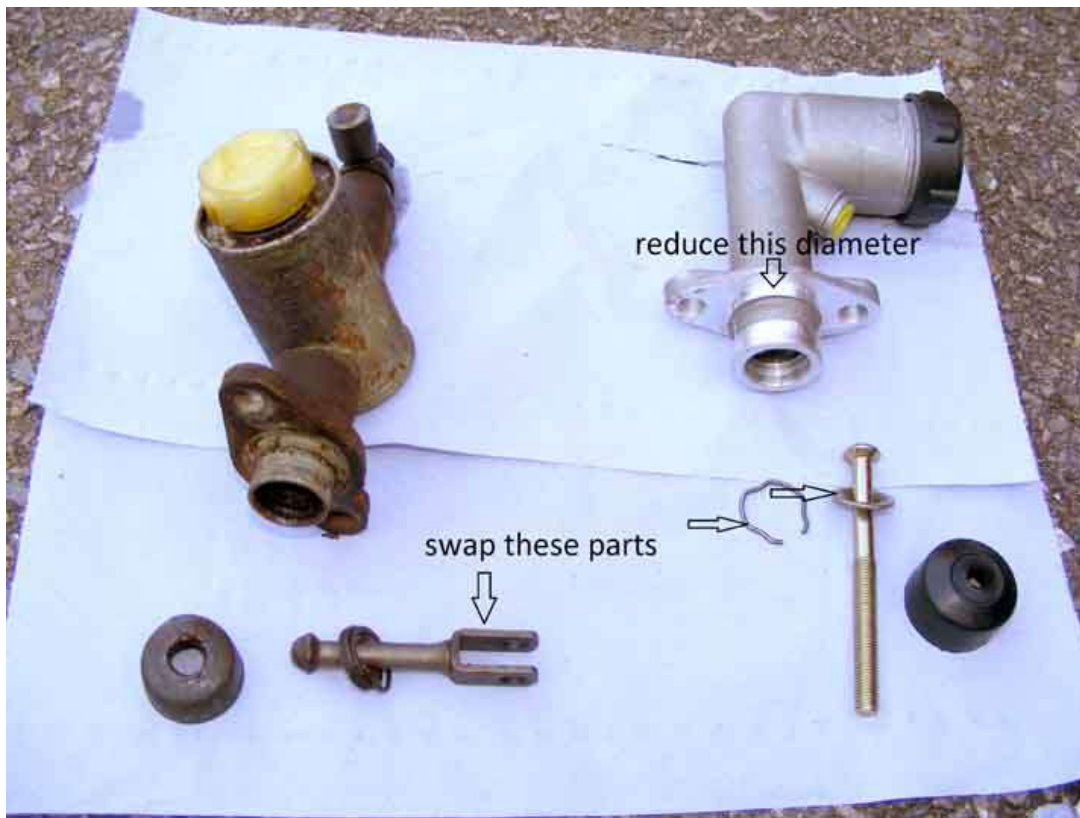
Just swap the push rod, circlip and the retaining washer (this needs to have a notch cut out to be fitted onto the push rod):

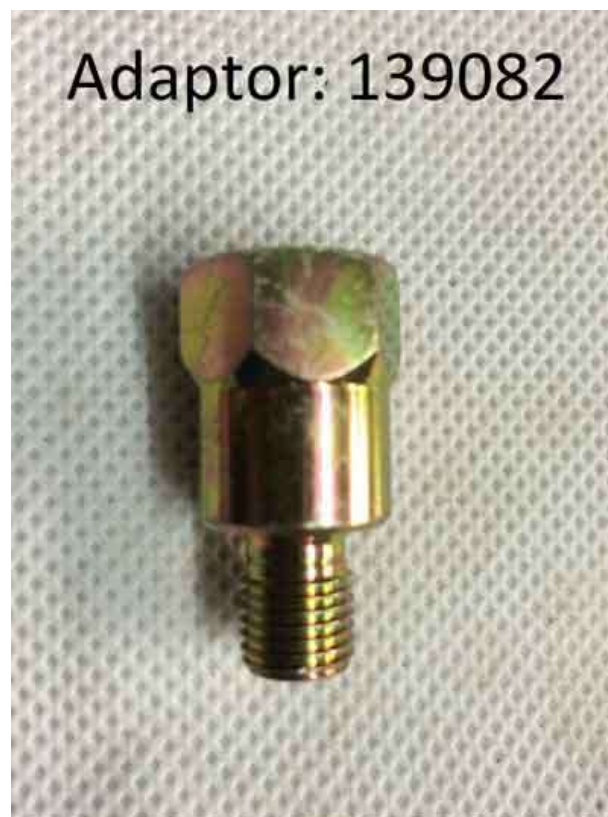
The MGB uses a larger diameter solid pipe, so the adaptor, (as used on Land Rovers) is required to convert 3/8 to 7/16:

I had considered replacing the whole solid pipe with smaller diameter pipe, however the slave cylinder are also the larger 7/16 union.

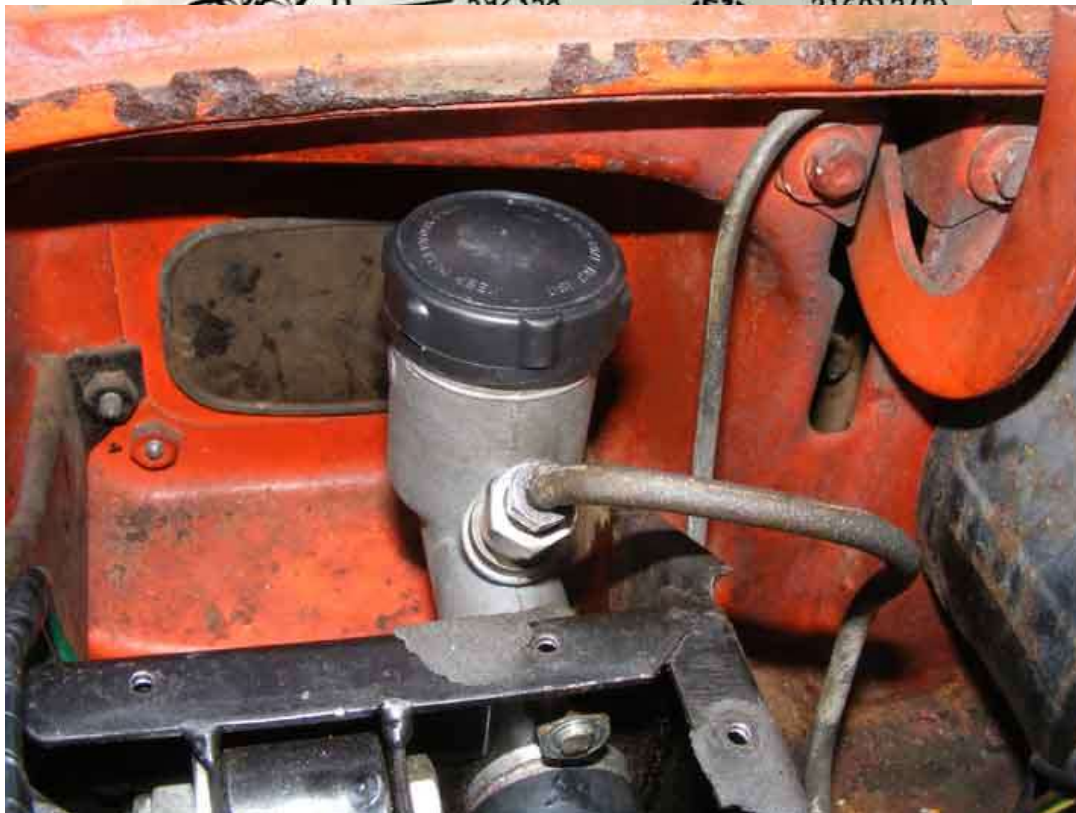
Gently bend the solid pipe to attach to the adaptor and master cylinder. Reconnect clevis pin etc.:

Bleed clutch in normal way (as you would do the brakes) now takes about 10 minutes instead of several days.

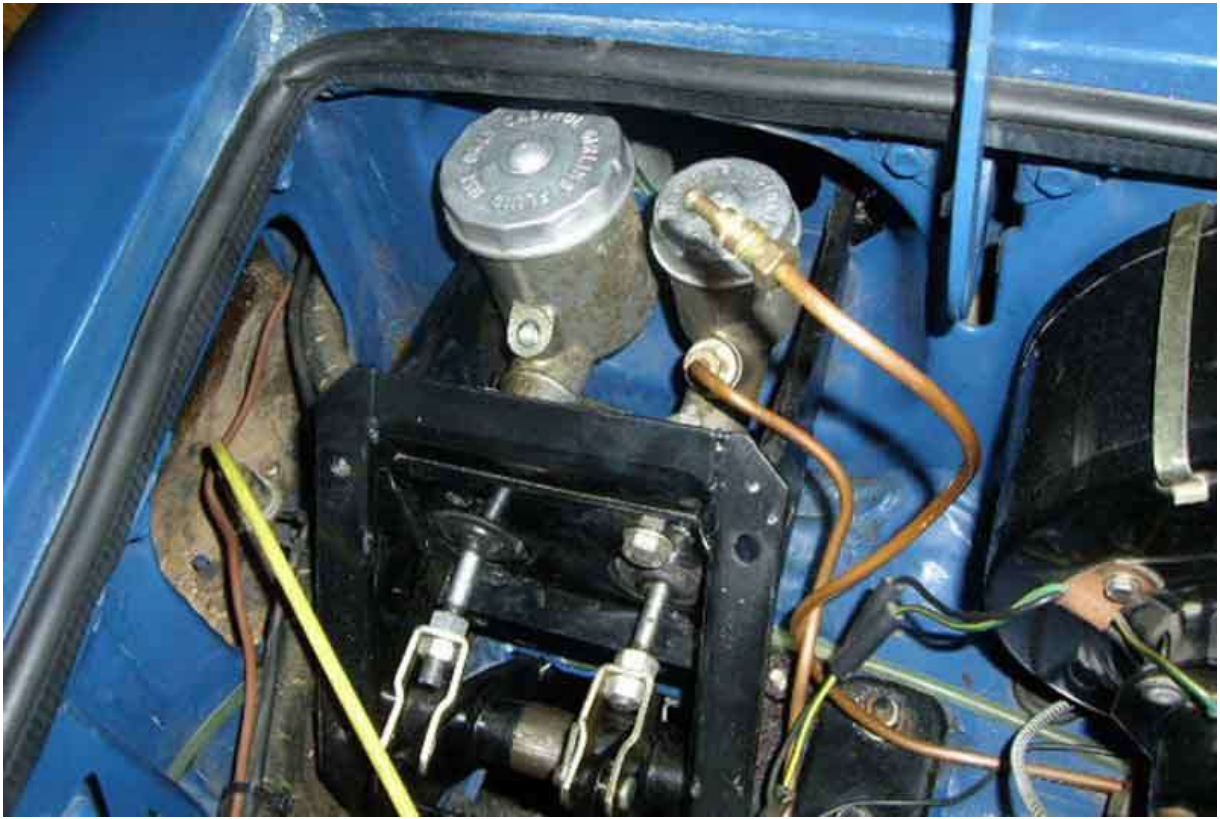
This Girling clutch master is original equipment on the MGC, which has a completely different pedal frame again, and this picture shows masses of clearance for the clutch - which is just as well given the height of the brake master. I'm wondering if the MGC frame positions the master cylinder mounting face forwards of both MGB positions, or is just lower:

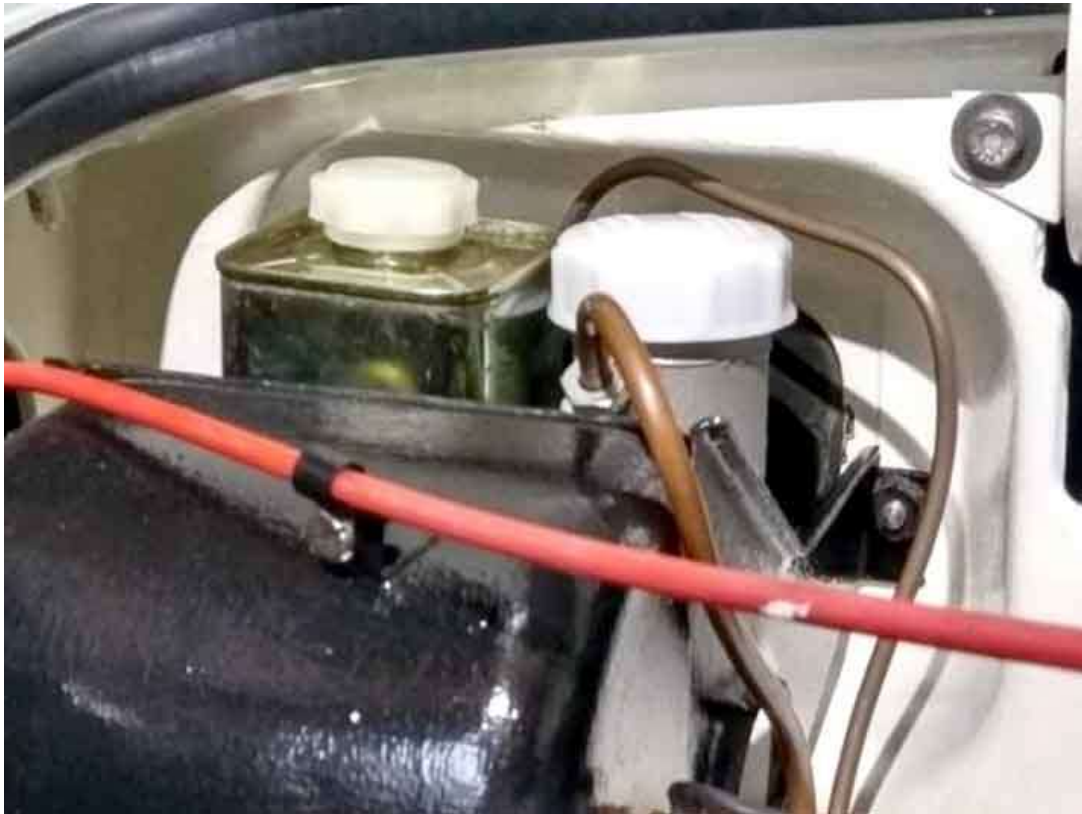
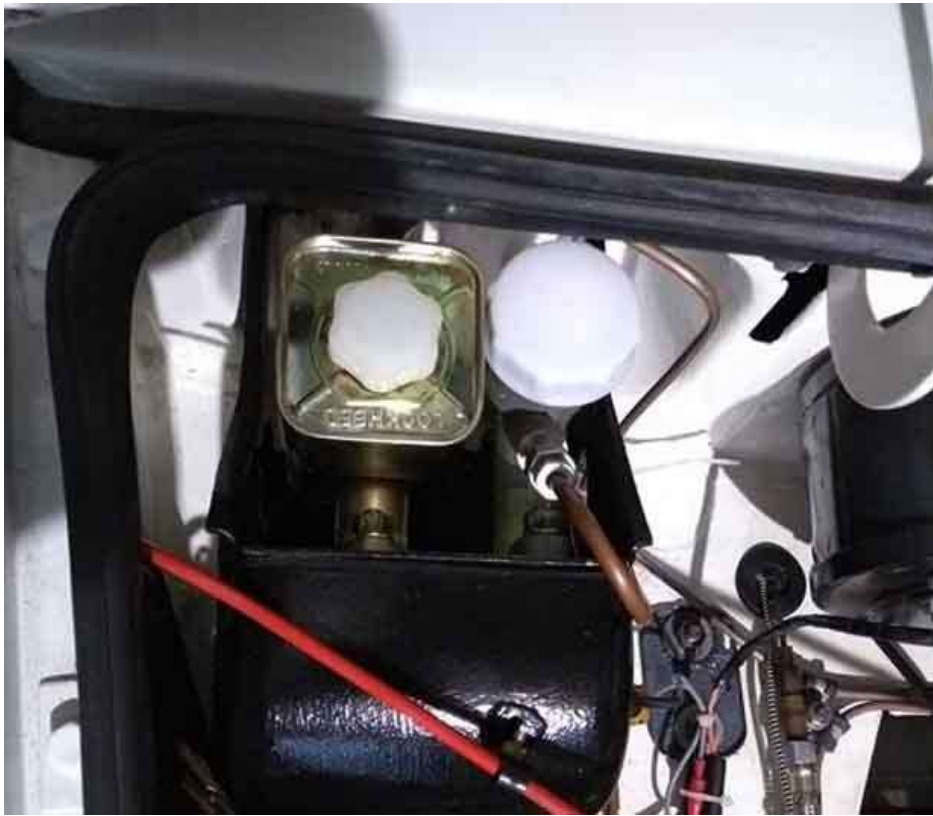
Ray Leborgne's RHD installation, alongside the original single-circuit brake master. The clutch cap is pretty close to the brake master but otherwise clearance looks OK. Ray is contemplating using a Girling brake master as well, but as can be seen from the MGC installation above the MGC brake master almost certainly won't fit in an MGB pedal frame. That's maybe why a second clutch master has been mentioned as an alternative, but with significantly reduced fluid capacity:

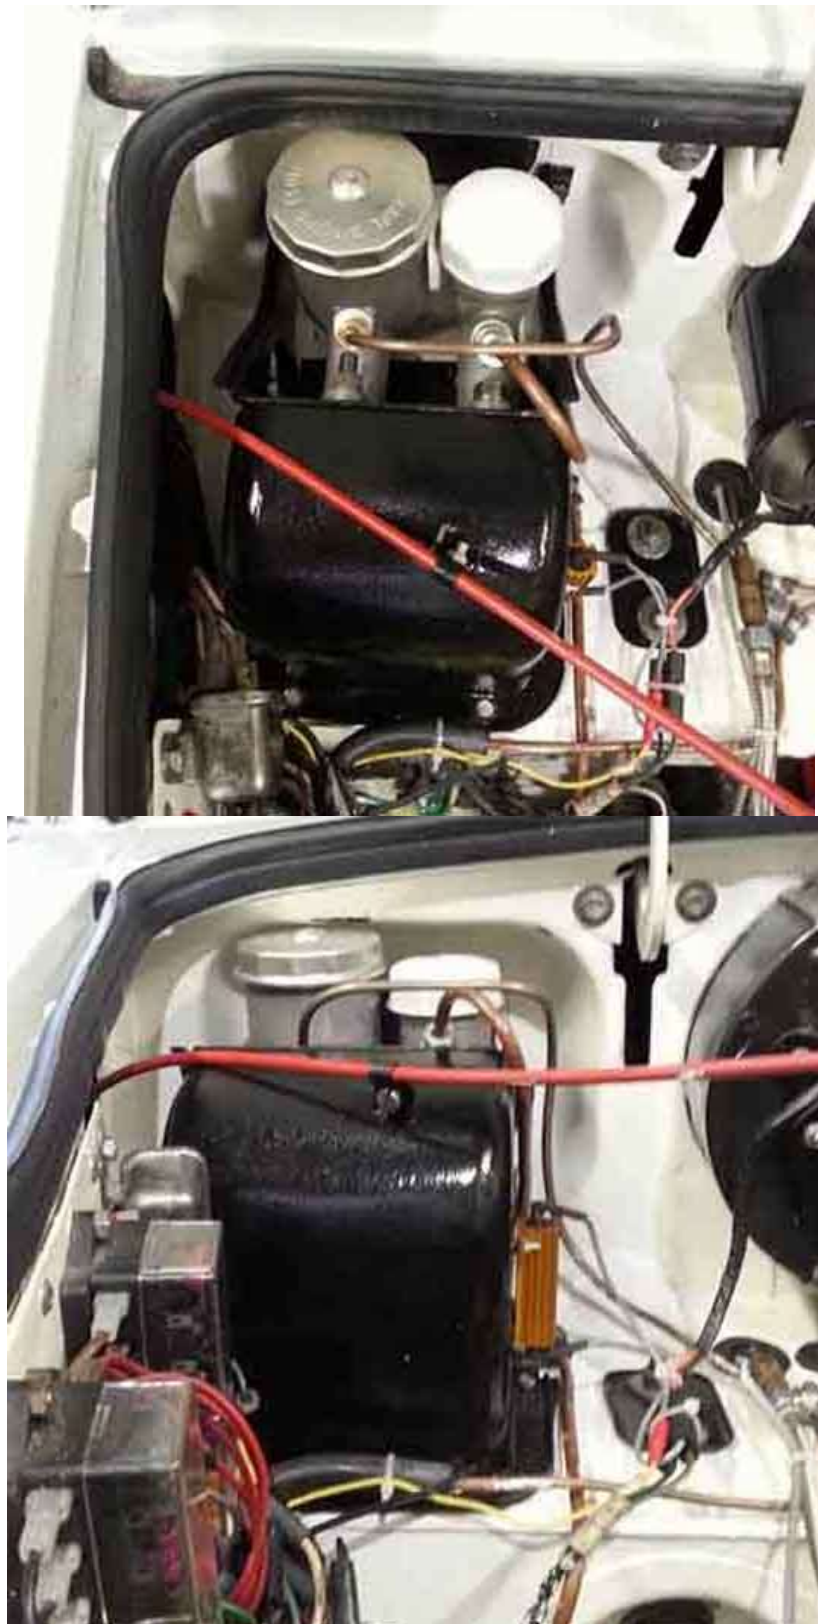
The 'ink' is hardly dry on the above and Ray has fitted a Girling brake master:
