EeziBleed

Dual Brake Masters

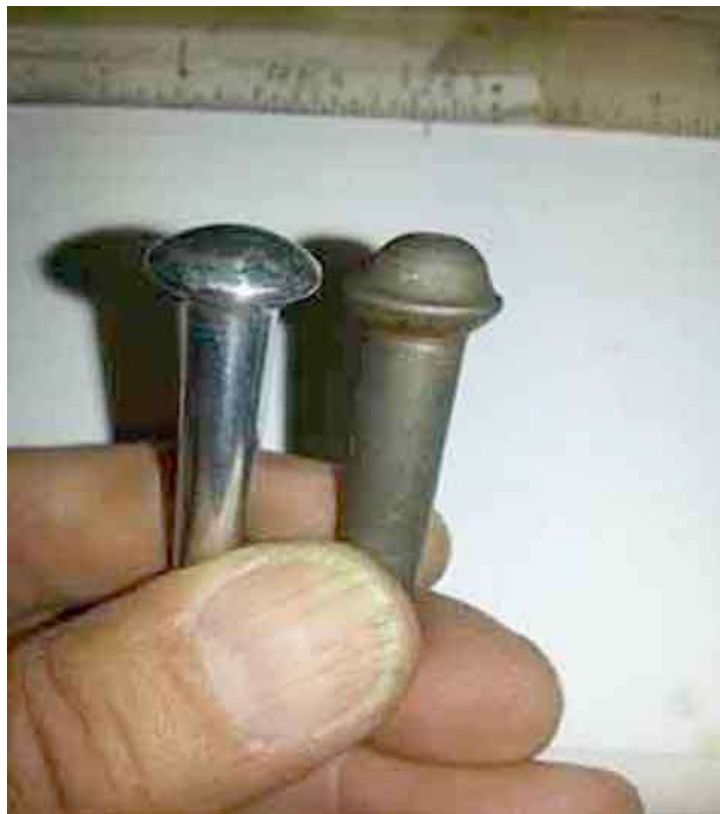
The Girling is on the left, Lockheed on the right. As the Lockheed is more pointed it would move around on the end of the cylinder's piston and because the retaining washer had a large hole the push rod would move to one side and catch the retaining washer on its return stroke. It's done this a number of times when driving, just flick the brake pedal and they would unlock.

The reason (in my view) is twofold, the shape of the old push rod and the size of the hole in the retaining washer.

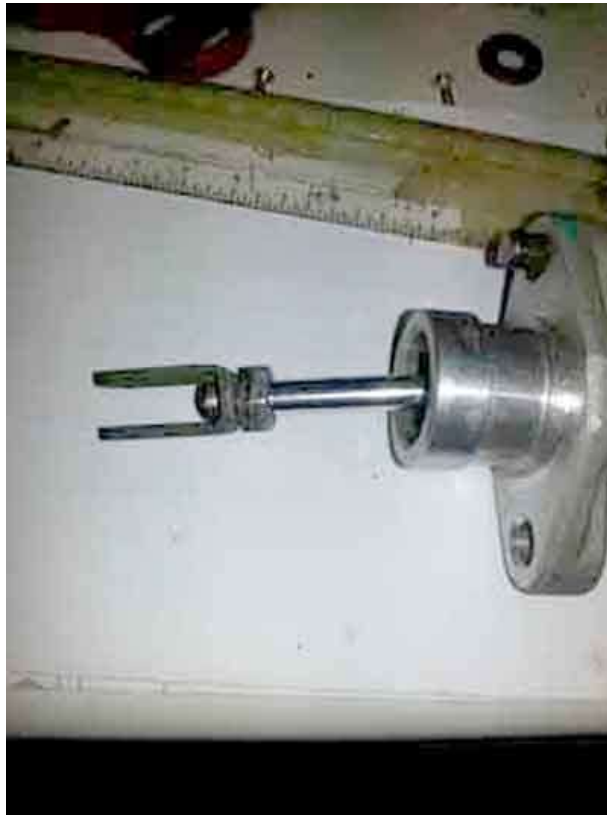
So went back to the Girling push rod, made a new retaining washer (smaller hole) and adapted the old Clevis (drilled and tapped) to fit on the Girling push rod with locking nut. Having a locking nut (half nut) does not interfere with the overall travel of the push rod.

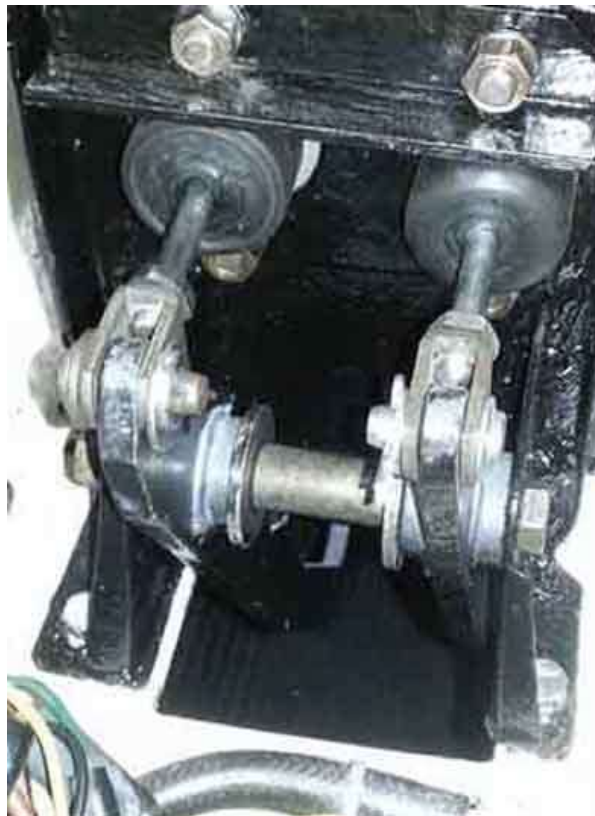
Converted the clutch to match.

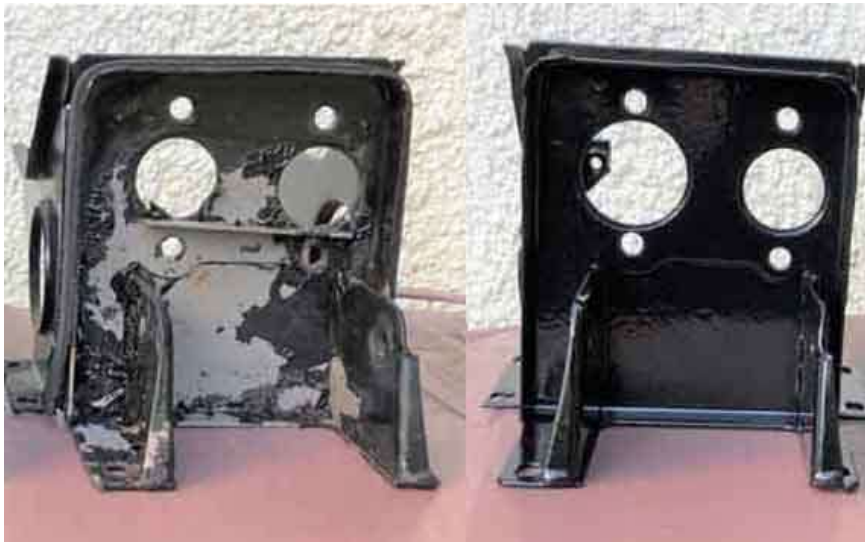
Going by this picture of Mk1 and Mk2 single-circuit pedal boxes side by side from Dave O'Neil the Mk1 does seem to position the master cylinders lower. The covers also changed which tends to support that:

Note that the pedals also changed from Mk1 to single-circuit Mk2 and matching items may be necessary to maintain the geometry of the pedal, push-rod and master cylinder. The box (and cover) changed again for single-circuit rubber bumper, but the pedals didn't.

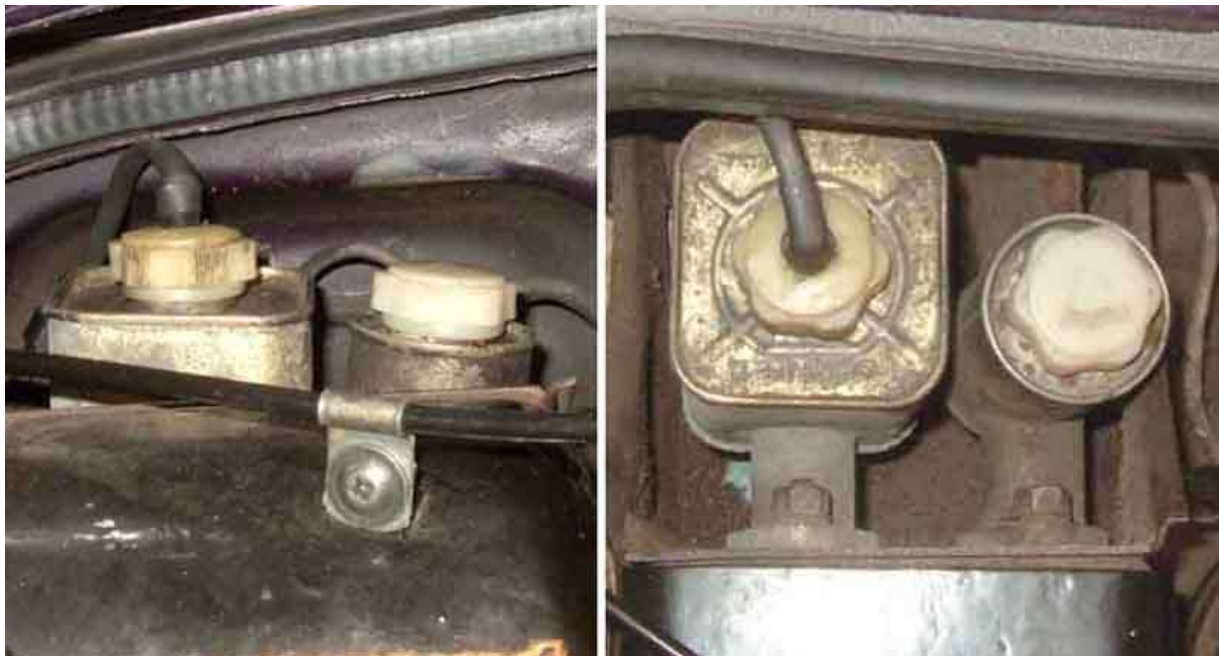
Mk2 Lockheed master cylinders for comparison:

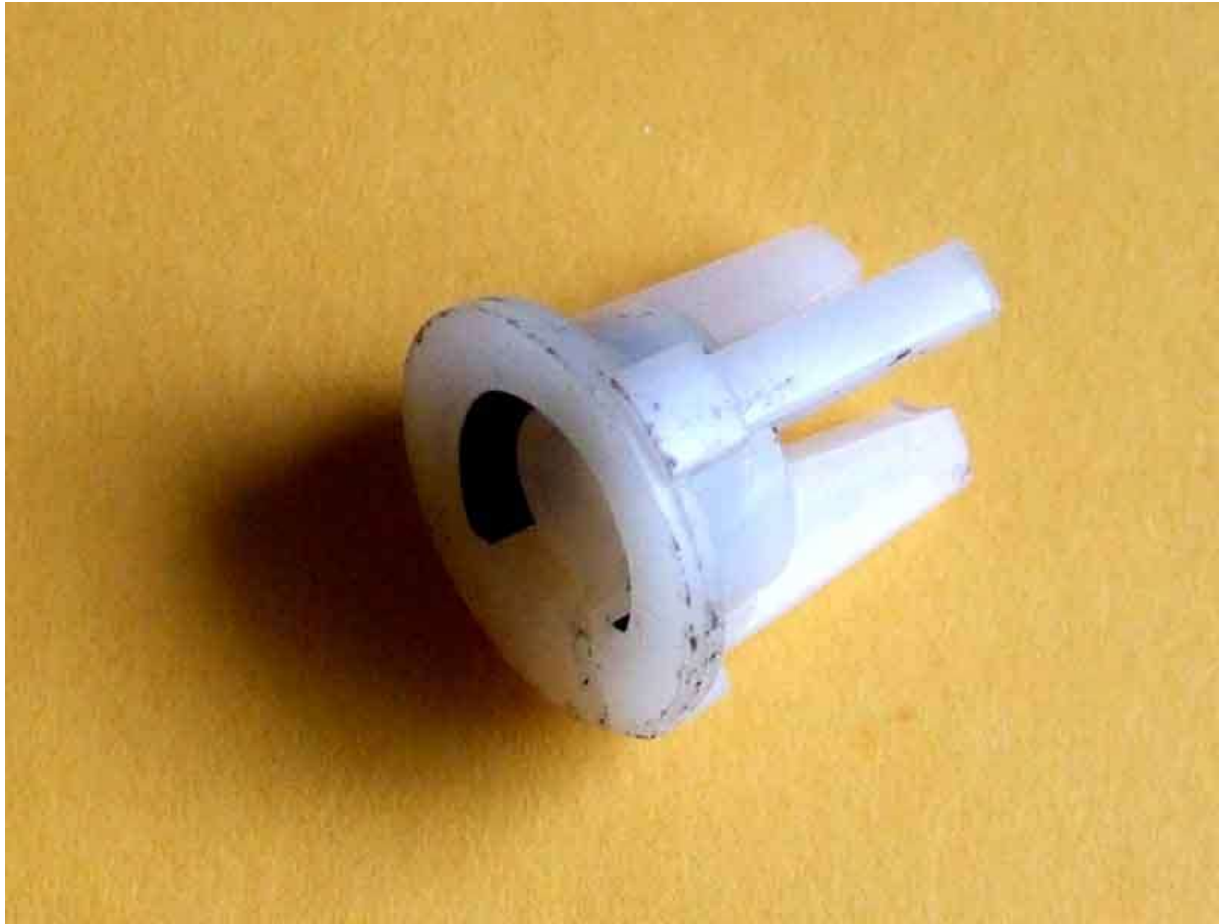
A general view of the single-circuit master valve, which comes as part of the seal replacement kit, but is not shown in the Parts Catalogue. The three 'legs' go in the end of the piston return spring, and the flat face against the end of the cylinder over the outlet port.

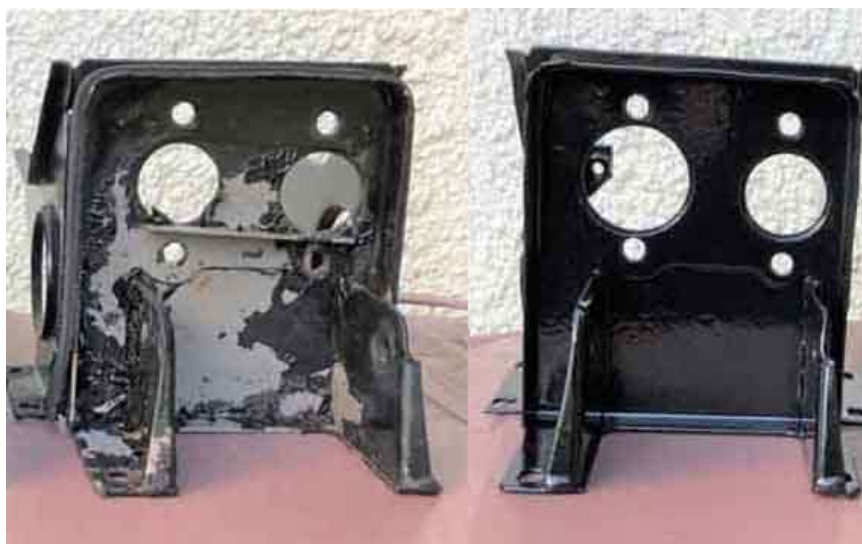
The pedal box on cars prior to the boosted dual circuit system: AHH6065 for Mk1 cars, AHH8421 for single-circuit Mk2 cars with an over-size hole for the brake master and no lower reinforcing to accept the unboosted dual circuit master, although they were fitted to all cars until they gained the boosted dual circuit system. These also have the clutch master canted over a bit to clear the dual-circuit master reservoir cap, but that may be in the construction of the master itself and not the position of the holes in the box. This picture from Dave O'Neill - Mk1 on the left, Mk2 on the right:

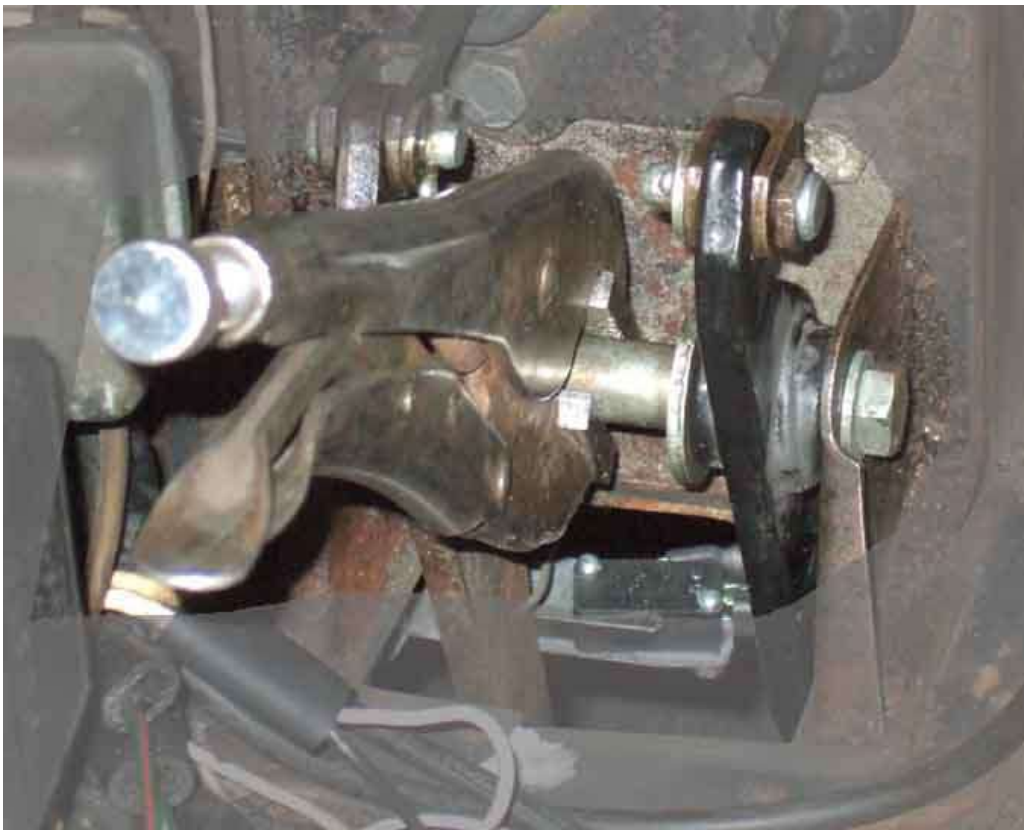
When gripping the distance tube 10 you should NOT be able to rotate it ...

... nor the spacer washers 11. If you can it's not clamped up as it should be. If clamping it prevents the pedals moving then either the pedal bush (15) is too wide or the pivot bush (6) is too narrow. If 10 and 11 are clamped up tight but the pedal still wobbles excessively then either or both of the pedal or pivot bushes are worn where they contact each other.

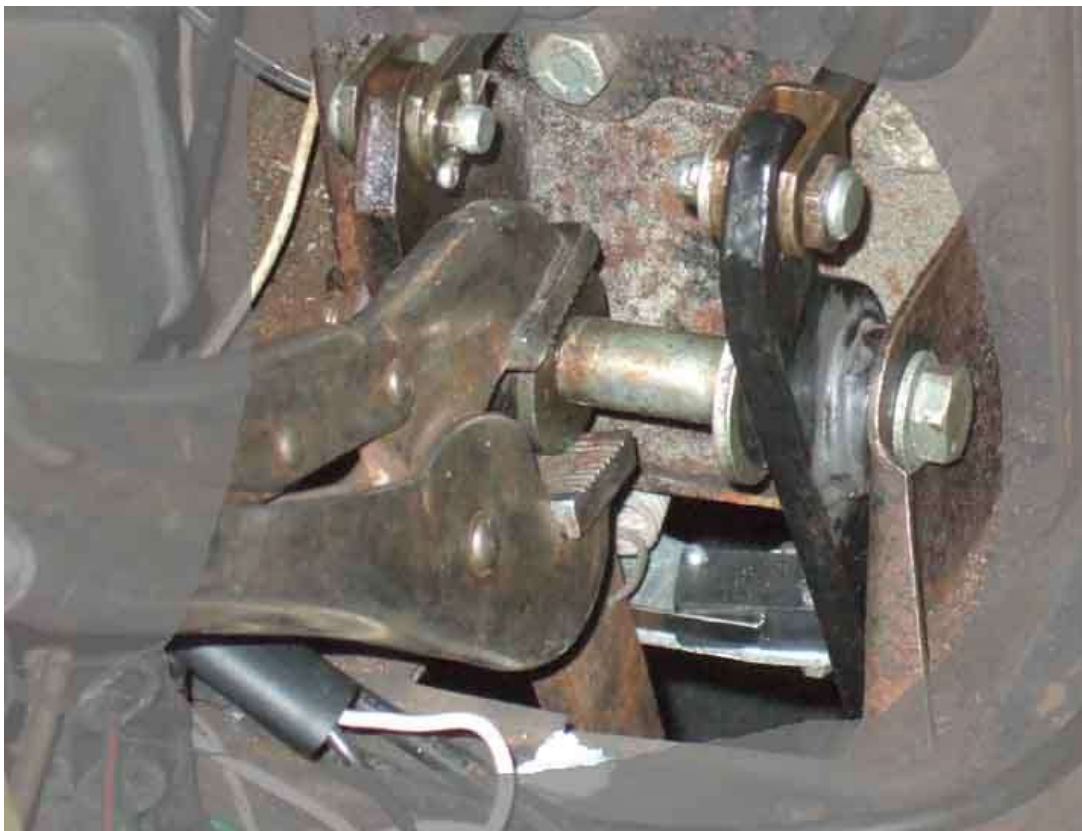
The boosted dual-circuit pedal box: Item 13 'Bush, pedal' BHH1101 for both pedals, not available as of January 2017. Item 12 'Distance Tube' BHH1099 is the pivot bush and item 11 'spacer' BHH1098 for the clutch pedal, neither are available. However the drawings are not to scale as will be seen in the photos below. The pivot bush is much wider than the pedal bush, and the spacer is short and fat and fits over the pivot bush with the pedal. Item 6 'Distance tube' BHH1097 is the pivot bush for the brake pedal and is available. Note that as the pedal bushes are the same item, two of the shorter brake pivot bushes could be used for the clutch pedal bush (one cut down to give the correct overall length). Items 5 and 7 are conventional washers and used under the bolt head and nut i.e. their thickness is not critical, unlike the spacer washers used in the earlier assembly: ([Moss Europe](#)).

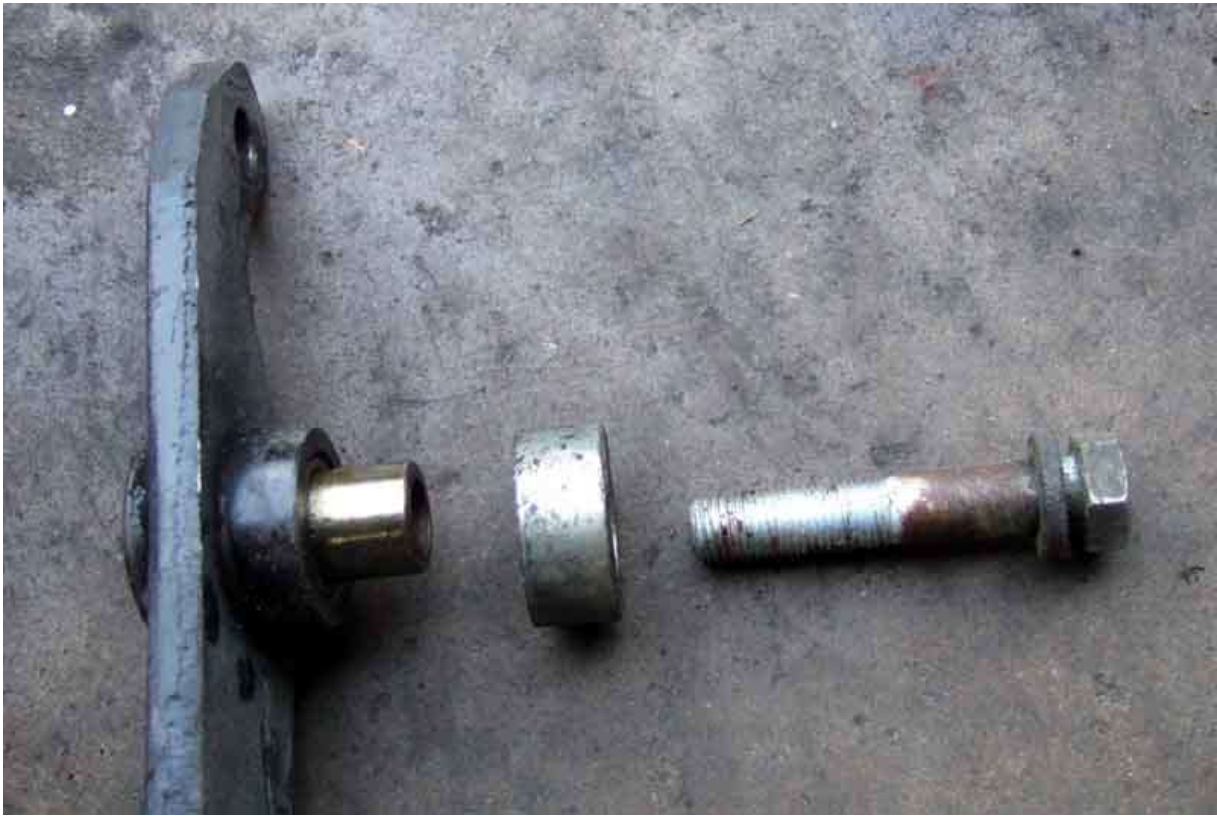
Clutch pedal with the distance tube (pivot bolt bush) flush with the pedal on the left, protruding on the right. The spacer sits on the distance tube with the pedal. The bolt head has a spring-washer. These original bolts do have a plain section below the head, which current replacements may not have, and the distance tube is initially a sloppy fit on the threads. However the distance tube is slightly wider than the pedal plus the spacer, so once the bolt is tightened the distance tube is clamped between the sides of the box, so the clearance between it and the pivot bolt threads is irrelevant.

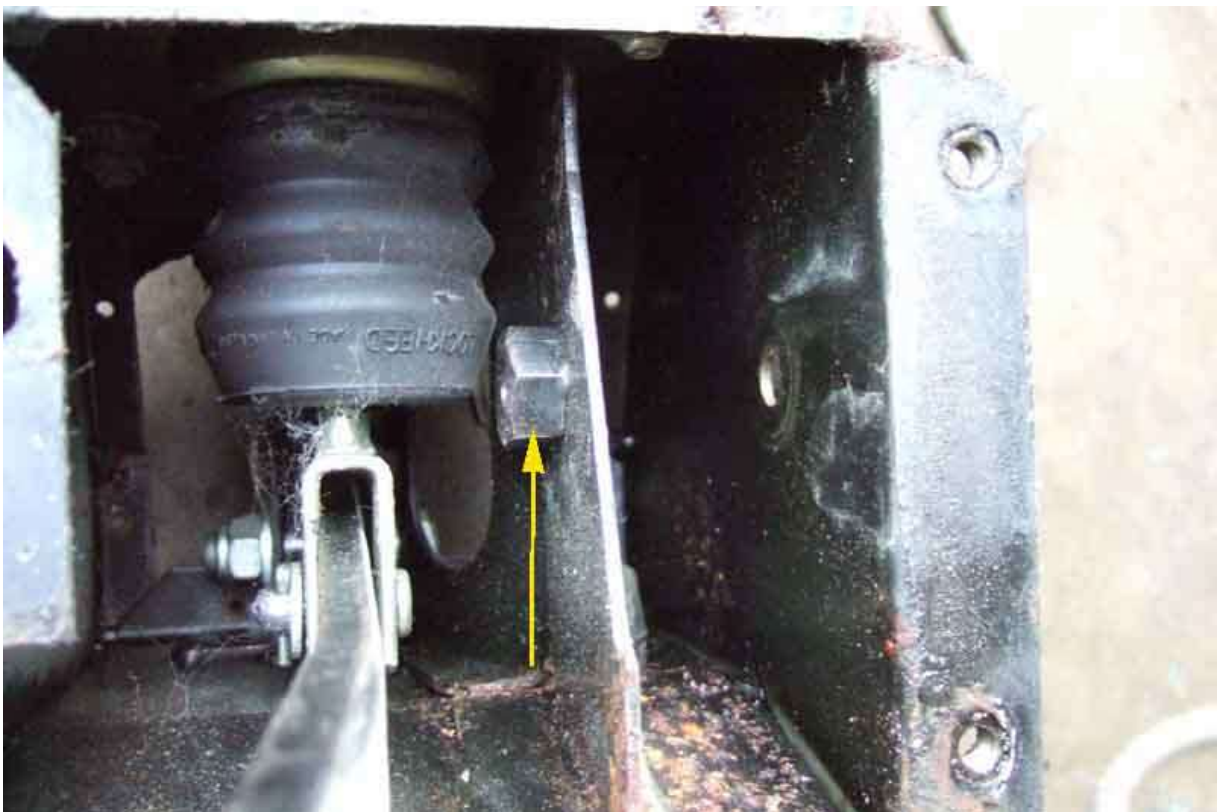
The nut (arrowed) is welded to the box. Tightening the bolt clamps the distance tube (pivot bolt bush) into the box leaving the pedal and this spacer (note) free to rotate but with minimal sideways movement and 'wobble'.

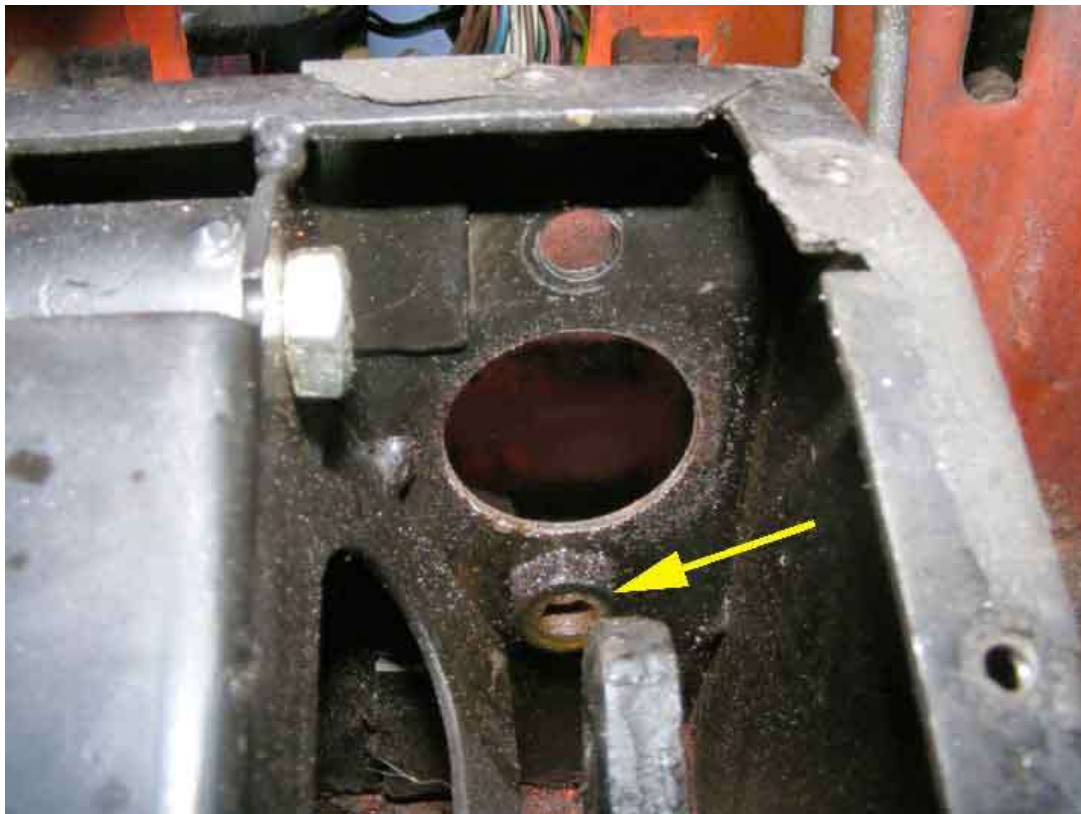
This view shows that the lower clutch master cylinder nut (arrowed) is welded to the inside of the frame, and therefore that the bolt goes in from the back of the master: (*Crispin Allen*)

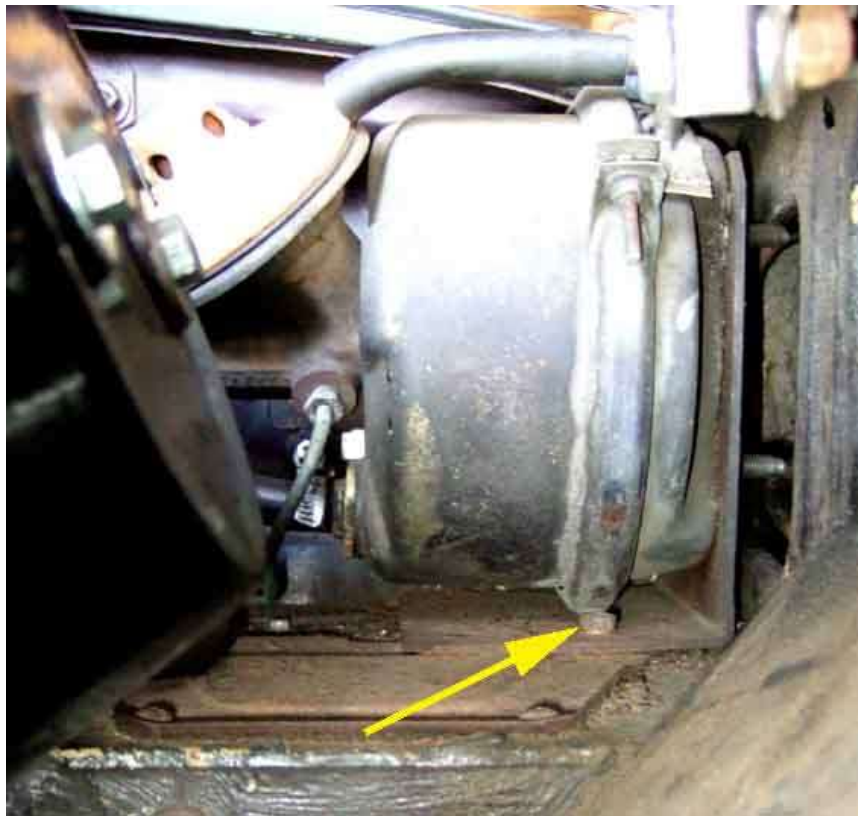
My 73 roadster - fixing bolt arrowed utilising the rear outer mounting point for the LHD pedal blanking plate, possibly another one further back, flattening part of the flange on the LHD pedal blanking plate:

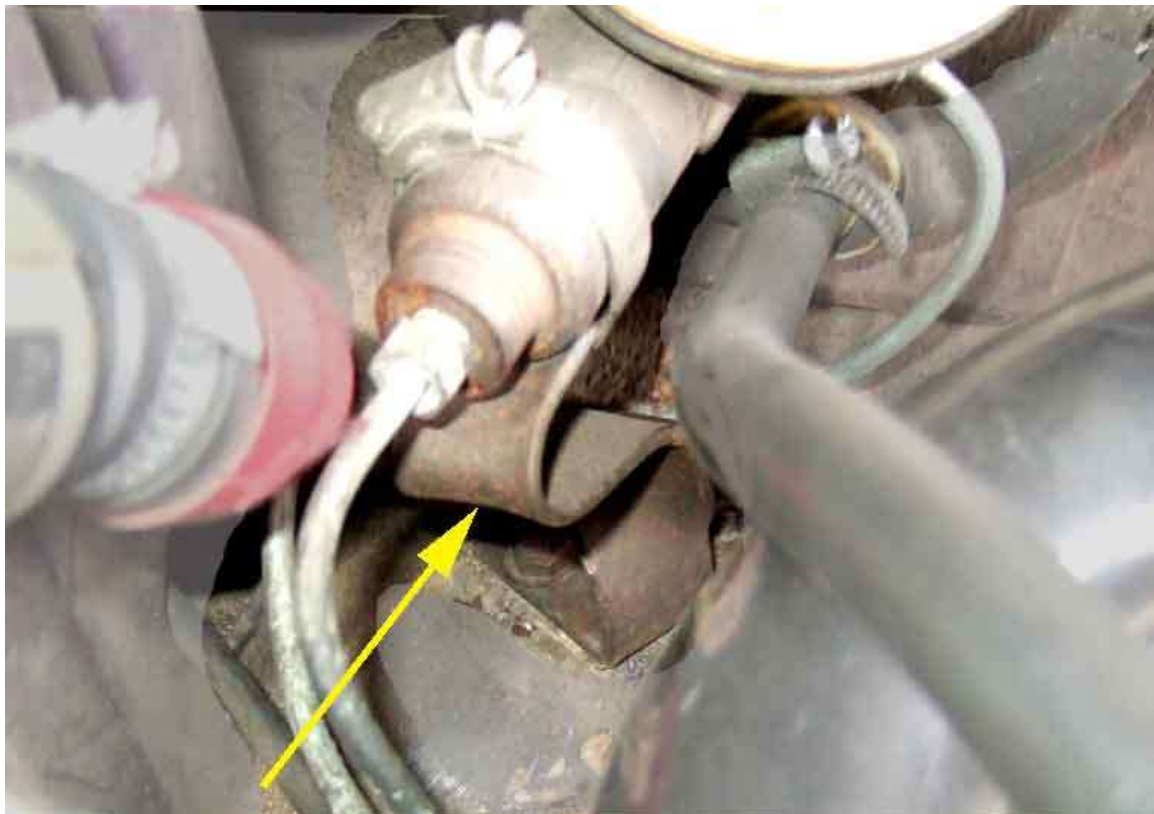
Cylinder support - a crude 'S'-shape secured to the servo with a Jubilee clip:

This has to be a PO retrofit as the servo didn't become standard on UK cars until more than a year after Bee was built and it's not listed under optional extras on the Heritage certificate.

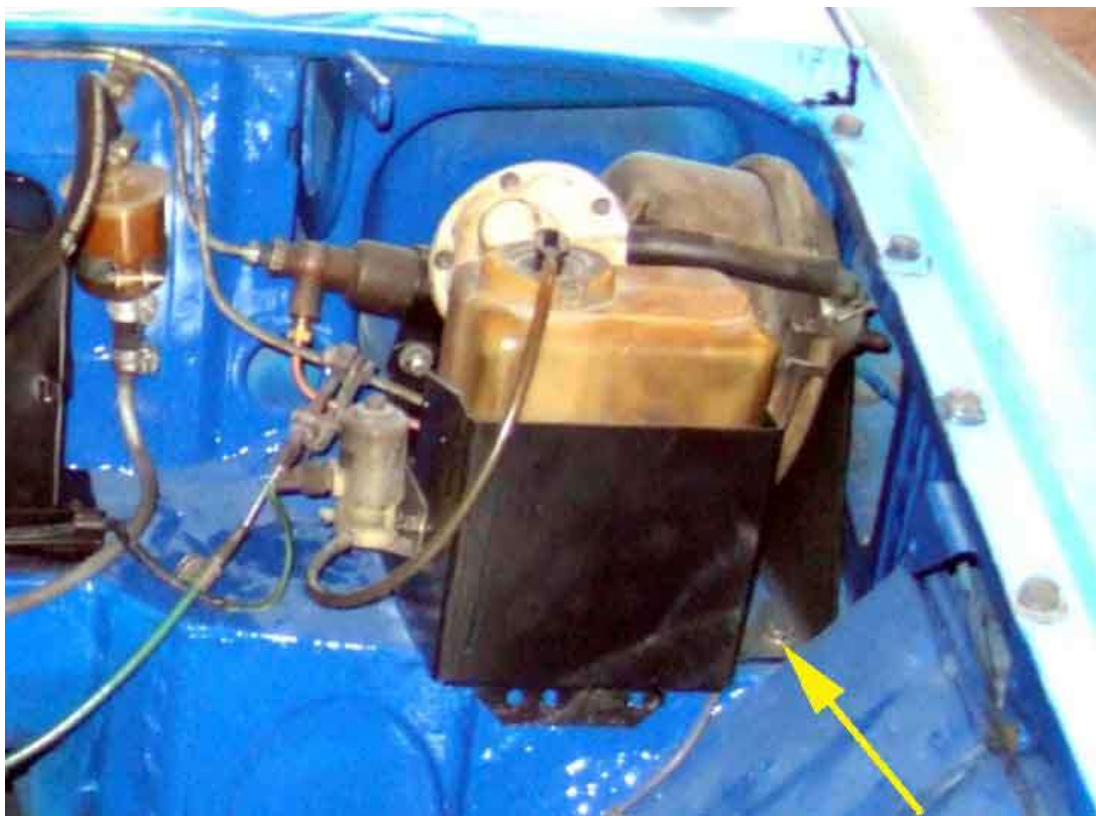
75 V8, fixing bolt arrowed, a bracket stud further back, positions the servo at a slight upward angle, but nothing like the AP/Lockheed drawing below. A much neater installation with the same positioning of air valve and cylinder as shown in the factory brochure:

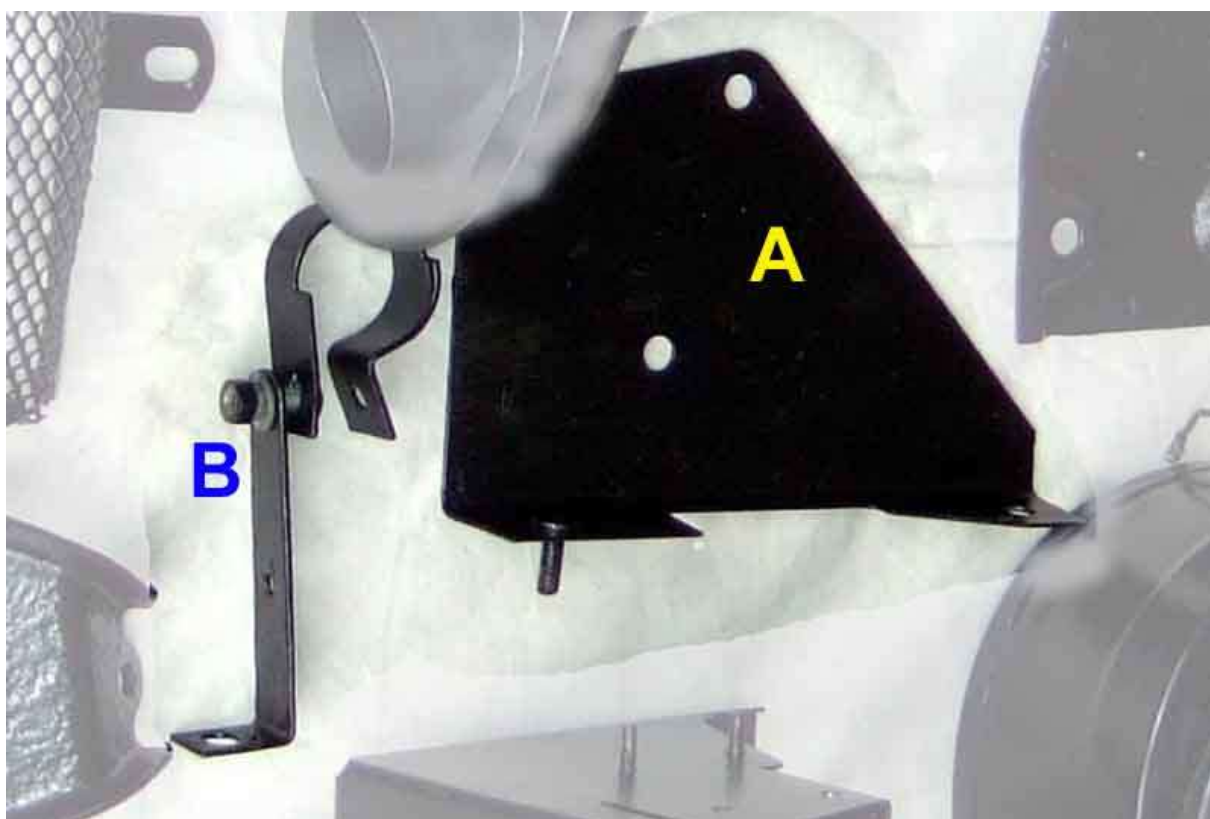
Partially concealed behind other components, 'A' - mounting bracket, 'B' - cylinder support allowing the servo to be angled, used on all V8s and 4-cylinder cars for the 1974 model year on. The feet of bracket 'A' must be angled slightly to tilt the servo on the shelf, but it isn't apparent here:

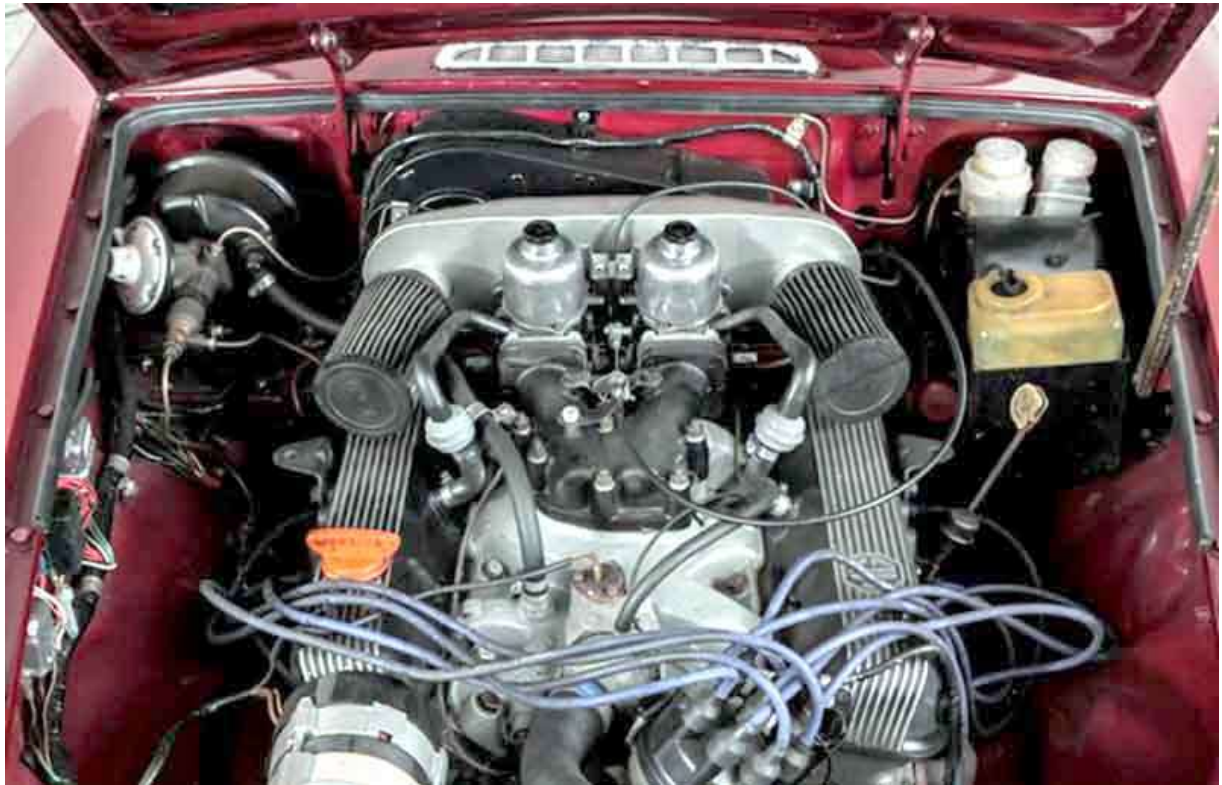
LHD single-circuit with servo: This picture of an LHD V8 clearly shows the servo pointing forwards. A number of LHD V8s were built for testing in North America, so this appears to be a factory installation. They were returned to the UK then sold into private hands in Europe. This appeared in an advert in Holland sent to me by Hans, presumably for one of those cars. There was one in Damask Red, which this appears to be:

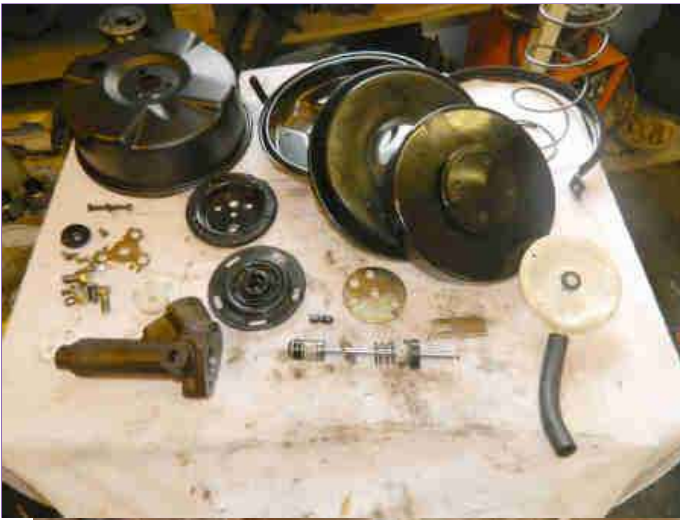
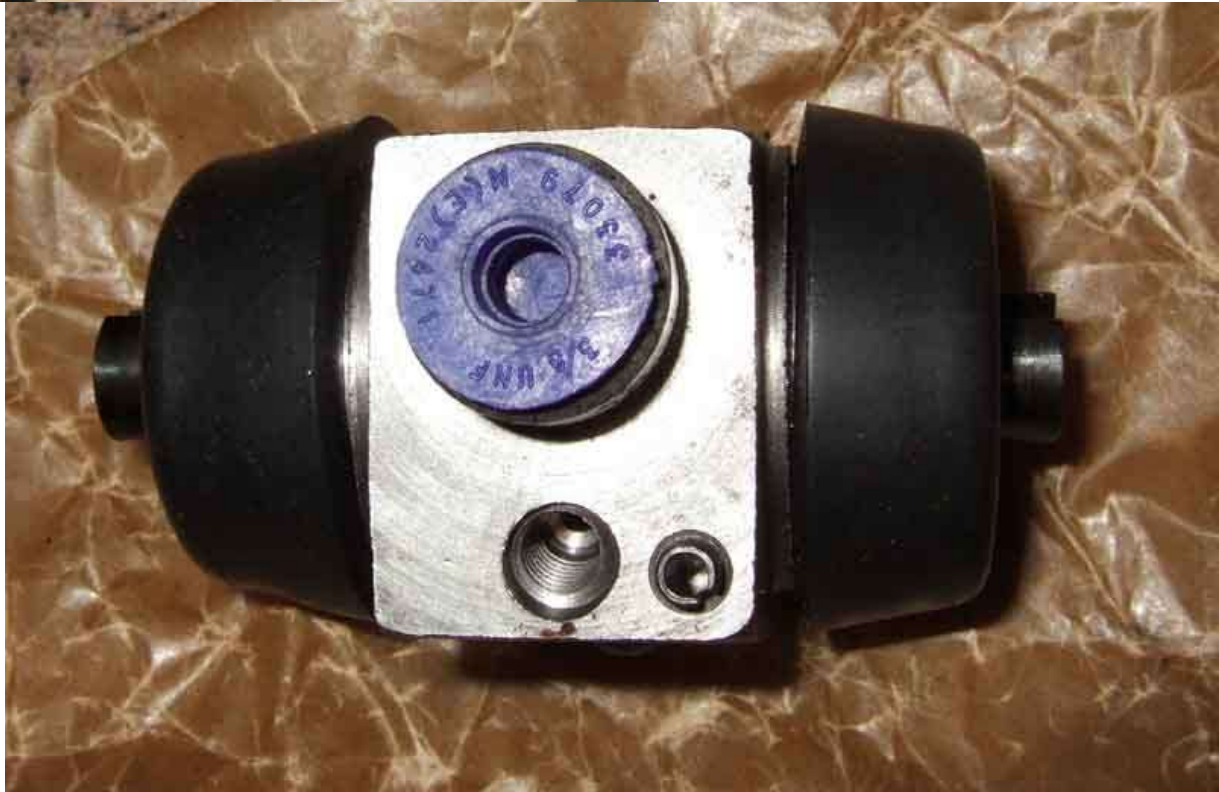
Later GT (not V8) cylinder showing the locating peg further away from the fluid port ...

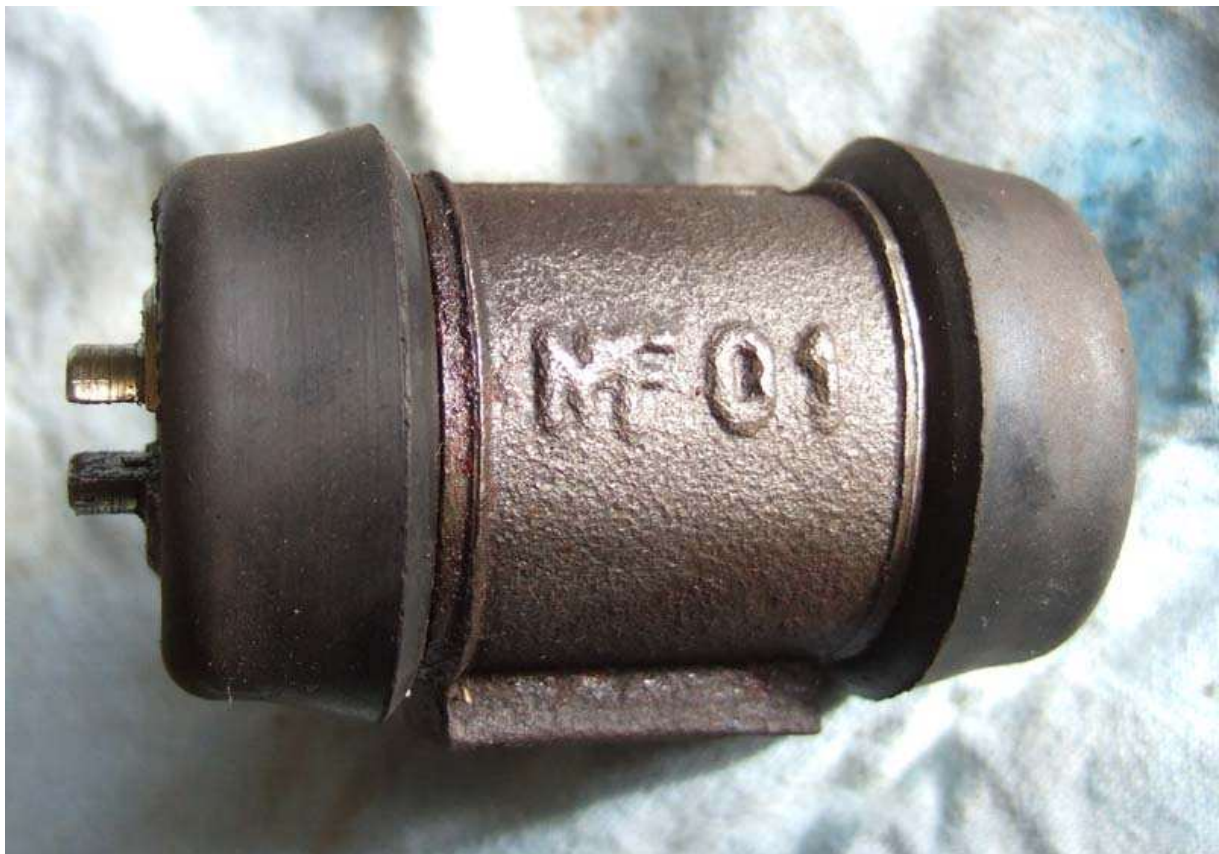
Bee's right-hand cylinder which had just started leaking during a service. This image makes the outside look very rough and rusty, but in fact it is shiny metal, just a rough casting.

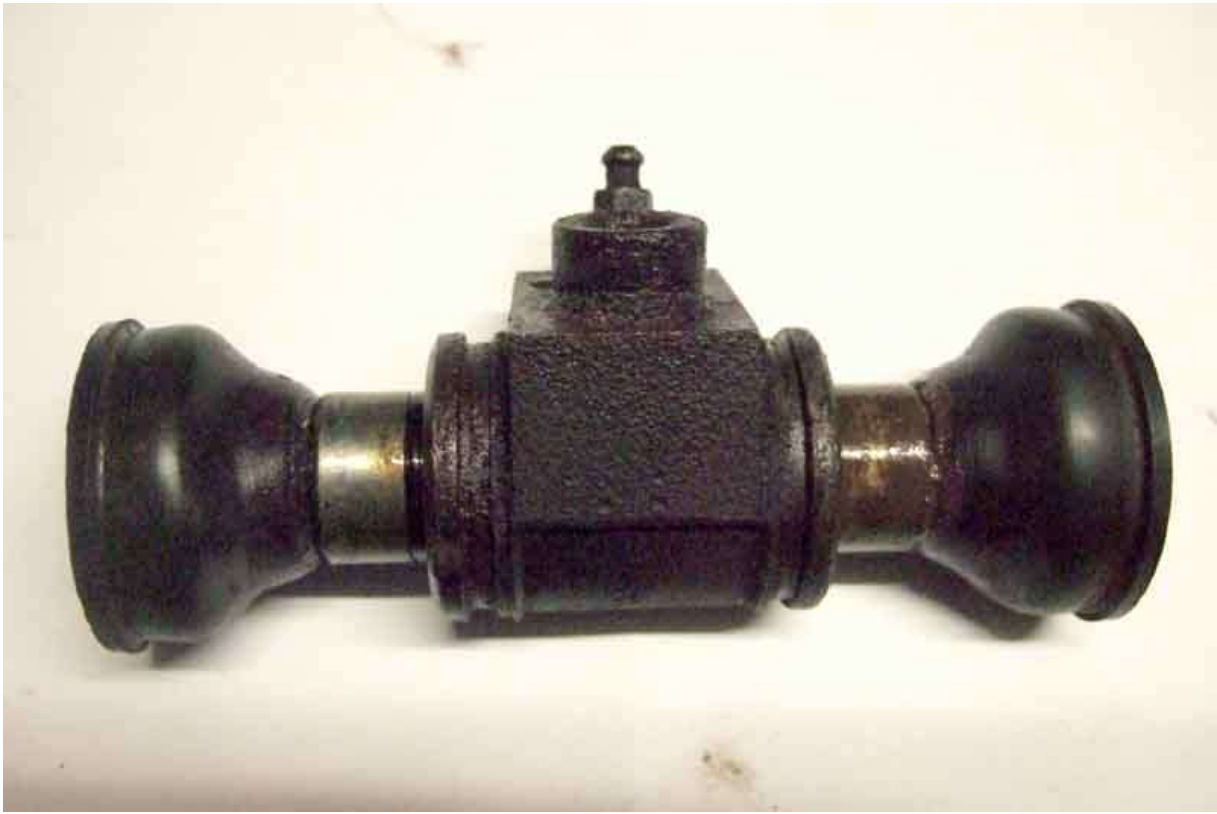
Right-hand end (the lower end when installed) containing rusty fluid in the boot and the bore with roughness, the other end was fine.

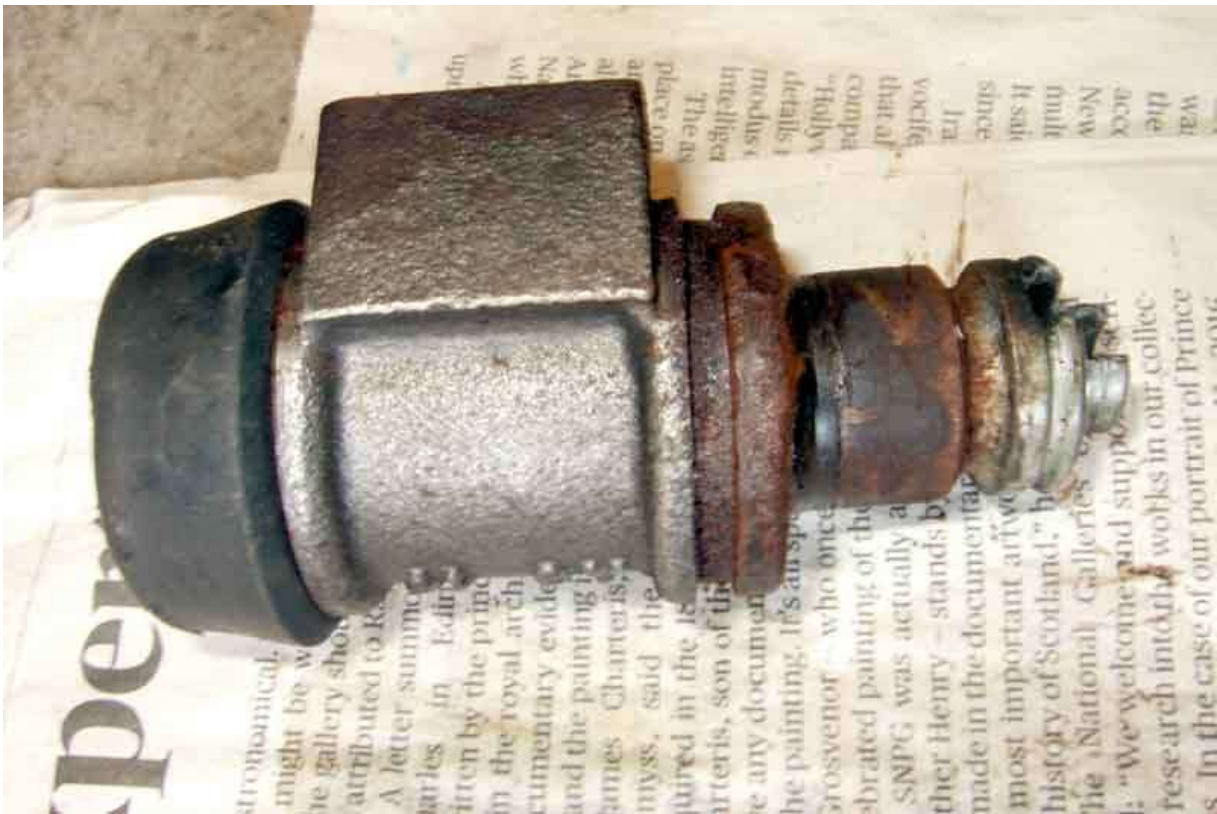
2021 and Vee's off-side wheel cylinder. Outside shiny metal but very rusty under the cover, as are the piston and bore outside the seals:

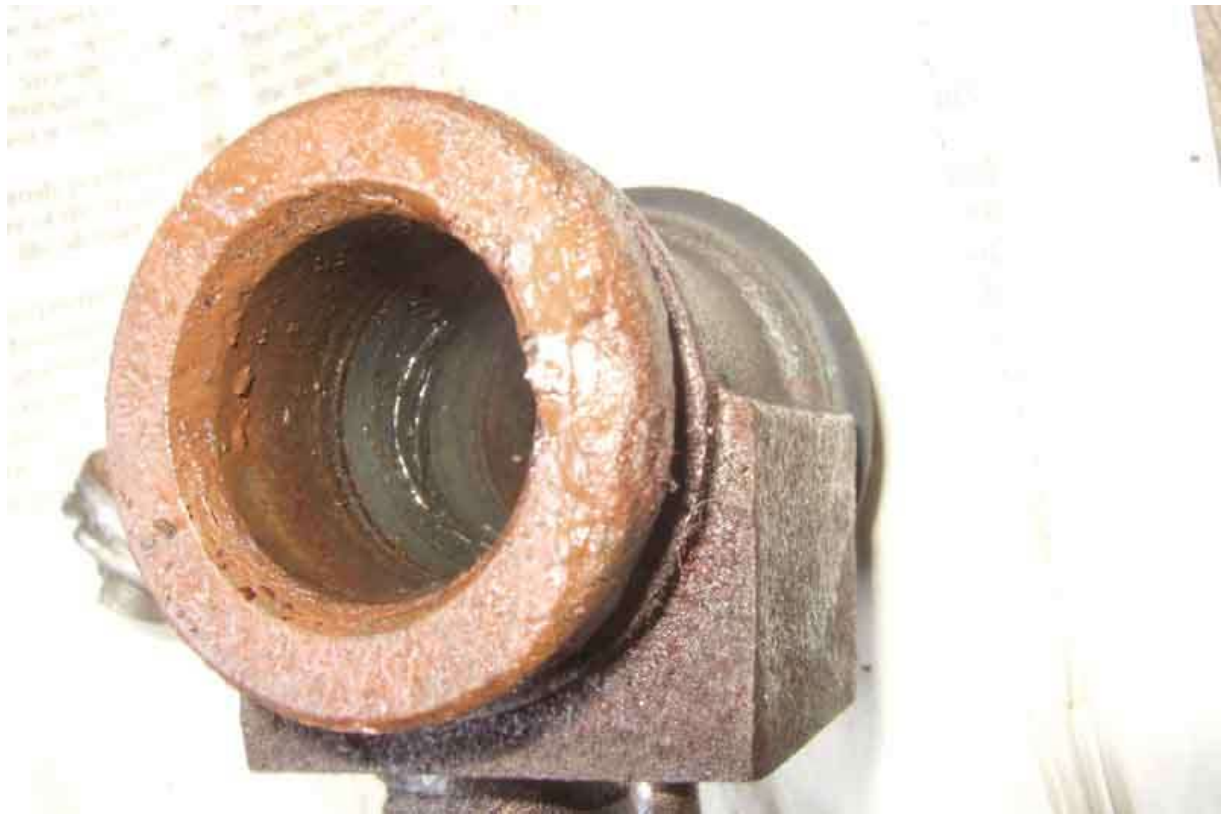
Clean bore where the seals run:

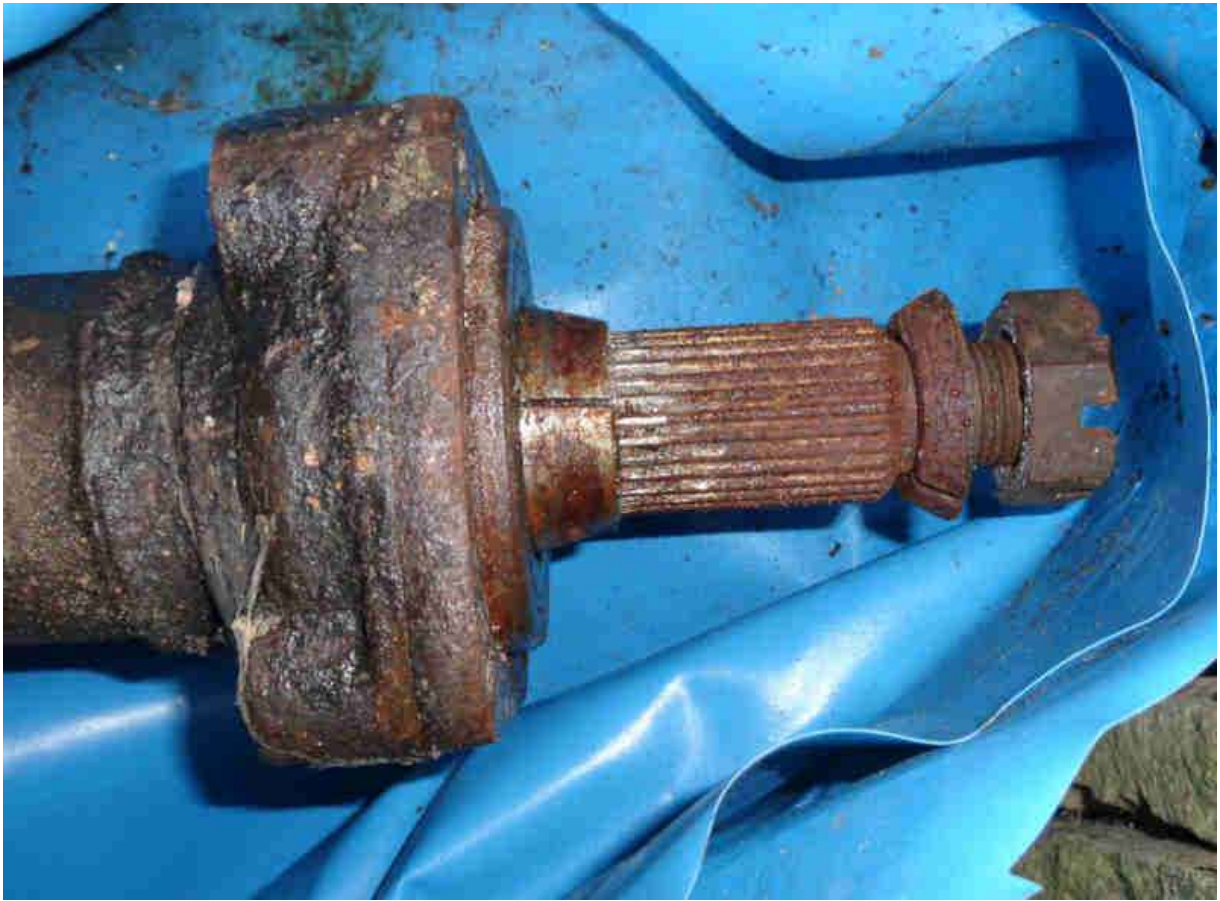
Axle with bearing cap. The join between the two can be difficult to see as the two halves are rough cast on the outside and the same size and shape:
