EeziBleed

Dual Brake Masters

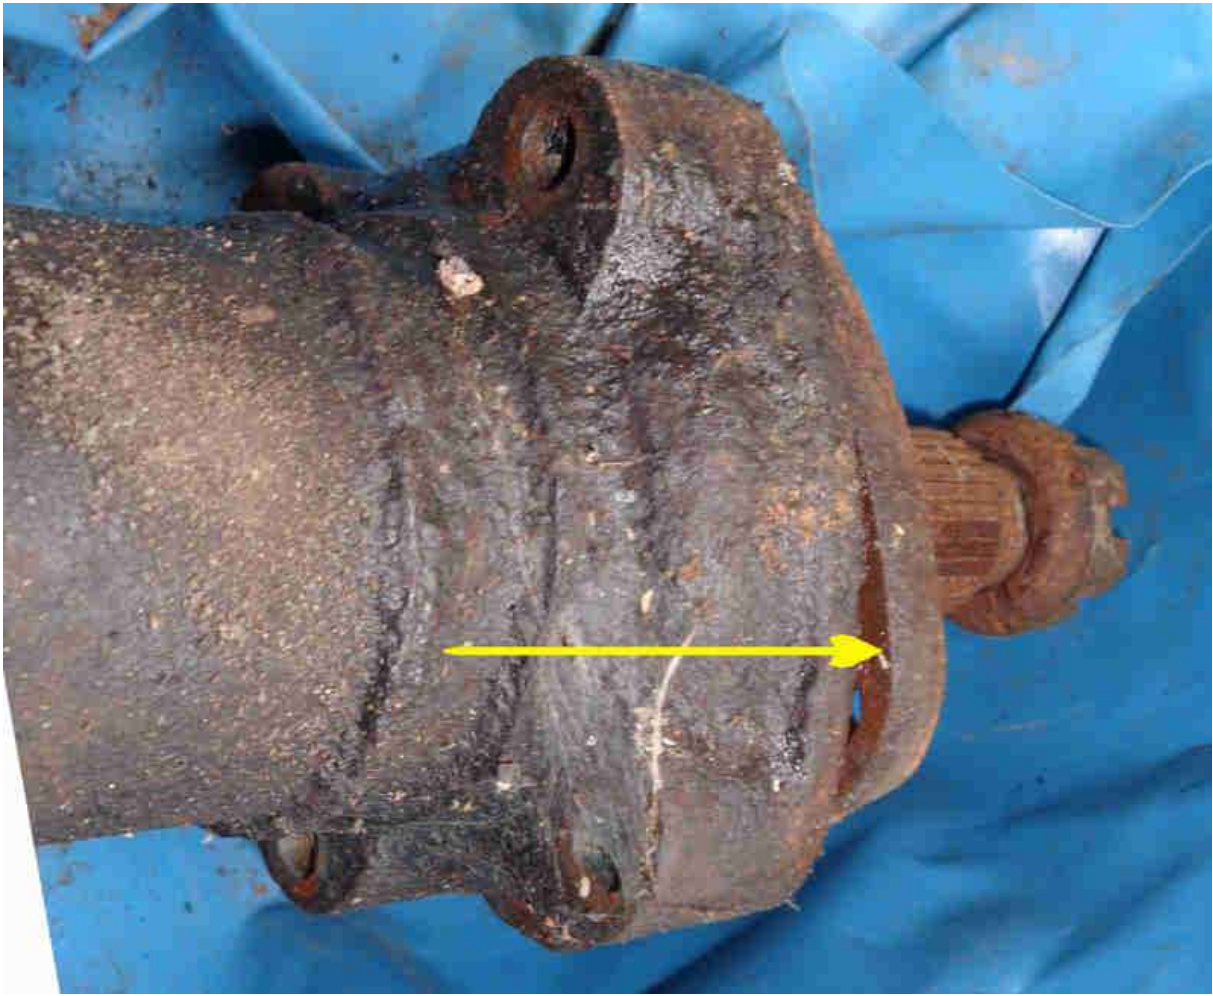
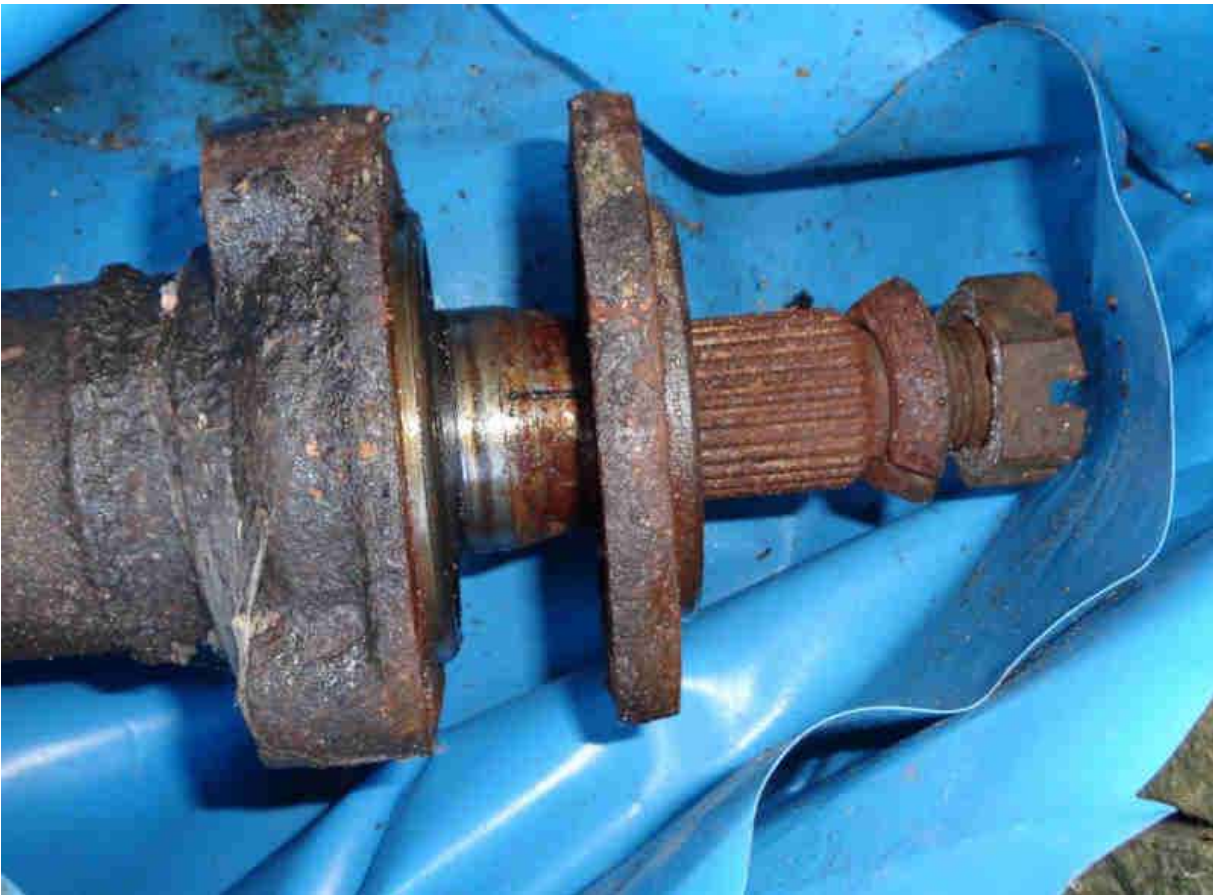
If struggling to part them try tapping the cap round with a hammer and drift above one of the holes, then a soft drift round the back of the cap on the now exposed parts should release it:

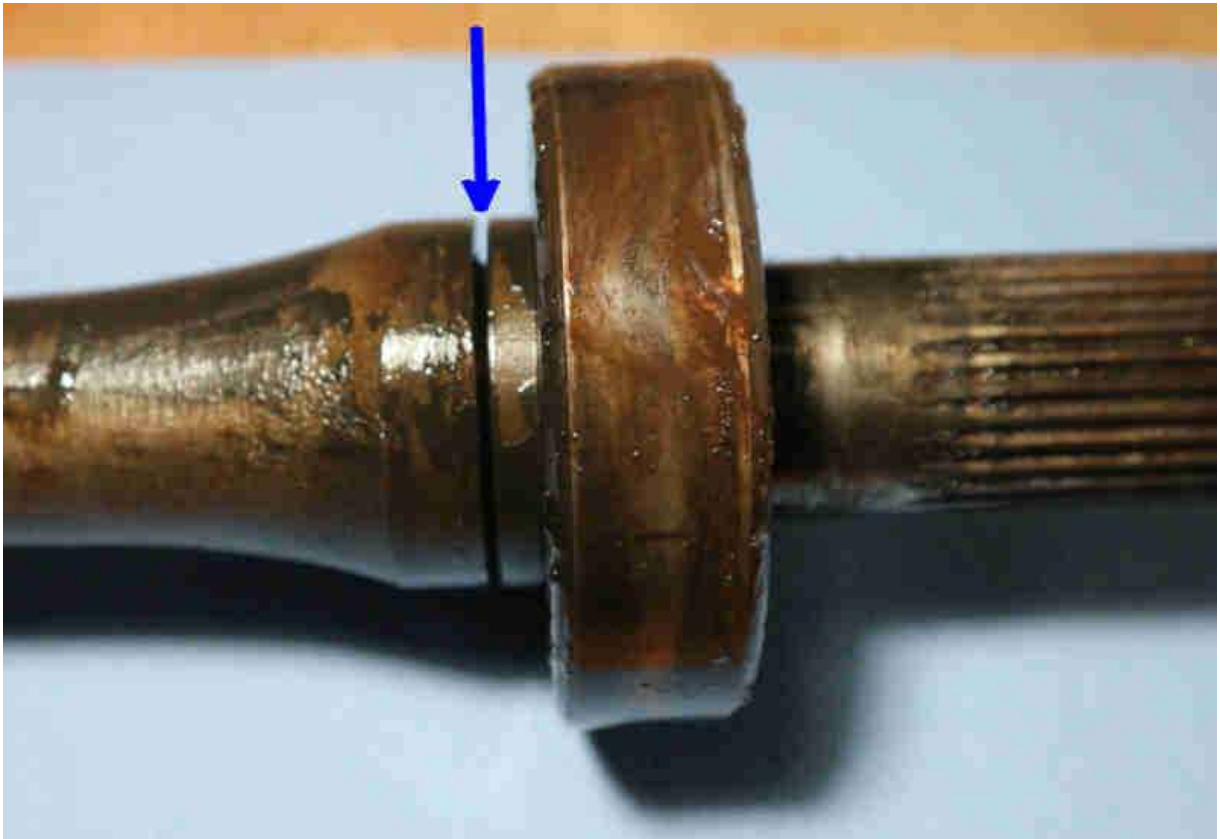
Father Ted's half-shaft with a clear gap between spacer and shaft shoulder:

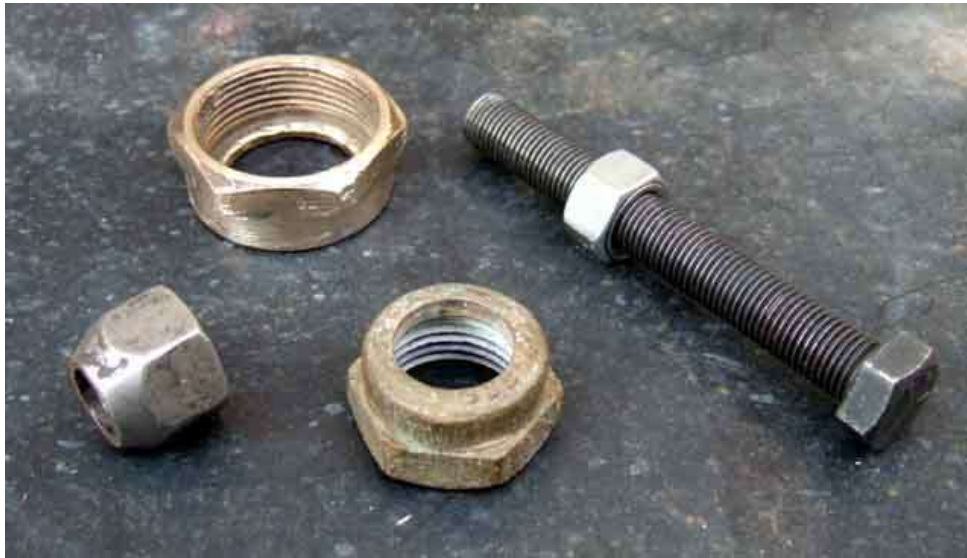
The tool I put together:

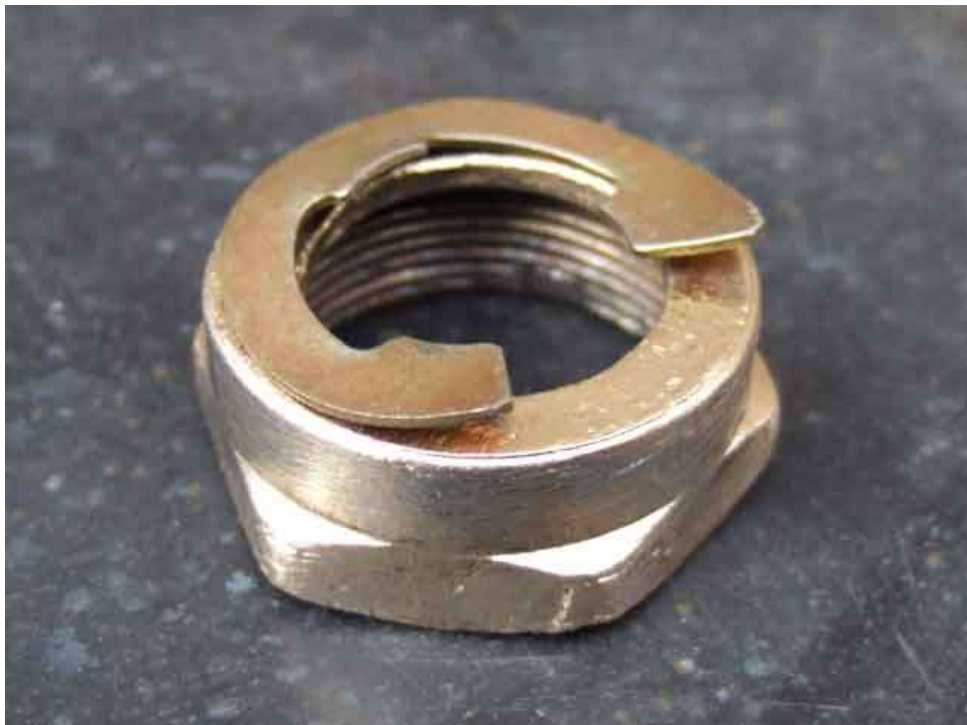
Looking at the clip it consists of a ring with a section cut out and three tongues pointing inwards. It isn't flat but slightly twisted such that the middle tongue is bent one way and the other two the other which makes it 'handed'. Whilst it can be fitted either way I found that if fitted with the two end tongues pointing towards the backplate held the cylinder in place, it was a bit sloppy, but fitting the clip the other way up results in the 'spring' in the clip holding the cylinder firmly. It seemed to me that by pressing down evenly on the outer part of the ring you could get the tongues to ride over the edge and slide down the sides of the boss on the cylinder at least part of the way. Then it should be a relatively easy matter of pressing the tongues down to drop into the groove of the boss. Both the commercially available tools use a bolt screwed into the pipe fitting of the cylinder, and a nut on the bolt to apply the force which seemed reasonable, and a 3/8" UNF bolt and nut satisfy that requirement.

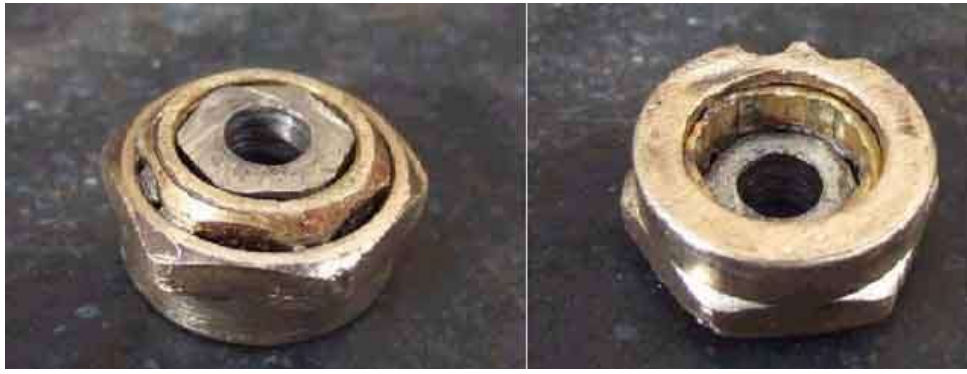
I found a brass pipe fitting in a box of bits where the outer circumference of the fitting was just slightly bigger than the clip as shown above (note that this picture shows the clip the 'wrong' way up).

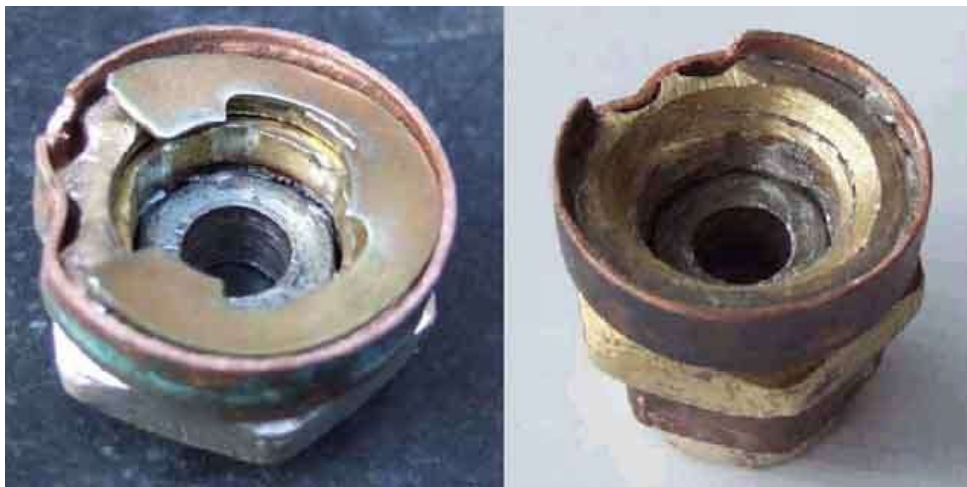
The next requirement is to be able to position the clip correctly and firmly before applying the pressure. The fitting above has a large hole in the centre which allows far too much lateral movement, but I found that the Outside Diameter (OD) of a nut off a 1/2" compression fitting was just slightly bigger than the Inside Diameter (ID) of the larger fitting, and with a little filing down of the angles of the spanner flats allowed it to be pressed into the larger fitting. This still left quite a bit of free play, but I found a wheel nut (off a Metro, or possibly dating back to when I had a Mini around 1970) again with a little filing could be pressed into the inner fitting. This was the same 3/8" thread as the bolt, so drilling a clearance hole allows it to slide up and down the bolt while giving very good lateral location. This left the tapered section of the wheel nut standing proud, which I cut off.

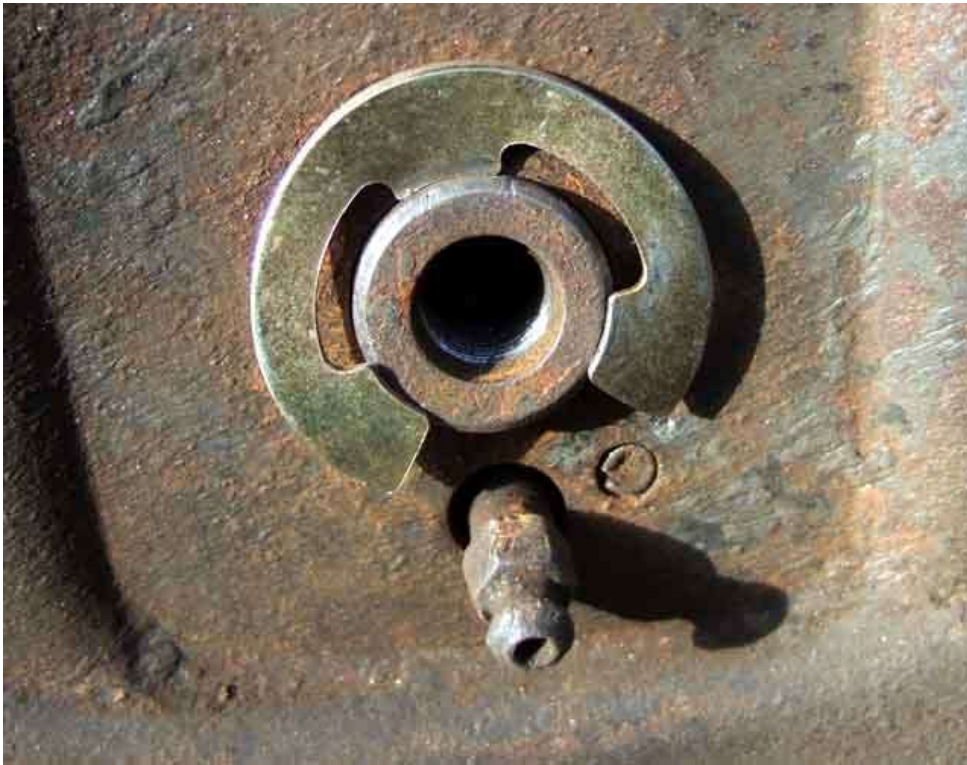
This still allowed the clip to move around under the 'tool', but I found an old copper U-bend a short length of which snugly fitted over the circular portion of the larger fitting to hold the clip in exactly the right position. To clear the bleeder valve and locating peg I shaped the brass fitting and copper sleeve as shown. A later refinement (right-hand picture) was to chamfer the ID of the outer fitting to make it easier for the tongues of the clip to be eased over the end of the cylinder boss. Note that in the left-hand picture the clip is in the correct orientation for fitting.

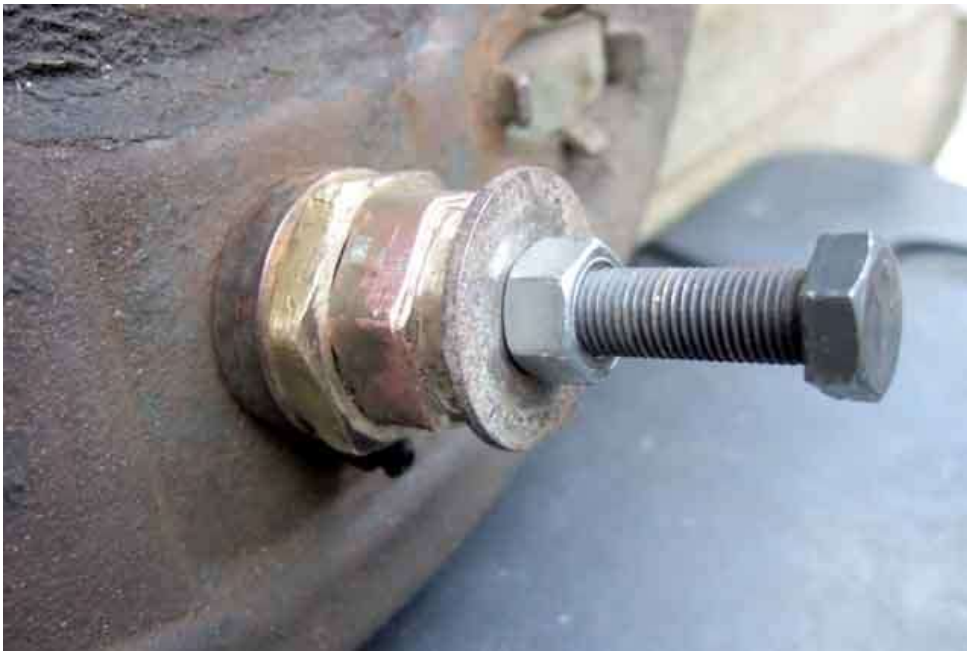
In use you just 'hang' the clip off the boss by its middle tongue ...

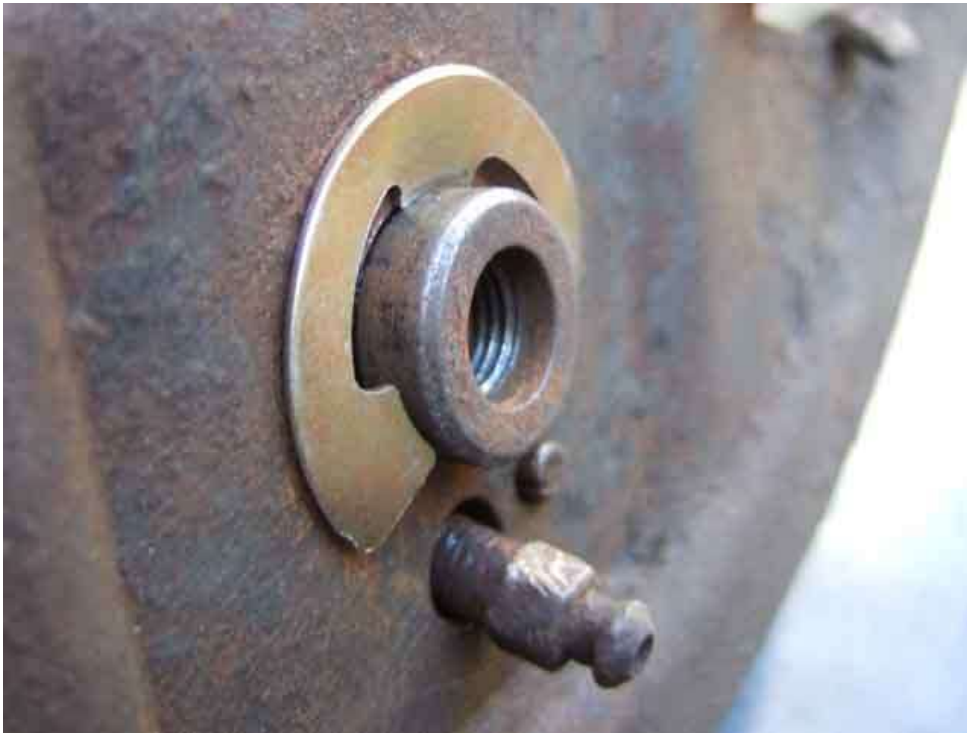
... then fit the tool over the clip while you screw the bolt into the pipe fitting. Gently turn the nut, there is a little resistance then a 'click' and the nut becomes much easier to turn ...

... as the clip slips onto the boss, although the tongues are not yet located in the groove. At this point you could press the tongues of the clip into the groove one-by-one with a screwdriver with no chance of it pinging off but I wanted to go a bit further. I had noticed that the ID of the 1/2" compression fitting nut I had used was just slightly smaller than the OD of the slave cylinder boss. I found another nut and a bit of work with a file opened it out so it just slides over the boss. This then can be used with the bolt and nut as before and a suitably sized washer to press all three tongues into place in one go. I felt it would be nicer to have both parts of the tool attached together and found another piece of copper pipe of smaller diameter than the first which with a bit of shaping was an interference fit over the spanner flats of the two 1/2" compression fitting nuts so holding them together. They could be brazed but I don't have the facilities.

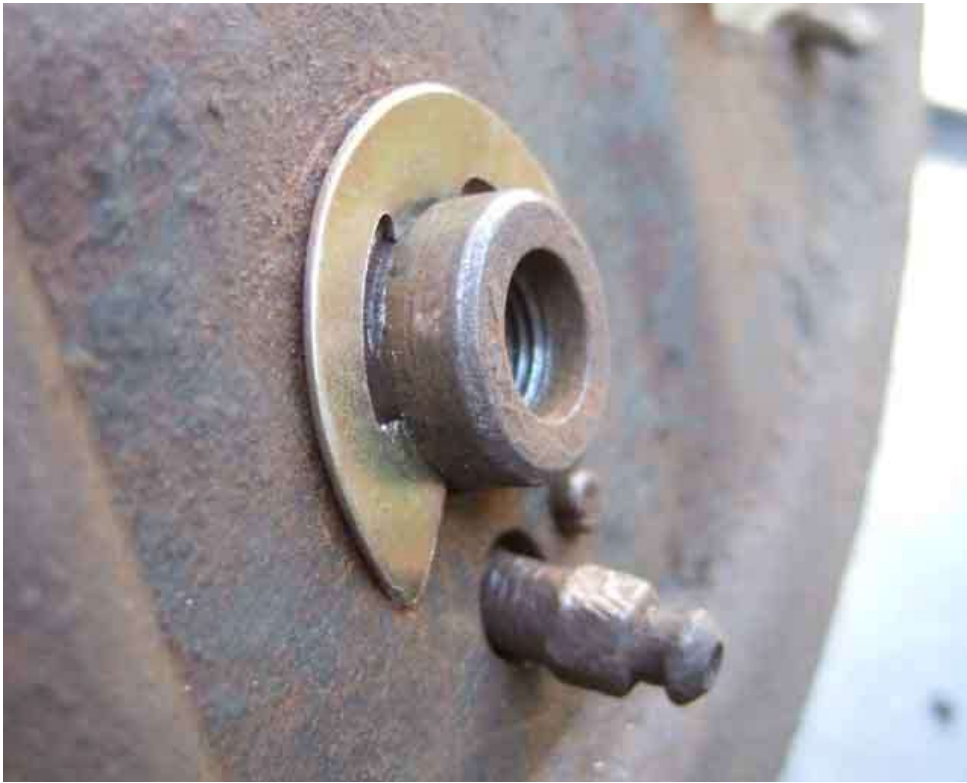
So now I just install the clip over the boss with the tool one way round, remove it and refit it the other way round as above, and with a couple of turns of the spanner you can hear the tongues clip into place in the groove.

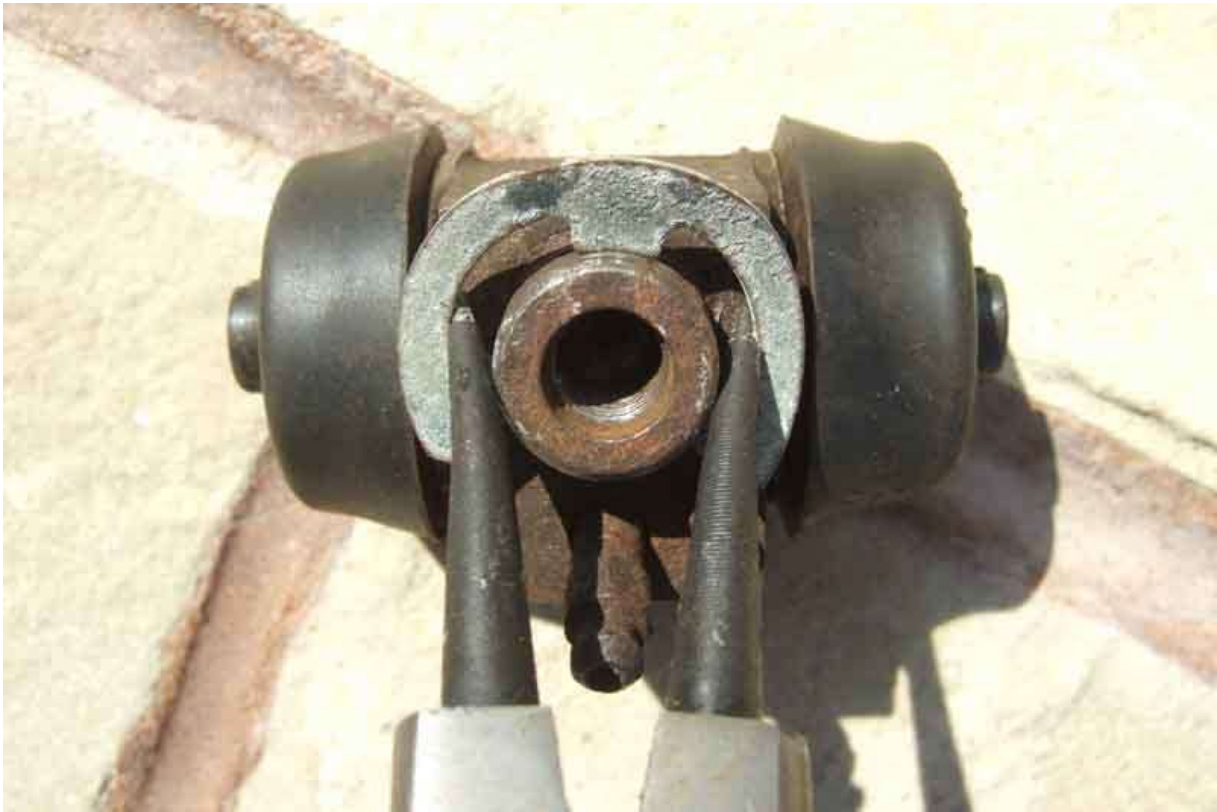
But one year I was not able to use the tool so came up with using a pair of outside circlip pliers to fit the clip. The pins on the pliers naturally gravitate to beside the end tabs, so just squeezing the handles opens up the clip:

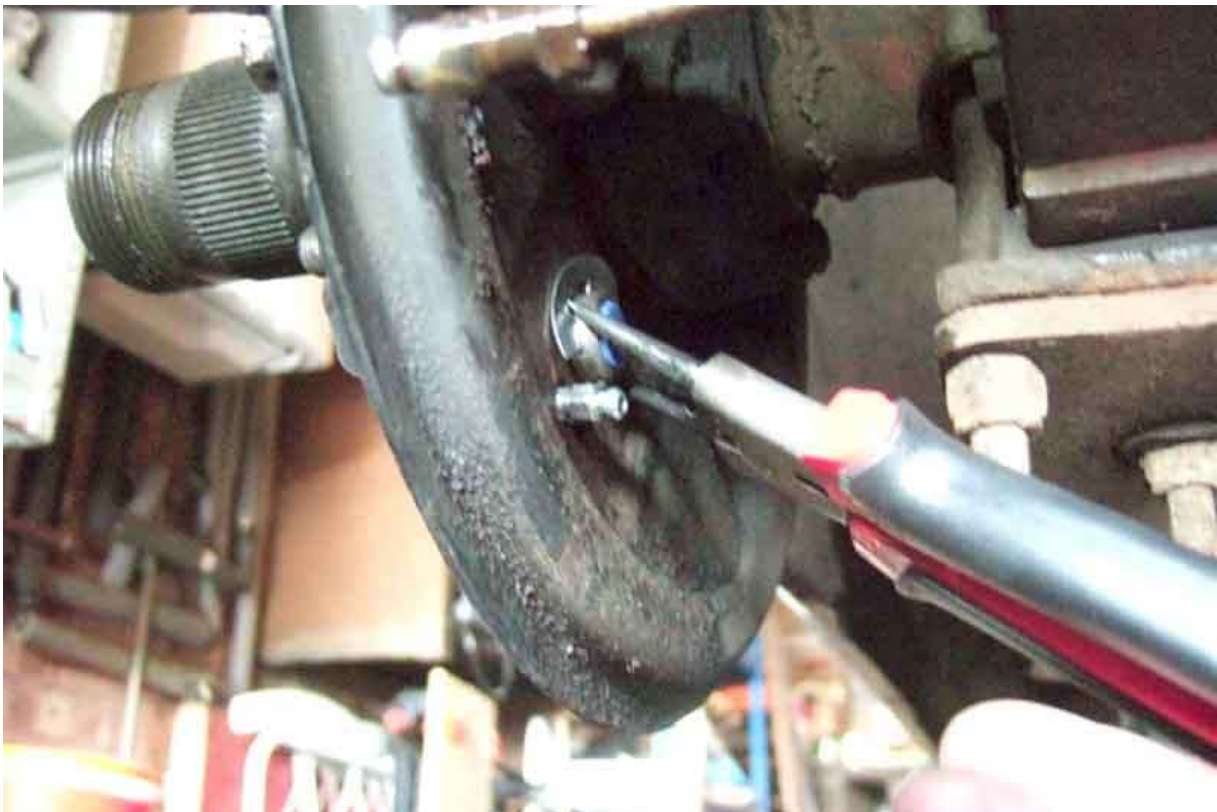
In practice the U-bolts get in the way of straight pliers, which have to be angled upwards, angled pliers would almost certainly be easier. But even so a hand around the edge of the back-plate with a thumb pressing the slave onto the back-plate, and a finger tip gently pressing the top of the E-clip so make it square with the boss on the slave, a squeeze of the handles, and Robert is your mother's brother.

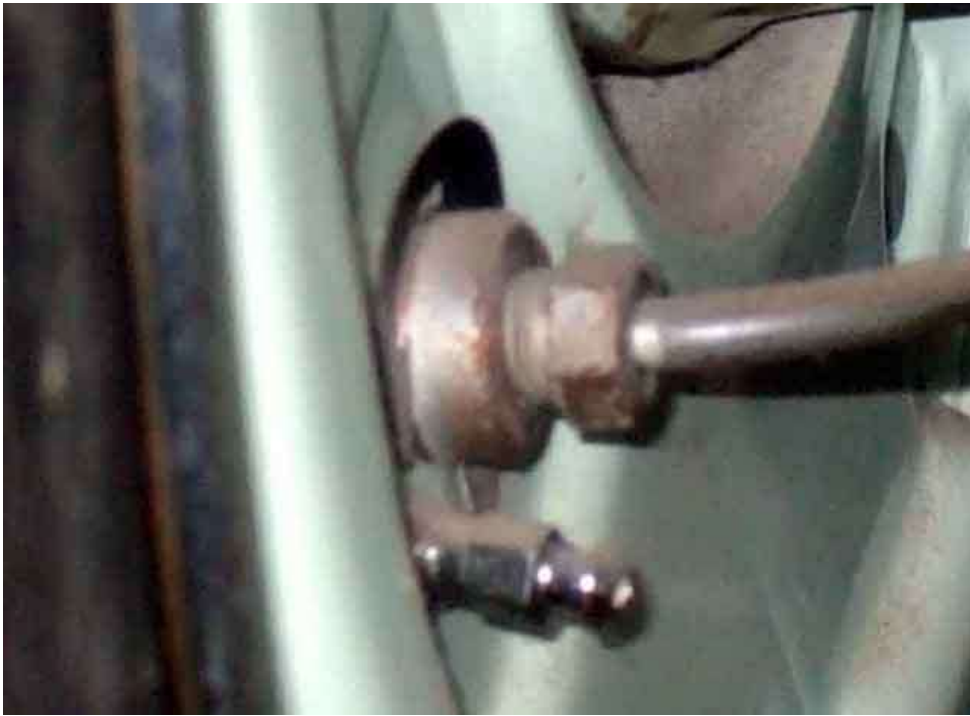
August 2015: A while ago someone on one of the fora got rather exercised about my orientation of these eclips insisting quite vociferously that my way was wrong. A couple of other people saying their known-history cars were as I describe from the from the factory made no difference, and this from the sectioned MGB at Gaydon looks the same to me.

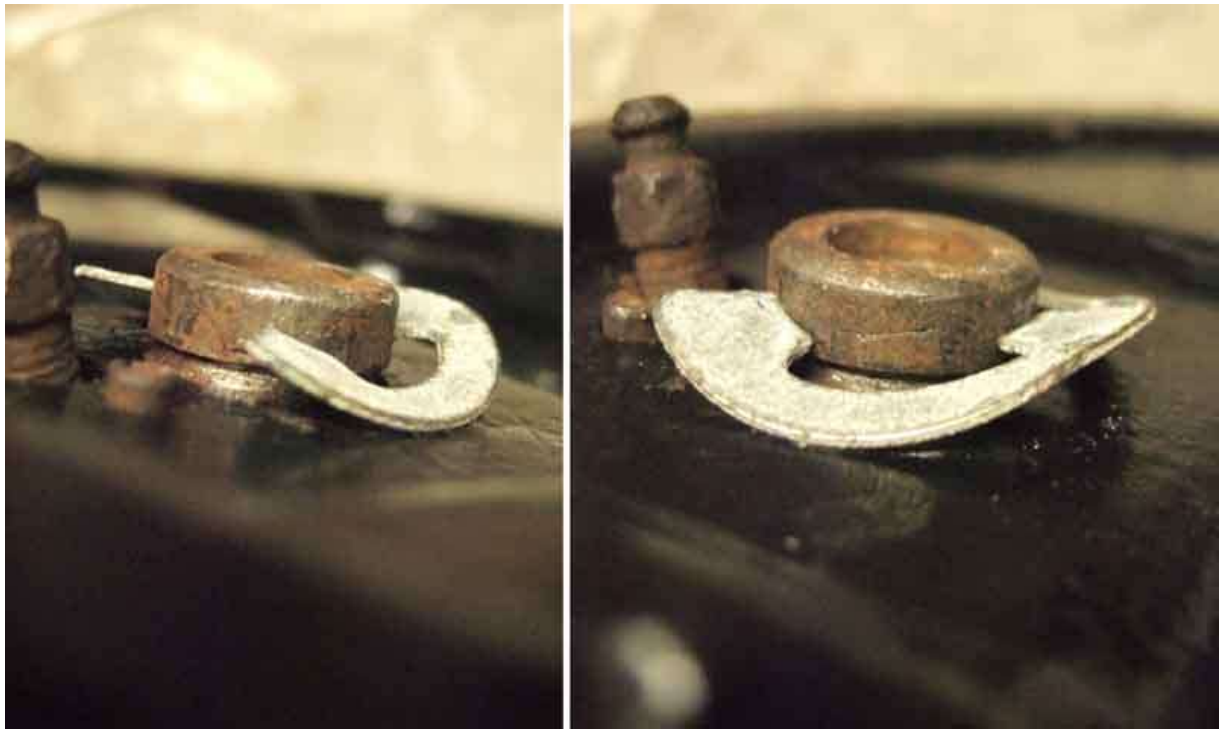
With the convex face of the clip towards the back-plate the curved part is pressed against it:

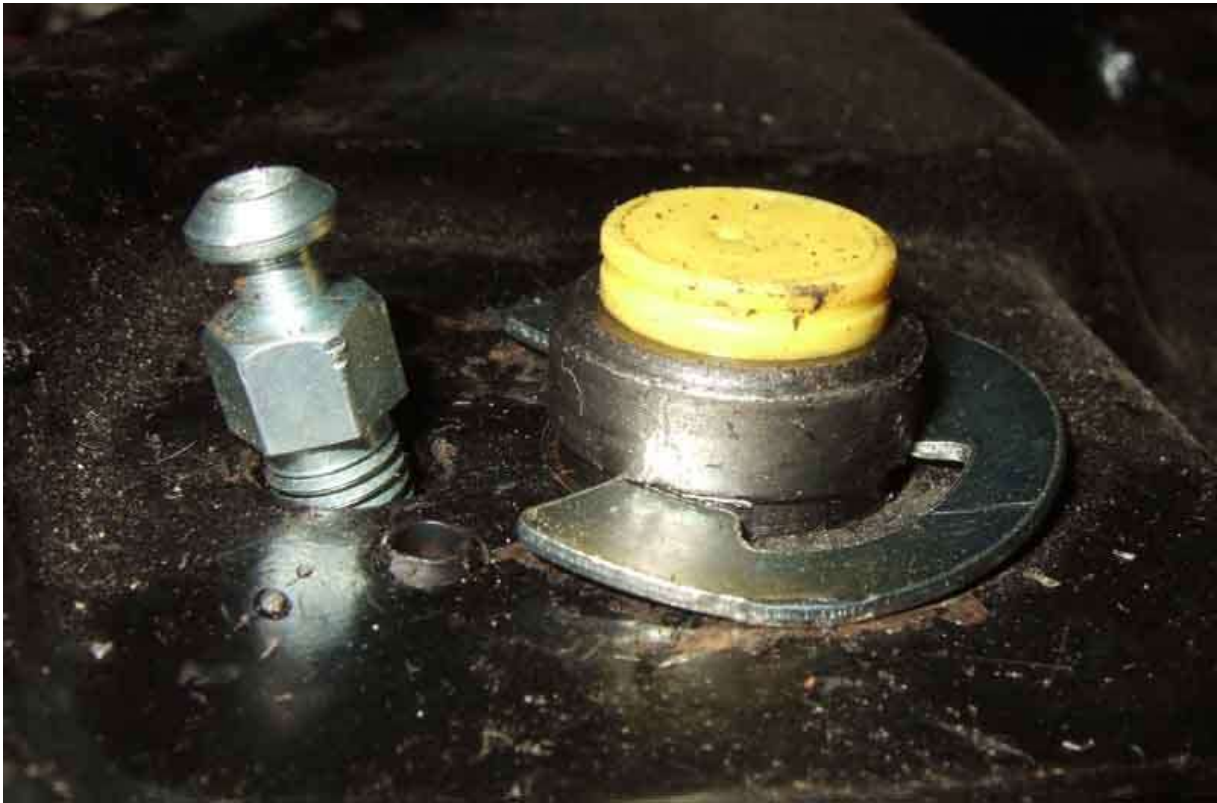
All three tabs snap into the slot on the cylinder:

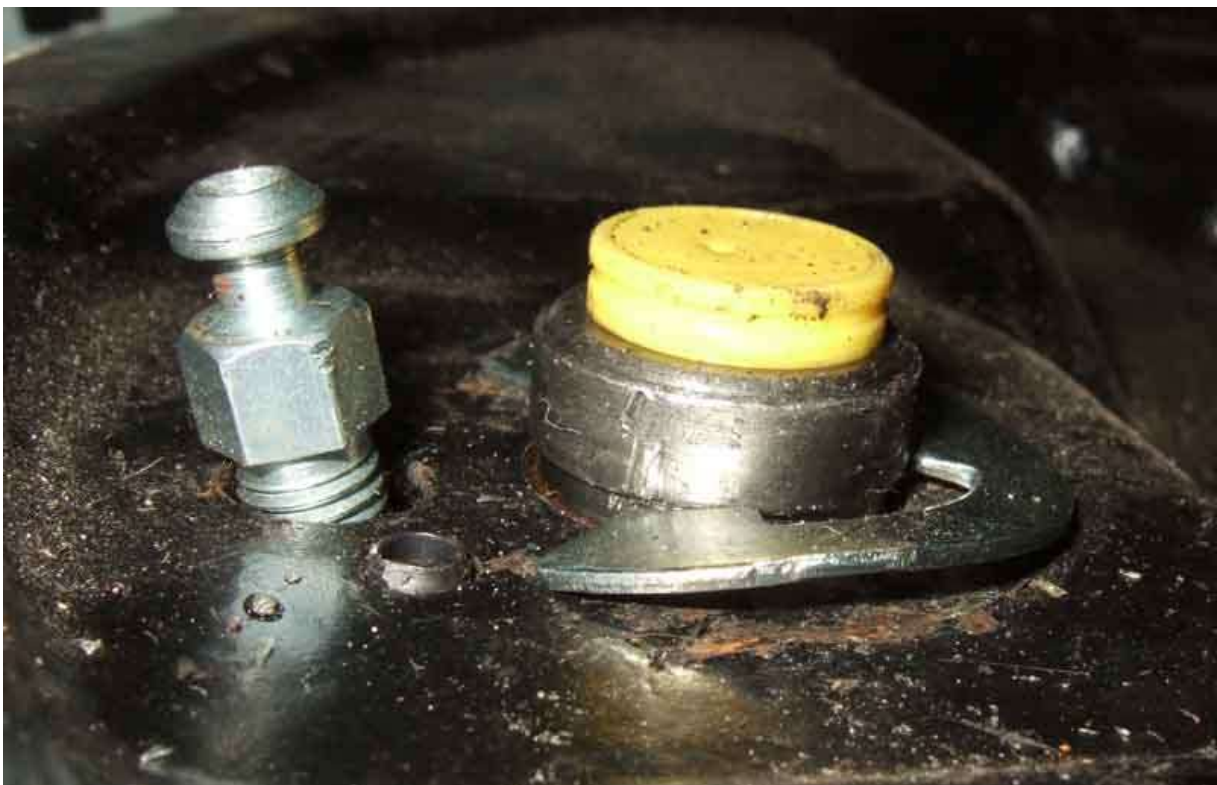
Whereas fitted the other way the corners of the clip are digging-in to the back-plate, the outer tabs do not snap into the slot, and pop out again all too easily:
