LOAD SPECTRUM EFFECTS ON BONDED COMPOSITE JOINTS

TECHNICAL REPORT AFFDL-TR-77-29
FINAL REPORT FOR PERIOD JANUARY 1972 to DECEMBER 1976

AIR FORCE FLIGHT DYNAMICS LABORATORY
AIR FORCE WRIGHT AERONAUTICAL LABORATORIES
AIR FORCE SYSTEMS COMMAND
WRIGHT-PATTERSON AIR FORCE BASE, OHIO 45433

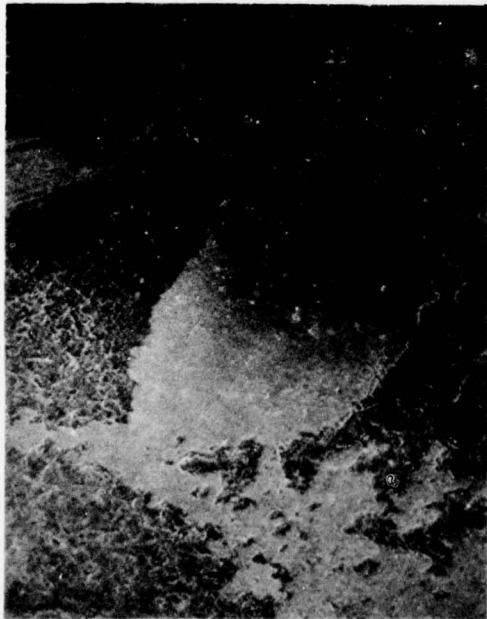
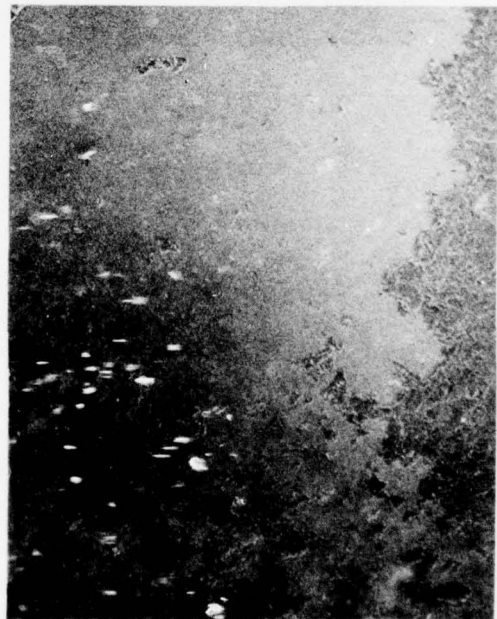
Figure 16. Typical Failed Areas on Titanium Strap, 15X.

Schedule 50 Specimen

Figure 15B was taken in the center of a large area of cohesive failure in the adhesive (Mode C). Figure 15C shows an area where the adhesive failed on the titanium surface (Mode A_T). To the naked eye this area had a dull appearance and it was suspected that a thin layer of adhesive might have remained on the surface. A shiny area where the titanium was scraped when prying the specimen apart was examined to compare with Figure 15C. This is shown in Figure 15D where the sanding pattern from the prebond surface treatment is clearly shown. Pictures of each of these areas taken at 15X are shown in Figure 16.

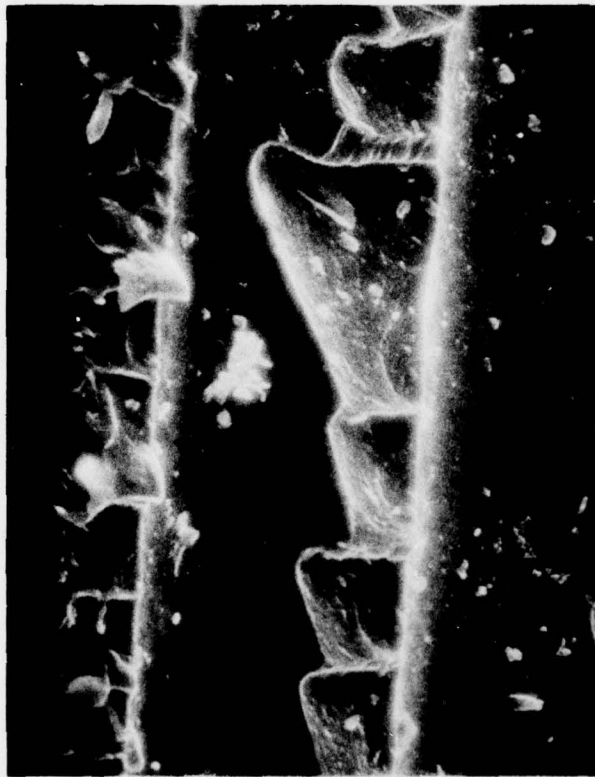
Figure 21. Saw Toothed Resin Fracture-Angle View.

Mode B area in center of lap, Specimen 51-9, Static Test, Strap View

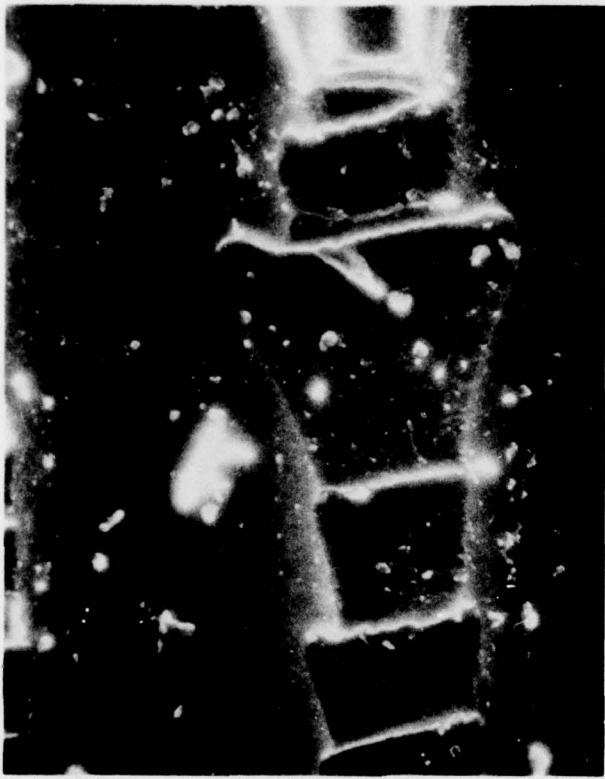
Edge T ←

Picture taken perpendicular to fracture residue on titanium strap.

Numerous observations along the Mode B failure surfaces on the boron/epoxy adherends, of representative specimens from each of the test groups and schedules, were taken. Pictures were taken near Edges T and F and at the mid-lap. In all cases where a Mode B failure existed, shear fractures were observed in the resin areas between the boron filaments. Figure 20, taken perpendicular to the ply planform, shows the interfilament tensile surfaces along planes inclined to the direction of load. The slope of these small surfaces with respect to the specimen tab or load direction can be better seen by observing the residue on the titanium strap that shears from the boron/epoxy adherend. Figure 21 presents an angle view of the interfilament region. Figure 22 shows the view of the Figure 21 area taken perpendicular to the surface. These sawtoothed cracks should be perpendicular to the direction of principal stress, and indicate that a static failure occurred. The angle is seen to be 30° or less and indicates that both shear and peel forces are operative. Similar patterns were observed on fatigued specimens. That is, 'pup tent' crack patterns, indicating reversed stresses during crack growth, were not observed. This was contrary to data in Reference 4 where fatigue failure under reversed loading was shown to occur in the laminating resin (Mode B) by toothed pattern where both sides of the tooth were sloped, indicating principal stress reversal. Unidirectional or static shear fracture patterns from this reference had sawtoothed patterns comparable to Figure 21.
