Test Report T65-11-1

ROTOR CREEP TEST OF FUZE, MT, T366

**UNITED STATES ARMY
FRANKFORD ARSENAL
RESEARCH & DEVELOPMENT
DIRECTORATE**

ABSTRACT

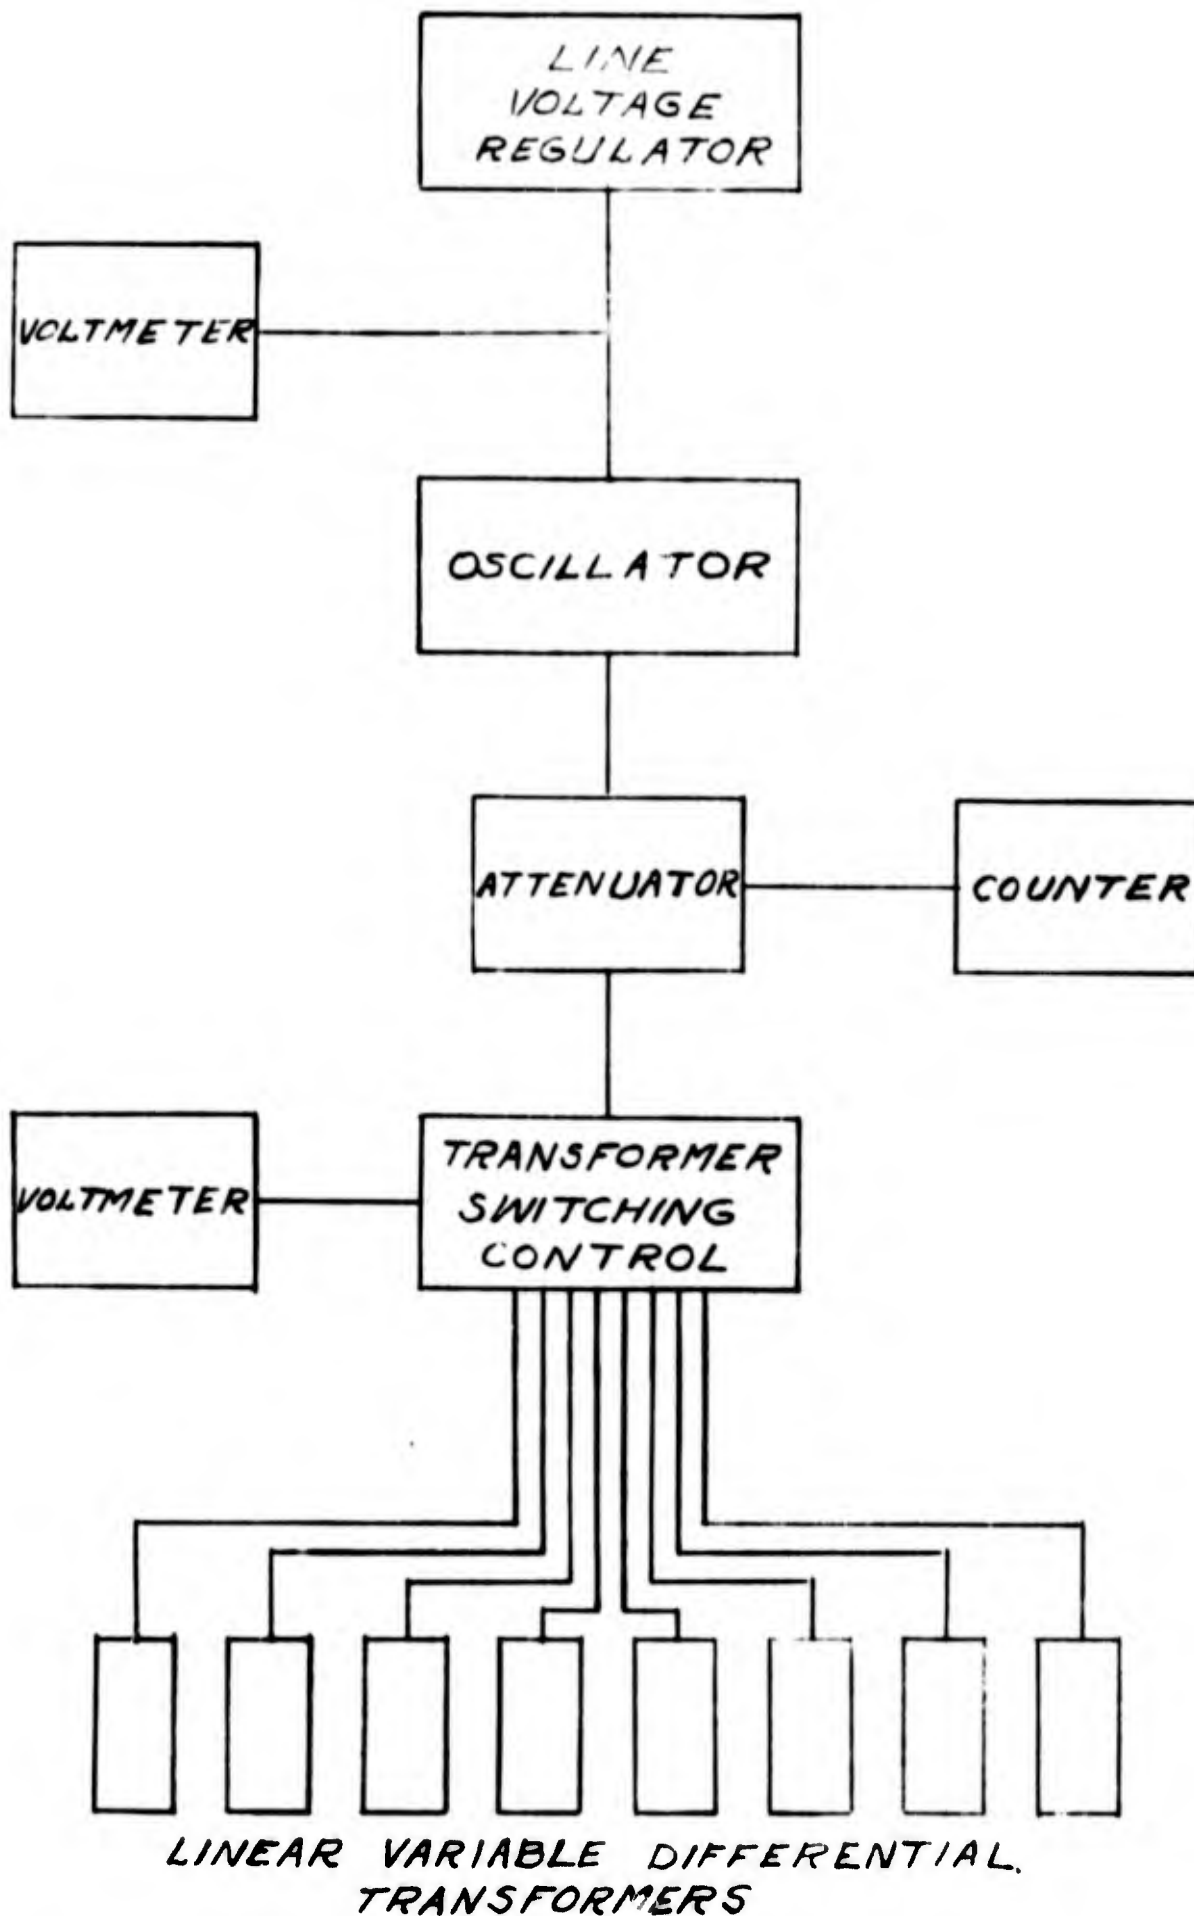
Figure 4. Block Diagram of Instrumentation

In order to record the differential voltage output of the LVDT the following instrumentation was utilized: (see Figure 3 and Figure 4).

| Voltage Regulator: | Used to eliminate frequency variations of the audio-oscillator due to fluctuations in the line voltage. |
| Voltmeter: | Used to provide a constant check on line voltage. |
| Audio Oscillator: | Used to produce an input voltage of .34 volts at a frequency of 10,000 cps to the primary coil of the LVDT. |

Counter:	Used to provide a constant check of the frequency output of the audio oscillator.
Attenuator:	Used to decrease the audio oscillator output voltage in order to operate it in a more accurate voltage range.
LVDT Switching Control:	Used to obtain the input and output voltage of each of the eight LVDT's.
