# Biological and Water Quality Study of the Minor Great Black Swamp Tributaries, 2015-2016

Defiance, Fulton, Hancock, Henry, Paulding, Putnam and  
Wood Counties

Ohio EPA Technical Report AMS/2015-MAUMT-2

July 2020

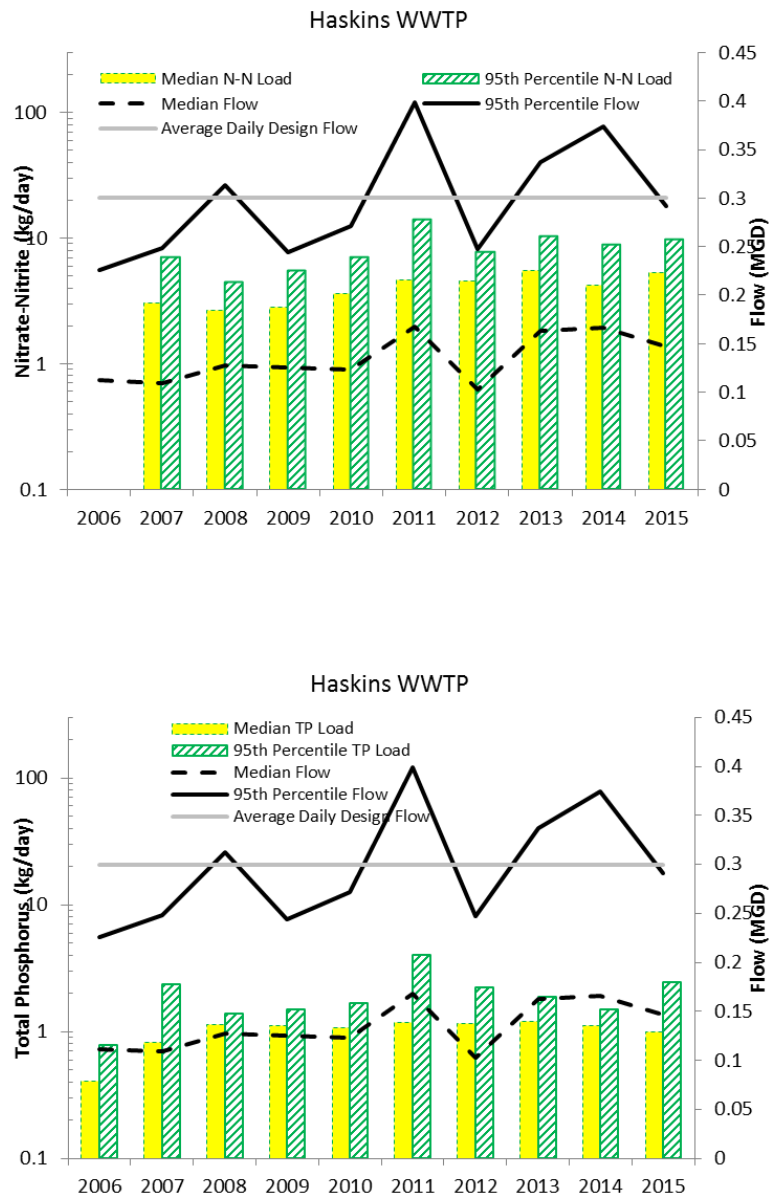
Figure 12 — Annual nitrate-nitrite (top) and total phosphorus (bottom) loadings from the Haskins WWTP, 2006 – 2015.

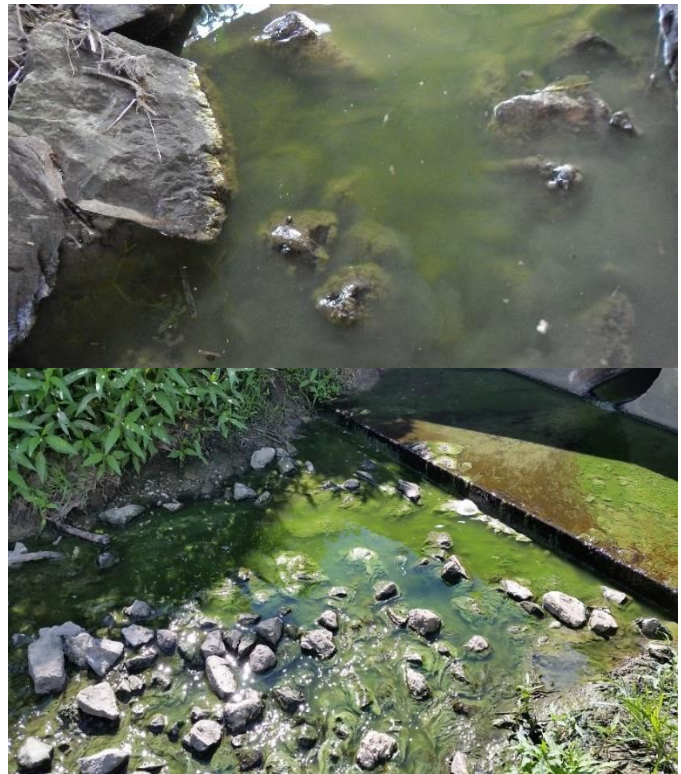
Figure 18 — Algae and sewage fungus on substrates downstream from the facility on 9/15/15 (top) and Holgate's WWTP discharge to stream on 8/12/15 (bottom). Brinkman Ditch was observed to be green at the downstream bridge on Co. Rd. H on the latter date.

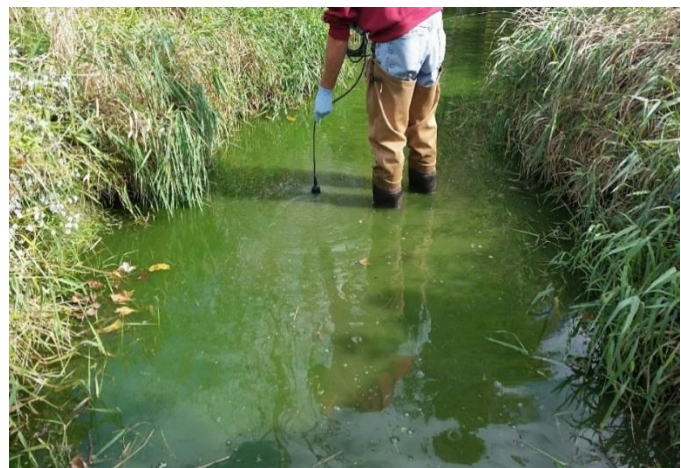
Figure 19 — Brinkman Ditch at Co. Rd. H, downstream of the Holgate WWTP discharge on Sept. 16, 2015.

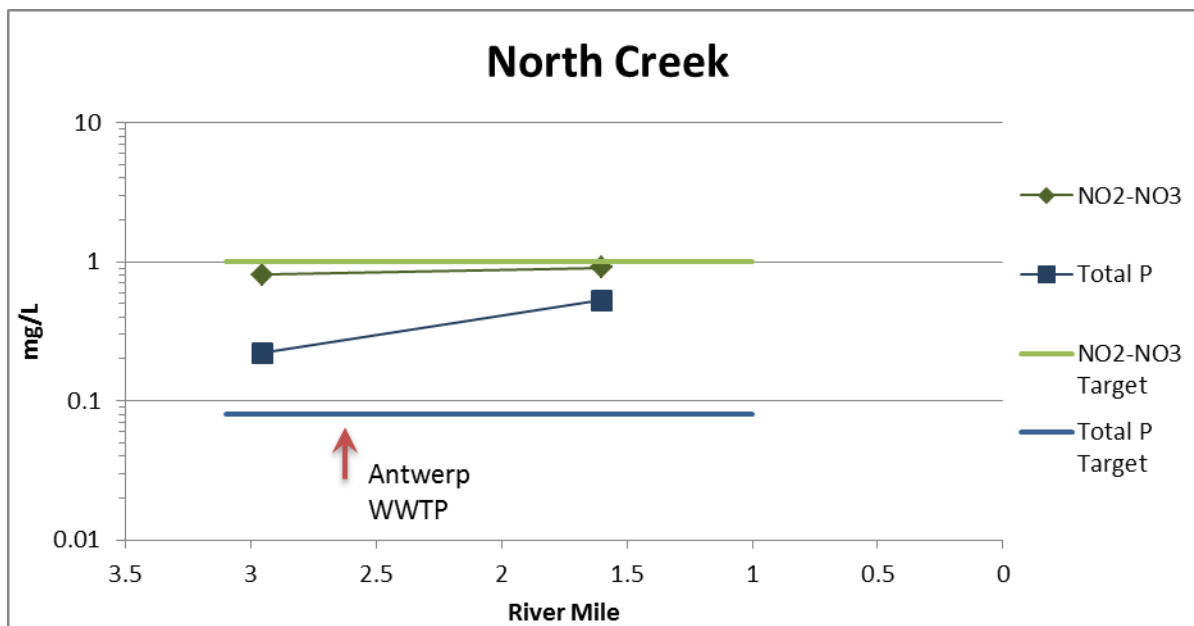
Figure 24 — Nitrate-nitrite (NO<sub>2</sub>-NO<sub>3</sub>) and total phosphorus (TP) geometric mean concentrations collected from North Creek from June 15 — Oct. 15, 2015. WWH benchmark concentrations are represented by appropriately colored horizontal lines.

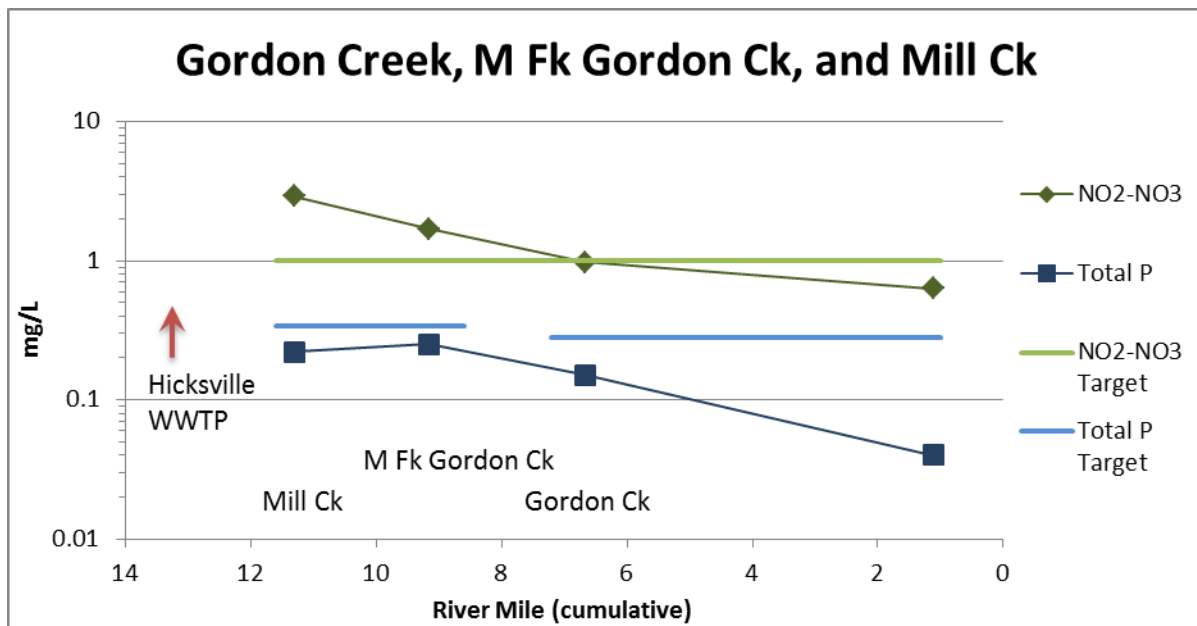
Figure 27 — Gordon Creek watershed, summer index period geometric means, 2015. WWH benchmark concentrations are represented by appropriately colored horizontal lines.

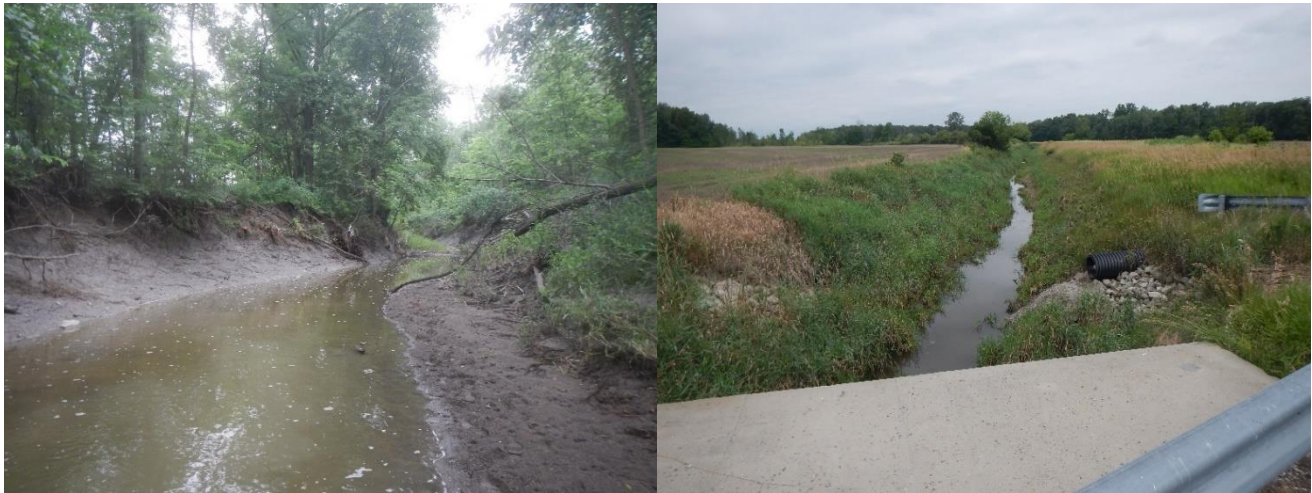
*Figure 50 — Photographs from Platter Creek RM 1.7 (left) and RM 7.95 (right). Note the presence of various natural habitat features present at RM 1.7 (some functional sinuosity, relatively wide and forested riparian, more instream cover for fish) and some connectivity to the adjacent riparian floodplain present at RM 1.7.*

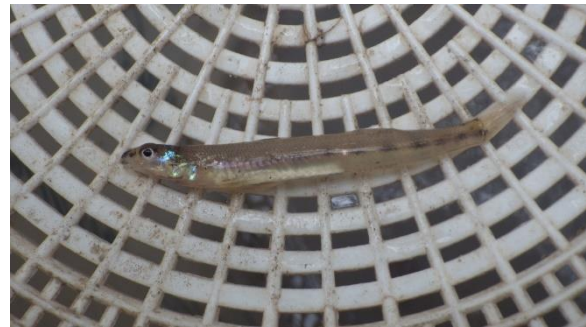
*Eastern Sand Darter (Ammocrypta pellucida),  
Bad Creek RM 2.47*

Two eastern sand darter specimens were collected from Bad Creek RM 2.5 (P11S04) and Beaver Creek RM 2.7 (P10K02). The eastern sand darter is exceptionally sensitive to excessive siltation and sedimentation. Historically, the eastern sand darter was widespread throughout the Maumee River and the lower portions of its tributaries, but was nearly eliminated by the early 1900s due to habitat degradation and changes in land use practices that accelerated delivery of silts and clays to river systems (Trautman 1981). Only recently has there been documented recovery of eastern sand darter populations throughout the Maumee River drainage system (Tessler et al. 2012, Ohio EPA 2015 a, b, c) which is seemingly related to improvements to substrate quality and reduced siltation throughout and excessive sediment discharge to the Maumee River watershed (Myers et al. 2000, and Richards et al. 2009).

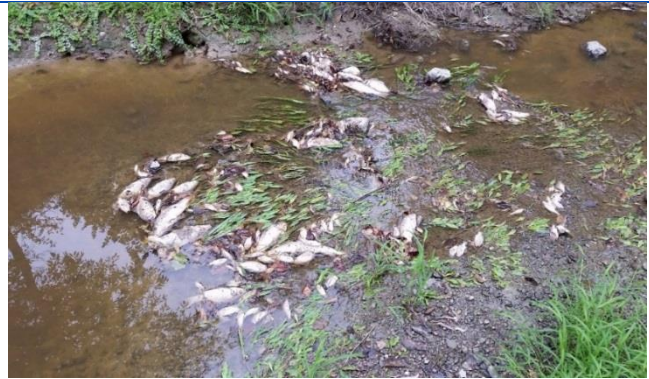
Figure 55 — South Creek fish kill, Co. Rd. 176 (Victory Rd), 10:02 a.m., Sept. 9, 2015.

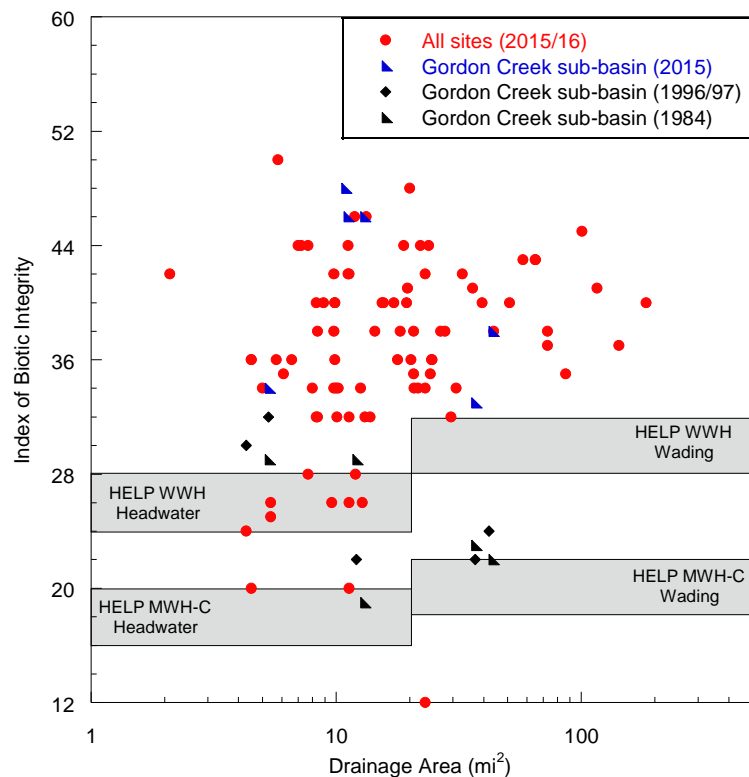
Figure 56 — Scatter plot of contemporary and historical IBI scores from stream locations evaluated within the Gordon Creek sub-basin. All sites sampled in 2015 and 2016 are displayed for reference. Shaded areas represent indicated biocriteria and areas of non-significant departure from noted criteria.

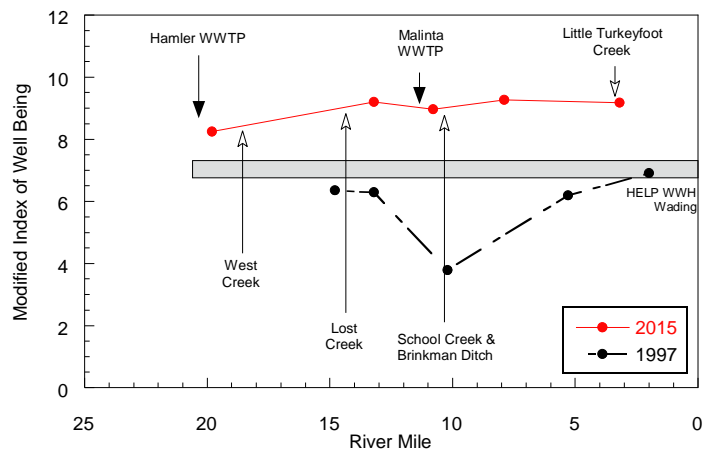
Figure 58 — Longitudinal MIwb scores from South Turkeyfoot Creek, 2015 and 1997. Shaded areas represent indicated biocriteria and areas of non-significant departure from noted criteria.

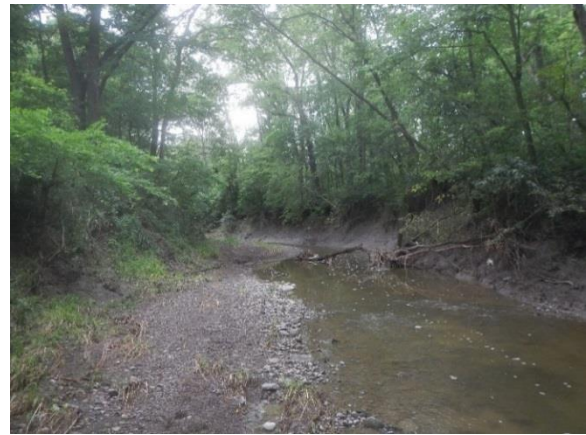
Figure 67 — Platter Creek downstream from Jericho Rd. (west crossing) at RM 1.65 before stream maintenance Hester Dendy setting (7/8/2015).

Platter Creek at RM 1.65 met applicable WWH biocriterion, despite substantial drainage maintenance activities that occurred during the survey. Figure 67 and Figure 68 depict pre- and post-instream maintenance with back hoe tracks and material (gravel, rocks, and woody debris) removed from the channel (Figure 68). Artificial macroinvertebrate colonizers were deployed on July 8, 2015 to attempt a quantitative sample collection but were inadvertently buried/removed from the stream prior to retrieval likely resulting from stream maintenance activities. Despite meeting WWH, qualitative sampling indicated a more diverse community overall prior to maintenance activities. Though these specific impacts are somewhat localized and relatively acute in terms of temporal influences, the cumulative influences from various stream maintenance activities (for example, sediment dipping, vegetative controls) within a given stream and throughout a watershed or sub-watershed have the potential for profound negative influences. It would be beneficial, here and throughout the study area, to have a “lighter touch” when conducting maintenance activities and to follow the recommendations of the Rural Drainage Committee and guidelines of the Rural Drainage Committee (ODNR 2008, 2009).

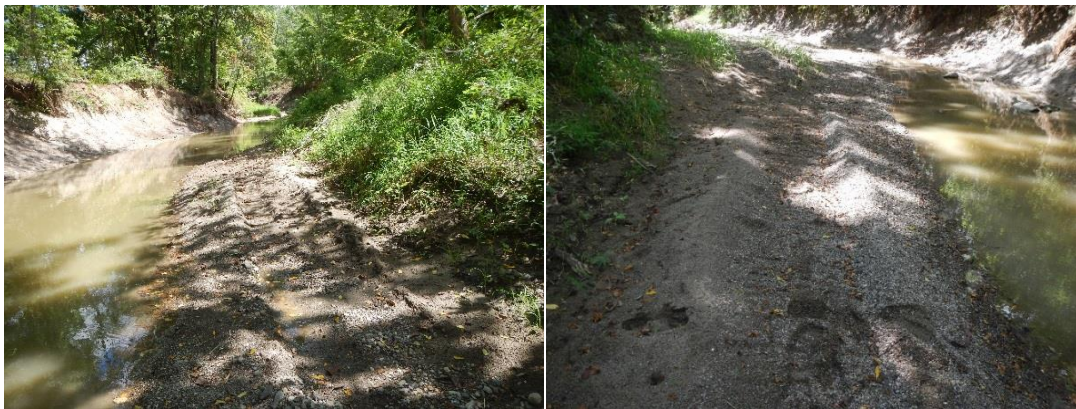
Figure 68 — Platter Creek RM 1.65 post-stream maintenance upstream and downstream (8/20/15).

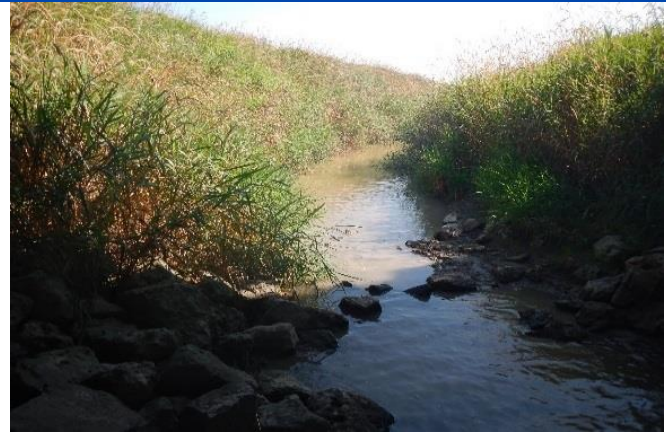
Figure 69 — Platter Creek at Fountain Rd. (RM 5.40).

Macroinvertebrate community sampling from Platter Creek RM 5.4 (302974) was in the fair range and performance fell short of HELP WWH expectations. An abundance of facultative filterers and scrapers (fingernail clams, flatworms, and Bryozoa) predominated and were reflective of the highly over-enriched conditions that occur throughout upper Platter Creek. Multiple sources of nutrient inputs (manure application runoff, a manure spill in 2015, an unsewered community just upstream, other nonpoint nutrient inputs), coupled with sub-optimal habitat quality throughout this reach are likely contributing to impairment at this location.

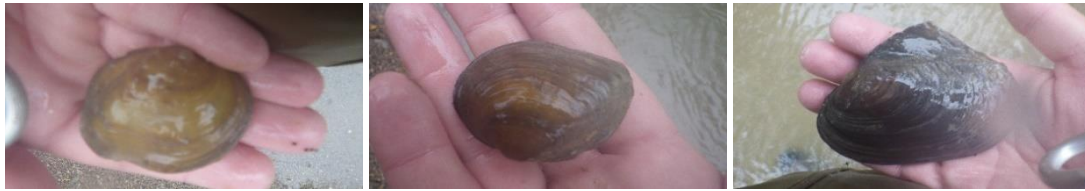
Figure 73 — Mapleleaf (*Quadrula quadrula*), Wabash Pigtoe (*Fusconaia flava*), and Pink Heelsplitter (*Potamilus alatus*) in Gordon Creek at RM 1.12 (2015).

The number of EPT taxa collected from locations near the mouth of Gordon Creek (RMs 1.1-2.2) were similar between 2015 (15) and 1997 (14), but have increased substantially since 1984 (four). The number of sensitive taxa collected was higher in 2015 (13) than both 1997 (six) and 1984 (three or less). Several species of freshwater mussels were also collected from the downstream reaches in 2015 (Figure 73). Similarly, the number of EPT and sensitive taxa present

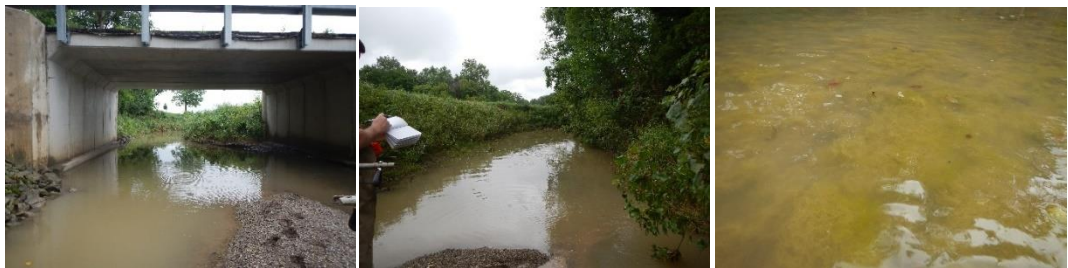
Figure 74 — Konzen Ditch at RM 4.15, upstream view (left) and downstream view (center). Algal mats present on Konzen Ditch at RM 1.55 (right).

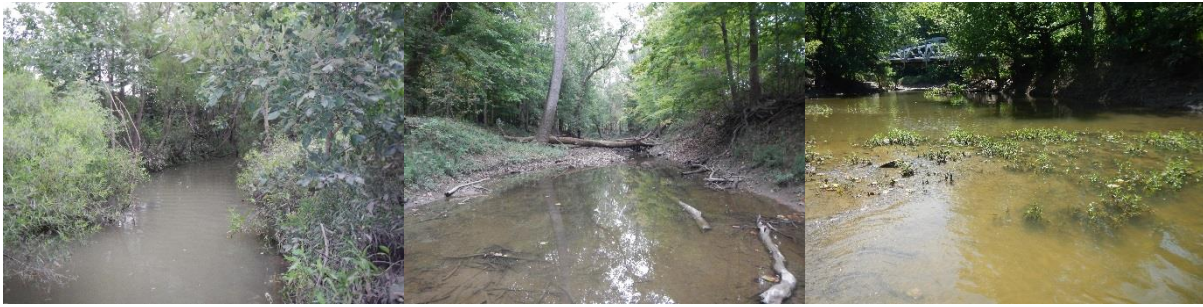
Figure 85 — Beaver Creek at RM 16.16 (left), RM 8.3 (center) and RM 2.73 (right), 2015.
