PUBLIC COMMENTS ON THE PETROCHEM PLANNED DEVELOPMENT PERMIT PROJECT AND PLANNING DIVISION STAFF'S RESPONSE TO PUBLIC COMMENTS, PL16-0118

County of Ventura
Planning Director Hearing
PL16-0118

Exhibit 9 - Public Comments and Response to Public Comments

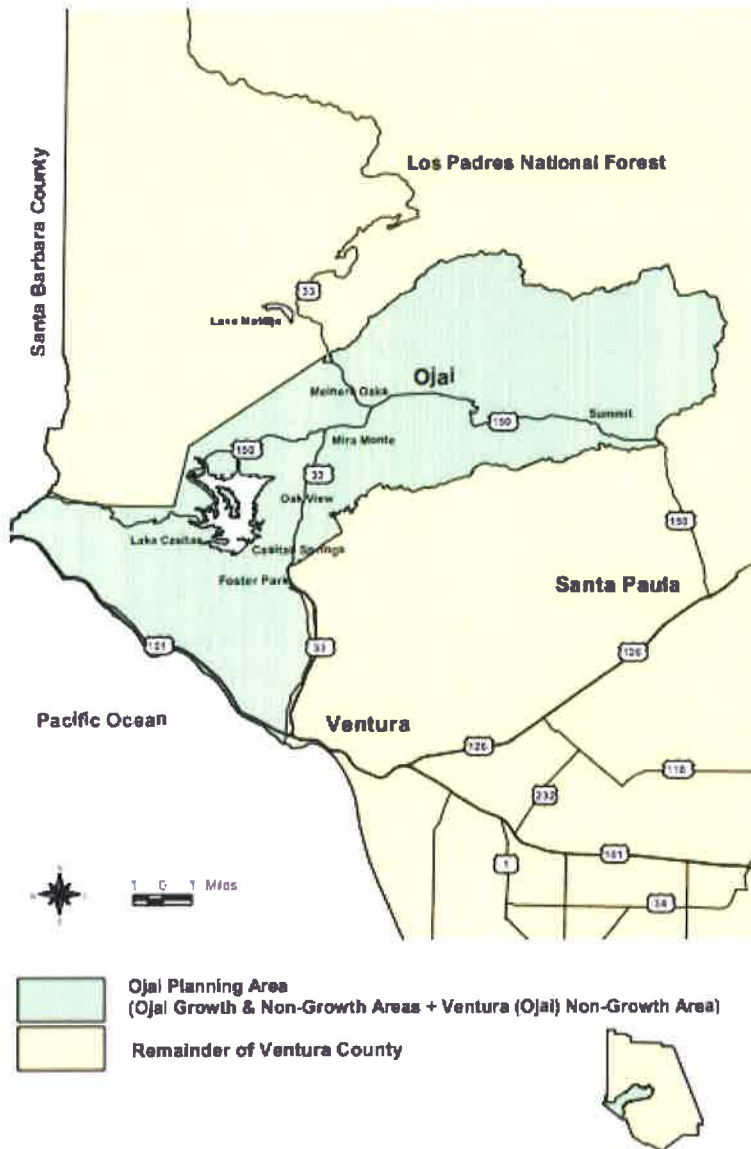
**Figure 3-1
Ojai Planning Area**

*The Ojai Planning Area is the area defined as the "Ojai Valley" in Ventura County Non-Coastal Zoning Ordinance, Article 12, Section 8112-2, plus the Ventura (Ojai) Non-growth Area (NGA) (as depicted in the 1987 Ventura County Air Quality Management Plan (AQMP), Appendix E-87, Figure E-1, "Map of Ventura County with Growth/Nongrowth Areas," page E-11). In these Guidelines, see Figure 3-1, "Ojai Planning Area."

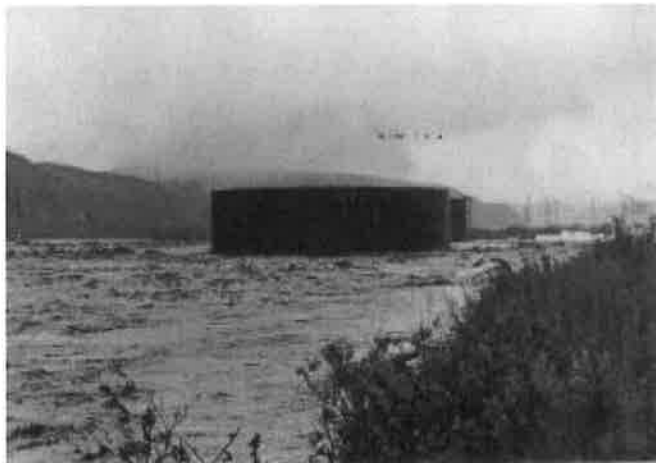
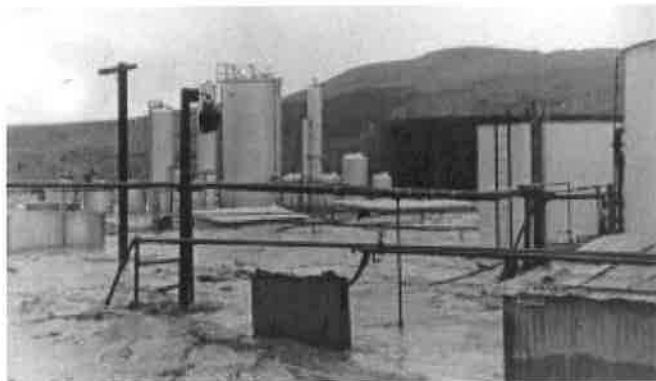
As a picture is worth a thousand words, these show a past 100-year flooding events in the Ventura River. The first color photo and headline was printed in the VC Star in either the floods of 2005 (or possibly 1997). The locale of that photo is the flooded RV park in the lower Ventura River close to the river's estuary. The 2 photographs below show a 1938 flood event was smaller than several events that have occurred in the past 30 years, however, it caused over one million dollars in damage and inundated oil fields along Ventura Avenue. (URS 2004). (Note: This 1938 flood event was also significantly smaller than the 1969 flooding event that cost 13 lives and caused \$60 million of property damage.)

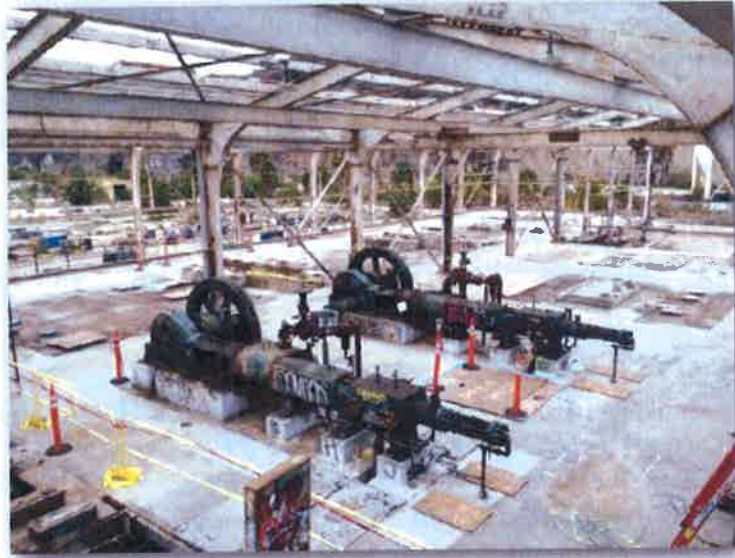
*Compressor Building Floor Deck
(Note remaining compressors)*

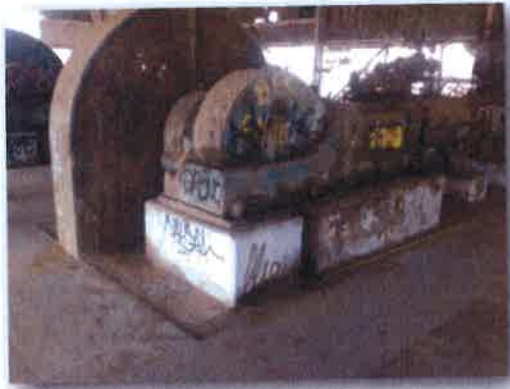
*Oil Staining on Compressor No. 1
at Building Floor Deck Level
(part of original oily material cleanup)*

PCBs were unexpectedly discovered when the oily material was profiled for waste disposal. One waste profile sample obtained from a partially filled drum of oily material removed from the crawl space was found to contain 1,225 mg/kg Aroclor 1260. A profile sample collected from a roll-off bin containing sludge removed from sumps located in the crawl space contained 30 mg/kg Aroclor 1260. The remaining waste profile samples had no detectable concentrations of PCBs. EPA was notified of these findings. The oily material was removed in September and October 2013 and a summary of the removal and waste profiling activities that led to the discovery of PCBs at the Compressor Building was reported to EPA.¹²

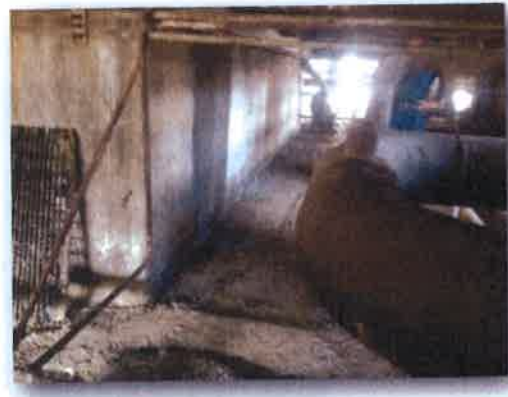
*Oil Staining on Compressor No. 1
Foundation in Crawl Space Below
(part of original oily material cleanup)*

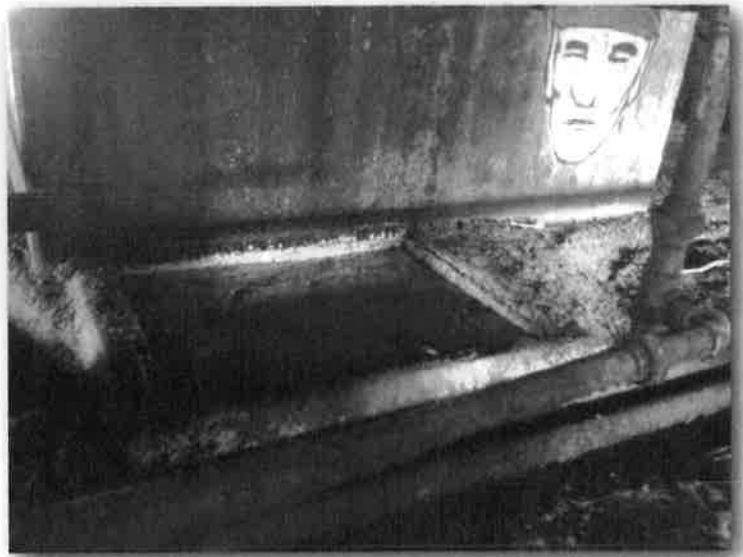
Gross Residues in CrawlSpace
(Note Concrete-Filled Sump)

- Limited samples of oil obtained from Compressor 2 found no detectable concentrations of PCBs;
- Oily residues collected from the remaining compressors and the concrete compressor foundations located in the elevated floor deck portion of the Compressor Building were found to contain PCBs in concentrations ranging from 0.55 mg/kg to 5.9 mg/kg (Aroclors 1254 and 1260). Note that the matrices contaminated with these residues primarily included painted and unpainted steel and concrete;
- Composite samples of loose soil found in proximity to the concrete compressor foundations in the crawl space area of the Compressor Building found PCBs concentrations ranging from 0.59 mg/kg to 22 mg/kg (Aroclor 1260).

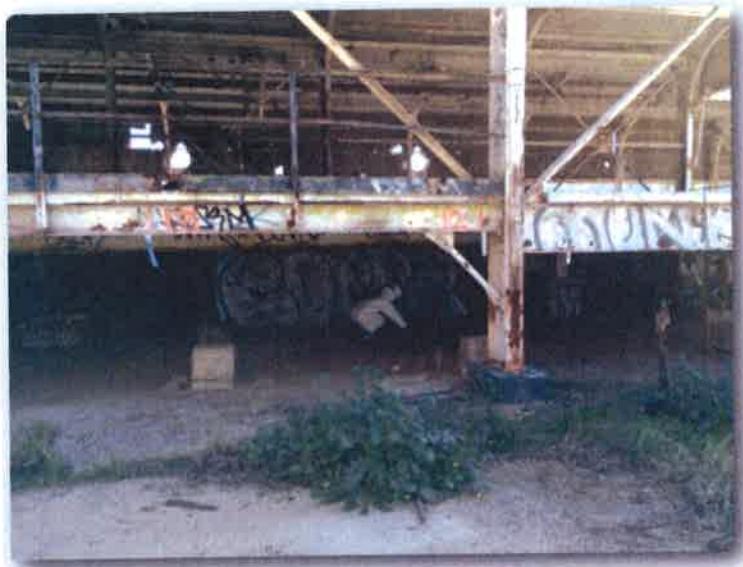
*Dudek Crawl Space Soil Sampling
March 2014*

The extent of PCB-contaminated soils (>1 mg/kg) extended approximately 15,900 square feet within and around the Compressor Building (see Figure 4). One area adjacent to the Compressor Foundation 2 was the only location where PCBs were identified at concentrations ≥ 50 mg/kg (and less than 500 mg/kg). This area covered approximately 484 square feet as illustrated on Figure 4.

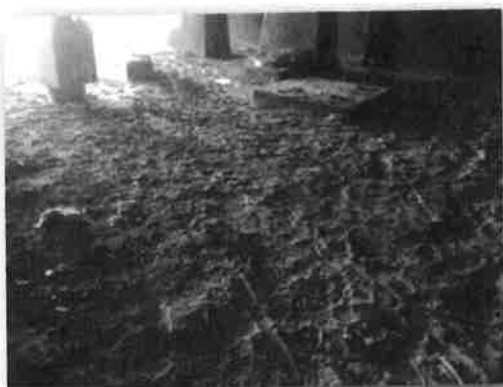
*Loose Soil in Crawl Space
(Bulk PCB Remediation Waste)*

An interim cleanup operation was conducted between October 2015 and February 2016 to remove accumulations of this Bulk PCB remediation waste from the crawl space and building perimeter by scraping, shoveling, HEPA vacuuming, wet wiping and other similar methods. Areas underlain by concrete or asphalt were vacuumed clean. Areas underlain by bare soil around the perimeter of the building were vacuum-excavated approximately six inches deep. The removal of Bulk PCB Remediation Waste extended to the excavation limits shown on Figure 4 (based on the 2014 Dudek sampling).

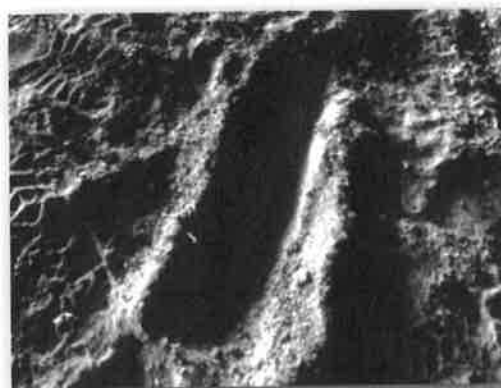
*Detail of Loose Soil
Note Concrete Slab Below*

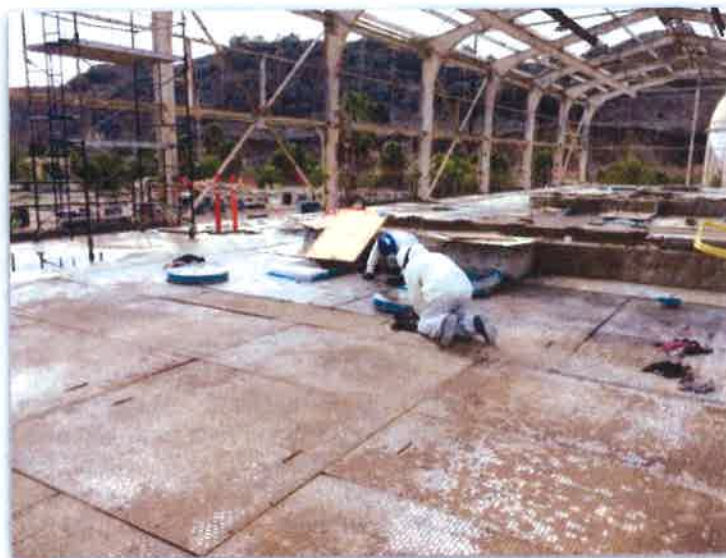
*Decontamination of Gross Residues
in Floor Deck Area During Interim Cleanup
(note painted steel diamond plate floor coverings)*

PCB concentrations of Bulk PCB Remediation Waste and gross residues removed during the interim cleanup operation were based on sample results obtained by Dudek during site characterization events in 2014. During this characterization, the Bulk PCB Remediation Waste was found to exceed 50 mg/kg PCBs in one limited area in the crawl space of the Compressor Building (see Section 2.4). This area was cleaned separately and the waste from this area was segregated and disposed as PCB waste (≥ 50 mg/kg). The remainder of the Bulk PCB Remediation Waste in the crawl space was found to be less than 50 mg/kg and was designated for disposal as < 50 mg/kg PCBs. The gross residues (oily residues) found in the Compressor Building underwent limited sampling during the Dudek characterization efforts. These samples were less than 50 mg/kg but based on the limited number of samples, these wastes were disposed as PCB waste (presumed ≥ 50 mg/kg).²⁰

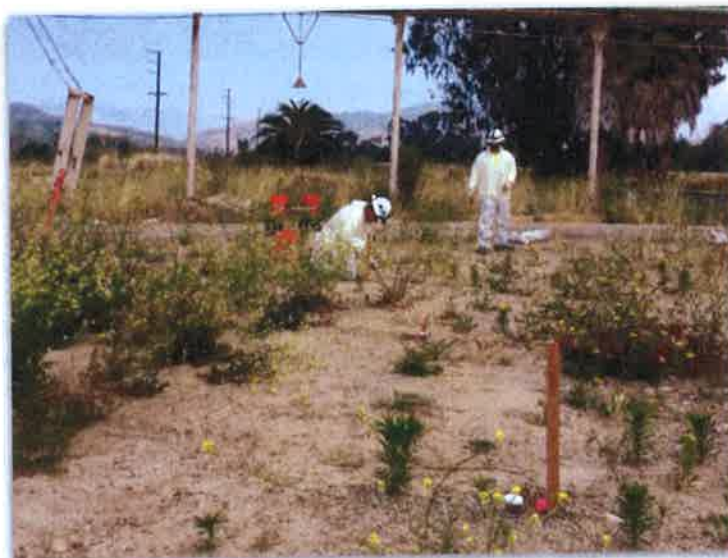
Perimeter Soil Sampling

The concrete present at ground level in the crawl space area of the building and the two-dimensional, elevated building floor deck area were also characterized to evaluate PCB concentrations. The concrete surfaces in these areas appeared to be most highly impacted nearest the concrete equipment foundations and appeared less impacted (stained or damaged) further away from these foundations. These surfaces were also decontaminated during the interim cleanup activity. Based on these observations, a characterization sampling approach using a modified (wider spaced) six meter grid-based approach was used rather than the 3 m grid prescribed in Subpart N based on the fact that concrete was scheduled to be removed and disposed offsite during demolition rather than to remain on site.²⁵

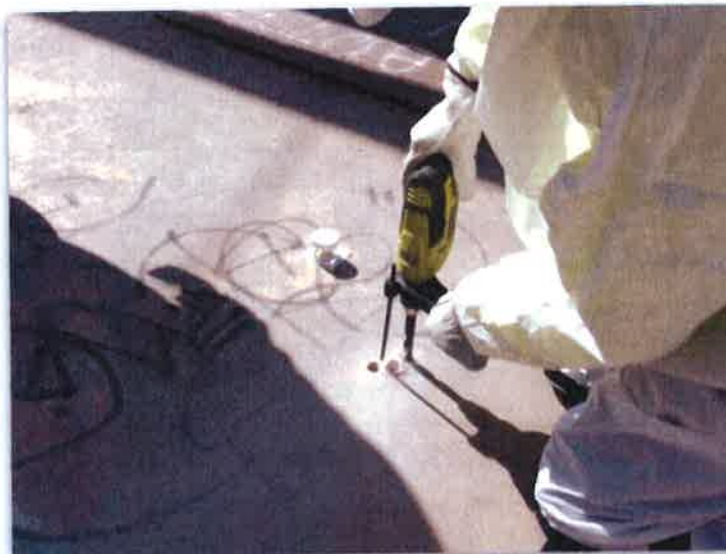
Concrete Hammer Drill Sampling

Twenty-eight discrete concrete samples and three duplicates were collected from the Compressor Building (elevated) floor deck locations. Eleven of the 28 locations (39%) were found to exceed project action levels for PCB 1260 (eleven samples and one duplicate). One sample exceeded the TSCA High-Occupancy criteria of 1.0 mg/kg. PCB concentrations ranged from 0.00558 mg/kg to 1.27 mg/kg. Figure 7 illustrates the ground level concrete PCB sampling results (crawl space, perimeter and equipment foundations).

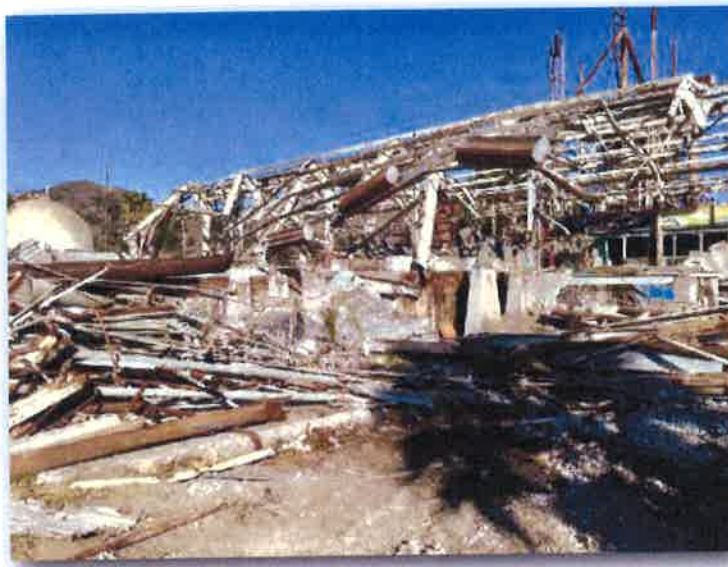
Compressor Building Demolition

Demolition of the Compressor Building and adjacent ammonia plant was performed using “machine demolition” methods. Hydraulic excavators equipped with hydraulic demolition attachments such as concrete breakers and shears were used to methodically demolish the structural steel framework and concrete features of the building.

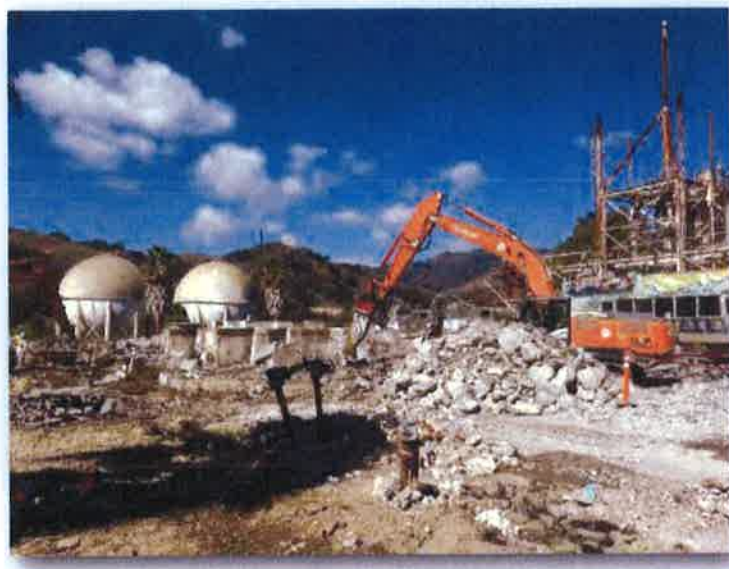
Concrete Demolition

Approximately 5,278 tons of waste concrete and debris were removed and disposed offsite during this first phase of demolition and remediation.

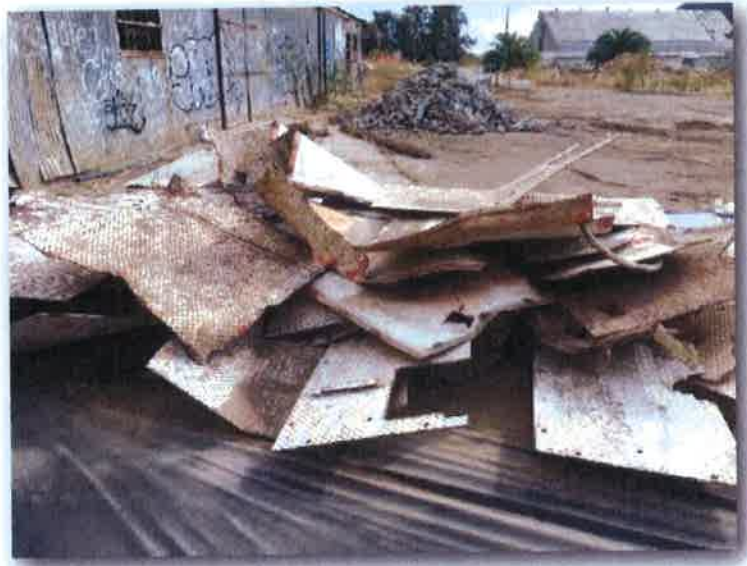
Painted Steel Diamond Plate
Staged for Disposal

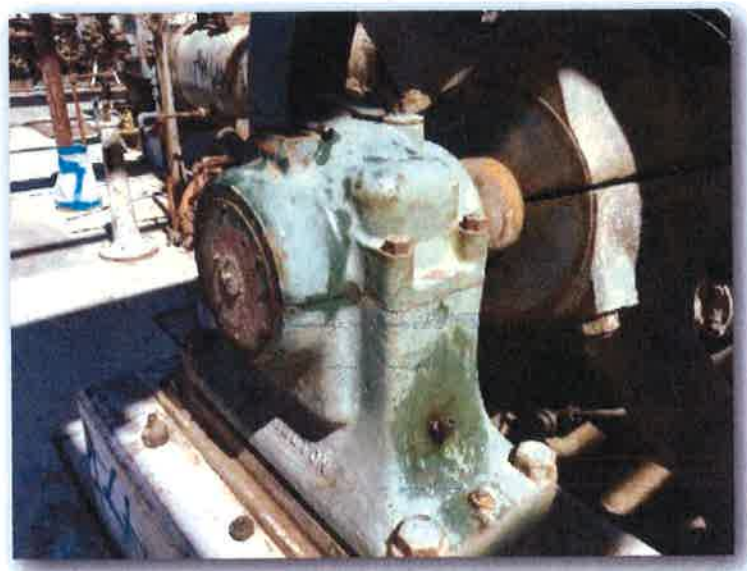
Compressor Flywheel Bearing Housing

During demolition it was determined that additional evaluation of oily residues contained within compressor flywheel bearings housings separate from the main compressors was warranted since these housings had not been evaluated during the original sampling event.

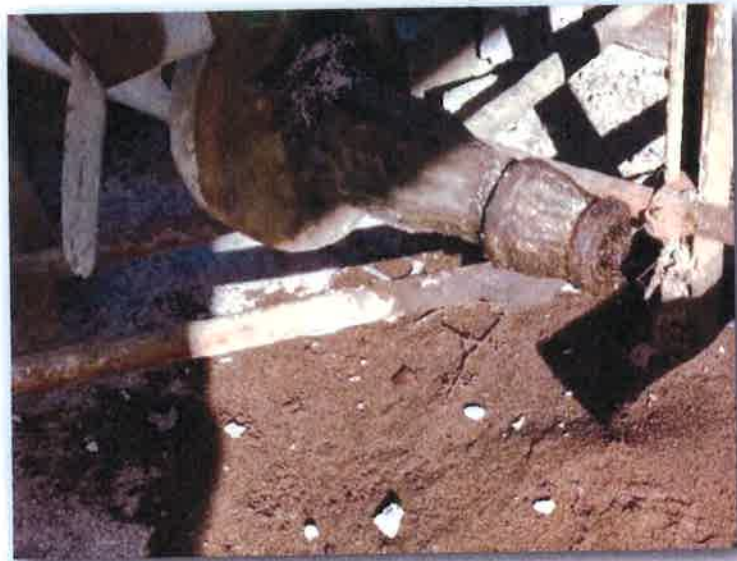
Suspect Pipe and Sorbent

During demolition only one pipe was identified to contain oily material. This pipe was located immediately under the elevated concrete floor deck and ran from the east end of the building westward to the two remaining compressors. The eastern end of the pipe was terminated in a banjo fitting typically used as a fill port. Some oily residue was found leaking from this end of the pipe and was collected using granular sorbent.

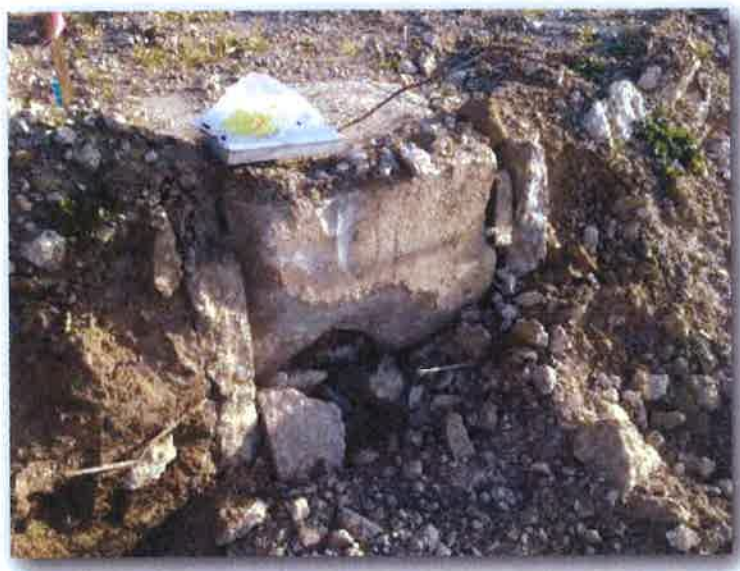
Concrete-Filled *Sump-01* During Removal

Due to the depth of the sumps, some samples were retrieved from an excavator bucket. The locations of the concrete filled sumps are shown on Figure 8, above.

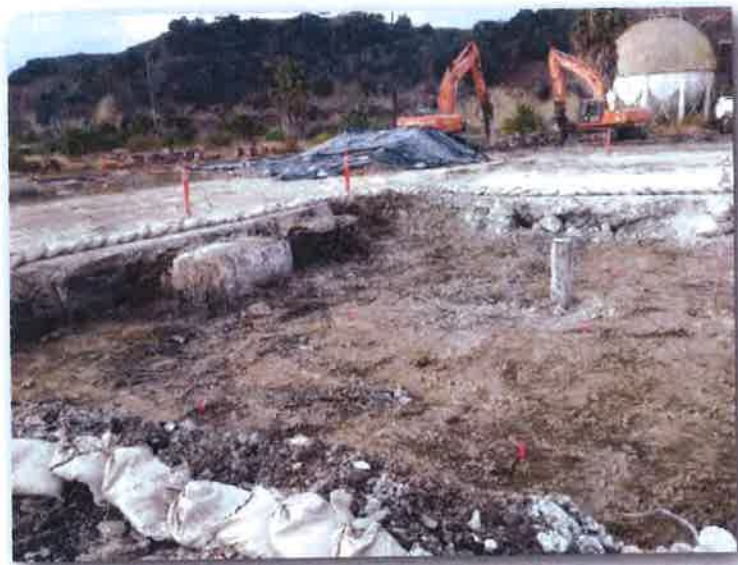
Typical *Under Slab* Samples
(Vicinity of Grid I-L/20-24; Also Note *Sumps -06 & -07*)

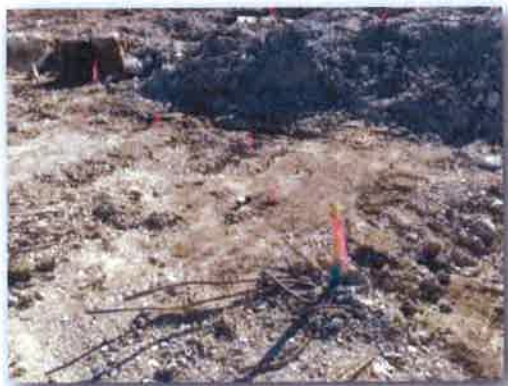
Oil-Stained Soil Encountered During Initial *Under Slab* Sampling

One of the *Stain* samples was collected from an underground cast iron pipe running east-west adjacent to former equipment foundation "L" (*FNDL*, see Figure 7 and Section 2.7, above). This pipe appeared to be a sewer pipe. This sample (*FNDL PIPE*) contained **374 mg/kg PCB 1260**. This sample location corresponds to grid IJ23.5. Further samples of other stained areas including this pipe alignment are described below in Sections 4.3, 4.4, and 4.7.

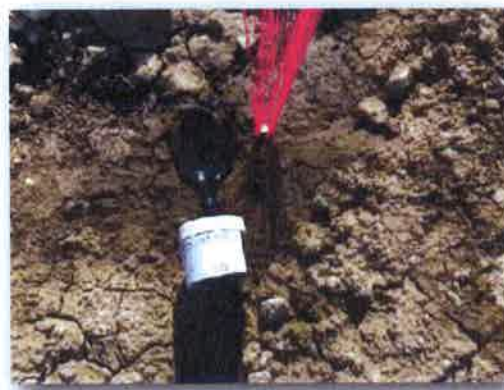
Detail of Staining

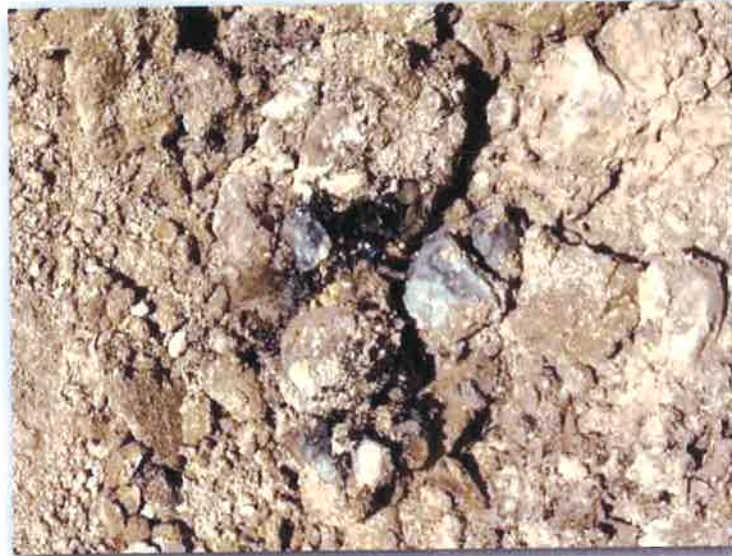
Tar-Like Material in Vicinity of Grid LM12.5

In addition to the stained soil samples described above, a small (approx. one cubic foot) amount of tar-like material was discovered in the vicinity of grid LM12.5. This material appeared to be consistent with heavy hydrocarbons such as crude oil residue. One sample was collected from this material and submitted to the laboratory for PCB analysis (sample *TAR-01*, laboratory sample number L871380-01). The results of this sample analysis indicated a concentration of **0.0071 mg/kg PCB 1254** (estimated concentration below the Reporting Limit). Based on these results the small amount of tar-like material was disposed along with waste asphalt as Non-RCRA Hazardous Waste under profile CA608682 (see Section 3.3, above).

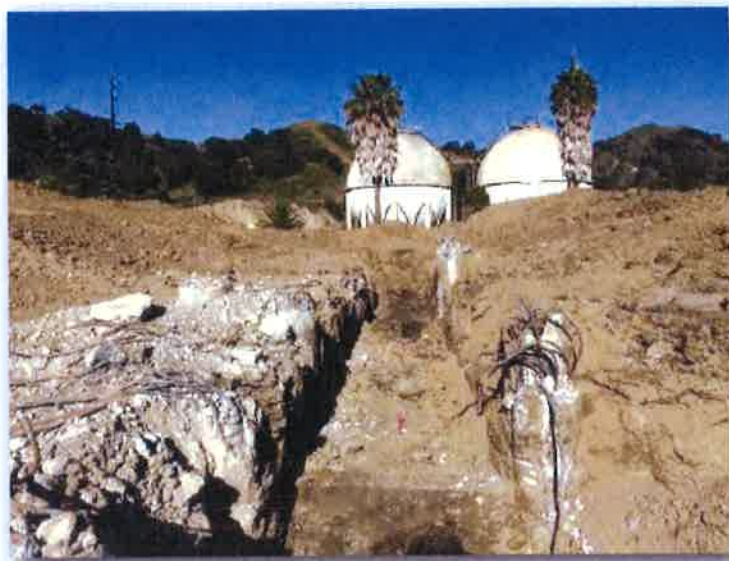
Round 2 Sampling Trench
(Sample IJ17.5 in Foreground; *FNDL PIPE* Visible in Background)

Seventeen sample locations were found to exceed project action levels — thirteen *Re-Excavation* samples and four round two *Step-Out* locations. PCB results exceeding action levels ranged from **0.309 mg/kg** to **280 mg/kg PCB 1260**. Five samples exceeded 1 mg/kg and one sample exceeded 50 mg/kg.

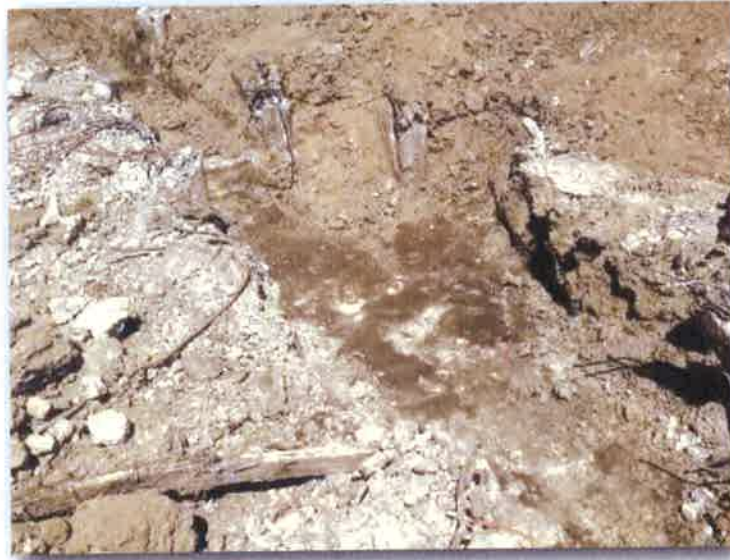
Staining Observed Prior to Round 3
(Vicinity Grid IJ19.5/Sump-05)

Nine locations (9 samples plus one duplicate) exceeded project action levels. Sample results exceeding action levels ranged from **0.39 mg/kg** to **4.84 mg/kg PCB 1260**. Nine of the ten samples exceeding project action levels were greater than 1 mg/kg. All of the samples exceeding action levels consisted of *Re-Excavation* samples, no *Step-Out* samples were affected.

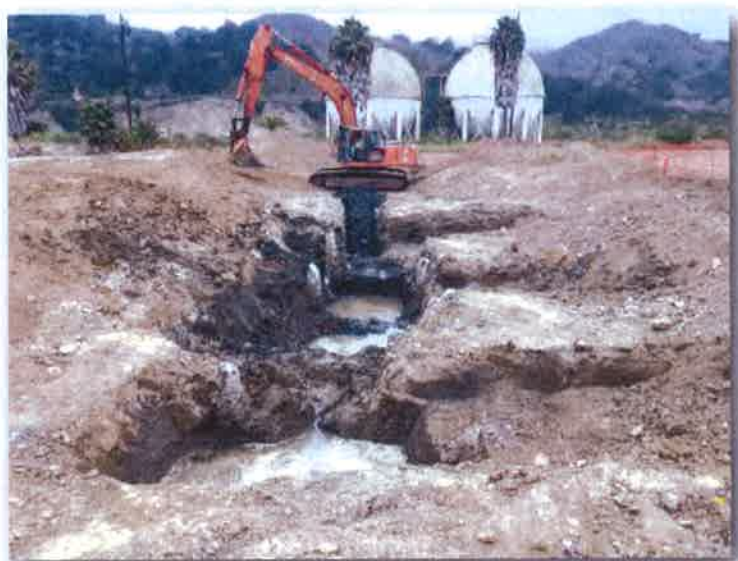
Round Four Excavation

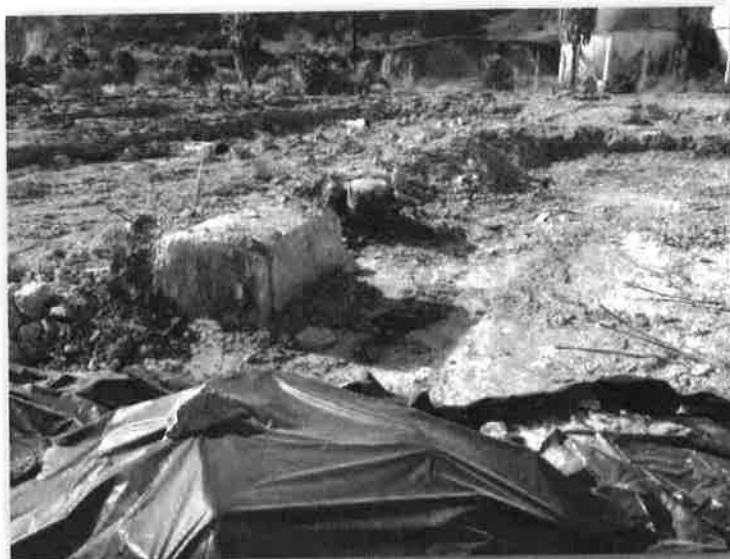
Sump-07 (foreground) and *Sump-06* (drums)
During Round One
(Note staining in adjacent soil)

Four of the nine sump locations exceeded project action levels. PCB concentrations ranged from **0.317 mg/kg** to **6.1 mg/kg PCB 1260** (see Table 11, below). Figure 13 illustrates the sump sampling locations and results.

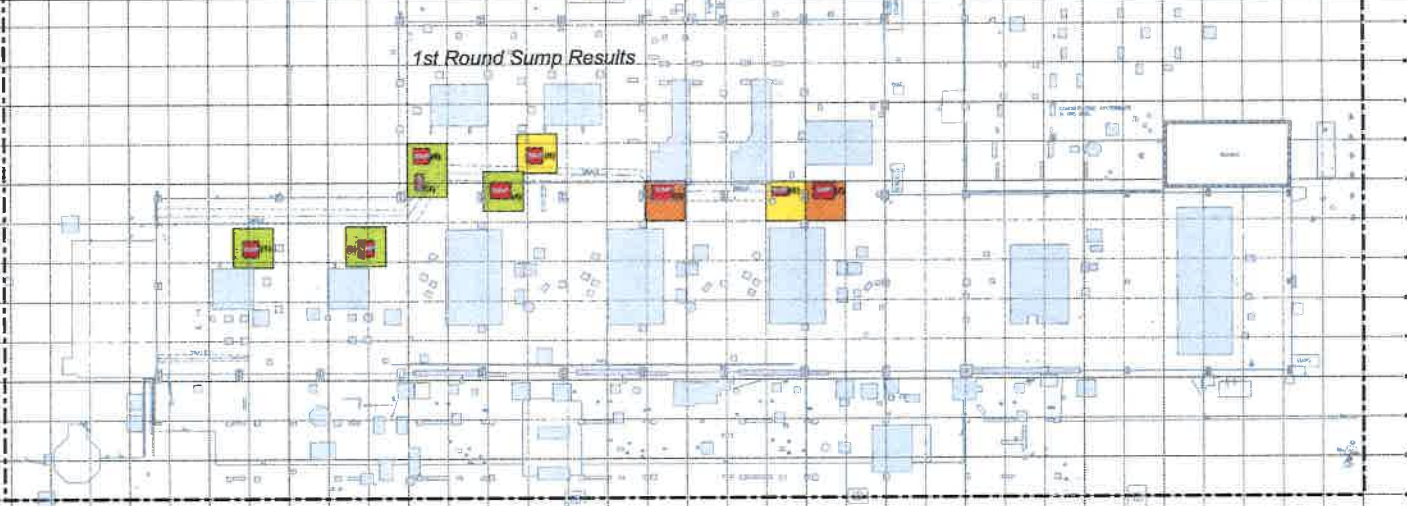
Notes: Results shown on this figure include 1st, 2nd and 3rd round concrete-filled sump soil samples shown on Tables 11, 12, and 13.

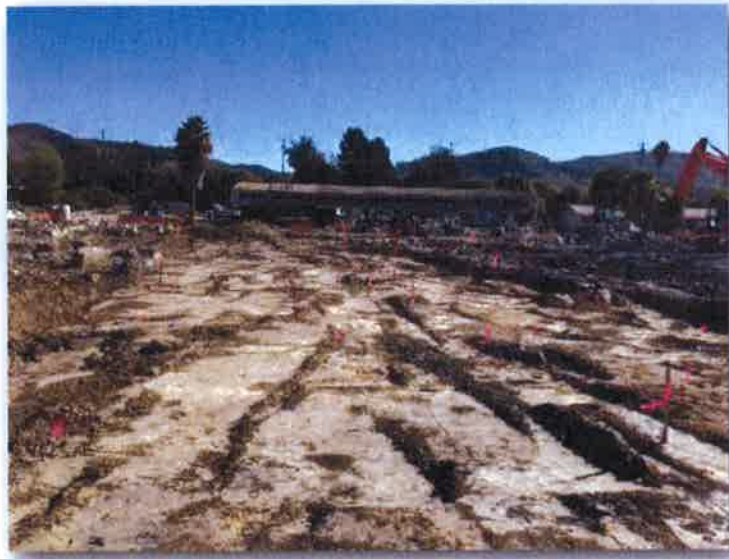
Typical Perimeter Sampling Grid
in Former Asphalt Covered Area
(Approx. 1' Below Grade)

Under Slab characterization samples were also not specifically excavated prior to initial sampling. However, demolition of concrete footings and foundations both created disturbed soil conditions and left significant voids — initial *Under Slab* samples in these locations were often up to 3.5' below surrounding grade.

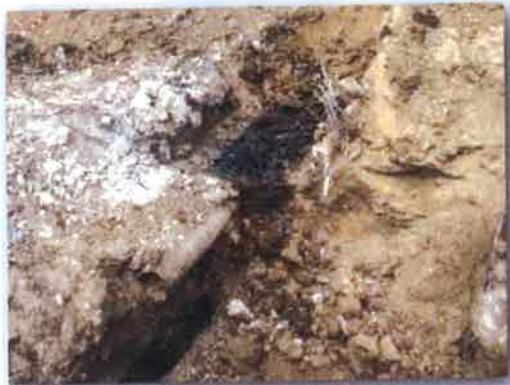
FNDL PIPE Prior to Round 2 Excavation
(Vicinity of IJ18.5)

As noted above, visibly stained soil was excavated and addressed during Rounds One, Two and Three. These excavations were associated either with visual observation of oil-stained soil or were associated with the *FNDL PIPE*. Oil-stained soil excavation and sampling was primarily conducted in the vicinity of grid cells JK19.5 to JK 23.5. Excavation and sampling associated with the *FNDL PIPE* was performed in an east-to-west sequence beginning with grid IJ23.5 and terminating at grids IJ12.5 and HI13.5 (Pipe Wye). This pipe was also coincident with the row of concrete-filled sumps beginning adjacent to *SUMP-07* and terminating westward at *SUMP-03* (reinforcing the observation that it may have been a sewer line associated with the sumps).

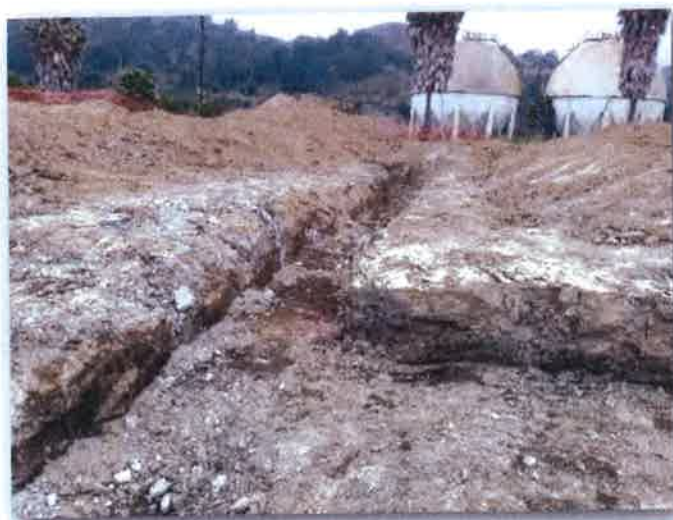
Staining Prior to Round 4 Excavation
(*FNDL PIPE* is below staining level in Row IJ trench)

As a result of these observations, significant additional excavation was performed immediately prior to and during re-excavation sampling events on June 14 and June 29 (corresponding to Rounds 2 and 3). Excavation depths in the remediation excavation within rows IJ and JK were approximately 5.0' feet below grade during Round 2 and approximately 7.0' feet below grade during Round 3.

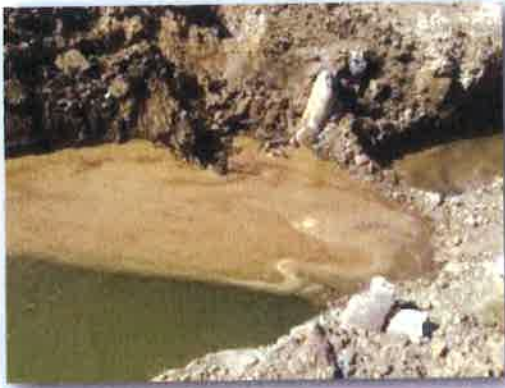
Hydrocarbon Product After
Round 4 Excavation
(Vicinity of IJ19.5)

Sorbent pads were employed to collect the LNAPL and a grab sample of the surface of the water was obtained (see Section 4.8). Visible accumulations of LNAPL appeared to be successfully mitigated after an application of sorbent pads, however as a precaution, sorbent pads were employed through Round 5 on August 2, 2017.

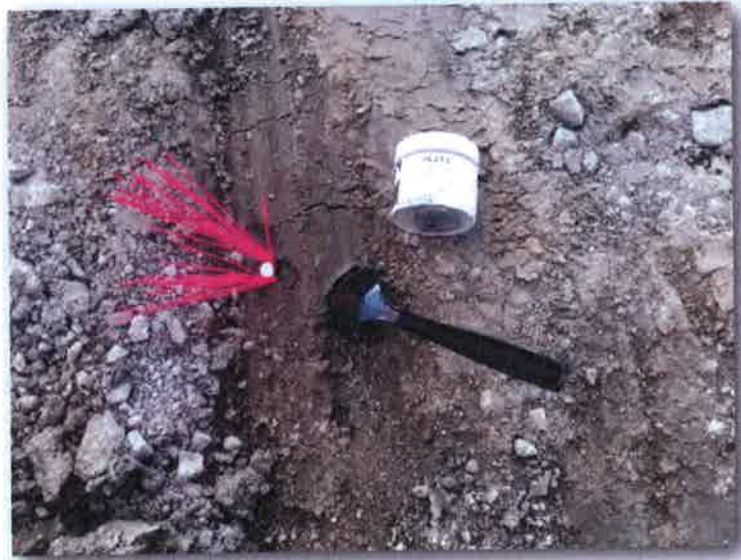
Typical Soil Sample

Sample jars were wrapped in bubble wrap sleeves and placed in individual resealable plastic bags. Samples were immediately chilled to 4°C using water ice and placed in a reusable cooler provided by the laboratory. No other preservatives were used. Samples were shipped via Federal Express to ESC Lab Sciences in Mount Juliet, Tennessee. Samples were submitted for Cd and/or Pb analysis by inductively coupled plasma spectrometry using EPA Method 6010B.

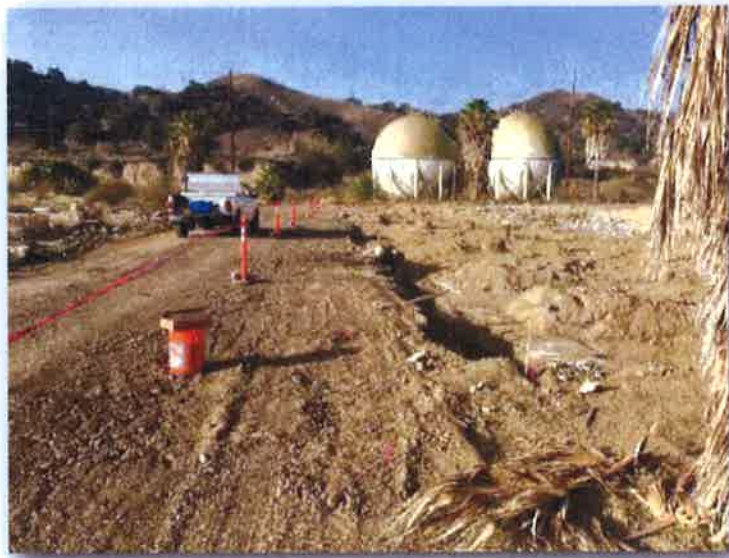
Step-Out Samples in Road
(Row AB)

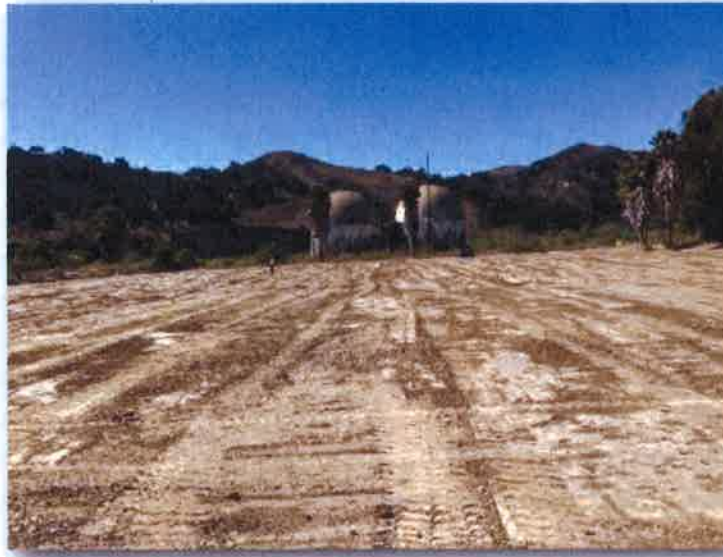
Finish Grade October 2017

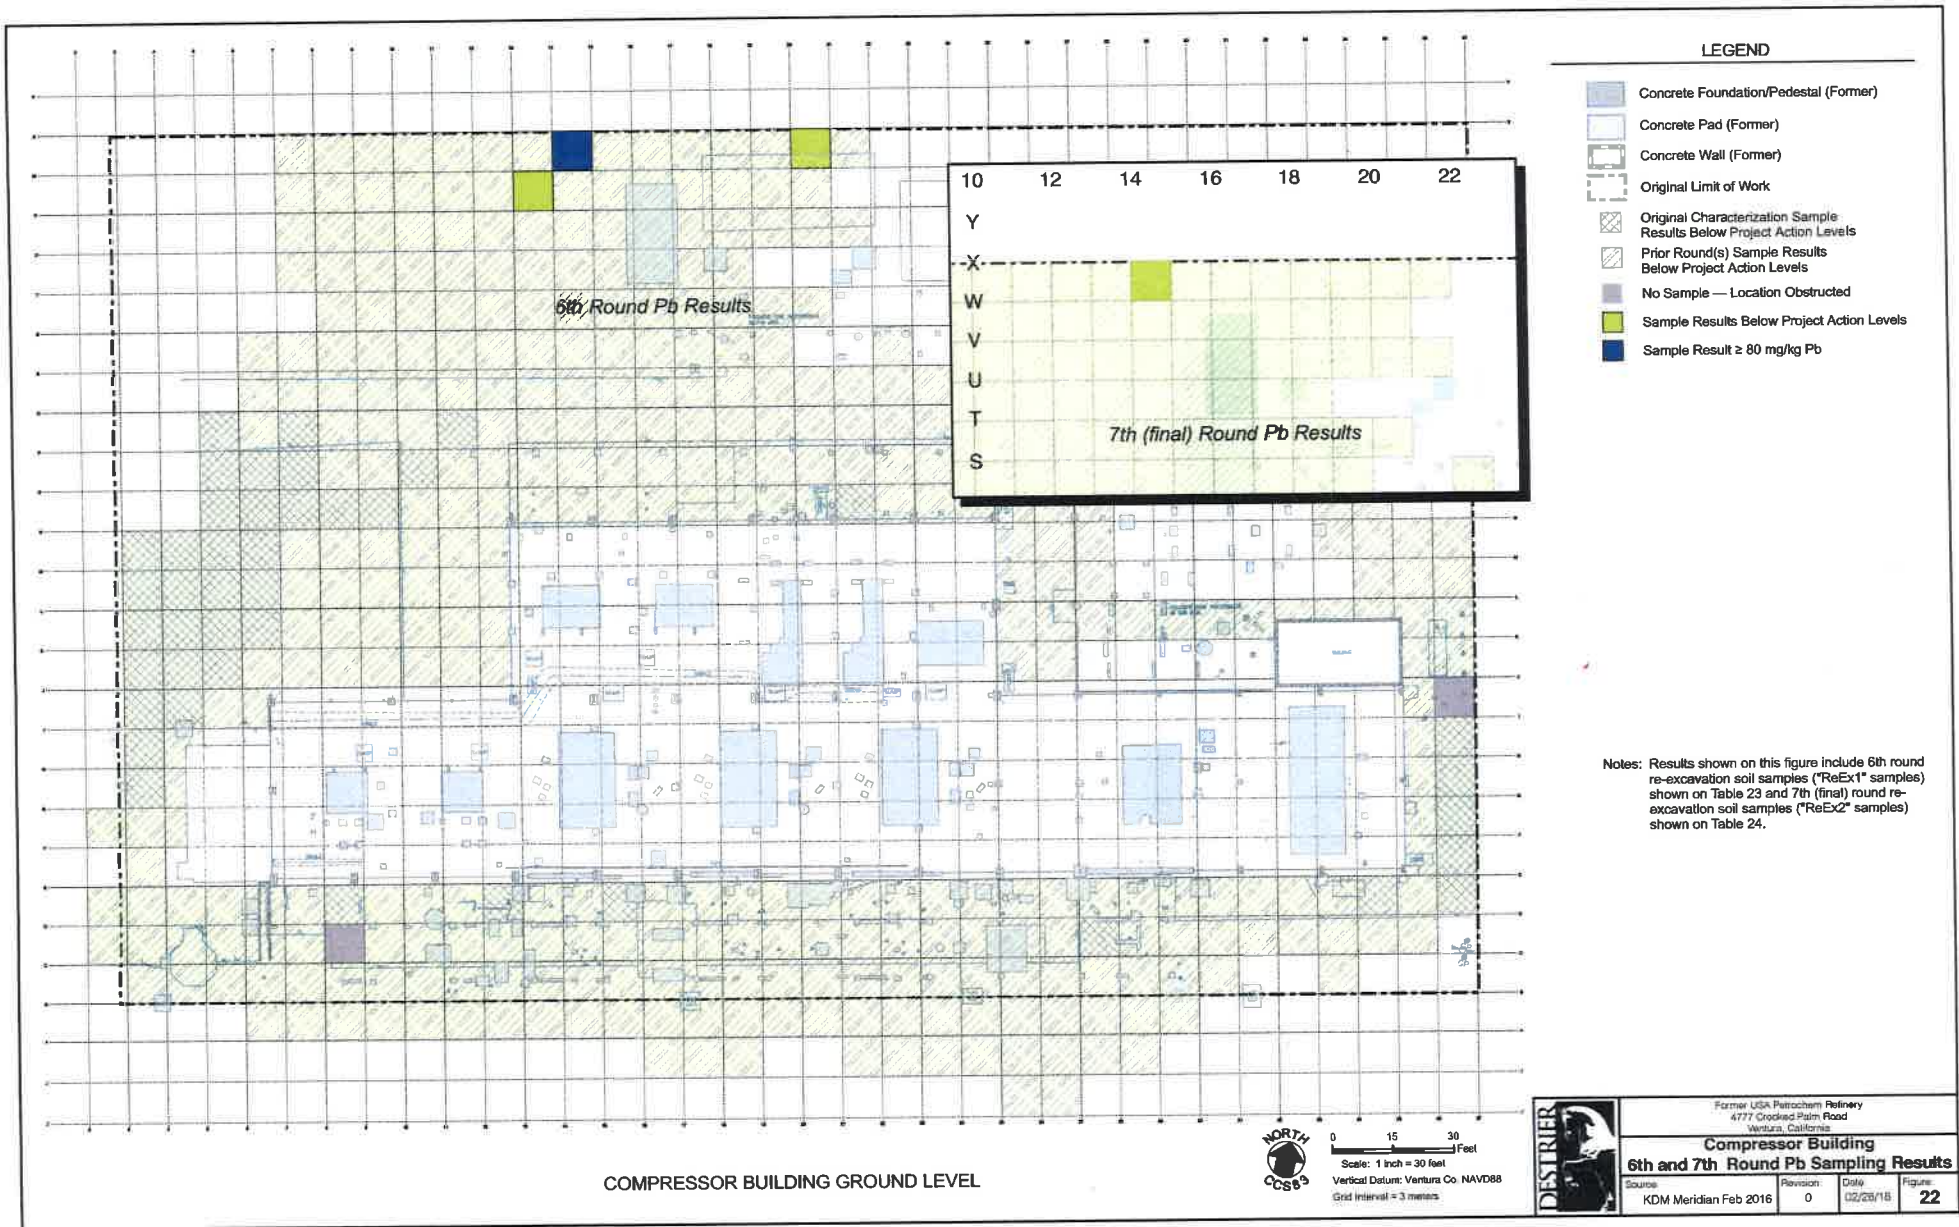
Notes: Results shown on this figure include 6th round re-excavation soil samples ("ReEx1" samples) shown on Table 23 and 7th (final) round re-excavation soil samples ("ReEx2" samples) shown on Table 24.

Figure 22 and Table 23 illustrate these results.

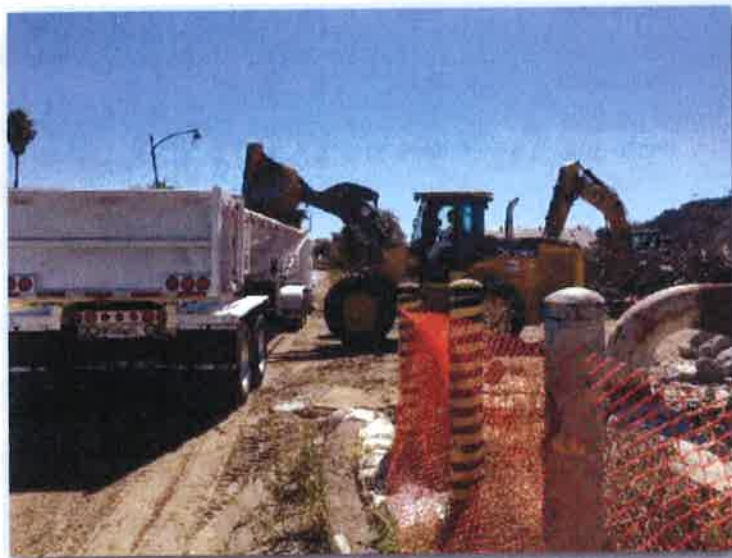
Truck Loading Operations

Table 26, below, tabulates each of these waste shipments associated with the Compressor Building demolition and remediation.
