**CHANNEL FROM BACK SOUND TO  
LOOKOUT BIGHT  
MAINTENANCE OF  
U.S. ARMY CORPS OF ENGINEERS AND  
U.S. NATIONAL PARK SERVICE  
NAVIGATION CHANNELS  
ENVIRONMENTAL ASSESSMENT**

**September 2023**

**Finding of No Significant Impact (FONSI)**  
**Channel from Back Sound to Lookout Bight**  
**Maintenance of U.S. Army Corps of Engineers**  
**and U.S. National Park Service Navigation Channels**  
**Carteret County**  
**North Carolina**

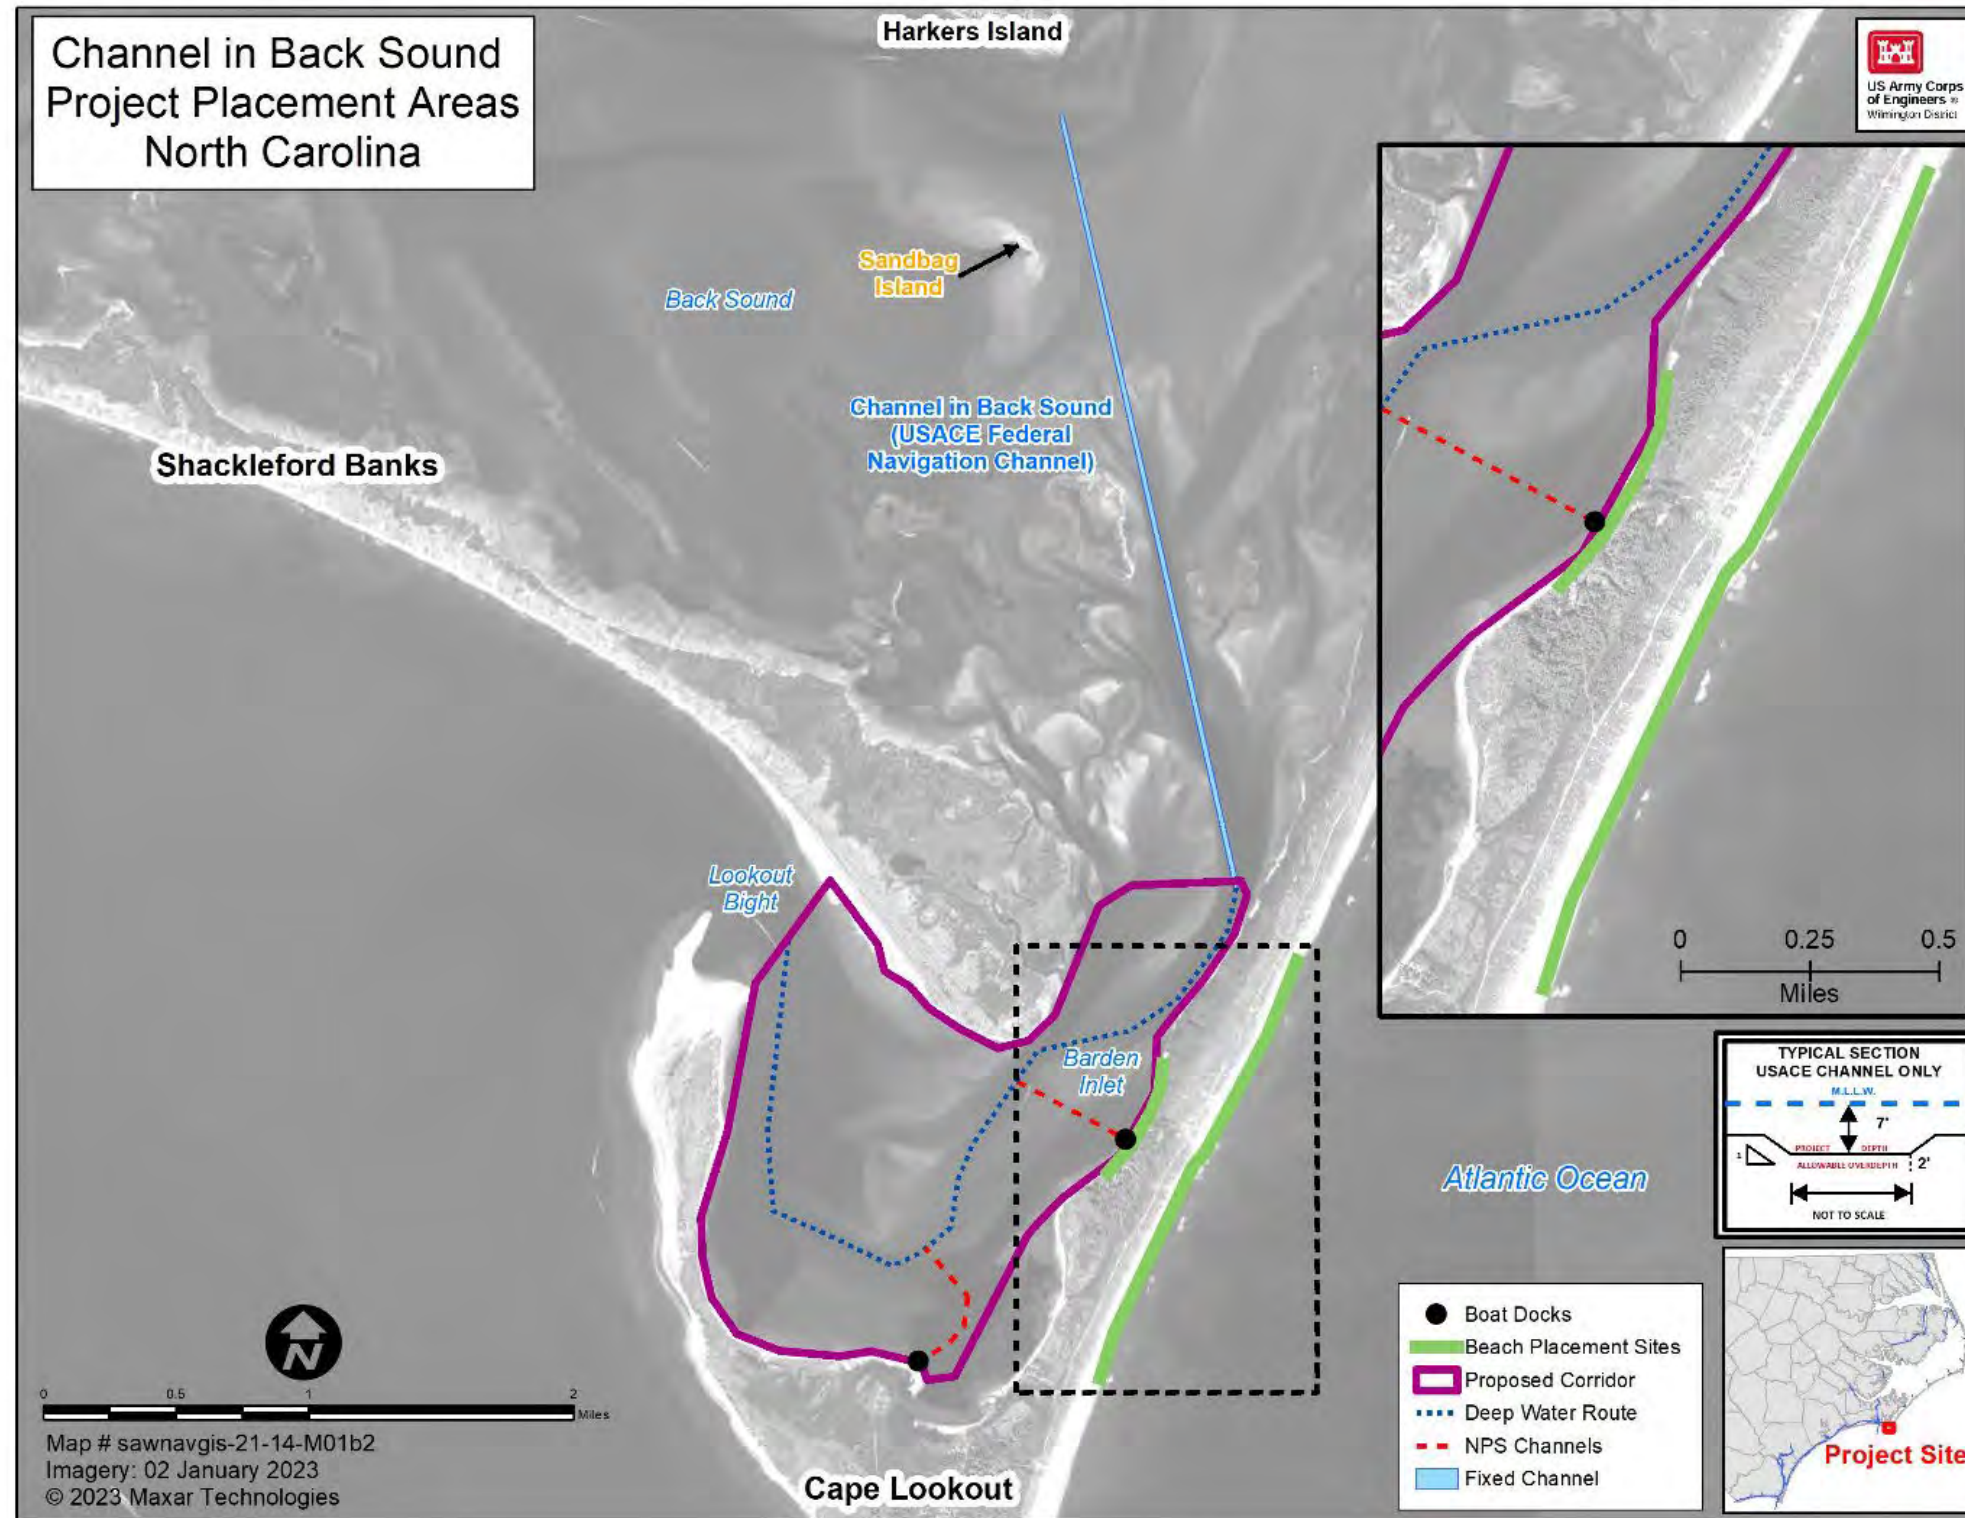
Figure 6. CALO Soundside and Oceanside Beach Placement Areas

The beach placement area would depend on the quantity of material available, and the area identified would be approved by NPS. The beach template design would mimic the natural beach as much as possible, typically having a berm elevation of 6 feet and berm width of 175-200 feet, allowing for successful sea turtle nesting.

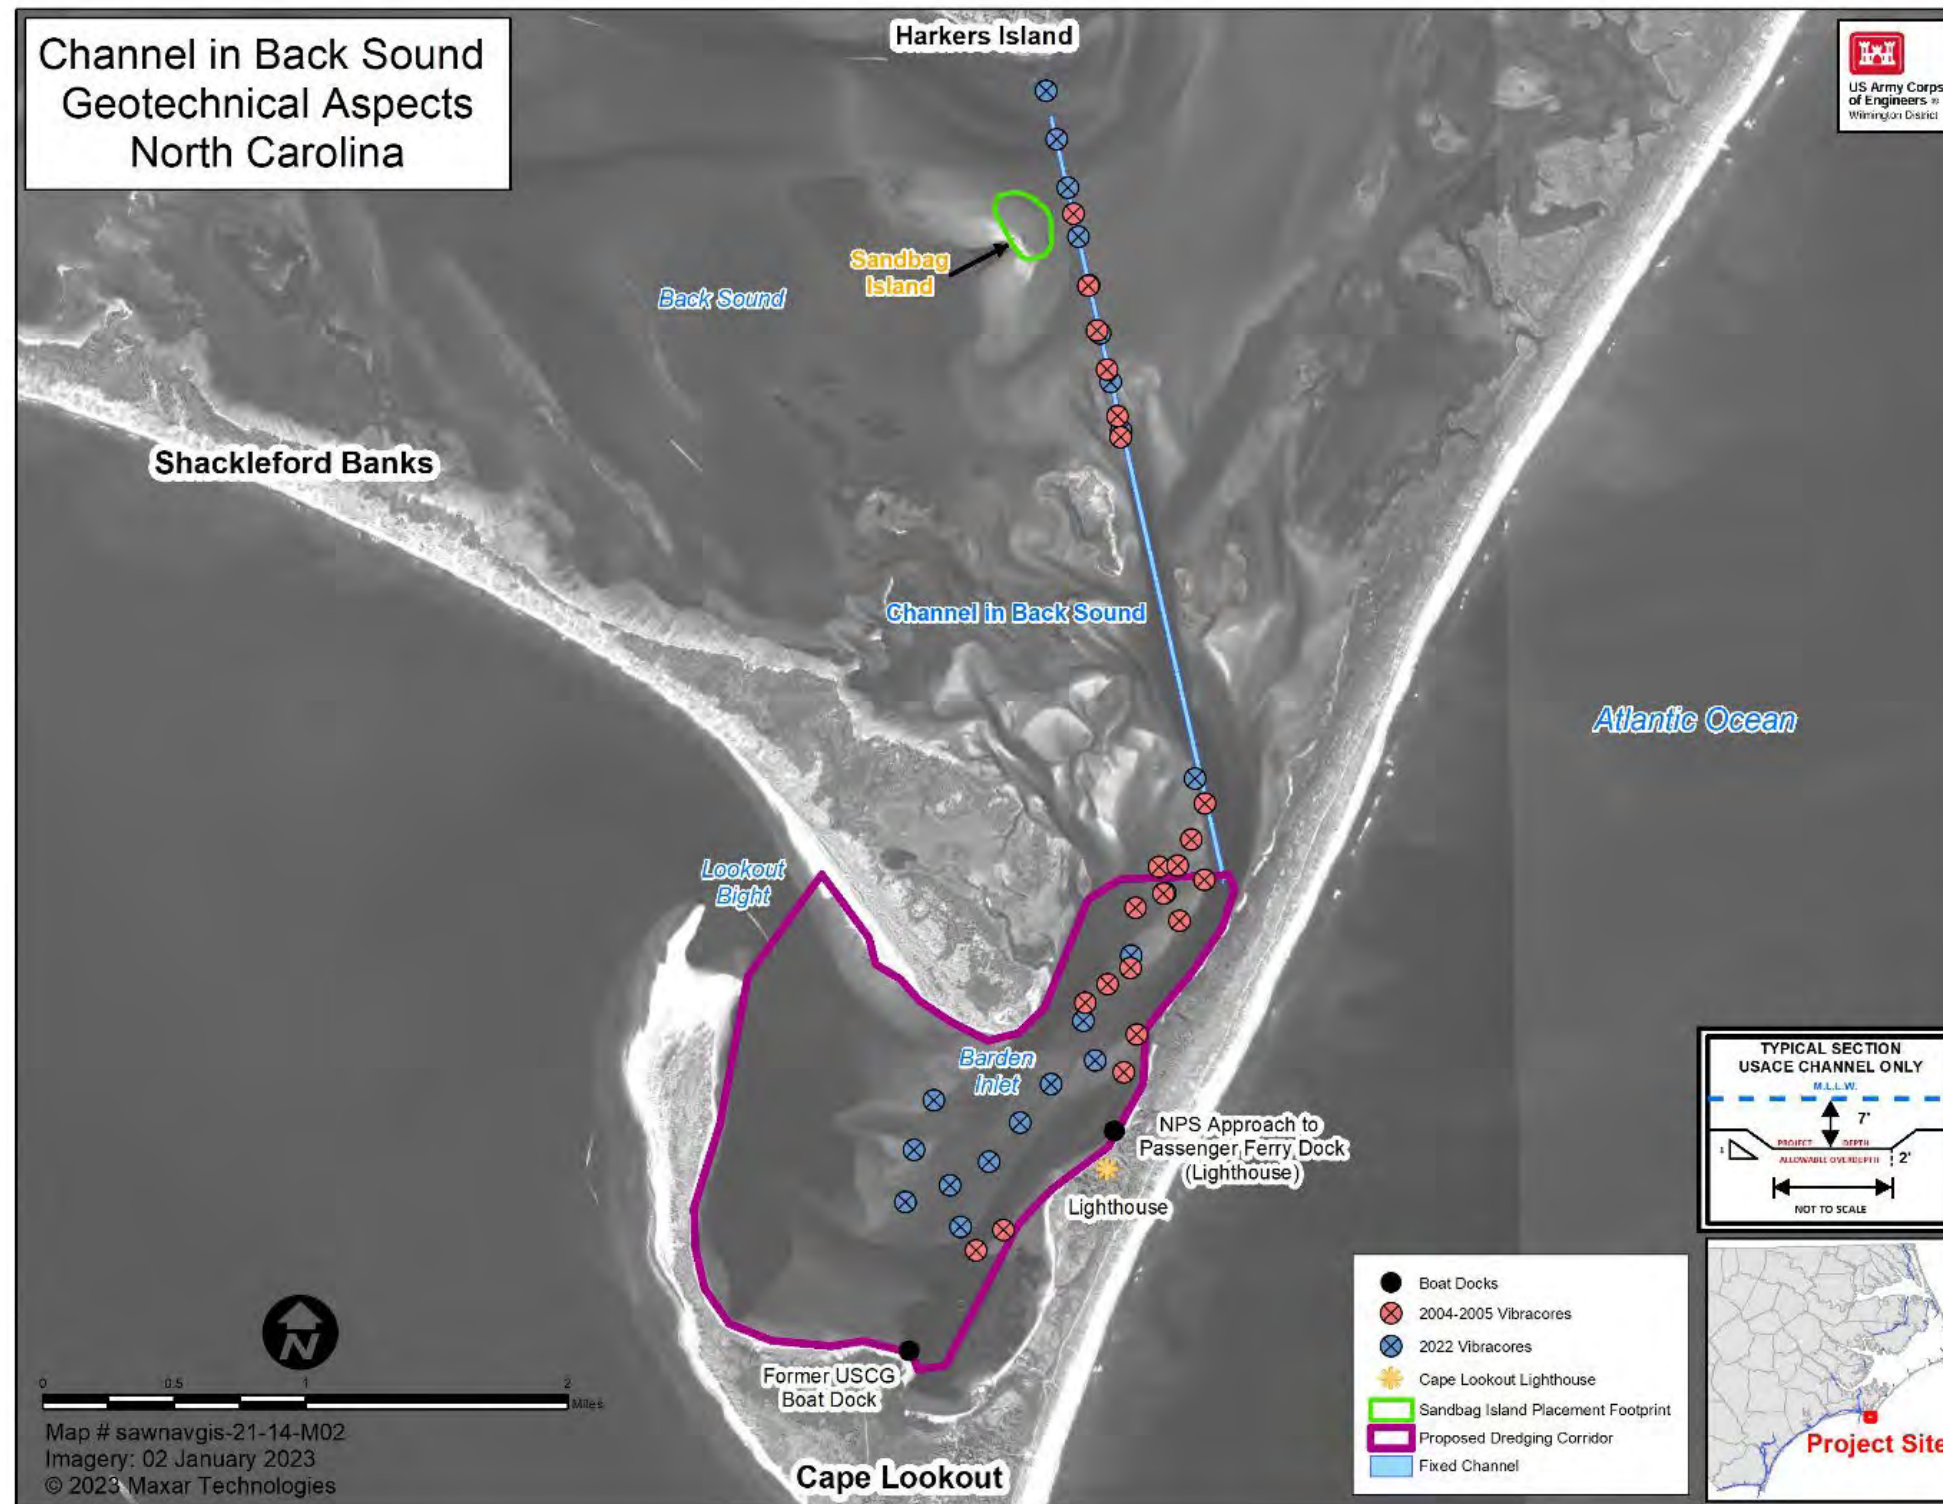
Figure 10. Location of 2004-05 and 2022 USACE Vibracores

Two geotechnical investigations involving the collection of vibracores were performed across the project area (Figure 10), the first was in 2004-2005, and the second was in 2022. The purpose of these investigations was to analyze the subsurface sediments and determine whether the sediments were suitable for beach or bird island placement.

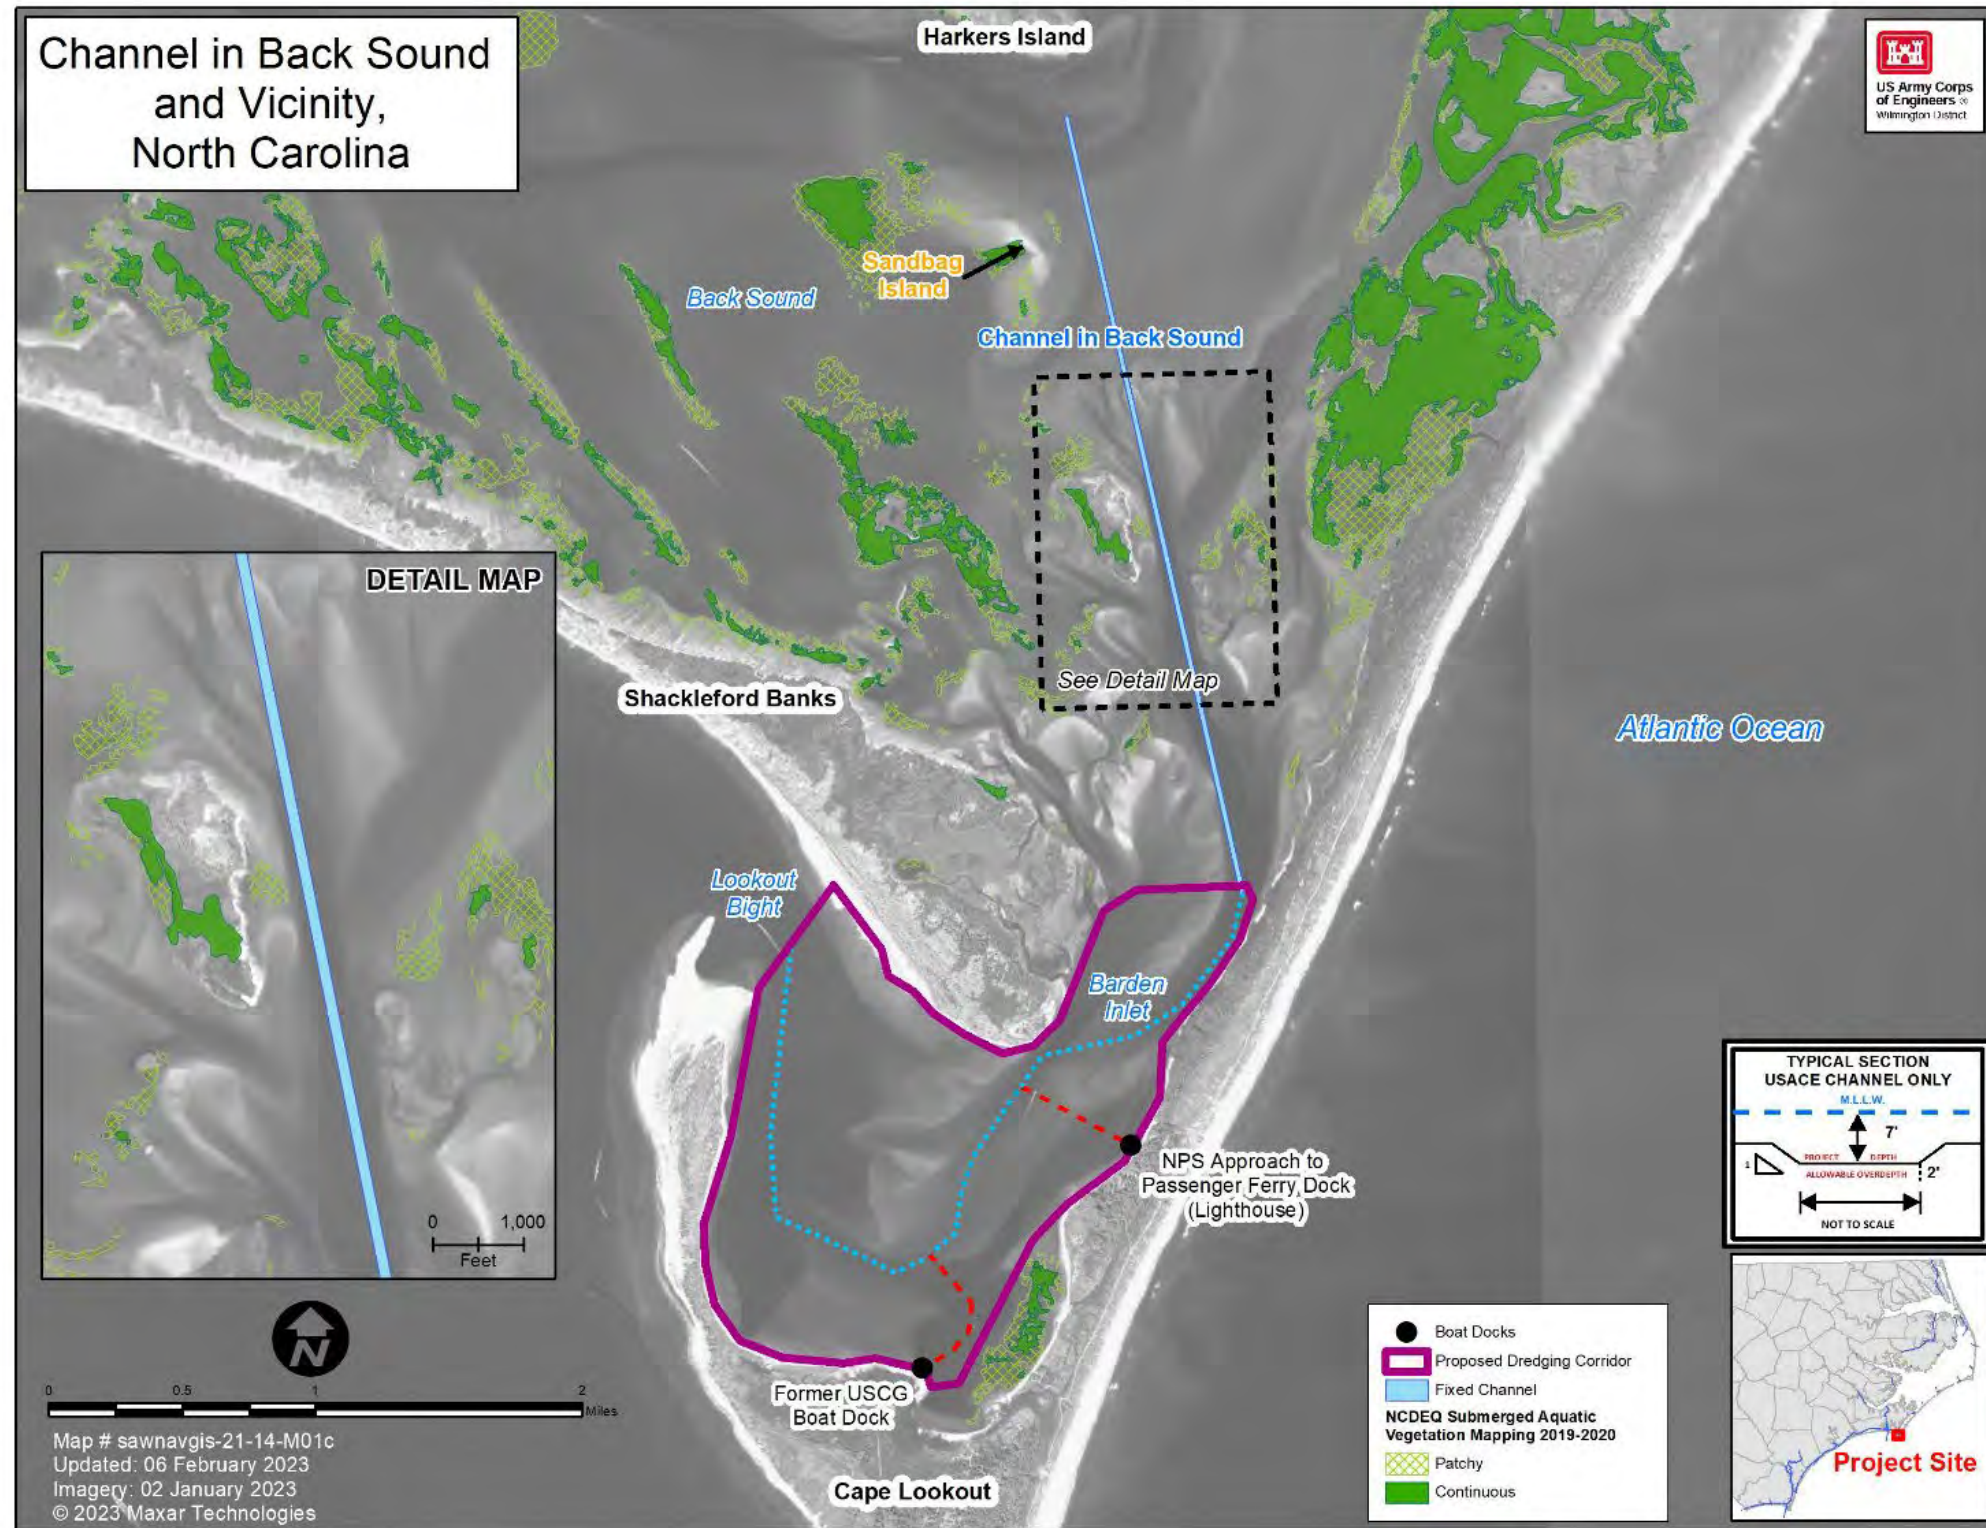
Figure 12. Location of Submerged Aquatic Vegetation (SAV), NCDEQ 2019-2020 SAV Mapper

SAV is prolific in shallow estuaries of Back Sound and Lookout Bight as shown in NCDEQ's 2019-2020 SAV mapping data (Figure 12). SAV was also identified using aerial imagery of the 2022 growing season (April – October). Although SAV can quickly populate shallow bottom when conditions are conducive, currents, sand movement, and turbid water in the project area can minimize or eliminate the presence of SAV. This is expected in open, unprotected areas and areas following designated and undesignated navigation routes. In November 2022, a ground-truthed survey resulted in no SAV being present within and immediately adjacent to USACE and NPS channels, as well as Sandbag Island. The nearest SAV identified during the November survey was a small “patchy” cluster approximately 250 feet west of the Channel in Back Sound (Figure 12), which could be affected by dredging and dredged material placement (sidecasting). In July 2023, an additional ground-truthed survey resulted in SAV being identified, specifically in twenty-five patchy areas within the overall 25-acre footprint of Sandbag Island, and in several, approximately 400 square-foot patches within a 500 linear foot portion of the USACE channel. SAV is also present to the south and southwest of Sandbag Island. Dredging would avoid known areas of SAV to the maximum extent practicable by identifying the presence of SAV using the State's online database and recent aerial imagery. Government plant dredging and placement activities would occur during the recommended timeframe of October 1 – March 31 to avoid the SAV growing season, thereby making impacts to SAV insignificant. In addition, USACE will maintain a 100 foot buffer from all SAV during placement of dredged material within deep scour holes or sidecasting in the Barden Inlet area during the October 1 – March 31 timeframe.

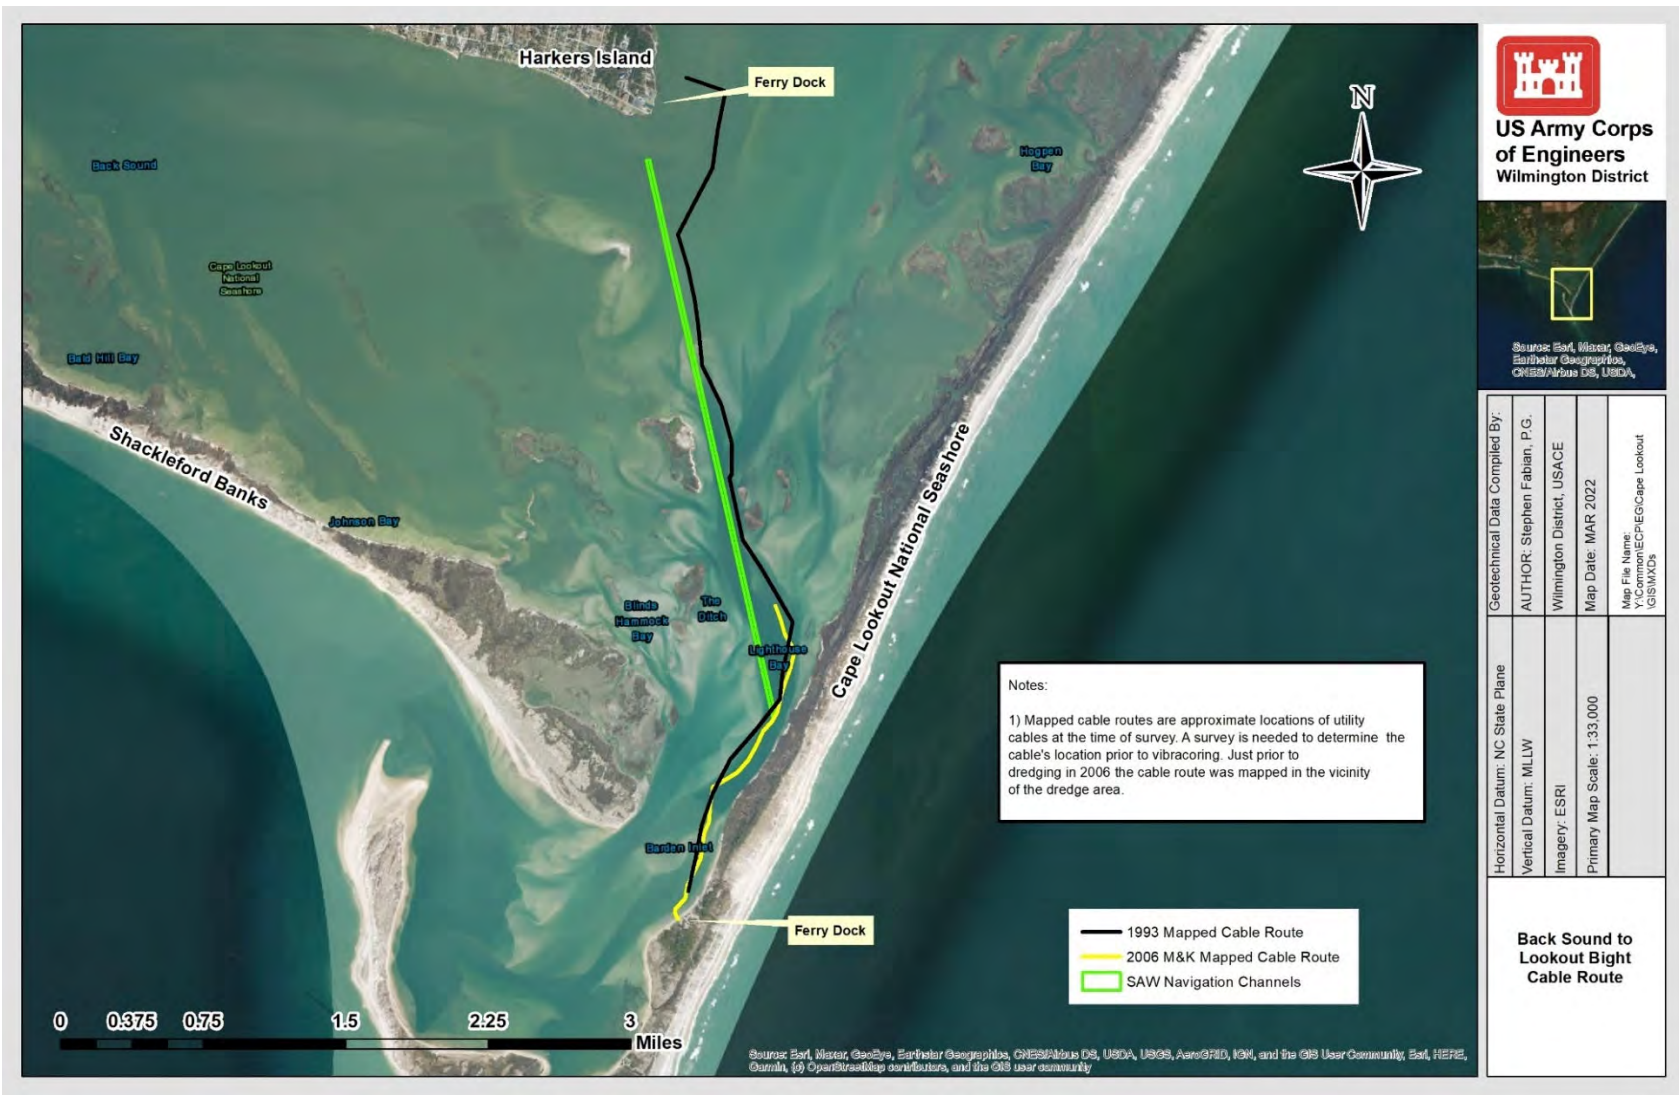
Figure 2. Mapped cable routes from Harkers Island to Cape Lookout Lighthouse. The 1993 route covers most of the cable route while the 2006 mapped cable route covers a small portion of the cable's location, which was in the vicinity of where dredging occurred 2006.

The lighthouse's main power source use to supplied by an electrical service cable from Harkers Island to Cape Lookout (Figure 2). The entire cable was mapped in 1993, with subsequent mapping was conducted on a portion of the cable in 2006 prior to a dredging event. The buried cable extends for 5 miles and has powered the Cape Lookout Lighthouse and life-saving station for decades. The survey from 1993 shows the cable running alongside the federal navigation channel and intersecting the southern portion of the federal navigation channel. The cable then follows the sound-side shoreline before terminating at the national historic district, where the lighthouse and lifesaving station are located. However, due to a recent improvement of solar panels that now provide sustainable energy power to the lighthouse the need for the cable is not needed and was abandoned. It is recommended the cable route be mapped prior to any dredging occurring within the study area to prevent damage to any dredging equipment.

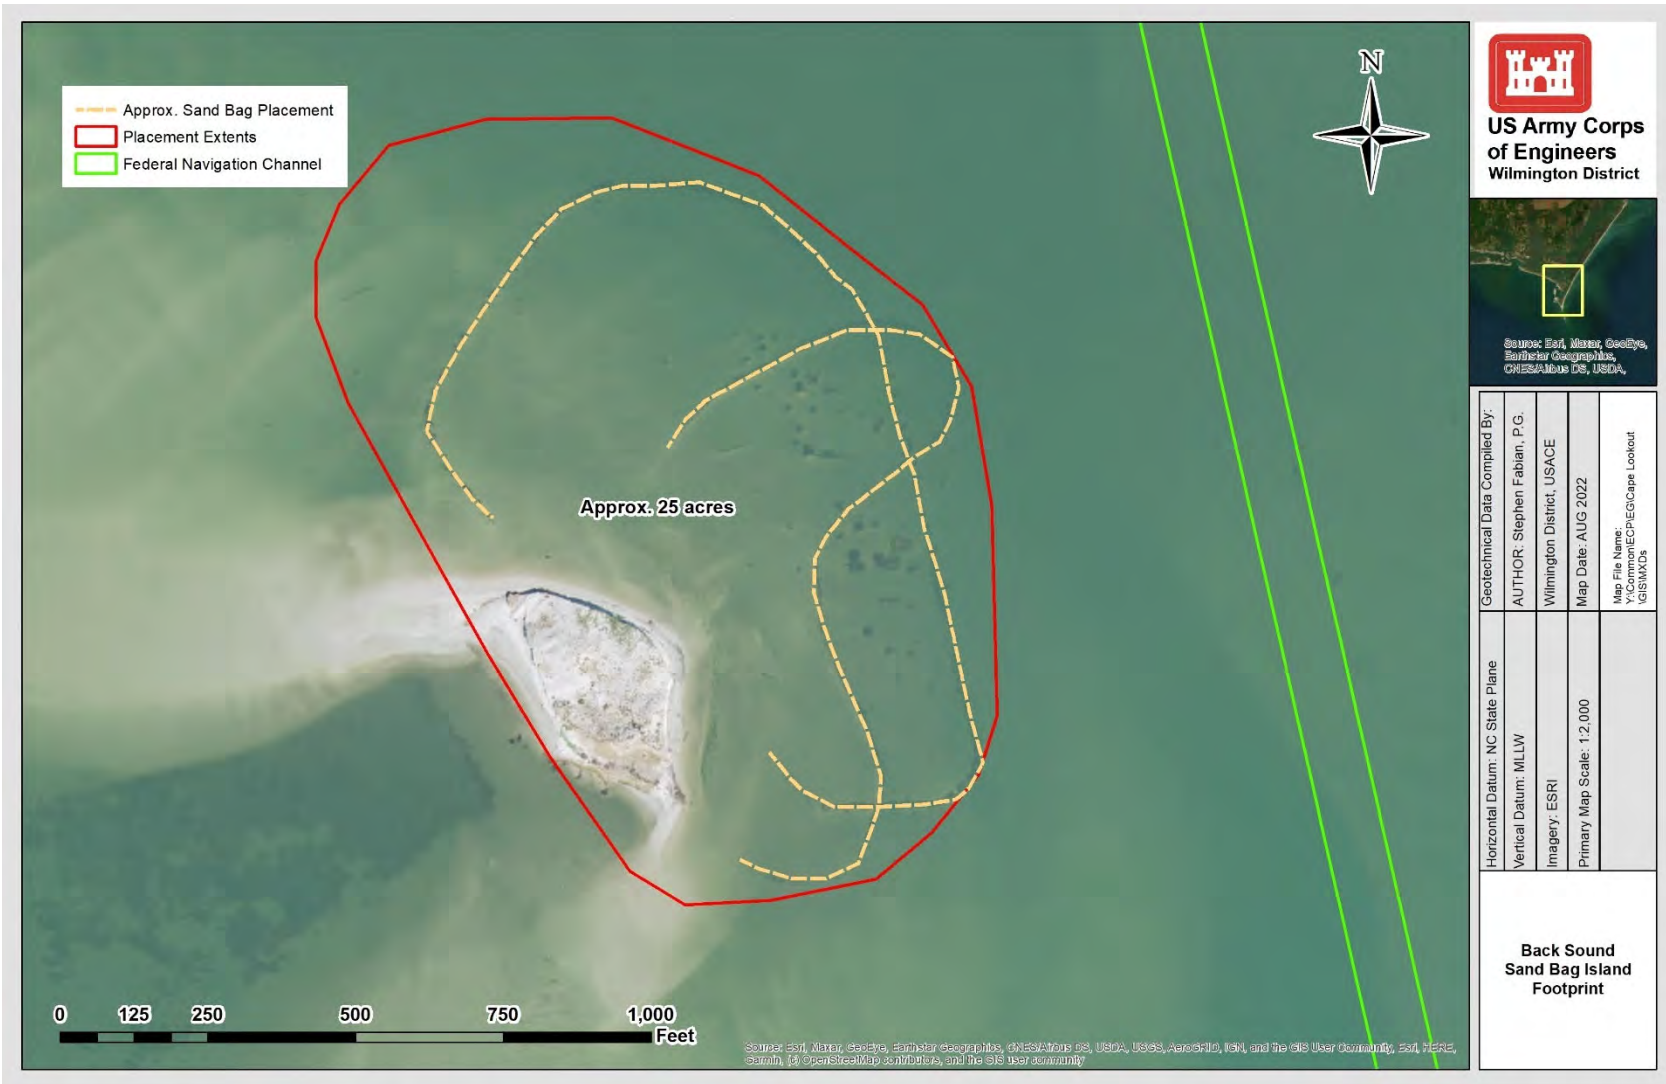
Figure 3. Sandbag island, a disposal site, was last used in 1997. The island's footprint has changed numerous times due sediments being reworked by wind, tides, and coastal storms. The sandbag ring (dashed red line) used to control the movement of material is still visible today.

In April 1997, the federal navigation channel was dredged to provide easier mariner access from Harkers Island to Cape Lookout. The dredged material was used to create a bird island adjacent to the federal channel, known as “Sandbag Island” (Figure 1 and Figure 3). Prior to dredging and placement of material, a sandbag ring was constructed to prevent sluffing and dispersion of material away from the desired placement area (Figure 3). The sandbag ring is still visible today, but the sediment placed here in 1997 has been removed over time through wind, waves, and tidal processes and now most of the island is submerged. This disposal site has not been used since 1997.

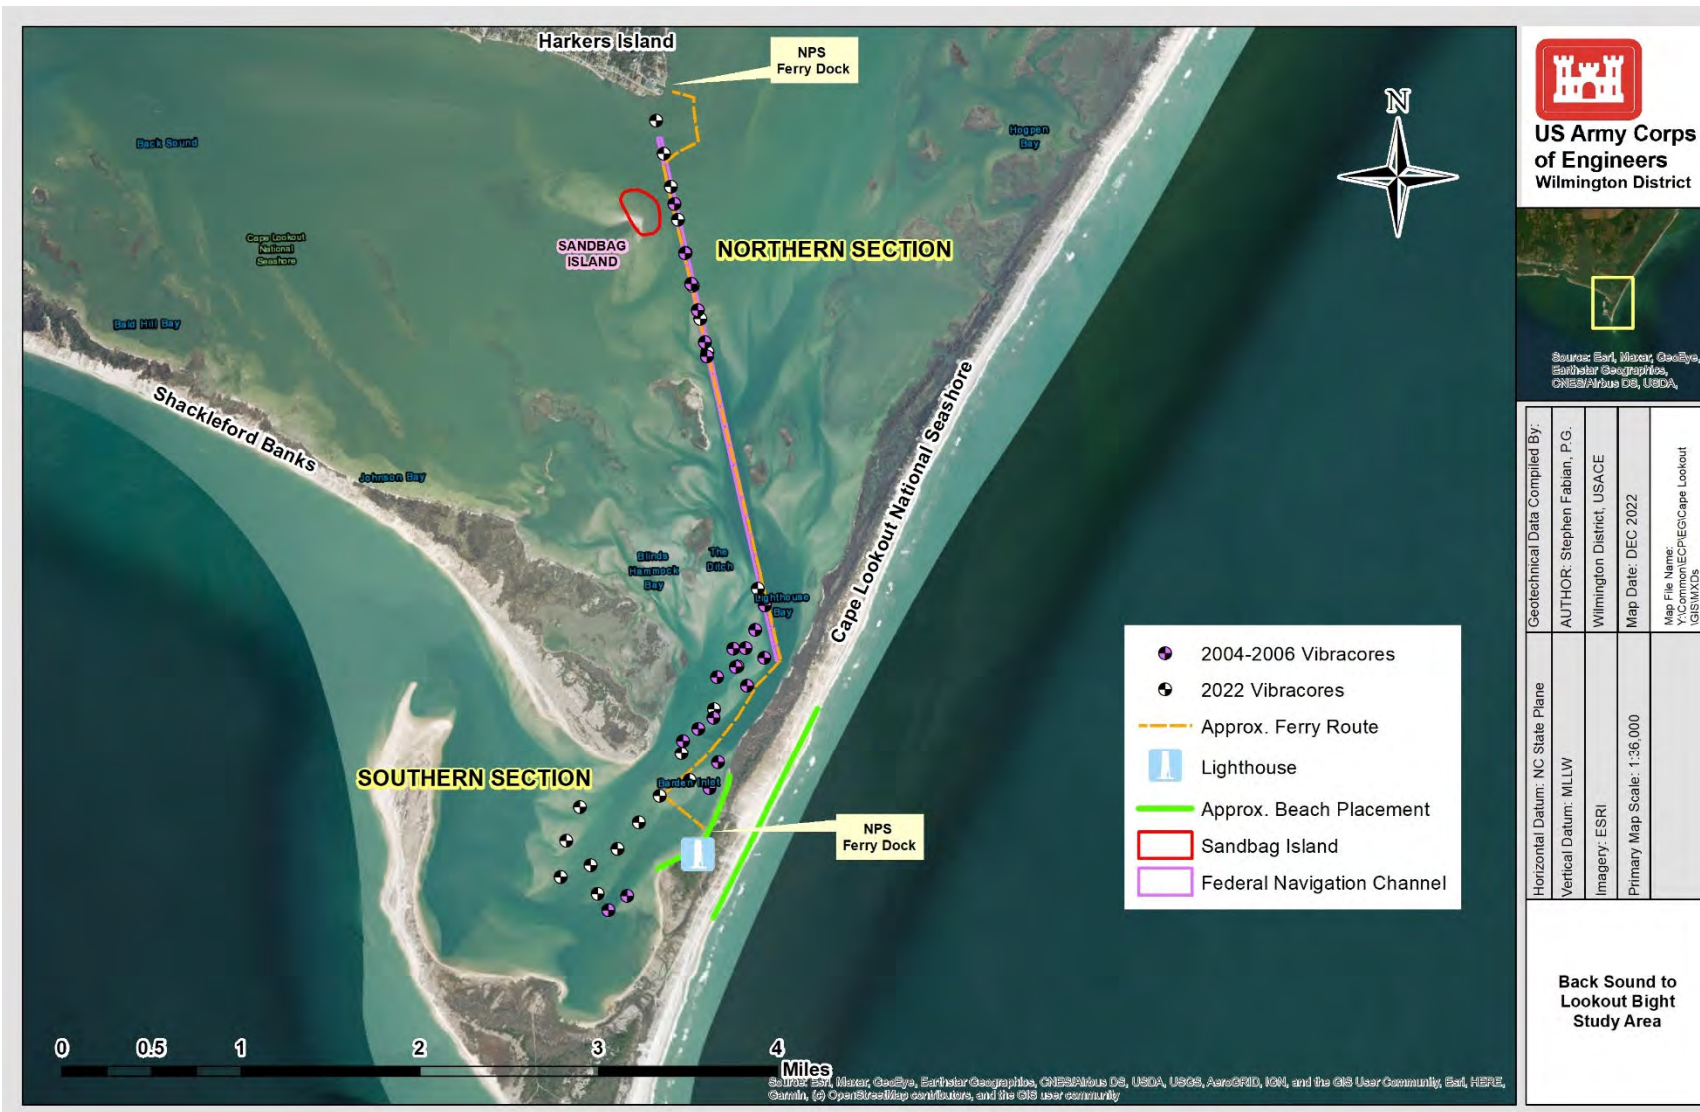
Figure 6. Vibracores collected throughout the study area during the 2004-2005 and 2022 drilling efforts.

Two geotechnical investigations involving the collection of vibracores were performed across the study area (Figure 6), the first being in 2004-2005 and the second in 2022. The purpose of these investigations was to analyze the subsurface sediments and determine whether the sediments were suitable for beach or bird island placement. Vibracores were strategically placed to target areas of significant shoaling. Where naturally deep water exists, deeper than -9 ft. MLLW, these areas were not targeted since dredging would not occur in these locations. If naturally deep-water areas do become shoaled-in additional geotechnical investigations may need to occur if sufficient subsurface information is lacking within the surrounding area. Details regarding these investigations are described in the below sections.

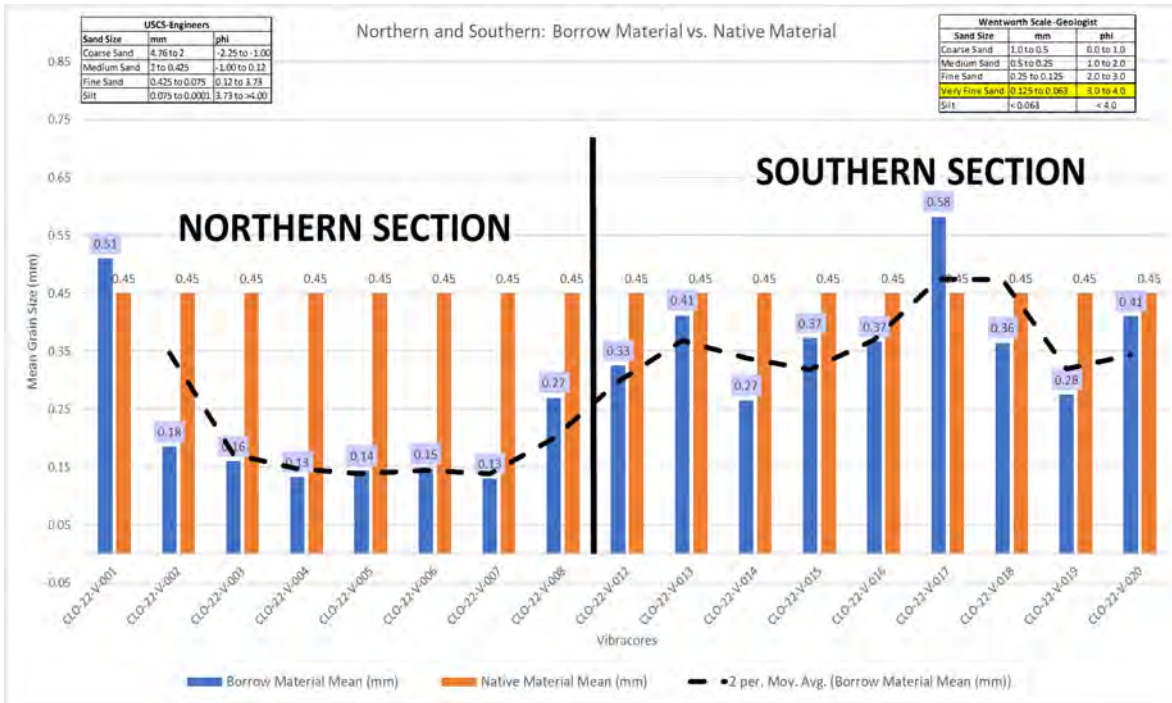
Figure 11. Vibracore data from 2022 collection showing the mean grain size comparison of the northern and southern section vs. the native beach.

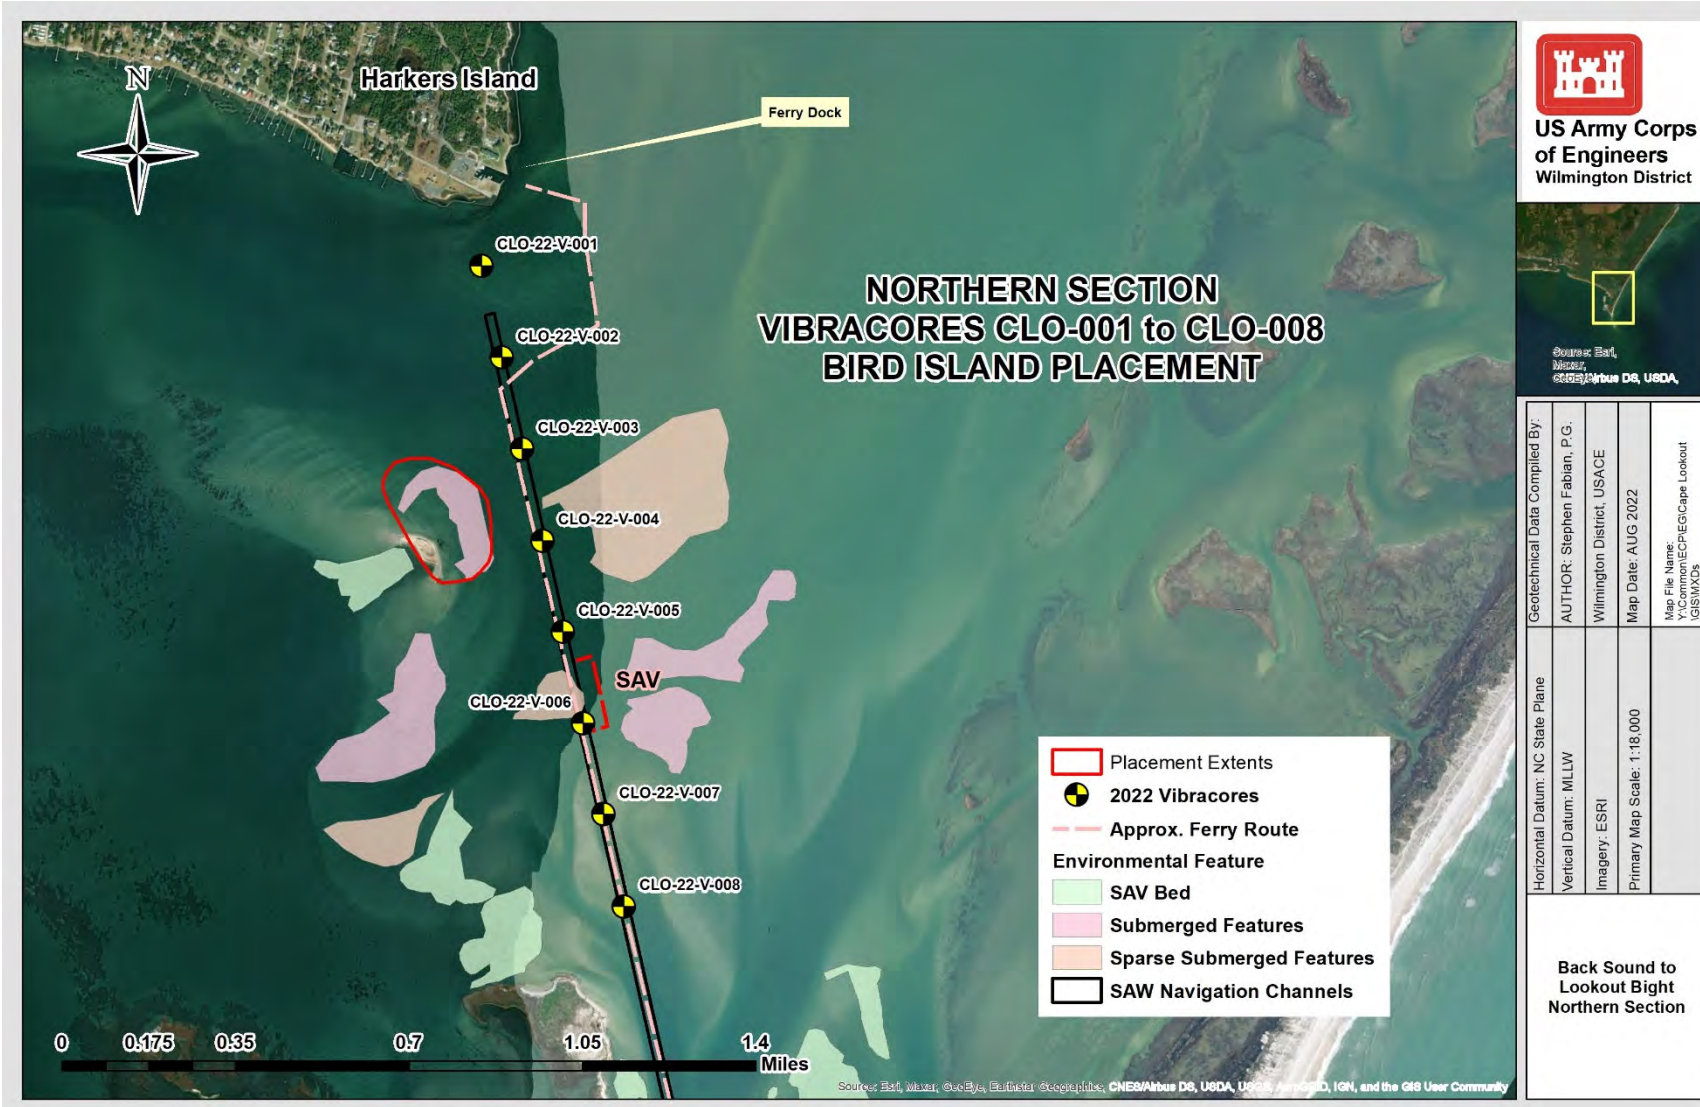
Figure 12. Showing dredging limitations within the northern section of the study area. It is recommended all material dredged within the federal navigation channel be placed on the sandbag island (red polygon).

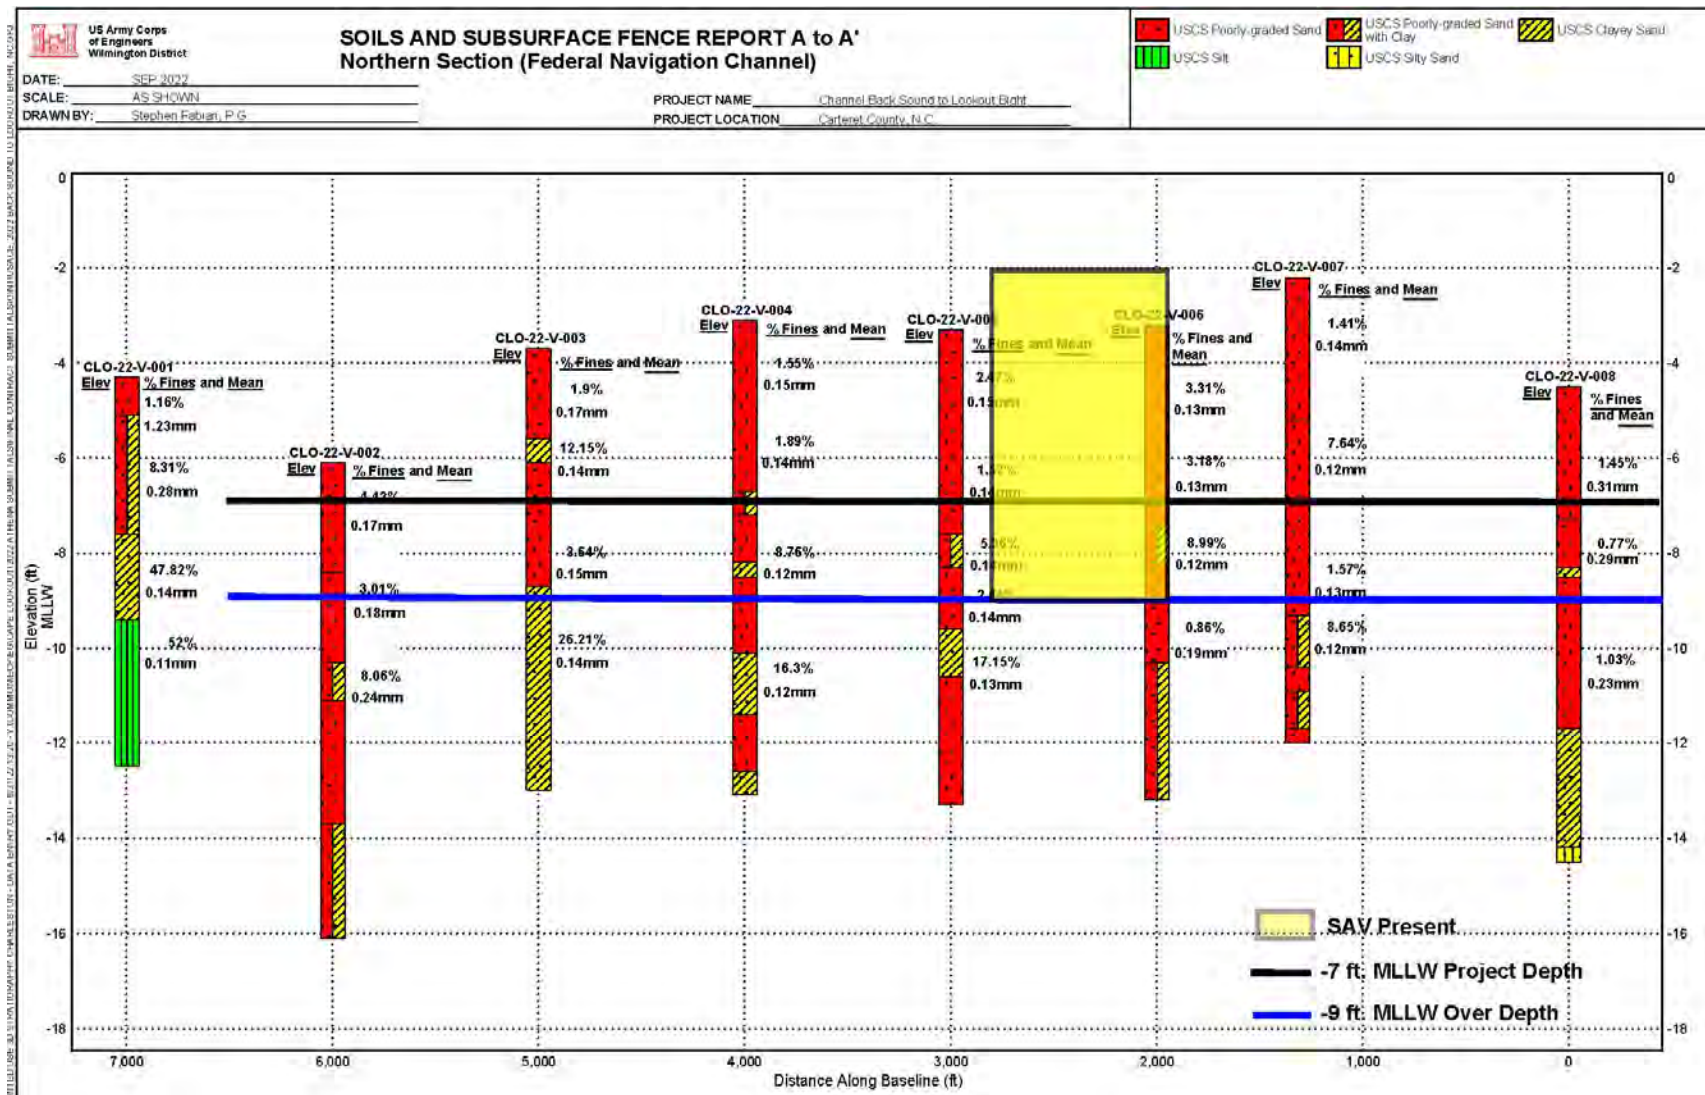
Figure 14. Cross section A to A' showing allowable dredge areas throughout the northern section.

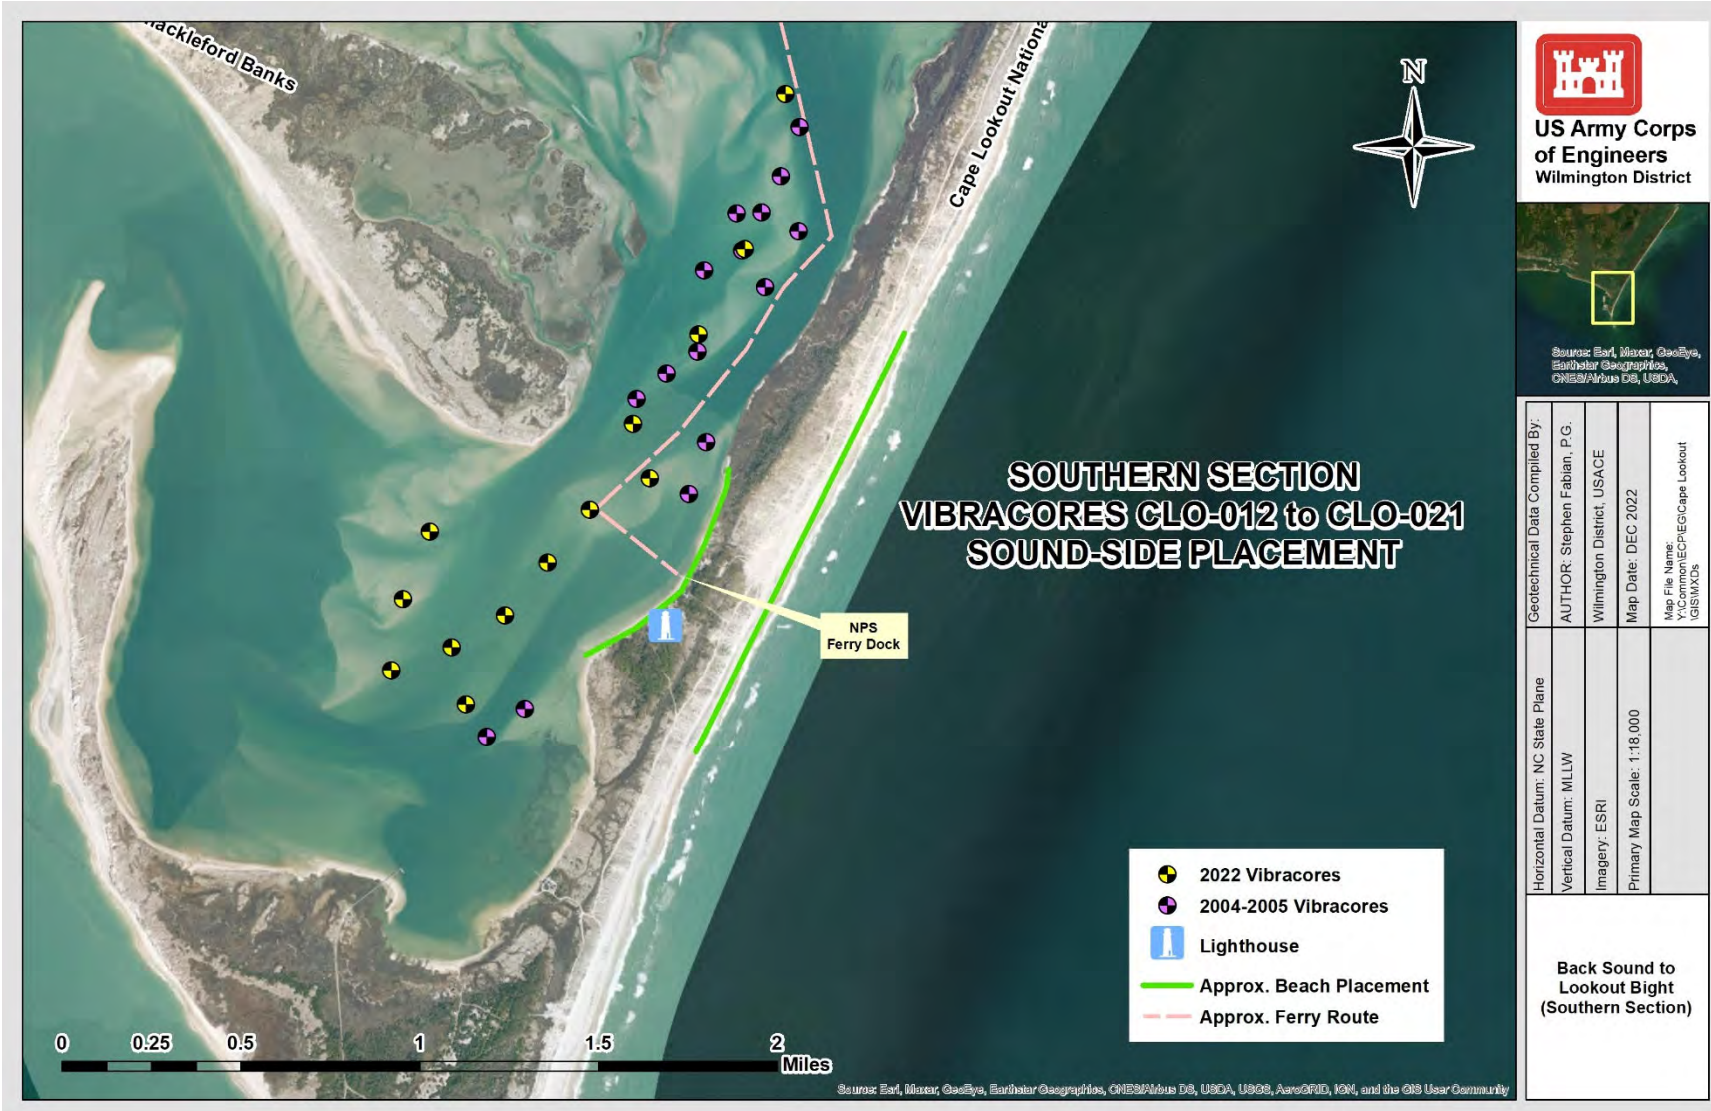
Figure 15. Vibracores collected within the southern section of the study area. It is recommended all dredged material within this area be placed on the sound-side beach in front of the Cape Lookout Lighthouse.
