**CHANNEL FROM BACK SOUND TO  
LOOKOUT BIGHT  
MAINTENANCE OF  
U.S. ARMY CORPS OF ENGINEERS AND  
U.S. NATIONAL PARK SERVICE  
NAVIGATION CHANNELS  
ENVIRONMENTAL ASSESSMENT**

**September 2023**

**Finding of No Significant Impact (FONSI)**  
**Channel from Back Sound to Lookout Bight**  
**Maintenance of U.S. Army Corps of Engineers**  
**and U.S. National Park Service Navigation Channels**  
**Carteret County**  
**North Carolina**

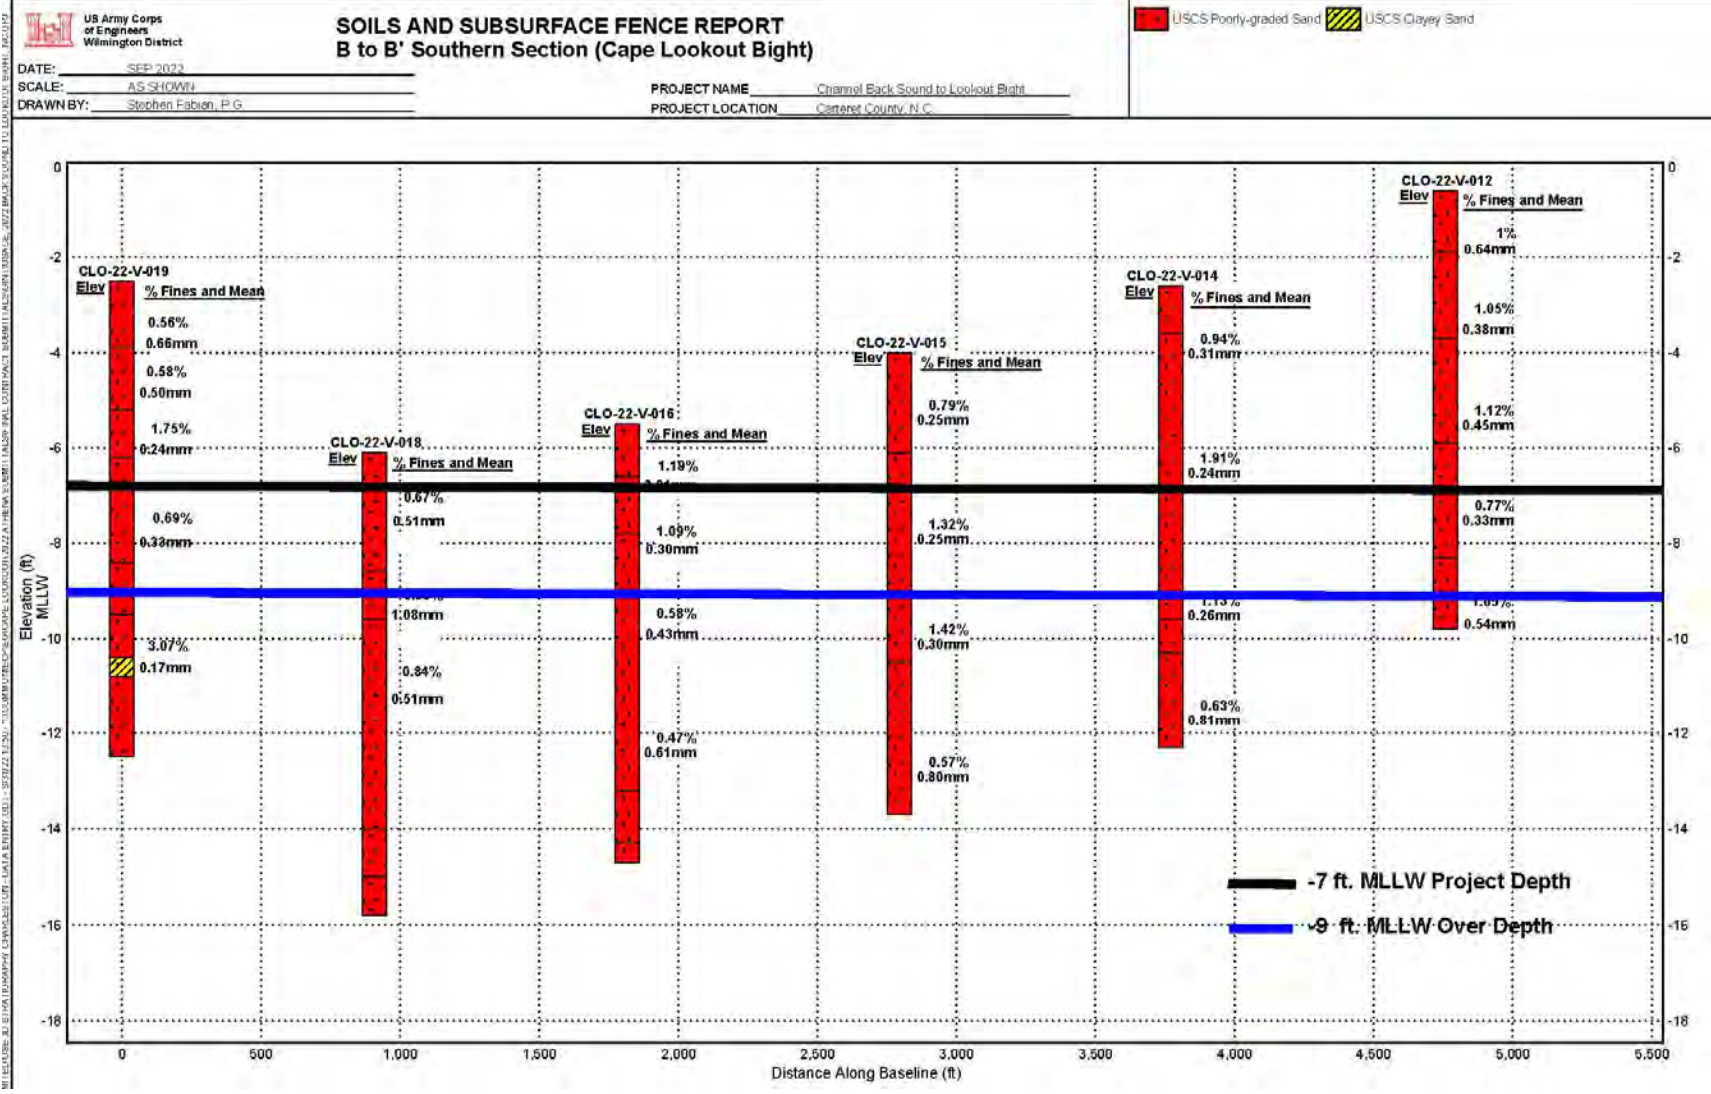
Figure 16. Cross section B to B' showing allowable dredge areas throughout the southern section.

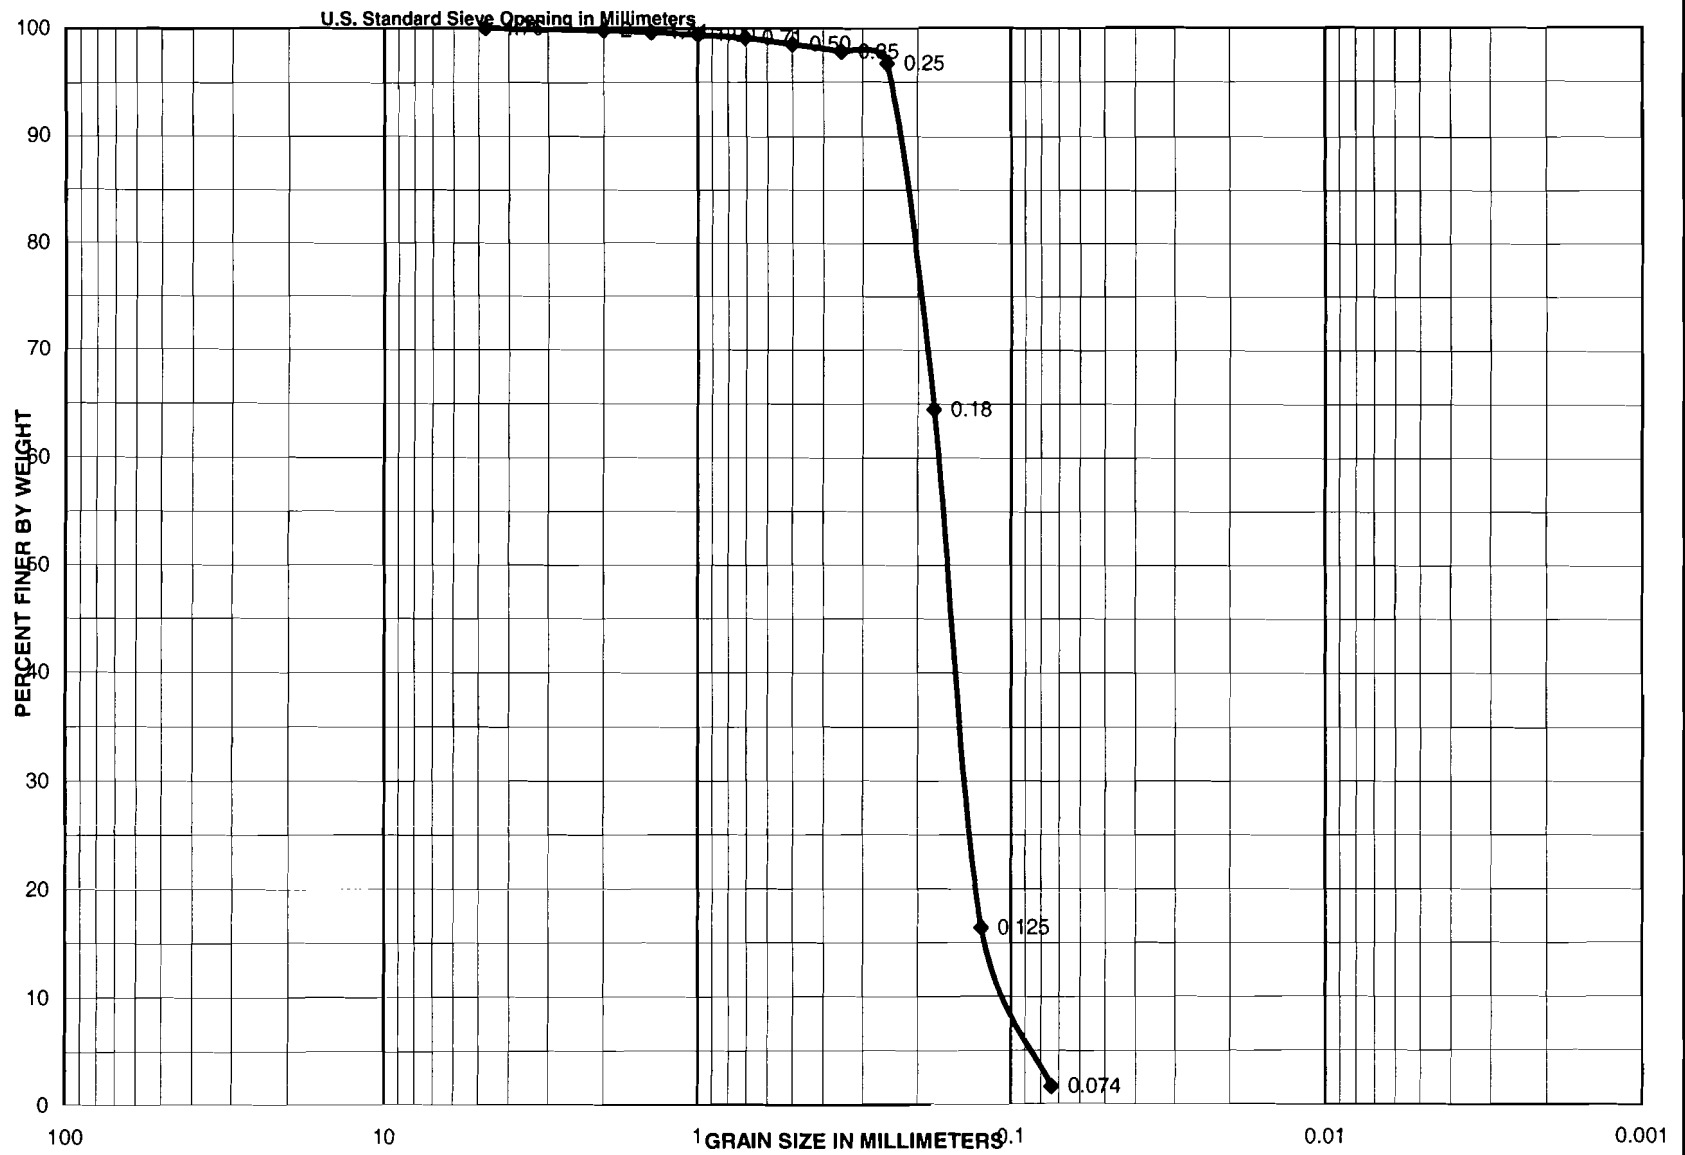
<b>Sample No.</b>	<b>Depth (ft)</b>	<b>Classification</b>	<b>Project</b> USACOE Various Sites
1	3.2-3.7	Dark gray poorly graded sand with trace shells, SP	<b>Area</b> Cape Lookout
		0.18% Shells	<b>CATLIN Geotechnical Laboratory</b>
			<b>Boring No.</b> CL-04-V-2A
			<b>Date</b> 7/29/2004

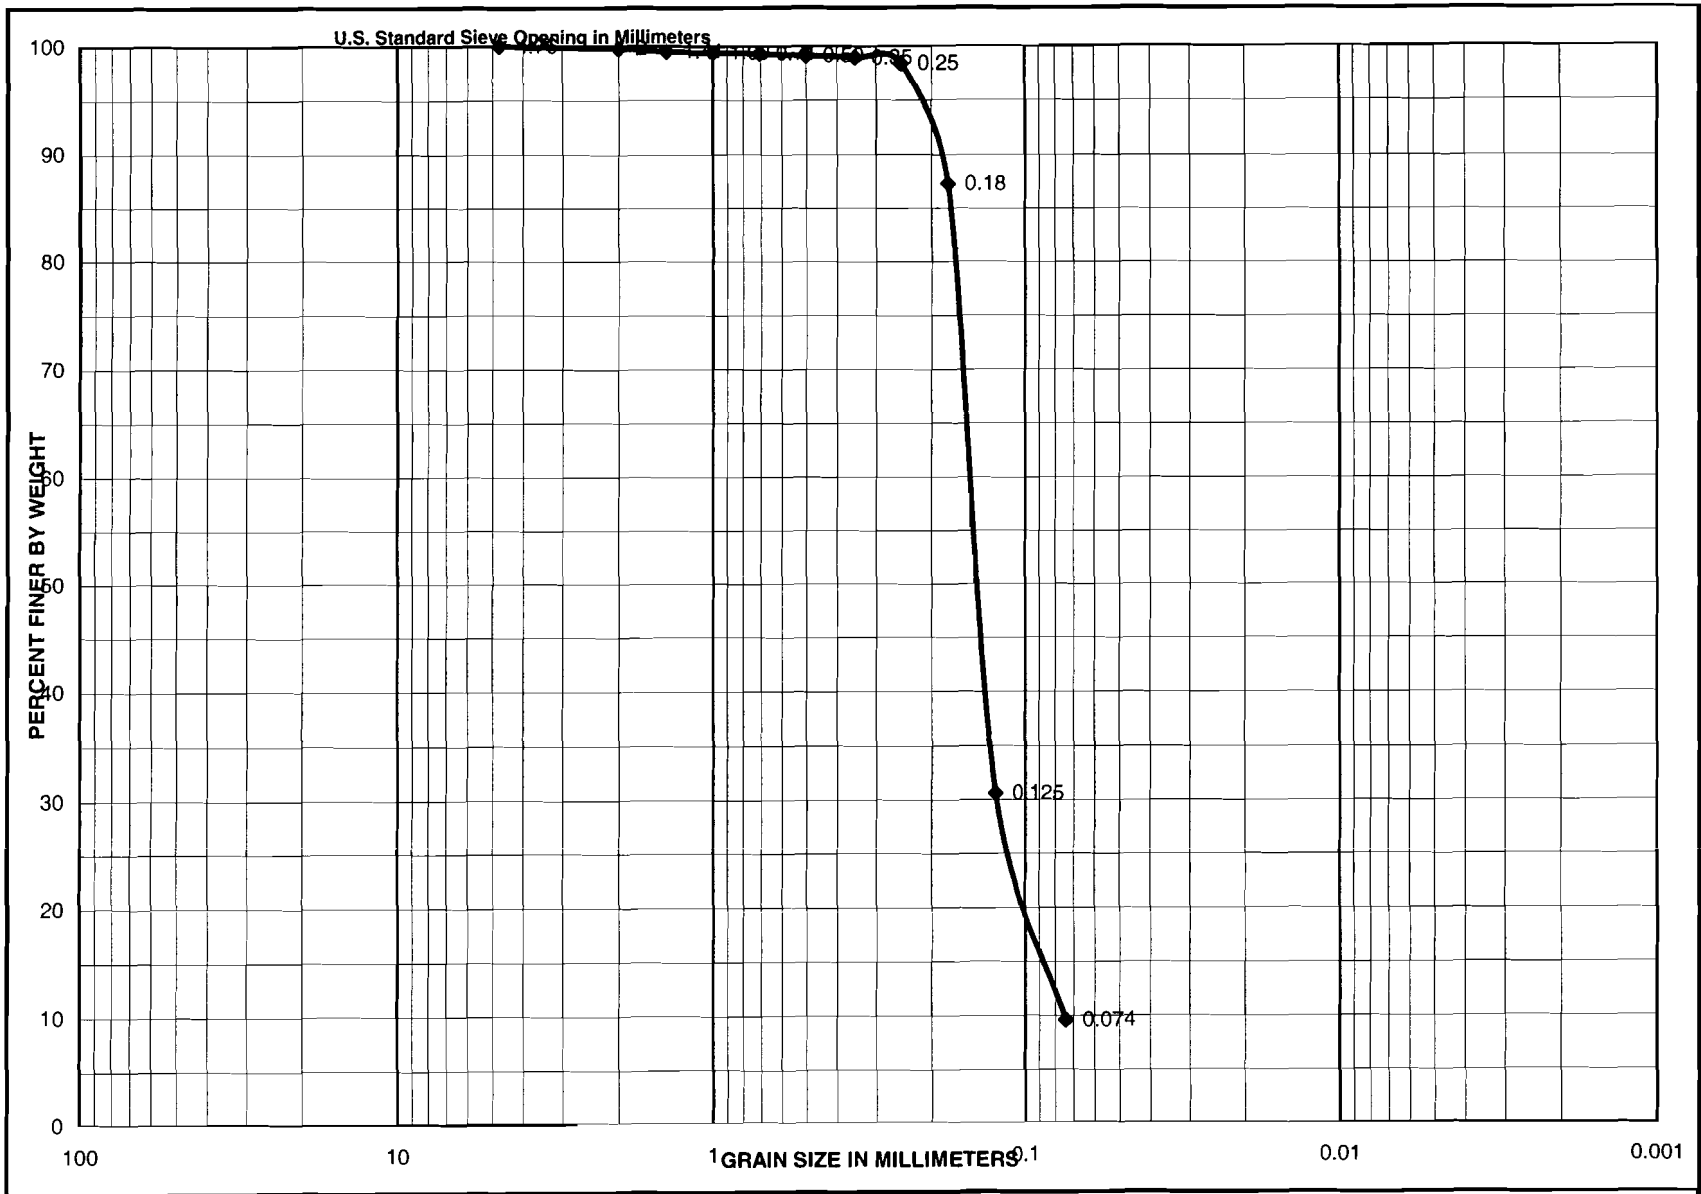
<b>Sample No.</b>	<b>Depth (ft)</b>	<b>Classification</b>	<b>Project</b> USACOE Various Sites
3	8.6-9.1	Dark gray poorly graded sand with silt and trace shells, SP-SM 0.43% Shells	<b>Area</b> Cape Lookout
			<b>CATLIN Geotechnical Laboratory</b>
			<b>Boring No.</b> CL-04-V-2A
			<b>Date</b> 7/29/2004

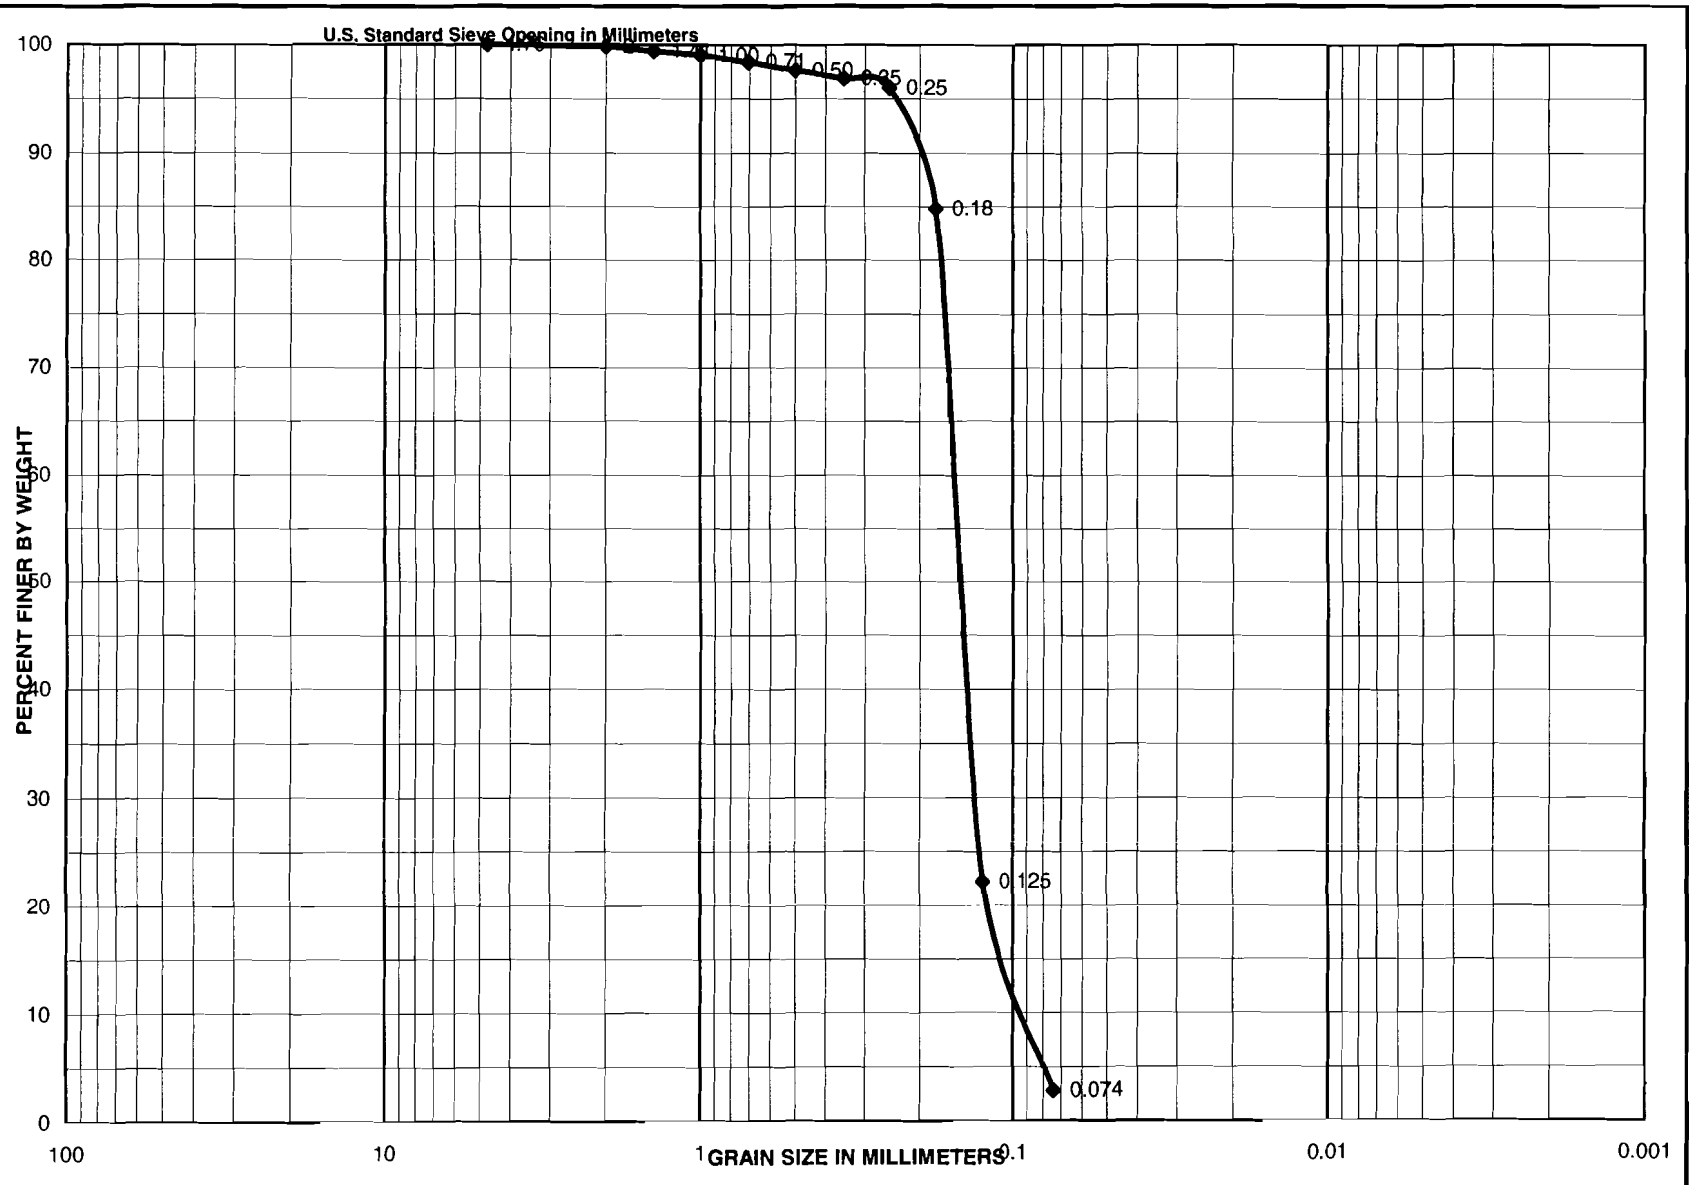
Sample No.	Depth (ft)	Classification	Project
1	4.4-4.9	Dark gray poorly graded sand with trace shells, SP	USACOE Various Sites
		1.04% Shells	Area Cape Lookout
			CATLIN Geotechnical Laboratory
			Boring No. CL-04-V-3
			Date 7/29/2004

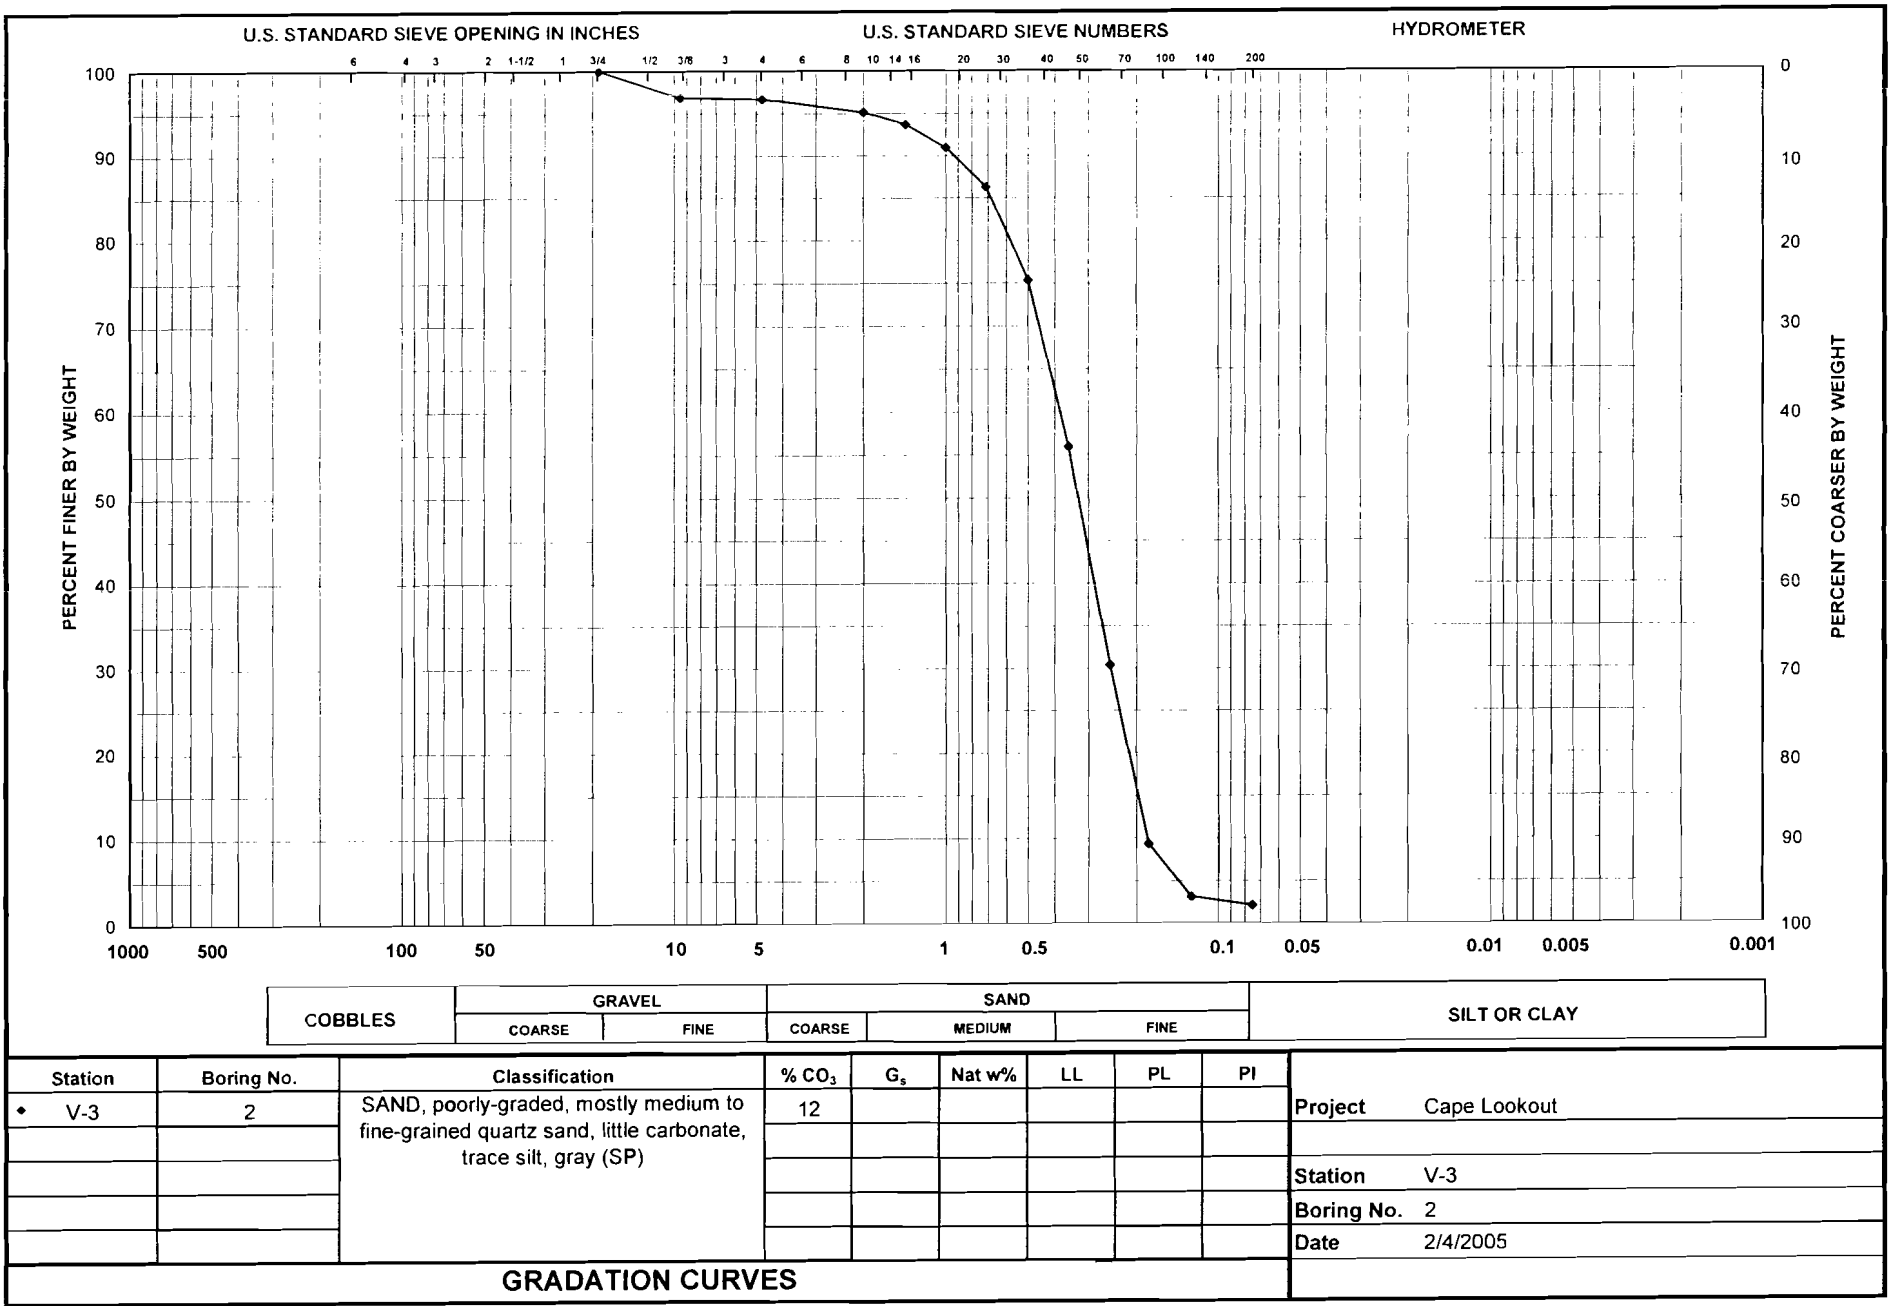
Station	Boring No.	Classification	% CO <sub>3</sub>	G <sub>s</sub>	Nat w%	LL	PL	PI	Project	
									COBBLES	GRAVEL
V-3	2	SAND, poorly-graded, mostly medium to fine-grained quartz sand, little carbonate, trace silt, gray (SP)	12						Cape Lookout	
									Station	V-3
									Boring No.	2
									Date	2/4/2005

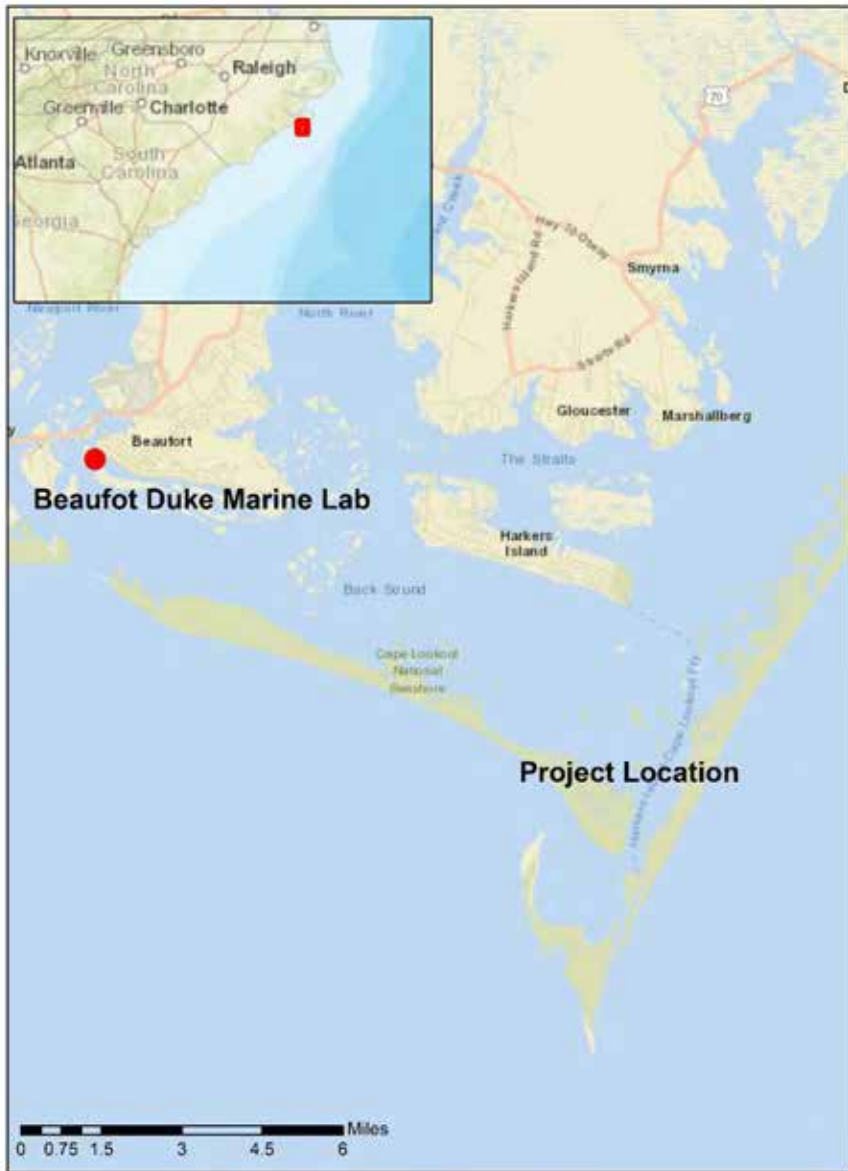
Figure 6. NOAA tidal station location.

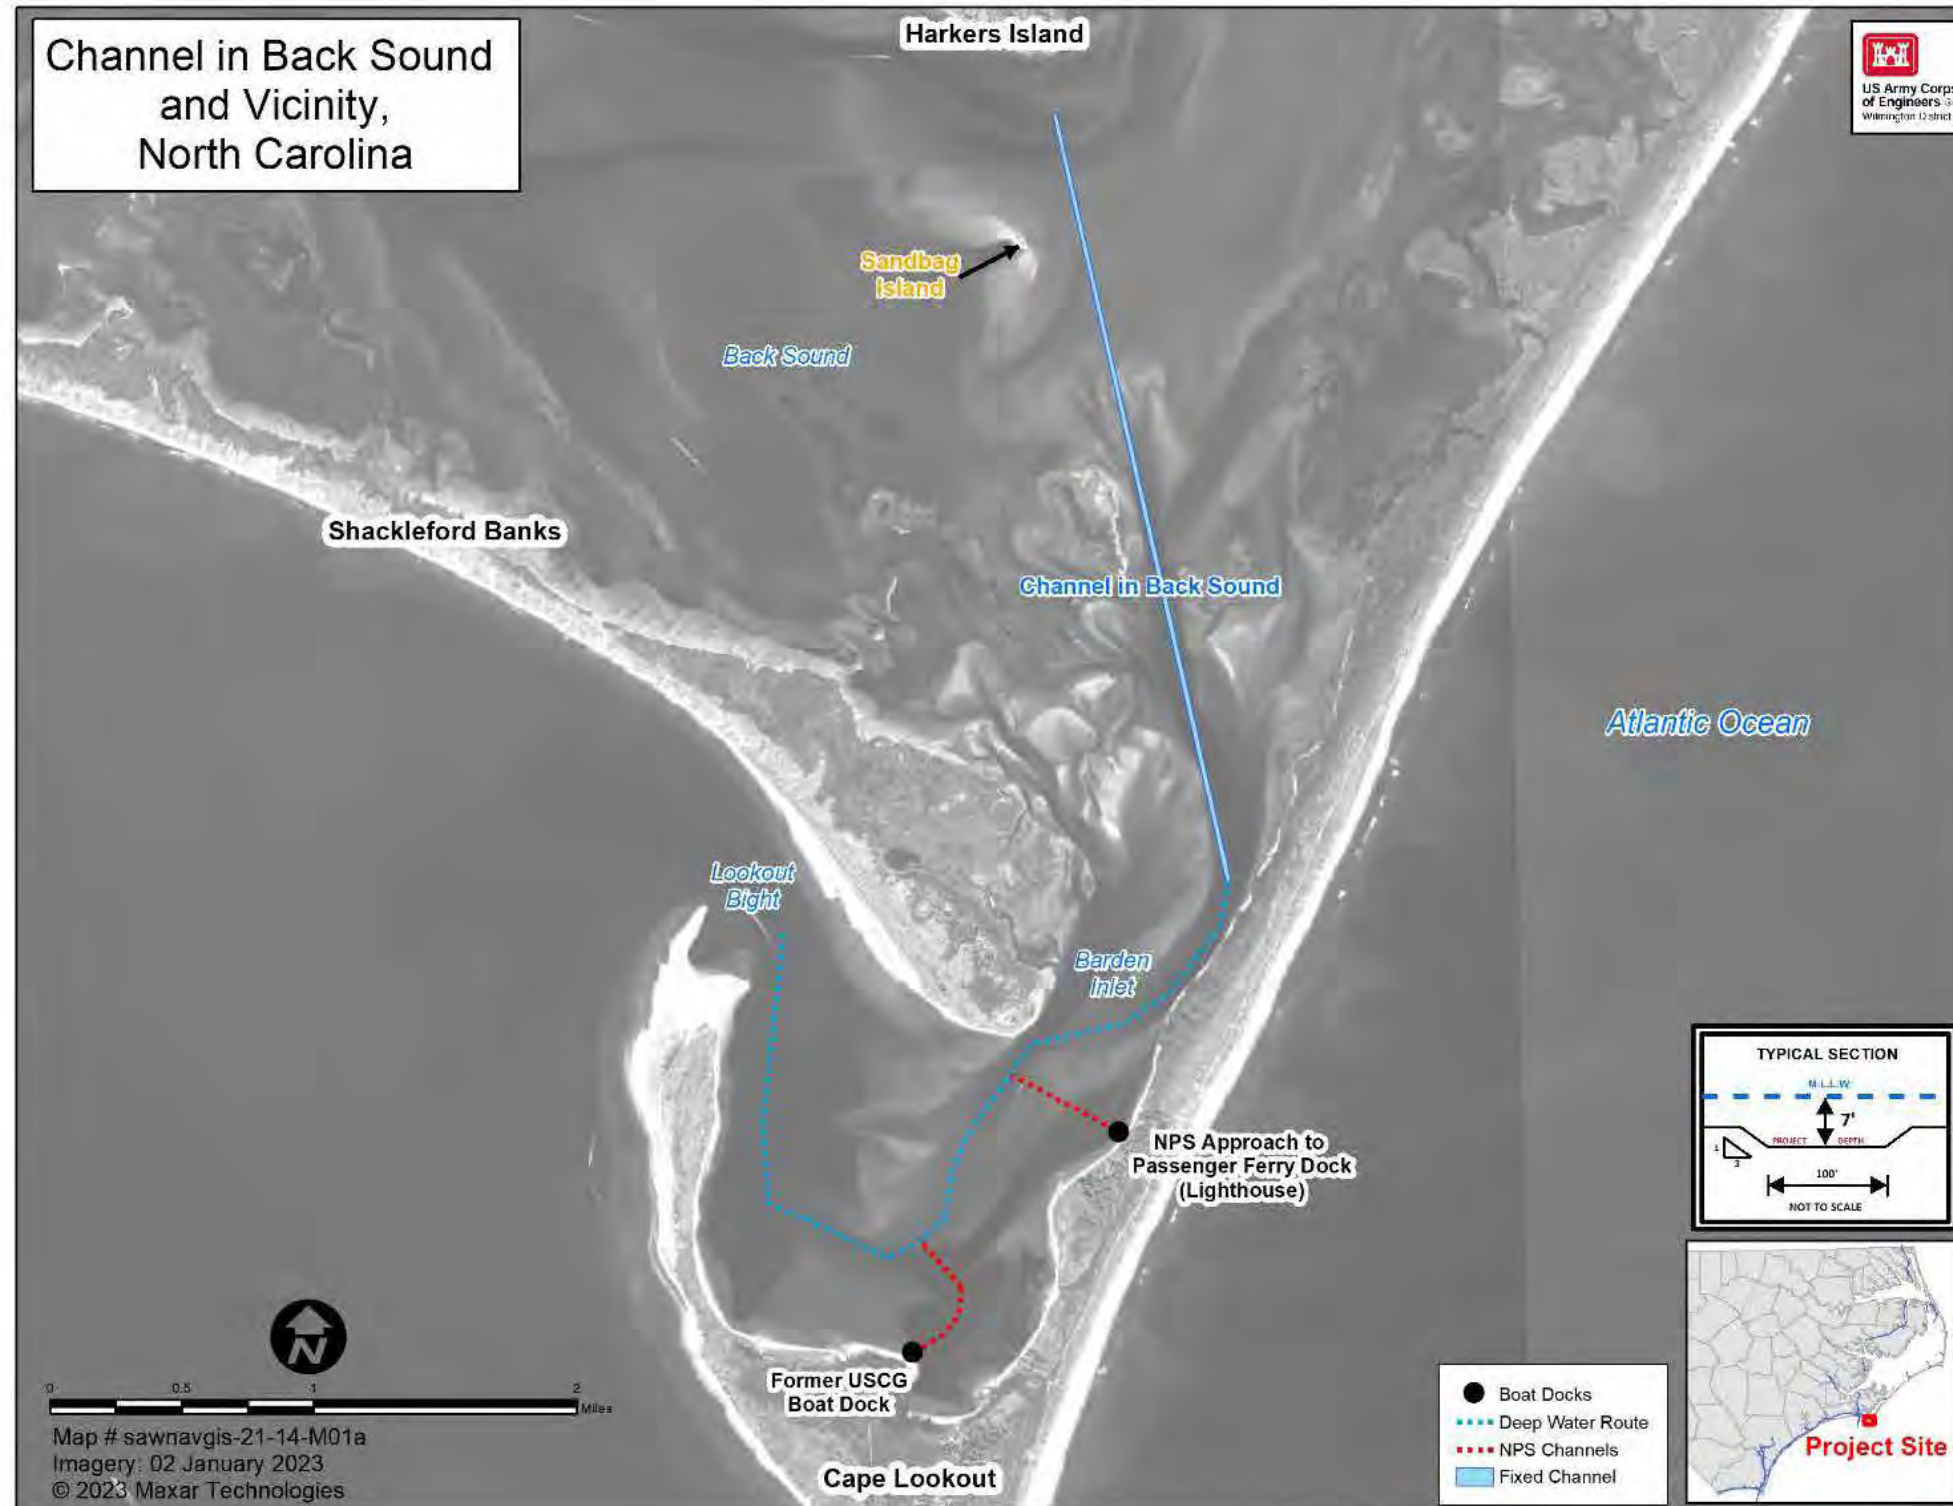
Figure 1. Project Area Overview

This determination addresses the proposed dredging of USACE and NPS federal navigation channels located within Back Sound and Lookout Bight, Carteret County, North Carolina (Figure 1). The proposed maintenance dredging is divided into two sections. The northern section includes the fixed USACE federal channel through Back Sound toward Barden Inlet. The southern section includes a corridor encompassing Barden Inlet and Lookout Bight, where the USACE and NPS channels follow natural deep waters and include two NPS channels that provide access to two existing NPS boat docks. The proposed dredging would use Government-owned shallow draft plant and contracted hydraulic cutterhead pipeline dredges. Pipeline dredging would be used for initial dredging, then every 3 to 5 years, depending on shoaling rates and available funding. Pipeline dredged material would be placed on Sandbag Island bird island or on nearby NPS soundside or oceanside beaches. Between pipeline dredging events, Government-owned shallow draft plant (i.e., special purpose hopper dredge or sidecast dredge) would remove any shoals impeding navigation. Special purpose hopper dredged material would be placed in naturally occurring scour holes within the Barden Inlet and Lookout Bight channel. Sidecast dredging is also proposed to be used to maintain the USACE and NPS channels when other dredge plants are not available and would sidecast material 80-feet from the vessel's starboard or port side. Figure 2 depicts proposed dredged material placement locations within the project area.

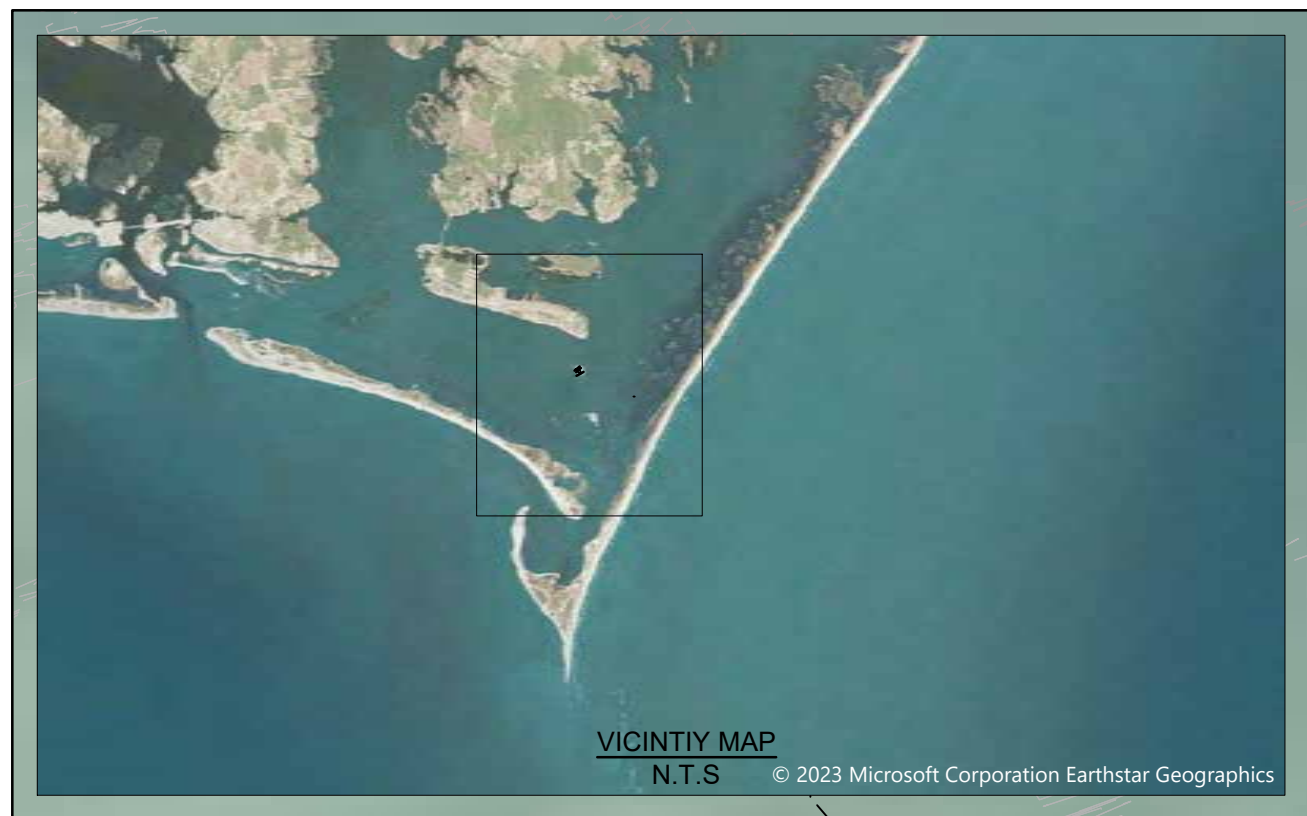
Figure 1. Proposed island footprint adjacent to the ground-truthed SAV bed (in blue). A combination of geotubes and/or sandbags, constructed berms, and turbidity curtains are being considered to assist with the containment of placed dredged material.

**NOTE:**  
 FIGURE 1. PROPOSED ISLAND FOOTPRINT ADJACENT TO GROUND TRUTHED SAV BED. A COMBINATION OF GEOTUBES AND/OR SANDBAGS, CONSTRUCTION BERMS, AND TURBIDITY CURTAINS ARE BEING CONSIDERED TO ASSIST WITH THE CONTAINMENT OF PLACED DREDGED MATERIAL.  
 DURING CONSTRUCTION THE CONTRACTOR SHALL EVENLY PLACE DREDGED MATERIAL WITH A NATURAL SLOPE. THE NATURAL SLOPE SHALL NOT EXCEED A RATIO OF 4H:1V IN STEEPNESS.

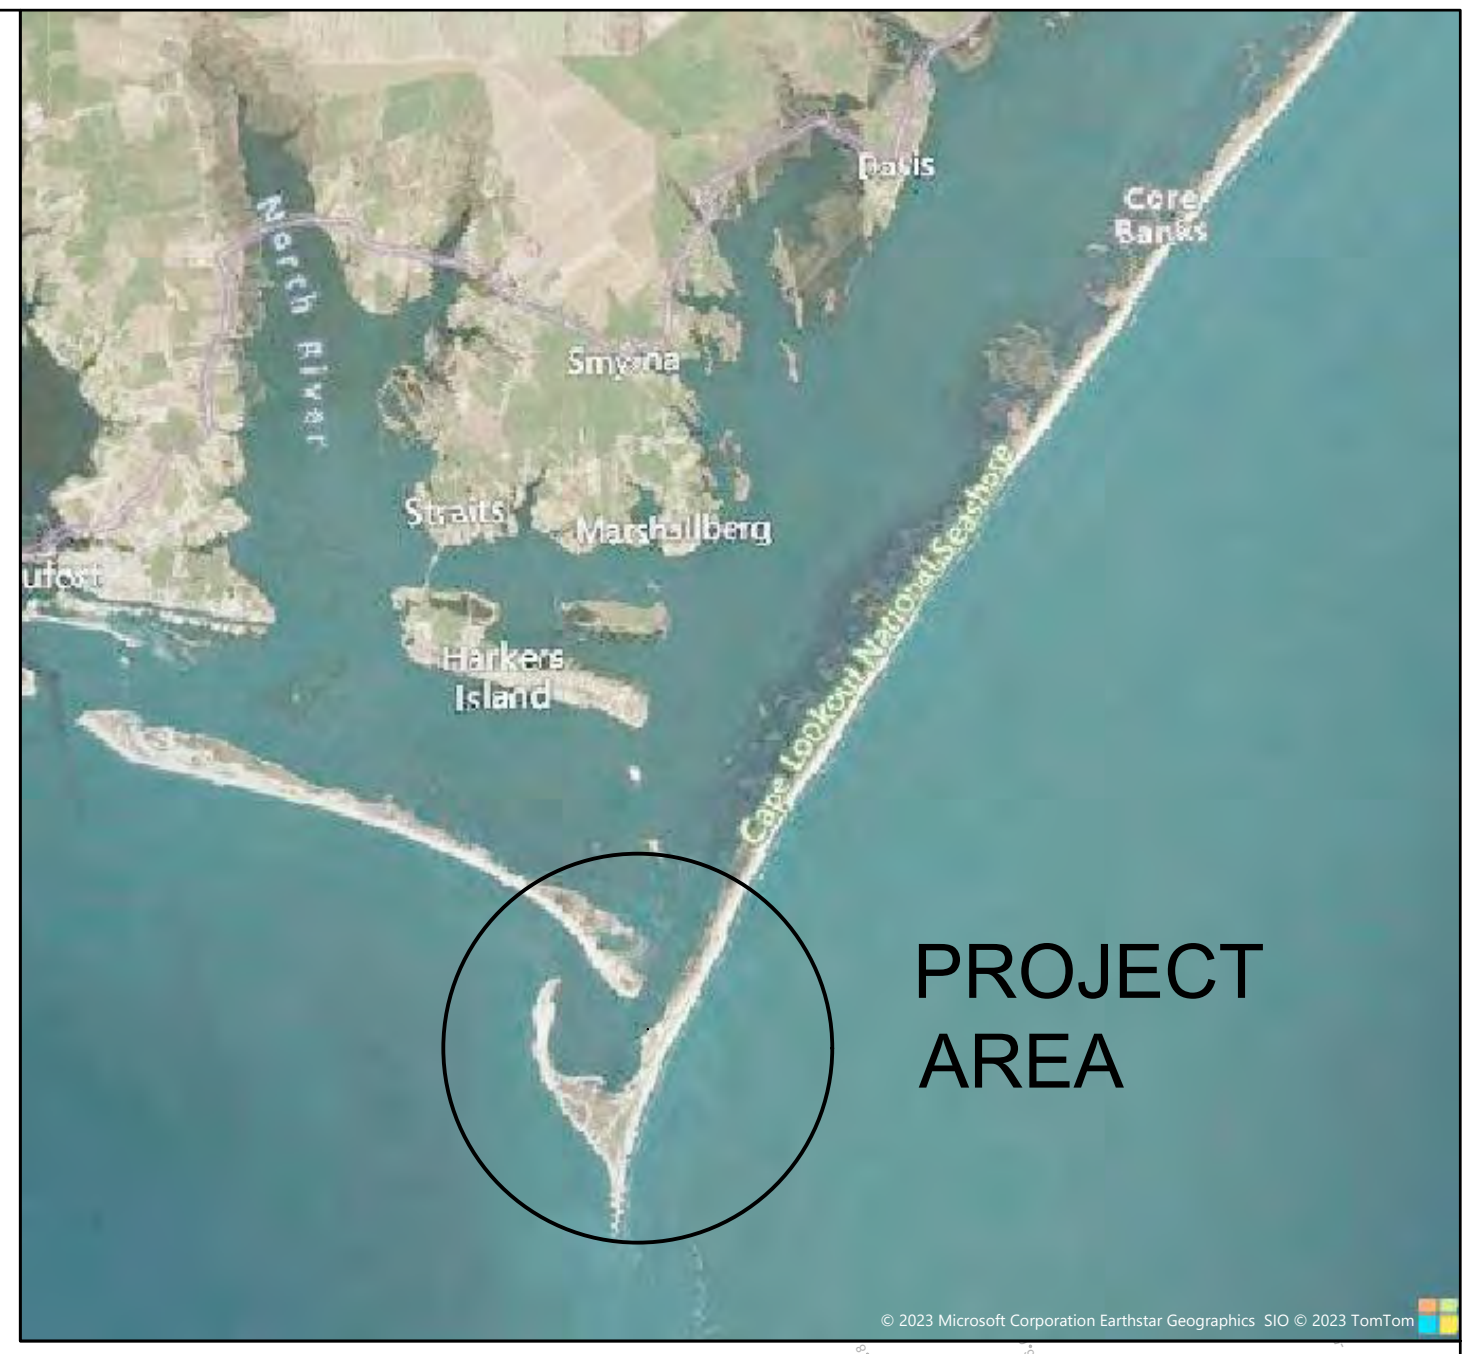
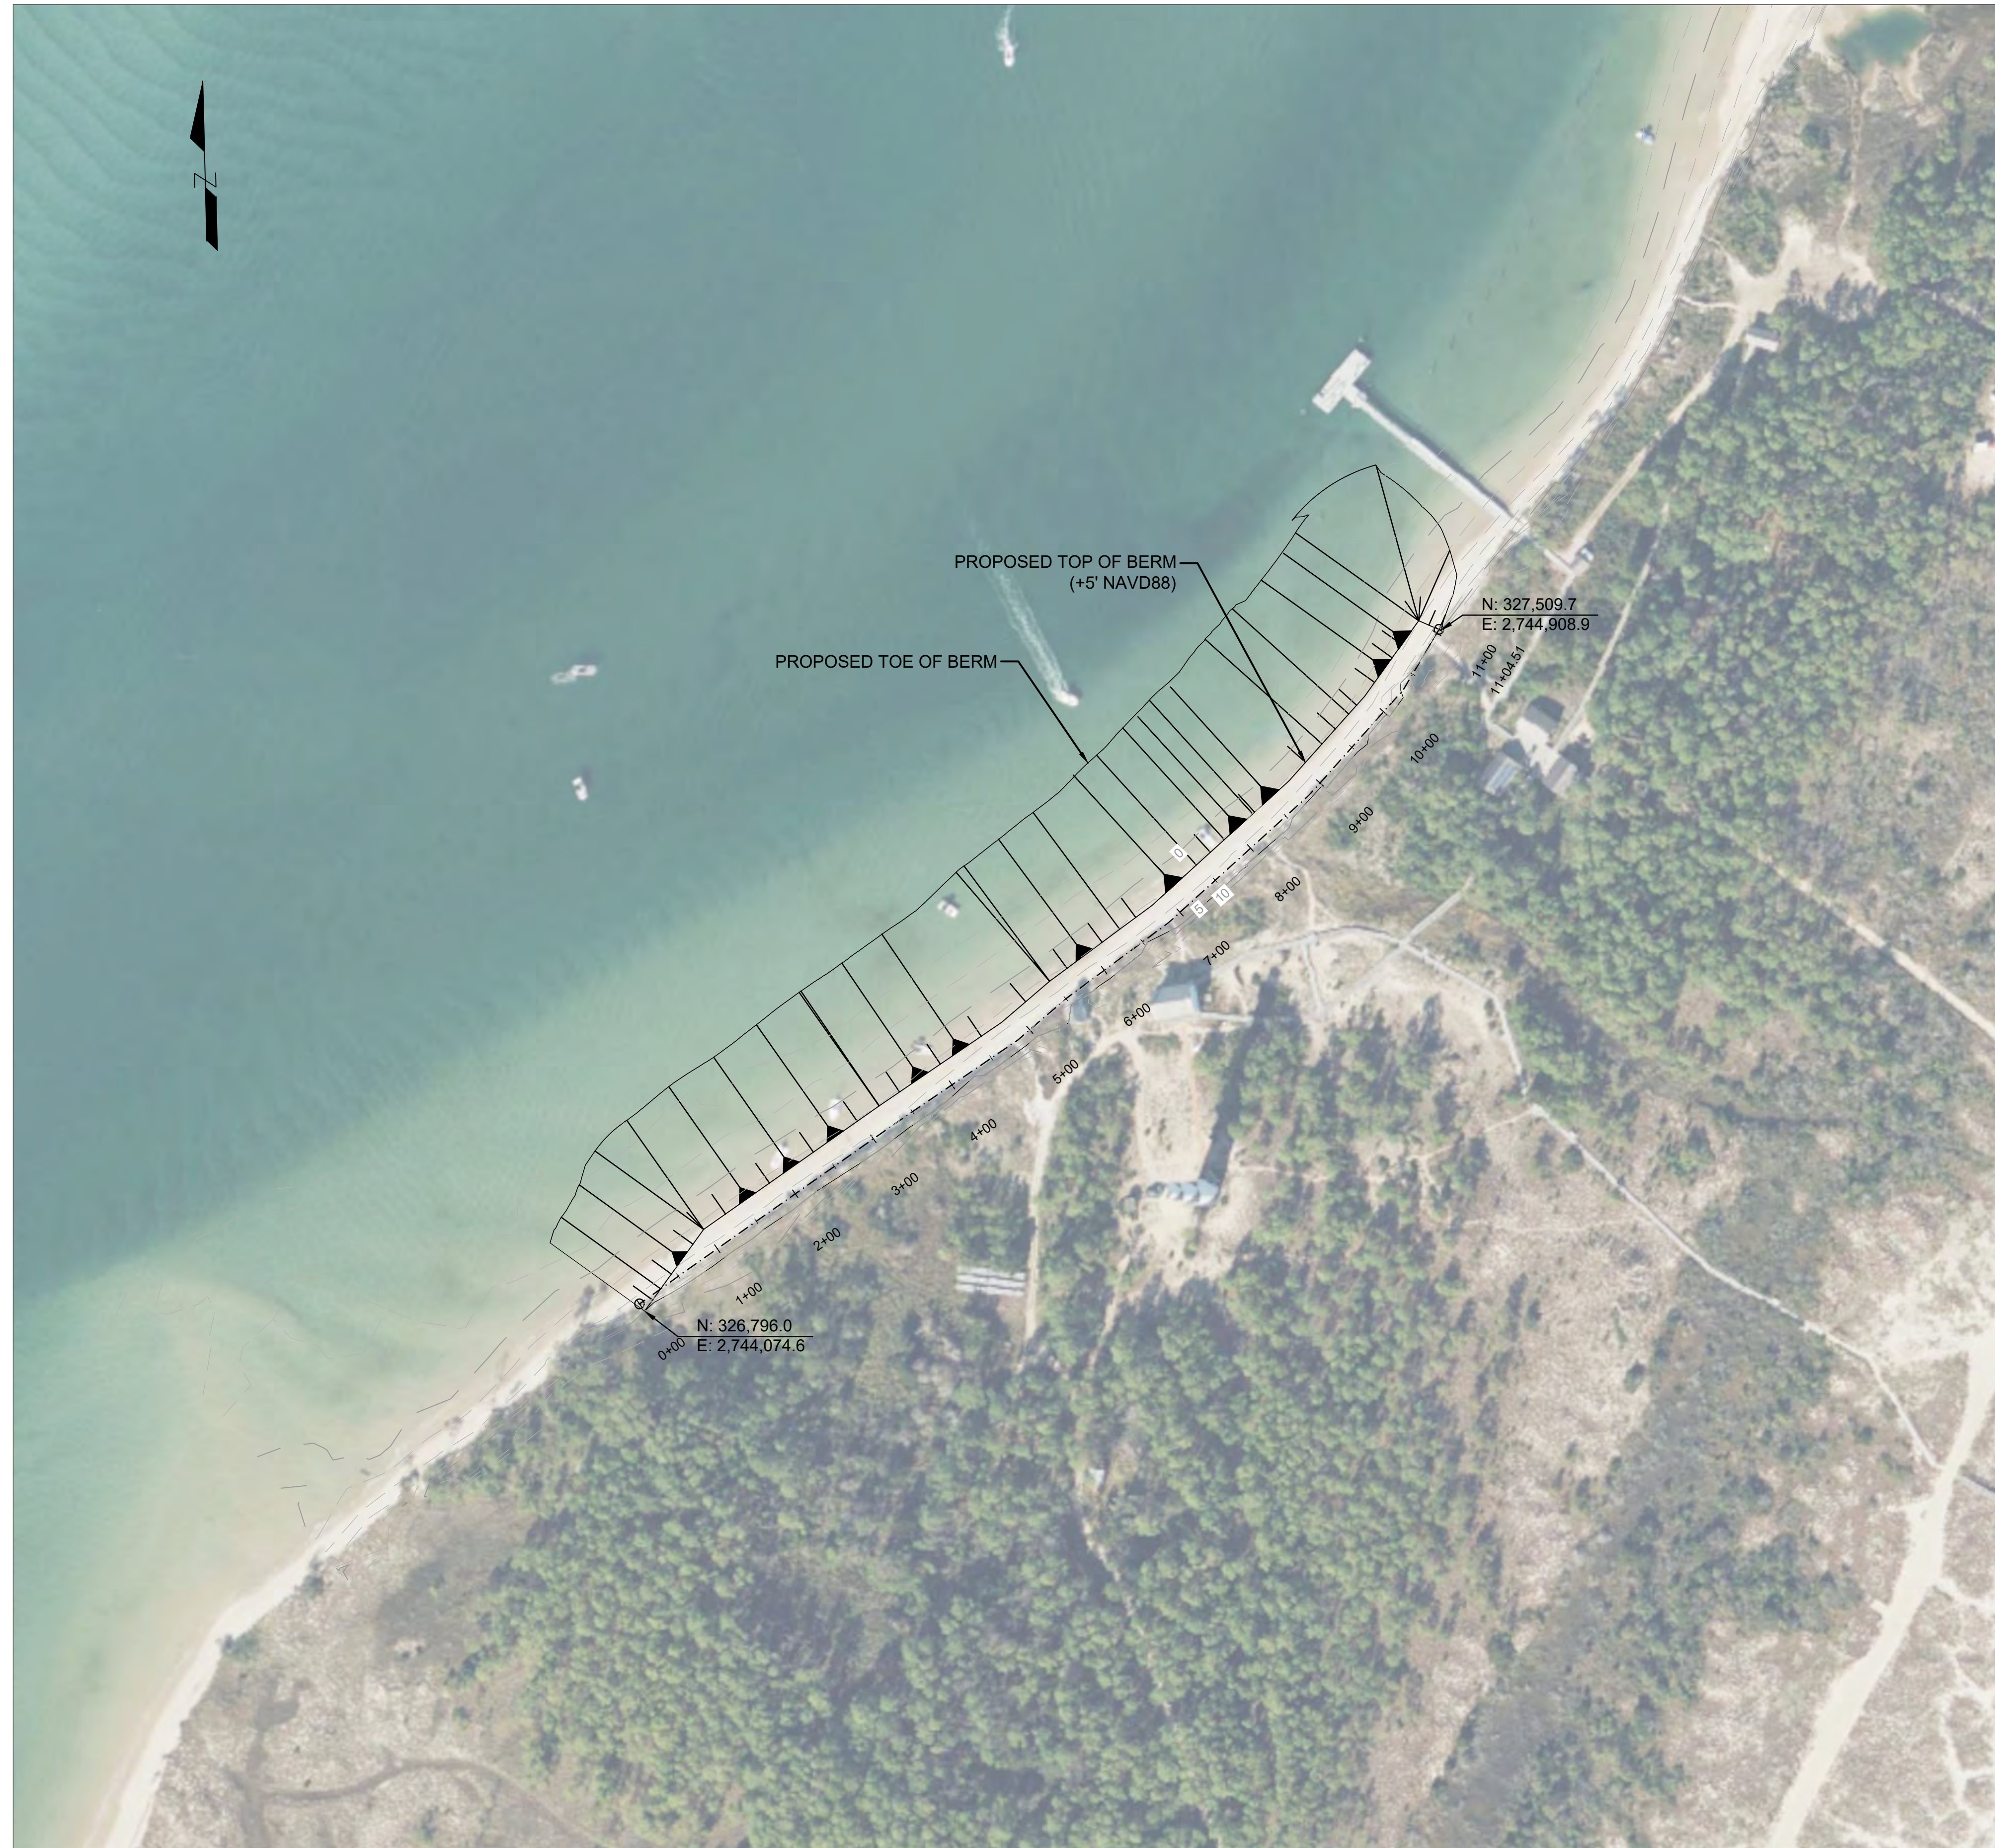
NATIONAL PARK SERVICE CHANNEL  
 LIGHTHOUSE  
 DREDGING LAYOUT

MAINTENANCE DREDGING  
 CHANNEL TO BACK SOUND & LOOKOUT BIGHT  
 CARTERET COUNTY, NORTH CAROLINA
