# **SITE DECOMMISSIONING PLAN FOR THE CALTECH SUBMILLIMETER OBSERVATORY**

**TMK: (3) 4-4-015:009 (por.)**

**FEBRUARY 24, 2021**

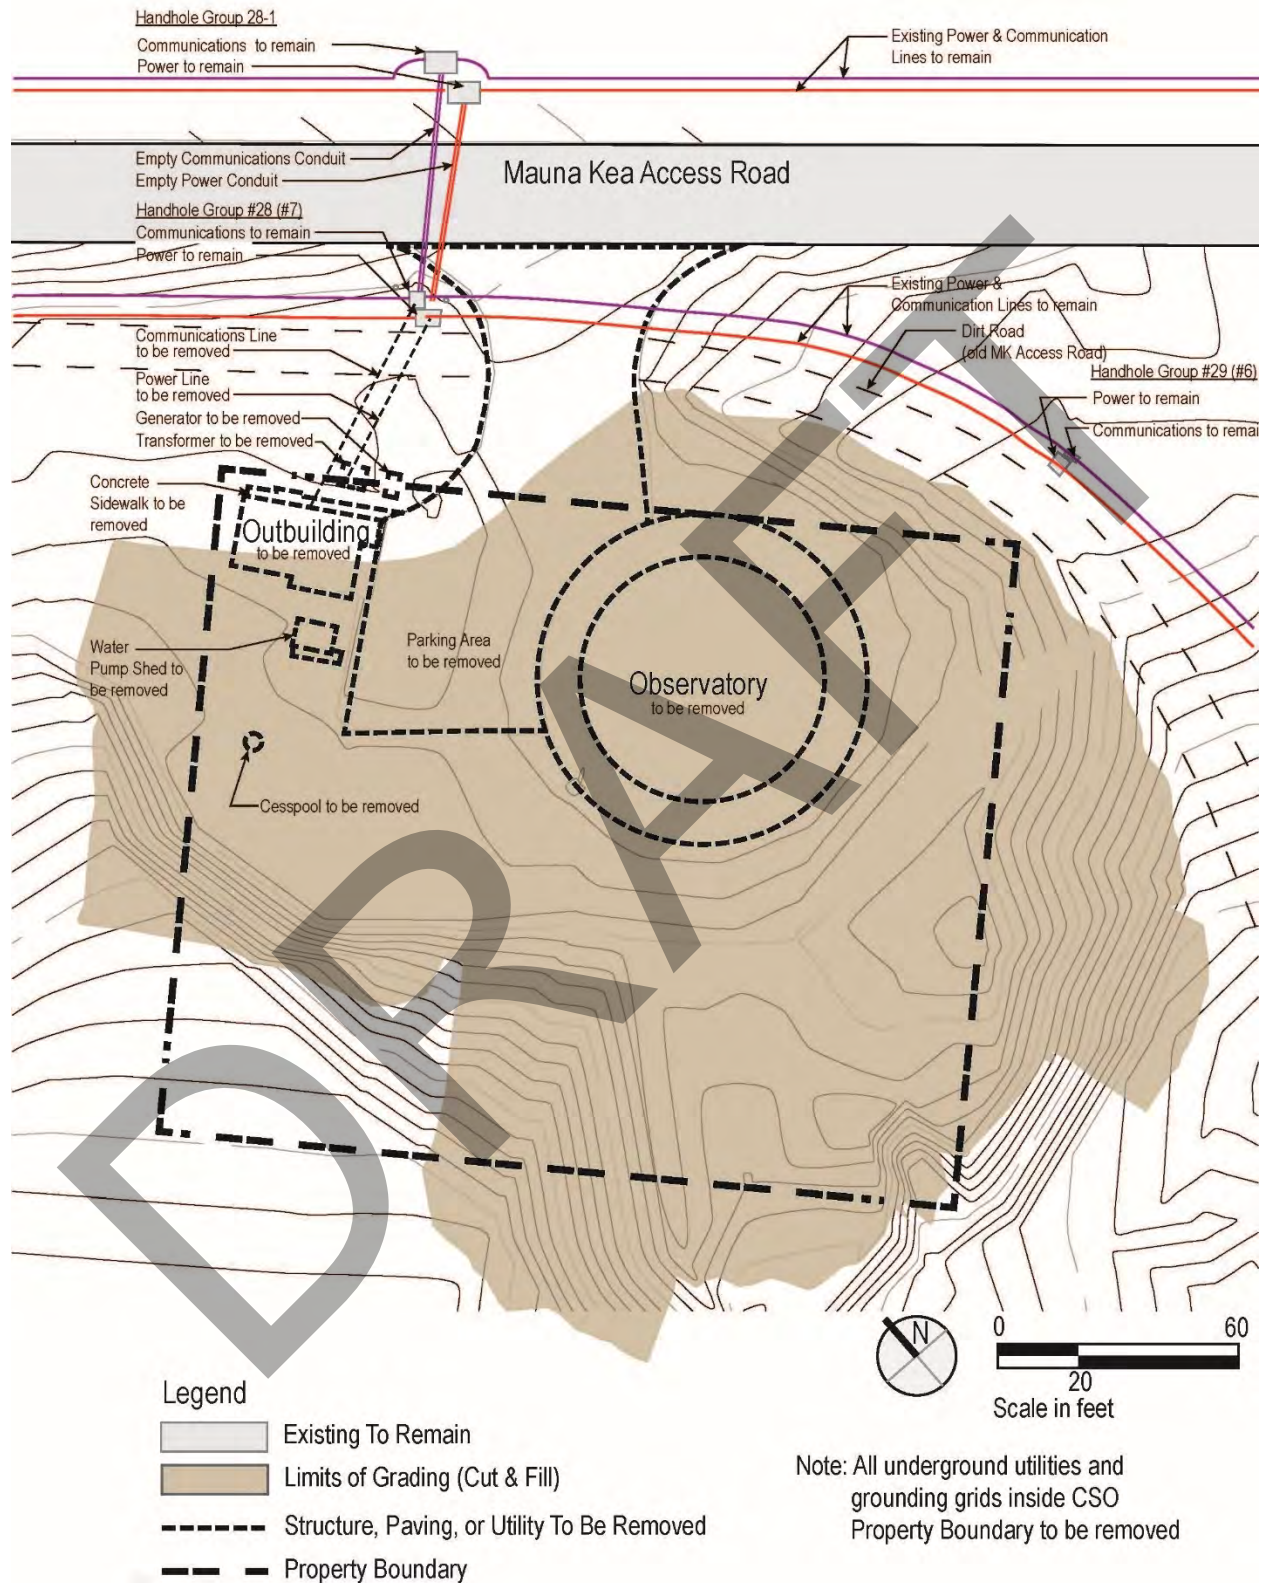
**Figure 4-1: ALT-2 Scope of Work**

Figure 4-1 illustrates the ALT-2 scope of work and Figure 4-2 illustrates anticipated site conditions following the implementation of the ALT-2 removal and restoration scope of work.

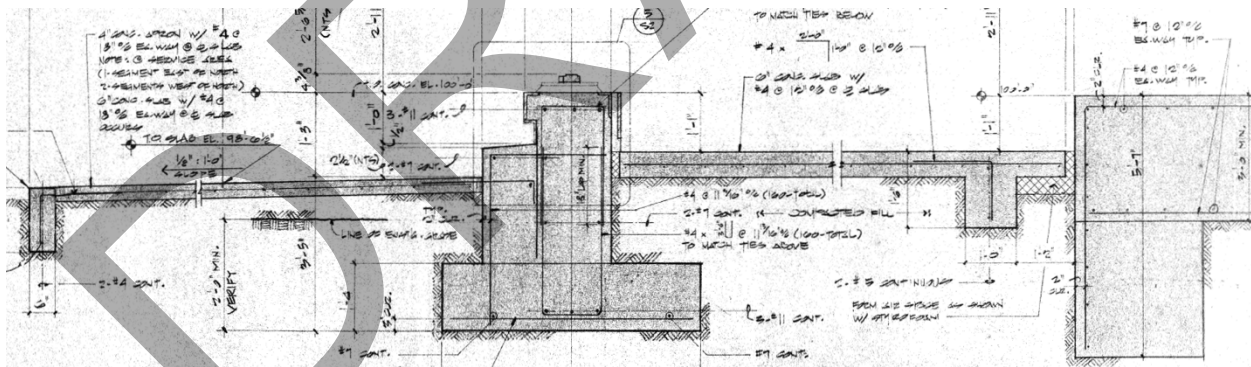
**Figure 5-7: Section Drawing Illustrating a Portion of CSO's Foundation**

Source: CSO Foundation Plan by H. Robert Hoggan & Associates dated 12/5/83.

The reinforced concrete foundation will be broken or cut, removed from the ground, and placed in roll-off bins. The portions of the grounding grid near the CSO's foundation will be removed during this phase; construction drawings indicate that the grounding grid is roughly one foot below grade and, therefore, all within the fill material placed on the CSO Site during construction. All material removed will be designated as deconstruction waste material and will be removed from the CSO Site and transported to an approved landfill, with the exception of recyclable material such as copper piping or grounding mats, which will be transported to a designated recycling center.

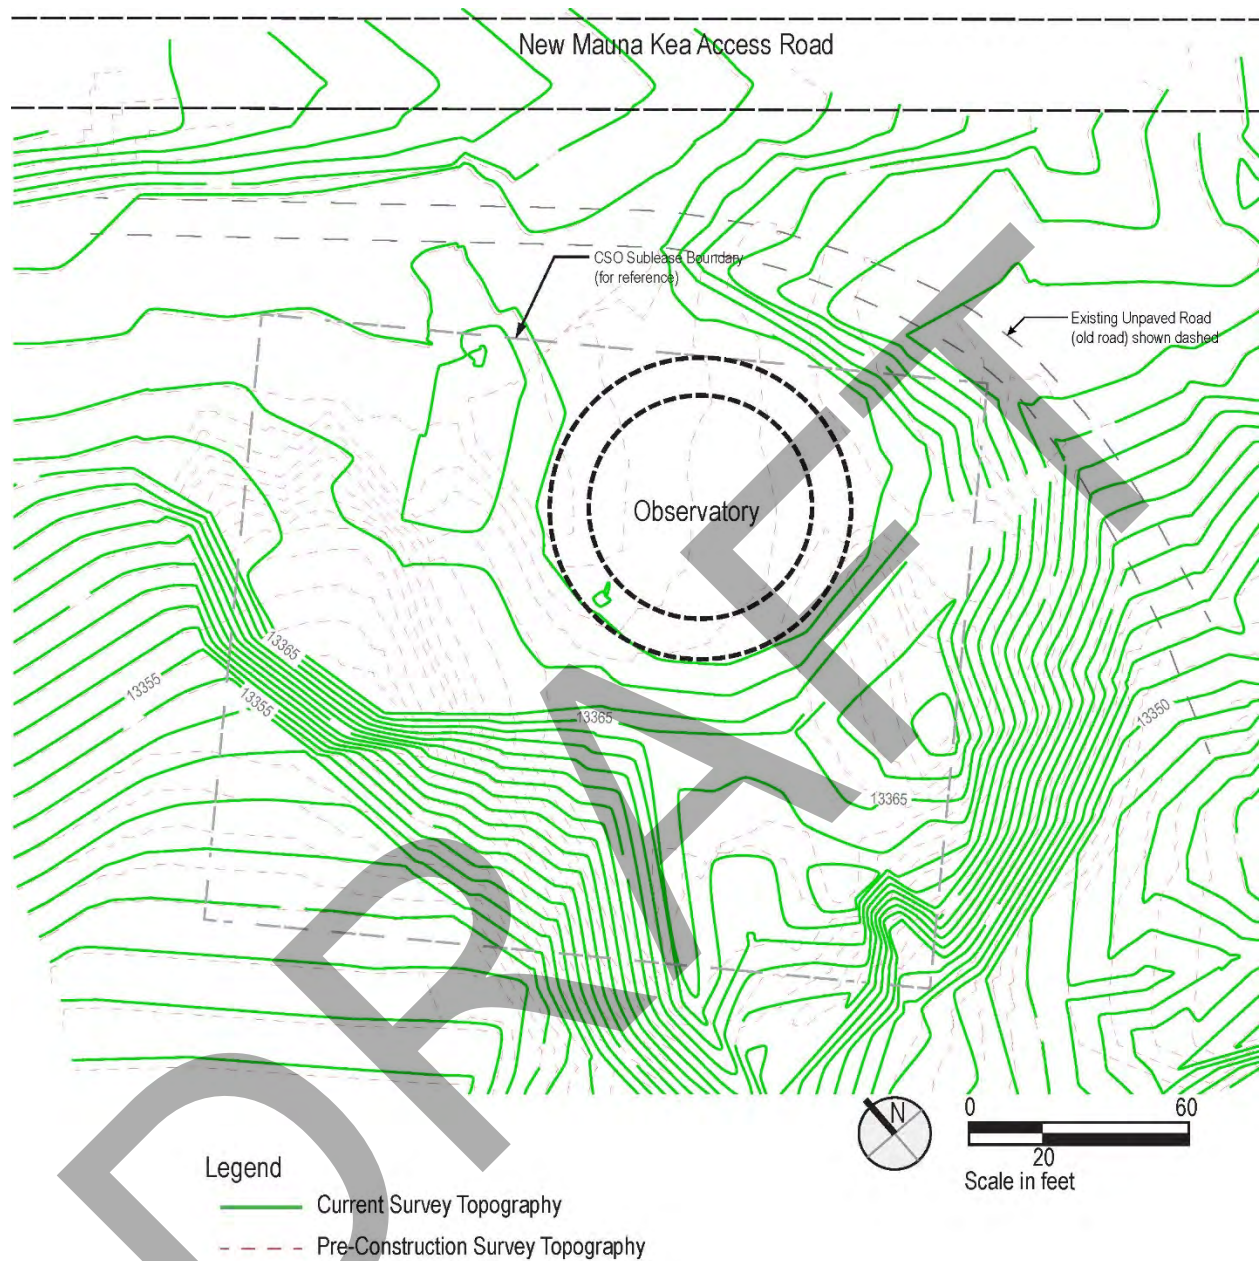
**Figure 6-3: Comparison of Pre-Construction and 2016 Topographical Surveys**

*This figure reproduces information not legible in the 1982 pre-construction topographical conducted by Austin, Tsutsumi and Associates, Inc. Source: dlb & Associates (2016)*

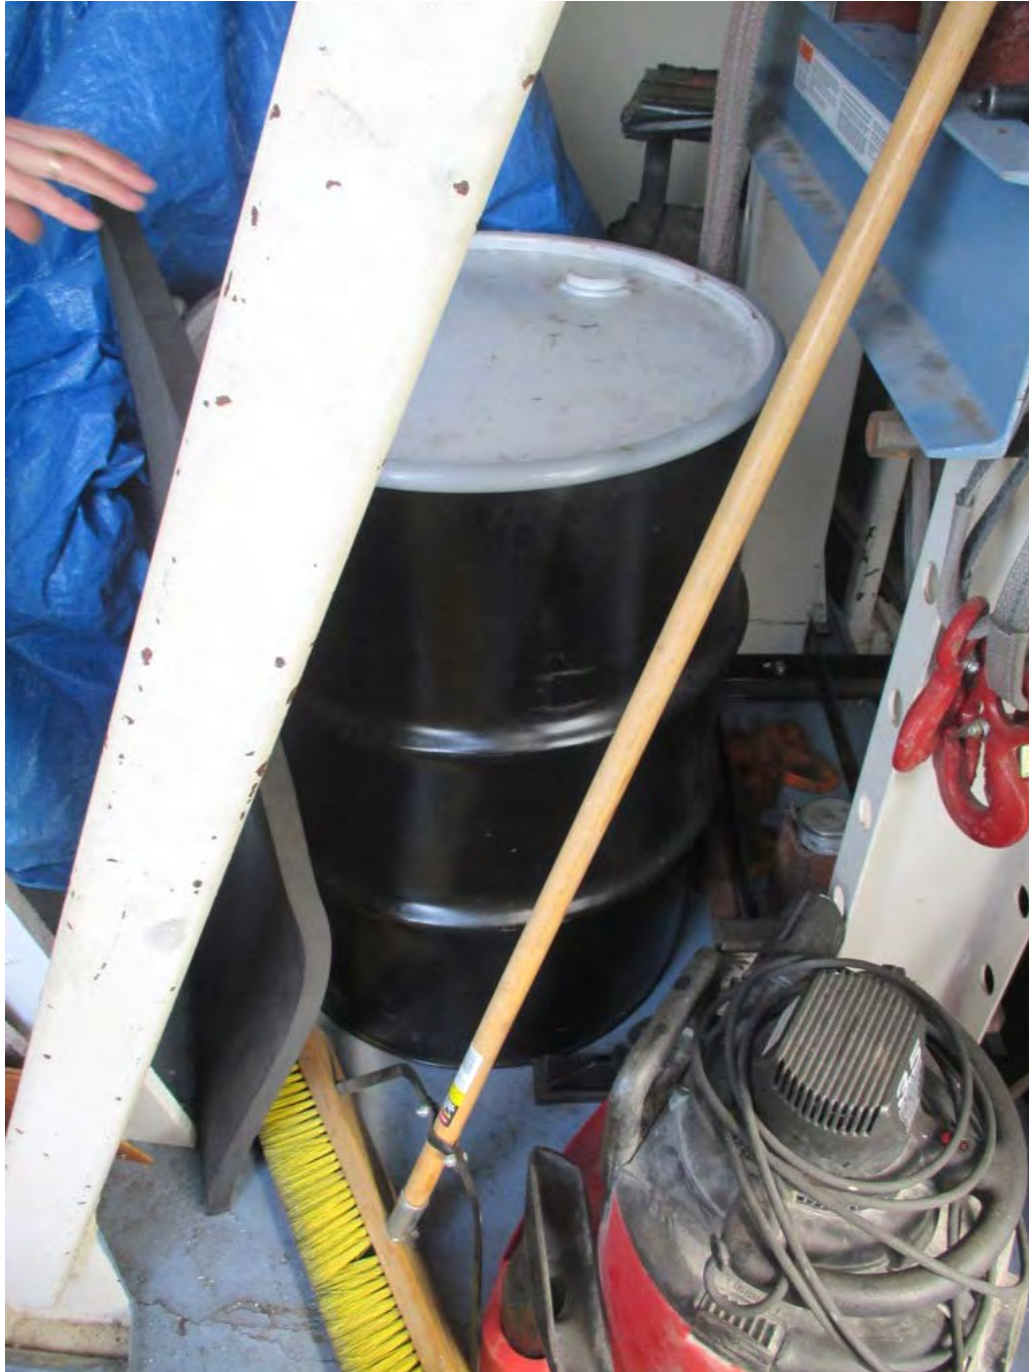
**Photo 22**

Unlabeled Drum on the Second Level
