## PHASE ONE ENVIRONMENTAL ASSESSMENT 636040 PRINCE OF WALES ROAD WEST, PRIMROSE, ONTARIO

PROJECT NO.: 181-01582-00 DATE: FEBRUARY 2018

Subject: Phase One Environmental Site Assessment 636040 Prince of Wales Rd W, Primrose Township of Mulmur, Ontario Project No.: 181-01582-00

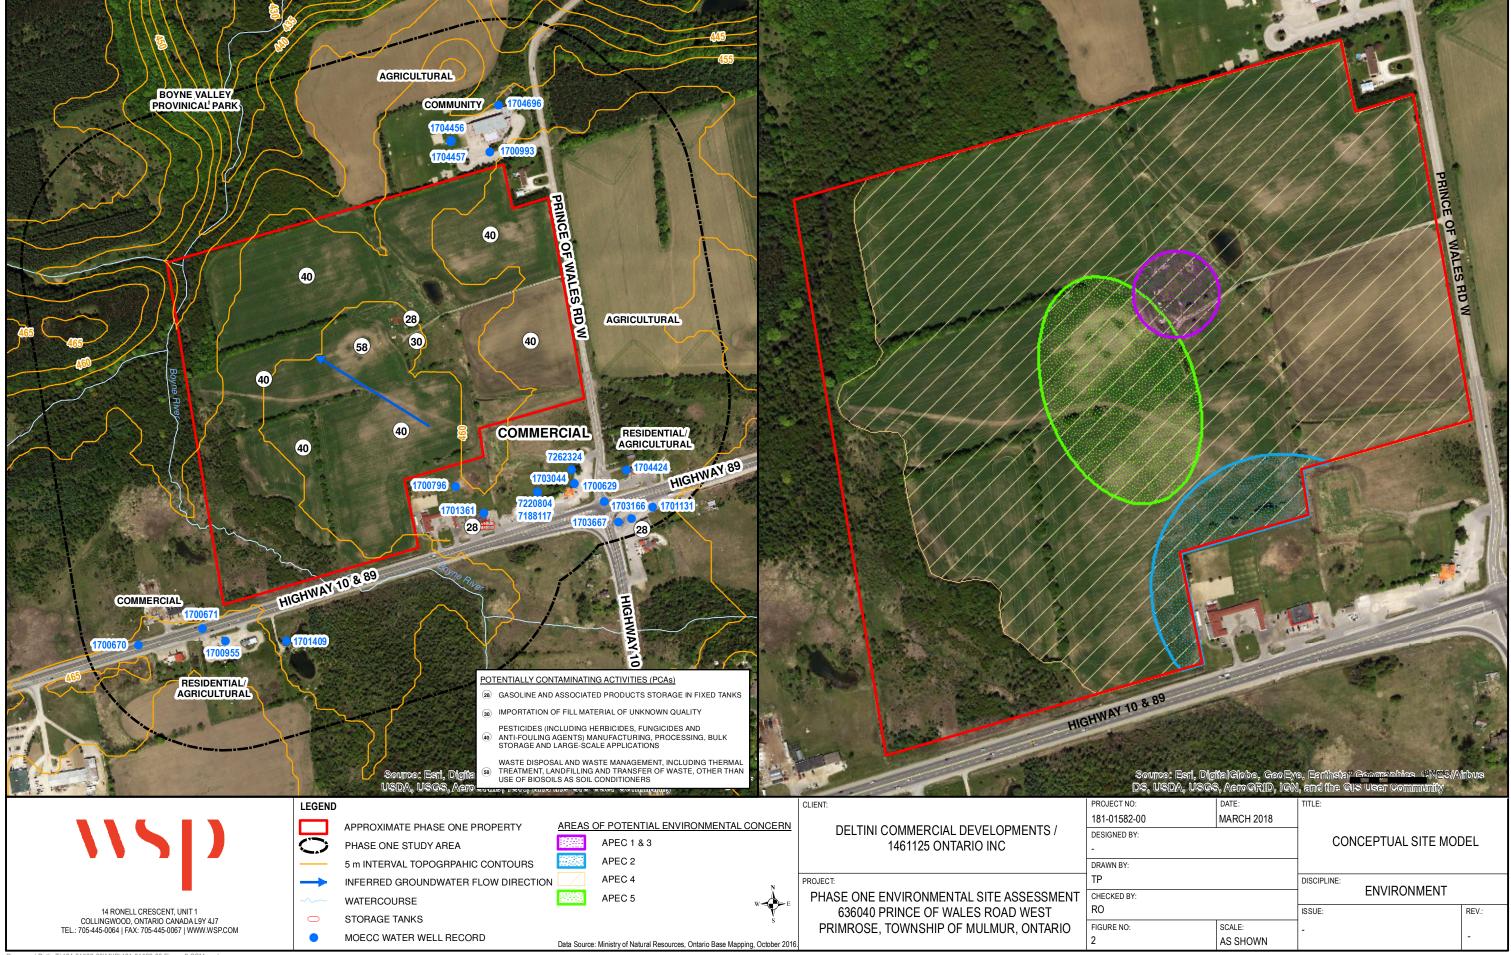
Document Path: T:\181-01582-00\MXD\181-01582-00 Figure 2 CSM.mxd

PCAs observed on the Site or within the Phase One Study Area are summarized in Table 7.2 below. Identified PCAs, including the number and location (if known) of USTs, are illustrated on the Phase One Conceptual Site Model (CSM) provided as Drawing 2.

vii.	Identify and locate areas where any potentially contaminating activity has occurred, and show tanks in such areas	<ul> <li>The table of PCAs included in Section 7.2 identify all areas where PCAs were observed. These PCAs are illustrated in Drawing 2.</li> <li>Three potentially contaminating activities were identified in this investigation: <ul> <li>PCA No. 28: Gasoline and Associated Products Storage in Fixed Tanks</li> <li>PCA No. 40: Pesticides (including Herbicides, Fungicides, and Anti-Fouling Agents) Manufacturing, Processing, Bulk Storage and Large-Scale Applications</li> <li>PCA No. 58 Waste Disposal and Waste Management, including thermal treatment, landfilling and transfer of waste, other than use of biosoils as soil conditioners</li> </ul> </li> <li>Refer to Drawing 2 for a visual depiction of the PCAs identified.</li> </ul>
viii.	Identify and locate any areas of potential environmental concern	The table of APECs included in Section 7.3, identify all areas where APECs have been identified. These APECs are illustrated in Drawing 2.
