Descriptions and Photos of Modifications within the  
Camp Creek Watershed

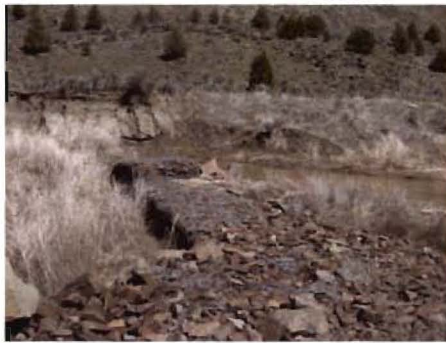
Modification 1 – This is a rock gabion structure that was constructed cross channel on BLM property. Camp Creek has cut around the right side (looking downstream) of the structure and has created a fifteen foot vertically exposed cutbank. See photo below. There is no active headcut associated with this structure.

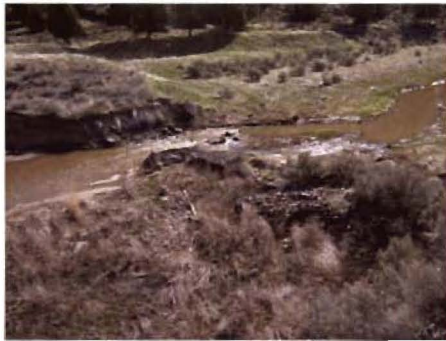
Modification 2 – This is another rock gabion structure that was constructed cross channel. Camp Creek has again washed around the right side. See photo below. There is no active headcut associated with this structure.

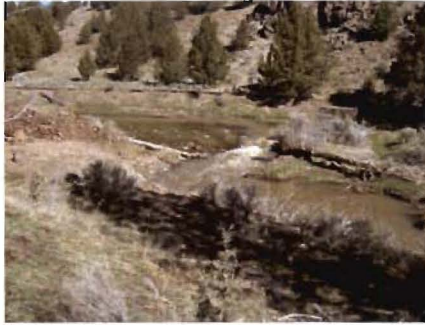
Modification 3 – This is a rock gabion structure that was constructed cross channel. Camp Creek has washed around the right side. There is an active headcut where the stream has washed around the structure. The structure has been effective at catching sediment, however the headcut is currently cutting through the sediment that has been deposited. See photo below.

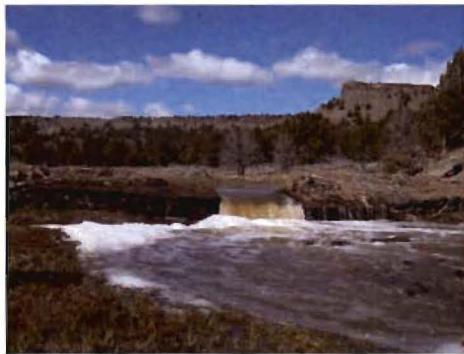
Modification 4 – This modification is another rock gabion structure that is cross channel. Unlike the other structures, this structure has not been washed around. Beaver have been active in building a dam upon the rock structure. This structure has been effective at trapping approximately four to five feet of sediment upstream. The hydraulic jump associated with this structure is approximately two feet. See photo below.

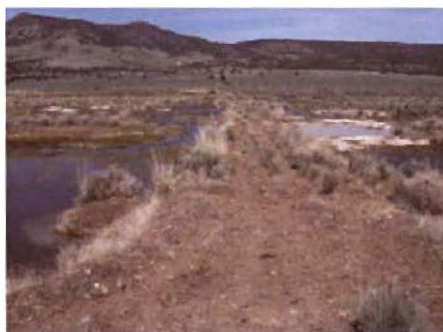
Modification 5 – This modification is on the lower portion of Clover Creek, near the confluence with Camp Creek. It is a cross valley earthen dam/road with several other berms upstream and downstream of the dam. Clover Creek has washed through the middle of the dam, however there is no active headcut associated with the wash. See photo below.

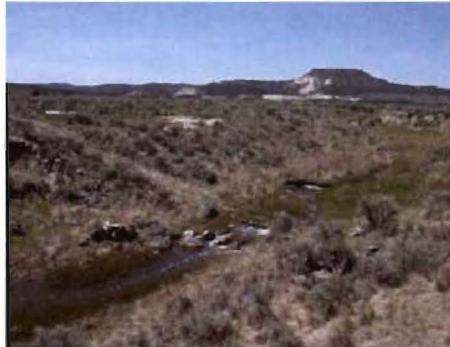
Modification 8 – This is a road crossing on Camp Creek that accesses the Davis Creek drainage. The crossing has essentially performed as a low elevation dam. The streambed elevation difference above and below the road crossing is approximately five feet. There has been some discussion as to how this crossing may be affecting the recovery of Camp Creek. See photo below.

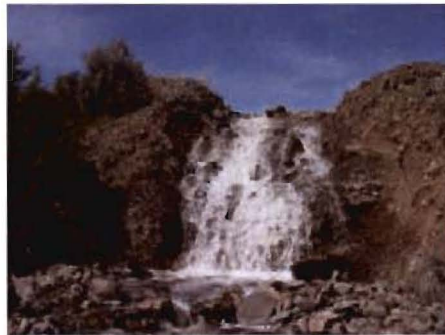
Modification 9 – This modification is upstream of the Weaver Place on Clover Creek. It is an earthen dam that is approximately ten feet in height. The upstream reservoir has a controlled outlet around the west side that includes a waterfall that is approximately seven feet in height. See photo below.

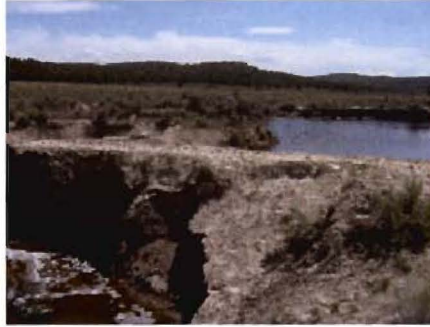
Modification 12 – This modification is an earthen dam which has created Clover Creek Reservoir.

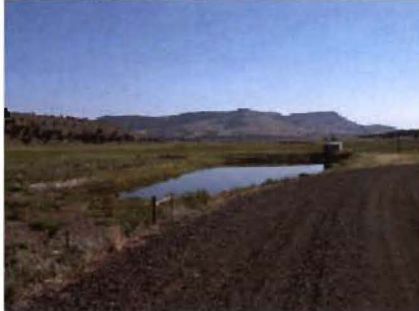
Modification 24 – This modification is on the Middle Fork of Camp Creek. It is an earthen dam with irrigation pond. This area has been modified such that a definable channel is often un-noticeable through the adjacent meadows.

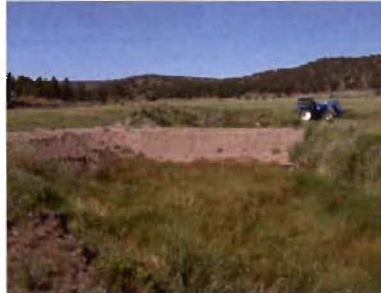
Modification 27 – This modification is an eight foot earthen dam with a small reservoir upstream. See photo below.

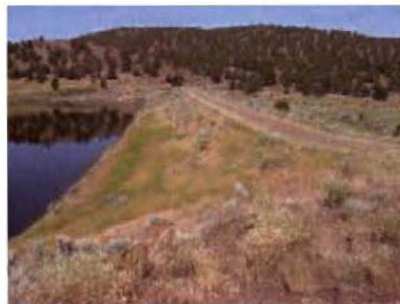
Modification 28 – This is a seventy foot high earthen dam (with road) in the headwaters of the Middle Fork Camp Creek. The earthen dam has created Logan Butte Reservoir.

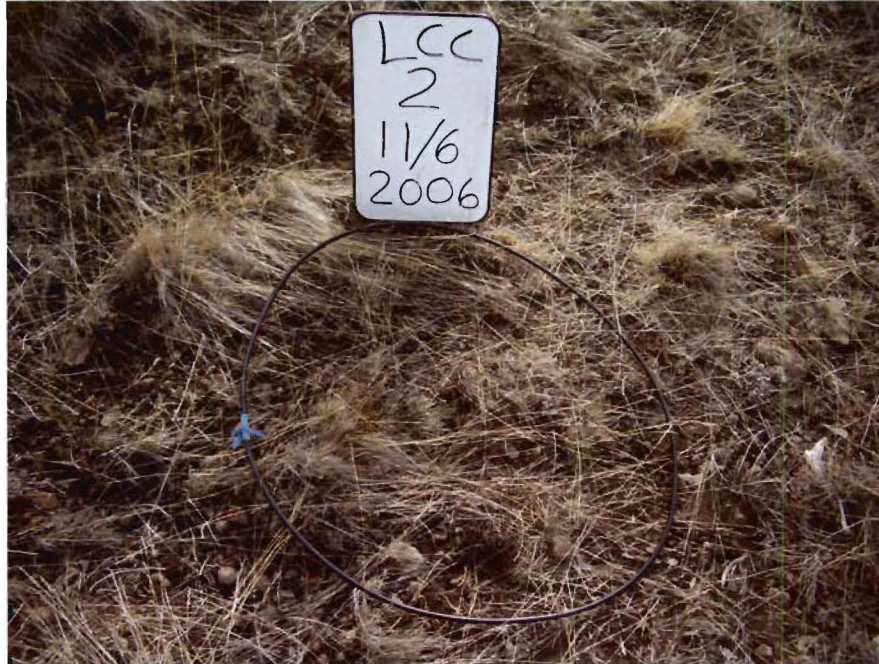
**Date of Photo:** 25 September 2006

**Notes:** No apparent grazing, West Aspect

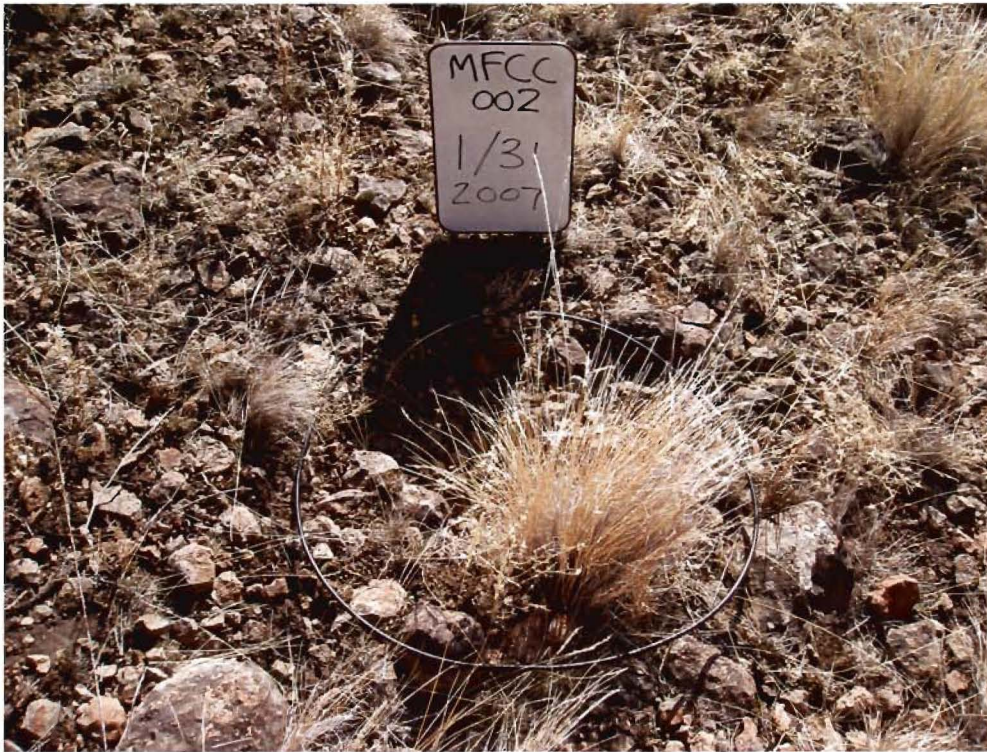
**Date of Photo:** 31 January 2007

**Notes:** No apparent grazing, Southwest aspect, Moderate Western juniper cover

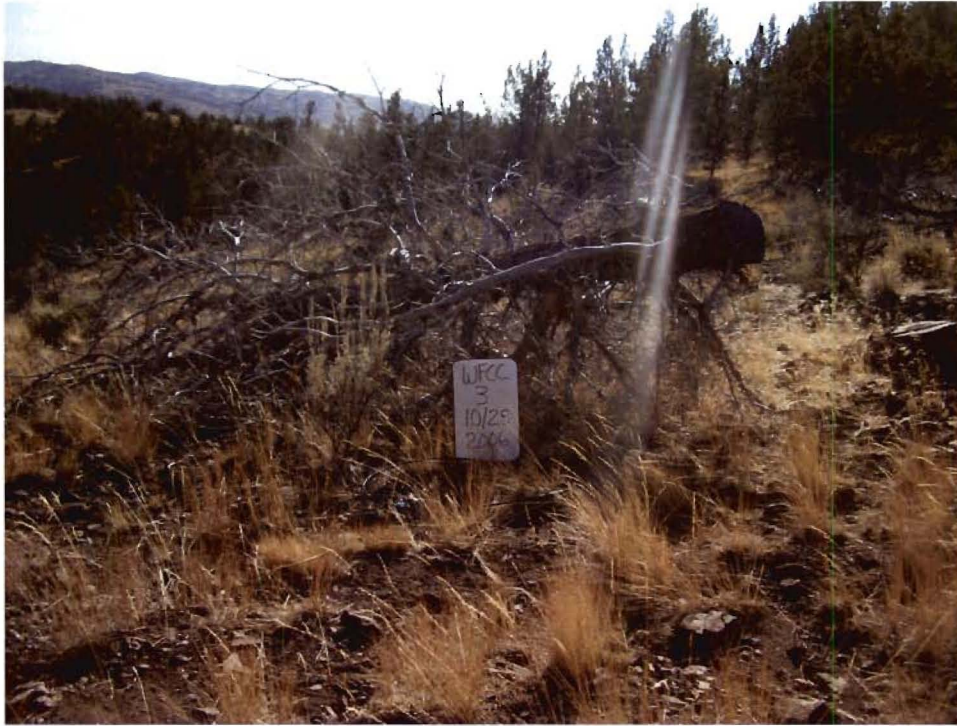
**Date of Photo:** 25 October 2006

**Notes:** No apparent grazing, Southeast aspect, Most Western juniper removed
