REPORT GDC-BTD68-058  
CONTRACT NAS 3-3248, T.O.9

# FIXED INSULATION DEVELOPMENT PROGRAM FINAL REPORT

May 1969

Prepared by  
CONVAIR DIVISION OF GENERAL DYNAMICS  
San Diego, California

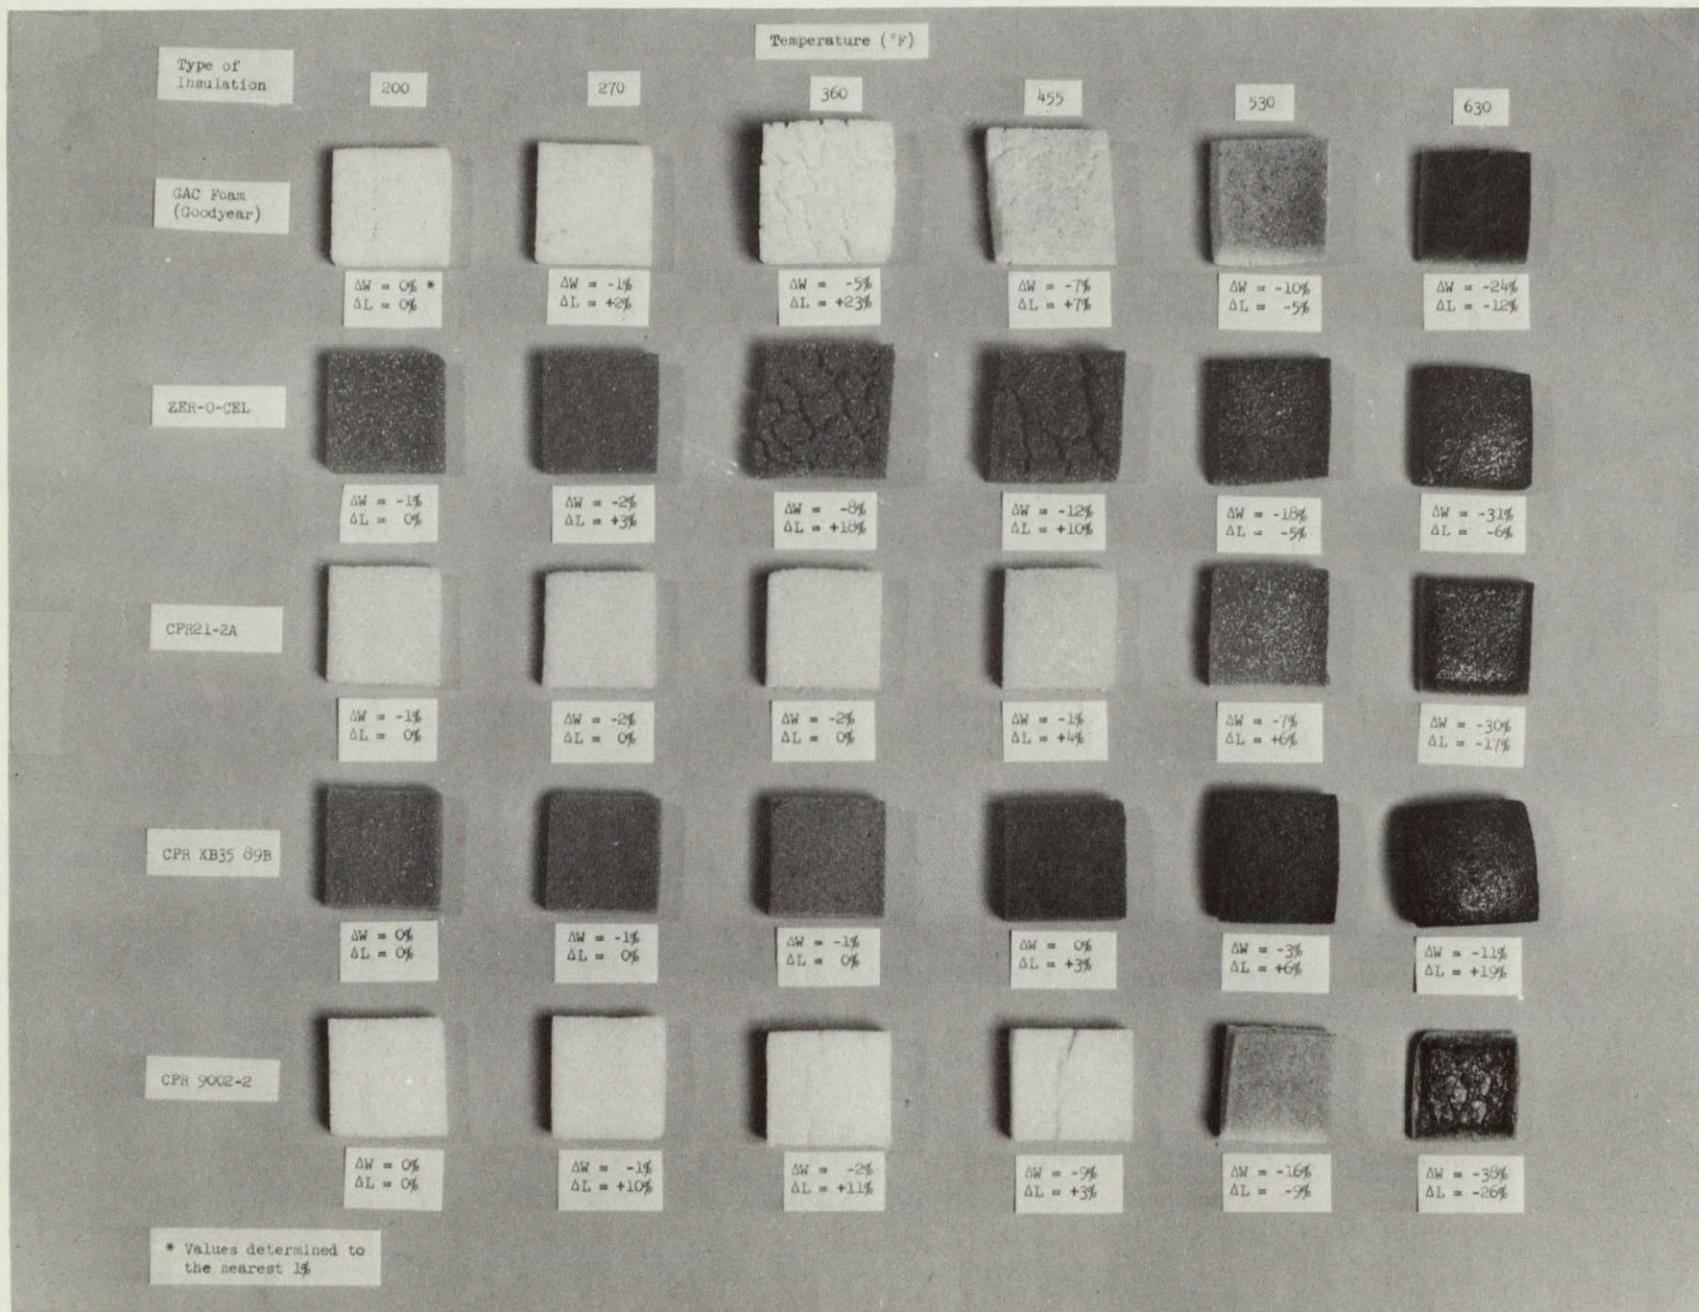
Figure 2-6. The Effect of Thermal Exposure Tests on Various Rigid Polyurethane Foams

Figure 2-6 is a photograph showing representative samples of five types of foam after being exposed to temperatures up to 630° F. The photograph shows the temperature at which severe discoloration and degradation of the foams occur. Also listed is the percentage change of weight and dimension of each foam sample for each test temperature.

Based upon the results of these tests, the CPR 32-2C and CPR 21-2A polyurethane foams were found to be the most stable at all temperatures up to 400° F. At temperatures above 400° F, the CPR 32-2C foam appeared to be the most stable. (See Figure 2-7.)

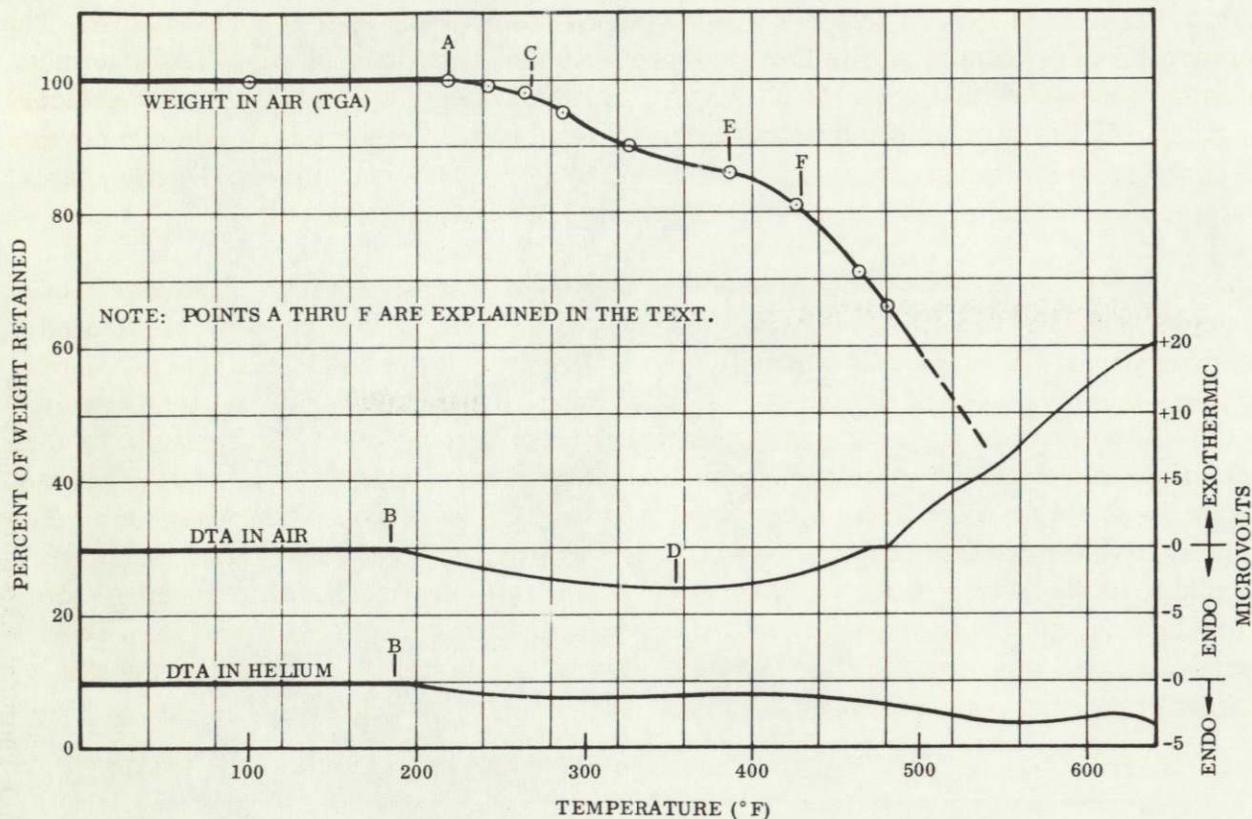
Figure 2-17. Thermogravimetric (TGA) and Differential Thermal Analyses (DTA) of the Zer-O-Cel Polyurethane Foam

Figure 2-17 shows the results of these analyses on the Zer-O-Cel foam and are typical of results obtained for all the other foams. The first or upper curve represents the percent of weight loss occurring at the various temperatures. Point A indicates where the initial weight loss occurred. This weight loss appears to have resulted from the endothermic reaction shown by the two lower DTA curves. The first indication of this endothermic reaction is noted by point B. The temperature at point B is slightly lower than at A, indicating the greater sensitivity of the differential thermal analysis. This greater sensitivity was also noted for the CPR 32-2C specimens. With this foam, a slight endothermic reaction was noted; however, no distinct weight loss was observed. (See Table 2-1.)

Point C indicates the temperature at which the maximum rate of weight change was observed for the endothermic reaction. By examining the two lower or DTA curves, no exothermic reactions were noted for the foam when run in a helium atmosphere. Therefore, by noting that the endothermic reaction rate in an inert atmosphere is relatively constant and that only an exothermic reaction could cause a positive slope at point D for "DTA-in-air" curve, this point must be the temperature at which the exothermic reaction was initiated. This point is also reflected by the weight loss curve (TGA) by point E. Point F indicates the temperature at which the maximum rate of weight change was observed for this exothermic reaction. The temperatures indicated by the above-mentioned points in Figure 2-17 were determined for each of the as-received foams and are listed in Table 2-1.

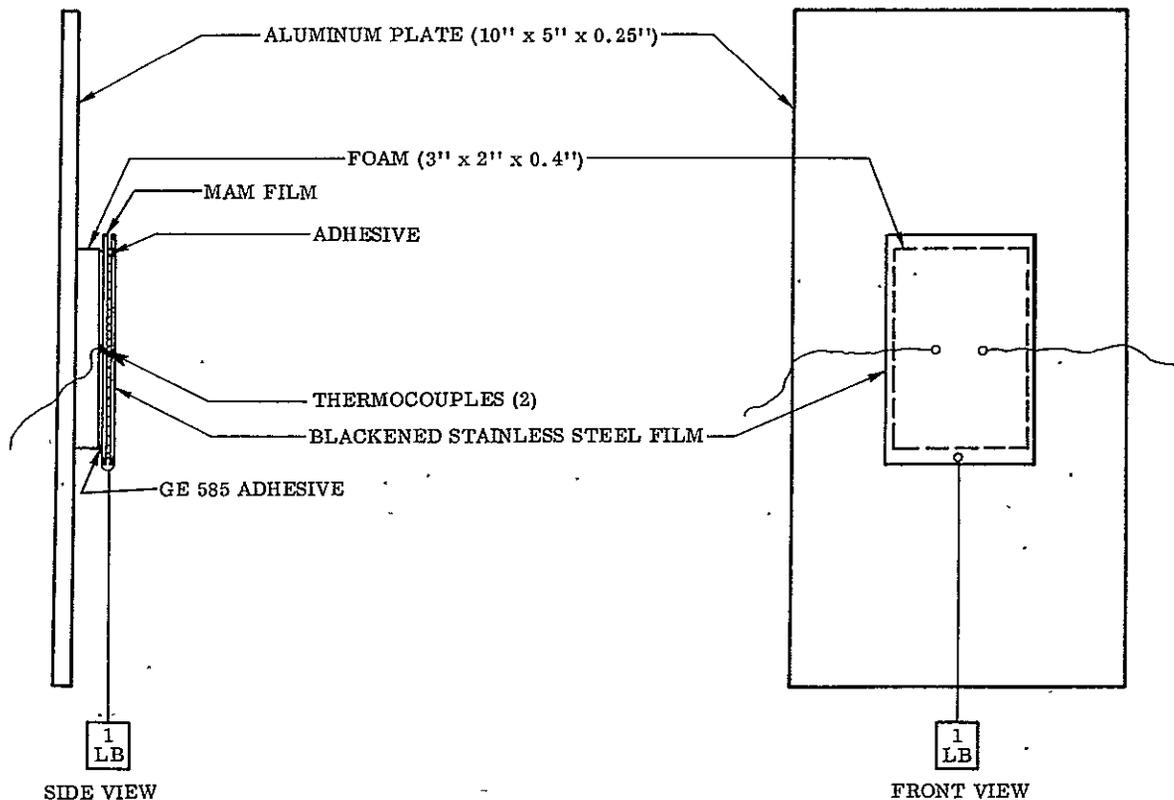
Figure 2-19. Specimen Configuration for Applying Constant Load to Outer Film During Heating

The specimen was mounted vertically and a one-pound weight hung from the MAM and stainless steel film. Again the 700°F time-temperature curve of Figure 2-18 was followed. Specimen Number 1, using the GAC foam, failed at the MAM-stainless steel interface upon reaching a temperature of 600°F. Specimen Number 2, using the CPR 21-2A foam, failed at the foam-MAM interface at 625°F. Specimen Number 3, using the CPR 32-2C foam, also failed at the foam-MAM interface at 660°F. Specimen Number 4, using Zer-O-Cel foam failed in the foam at 655°F. In all of the tests, the MAM film remained intact and revealed no apparent degradation.

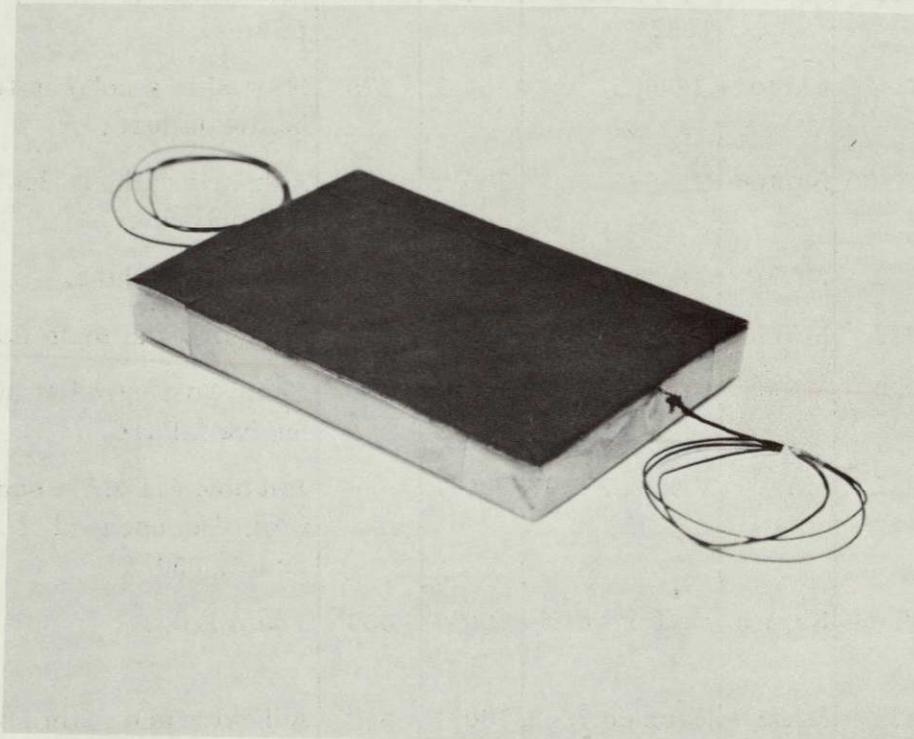
Figure 2-20. Simulated Insulation Panel for the Third Series of Tests

In the third series of tests, small (4 in. by 6 in. by 0.5 in.) sealed insulation panels were used. Although the panels were small, they simulated the full size panels and served as excellent screening devices. When the Vitel PE-207 adhesive was used, the front face was bonded in the same manner as that documented in Reference 1-1. In all other panels, the front face was bonded per the adhesive manufacturer's recommendation. However, the back face and edge channels were fabricated in the same manner on all panels. Two thermocouples were located in the foam-front face bondline. Figure 2-20 shows a typical panel prior to testing.

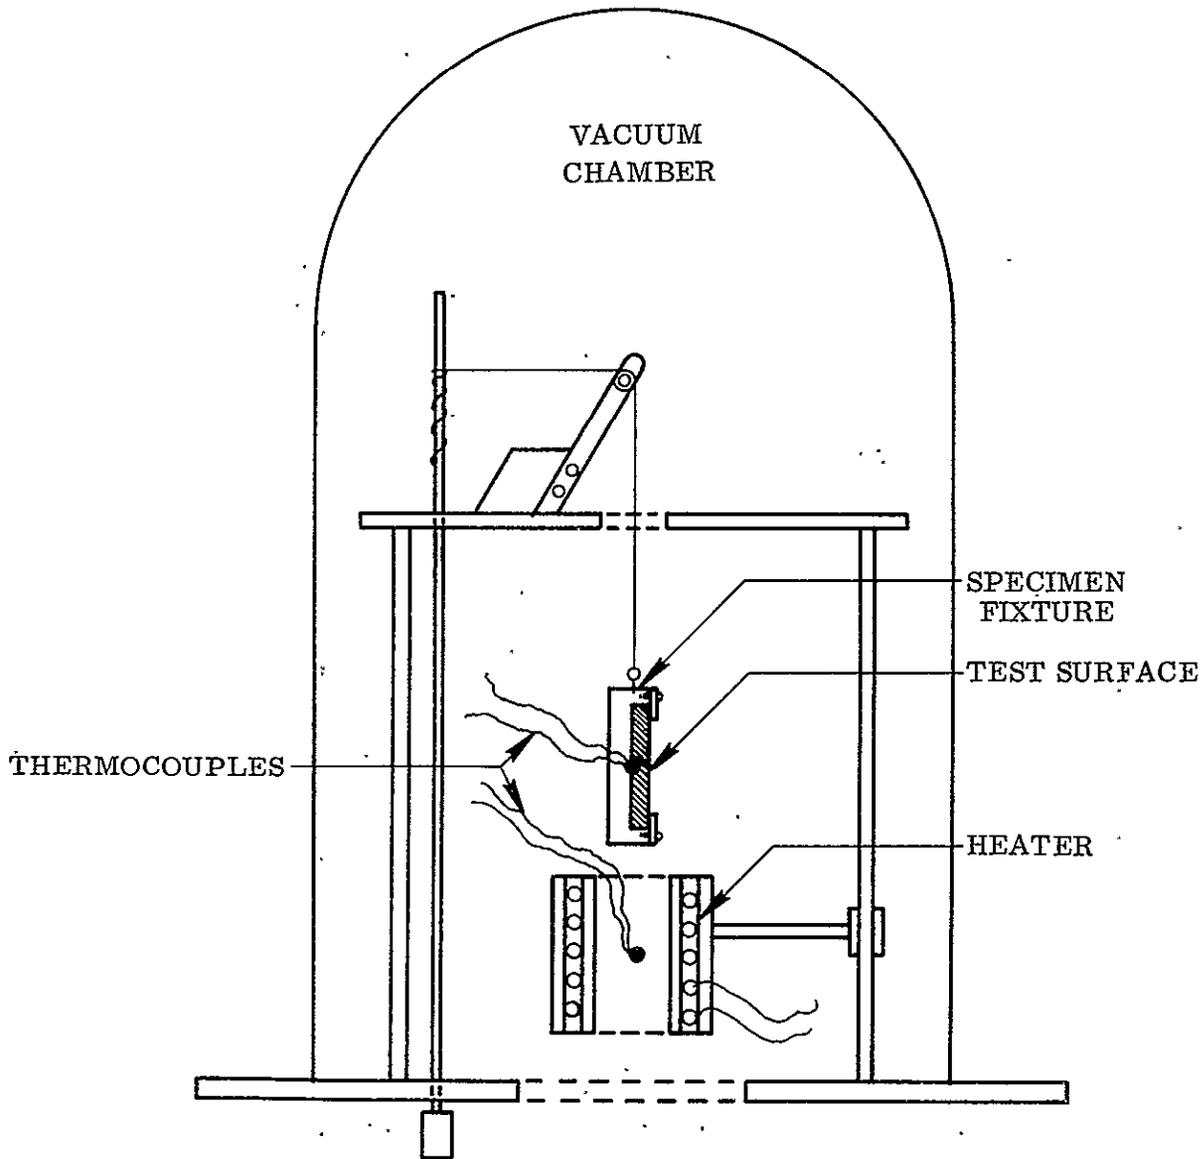
Figure 2-22. Thermal Radiation Property Test Configuration

2.4.3.1 Test Specimen Preparation. Thirteen prospective surface finish materials were evaluated during the radiation property test program, including six paint coatings and seven film-type coatings. Specimens were applied to 15/16-inch diameter discs and mounted in the fixture shown in Figure 2-22.

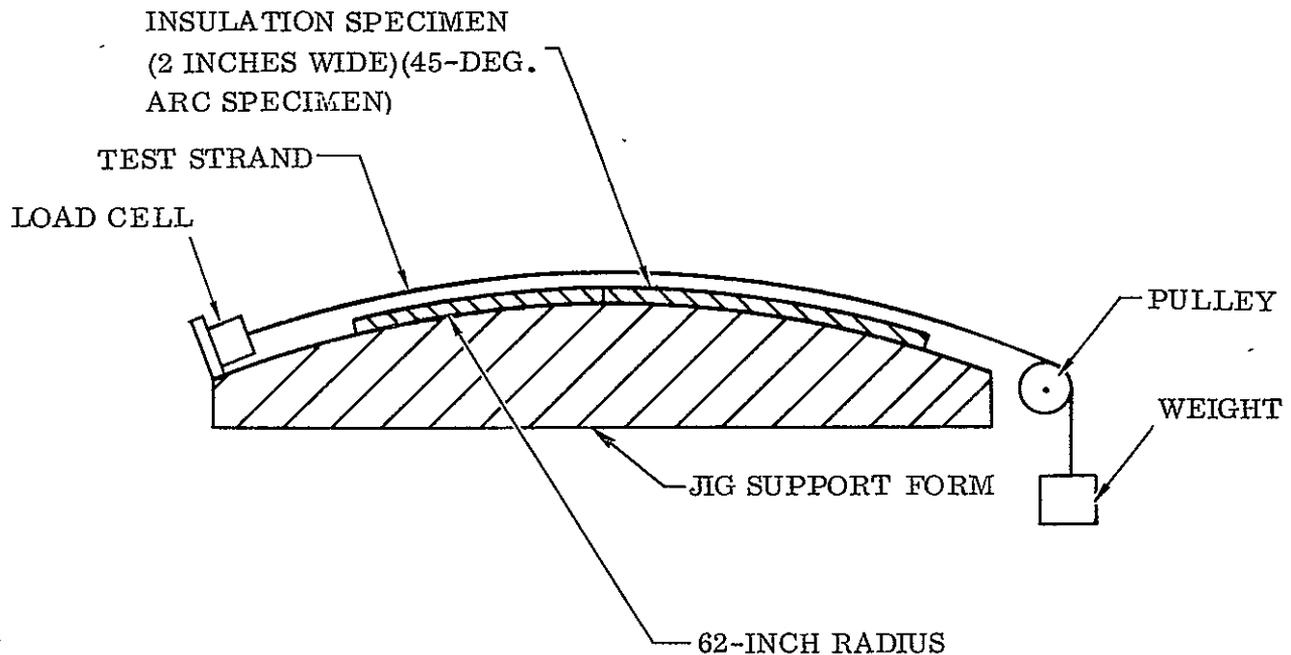
Figure 2-36. Strand Friction Test Apparatus

The jig was placed in a horizontal position, with the fiberglass strand on top of the insulation panels, as shown in Figure 2-36. One end of the strand passed over a pulley to a hook and loading bucket. The other end of the strand was attached to a load cell. The signal from the load cell was recorded on a strip chart recorder. Total error in the load application sensing and recording system was less than  $\pm 0.3$ -pound, including allowances for pulley friction in the applied load.

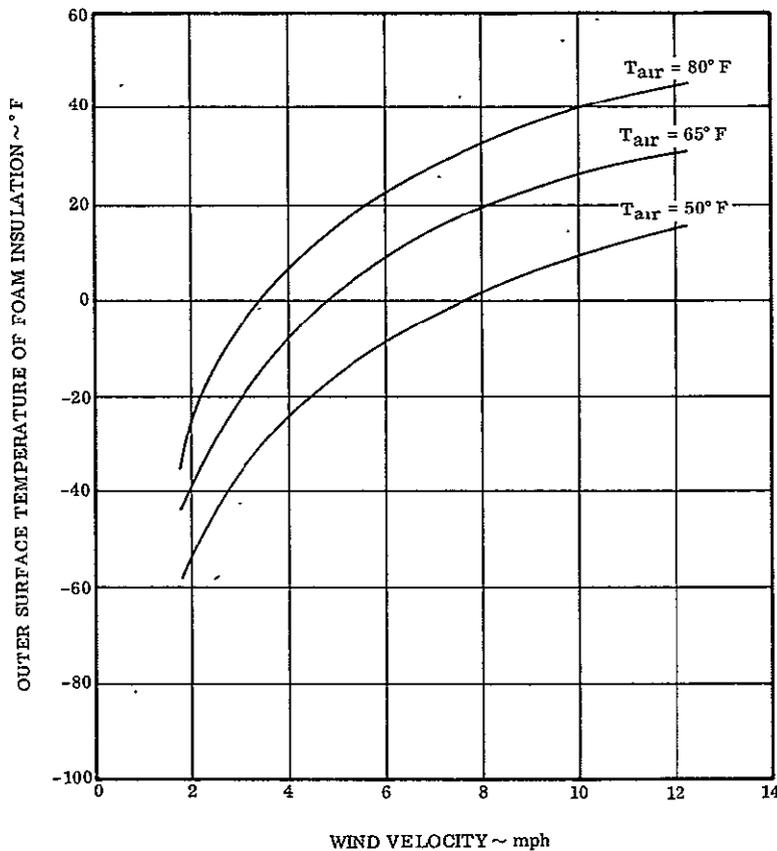
Figure 3-16. Predicted Surface Temperature of 0.4-Inch Foam Versus Wind Velocity

**3.1.2.1 Prelaunch Insulation Surface Temperature.** Prelaunch surface temperatures are dependent upon ambient temperature and wind velocity as shown on Figure 3-16. Only with a combination of high temperature and high wind velocity will the surface temperature exceed 32°F. Therefore, ice will usually form on the insulation panels during pre-launch operations after LH<sub>2</sub> is tanked.

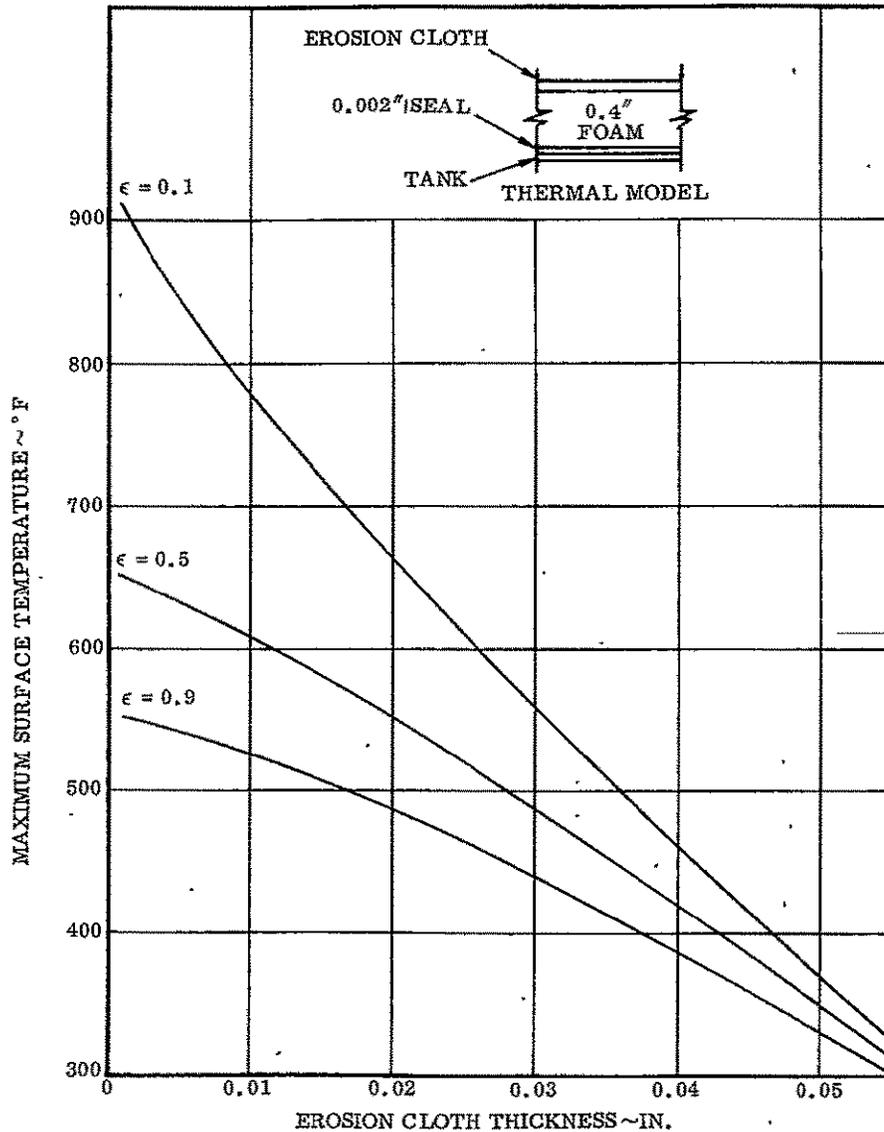
Figure 3-17. Comparative Maximum Outside Surface Temperature for Constrictive - Wrapped Insulation (Trajectory SP47-3C) (Maximum Heating) (Includes Angle-of-Attack Effects)

effects not included). Note that a heavier erosion cloth thickness reduces the maximum temperature, but that the erosion cloth temperature stays hot for a longer period of time, which results in a higher heat flow into the hydrogen during Centaur main engine firing and the early stages of coast, as shown on Figures 3-5 through 3-10. The decrease in payload capability caused by additional hydrogen boiloff is shown in Table 3-6. Thick erosion cloths, therefore, are undesirable from a payload tradeoff standpoint because of the increase in panel weight and because of an increase in hydrogen boiloff.

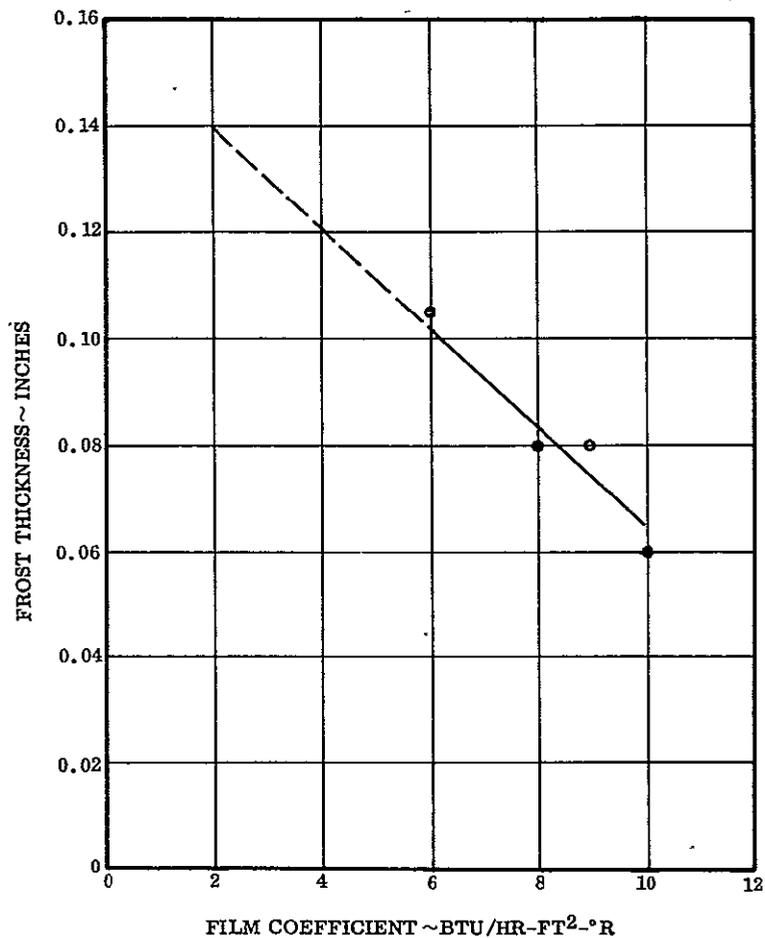
Figure 3-22. Frost Thickness Versus Film Coefficient

The quantity of ice that will form on the outer surface of the insulation panels is difficult to predict with certainty. An approximation of ice thickness was made and was based upon published data for ice formation on a surface at a temperature that approximates the insulation panel surface temperature. Reference 3-10 reports test results of frost formation on a cylinder in a crossflow of humid air while the surface temperature of the cylinder was maintained at 20° F. Ice thickness was measured for several different air velocities across the cylinder. Ice thickness for a steady-state condition is plotted in Figure 3-22 as a function of the average film coefficient on the cylinder. Ice thickness increases as the film coefficient and air velocity decrease.

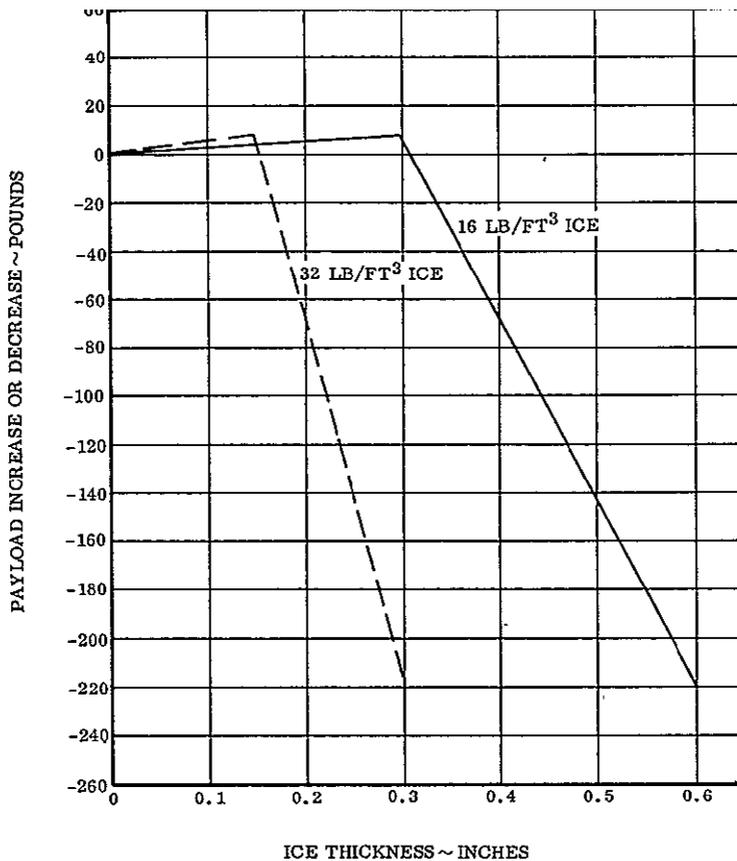
Figure 3-23. Payload Change Attributable to Ice on Insulation Surface Prior to Launch

1. Much of the ice melts off during the early moments of flight when the payload tradeoff factors are high, and
2. The ice acts as an ablator to keep the insulation skin temperature low, which reduces LH<sub>2</sub> heating, thereby reducing boiloff losses.

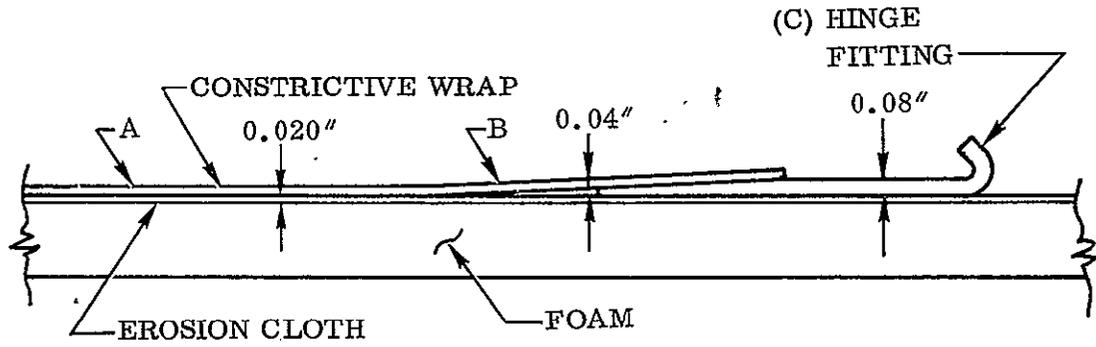
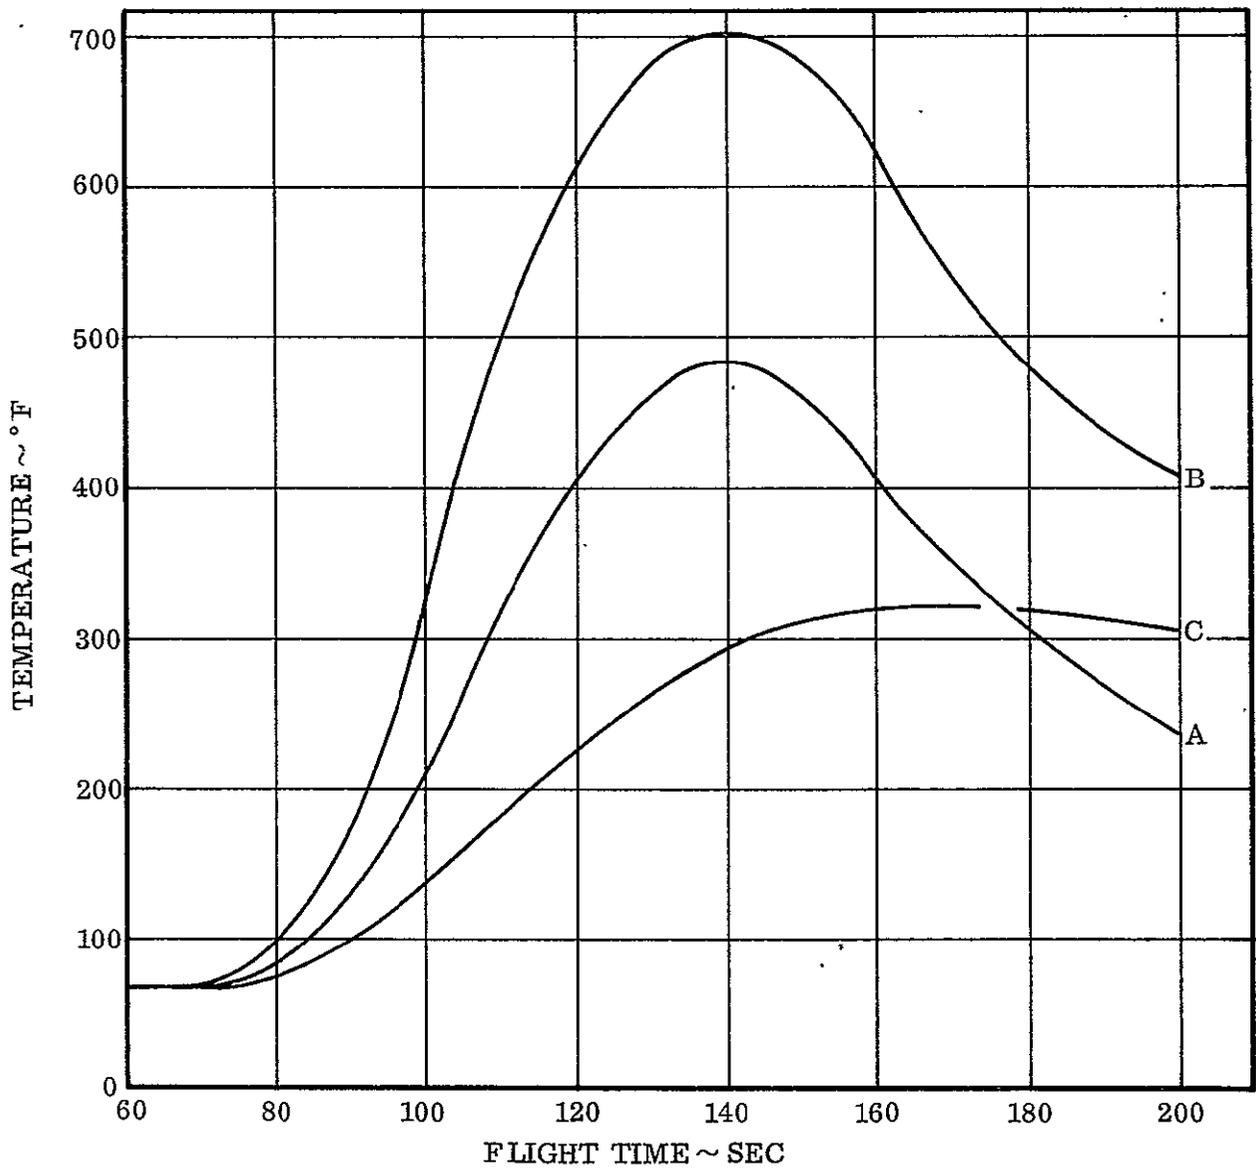
Figure 3-24. Predicted Temperatures on Hinge Fitting and Constrictive Wrap as a Function of Flight Time

An analysis was accomplished on an 0.020-inch corrugated aluminum constrictive wrap to determine the temperature distribution on the corrugated surface and to determine the effect of the corrugated wrap on payload losses.

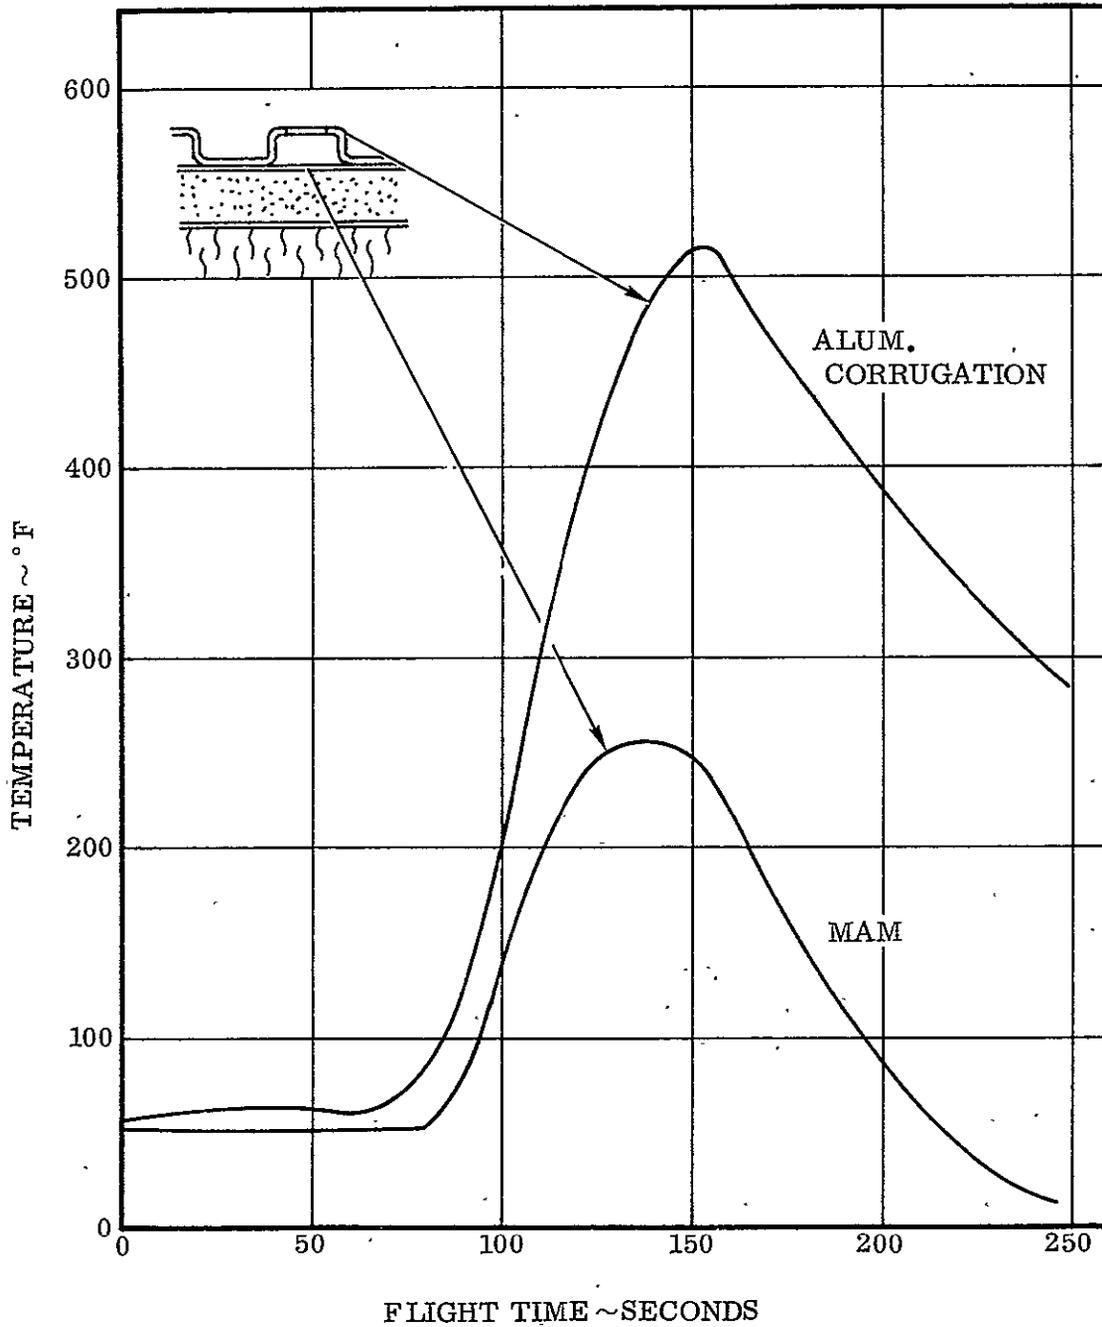
Figure 3-27. Temperature Predictions for the Aluminum Corrugated Wrap System

absence of ice reaches a maximum temperature of 255°F. MAM and/or foam temperatures in excess of about 350°F may cause the panel to blister. This temperature will be exceeded only where the corrugation comes in contact with the MAM.

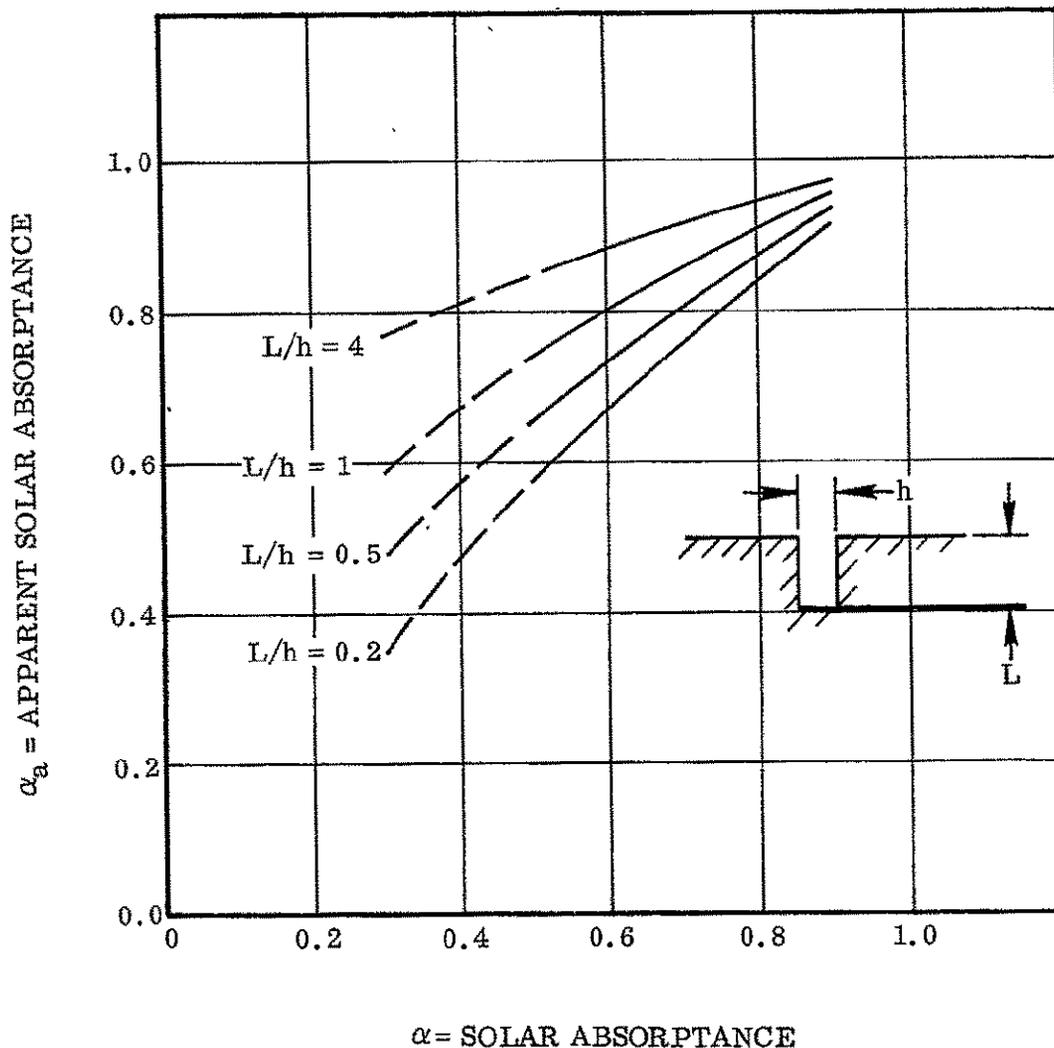
Figure 3-28. Apparent Solar Absorptance Versus Solar Absorptance for a Corrugated Surface with  $L/h$  as a Parameter

3.2.2 EFFECT OF CORRUGATIONS ON SOLAR ABSORPTANCE. The corrugations increase the solar absorptance of the insulation surface. This increases the heat input to the liquid hydrogen during coast and decreases payload capability. Reference 3-12 describes the effect of corrugations (surface cavities) on solar absorptance as a function of  $L/h$ , where  $L$  is the height of the corrugation and  $h$  is the width. The increase in solar absorptance (apparent absorptance), is plotted on Figure 3-28 for several ratios of  $L/h$ . It was assumed that the solar absorptance was 0.3 on a non-corrugated surface. A corrugated surface painted with a surface coating having an absorptance of 0.3 has a greater apparent absorptance in the cavities (or depressions) in the corrugations because solar energy becomes "trapped." (Solar absorptance at the top of the corrugations is unaffected by the cavities.) For a surface with an  $L/h$  ratio of 0.2, the apparent absorptance in the cavities is 0.35, thereby increasing the hydrogen boiloff losses and reducing payload capability.

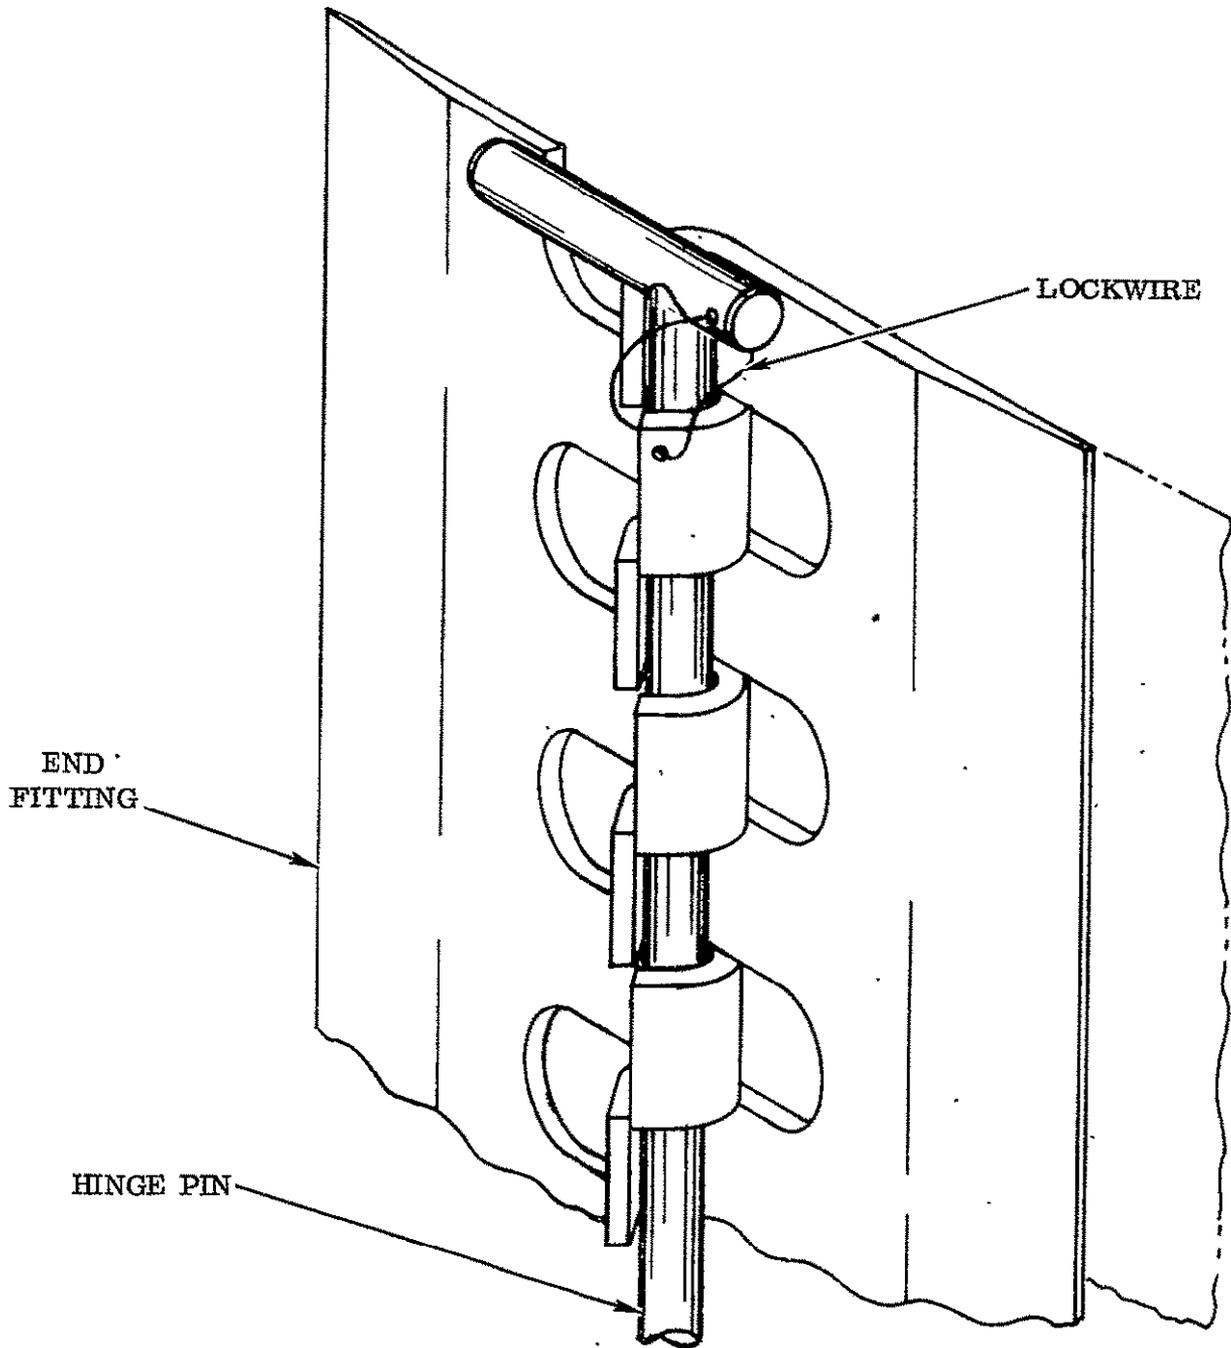
Figure 4-4. Constrictive Wrap End Fitting Configuration

concept is shown pictorially in Figure 4-5. Since the bend radius of the hinge fitting had to be smaller than that recommended for normal practice, tests were run to determine the strength of the fitting at the bend radius. The test results are shown in Table 4-3. It should be recalled from Table 4-2 that the maximum expected strand load is 63 pounds, while the test results of Table 4-3 show load cycling capability of greater than 200 pounds with no yielding, and a yield load of greater than 300 pounds.

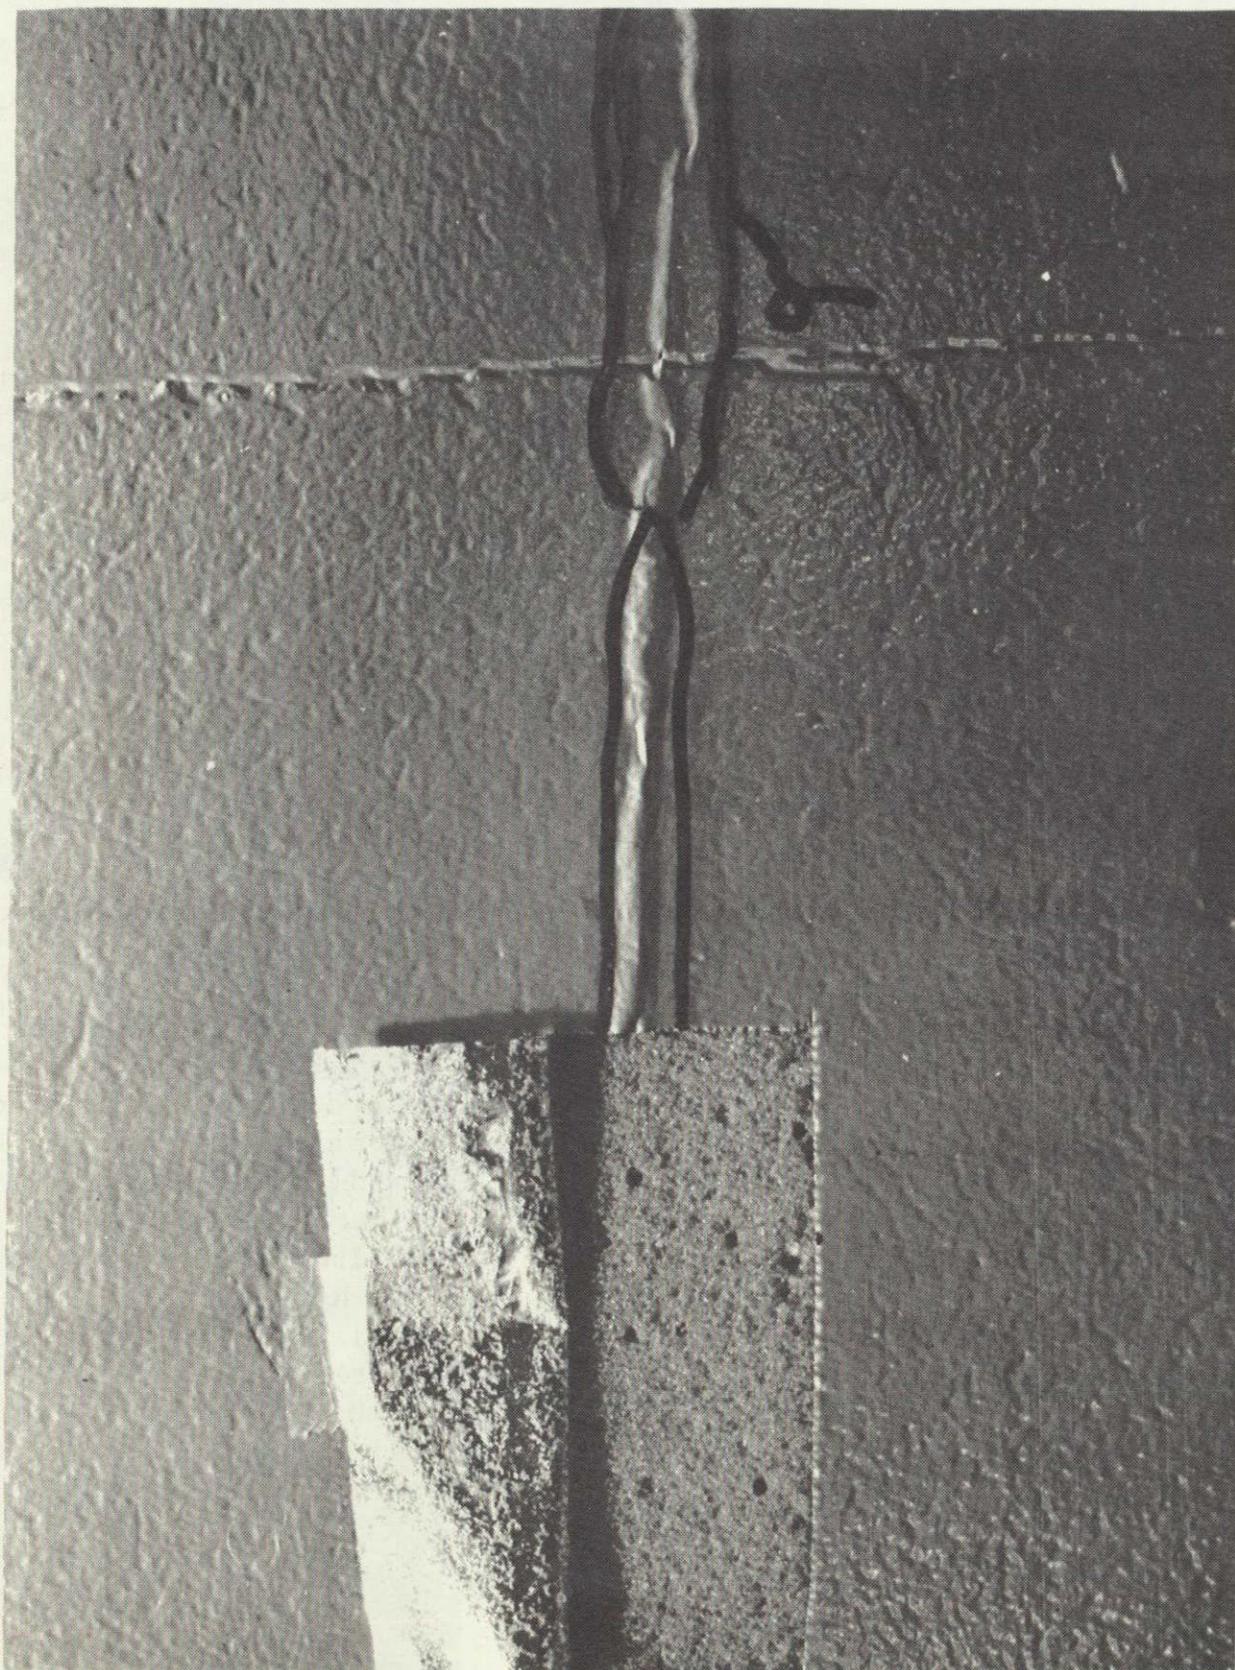
Figure 5-3. Blister in the Center of the Concave Surface of the System B DPT Test Panel

During the first LN<sub>2</sub> dip test cycle a small blister approximately 3/8 inch in diameter was noted in the MAM skin on the concave side of the panel. The blister appeared to be associated with a void or soft area in the foam, therefore, it was decided to continue the test and observe the blister. During the second LN<sub>2</sub> dip cycle three more small blisters were noted which were about the same size and character as the first blister. During the third dip test cycle three very small blisters were noted in the area of foam joints. During the fourth dip test cycle two blisters approximately 1-1/2 inches long were noted in the edges of the panel and one wrinkle blister approximately 1/8 inch wide by 4 inches long was found in the center of the concave surface of the panel. This blister was aligned parallel to the long axis of the panel and appeared to be a compressive buckle type of wrinkle that may have been caused by panel deflection during immersion in LN<sub>2</sub>. During the fifth dip test cycle the wrinkle blister grew approximately two inches longer and one edge blister doubled in length. During the sixth dip test cycle the above noted blisters did not change; however, numerous very small blisters up to 1/8 inch in diameter were observed on the concave surface. These small blisters all appeared to be associated with void holes in the surface of the foam. All the blisters lost pressure within 30 minutes after the conclusion of the test. After the conclusion of the sixth dip test, the blistered areas were cut open. Figure 5-3 shows the long blister in the center of the concave surface of the panel; the blister first appeared on the fourth dip cycle. Figure 5-4 shows typical blisters which have been cut open, showing that the blisters were associated with voids or soft spots in the foam.

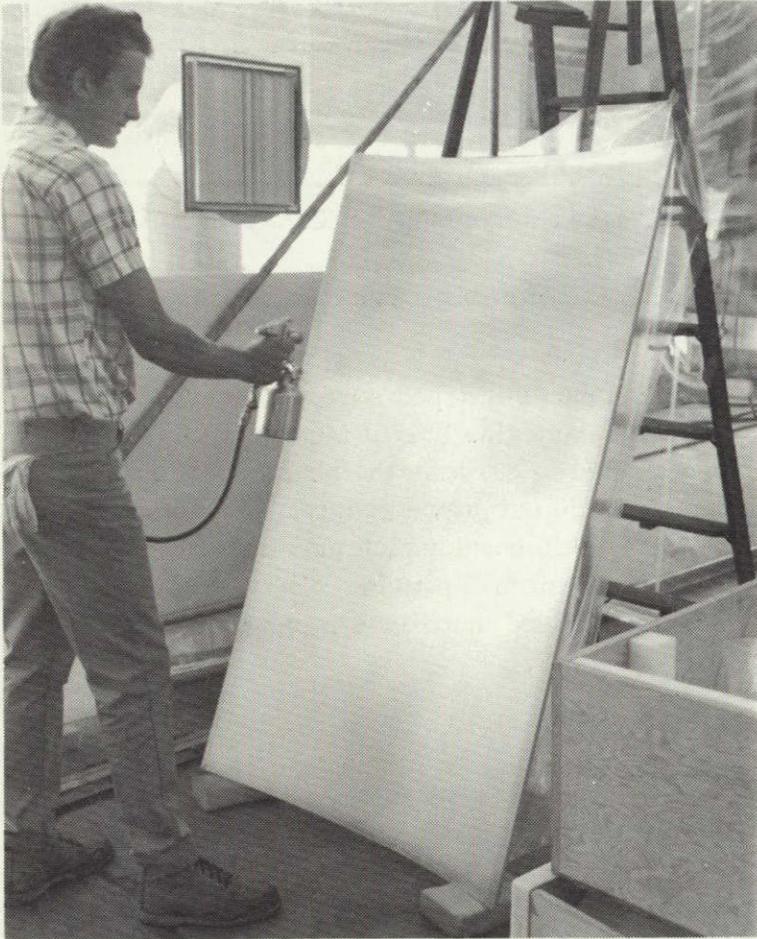
Figure 5-5. Priming An  
Insulation Panel

1. The tank and panels were first cleaned with trichloroethane.
2. The tank and panels were then primed with PE-207 and allowed to cure a minimum of six hours. See Figure 5-5 for a picture of a typical priming operation of an insulation panel.

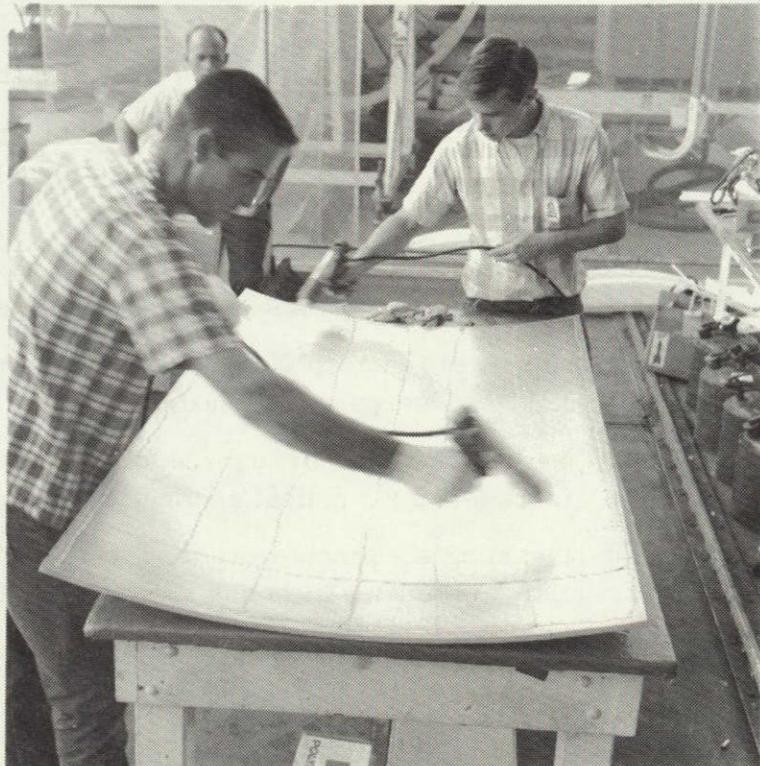
Figure 5-6. Applying Adhesive  
Beads To An  
Insulation Panel

3. Beads of Narmco 7343 adhesive were applied in a 6-inch grid pattern to the concave surfaces of six insulation panels (Figure 5-6).
4. The panels were then applied to the tank and vacuum bagged at a minimum of 20.5 inches of mercury for 8 hours.
