REPORT GDC-BTD68-058  
CONTRACT NAS 3-3248, T.O.9

# FIXED INSULATION DEVELOPMENT PROGRAM FINAL REPORT

May 1969

Prepared by  
CONVAIR DIVISION OF GENERAL DYNAMICS  
San Diego, California

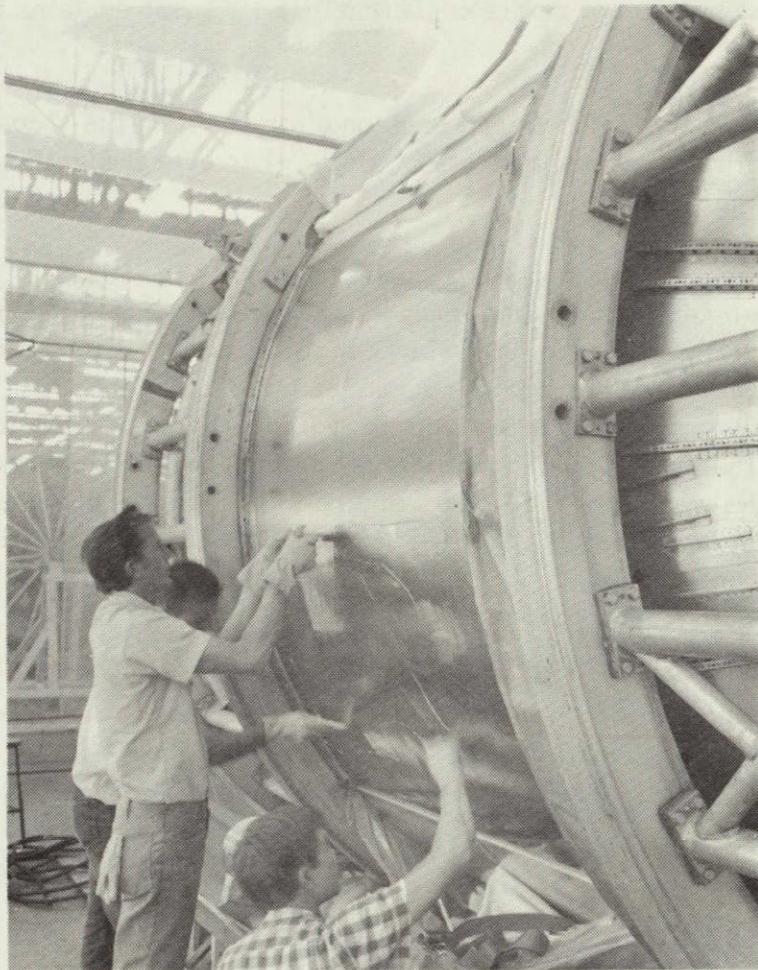
Figure 5-7. Applying Adhesive To The T-9 Tank

5. A 100 percent coat of Narmco 7343 was applied to the remainder of the tank. See Figure 5-7 for a typical application operation.
6. The remaining six panels were then installed on the tank and vacuum bagged at a minimum of 20.5 inches of mercury for 8 hours.

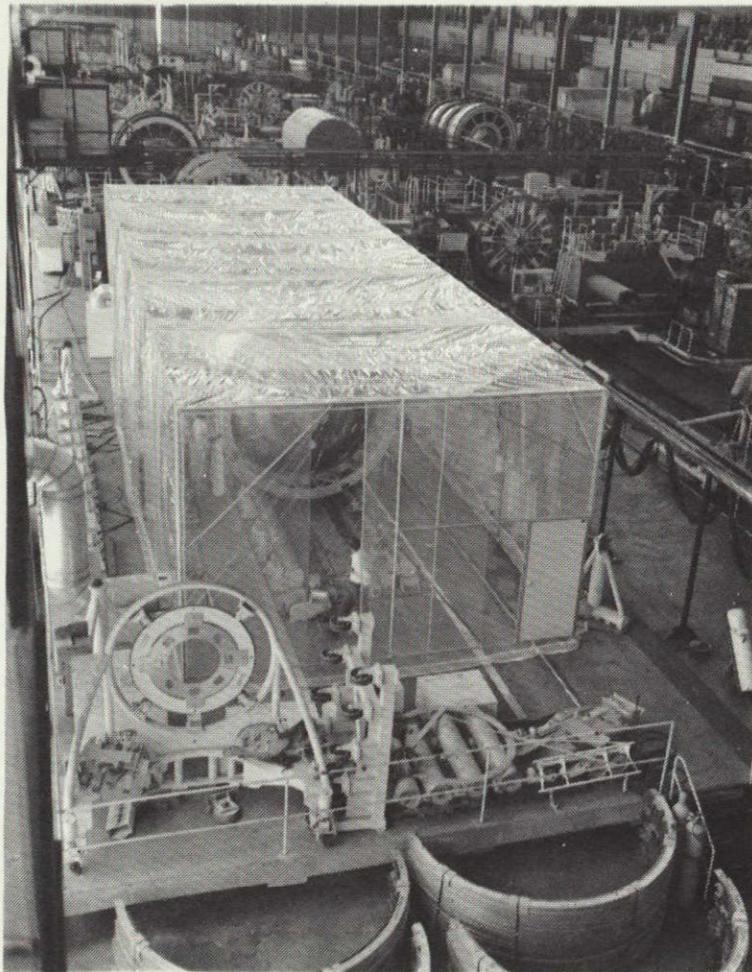
Figure 5-8. Installing Insulation Panels On The T-9 Tank In A Portable Plastic Clean Room

5.2.2 INSTALLATION OF THE PANELS ON THE T-9 TANK. In order to provide a clean environment for mixing and applying adhesives, and to comply with Convair's fire and safety requirements for handling and applying flammable materials, application of the insulation panels and erosion cloth was accomplished in a portable clean room. See Figure 5-8 for a picture of the portable clean room with the T-9 tank inside.

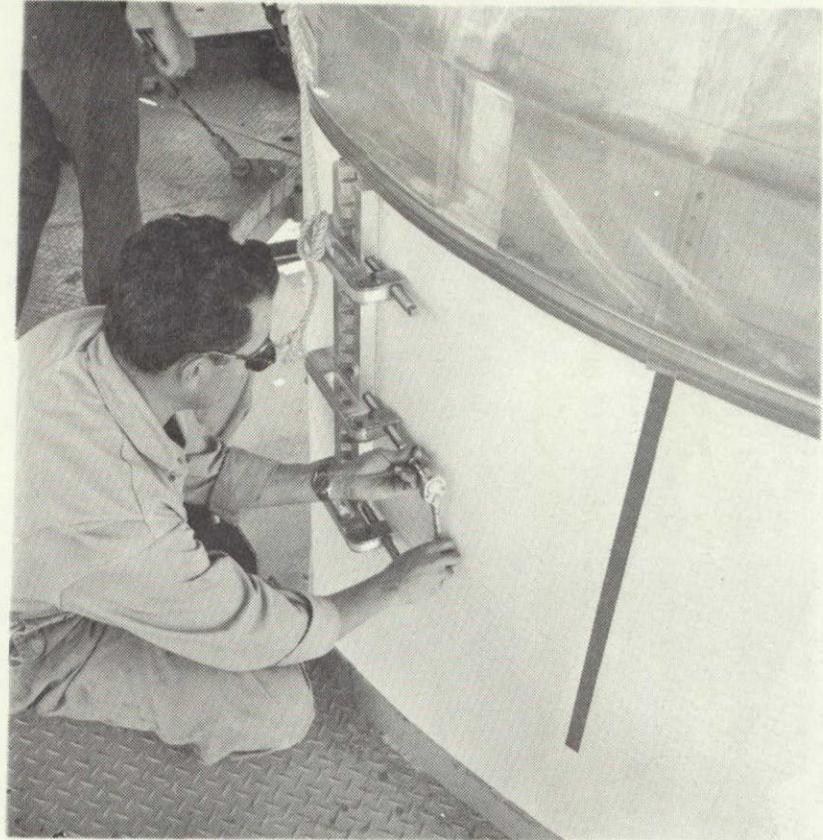
Figure 5-19. Clamping The Constrictive Wrap

2. The four 55-07227-BN constrictive wrap assembly tools were then installed on the hinge ends, as shown in Figure 5-18. The tools were mounted into the nodes of the hinges, and provided a threaded "C" clamp for clamping and stretching the wrap segments. Figure 5-19 shows the "C" clamps being tightened. All four tools were tightened simultaneously, thereby putting equal strain in all four wrap segments. Note that the assembly tool in Figure 5-18 has two "C" clamps, while that in Figure 5-19 has three "C" clamps. It was found that the two-clamp arrangement allowed too much beam deflection between clamps, making it impossible to properly line up the hinge nodes. The tool was subsequently modified by adding one clamp.

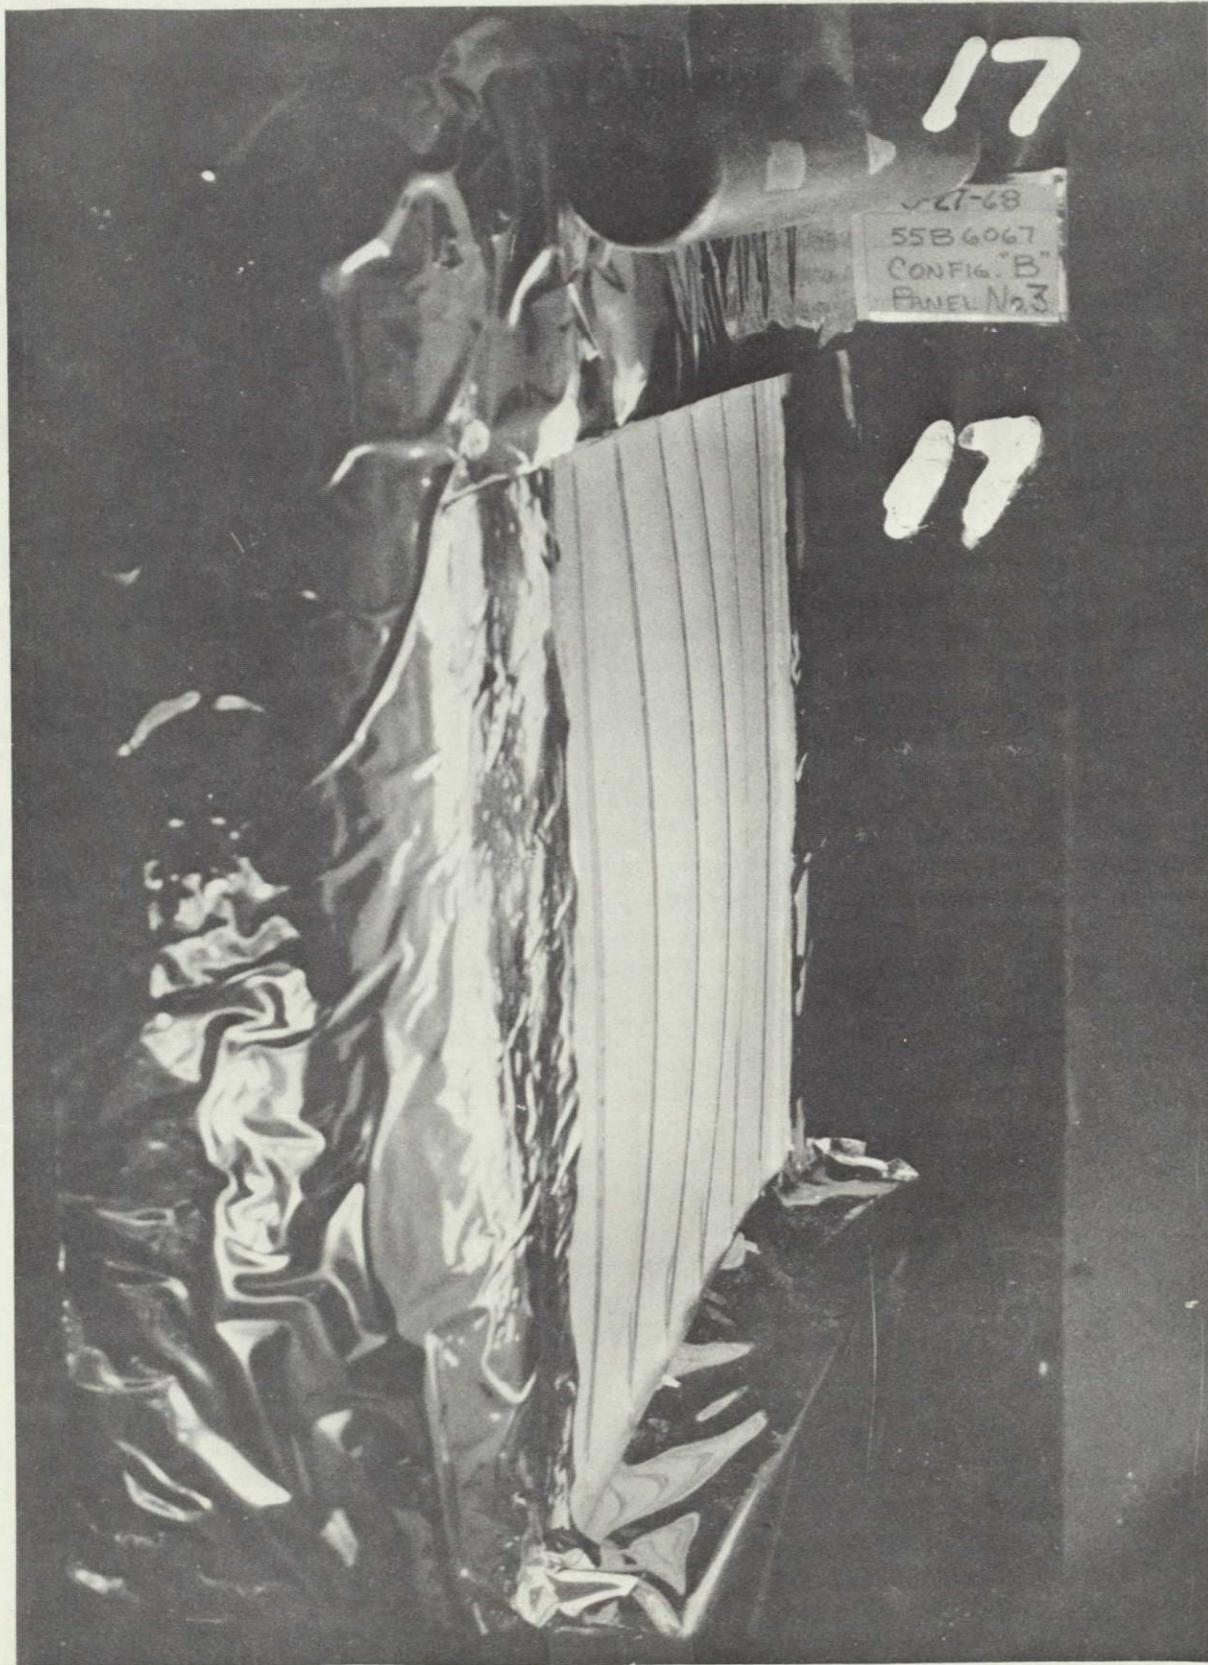
Figure 8-10. Specimen Panel B3 Showing Maximum Blister Formation — Back Face of Panel at LH<sub>2</sub> Temperature for 20 Minutes Before Test

Some blistering occurred in all panels of configurations A through D. Photographs of typical blisters are shown in Figures 8-6 through 8-14. Figures 8-6 through 8-8 show blisters in panels tested without LH<sub>2</sub> in the test fixture (back face of panel at ambient temperature.) Figures 8-9 through 8-11 show blisters in sealed panels which have been held with the back face at LH<sub>2</sub> temperature for 20 minutes. Figures 8-12 through 8-14 show blisters in those panels fabricated with small leaks, and held with the back face at LH<sub>2</sub> temperature for two hours.

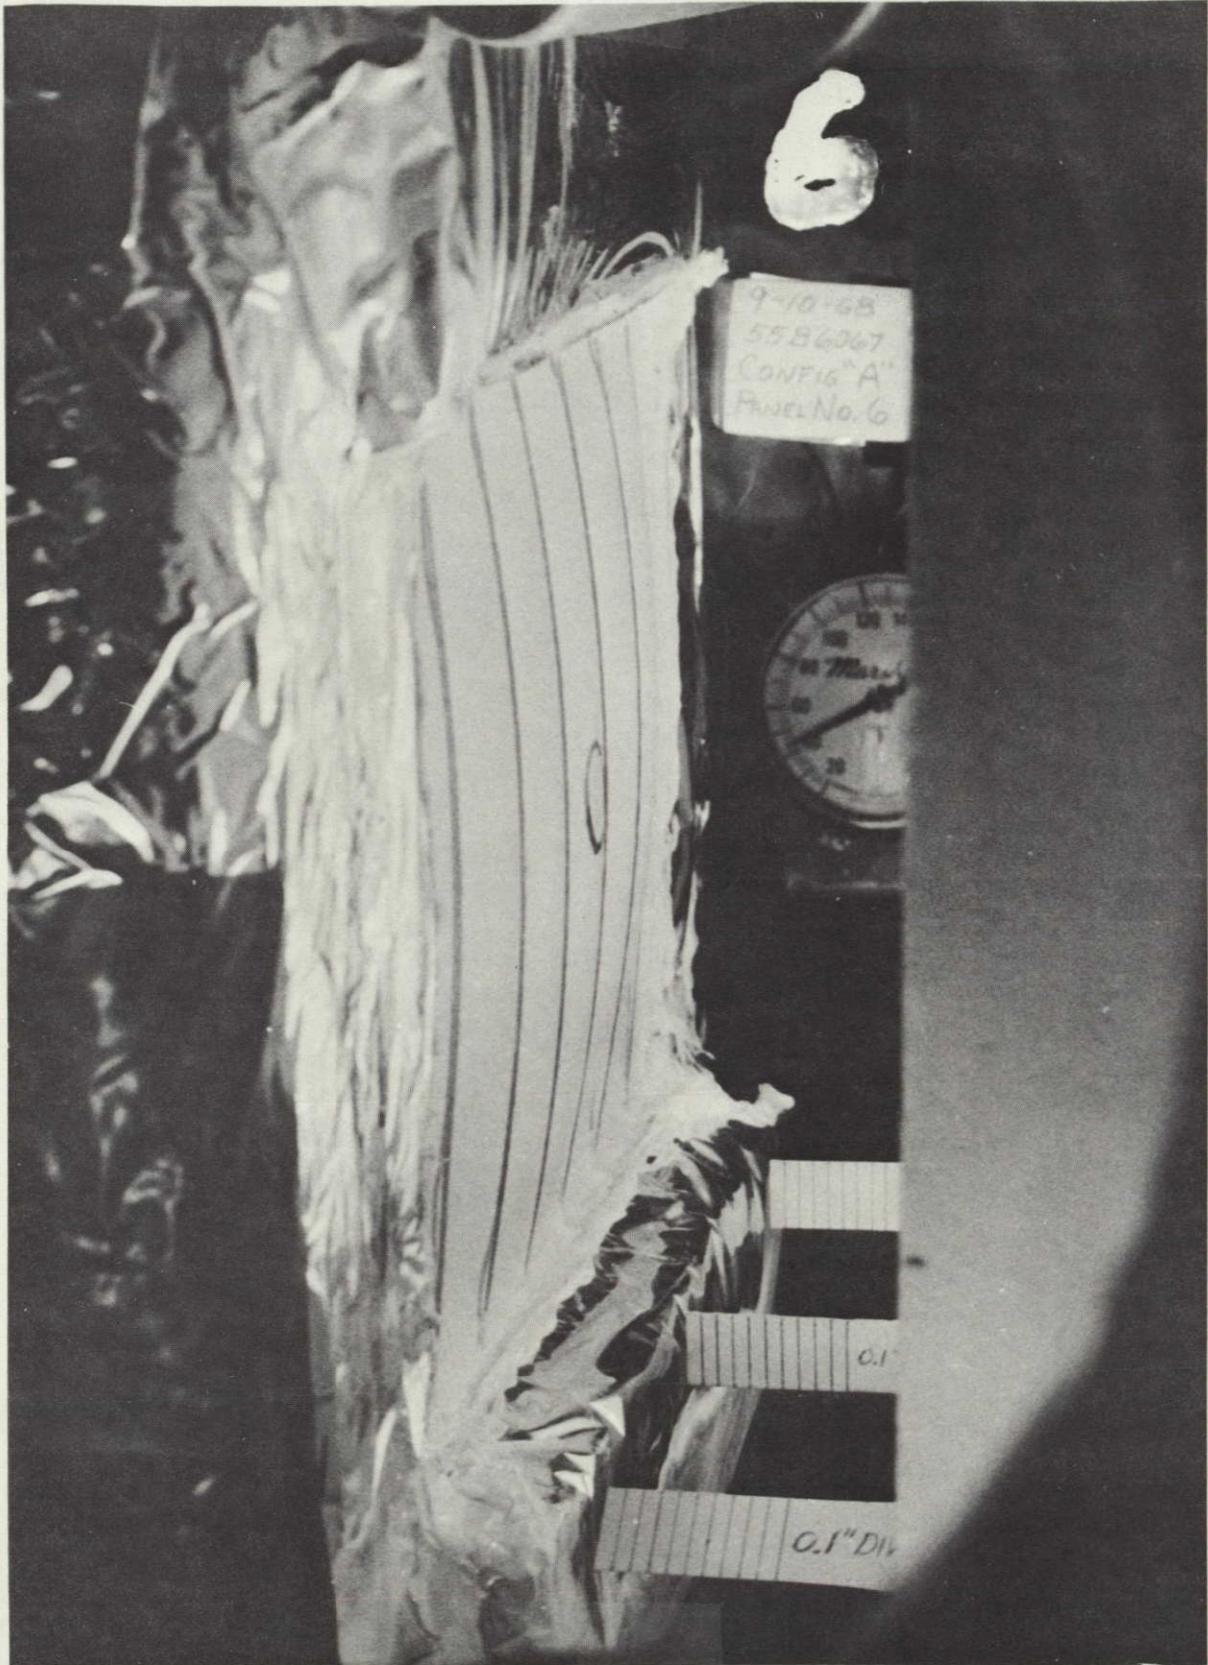
Figure 8-12. Specimen Panel A6 Showing Maximum Blister Formation -- Back Face of Panel at LH<sub>2</sub> Temperature for 2 Hours Before Test

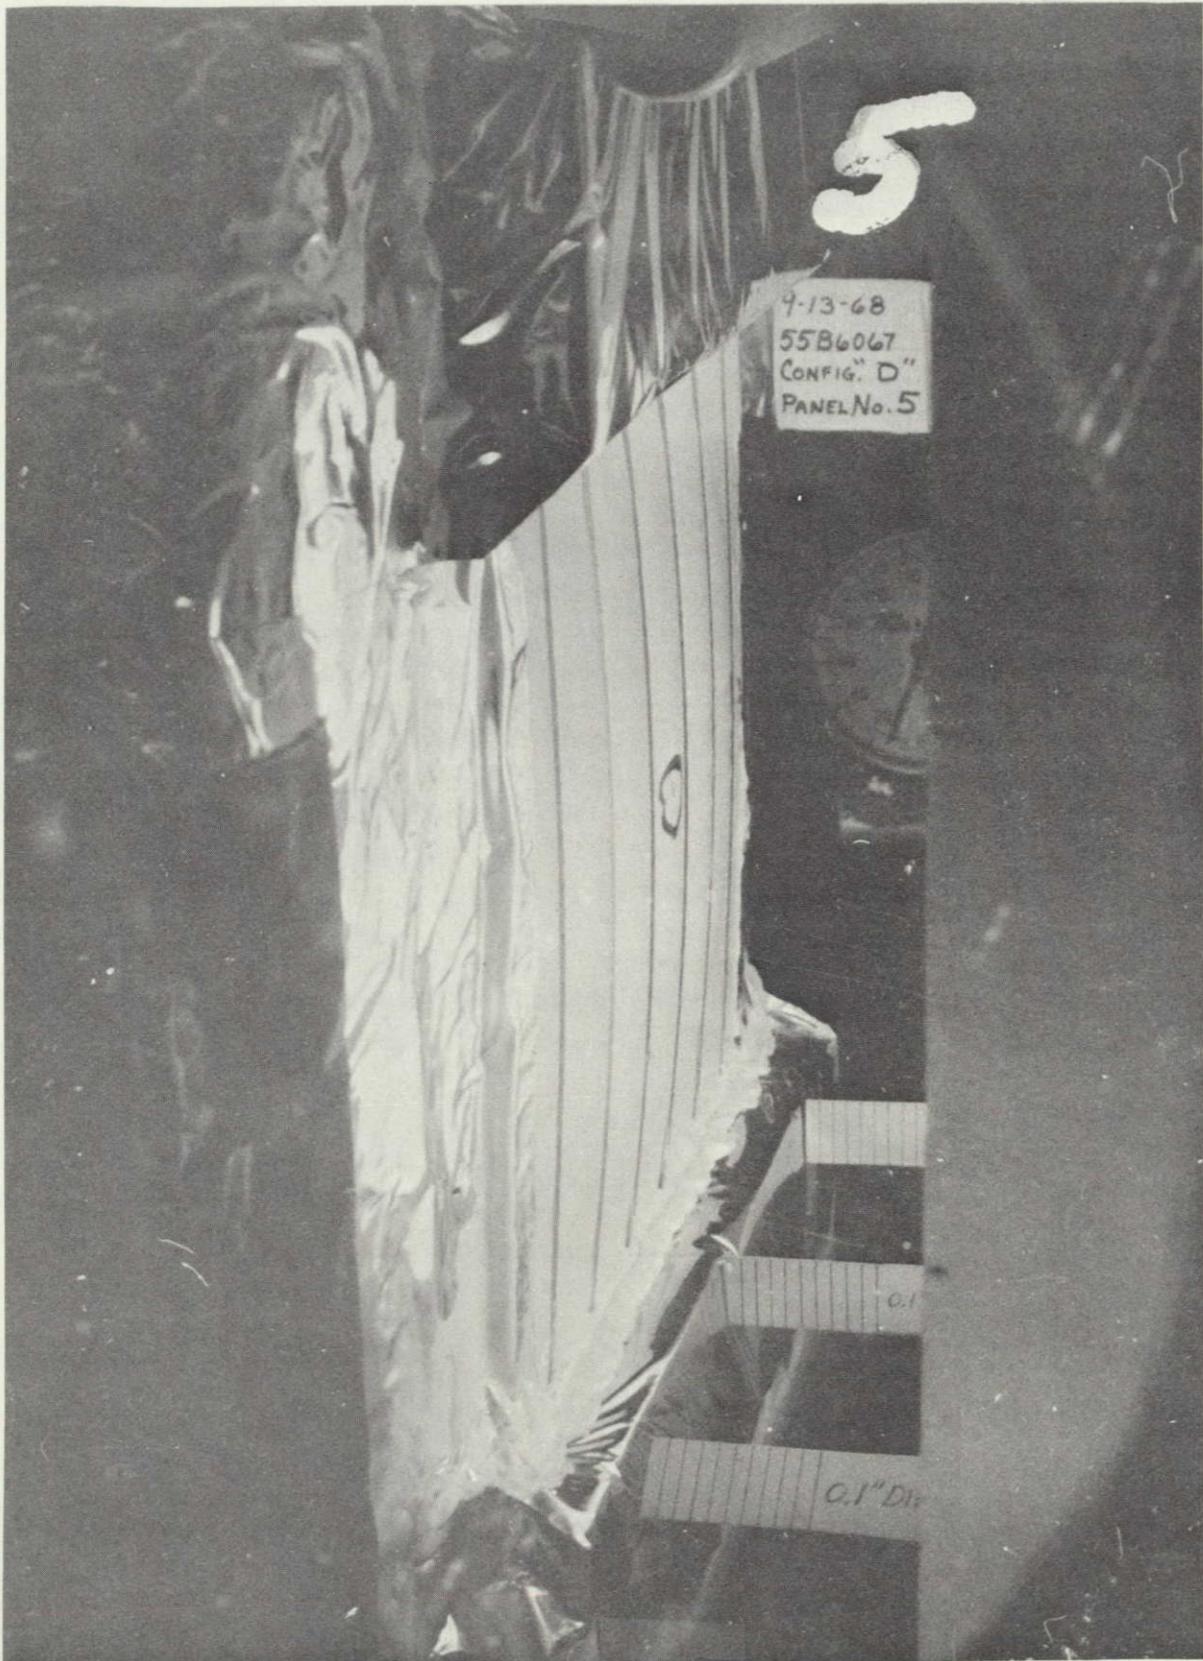
Figure 8-14. Specimen Panel D5 Showing Maximum Blister Formation — Back Face of Panel at  $\text{LH}_2$  Temperature for 2 Hours Before Test

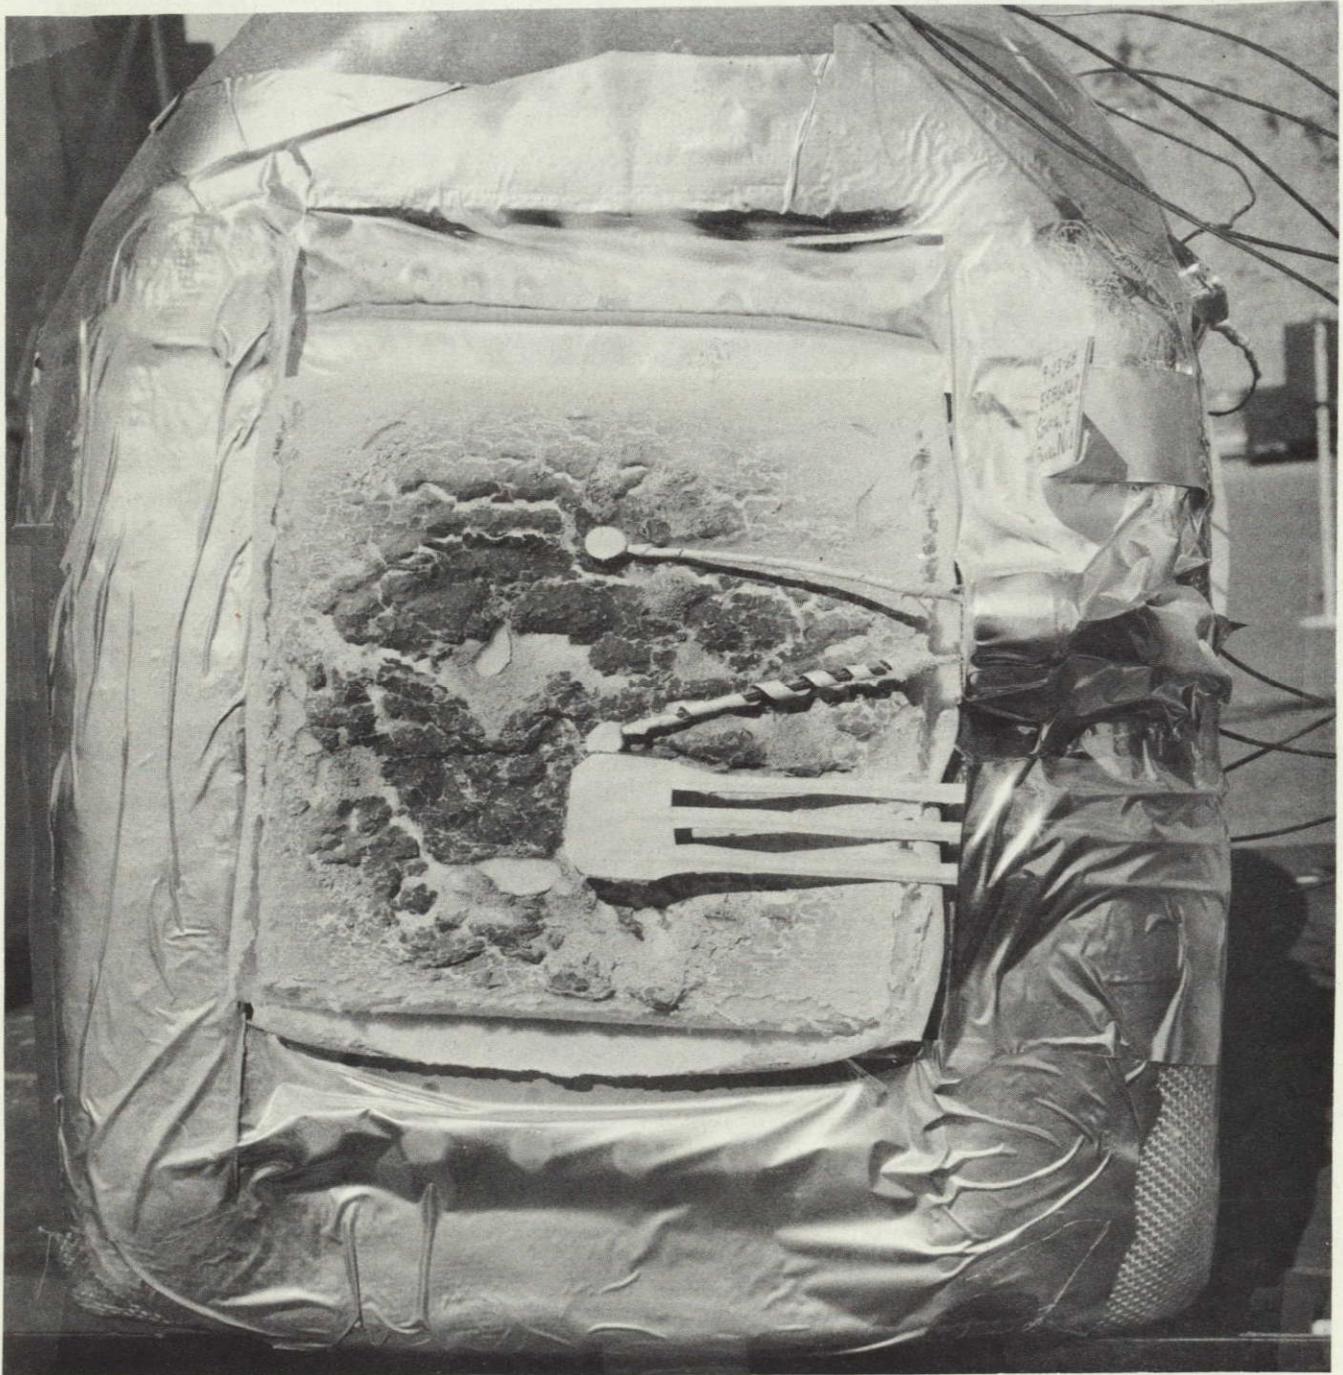
Figure 8-15. Specimen Panel E1 after Test

The configuration E panels (the spray-on foam panels obtained from North American Rockwell Corporation) were tested to the same procedure as the configuration A through D panels. It was of interest to observe their behavior during a simulated Atlas/Centaur ascent environment. Photographs of the foam after the completion of testing for three of the specimens are shown in Figures 8-15 through 8-17.

Two interesting characteristics of this foam insulation are evidenced in the photographs. First, the surface coating is badly charred, which would give extremely adverse outer surface thermodynamic properties for space coast. And second, even though the surface coating is charred and broken, the foam structure appears to be relatively unaffected.
