TITANIUM PUMP IMPELLER TESTING

FINAL REPORT

ROCKETDYNE  
A DIVISION OF NORTH AMERICAN ROCKWELL CORPORATION

Contract NAS8-25860

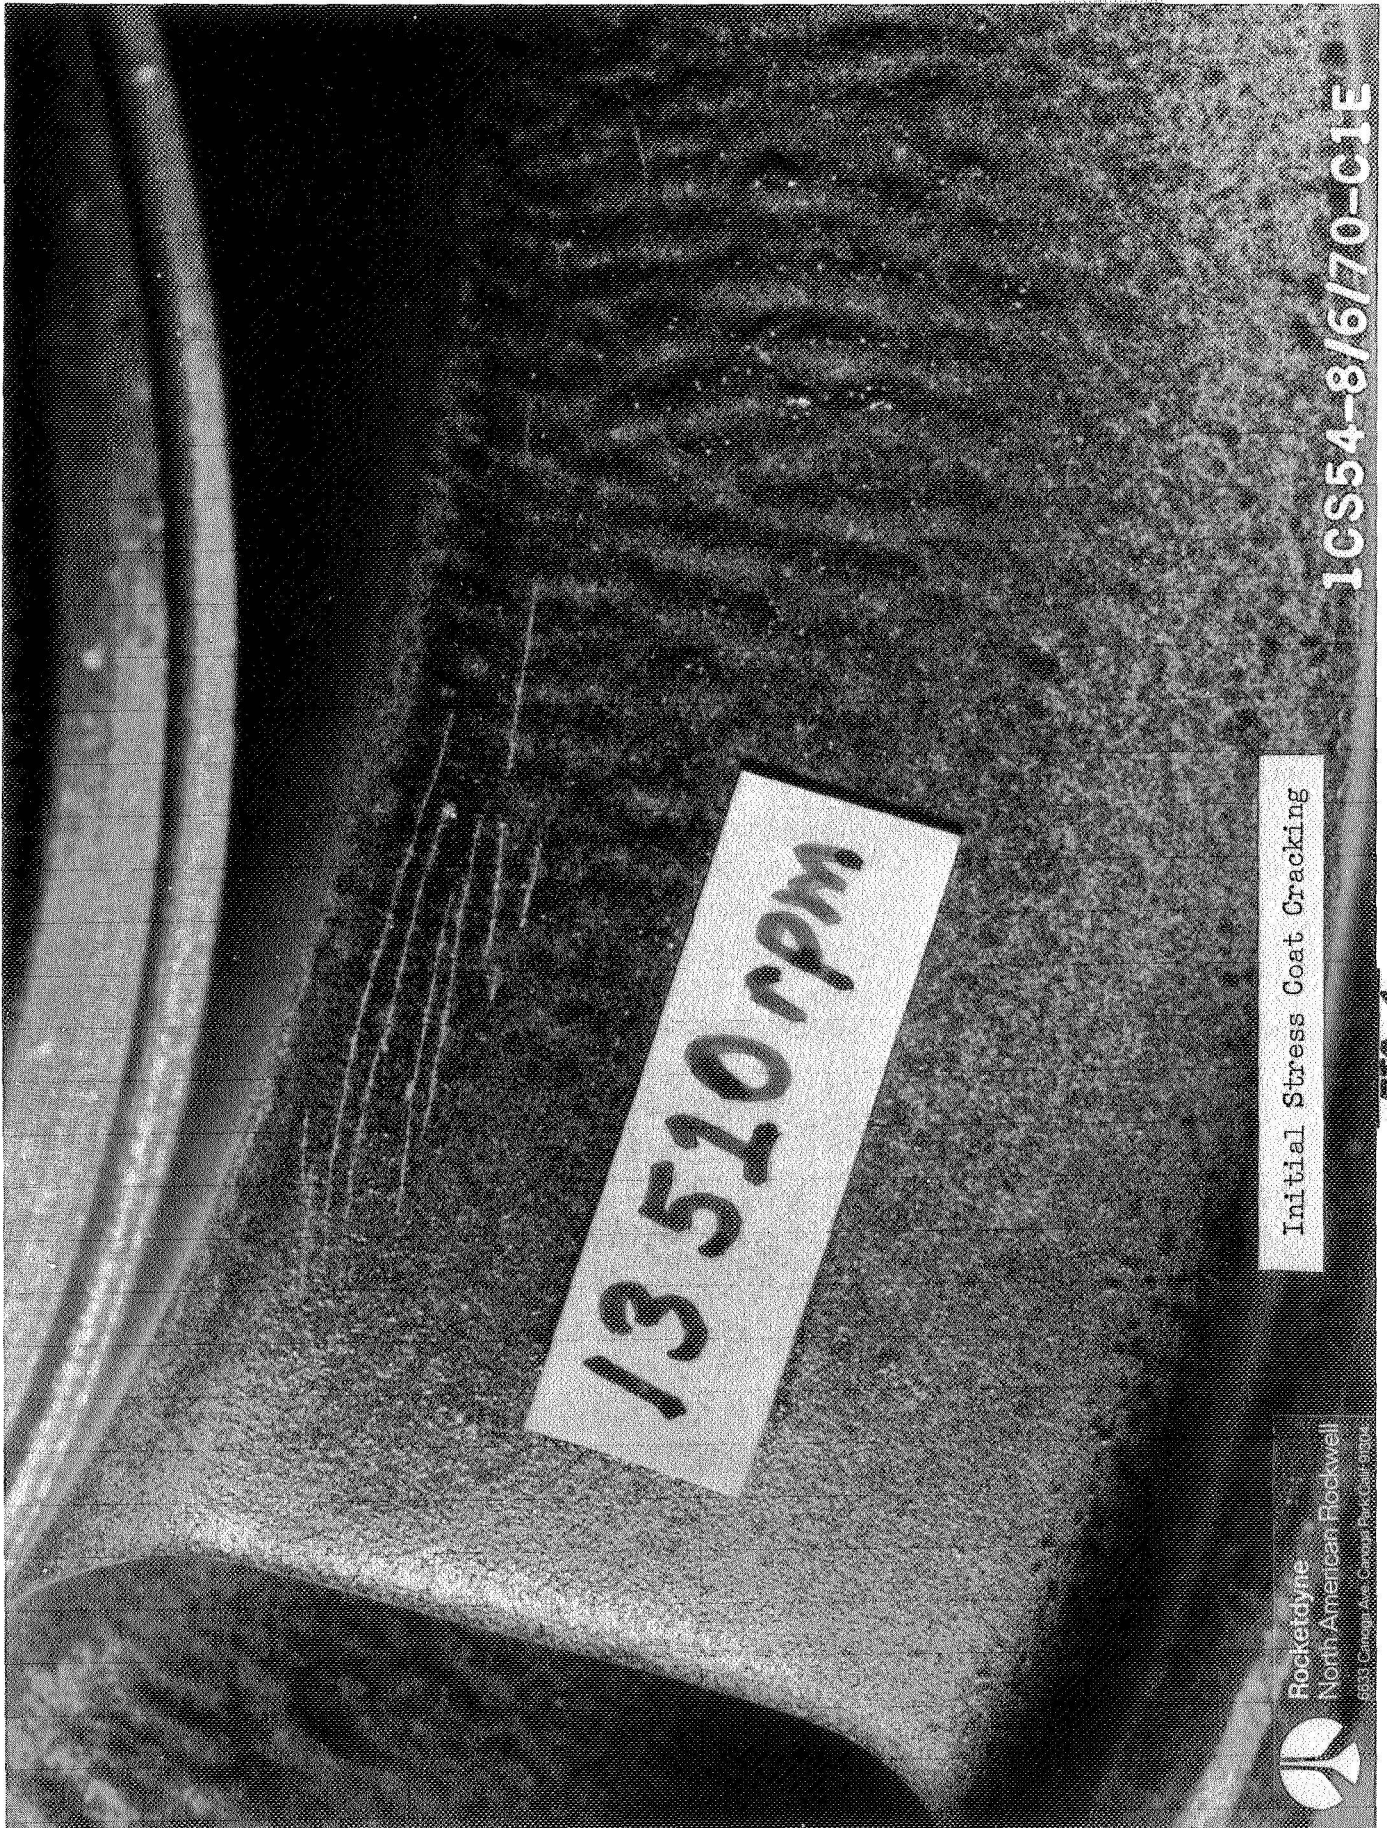
FIG. 1

Initial Stress Coat Cracking

48.4	On the vanes at the vane-to-hub radius just back of the leading edge. (Fig. 1, region of cracks, and Fig. 8, the smallest enclosure.)  On the flat in the upstream hole at the junction of the balance piston holes. (Fig. 3, noted by arrows.)

cracks, for they are aligned perpendicular to the maximum principal stress. The most highly stressed regions are the vanes and the flat in the upstream hole. Figures 1 and 2 illustrate typical vane Stresscoat cracking, initial and extensive, respectively. Figure 3 illustrates the extensive Stresscoat cracking that was first observed in the flat of the upstream hole at 15,200 rpm. Analysis indicated that the Stresscoat in this region first cracked very close to the speed at which first Stresscoat cracking was observed on the vanes, that is, at 12,850 rpm. Figure 4 illustrates the Stresscoat cracking on the shroud. Figure 5 illustrates a vane trailing edge region. Figure 6 illustrates Stresscoat cracking on the backplate, on the flat and on the radii from the low pressure balance piston rub ring land, and also shows some coating loss that occurred at the highest test speed. Figure 7 illustrates Stresscoat cracking that was observed in the circumferential groove at the extreme O.D.

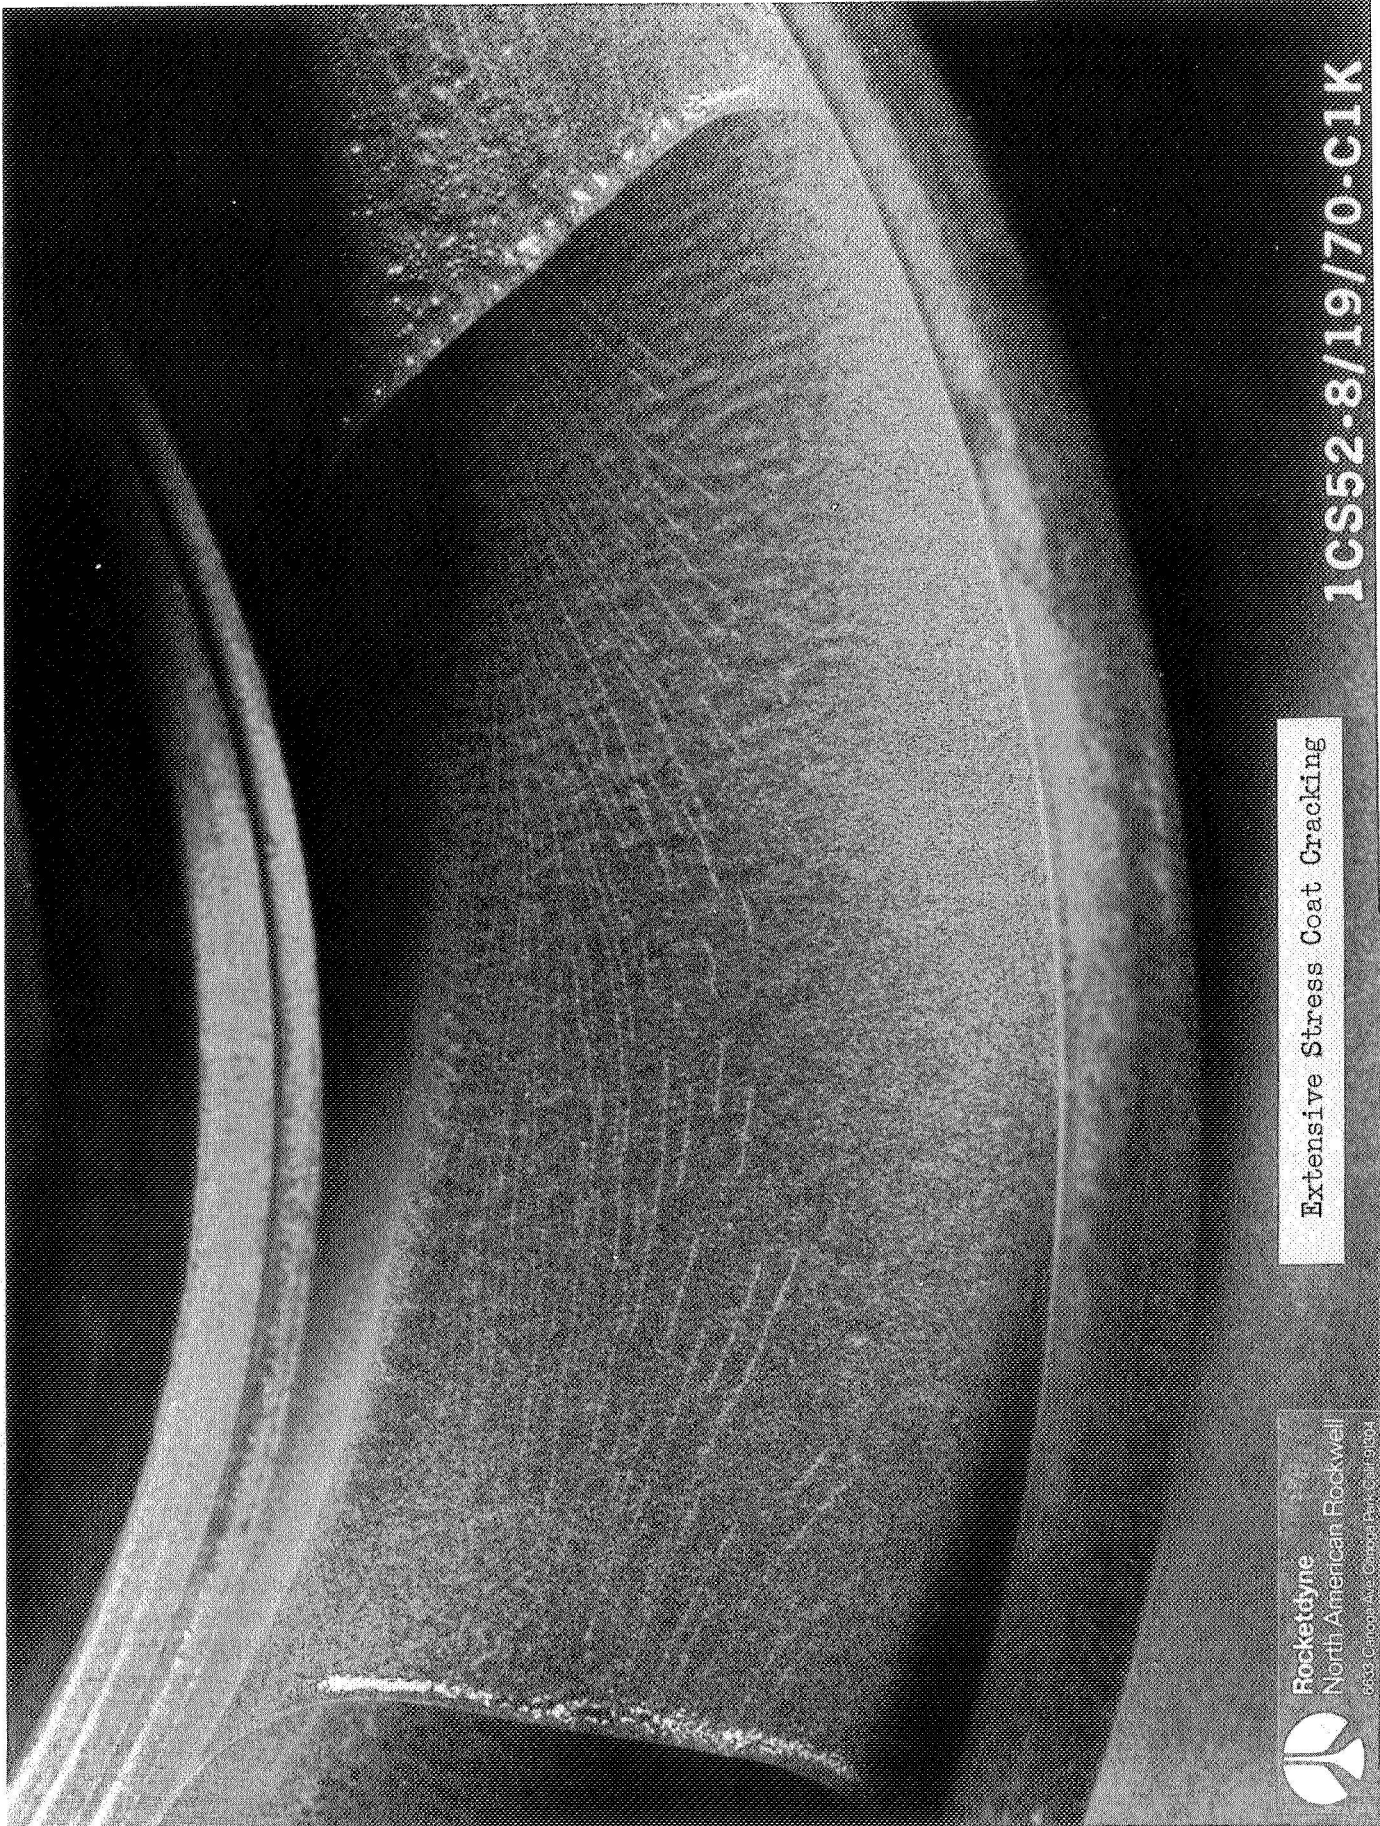
FIG. 2

Extensive Stress Coat Cracking

Detailed information was obtained regarding the magnitude, direction, and distribution of stress on the vanes. Figure 8 is a composite average of all seven vanes illustrating the stress boundaries that were observed due to the increasing speed increments, the stress values adjusted as the square of the speeds to an operating speed of 31,000 rpm. The direction of these stresses is normal to the crack pattern, best observed in Fig. 2.

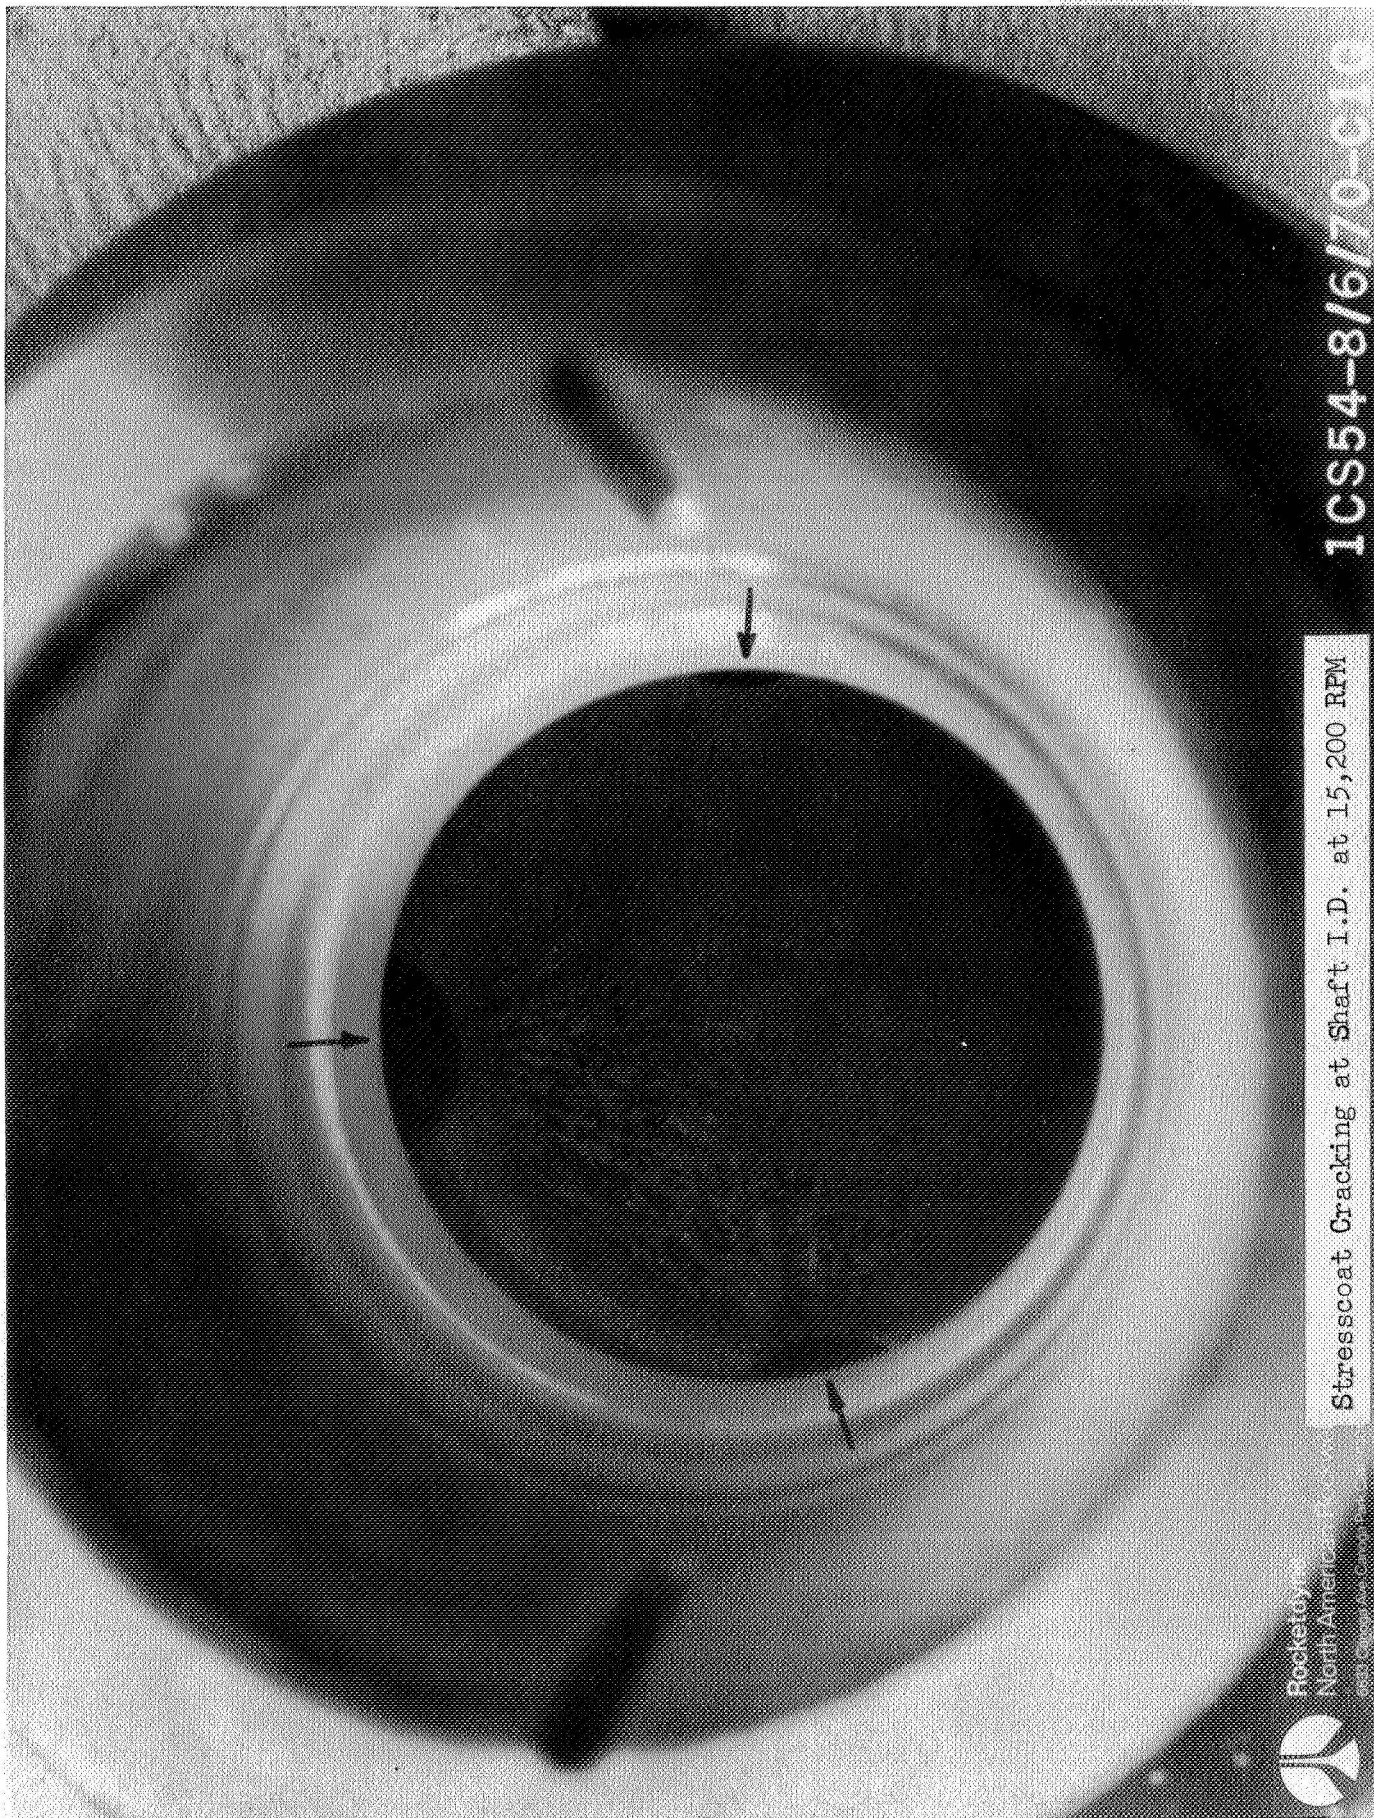
FIG. 3

Stresscoat Cracking at Shaft I.D. at 15,200 RPM

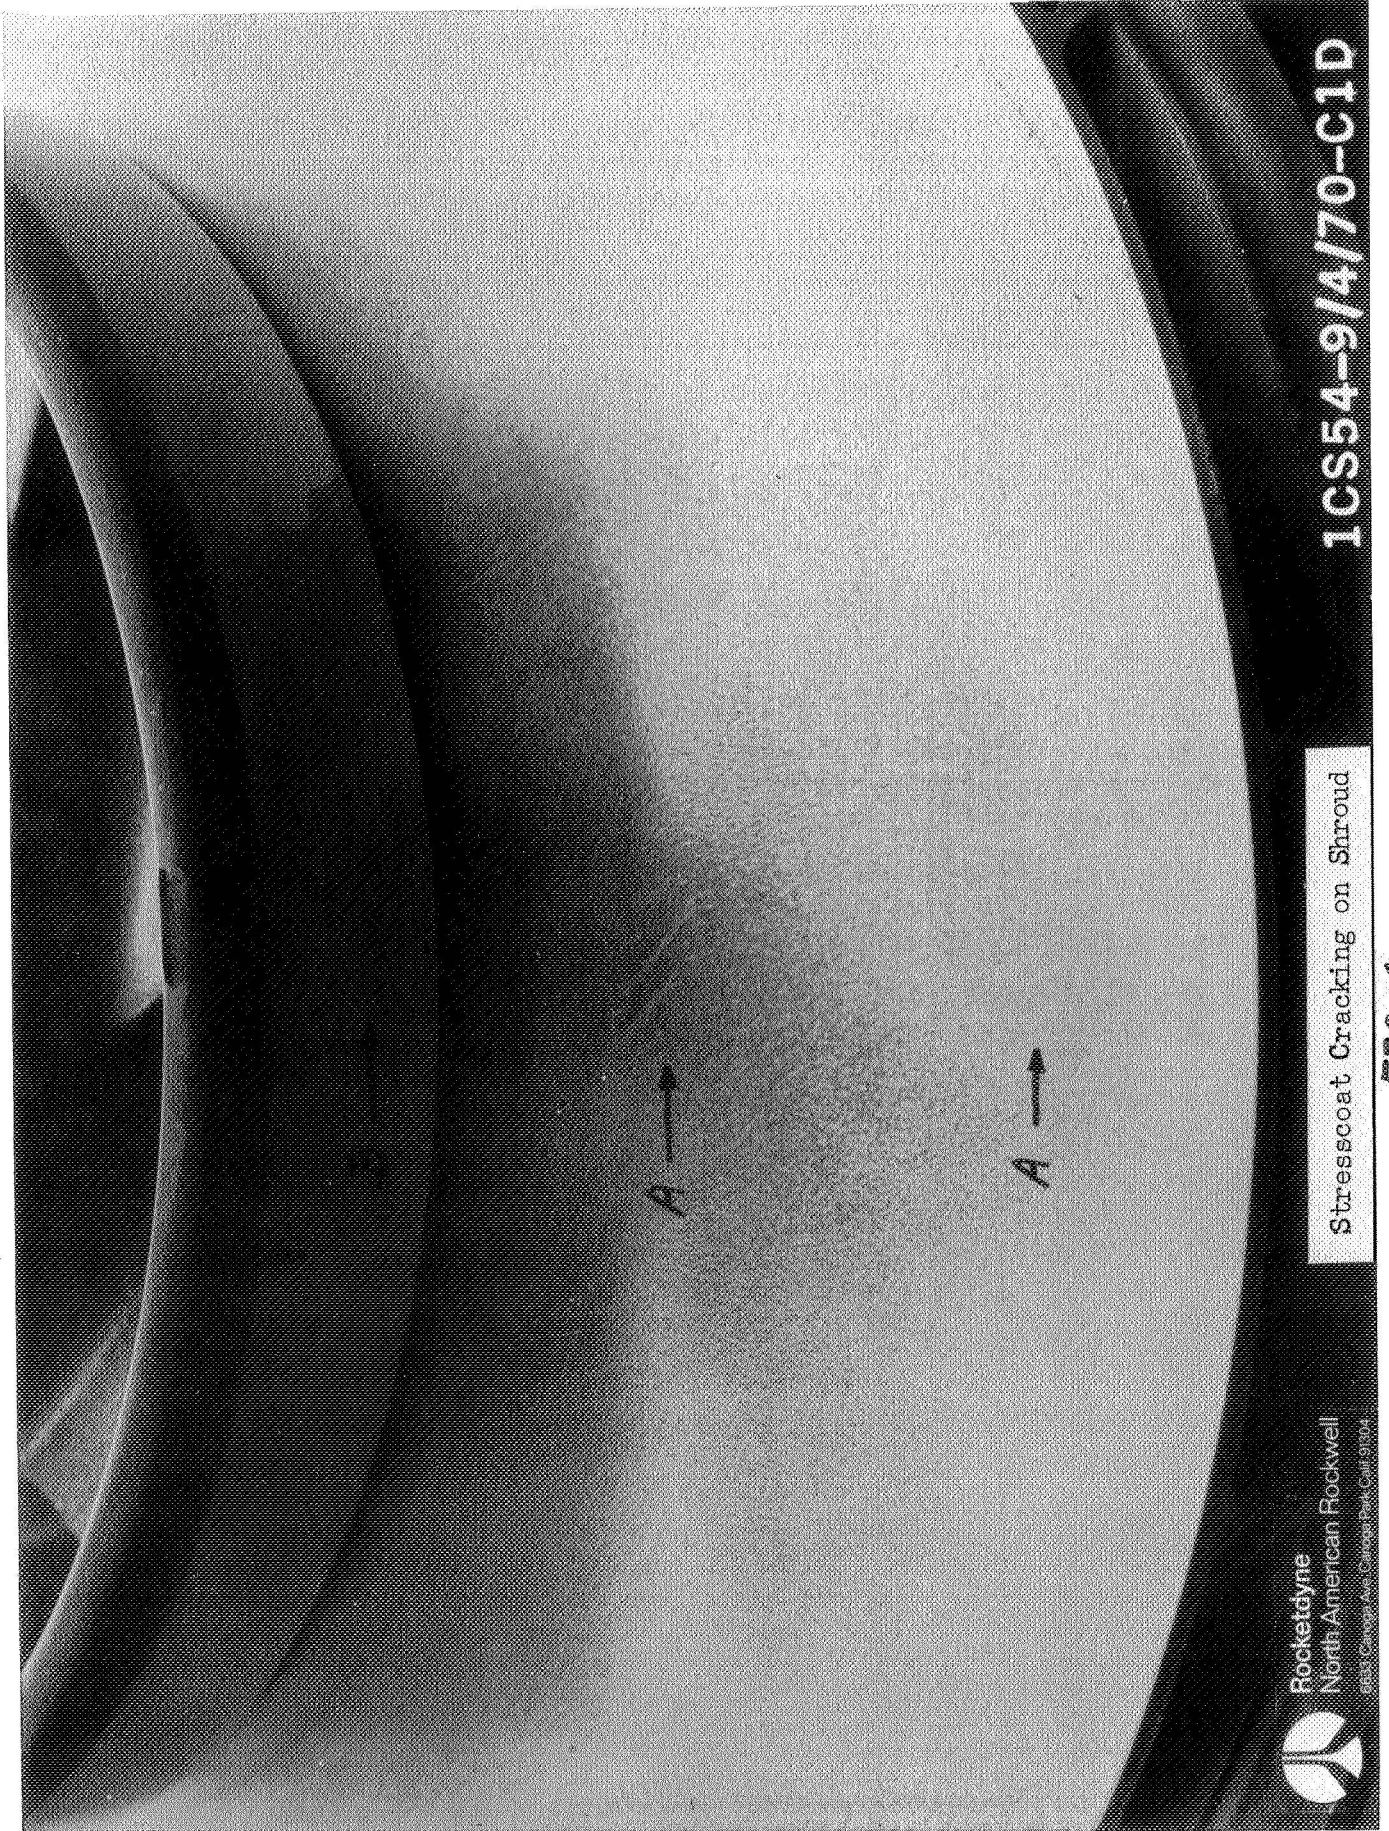
FIG. 4

Stresscoat Cracking on Shroud

34.6	On the shroud, both on the flat section and on the radius section. (Fig. 4, regions of cracks, noted by "A" arrows.)
28.0	On the backplate on the radius on both sides of the low pressure balance piston rub ring land. (Fig. 6, noted by "A" arrows.)

20.4	In the circumferential groove at the extreme O.D.--indication only. (Fig. 7, region of cracks.)  On the O.D. of the upper shroud. (Fig. 4, noted by "B" arrow.)  In the circumferential groove at the extreme O.D. (Fig. 7, region of cracks.)

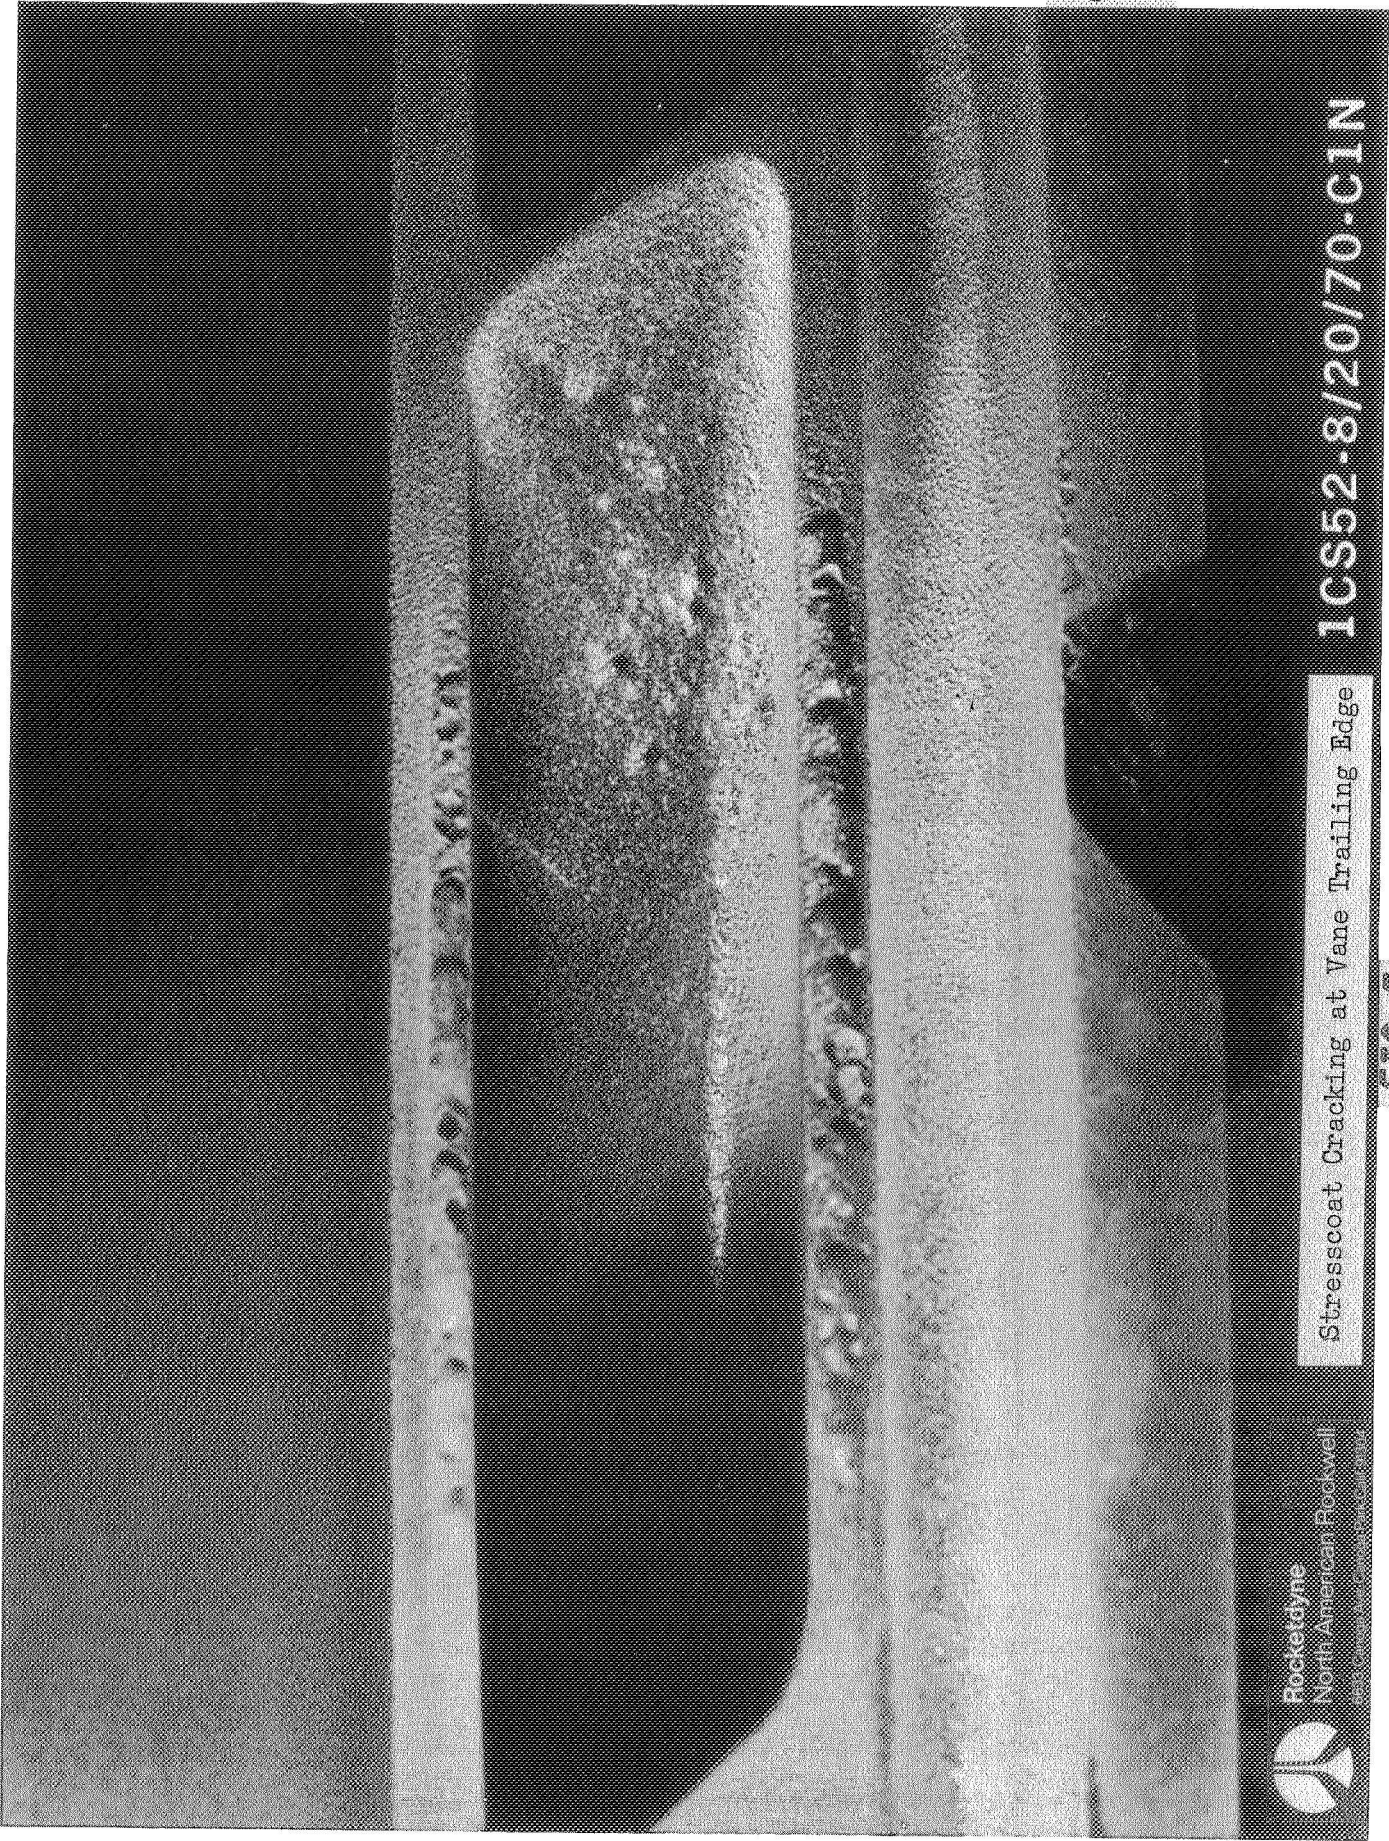
FIG. 5

Stresscoat Cracking at Vane Trailing Edge

24.9	At the vane trailing edge near the shroud. (Fig. 5, region of crack.)  On the backplate hub between the four balance piston holes and the low pressure balance piston rub ring land. (Fig. 6, noted by "B" arrows.)  On the flat part of the backplate. (Fig. 6, noted by "C" arrow.)

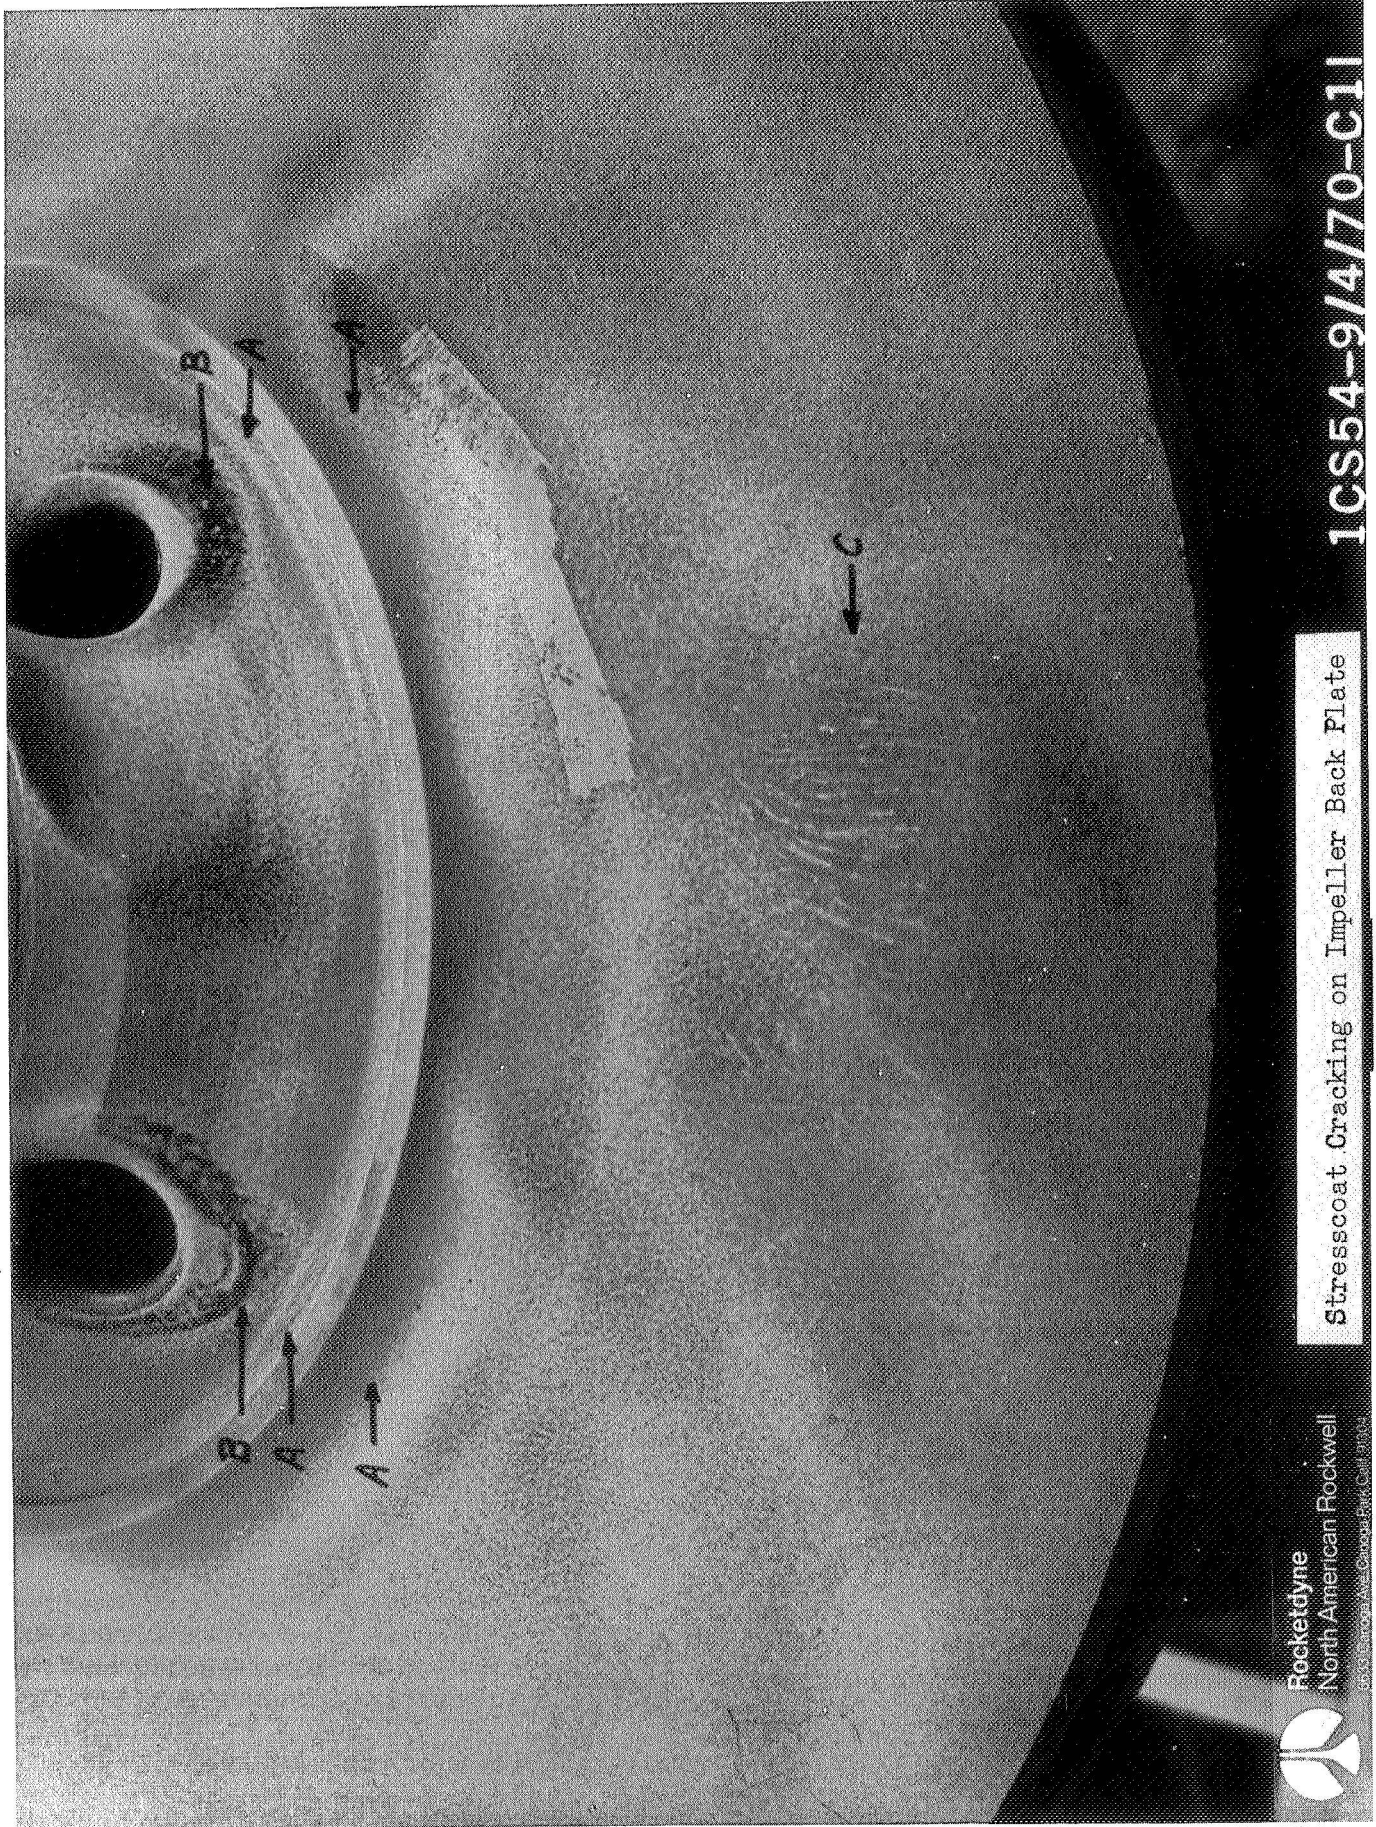
FIG. 6

Stresscoat Cracking on Impeller Back Plate

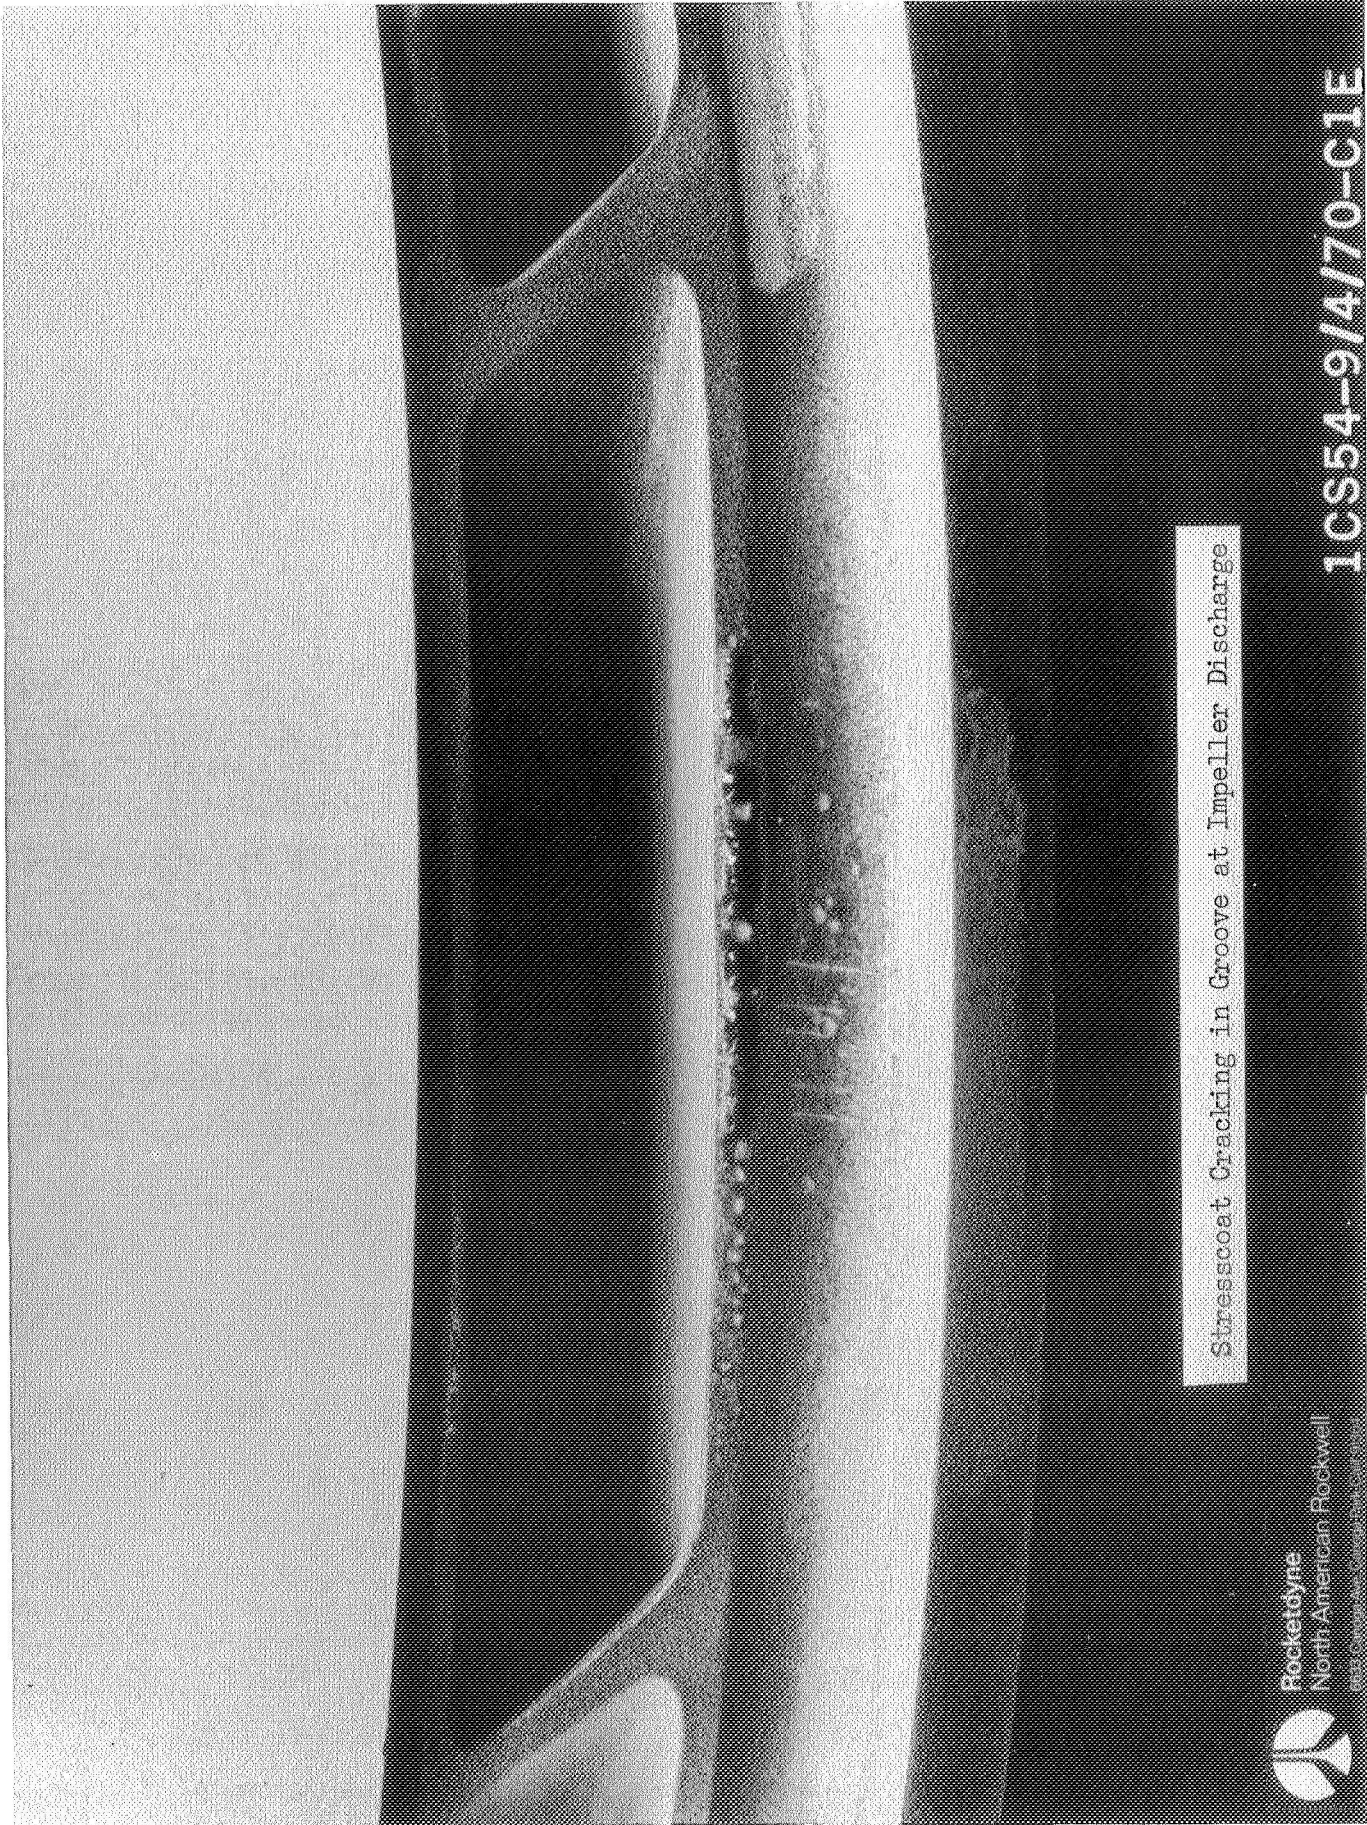
Stresscoat Cracking in Groove at Impeller Discharge

The threshold strain values from three bars were within  $\pm 5\%$ , remarkably close for this type of work. In addition, the impeller contained an area that could be used for "self-calibration" of the threshold strain. This was the circumferential groove at the extreme O.D. Using the stress results from a Rohm & Haas finite element program, there was a minor crack indication at the second highest speed, which would indicate a threshold strain somewhat above  $480 \mu\epsilon$ . Definite Stresscoat cracking occurred at the highest speed, Fig. 7, indicating a threshold strain less

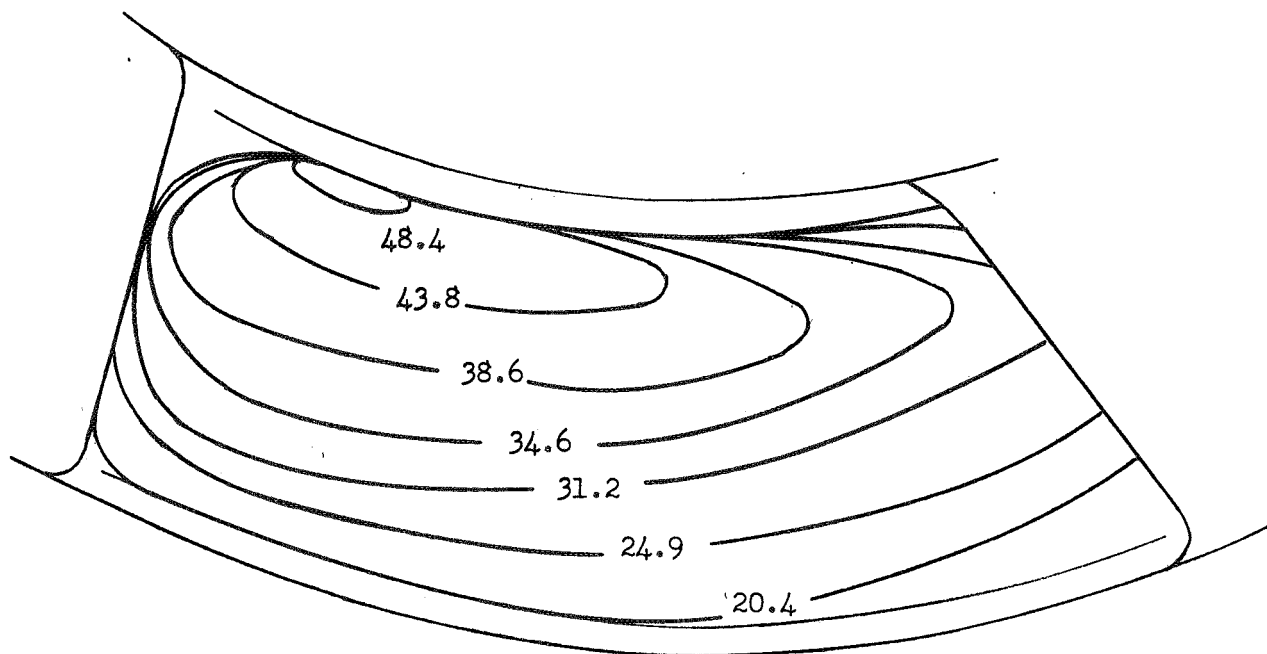
FIGURE 8

MAGNITUDE AND DISTRIBUTION OF VANE STRESSES  
ADJUSTED AS THE SQUARE OF THE SPEEDS  
TO 31,000 RPM OPERATING SPEED

Stress in Ksi

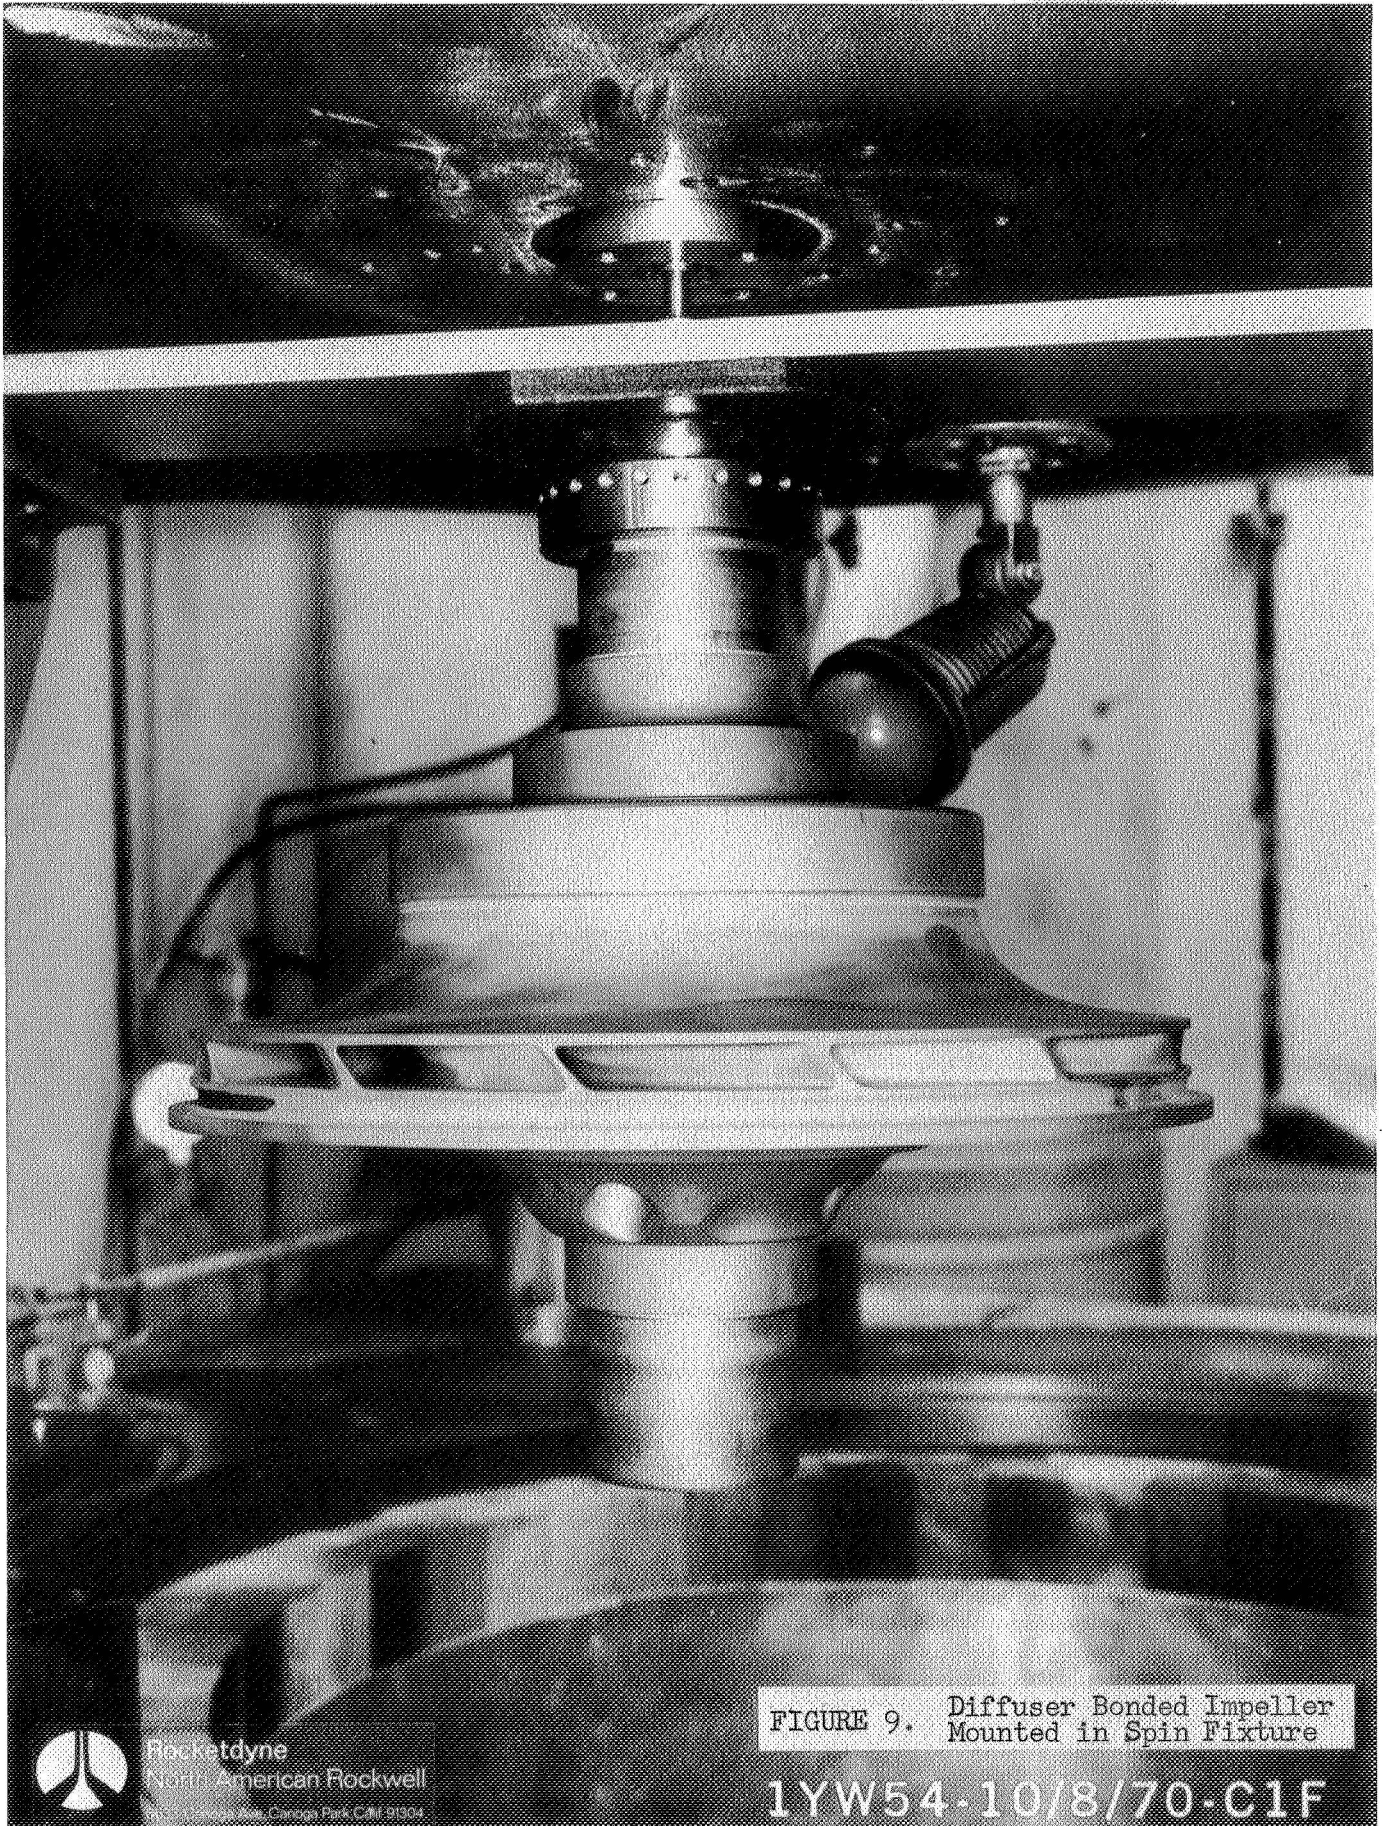
FIGURE 9. Diffuser Bonded Impeller Mounted in Spin Fixture

Figure 9 shows the diffusion bonded impeller mounted in the spin drive fixture ready to be lowered into the vacuum chamber. Figure 10 shows the impeller after the burst test at the bottom of the spin pit.
