TITANIUM PUMP IMPELLER TESTING

FINAL REPORT

ROCKETDYNE  
A DIVISION OF NORTH AMERICAN ROCKWELL CORPORATION

Contract NAS8-25860

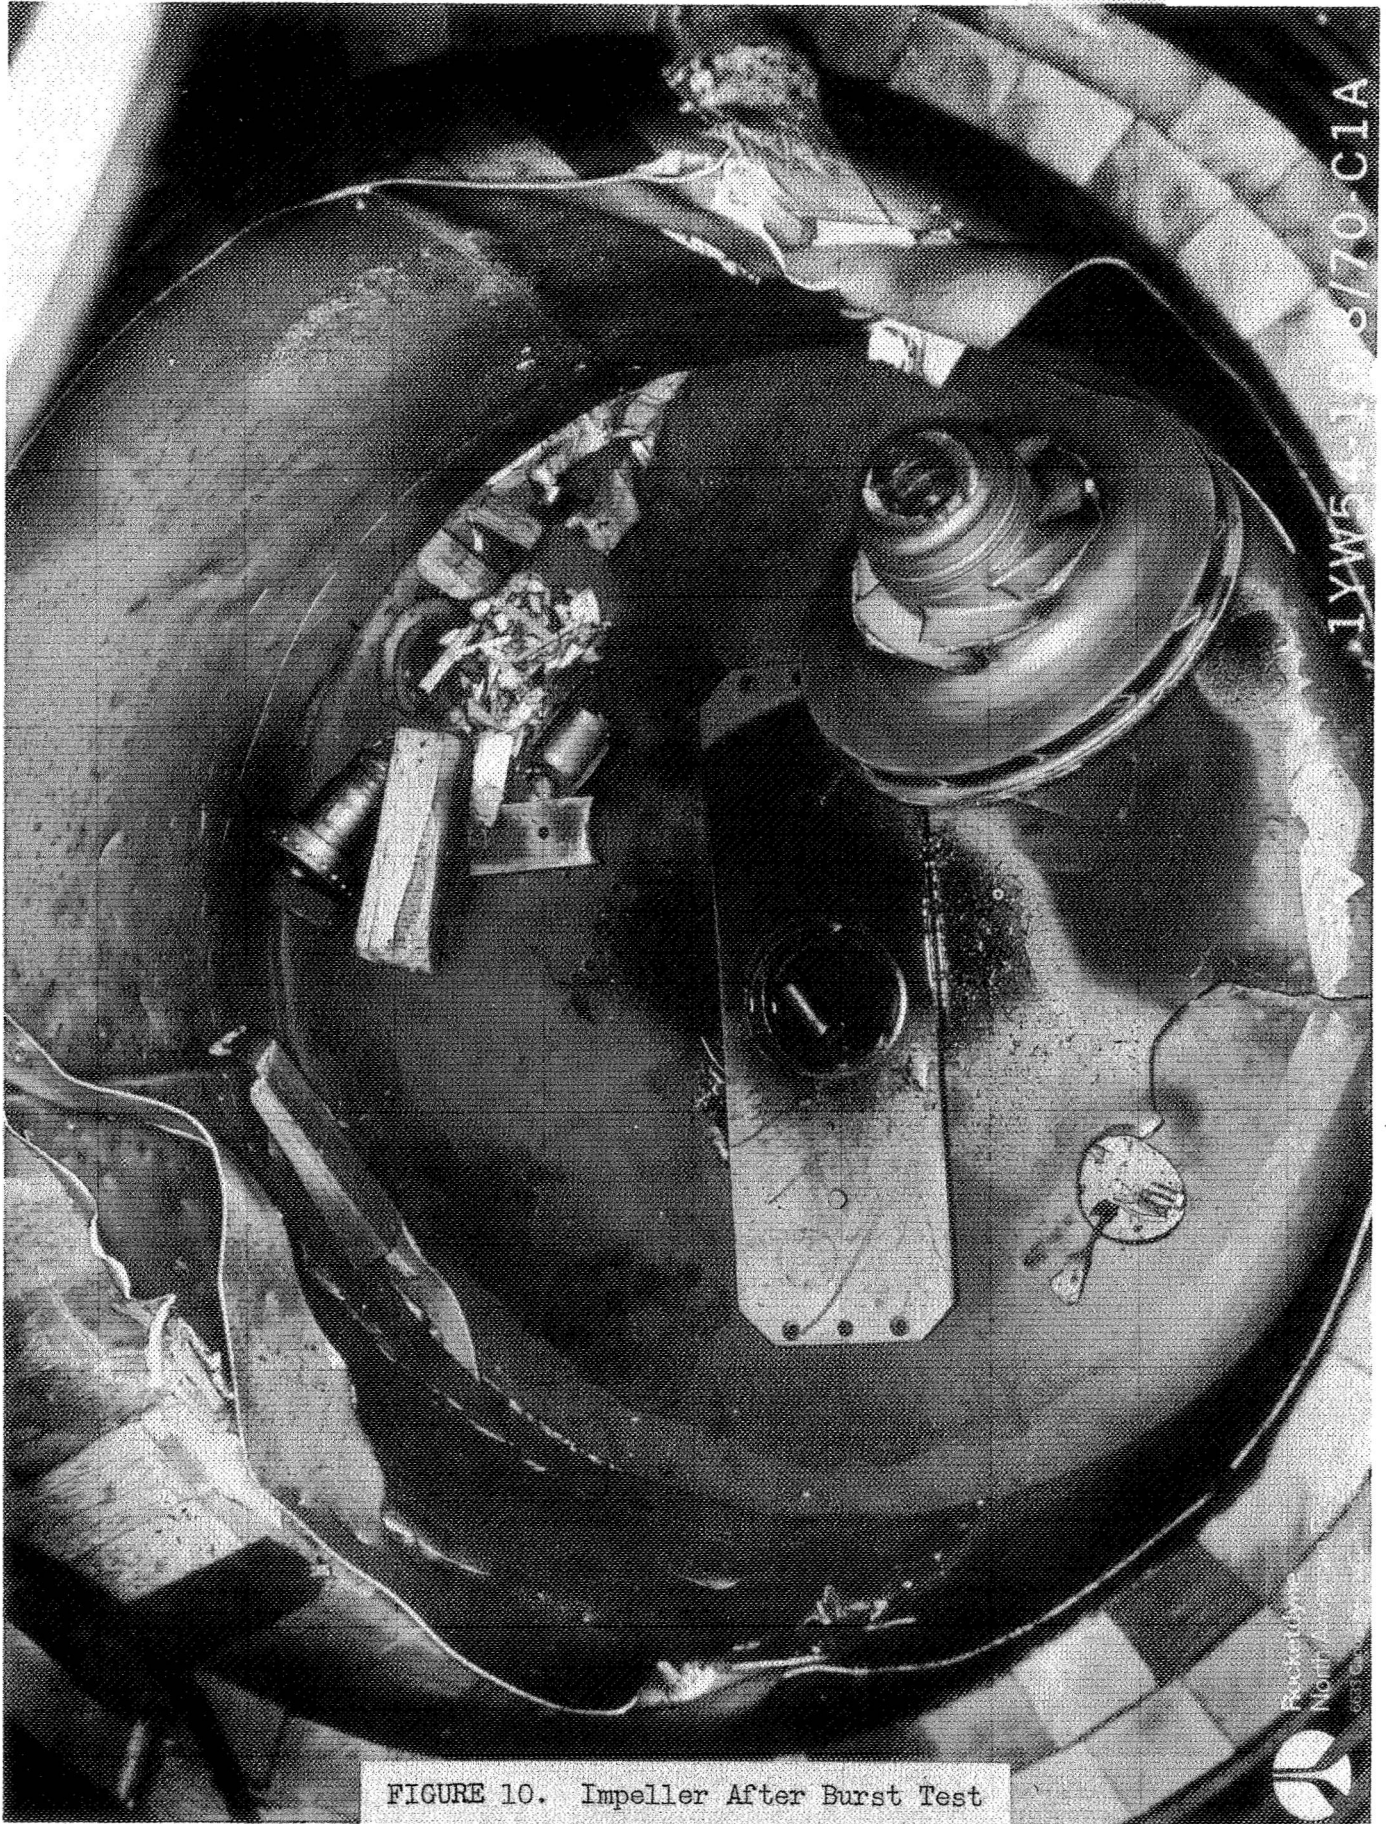
FIGURE 10. Impeller After Burst Test

Figure 9 shows the diffusion bonded impeller mounted in the spin drive fixture ready to be lowered into the vacuum chamber. Figure 10 shows the impeller after the burst test at the bottom of the spin pit.

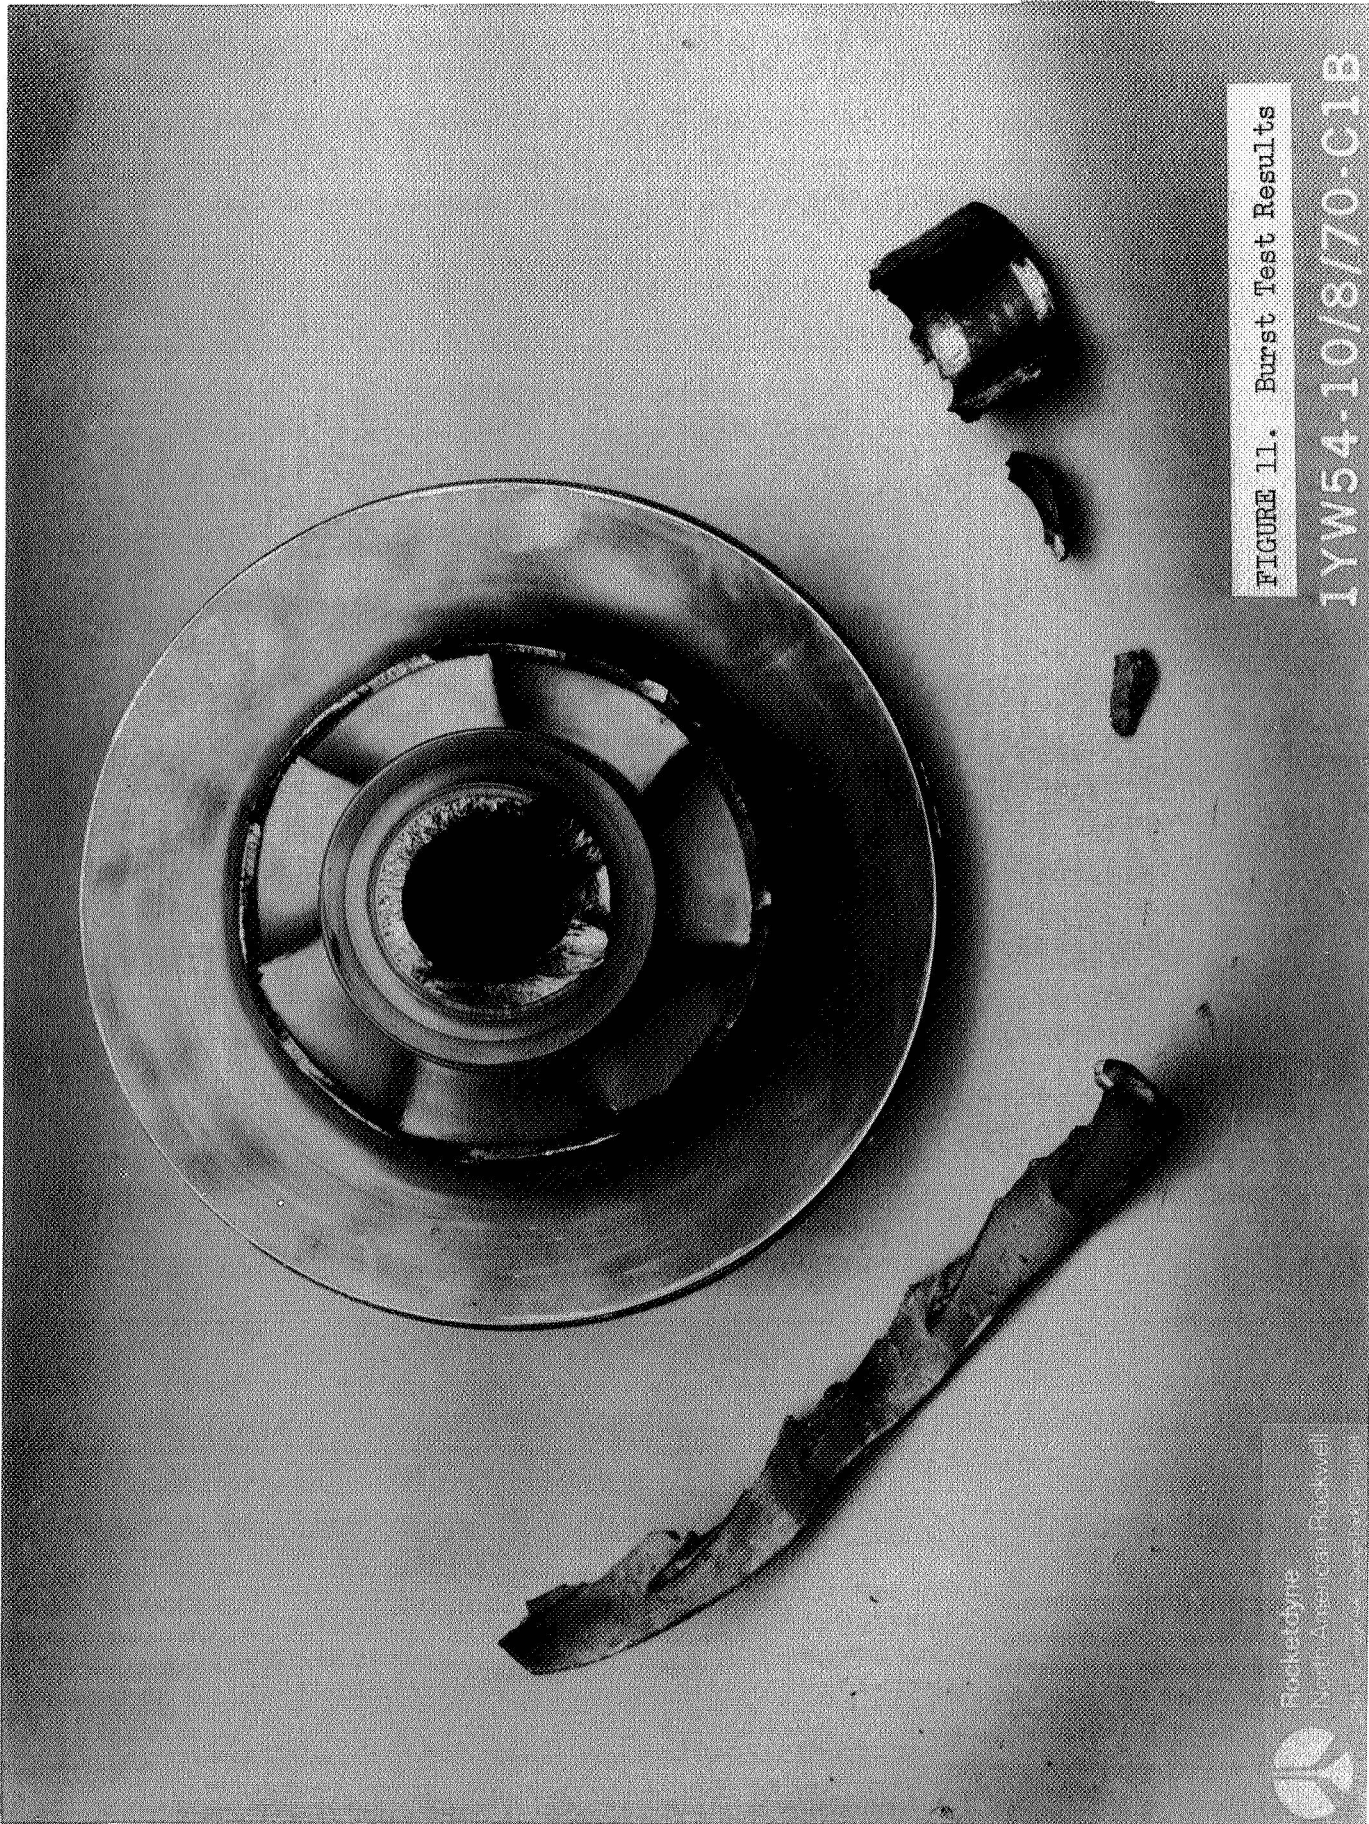
FIGURE 11. Burst Test Results

The primary mode of failure was separation of the shroud along the diffusion bond line in the impeller inlet region as shown in Fig. 11. The forward portion of the impeller shaft was broken off as a result of dropping the impeller in the spin pit after the primary failure occurred.

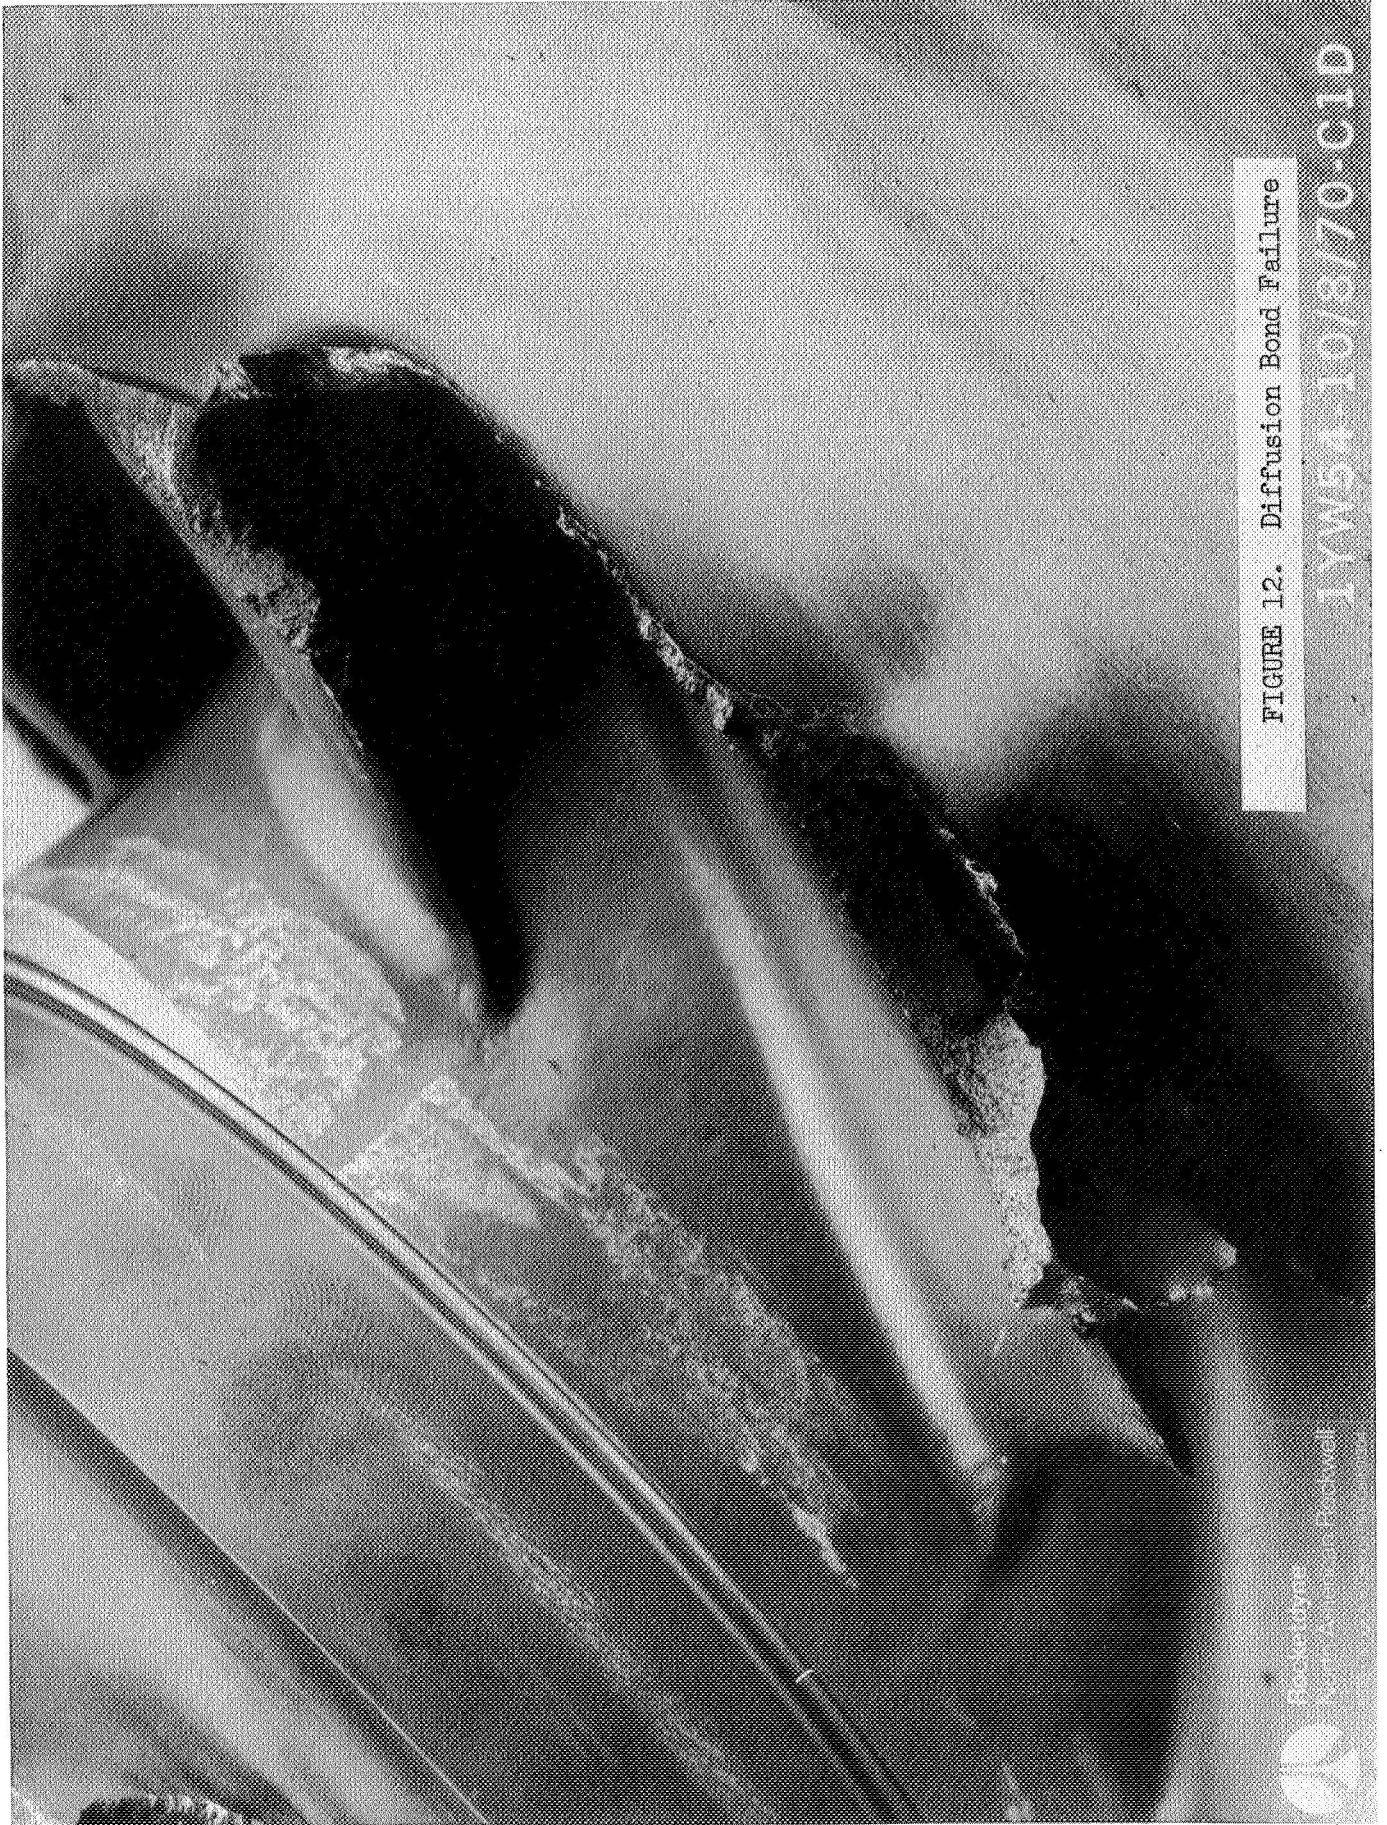
FIGURE 12. Diffusion Bond Failure

Examination of the diffusion bond failure indicated regions of poor bonding as shown in Fig. 12. Magnification of these regions revealed machining marks on the vanes as shown in Fig. 13. Extrapolation of the Stresscoat test data indicated that the stress at the failure location was 51,000 psi at the failure speed. This is well below the parent material room temperature minimum ultimate strength of 100,000 psi. At the highest stressed region of the vane, however, (vane to hub junction) the diffusion bond withstood an equivalent elastic stress of 121,000 psi as determined from the Stresscoat test data. This strength comparison, together with the examination of the bond failure, indicates that the

shroud to vane joint had areas of poor to intermittent bonding. This condition was not indicated at the bond surfaces by pre-test penetrant inspection. The imperfect bond would have the same effect as an initial crack, and would result in premature bond failure.

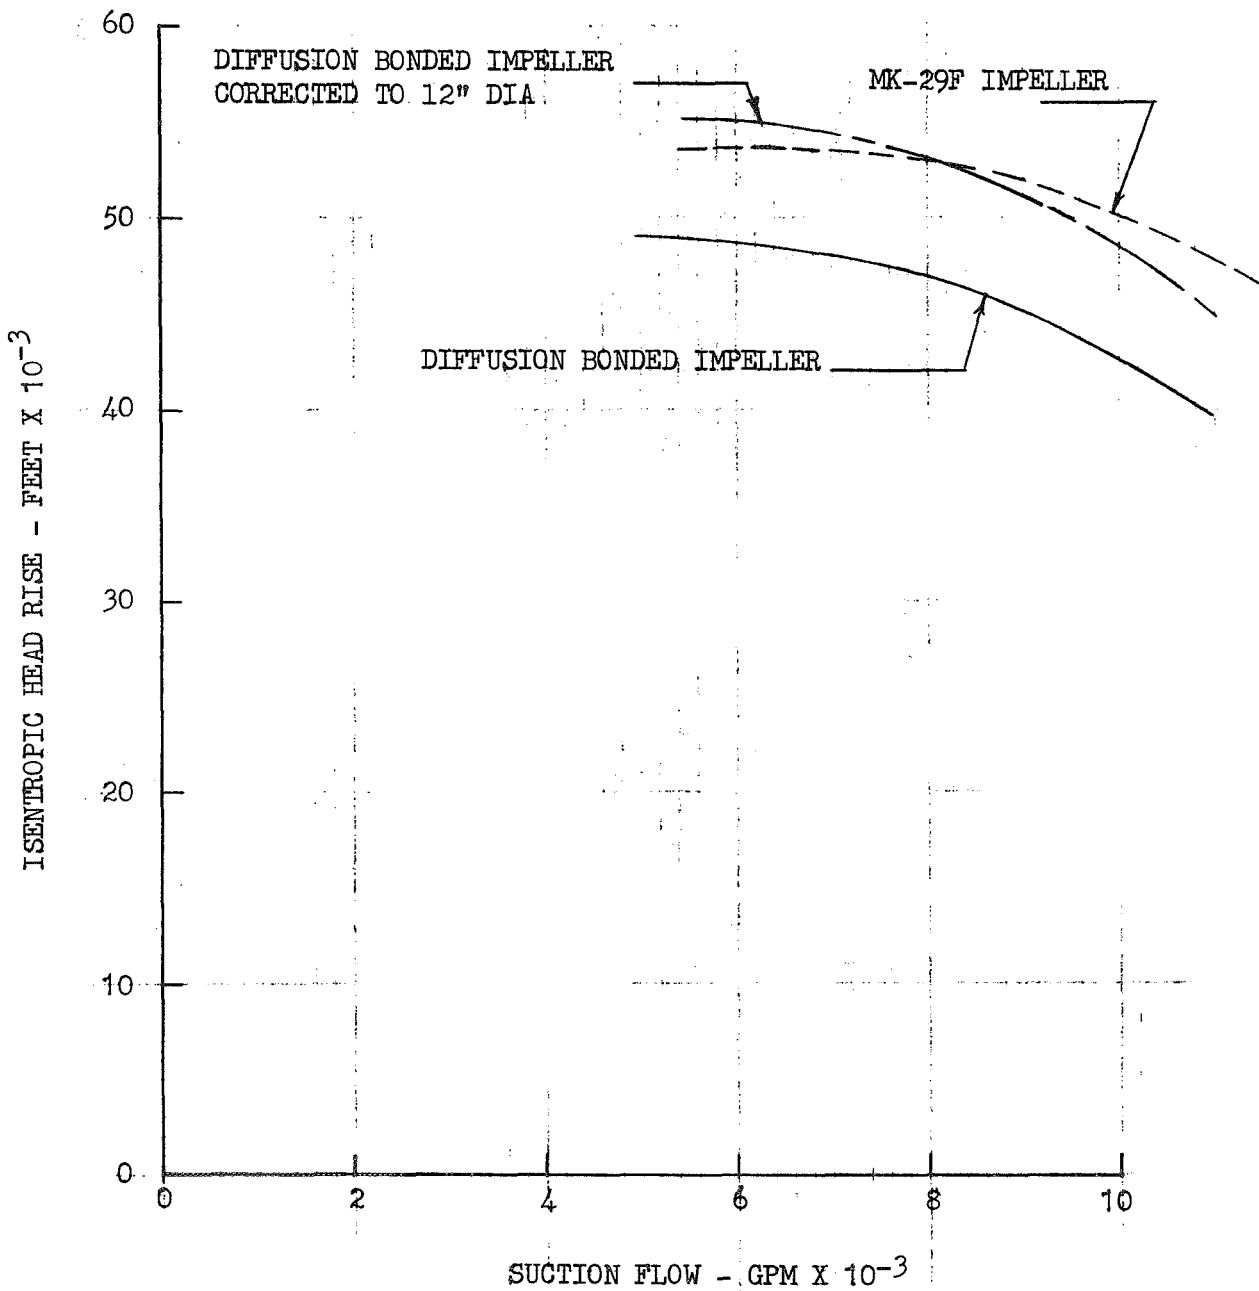
FIGURE 14

PREDICTED MK-29F PUMP PERFORMANCE  
WITH MARK 29F IMPELLER & DIFFUSION  
BONDED TITANIUM IMPELLER USING THE  
CENTRIFUGAL PUMP LOSS ISOLATION PROGRAM (MODIFIED)

N = 28,000 RPM

The results of this calculation are shown in Fig. 14. Also shown in Fig. 14 is the predicted performance of the Mark 29F impeller and the predicted performance of the diffusion bonded impeller corrected to the 12 inch design diameter. Because of the diffuser mismatch and the difference in the number of vanes between the two impellers, Fig. 14 does not present a true representation of the effects of the reduction in  $B_2$  angle. In order to show the effect of the  $B_2$  parameter calculations were made on a Mark 29F impeller using the loss isolation program and varying only the  $B_2$  angle with a matched diffuser. This data is presented in Fig. 15 and shows H-Q characteristics of (1) a Mark 29F  $60^\circ$   $B_2$  angle impeller, (2) a Mark 29F impeller with  $37^\circ$   $B_2$  angle and (3) a Mark 29F impeller with  $37^\circ$   $B_2$  angle corrected to a 12 inch diameter.

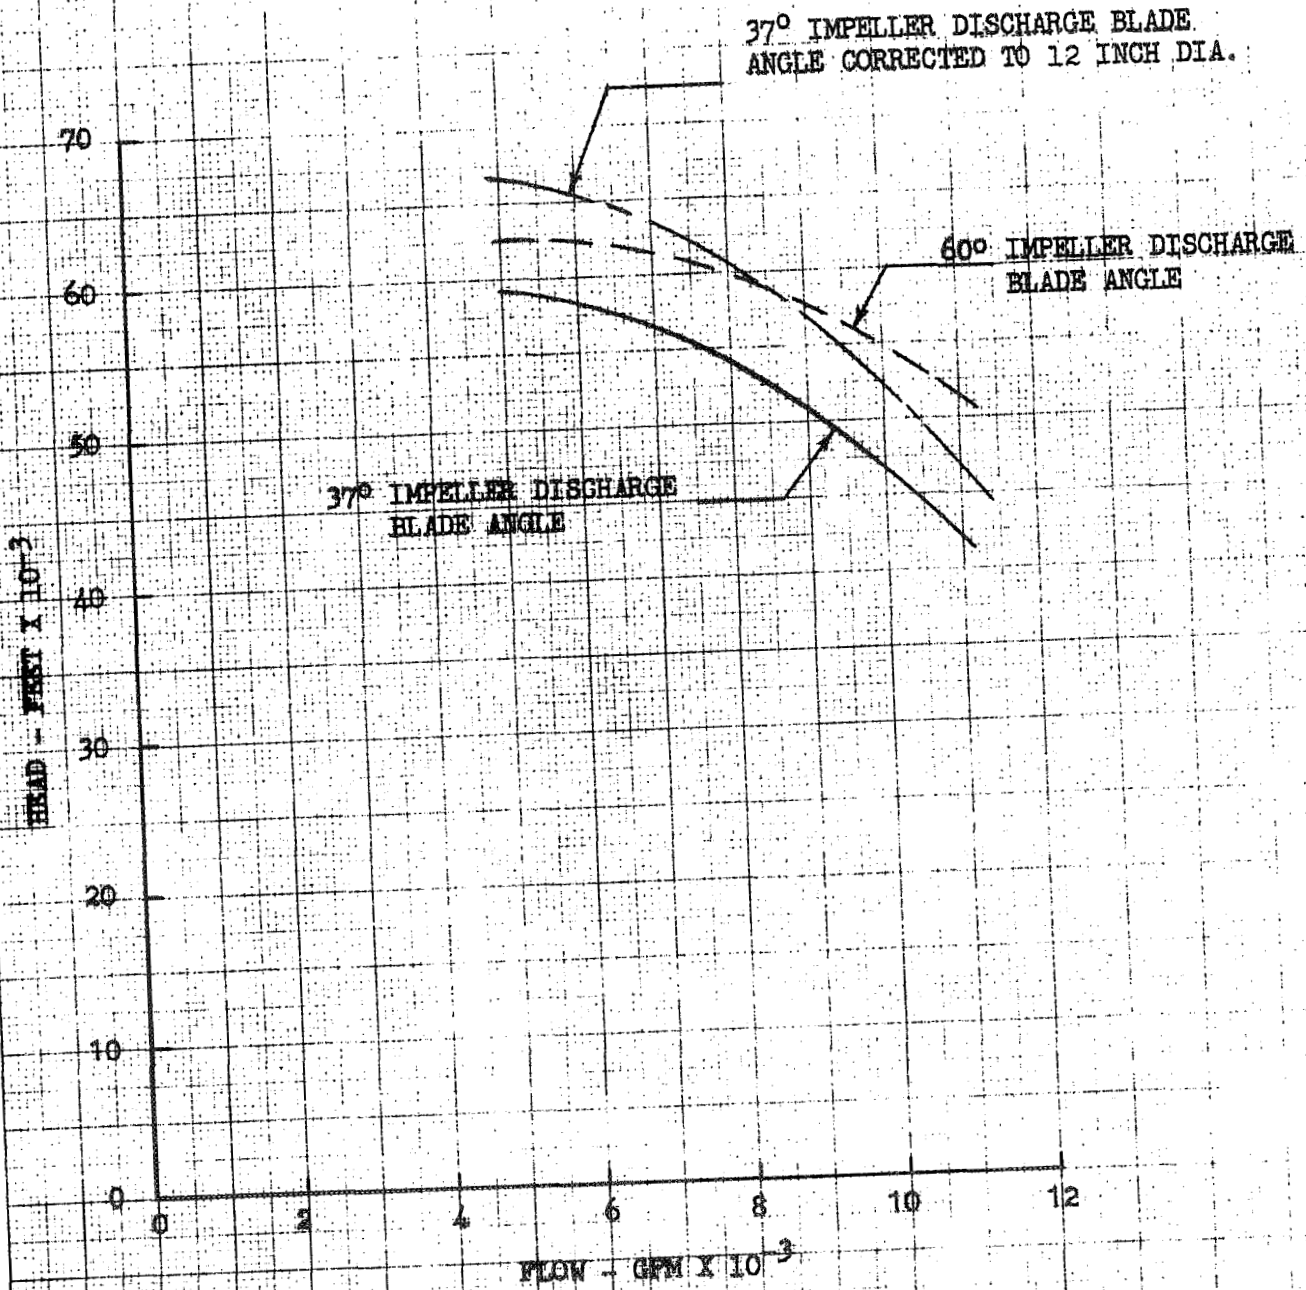
FIGURE 15

PREDICTED MK-29F PUMP PERFORMANCE  
USING THE CENTRIFUGAL PUMP LOSS  
ISOLATION PROGRAM

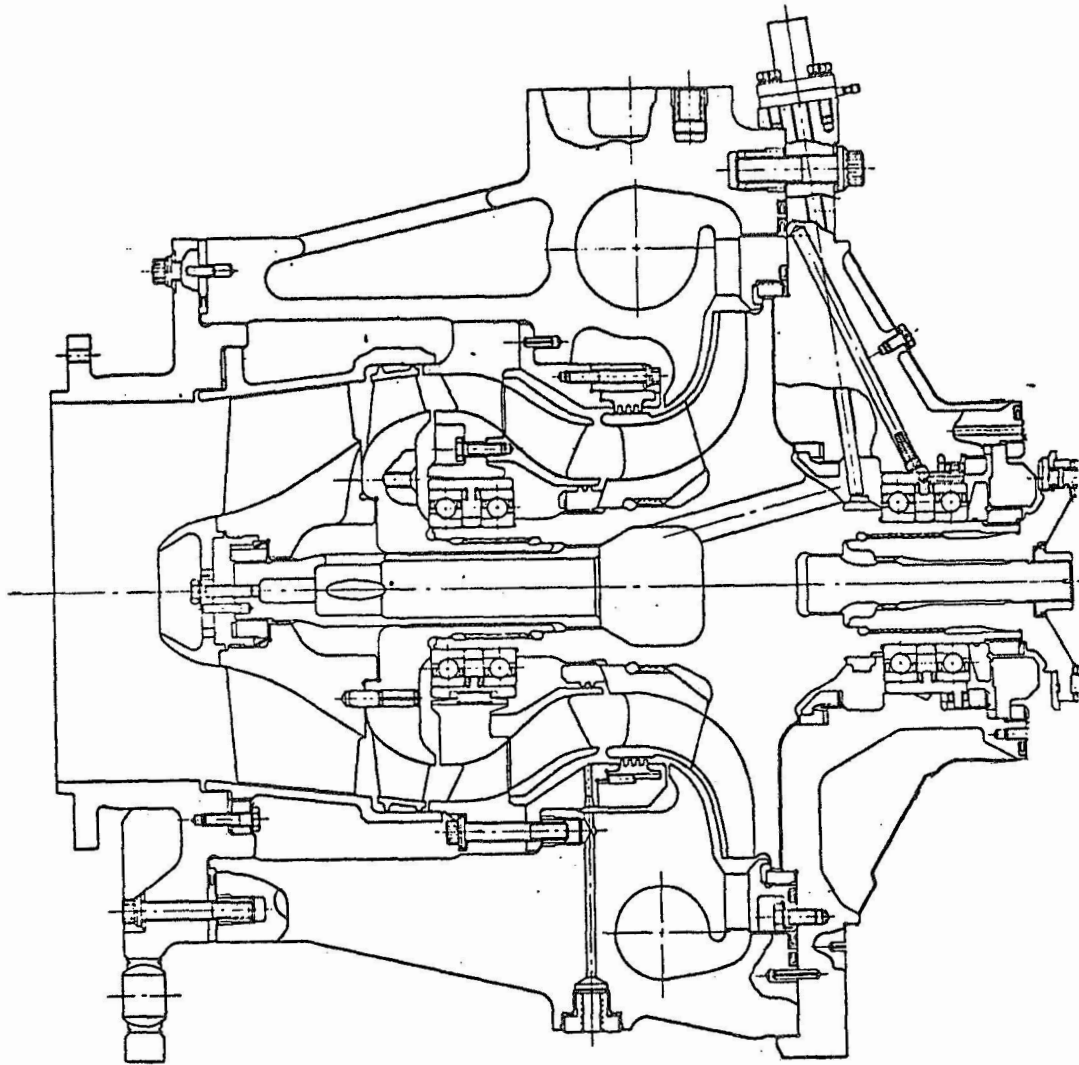
FIGURE 16

MK-29 FUEL PUMP

After the diffusion bonded impeller was assembled in the Mark 29F pump, a cross section of which is shown in Fig. 16, the pump was installed in Cell 3B of test facility CTL5.

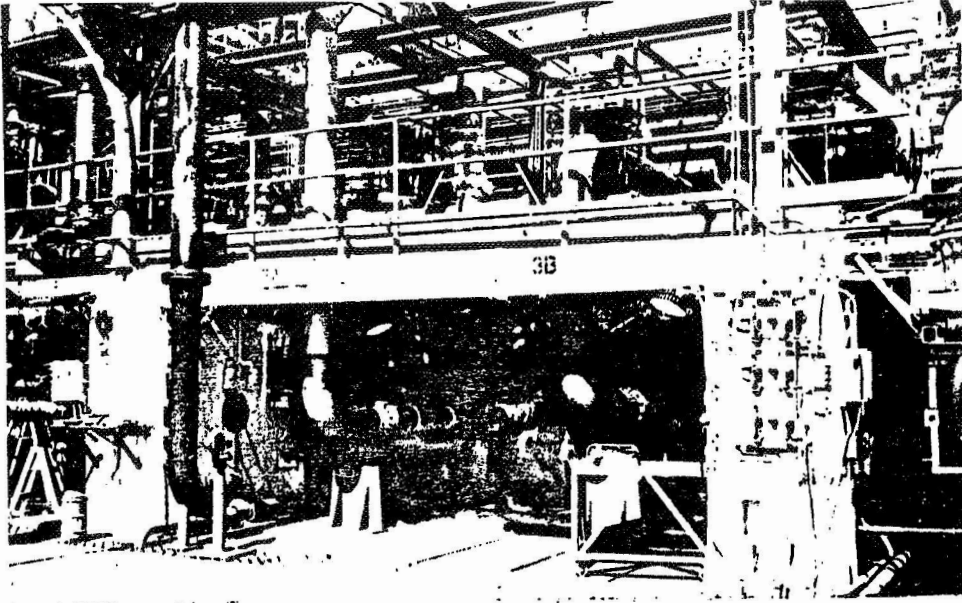
Figure 17. Liquid Hydrogen Pump Test Cell-3B at CTL-5

Cell 3B is shown in Fig. 17 and the cell flow circuit is shown in Fig. 18. The circuit includes two 20,000 gallon, 110 psi tanks. For extended operation, the flow mode is from the run tank through 10 inch vacuum-jacketed lines to the pump. The fluid returns by 10 inch ducting and flows to a heat exchanger in the catch tank (boil off is vented to a stack) and is then returned to the run tank. To minimize tanking interference an off-site fill point is plumbed to a 45,000 gallon liquid hydrogen storage vessel. Electric drive power is supplied by a variable speed, synchronous motor generator drive system of 17,500 horsepower. This system drives the Cell 3B gear box.

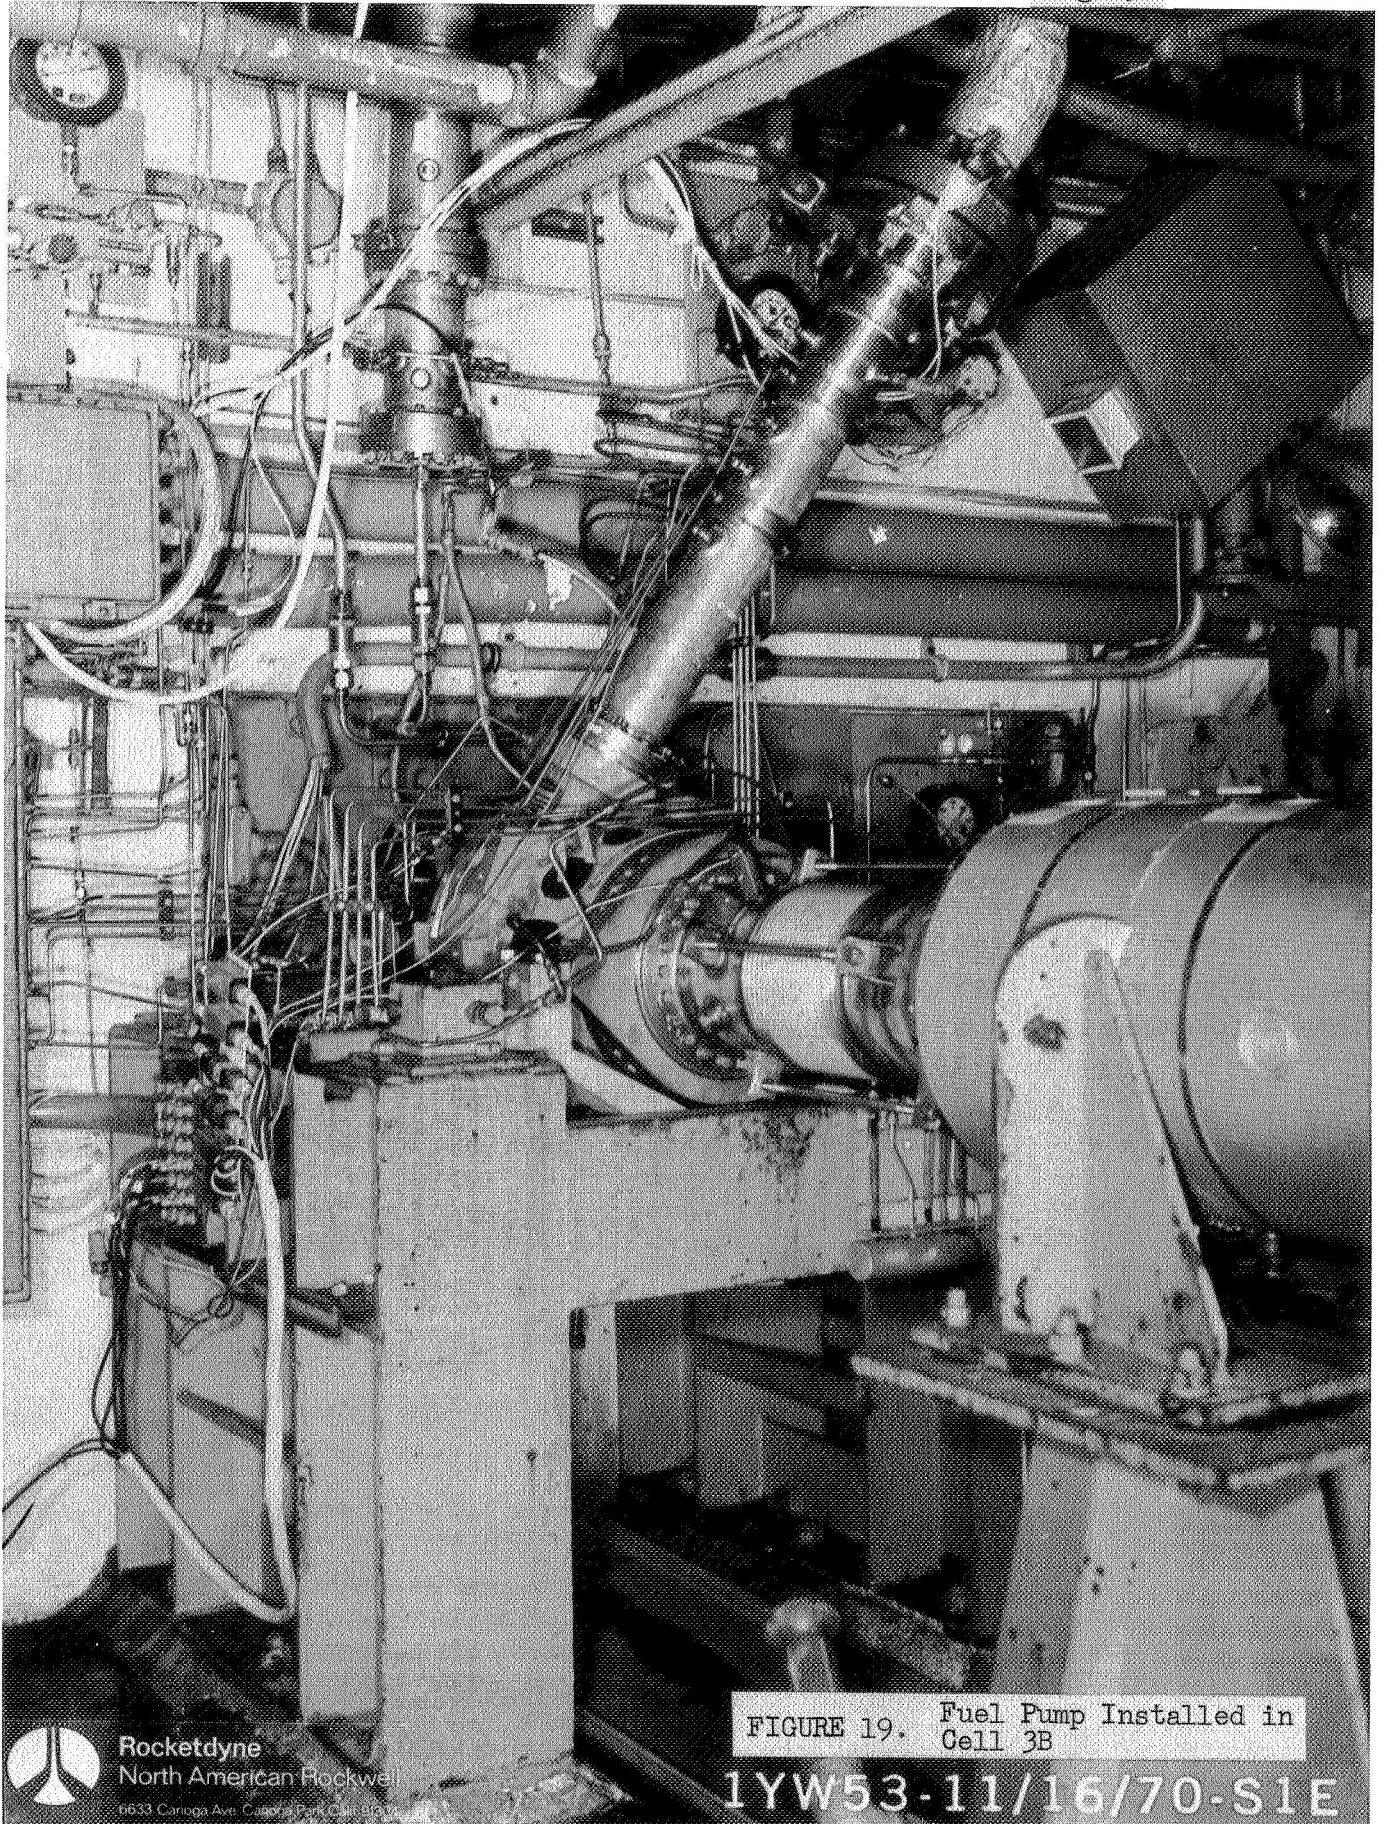
FIGURE 19. Fuel Pump Installed in Cell 3B

Mark 29 fuel pump S/N R004-2 with the diffusion bonded impeller is shown installed in Cell 3B in Fig. 19 and 20.

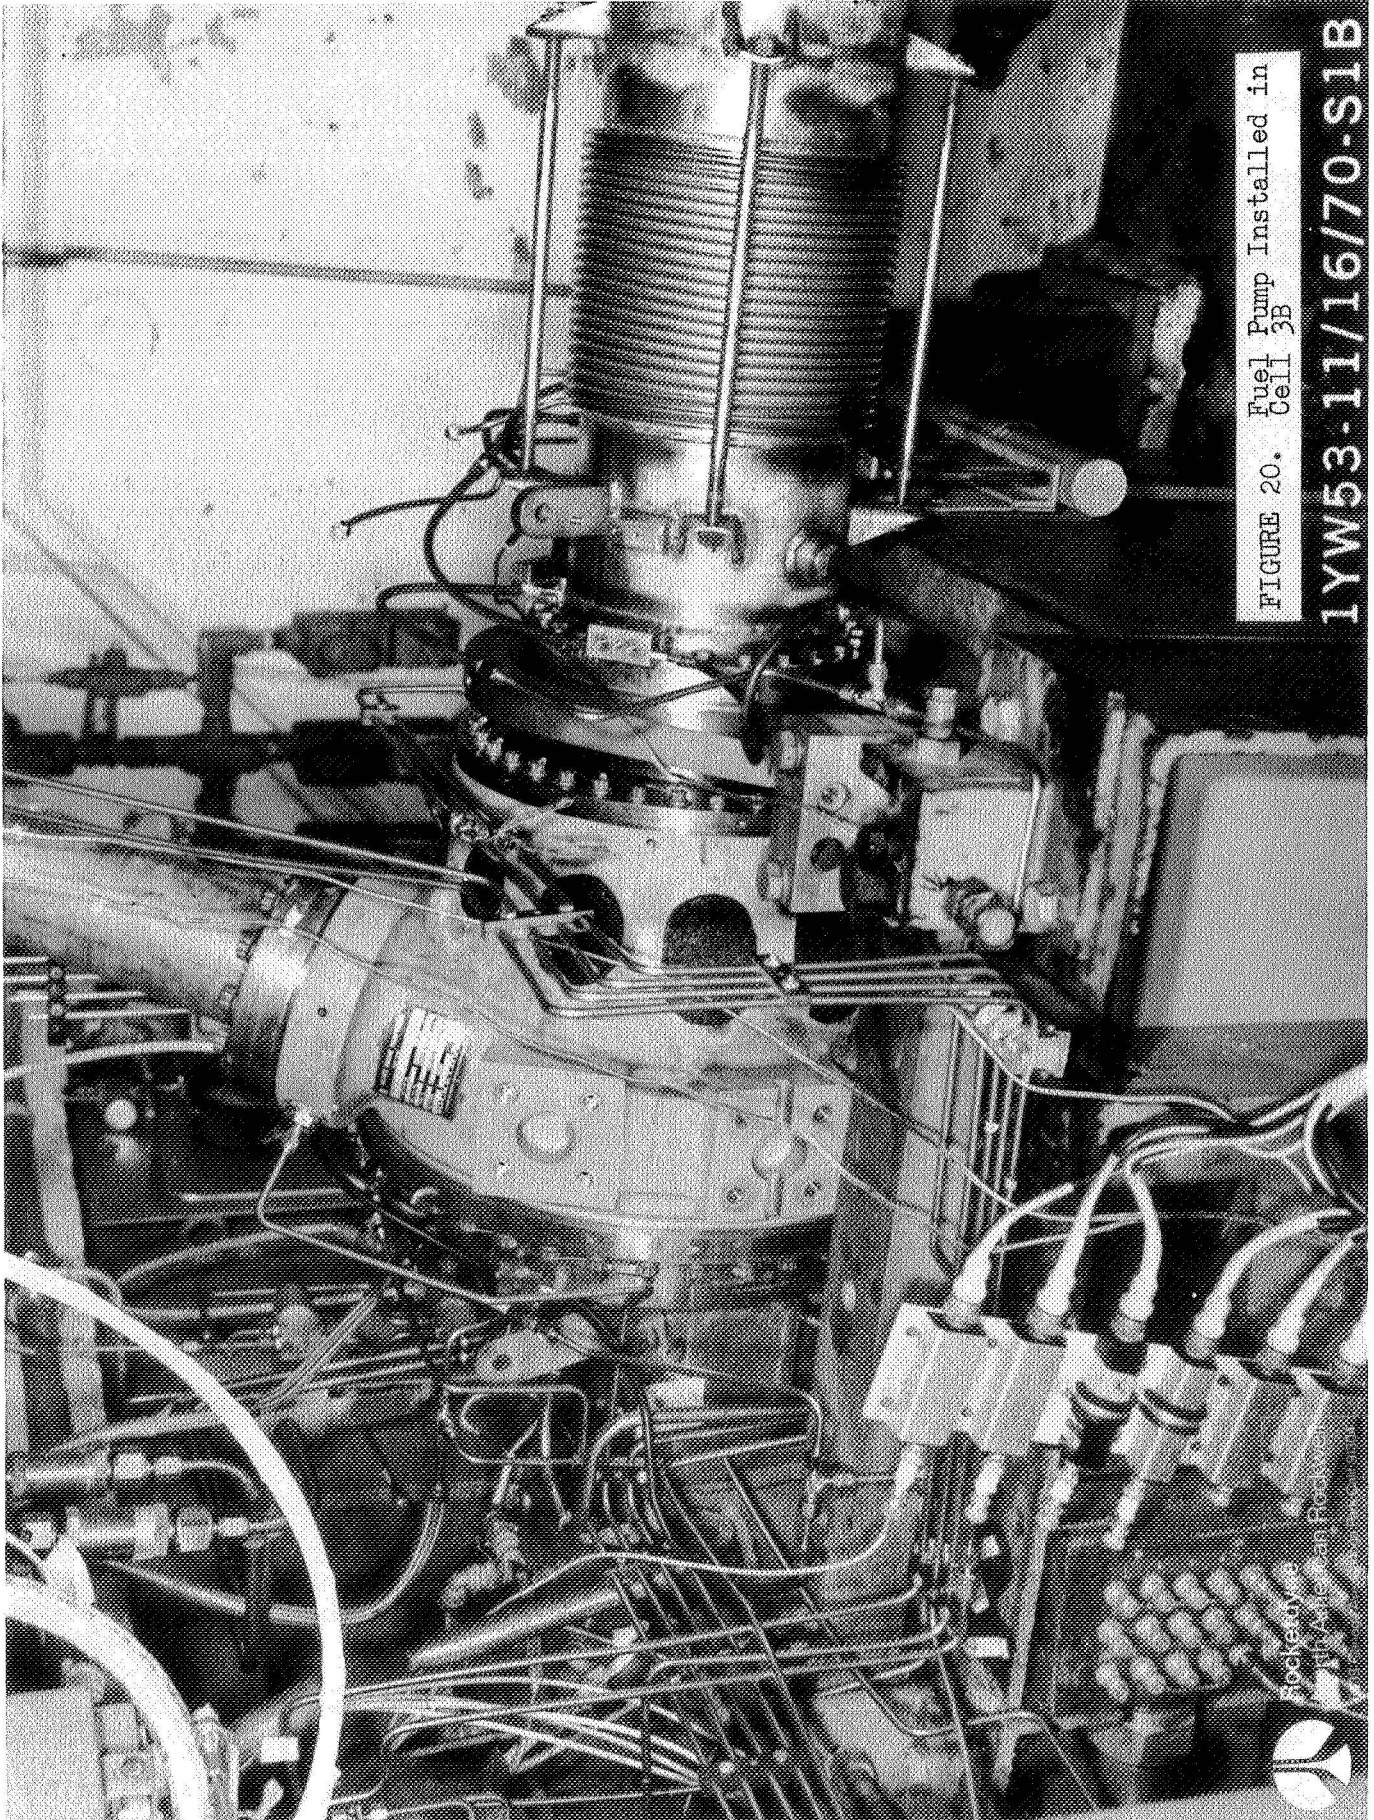
FIGURE 20. Fuel Pump Installed in Cell 3B

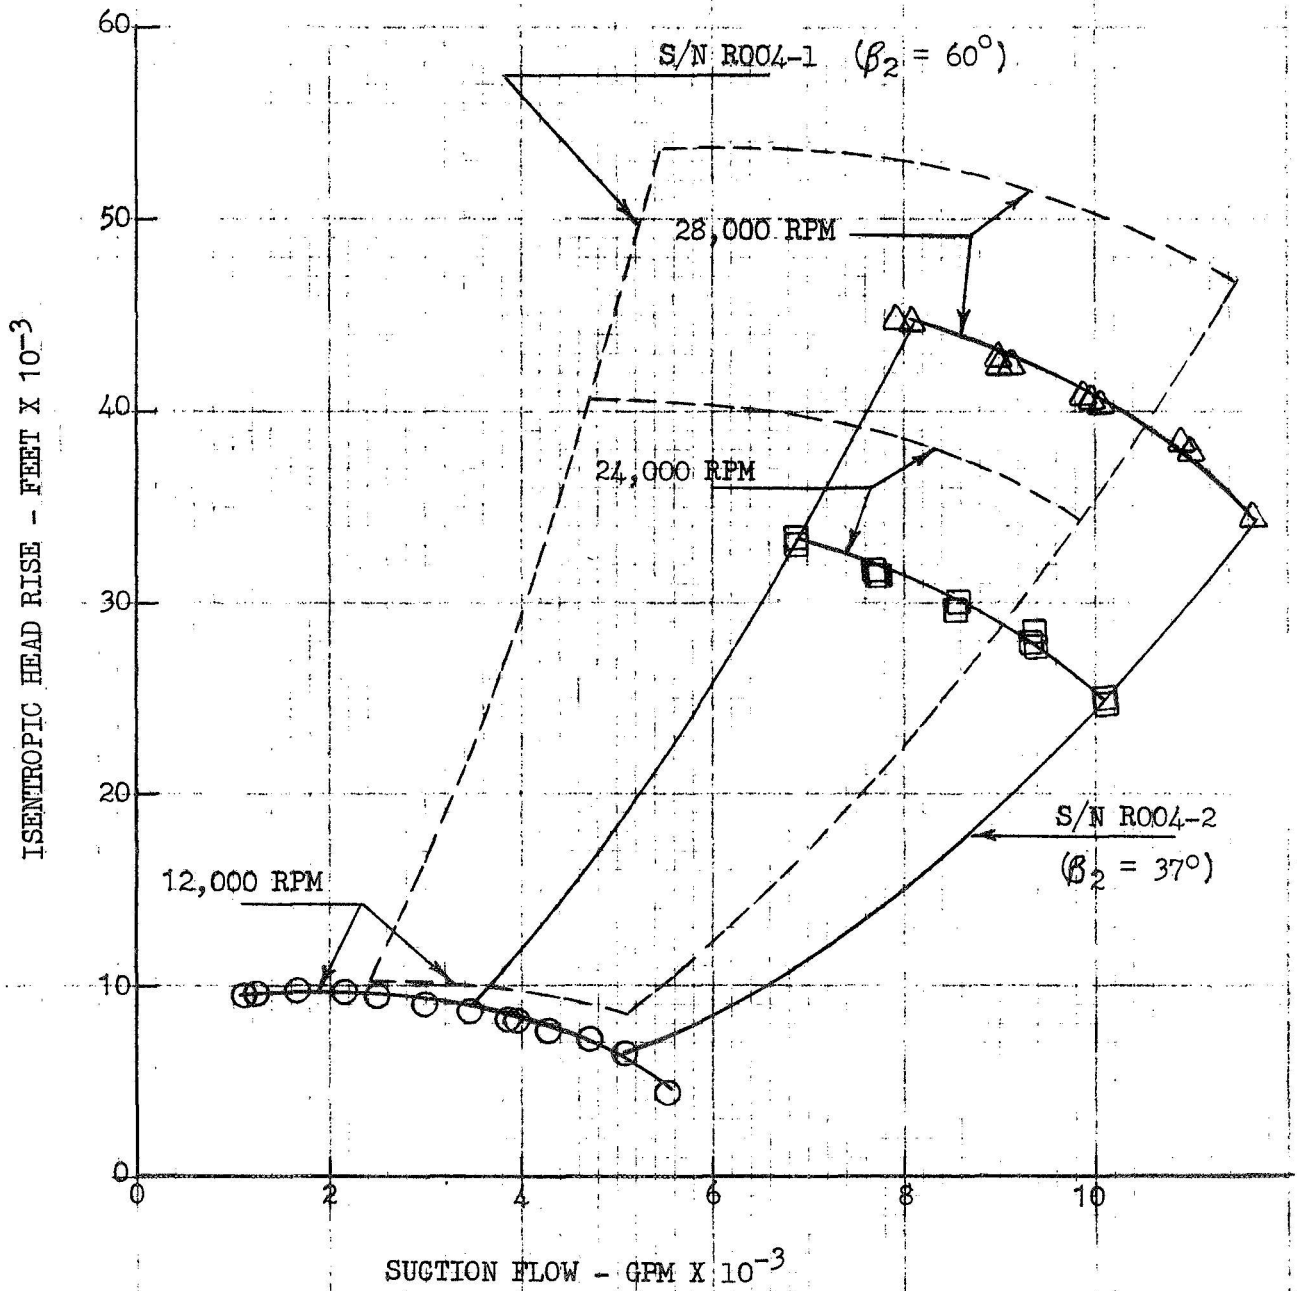
FIGURE 21

MARK 29 FUEL PUMP PERFORMANCE  
 WITH DIFFUSION BONDED TITANIUM  
 IMPELLER BASED ON TESTS OF PUMP  
 S/N R004-2  
 COMPARED WITH  
 MARK 29F PUMP PERFORMANCE WITH  
 STANDARD MARK 29F IMPELLER (R004-1)

Test results are plotted in Fig. 21, 22 and 23. Figure 21 shows the isentropic head rise as a function of flow which agrees quite closely with the predicted performance as shown in Fig. 14. The measured head is slightly lower than predicted at all flows which indicates the losses produced by the mismatch between the diffusion bonded impeller and the stationary elements of the Mark 29F pump are greater than predicted.

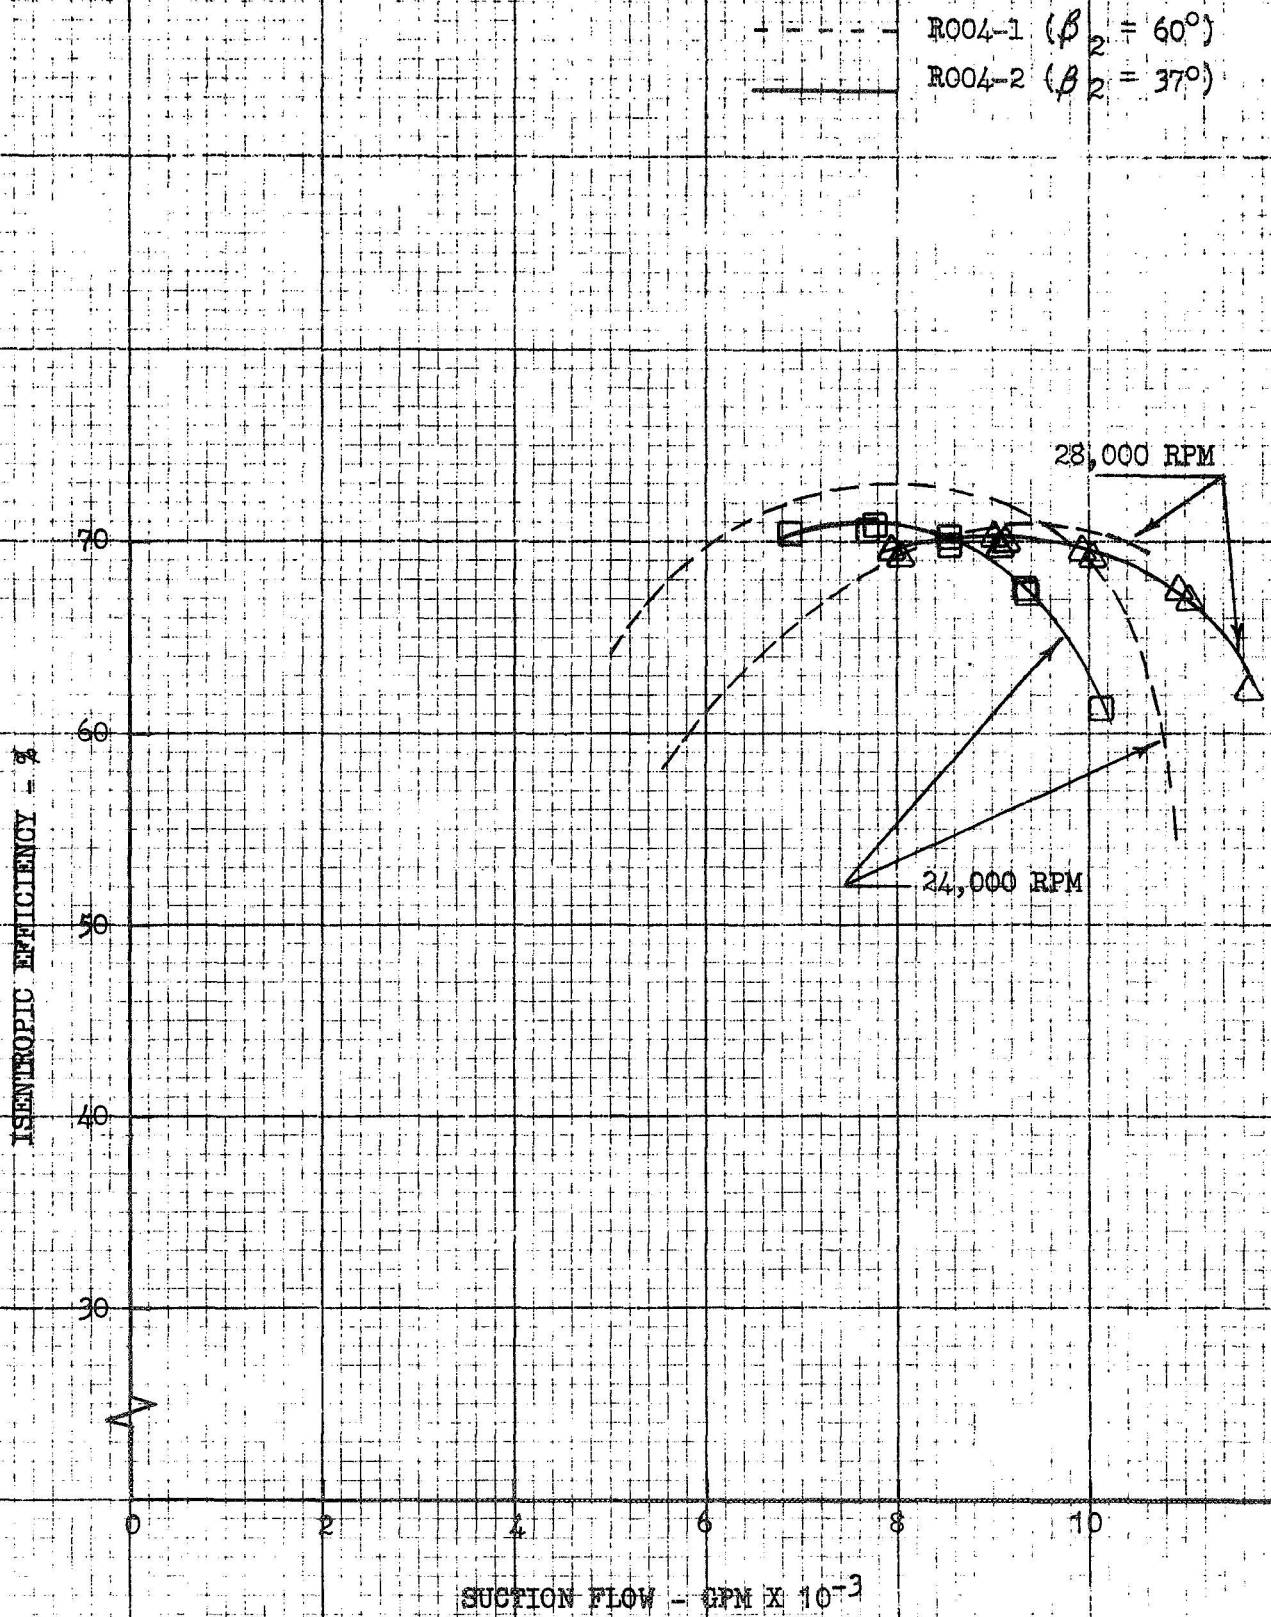
FIGURE 22

MARK 29 FUEL PUMP EFFICIENCY WITH  
 DIFFUSION BONDED TITANIUM IMPELLER (R004-2)  
 AND STANDARD MARK 29F IMPELLER (R004-1)

Figure 22 shows the pump isentropic efficiency as a function of suction flow and Fig. 23 shows head coefficient and isentropic efficiency as a function of flow coefficient. Similar data from testing a previous build of pump No. R004 are also shown on each figure for comparison.
