TITANIUM PUMP IMPELLER TESTING

FINAL REPORT

ROCKETDYNE  
A DIVISION OF NORTH AMERICAN ROCKWELL CORPORATION

Contract NAS8-25860

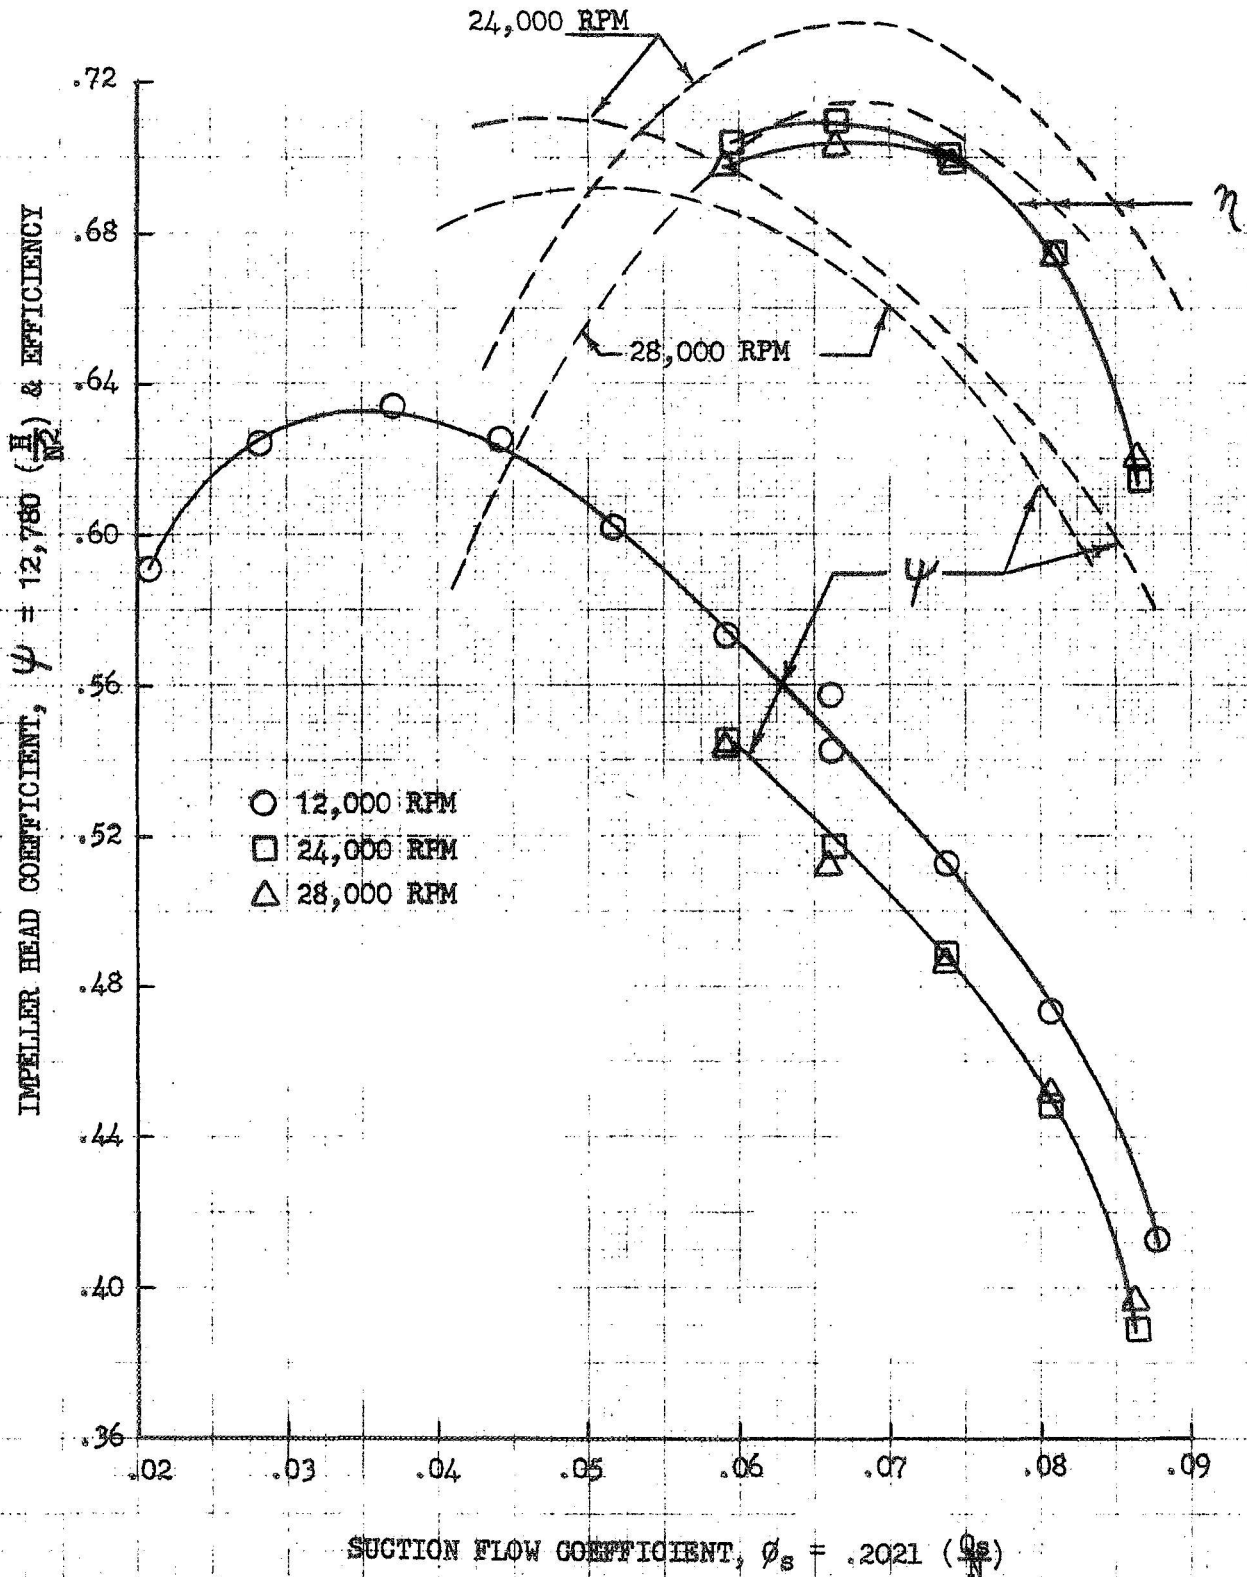
FIGURE 23

MARK 29 FUEL PUMP PERFORMANCE WITH  
 DIFFUSION BONDED TITANIUM IMPELLER (R004-2)  
 AND STANDARD MARK 29F IMPELLER (R004-1)

----- R004-1 ( $\beta_2 = 60^\circ$ )  
 ——— R004-2 ( $\beta_2 = 37^\circ$ )

Figure 22 shows the pump isentropic efficiency as a function of suction flow and Fig. 23 shows head coefficient and isentropic efficiency as a function of flow coefficient. Similar data from testing a previous build of pump No. R004 are also shown on each figure for comparison.
