NEPP Task: Guidelines for Selection of Ceramic Capacitors for Space  
Applications

# Cracking Problems in Low-Voltage Chip Ceramic Capacitors

Alexander Teverovsky

2018

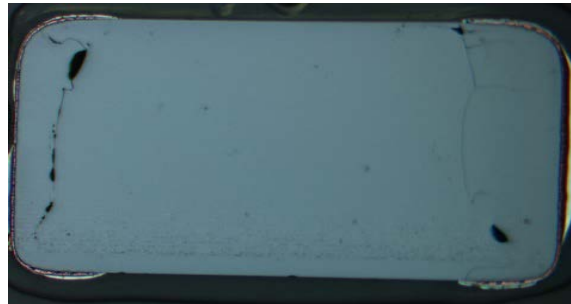
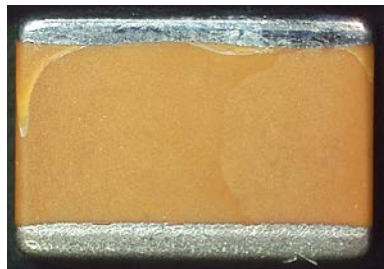
Figure 1.2. Different types of cracks in MLCCs.

a) Manufacturing defect: CDR 0.1  $\mu\text{F}$  100 V capacitor that failed due to delamination at  $\sim 1.5$  kohm during board-level testing

b) Manufacturing defect: voids and delaminations (knit line cracks).

c) Assembly-related defect: flex crack.

d) Assembly-related defect: thermal shock cracking.

e) Cracking caused by manual soldering.

f) Cracking caused by touch-up after reflow soldering.

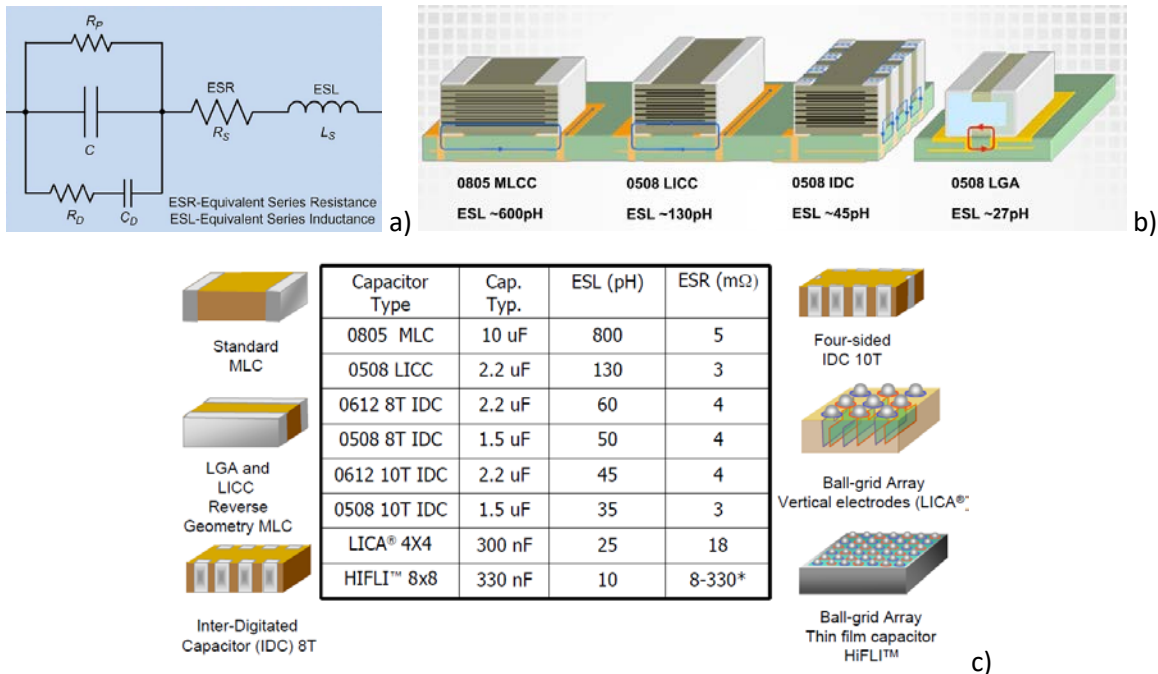
Figure 2.11. Equivalent circuit of a capacitor at high frequency(a) a schematic of the AC current flow in capacitors (b), J.Marshall [37], and types of low inductance MLCCs, R.Demko (c), [20].

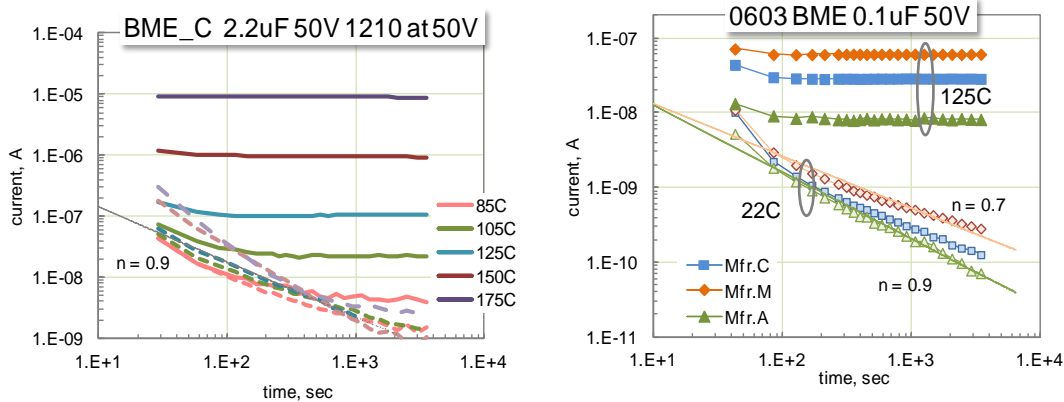
c) Dashed lines indicate depolarization, solid lines - polarization currents. Increasing  $T$  rises intrinsic currents exponentially and does not affect depolarization currents.

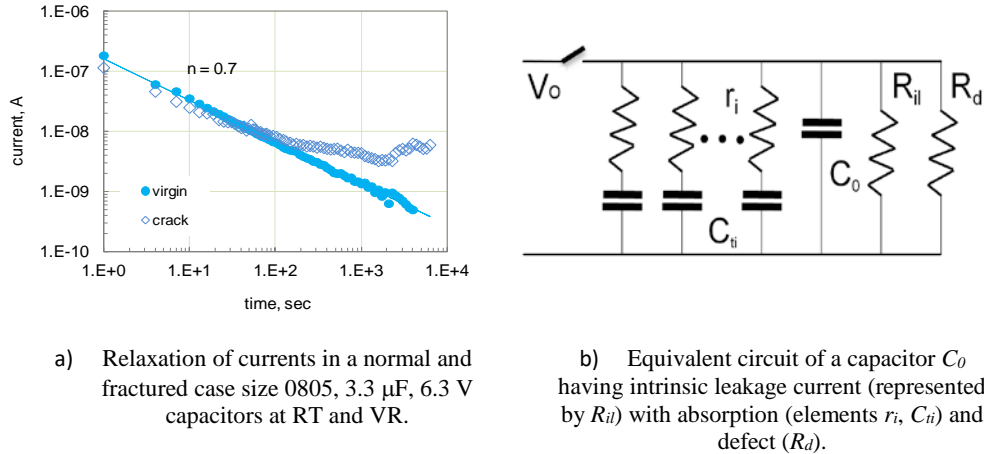
Figure 4.4. Effect of cracking on relaxation of leakage currents (a), and an equivalent circuit of a capacitor with cracks (b).

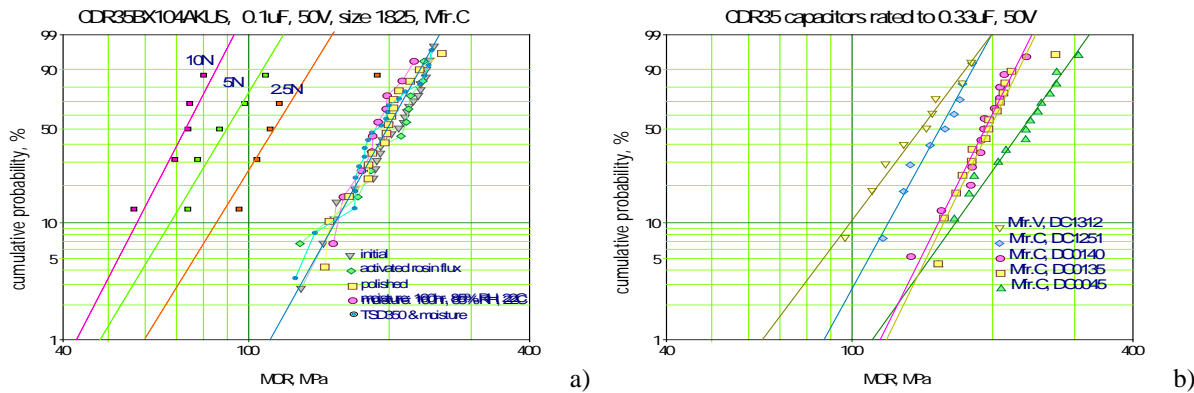
Figure 4.10. Weibull distributions of MOR for CDR35 capacitors after different treatment before testing (a) and different lot date codes and vendors (b).

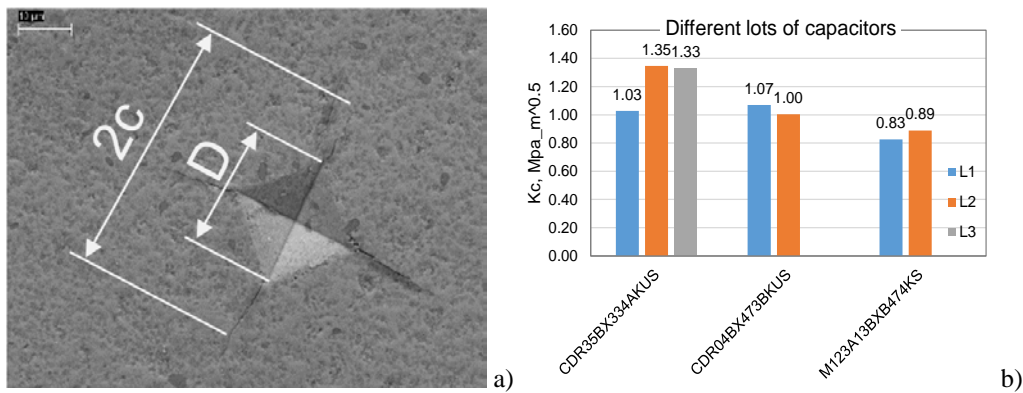
Figure 4.13. An example of the footprint during indentation fracture toughness testing (a) and Fracture toughness for different lots (L1, L2, and L3) for three types of military grade capacitors.

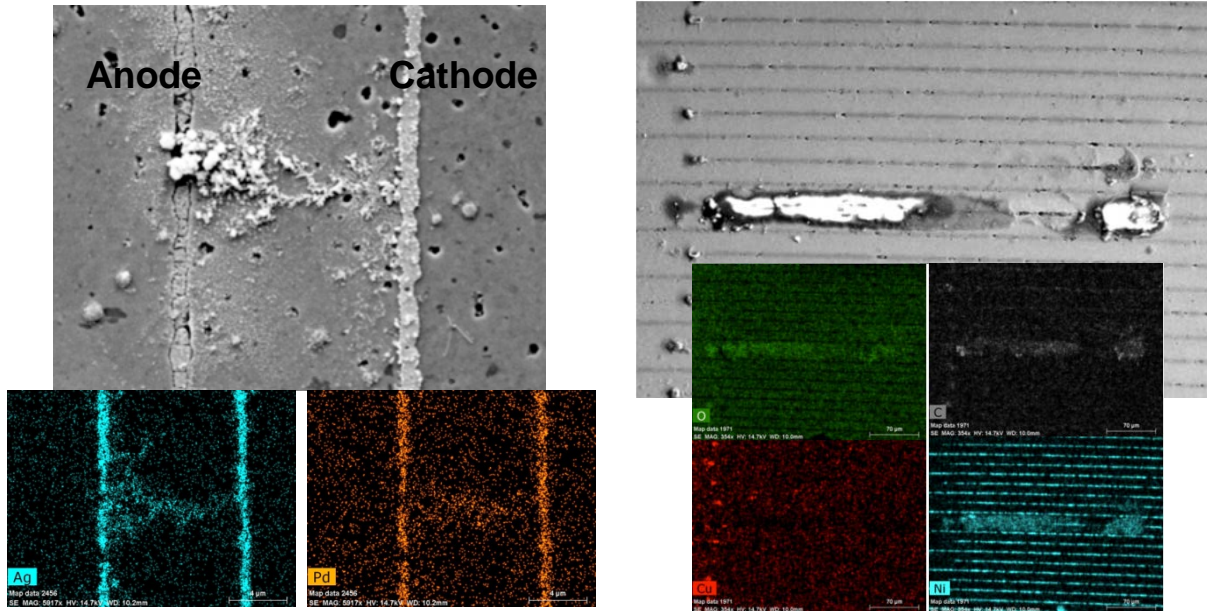
a) Ag/Pd dendrites on the surface of a PME capacitor failed after HSSLV testing. Note erosion of the anode electrode indicating the source of metal ions used to form dendrites.

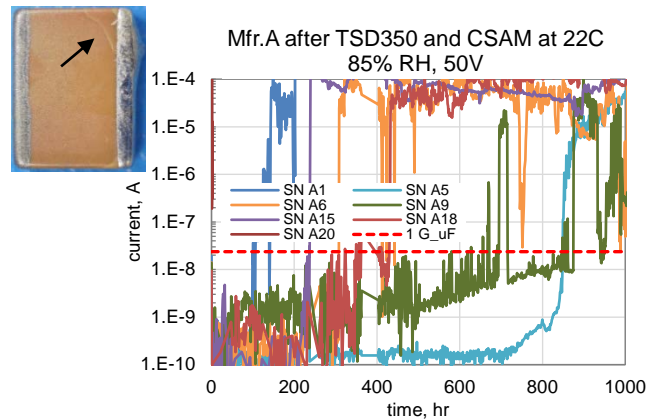
Figure 5.8. Leakage currents in CDR35 0.47  $\mu\text{F}$  50 V capacitors during 1000 hour testing at 22  $^{\circ}\text{C}$ , 85% RH, and 50 V. An insert shows example of cracks formed by TSD350.

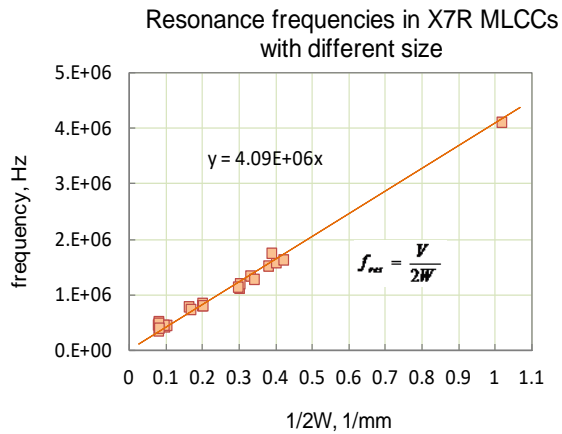
Figure 6.3. ESR spectrums for different types of X7R capacitor with and without DC bias (a-d), variation of the major resonance frequency with the width of capacitors (e), and a 9  $\mu\text{F}$  300 V stacked ceramic capacitor that has been damaged when operating frequency was close to  $f_{res}$  (f).

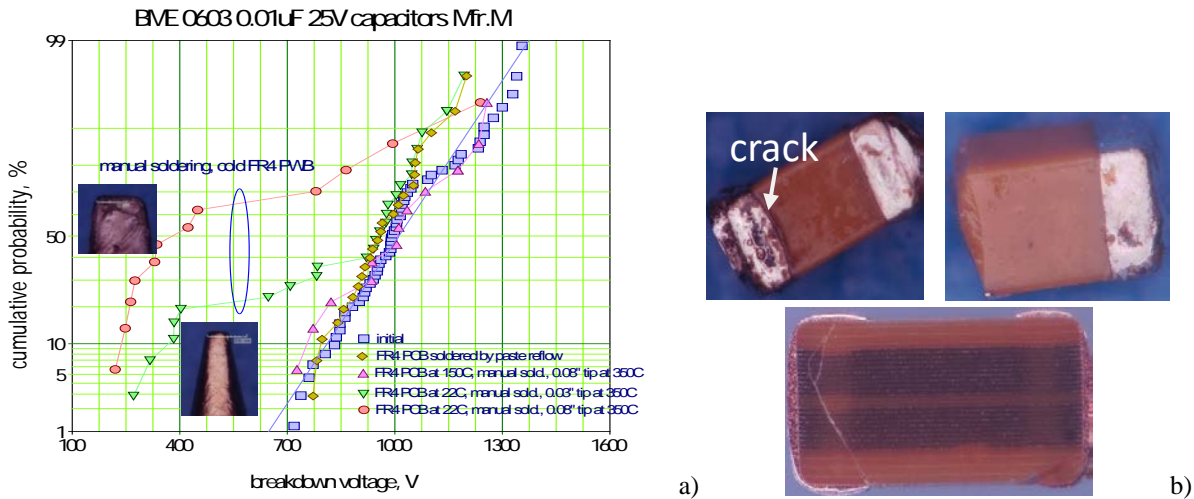
Figure 8.1. Distributions of breakdown voltages in 25 V, size 0603 capacitors (a) and examples of failed parts (b). MLCCs have been soldered onto FR4 boards using four methods: (i) standard reflow, (ii) assembly onto a PWB preheated to 150 °C using a soldering iron with 0.08" tip at 350 °C, (iii) manual soldering onto a cold PWB using a 0.08" tip at 350 °C, and (iiii) manual soldering onto a cold PWB using a 0.03" tip at 350 °C.
