For Calendar Year 2021

Annual Site Environmental Report

Pantex Plant

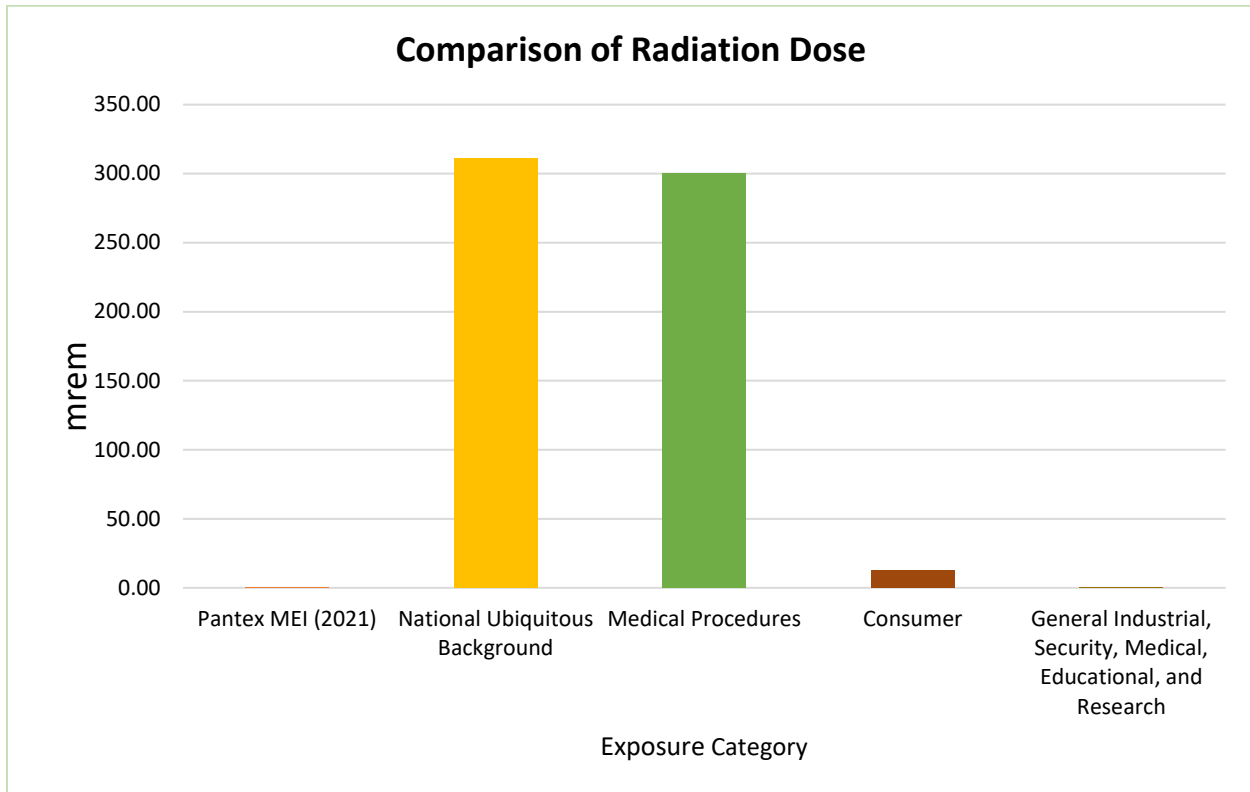
Pantex Plant Radiation Dose (mrem)	EPA Standard Air Pathway (mrem)	DOE Standard All Pathways (mrem)
2.17E-07	10	100

Figure ES.1 – Comparison of Radiation Dose

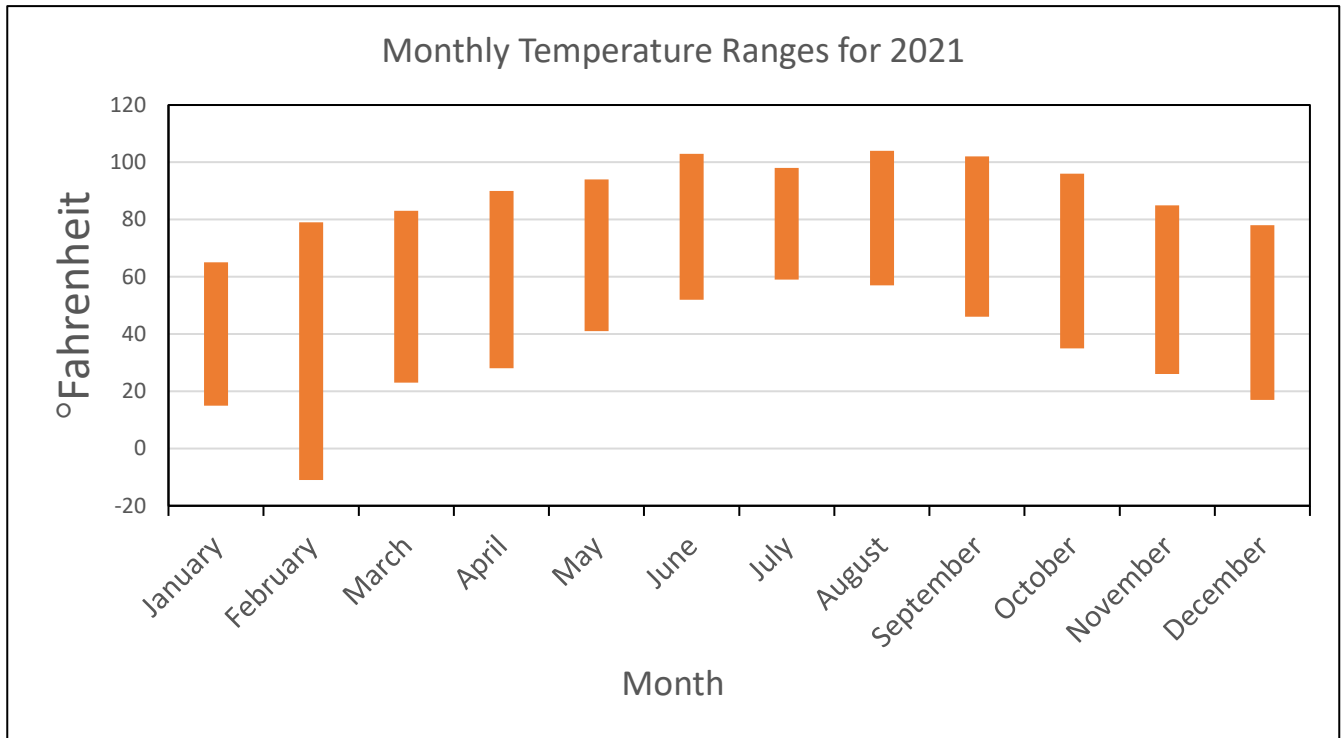
Figure 1.3 – Pantex Plant Monthly Temperature Range During 2021

Based upon monthly climatological data forms published by the NWS Forecast Office for Amarillo (located at Rick Husband International Airport), the mean temperature at the official NWS location during 2021 was 59.1 degrees Fahrenheit (°F), slightly above the normal annual mean temperature in Amarillo of 58.7°F. During 2021, the official NWS rain gauge recorded 15.03 in of precipitation (DOCa). Table 1.1 is a compilation of climatological data (temperature, relative humidity, precipitation; including the water equivalent of any snowfall and wind speed) for 2021 from Amarillo Airport NWS meteorological instrumentation. The range of mean monthly temperatures and the monthly precipitation totals as measured at the Amarillo Airport NWS site are shown in Figures 1.3 and 1.4.

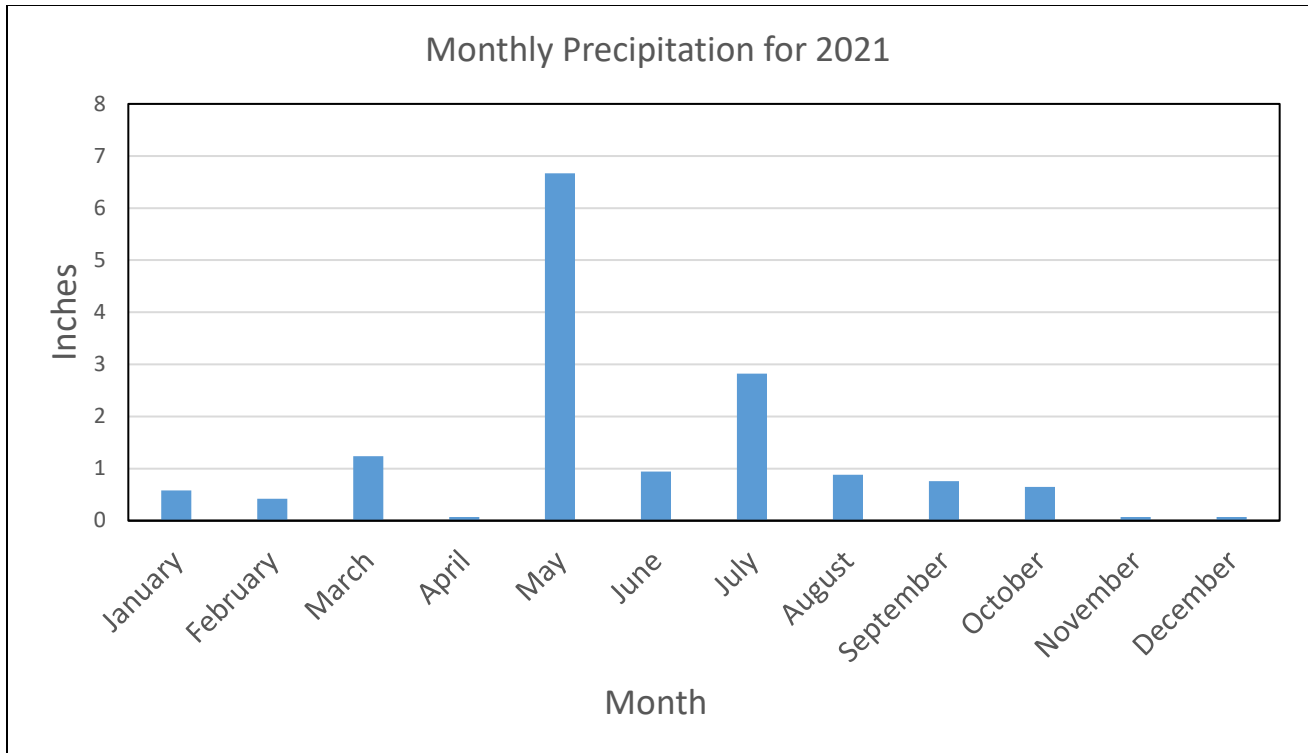
Figure 1.4 – Pantex Plant Precipitation During 2021

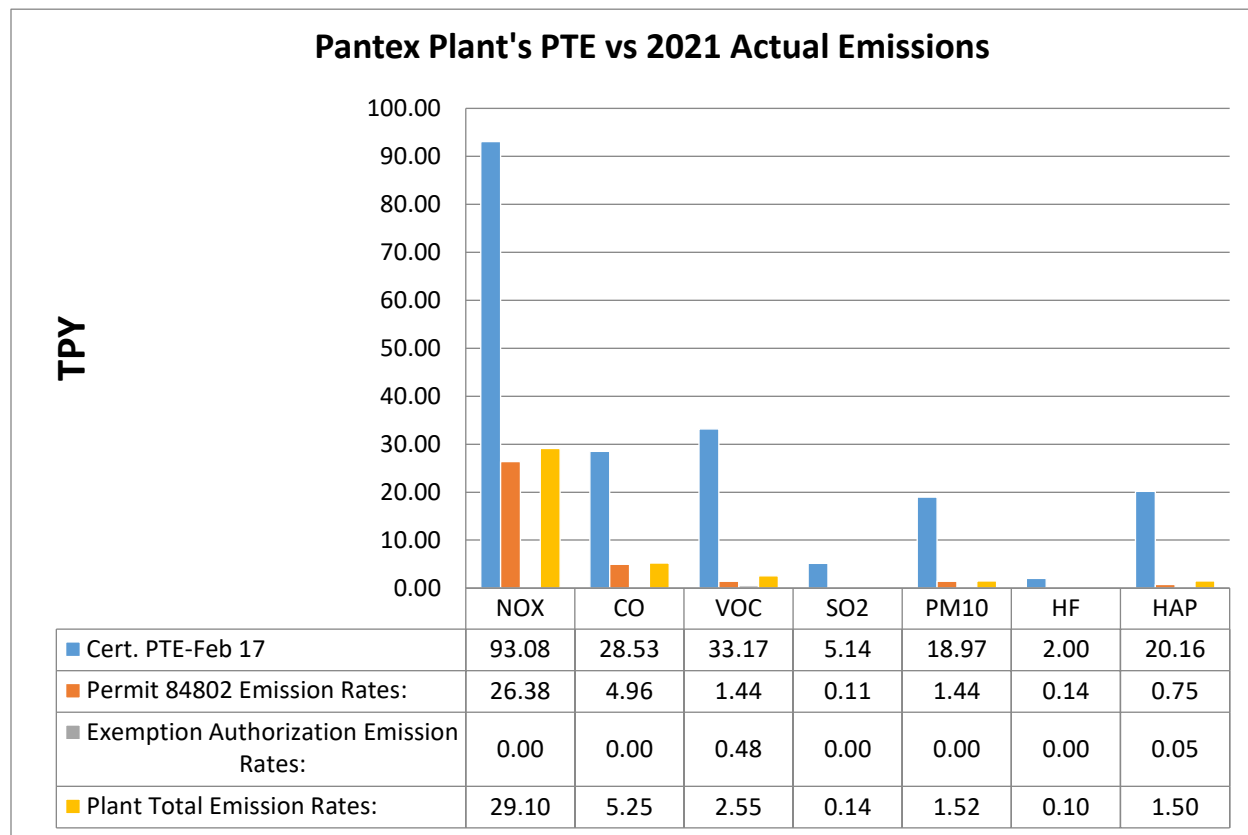
Figure 2.1 – Pantex Plant’s PTE vs January – December 2021 Actual Emissions

PTE certification in tons per year (TPY). It provides a demonstration that Pantex Plant continues to meet the requirements of the Title V program for the designation as a Synthetic Minor Source.

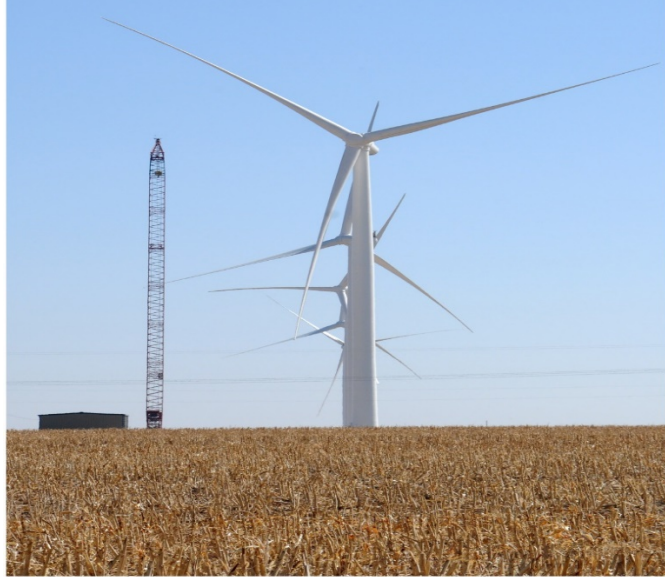
Figure 3.1 – Pantex Renewable Energy Project²

² Pantex Renewable Energy Project (PREP) consists of five 2.3-MW-Siemens wind turbines.

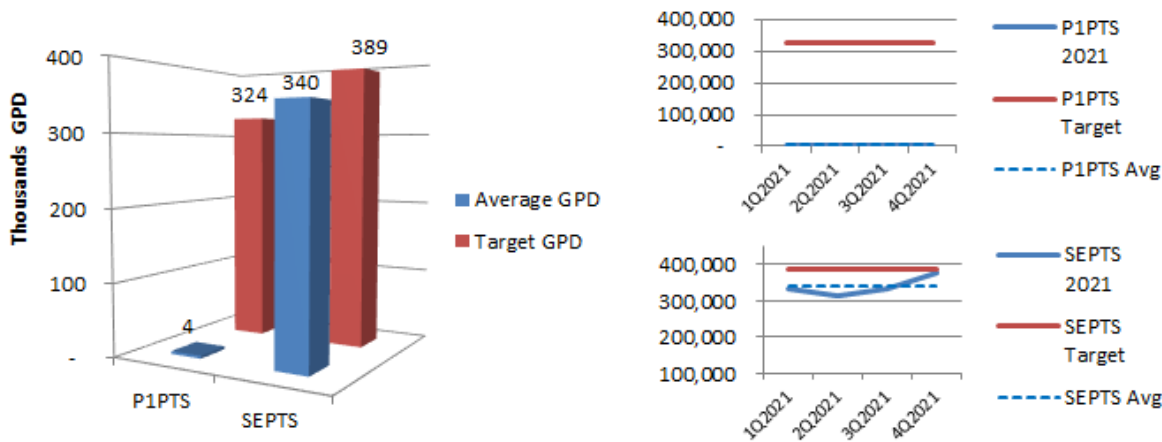
Figure 3.8 – 2021 Pump and Treat Systems Performance

startup of the systems. The SEPTS has been operating longer, and the greatest concentrations of HEs are found in the SEPTS extraction well field, so mass removal is higher at that system. P1PTS throughput and mass removal was also affected by shutdowns in 2021.

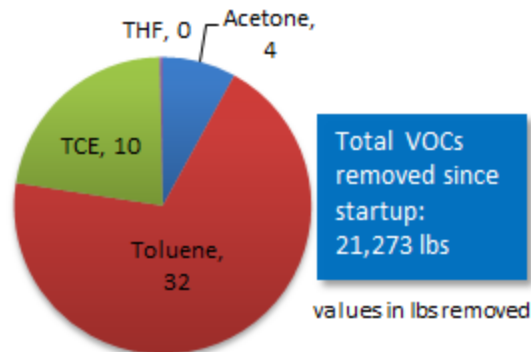
Figure 3.10 – 2021 SVE Mass Removal

A Soil Vapor Extraction (SVE) system was installed and has been operating at the Burning Ground since February 2002. After a large-scale system remediated a significant area at the Burning Ground, a small-scale activated carbon system was installed in late 2006 after the large-scale system became inefficient at continued removal of remaining soil gas and residual NAPL. The current system, consisting of a small-scale catalytic oxidizer and wet scrubber, was installed in early 2012 to replace the activated carbon system. The system was modified in 2017 to increase air flow through the soils to increase remediation and evaluate the system for closure. The current system continues to focus on treating residual soil gas and NAPL at a single well (SVE-S-20) where soil gas concentrations continue to remain high. Pantex Plant began actively pulsing the system in 2020 to gain information relating to closure. Data collected in 2021 indicates the NAPL source is nearly depleted and that shutdown of the system may be viable in the near future. As depicted in Figure 3.10, the SVE system removed about 46 lbs. of volatile organic compounds (VOCs) during 2021.

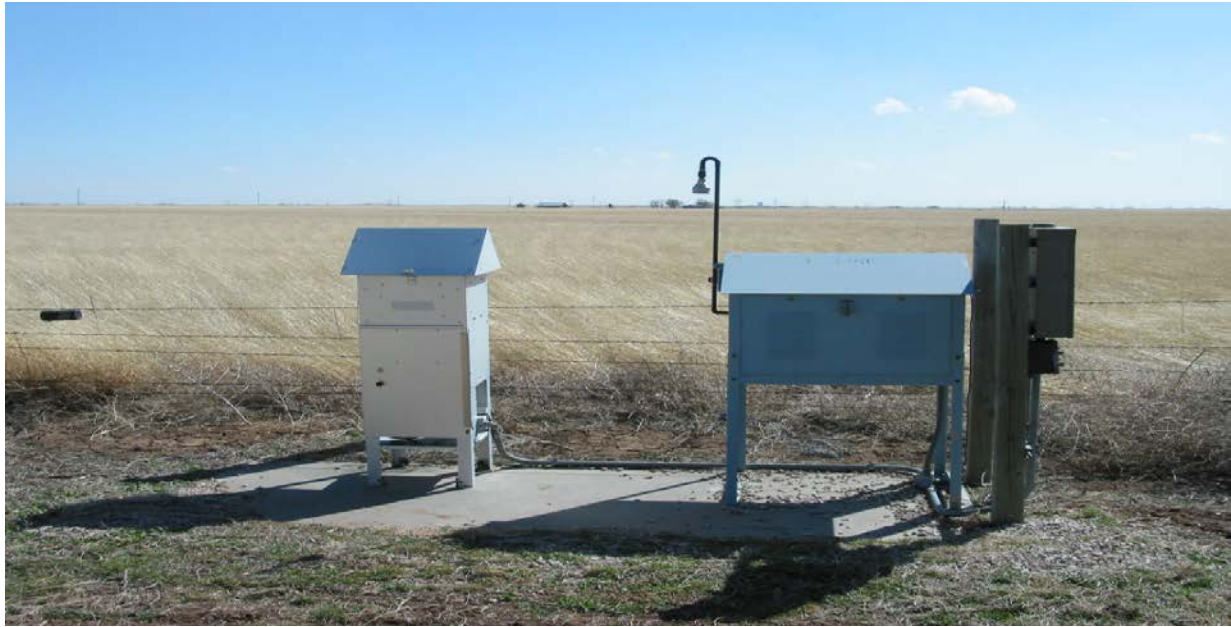
Figure 5.3 – Typical Air Monitoring Site

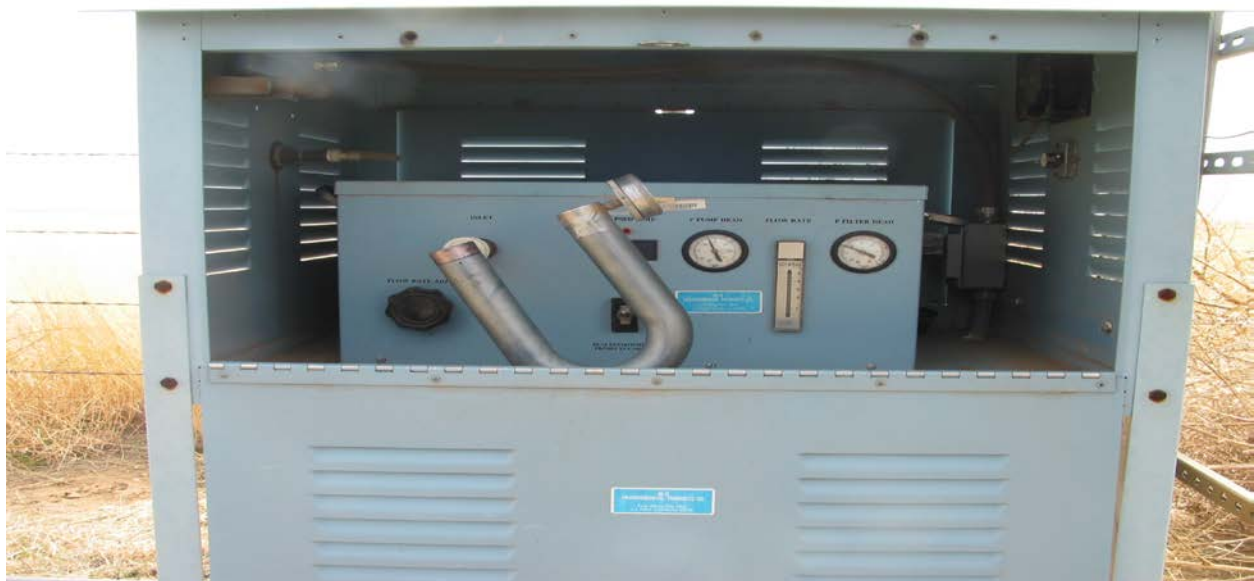
Figure 5.4 – Low-Volume Sampling Apparatus

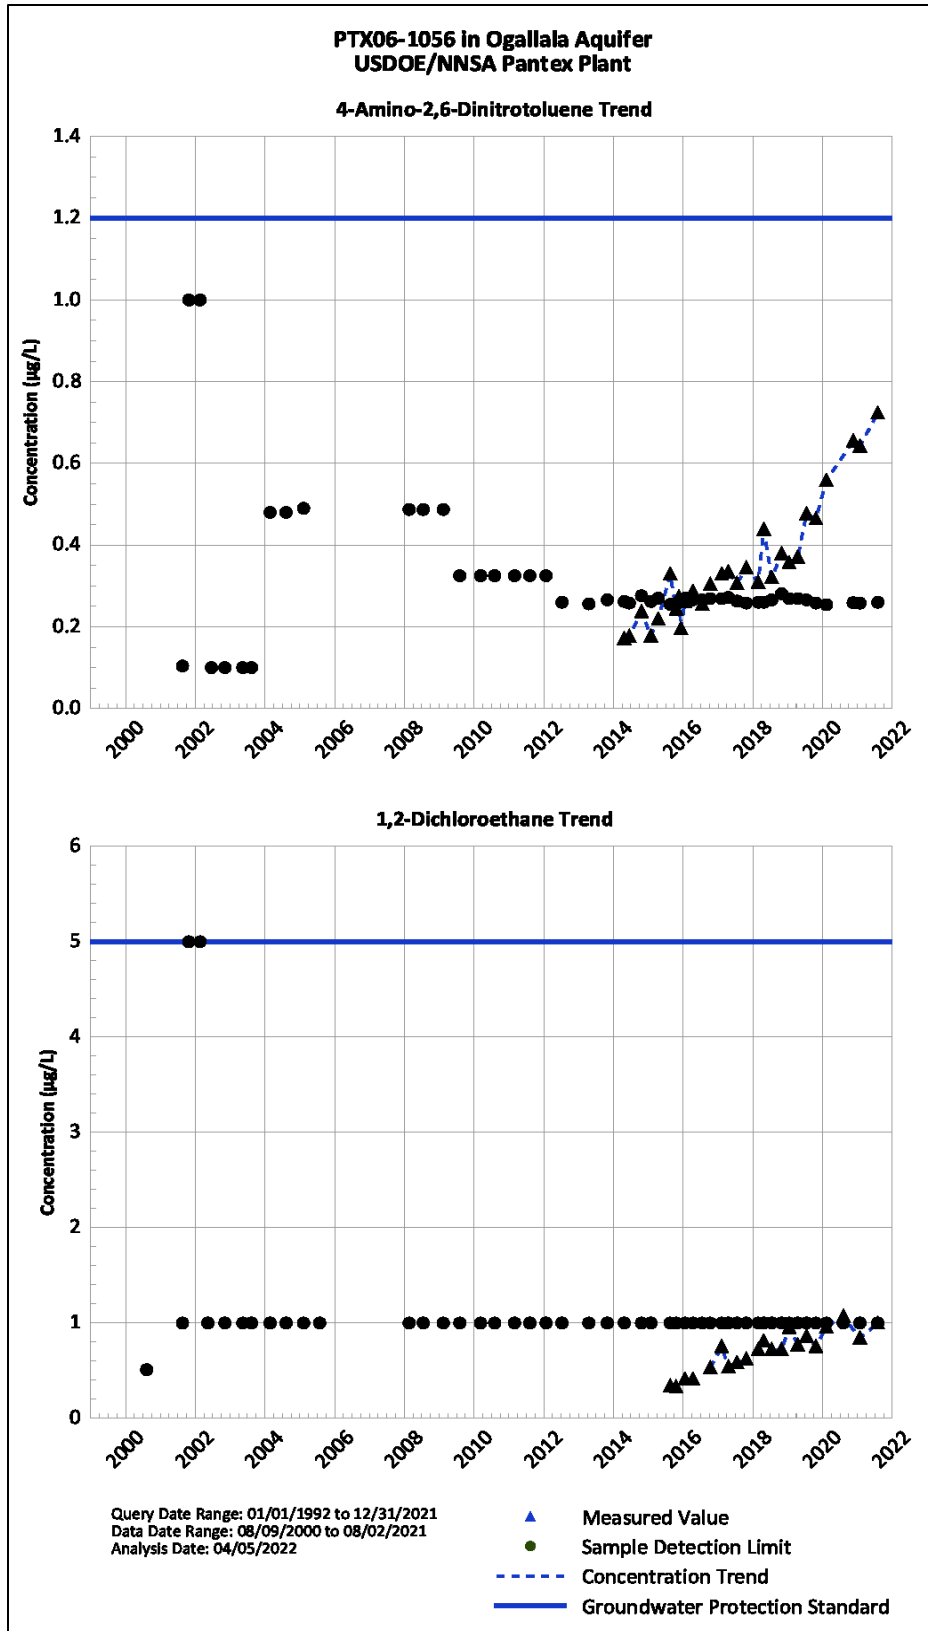
Figure 6.8 – Summary of Unexpected Conditions in Ogallala Aquifer Well PTX06-1056

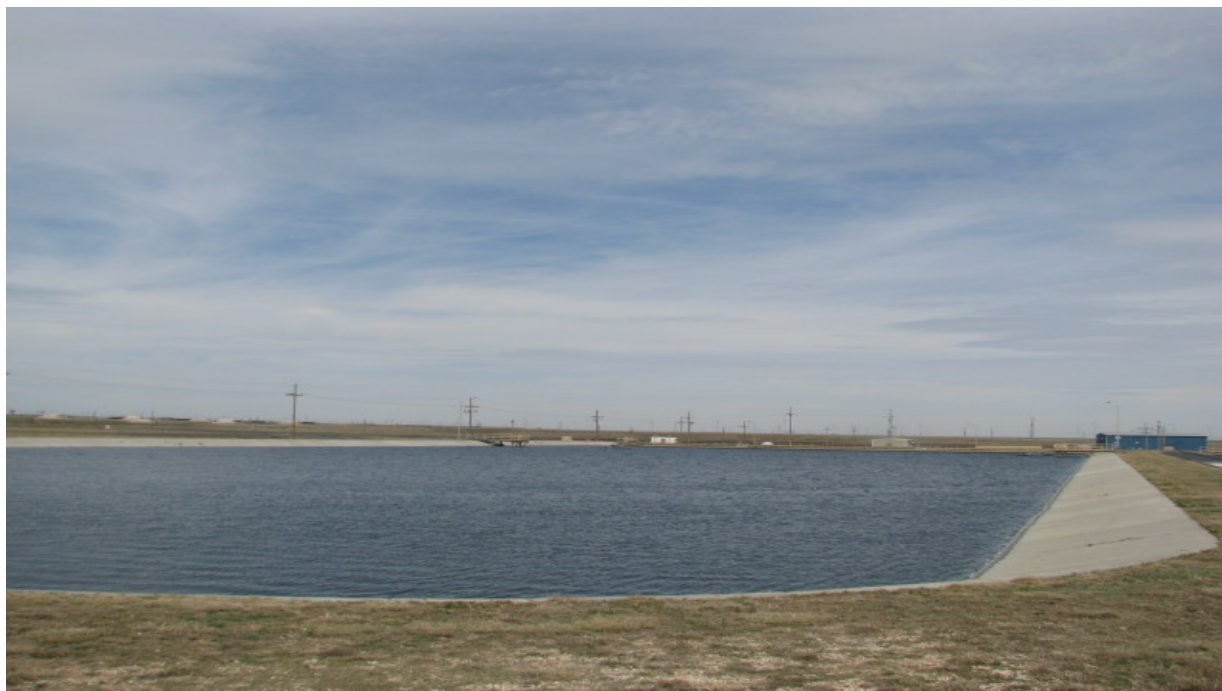
Figure 8.2 – Wastewater Treatment Facility, Facultative Lagoon

The treatment process in the facultative lagoon involves a combination of aerobic, anaerobic, and facultative bacteria. At the surface, aerobic bacteria and algae exist in a symbiotic relationship. Oxygen is provided by natural aeration processes, algal photosynthesis, and by solar-powered mechanical aerators. Bacteria utilize the oxygen for the aerobic degradation of organic matter, while algae utilize the nutrients and carbon dioxide released in the degradation process. Facultative bacteria within the water column are used in the treatment and degradation of organic matter. Anaerobic bacteria decompose organic matter that is deposited in a sludge layer at the bottom of the lagoon. The wastewater treatment process in a facultative lagoon is complex and nearly all treatment is accomplished by biological activity.

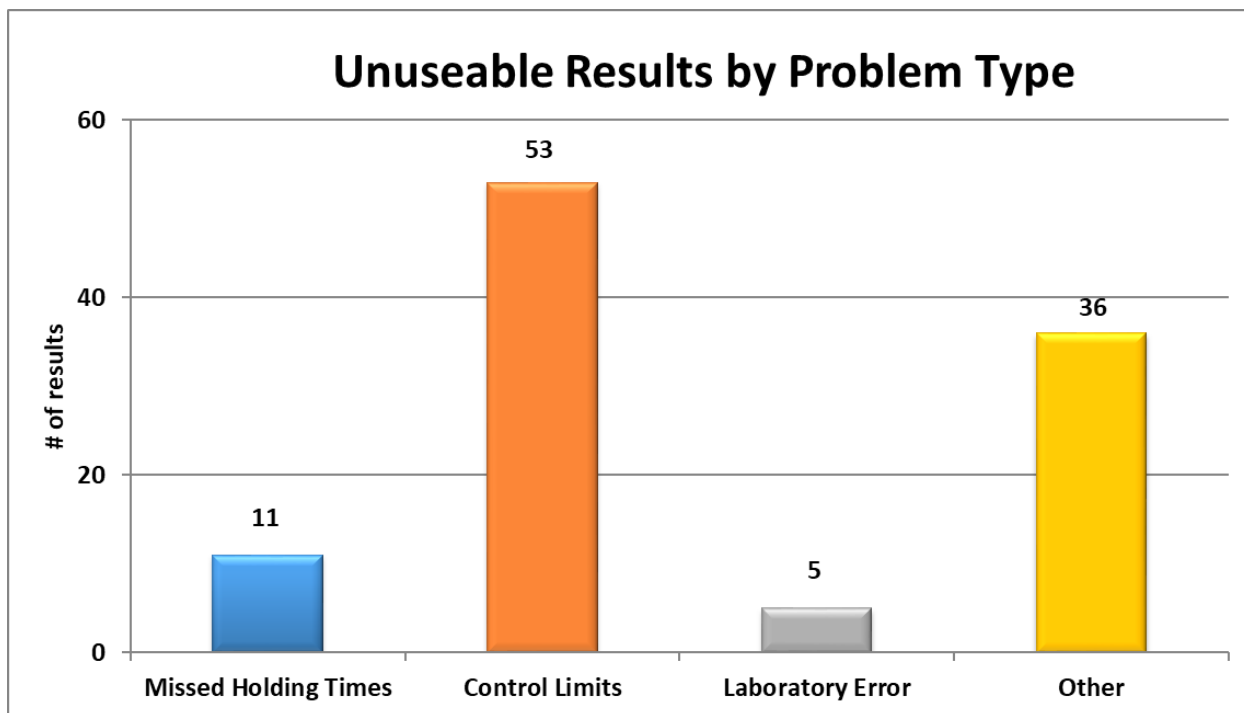
Figure 13.1 – 2021 Data Rejection Summary

The Pantex Plant media scientist was alerted to any limitations in the use of the data, based on the DQO requirements. Of the 24,656 individual results obtained in 2021 from all laboratory analyses, 99.57 percent were deemed to be of suitable quality for the intended end use of the data. Figure 13.1 graphically summarizes the causes for the 0.43 percent of data rejected.
