Light Water Reactor Sustainability Program

U.S. Efforts in Support of Examinations at Fukushima Daiichi – 2017 Evaluations

August 2017

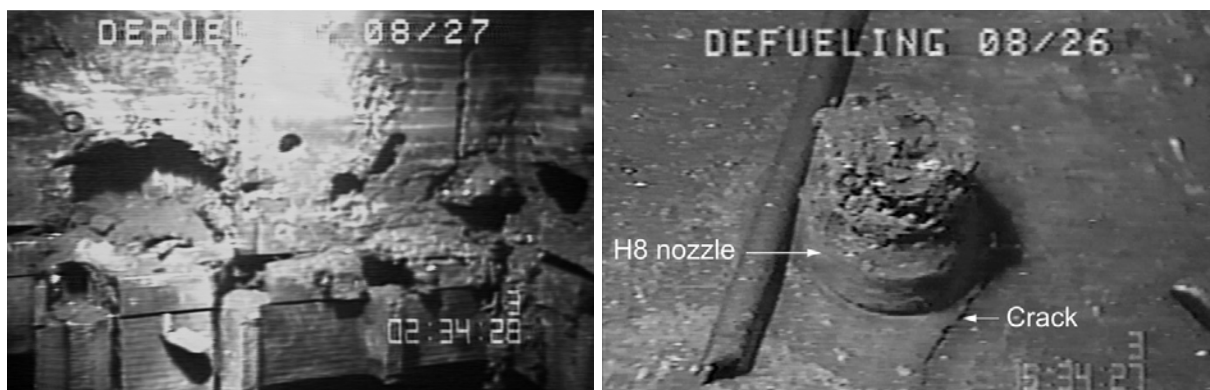
Figure 2. TMI-2 video examinations revealed locations where damage to core barrel and nozzles was more severe. (Courtesy of FirstEnergy)

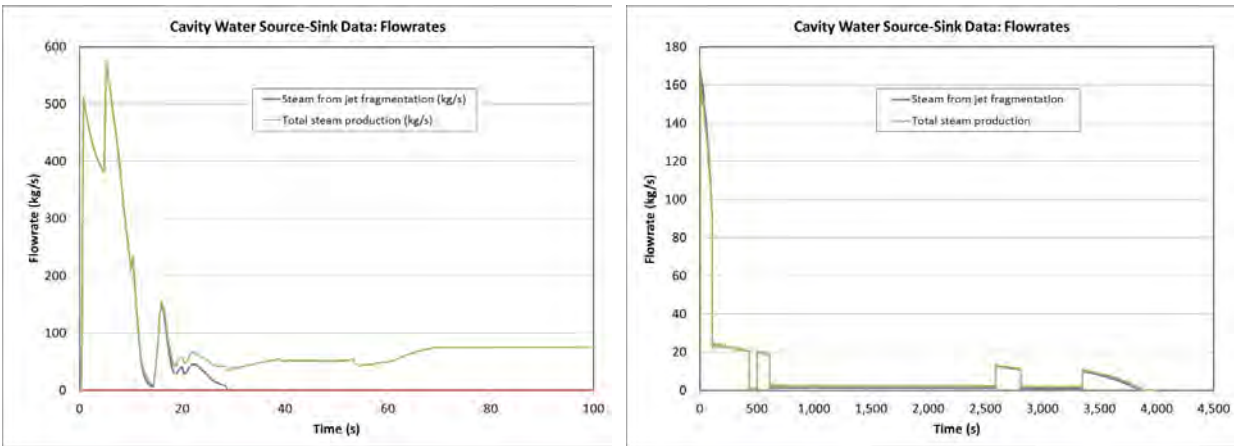
Figure 11. Predicted steam production from melt jet fragmentation during relocation into the sumps for MAAP and MELCOR pour conditions. (Courtesy of ANL [151])

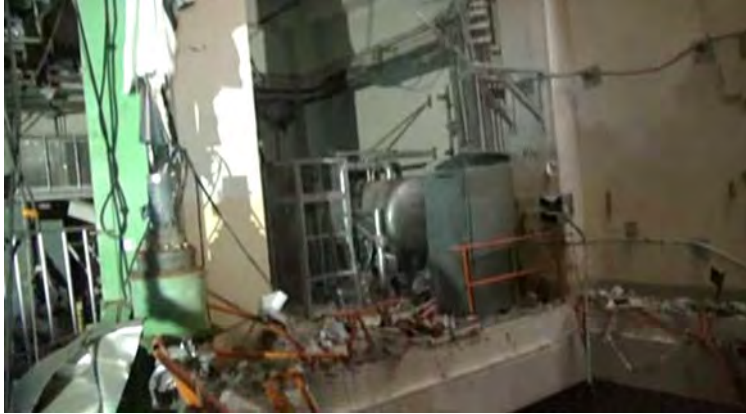
Figure 14. 1F1 RCW surge tank. (Courtesy of TEPCO Holdings [156])

Additional observations are as follows. Based on illustrations of the system [35], the static head of water between the drywell sumps and the surge tank on the 4th floor is approximately 0.26 MPa (differential). Comparing this pressure to the available drywell and wetwell data [154] for 1F1, the containment pressure was sufficiently high for an extended period of time that was sufficient to push water into the RCW system (if failure of the sump cooler piping occurred and water was available), see Figure 13. The pressure was also sufficiently high to possibly push water out of the surge tank. Based on images (see Figure 14) from [155, 156], the surge tank appears intact; however, inspection of the tank and nearby piping has not been reported.

Design details of the RCW at 1F1 are not readily available. In reviewing the design for a similar BWR4 in a Mark I containment at the Browns Ferry Nuclear Power Plant (Browns Ferry) [157], the pipe size for the drywell equipment drain sump heat exchanger is 3.81 cm (1.5 in). The rest of the RCW piping of relevance is much larger, in the 5-30.5 cm range (4-12 in). The volume of water in the system (relevant to RCW piping, surge tank, and heat exchangers of interest) is not readily known; however, it is estimated to be on the order of several cubic meters (i.e. on the order of 1000 gallons). The RCW piping is designed for 1.14 MPa-gauge (150 psig) at Browns Ferry which exceeds available values recorded for the 1F1 drywell pressure.

Available 1F1 drywell pressure data from 1:00 on March 12 until 10:00 on March 14 are greater than the RCW water static head (Figure 13). To reproduce the 1F1 drywell pressure during the March 12, 7:00-14:00 timeframe, previous simulations modeled a drywell head flange leak.[49, 50] The models require leakage areas (that vary with time) of approximately 4.4 cm² [49] and 5 cm² [50], which have an equivalent diameter of approximately 2.5 cm (1 in). Interestingly, this corresponds to the approximate size of the RCW piping for the drywell drain sump heat exchangers at Browns Ferry. Thus, a possible alternative to the 1F1 drywell head seal leakage path is through the RCW system during periods of high drywell pressure (i.e., greater than 0.36 MPa-abs.). However, as noted in Section 3.2.1.1, there is evidence the drywell head likely leaked during the events at 1F1. Substantially higher doses have not been measured near the surge tank or on the refueling floor above the surge tank. Thus, to date, the inspection evidence supports the possibility for drywell venting through the drywell head flange. While one explanation for the high doses observed by the RCW heat exchangers is due to contaminated water being pushed up into the system, there is currently a lack of evidence to support the possibility of ‘venting’ the drywell through the RCW piping and surge tank.

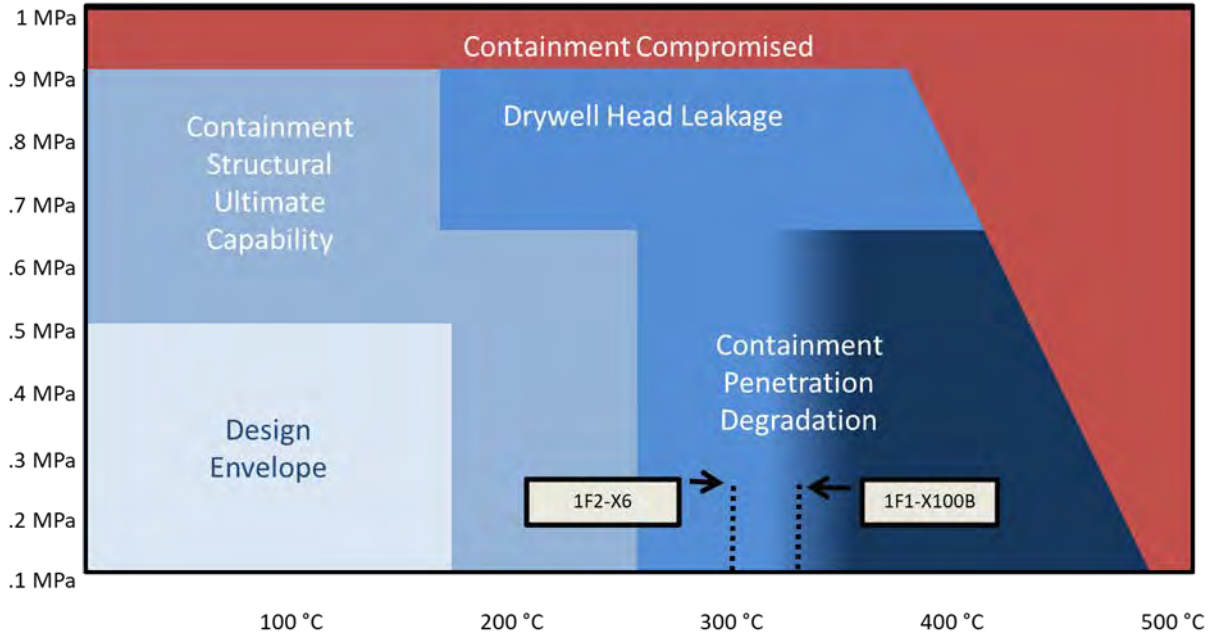
Figure 18. Containment pressure/temperature curve with available 1F1 and 1F2 information. (Graphic courtesy of Nuclear Energy Institute [85] as modified by Jensen Hughes)

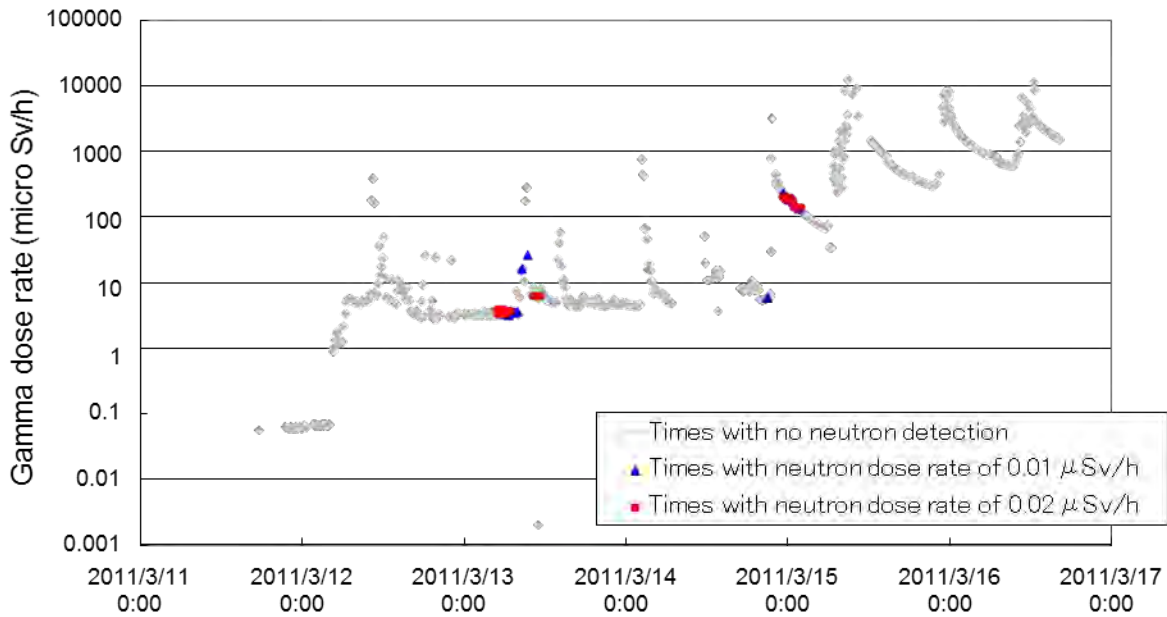
Figure 20. Gamma dose rate measurements at the main gain, indicating timings of coincident neutron dose rate. (Courtesy of TEPCO Holdings [37])

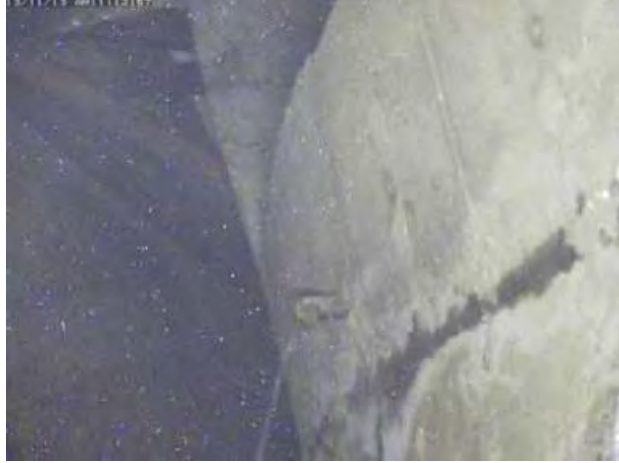
Figure 23. Leakage out of the sand cushion drain pipes at 1F1. (Courtesy of TEPCO Holdings [181])

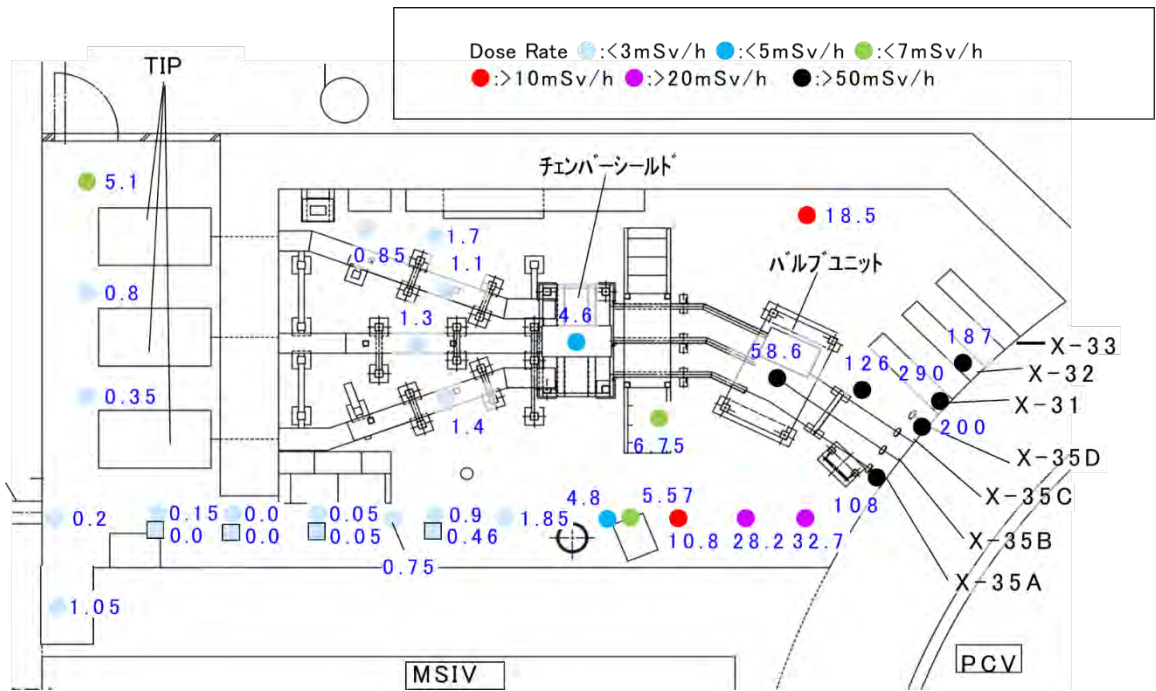
Figure 25. 1F1 reactor building TIP room dose rate measurements (in mSv/hr; taken above floor elevation between September 24 through October 2, 2015). (Courtesy of TEPCO [183])

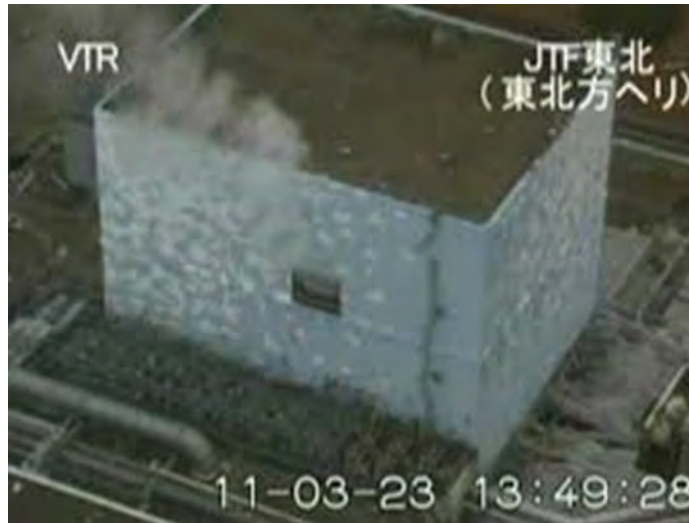
Figure 27. 1F2 reactor building with open blowout panel. (Courtesy of TEPCO Holdings [185])

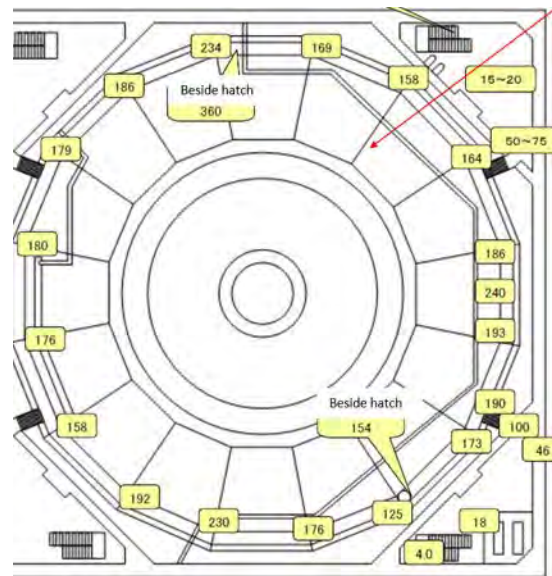
Figure 31. Torus room radiation level readings from entry into 1F3 reactor building (in mSv/hr; taken above floor elevation on April 25, 2011). (Courtesy of TEPCO Holdings [137])

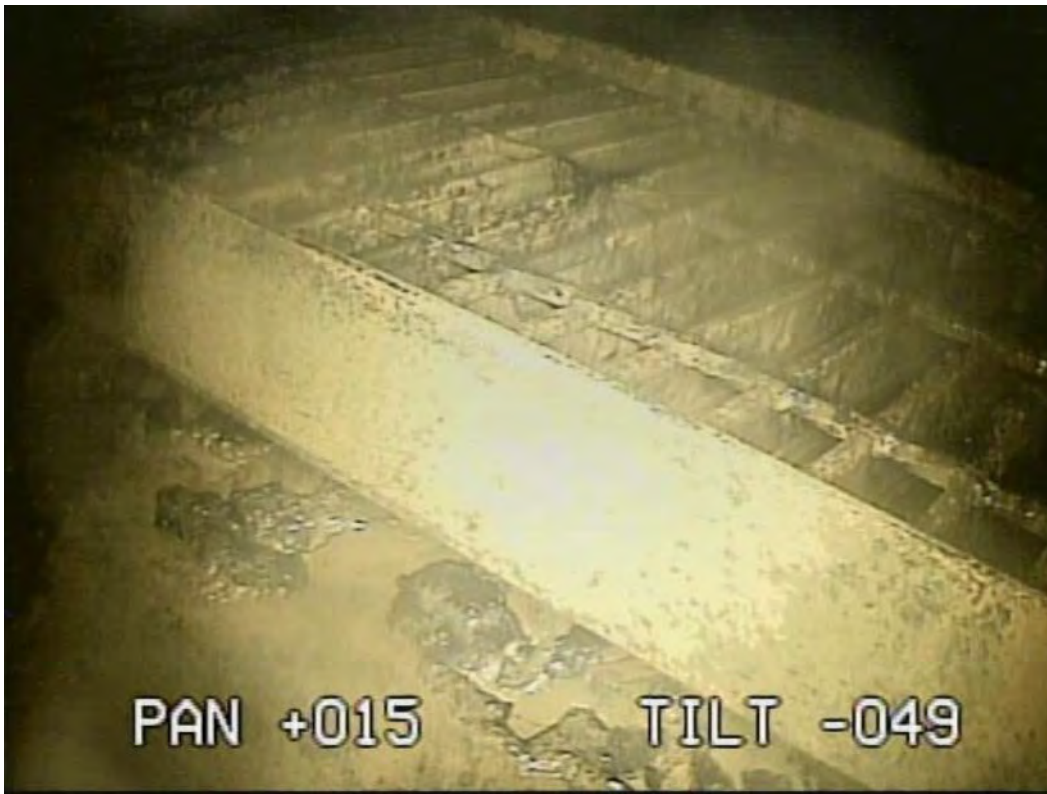
Figure 52. Photograph of CRD exchange rail surface near the CRD platform showing the presence of black material (Courtesy of TEPCO Holdings[205]).

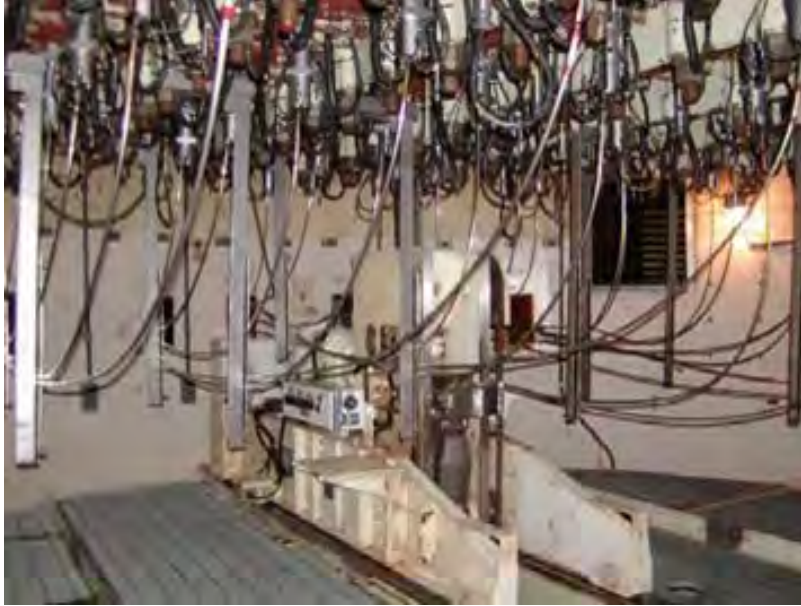
Figure 56. Photo showing the inside of 1F2 during a regular inspection. (Courtesy of TEPCO Holdings [207]).

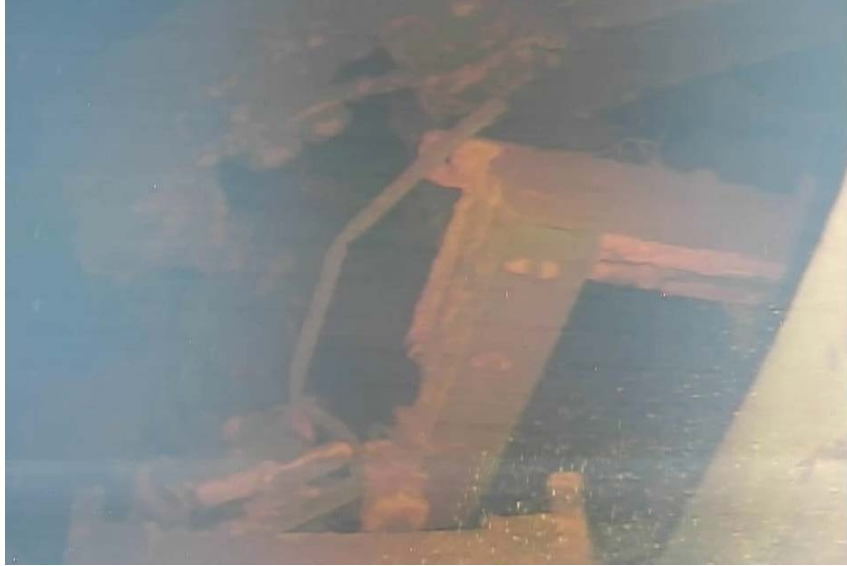
Figure 58. Image of relocated CRD rail on the 1F3 platform with no grating; obtained on July 19, 2017 (Courtesy of TEPCO Holdings [209]).

Investigations into the 1F3 containment performed in July 2017 have also yielded important information. Numerous images were obtained of relocated material from cameras that were installed on the submersible robot, “Little Sunfish” which was inserted into the X-53 penetration (Figure 57). These images indicate that some relocated materials were deposited on CRD housing and cable structures that remained relatively intact. However, in general, the damage to structures beneath the RPV lower head appear more severe than observed in 1F1 and 1F2 examinations (grating structures were no longer present, some CRD support structures had fallen onto the platform, and a significant amount of previously relocated material was detected on the containment floor within the pedestal region (see Figure 58 through Figure 60). Additional evaluations and examinations will be completed to discern the composition of these relocated materials.

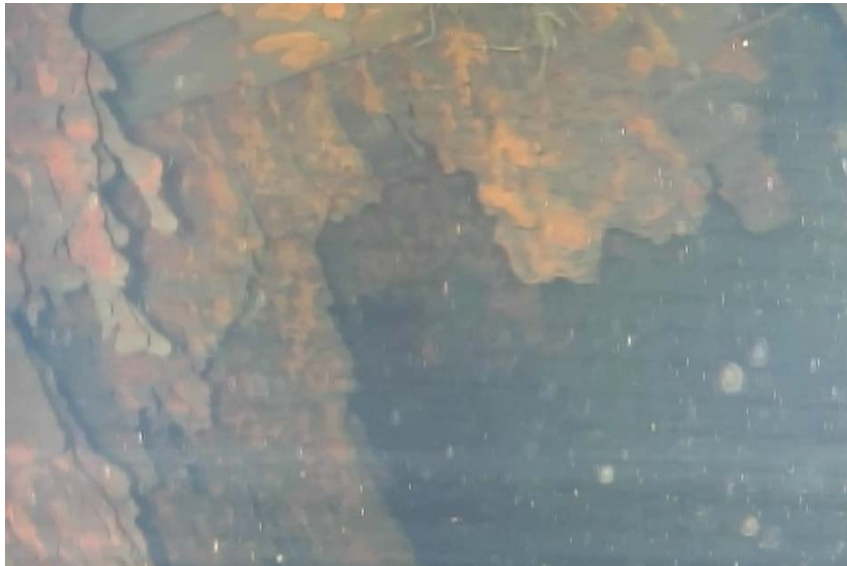
Figure 59. Image of relocated material adhered to remaining 1F3 CRD housing and cable structures; obtained on July 21, 2017 (Courtesy of TEPCO Holdings [210]).

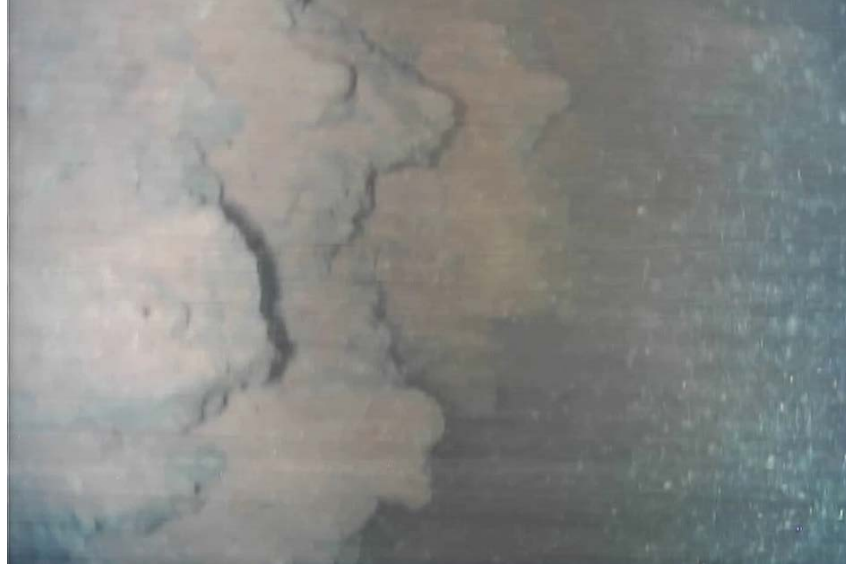
Figure 60. Image of material that had relocated beneath the 1F3 platform into the pedestal area; obtained on July 22, 2017 (Courtesy of TEPCO Holdings [211]).

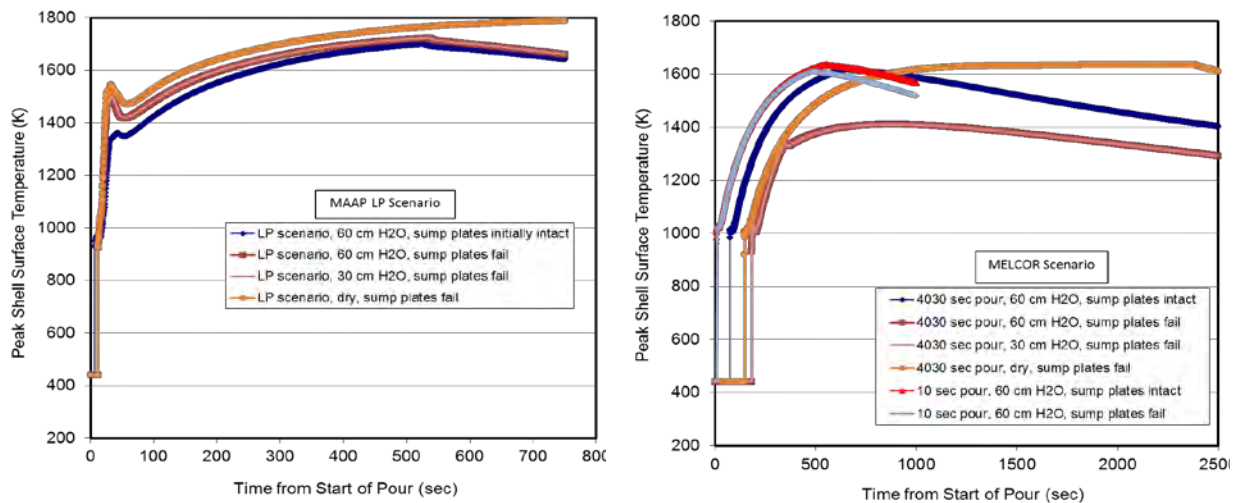
Figure 61. MELTSPREAD predictions of liner heatup due to heat transfer from impinging melt for 1F1 based on a MAAP low pressure (LP) scenario [50] (left) and MELCOR[49] (right) melt pour conditions. (Courtesy of ORNL [52])

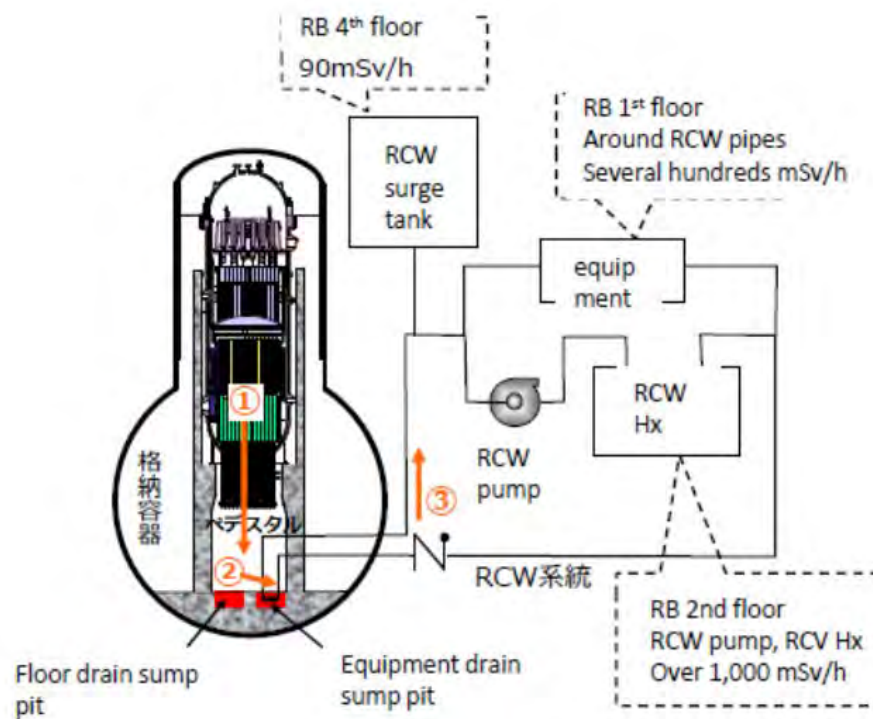
Figure 70. Illustration of 1F1 RCW system showing contamination levels within the system. (Courtesy of TEPCO Holdings [205])

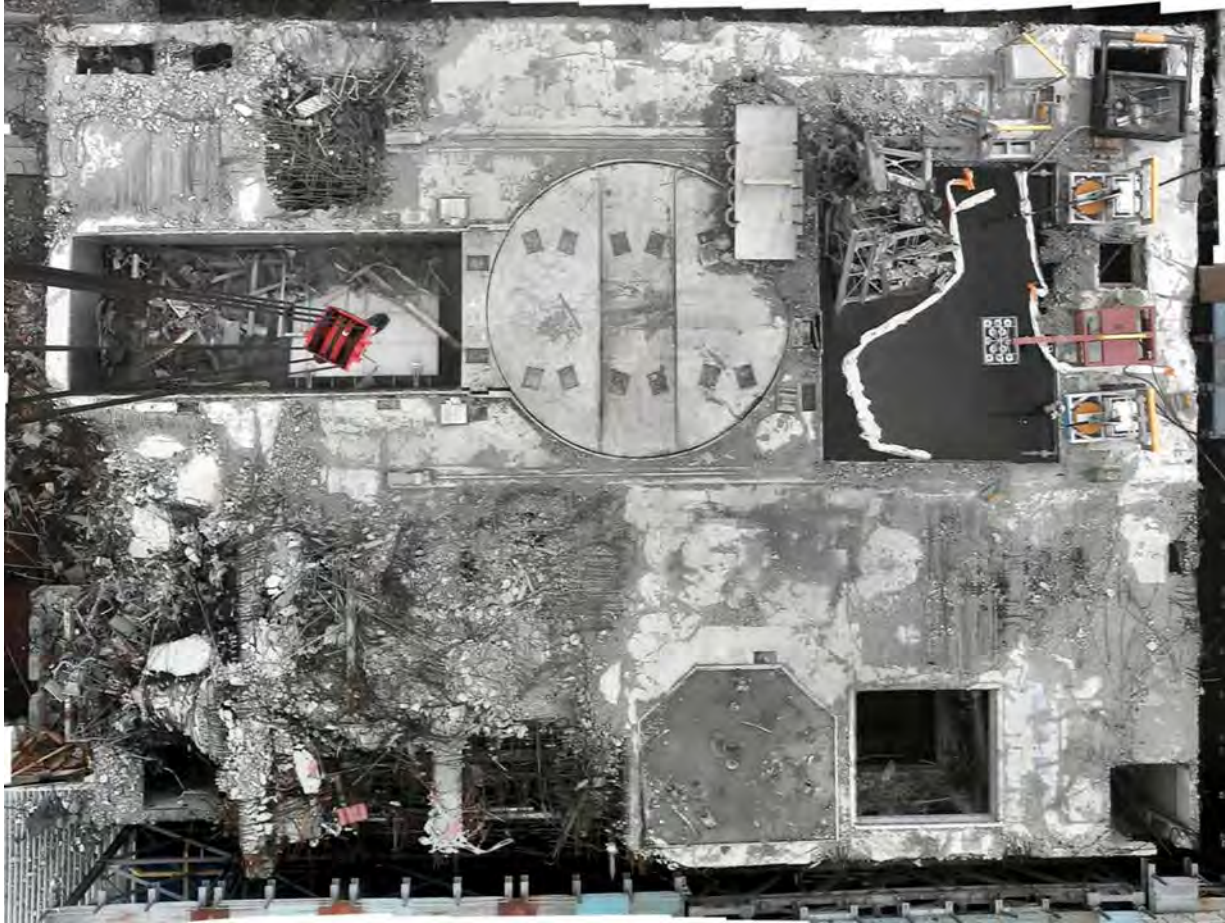
Figure 74. Damaged areas on 1F3 reactor building floor. (Courtesy of TEPCO Holdings [16])

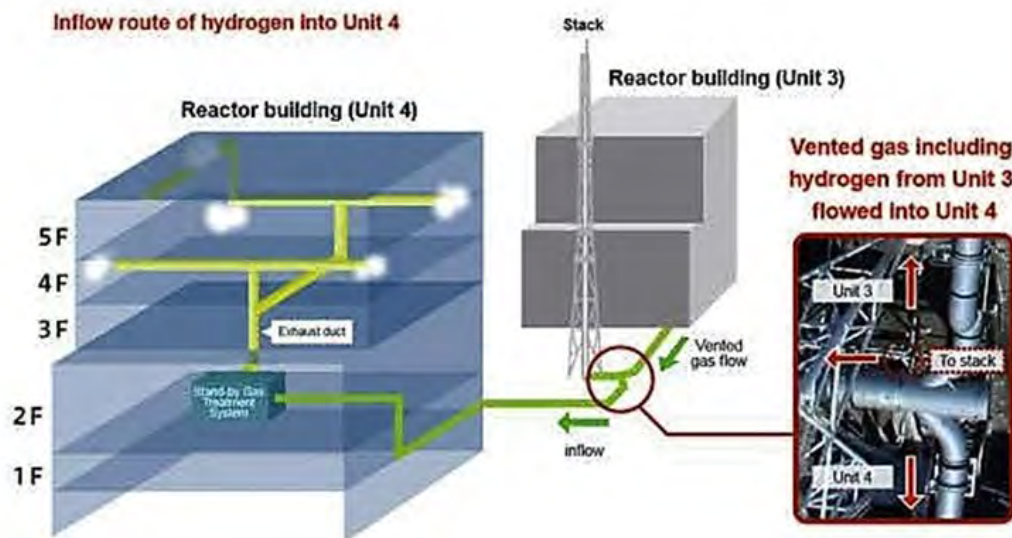
Figure 77. Hydrogen transport path from 1F3 to 1F4. (Courtesy of TEPCO Holdings [218])

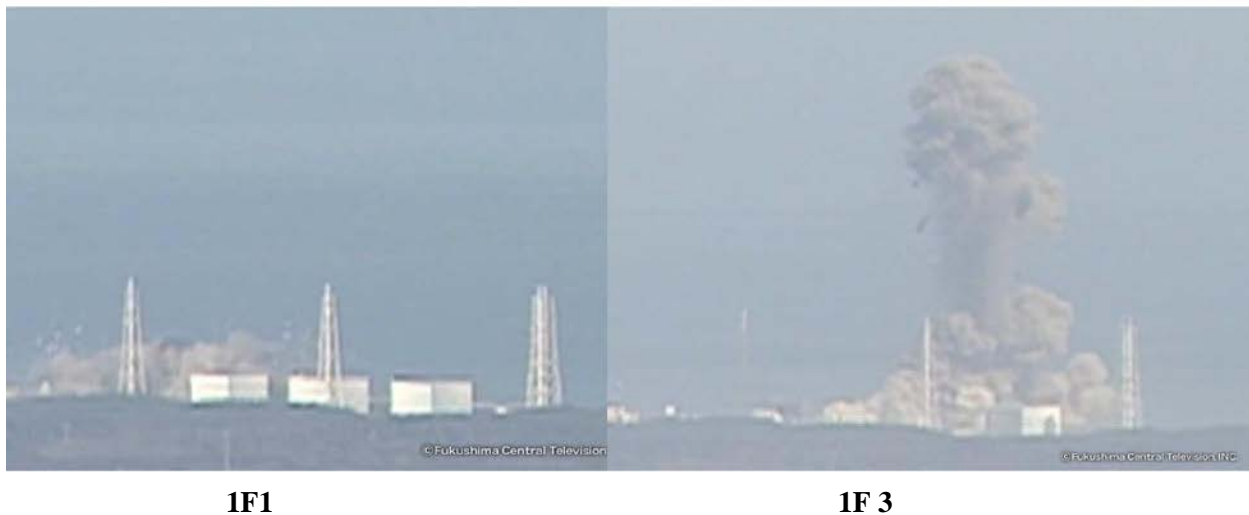
Figure 82. Images of 1F1 explosion compared with 1F3 explosion. (Courtesy of FCT [221])
