A COMPREHENSIVE FIELD TEST AND
EVALUATION OF AN ELECTRONIC SIGNPOST
AVM SYSTEM
Volume I: Test Results

G. W. Gruver

Hoffmann Information Identification Inc.
Fort Worth TX 76107

AUGUST 1977
FINAL REPORT

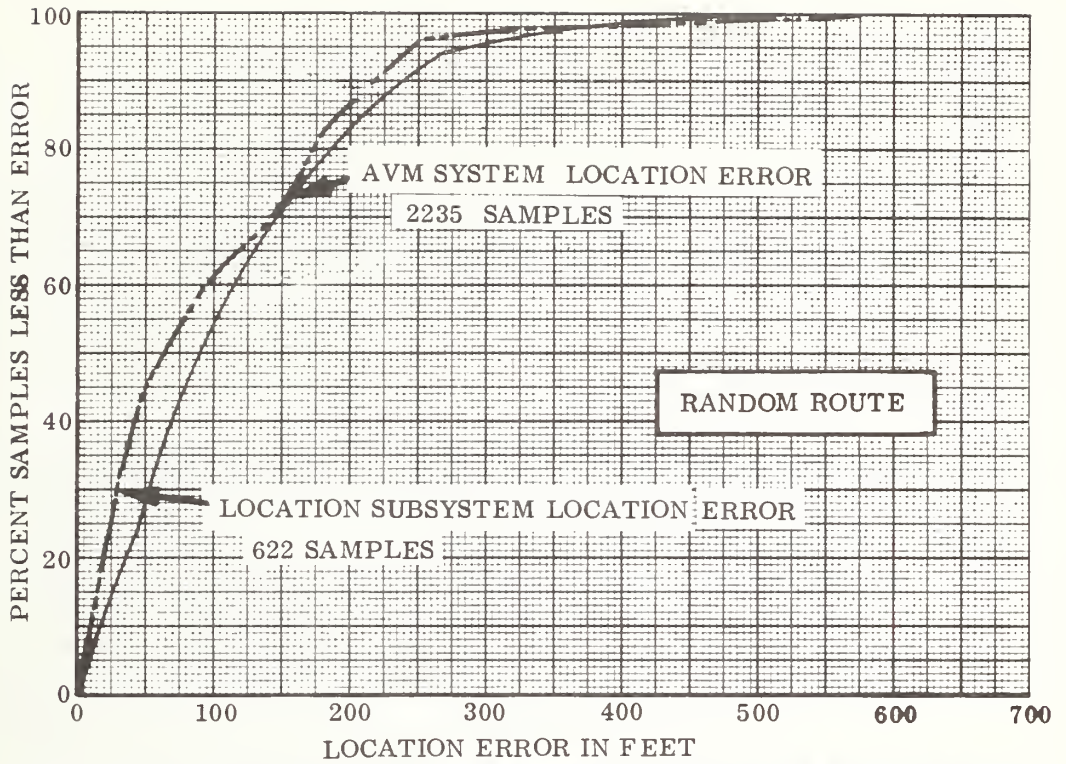
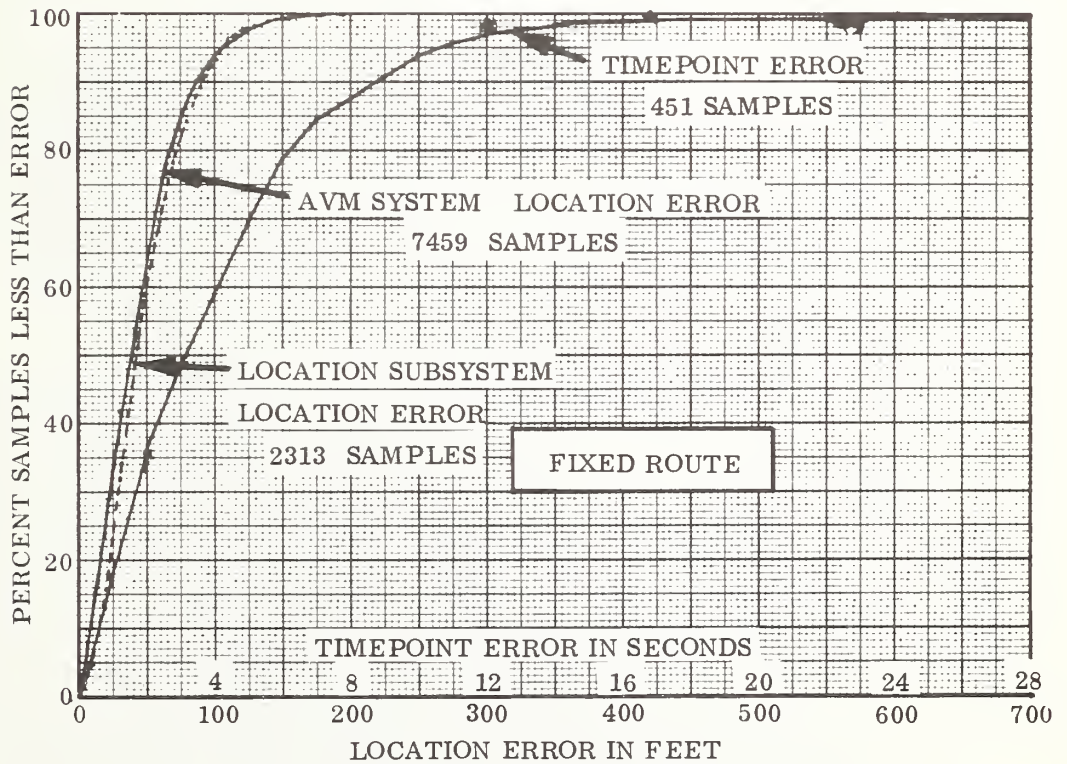
FIG. 2-3 DEMONSTRATED AVM SYSTEM PERFORMANCE

Figure 2-3 contains cumulative error distributions of random route and fixed route test data results. When translated into an operational system for random route vehicles, these data indicate that under similar urban conditions, a police dispatcher would know, with a 95 percent confidence level, the location of each and every AVM-equipped vehicle to within 282 feet. Similarly, the fixed route data indicates that a bus dispatcher would have at his fingertips the location and schedule performance of every bus on all routes to within 105 feet and to within 11 seconds at a 95 percent confidence level. The application of this information to providing increased service, improved response time, better schedule adherence, etc., forms the basis for the entire Phase II program.

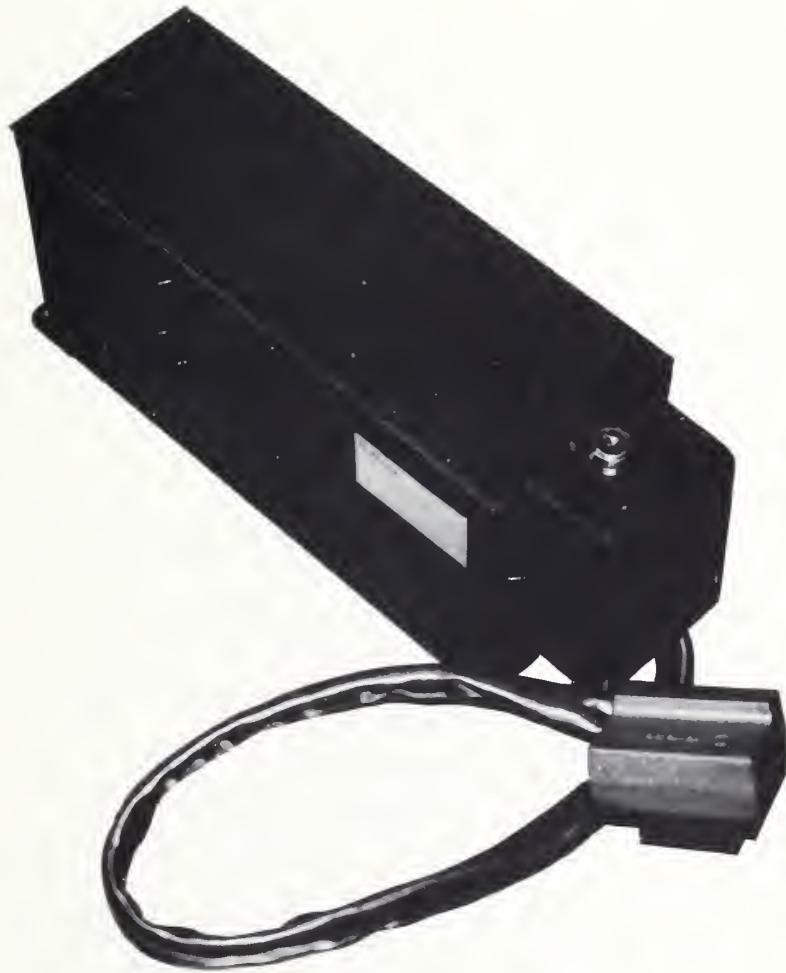
FIG. 3-5 HI³ TEST L.S. VEHICLE UNIT

The test LS vehicle unit draws its power directly from the test vehicle 12-volt system just as it will in the Phase II system. The vehicle unit is fused to prevent equipment damages and contains a built-in voltage regulator to compensate for voltage fluctuations.

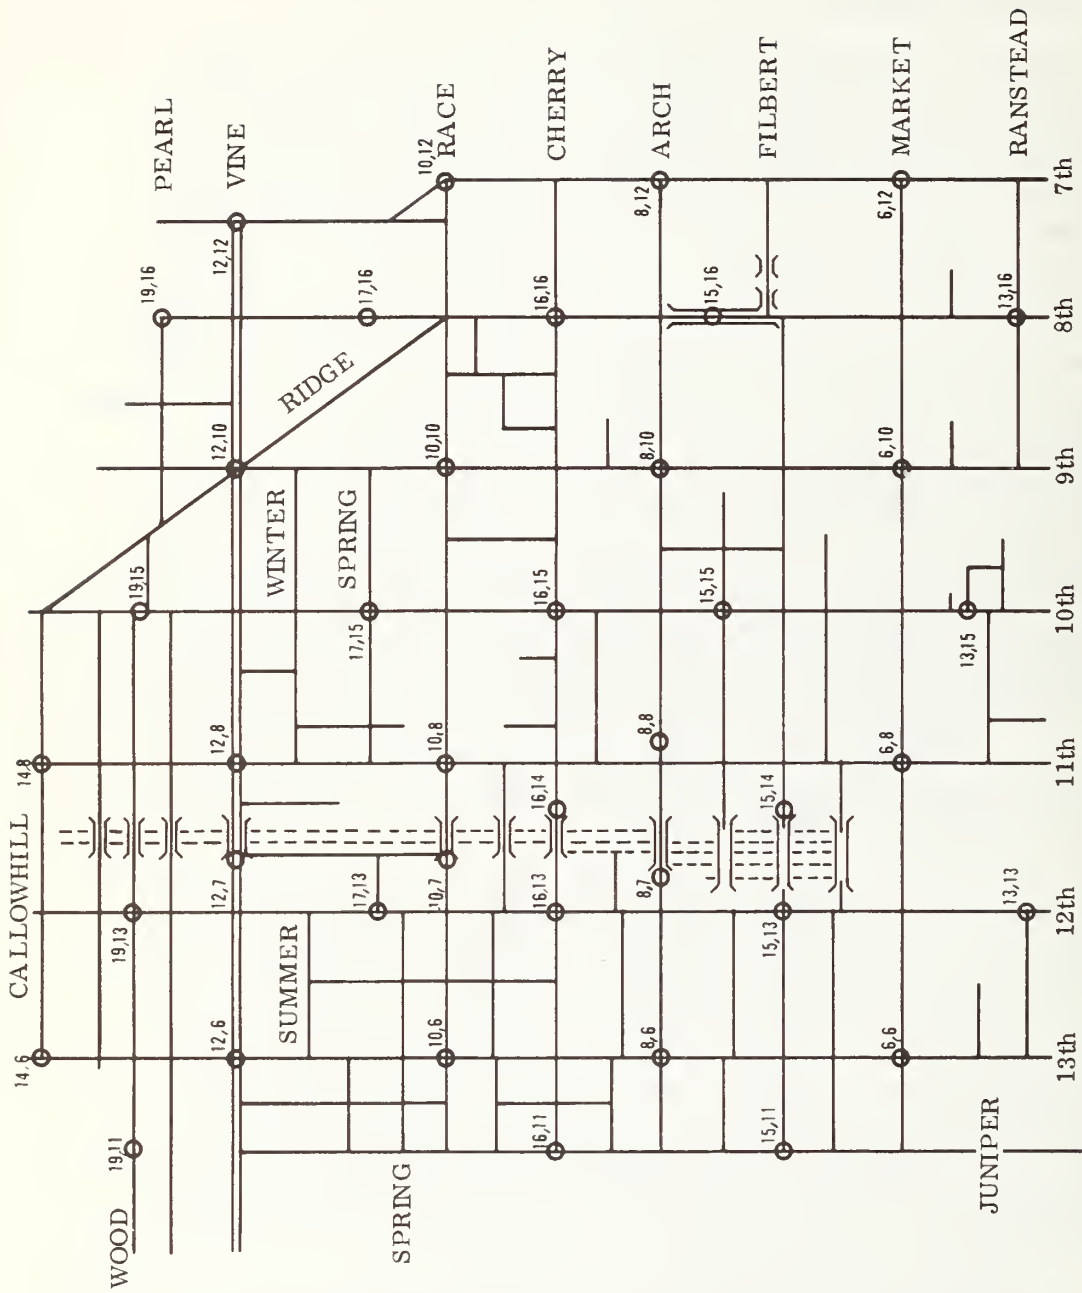
FIG. 3-12 HI³ RANDOM ROUTE TEST AREA AND SIGNPOST LAYOUT

The HI³ Random Route test area is shown in Figure 3-12 along with the signpost locations and the signpost codes. Figure 3-13 contains photographs of all installed random-route signposts.

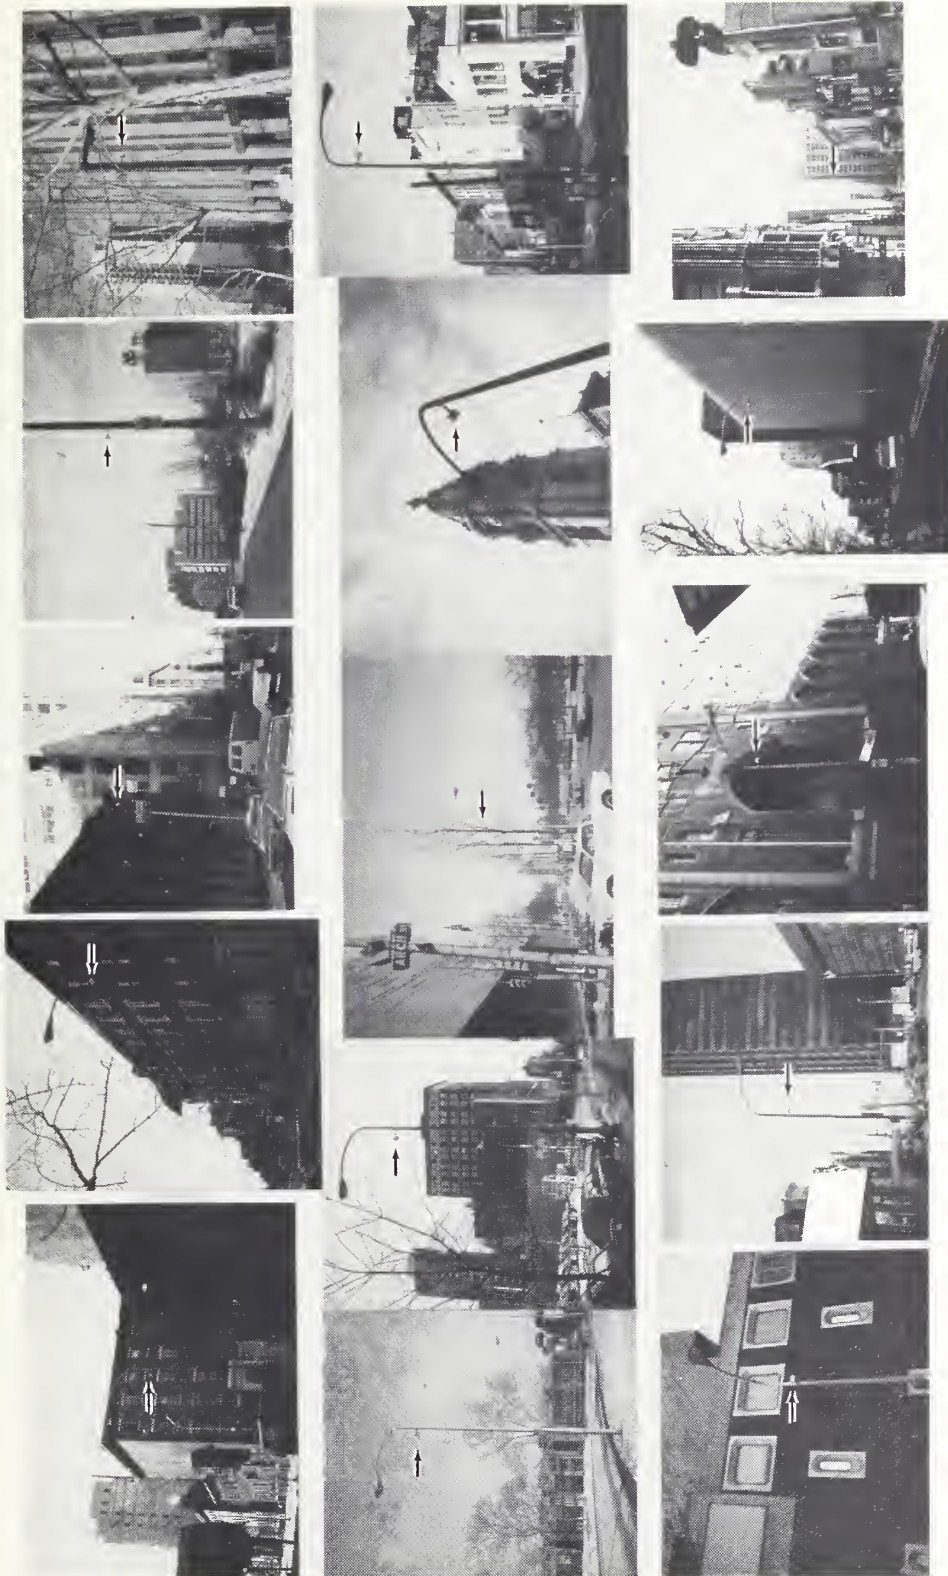
FIG. 6-5 FIXED ROUTE SIGNPOSTS

Figure 6-4 reflects the test route, the signpost locations, and the signpost codes. Figure 6-5 contains photographs of all 15 fixed route signposts.

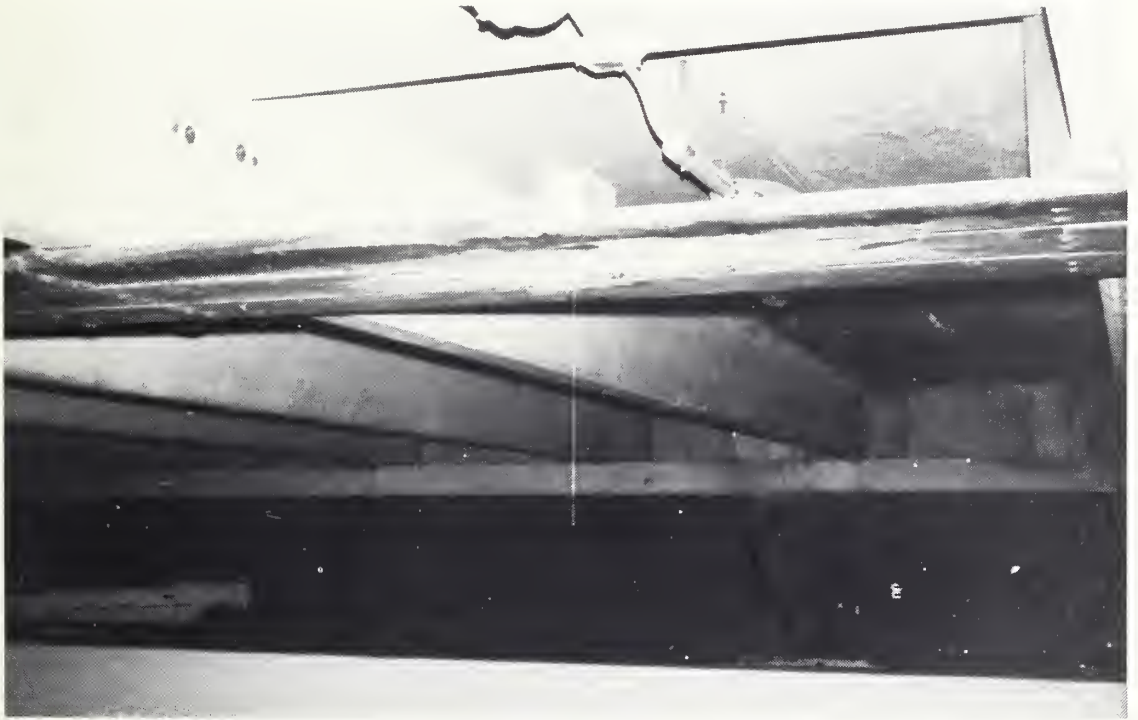
FIG. 9-2 SIGNPOST INSTALLATION IN 8TH STREET TUNNEL

A similar test involved installation of a signpost in the center of the 297-foot long covered roadway on 8th Street between Filbert and Arch. The signpost was installed, as shown in Figure 9-2, by simply setting the signpost on 2 by 12-inch wooden walkway with the antenna extended downward between two 2- by 12-inch boards. This signpost (15, 16) created a Region 1 location region within the tunnel and produced overlap regions in conjunction with signposts (16, 16) to the North and (13, 16) to the South. Data obtained during Random Route Test Run 8 are also shown in Figure 9-3. The vehicle was traveling South on 8th after passing signpost (16, 16) at 8th and Cherry. At the intersection of 8th and Arch, the vehicle received a Level 3 from signpost (15, 16) in the tunnel and declared a new location region (16, 16) R3S, 230 feet from signpost (15, 16). While the vehicle stopped, the location toggled to a (16, 16) R2S and a (15, 16) R3N. Just under the tunnel entrance, a Region 1 from signpost (15, 16) was declared. 144 feet from signpost (15, 16), a (15, 16) R3N was declared followed by a (15, 16) R1 at a distance of 128 feet from signpost (15, 16). This code was stored throughout the remainder of the tunnel until a (15, 16) R2S was declared 194 feet south of signpost (15, 16). The location error incurred during this run is shown plotted in Figure 9-3.

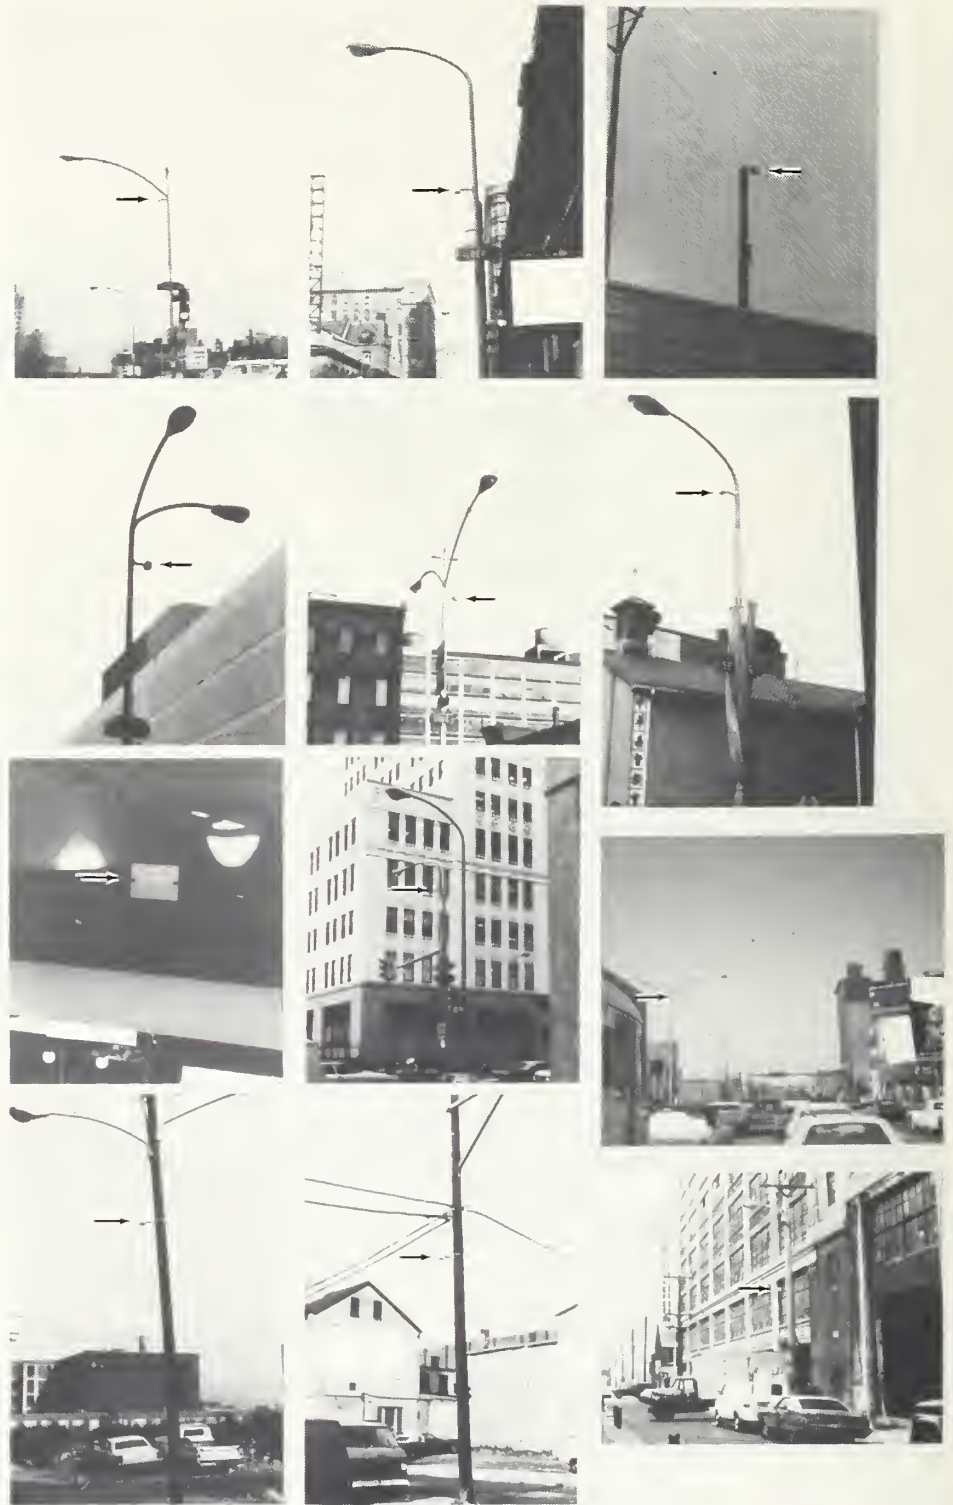
FIG. 9-6 A VARIETY OF SIGNPOST INSTALLATIONS

The same signpost was utilized and antennas mounted at the same height, 23 feet, during both sets of measurements although the poles were quite different, as shown
(Text continued on 9-16)

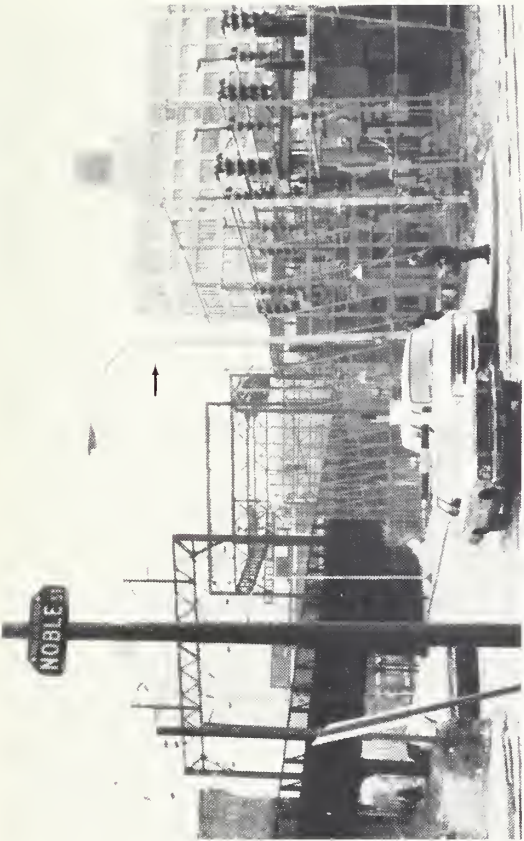
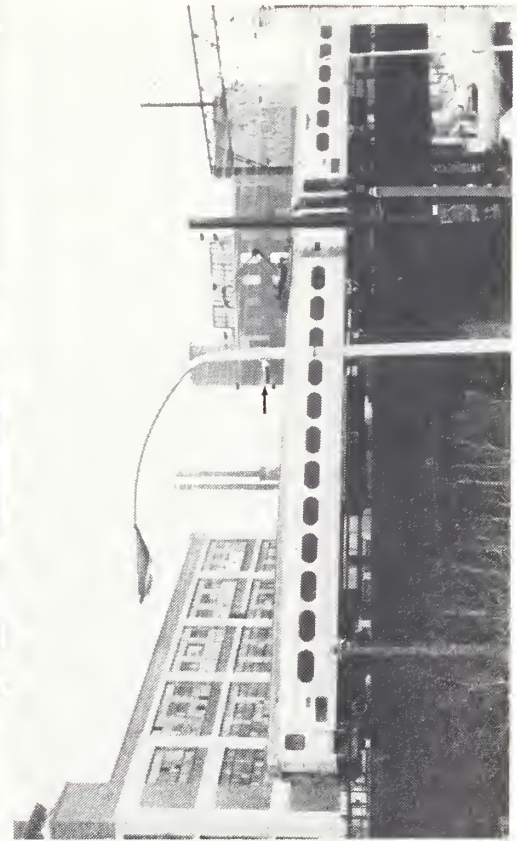
FIG. 9-10 POWER SUBSTATION TEST CONFIGURATION

These tests were conducted at the intersection of 11th and Noble. As shown in Figure 9-10, both the Southwest and Northwest corners of this intersection are covered by power substations. The tests were conducted by operating the test vehicle against signpost (15, 13) which was mounted on a street light on the Southwest corner. Table 9-4 contains the results obtained. The signpost was successfully received and decoded on each and every pass. When the test vehicle was located near the Reading Railroad crossing, on 11th Street, an overlap region between signpost (15, 13) and signpost (19, 13) was recorded. Signpost (19, 13) was located approximately 680 feet South on 11th Street. A strong 60 cycle hum could be distinctly heard emitting from the substation as far as 1 block away. The overall results obtained during this test document the fact that 60-cycle EMI has no perceptible effect on the HI³ location subsystem.

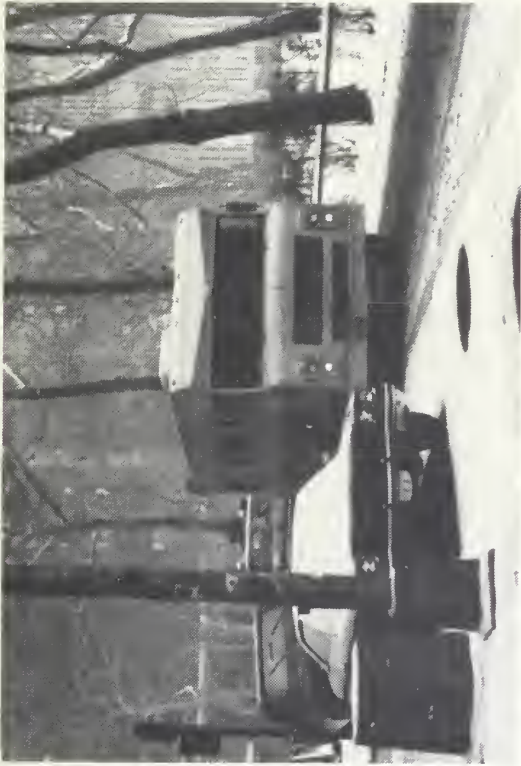
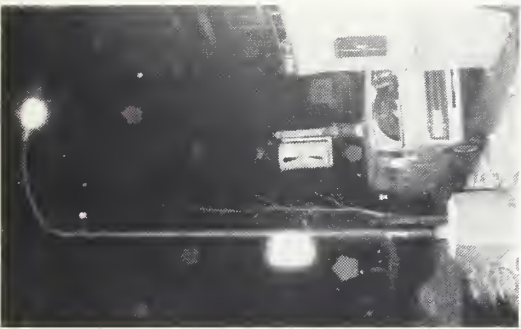
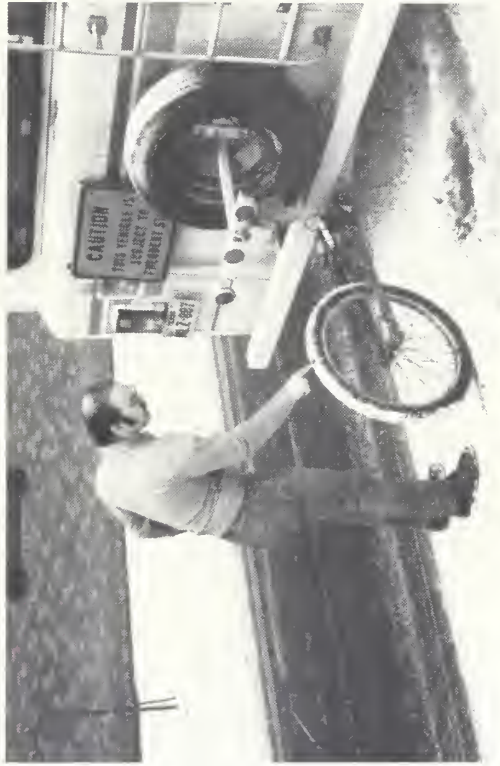
FIG. 9-11 INCREMENT WEATHER TEST CONDITIONS

The only problems created by the weather involved the 5th wheel. These included (1) a shorted connector caused by water on Run 26, (2) loss of a magnet during Run 32, probably because of roadway ice ruts, and (3) an accumulation of up to 1/4 inch of ice and slush on the 5th wheel as shown in Figure 9-11. An average accumulation of 1/8-inch increase in the radius of this 13-inch radius wheel produces an error since the wheel would turn 1 percent fewer revolutions per foot, or, on the basis of assuming a total distance traveled of 68,000 feet, a total of 100 fewer revolutions. This difference would produce an error (shorter indicated distance traveled by the 5th wheel) of 681 feet. A comparison of odometer and 5th wheel distances for the fixed route indicated that this buildup of snow and ice in conjunction with some sliding of the 5th wheel did indeed cause the 5th wheel to lose distance during those runs where the centers of streets were icy.

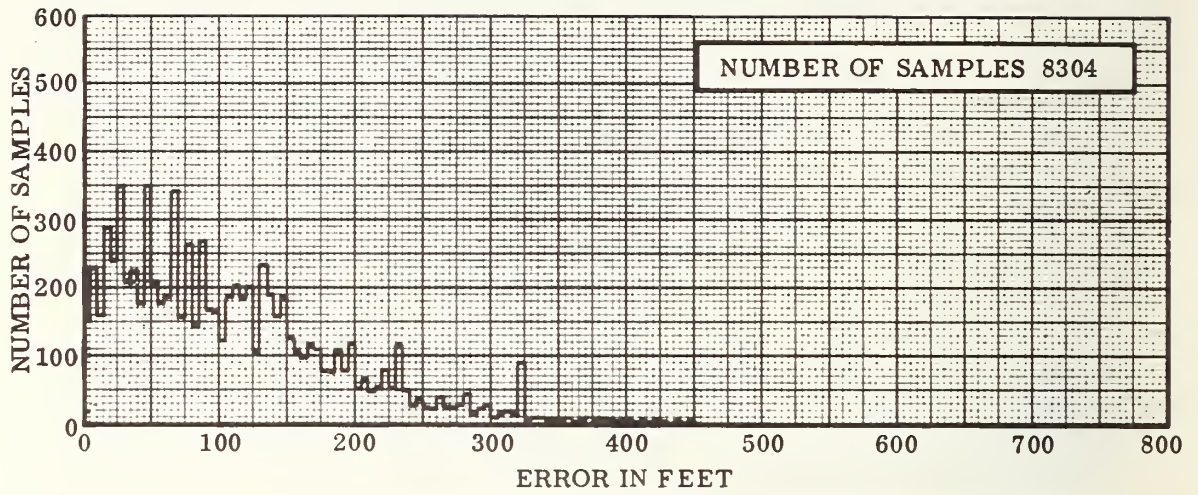
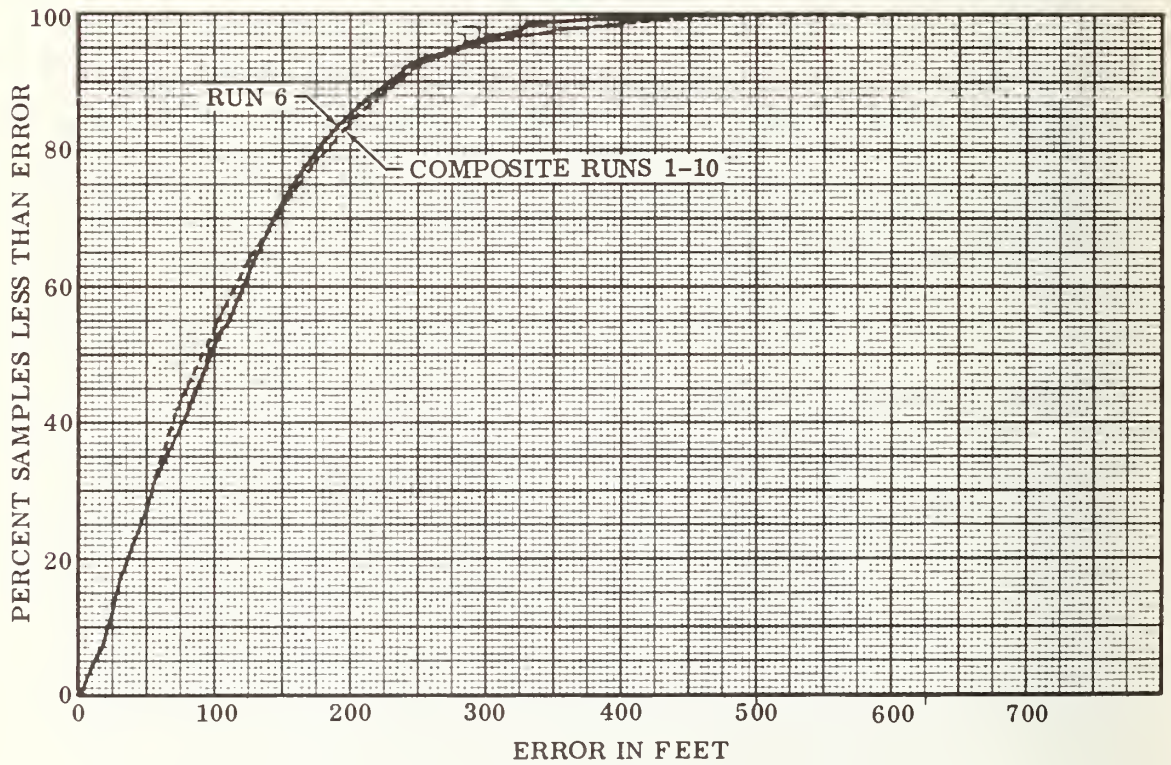
FIG. 10-2 HI³ RANDOM ROUTE LOCATION SUBSYSTEM ERROR DISTRIBUTION

Other parameters of interest relative to the HI³ location subsystem are the distribution of overlap region sizes. These parameters could not be explicitly determined from Phase I data because the passage of each signpost was not marked and the occurrence of cross-track overlaps partially obscured the occurrence of on-track overlaps. However, an approximation to these distributions was obtained by analyzing the listings of recorded data from Random Route Runs 6 through 10. The distances from the checkpoints which were located near signposts to the first occurrence of Region 2's and Region 3's was determined. Of the 5 runs analyzed, 116 such occurrences were observed. Of these, 91 occurrences involved receiving a region 2 after having passed through a Region 1 and 25 occurrences involved receiving a Region 3 after passing through a Region 1. 64 occurrences of Region 2 to Region 3 transitions (equivalent to Region 2 widths) were also analyzed. The distributions of these three distances
