Research Report No. 2 for ALDOT Project 930-762

**LABORATORY TESTING OF TRANSVERSE
JOINTS FOR PRECAST-PANEL BRIDGE-DECK
REPLACEMENT SYSTEMS**

AUGUST 2020

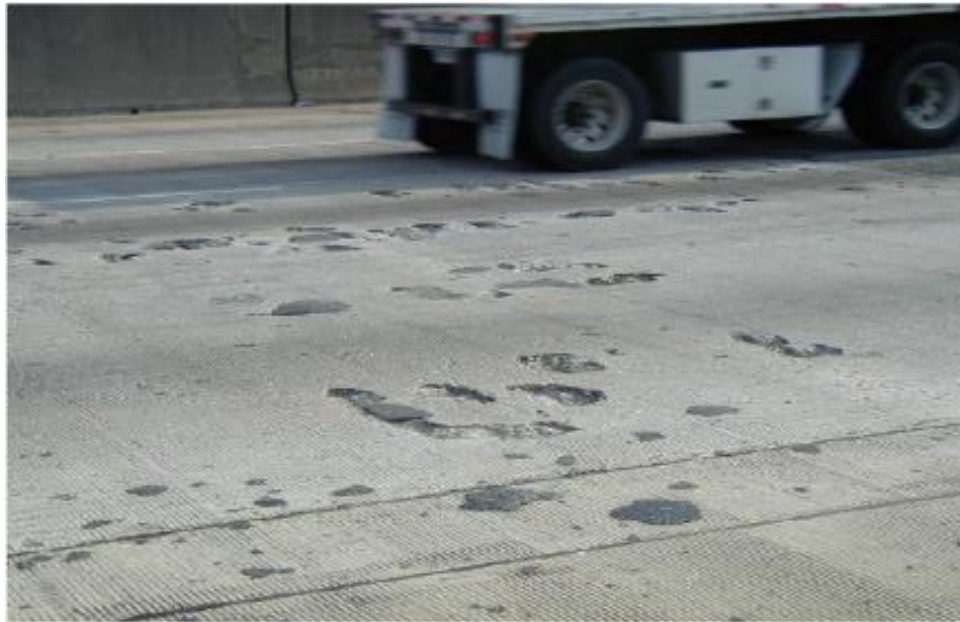
Out of the 16,098 bridges in Alabama, 1,229 are structurally deficient (FHWA 2016). The term structurally deficient means that a bridge has at least one structural defect which may indicate that a structural component does not satisfy current code requirements or that a structural component is damaged and thus has a reduction in structural capacity. In many instances this structural deficiency relates to the deck of the bridge. Deck degradation is very common in bridges over 25 years old (Biswas 1986). Many decks fail several years before the rest of the bridge superstructure and substructure reach the end of their useful life (Bettigole and Robison 1997). Figure 2.1 shows the deterioration of a typical bridge deck.

Figure 2.1 Typical Deck Deterioration (Umphrey 2006)

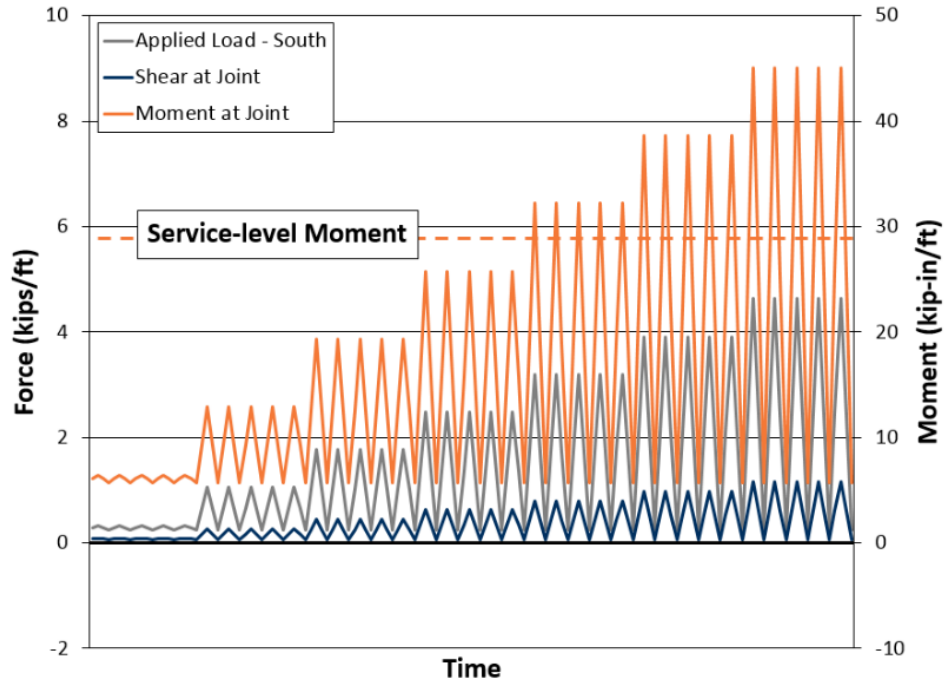
Figures 3.11, 3.12, and 3.13 show the loading procedure in relation to the theoretically calculated shear and moment at the joint per unit width for the positive bending, negative bending, and shear reversal tests, respectively.

Figure 3.11 Positive Bending Quasi-Static Loading Procedure

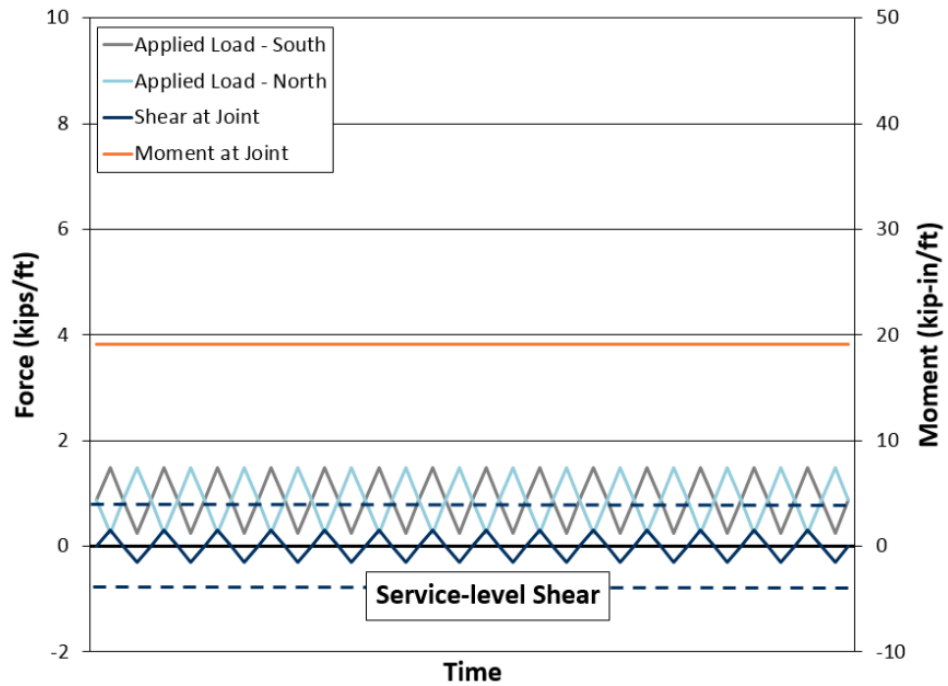
Figure 3.16 Shear Reversal Fatigue Loading Procedure

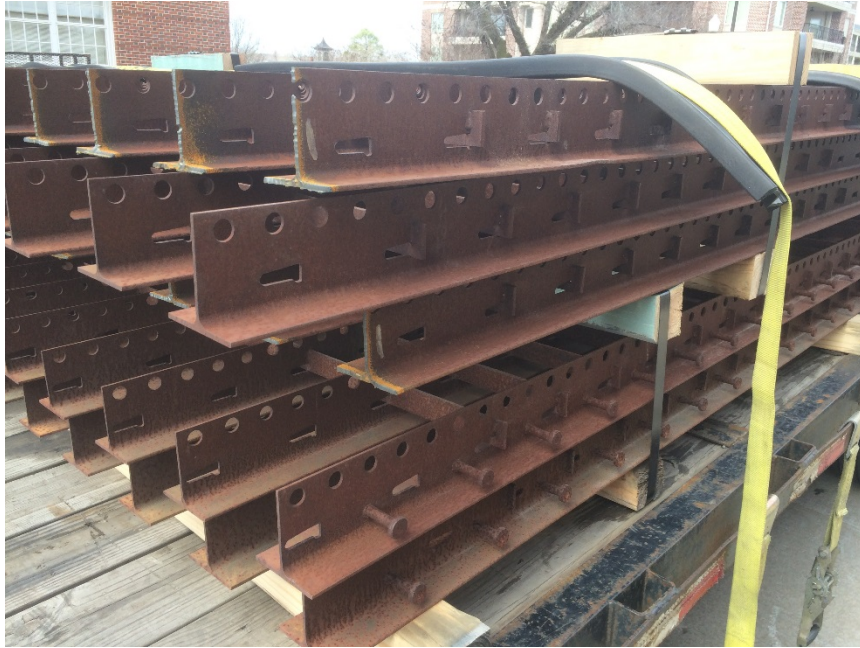
The grids were exposed to the weather on the D.S. Brown Company property for several years. Although light surface rusting had developed, the grids were still in adequate shape. Two of the five grids were designed for the unreinforced shear key joint decks while the other three grids were designed for the staggered hook reinforced joint decks. Figure 4.8 shows the difference between the steel grids. The two steel grids designed for the unreinforced shear key joint decks contained an additional attribute, specifically, $\frac{1}{2}$ in. x 2 in. welded studs at 6 in. on center.

Figure 4.8 Comparison of the Steel Grids

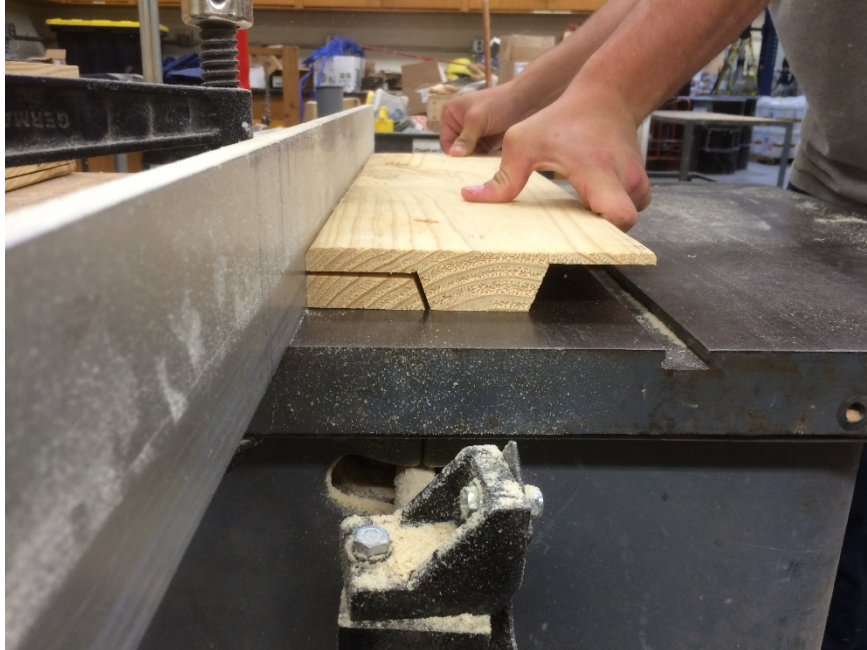
Figure 4.12 Unreinforced Shear Key Joint End Cap

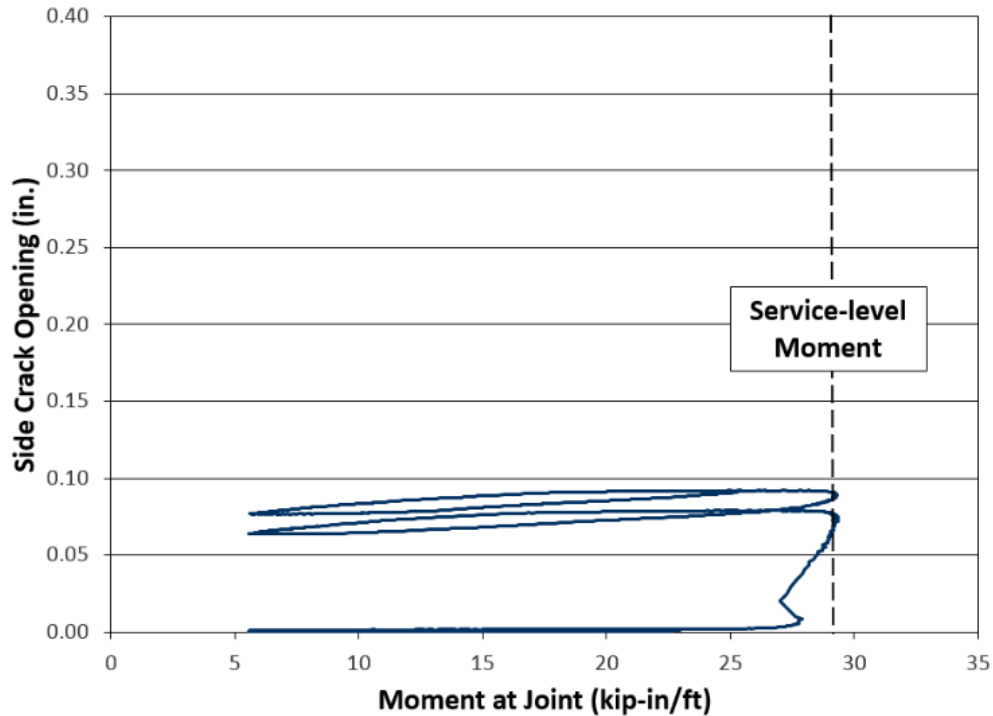
Figure 5.3 shows the behavior of the side crack opening versus moment at joint. Similarly, as noted above, at each load step as the moment at the joint increased, the side cracks opened wider.

Figure 5.3 Side Crack Opening versus Moment at Joint (U-POS-Q)

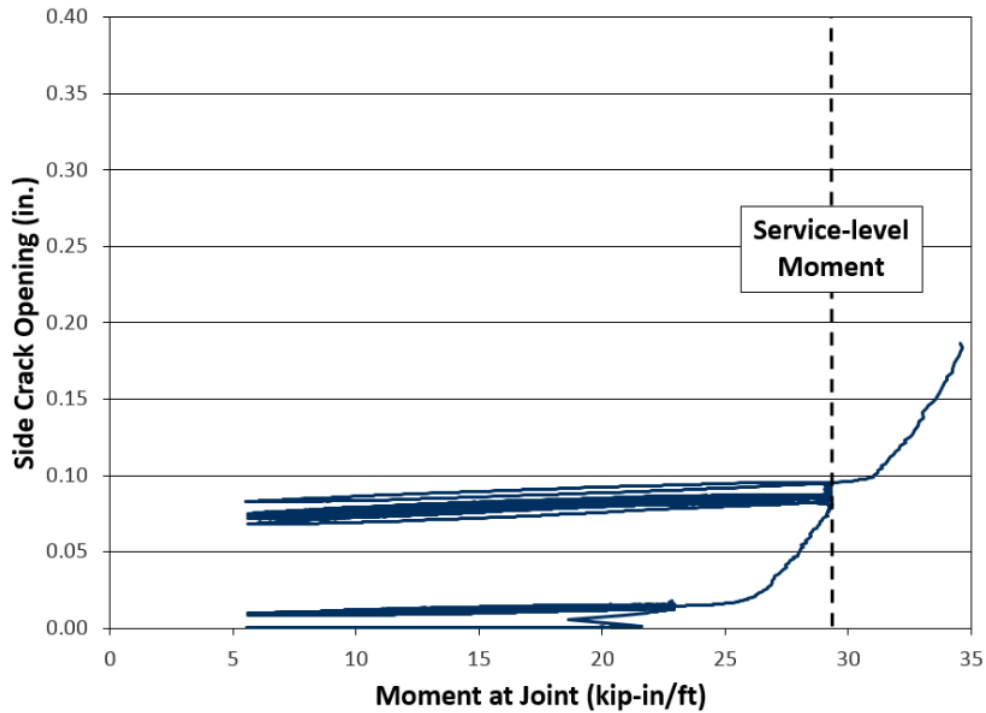
Figure 5.6 shows the behavior of the side crack opening versus moment at joint. Similarly, as noted above, at each load step as the moment at the joint increased, the side cracks opened wider.

Figure 5.6 Side Crack Opening versus Moment at Joint (R-POS-Q)

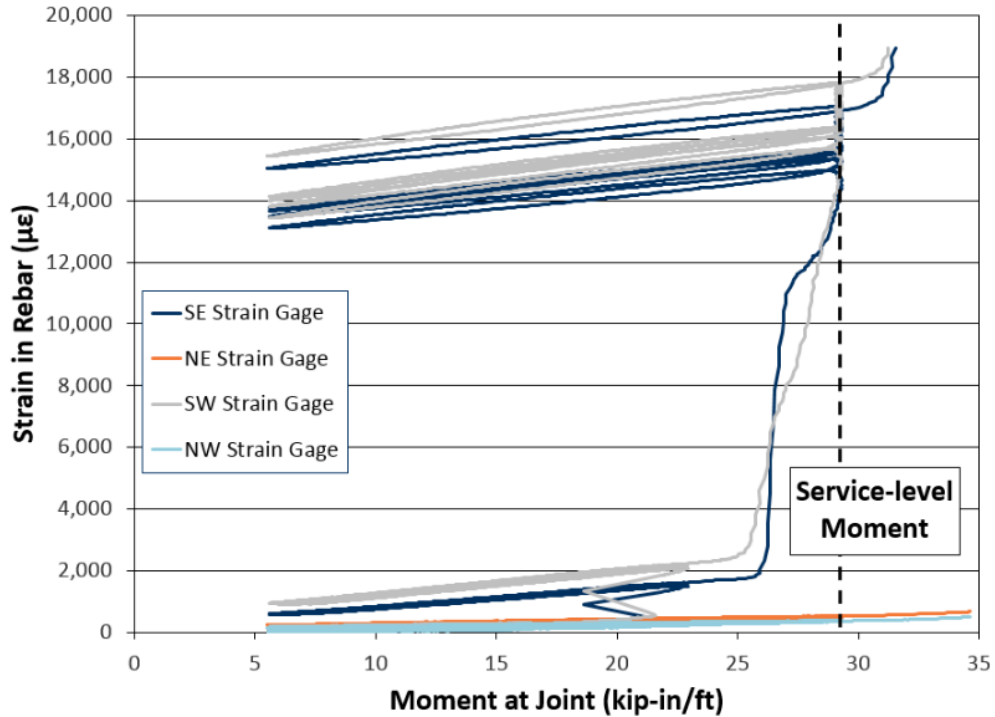
Figure 5.7 shows the behavior of the strain in reinforcing steel versus moment at joint. At each load step as the moment at the joint increases, more cracks form in the specimen and the strain in the reinforcement increases. Note that the SE and SW strain gages increased significantly between the third and fourth load step compared to the NE and NW strain gages. This shows that the south reinforcing steel yielded at 25.7 kip-in/ft. The strain gages reached their limit at approximately 19,000 $\mu\epsilon$.

Figure 5.7 Strain in Reinforcing Steel versus Moment at Joint (R-POS-Q)

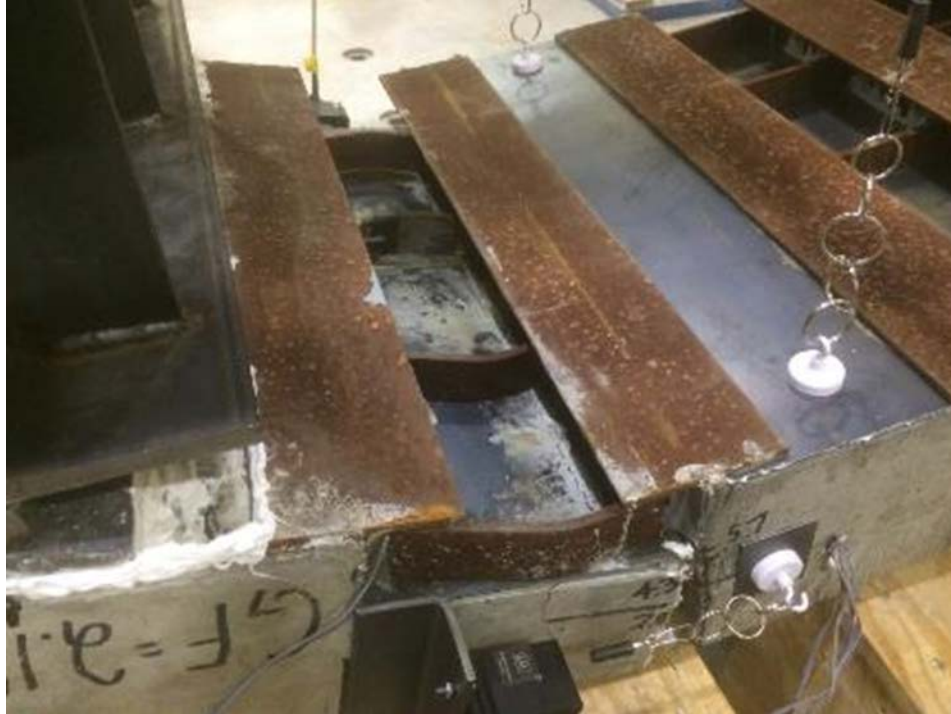
The distribution bars acted as part of the load-resisting mechanism of the specimen. These bars resisted compressive stresses and ultimately failed by buckling as shown in Figure 5.12.

Figure 5.12 R-NEG-Q Buckled Distribution Bars (Inverted Specimen)

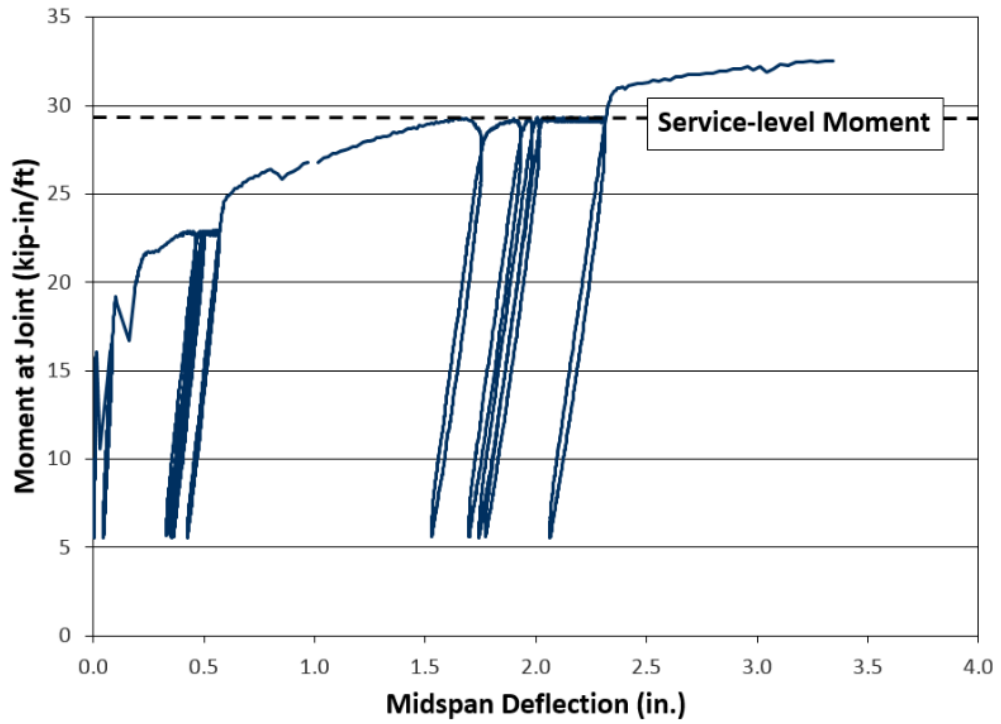
Figure 5.13 shows the behavior of the moment at joint versus midspan deflection. Note at each load step as the moment at the joint increased, more cracks formed in the specimen and the midspan deflection increased. The bottom wirepots were utilized to capture the specimen behavior after the top wirepots exceeded their stroke limit.

Figure 5.13 Moment at Joint versus Midspan Deflection (R-NEG-Q)

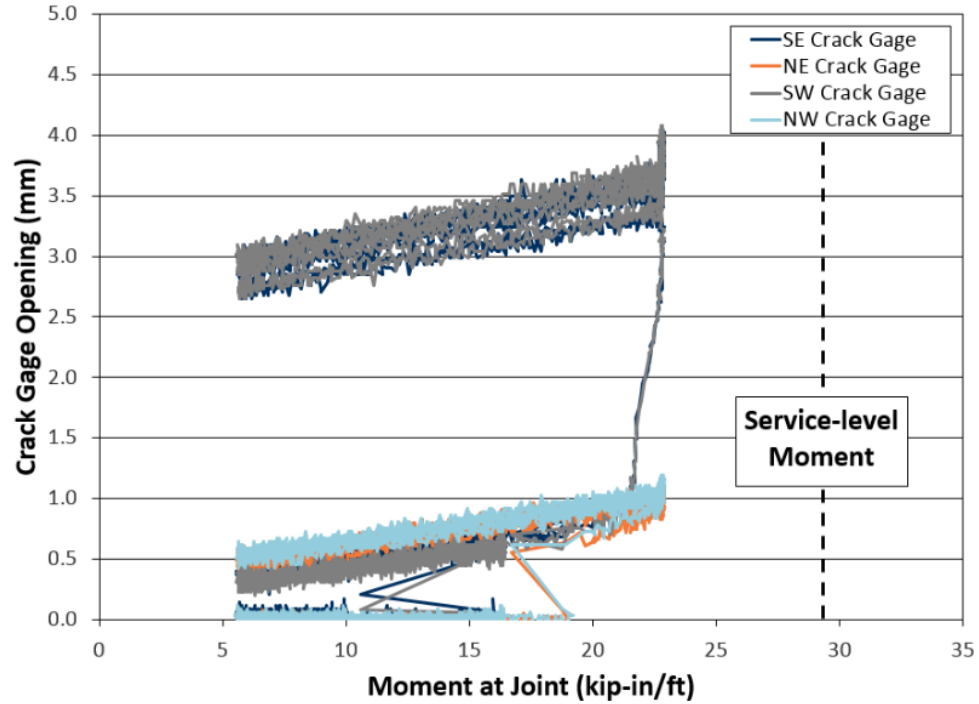
Figure 5.15 shows the behavior of crack gage opening versus moment at joint. Note that the SE and SW crack gages increased significantly during the third load step compared to the NE and NW crack gages. This shows the larger crack opening along the south joint interface compared to the north joint interface. The crack gages were removed after the third load step to avoid any potential damage to the gages.

Figure 5.15 Crack Gage Opening versus Moment at Joint (R-NEG-Q)

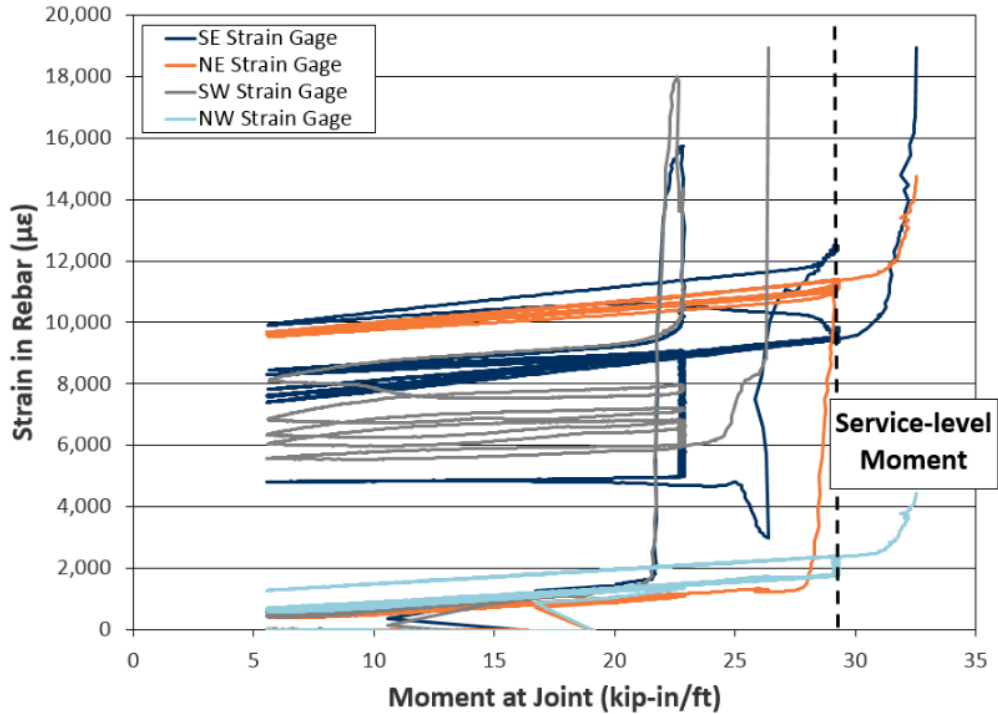
Figure 5.16 Strain in Reinforcing Steel versus Moment at Joint (R-NEG-Q)

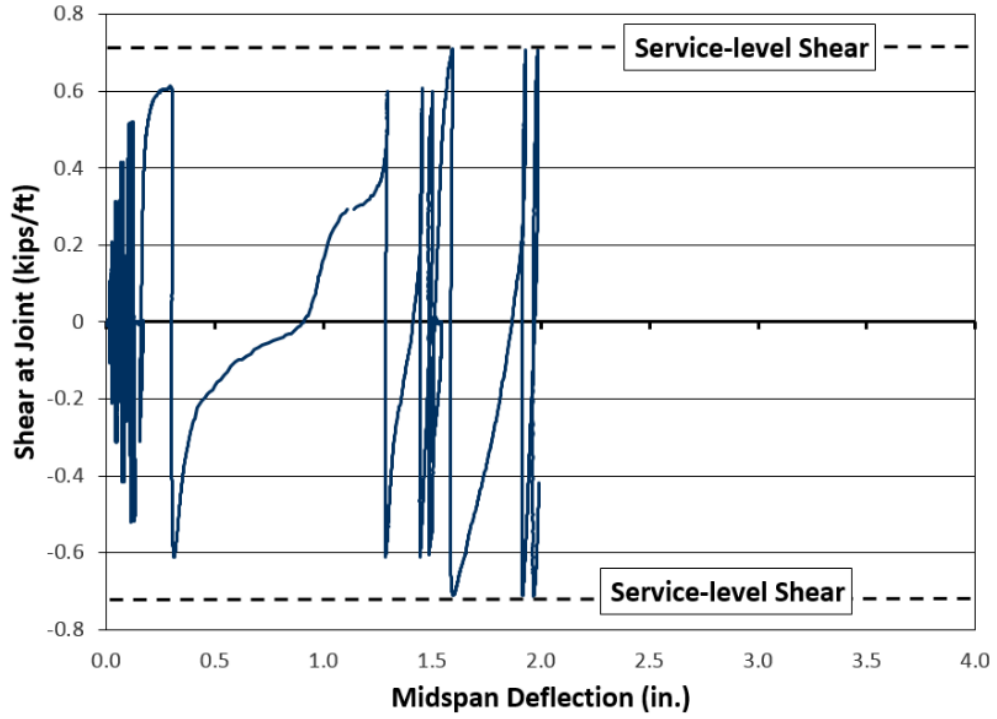
Figure 5.18 Shear at Joint versus Midspan Deflection (U-REV-Q)

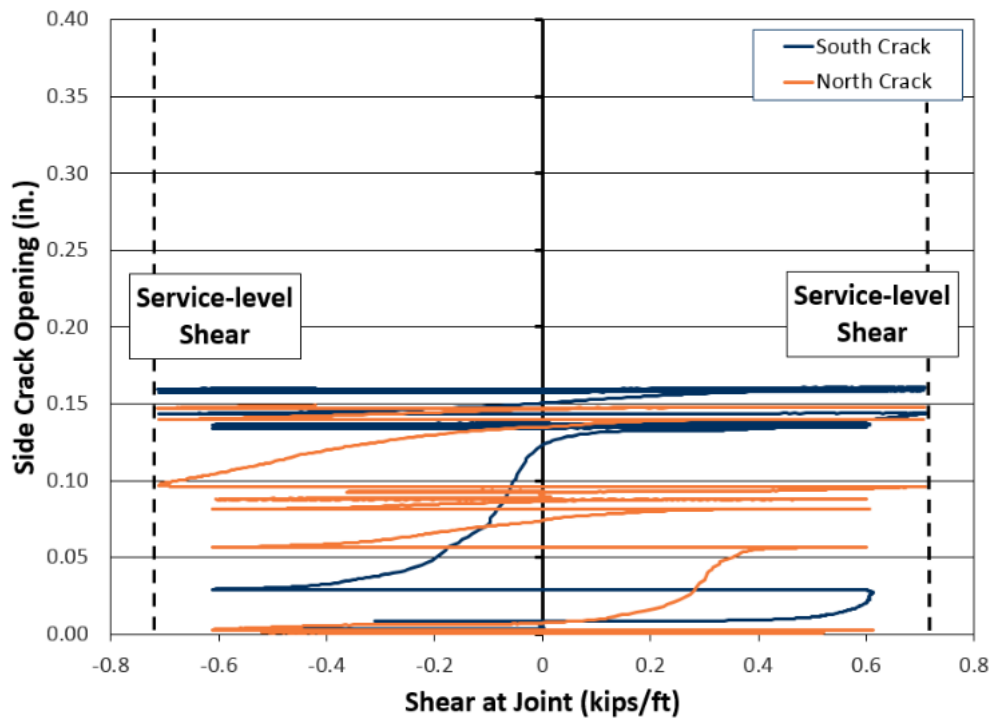
Figure 5.19 Side Crack Opening versus Shear at Joint (U-REV-Q)

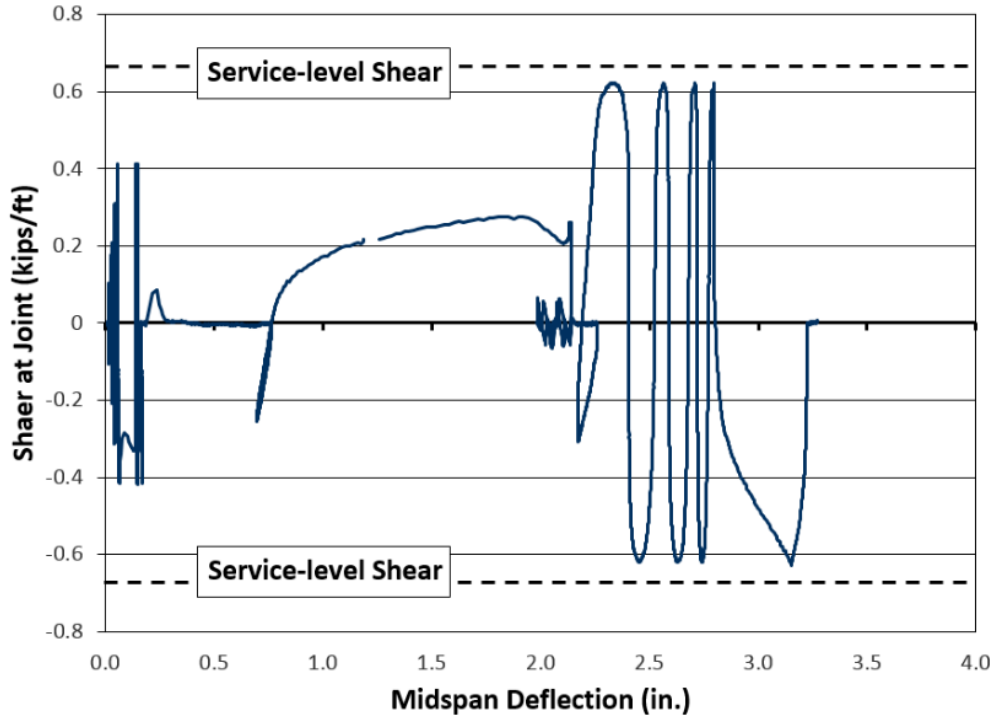
deflection increased. The bottom wirepots were utilized to capture the specimen behavior after the top wirepots exceeded their stroke limit.

Figure 5.21 Shear at Joint versus Midspan Deflection (R-REV-Q)

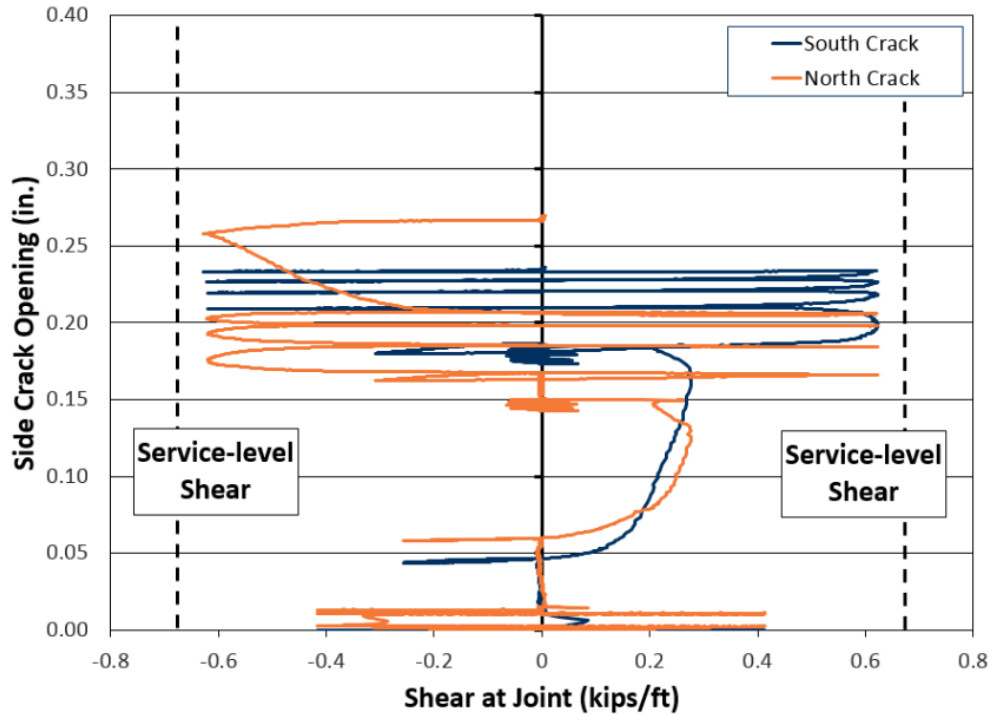
Figure 5.22 Side Crack Opening versus Shear at Joint (R-REV-Q)

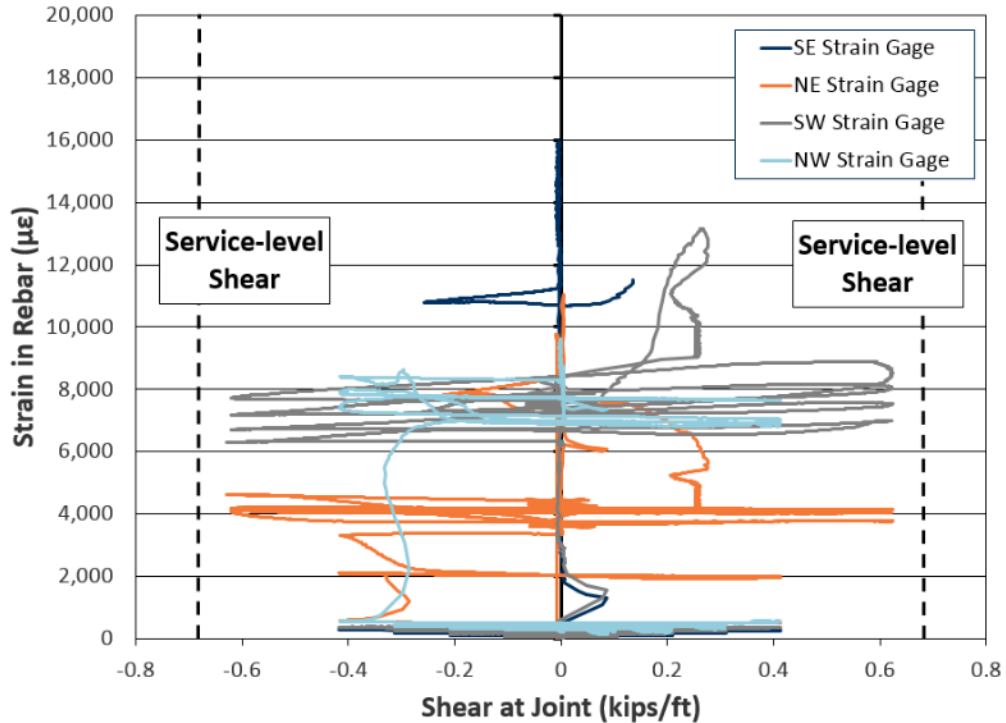
Figure 5.23 Strain in Reinforcing Steel versus Shear at Joint (R-REV-Q)

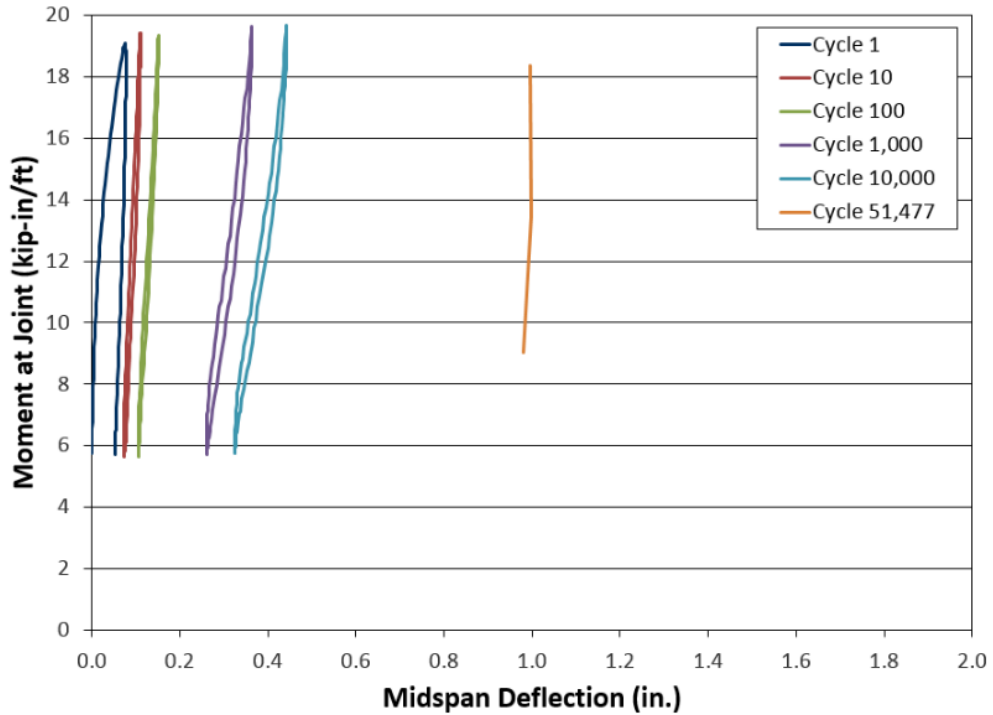
Figure 5.25 Moment at Joint versus Midspan Deflection (U-POS-F)

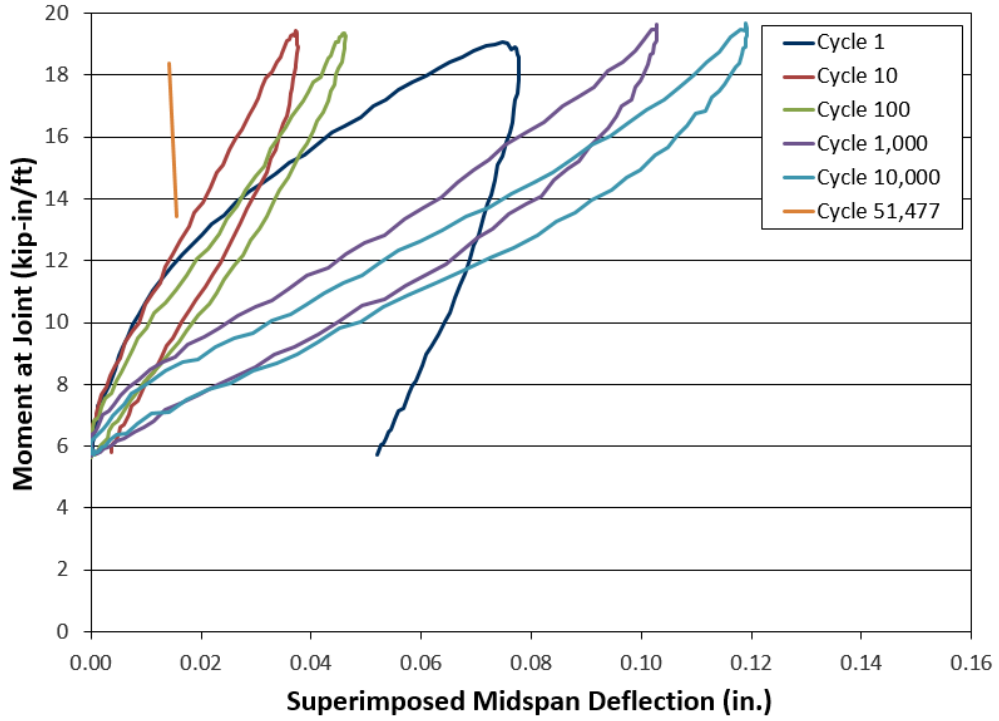
Figure 5.26 Moment at Joint versus Superimposed Midspan Deflection (U-POS-F)

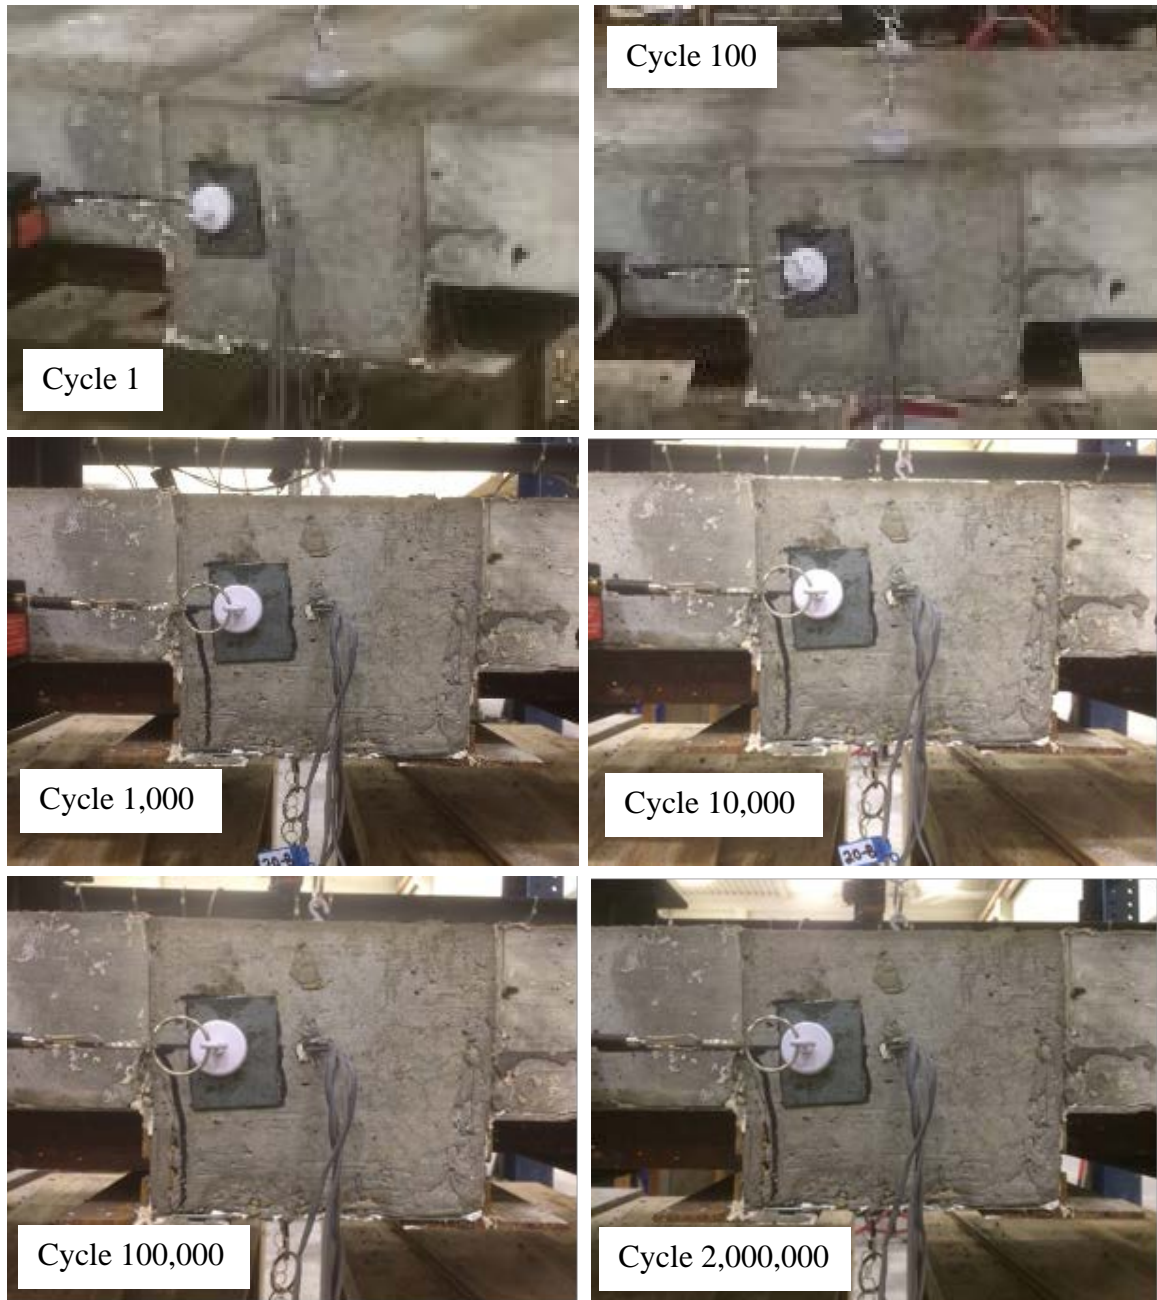
Figure 5.28 R-POS-F Joint Before at Discrete Intervals

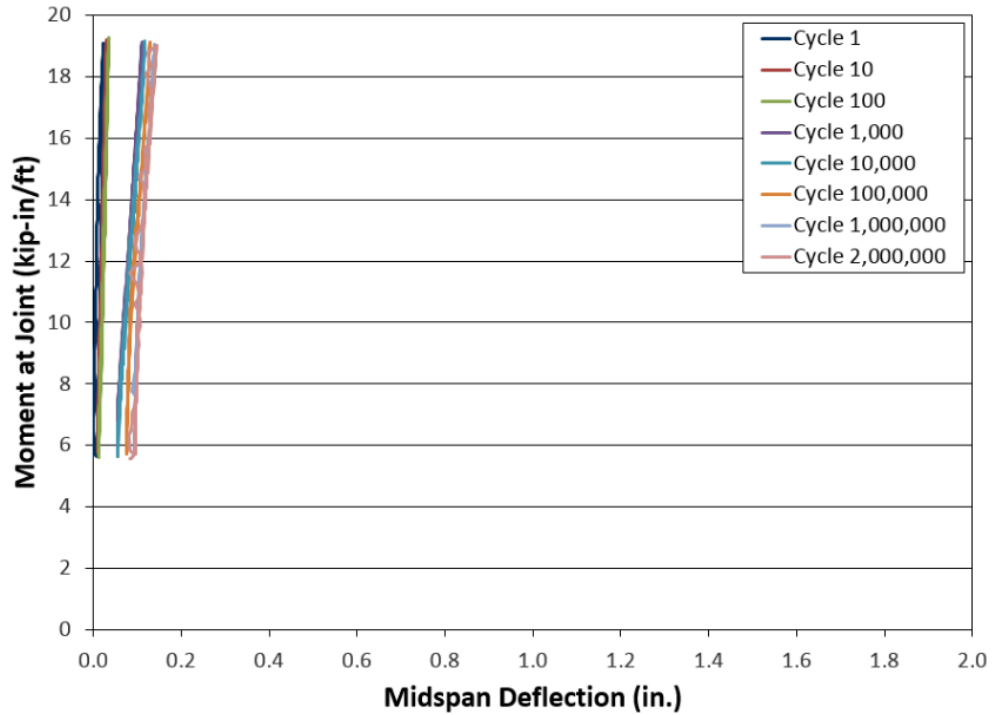
Figure 5.29 Moment at Joint versus Midspan Deflection (R-POS-F)

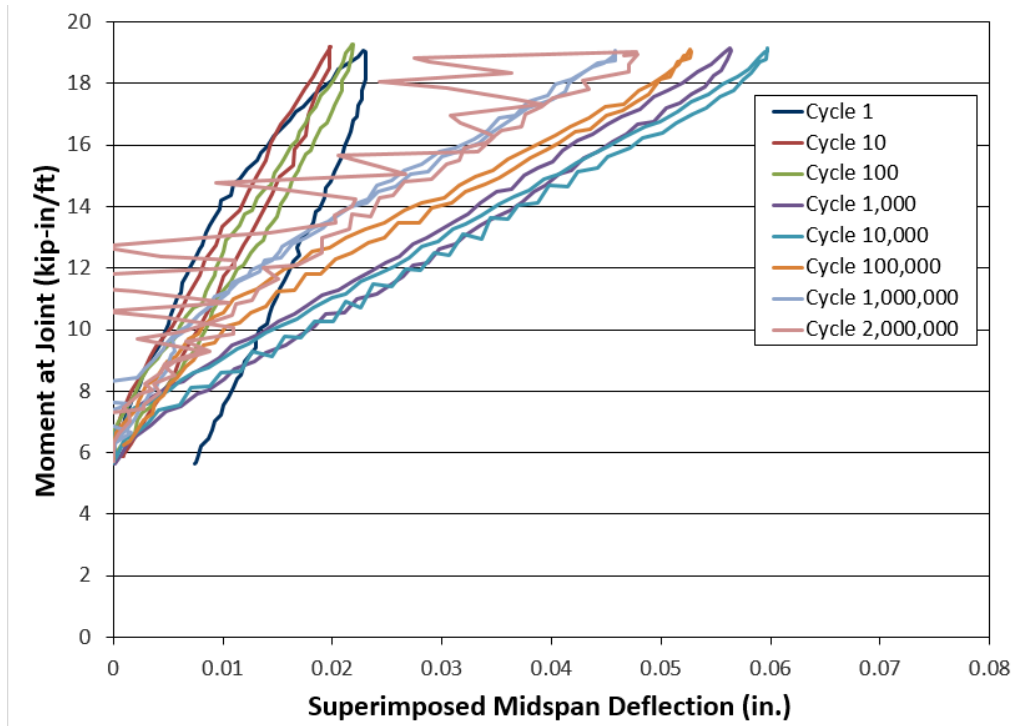
Figure 5.30 Moment at Joint versus Superimposed Deflection (R-POS-F)

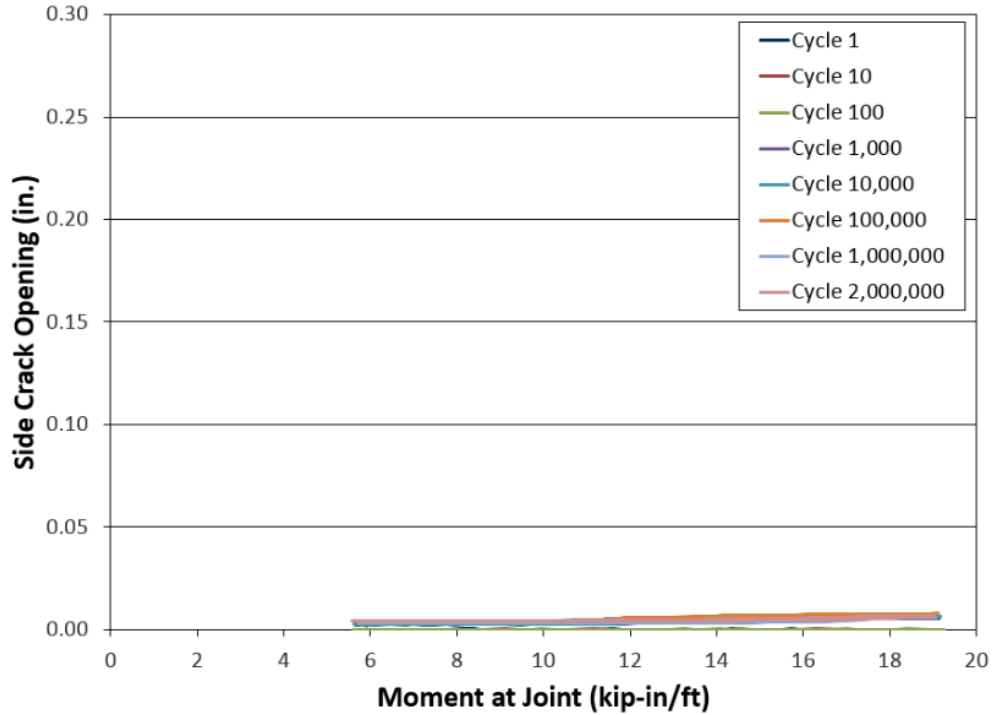
Figure 5.31 Side Crack Opening versus Moment at Joint (R-POS-F)

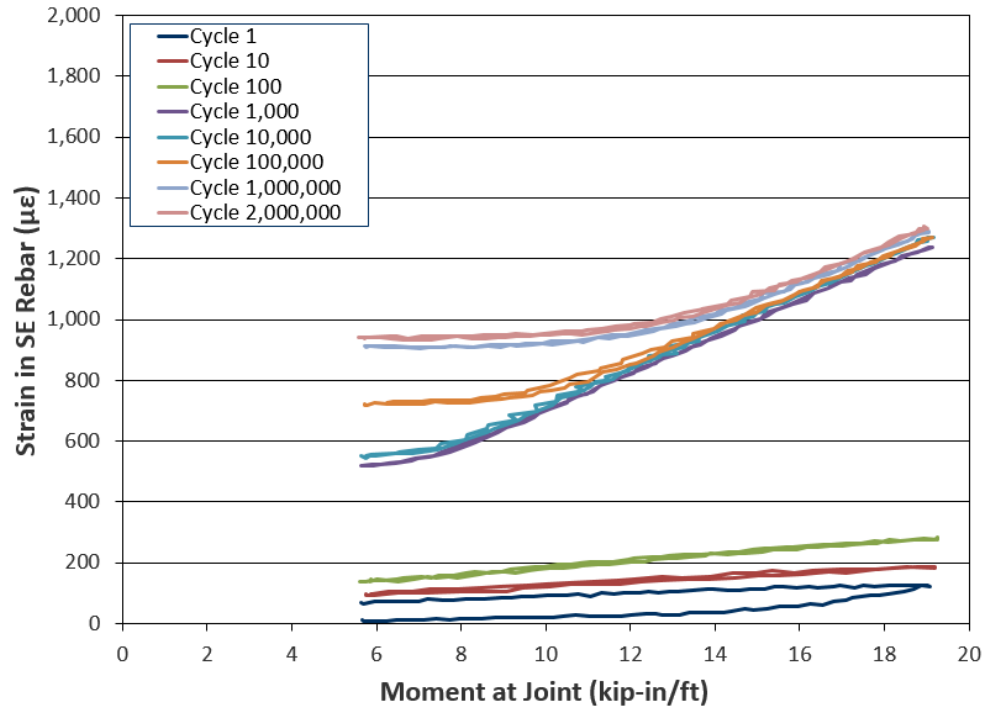
Figure 5.32 Strain in SE Reinforcing Steel versus Moment at Joint (R-POS-F)

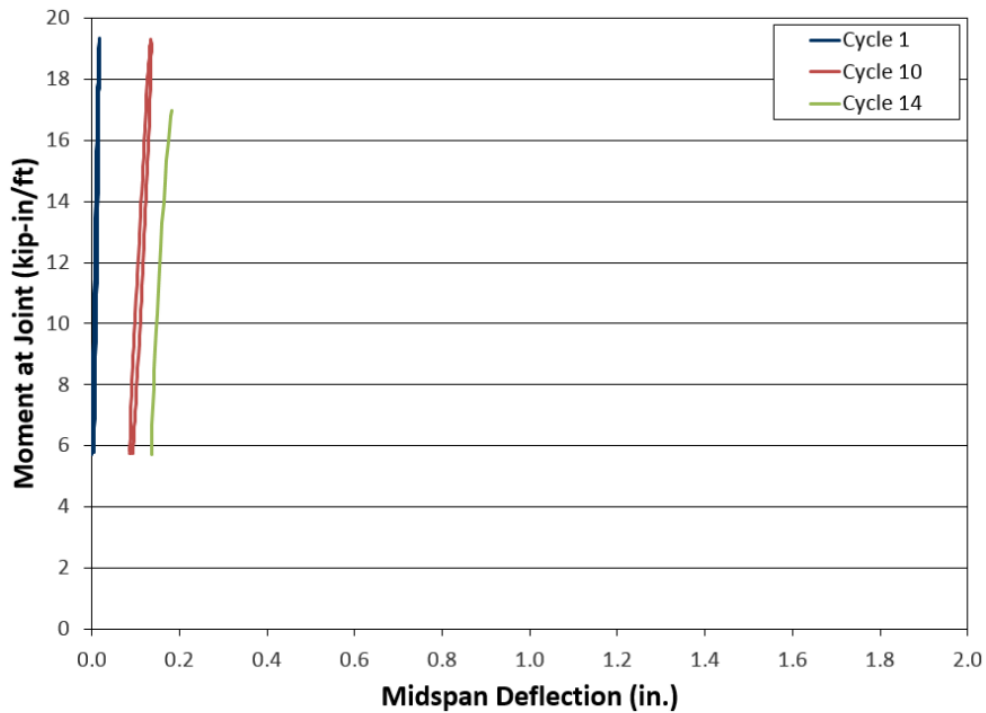
Figure 5.37 Moment at Joint versus Midspan Deflection (U-NEG-F)

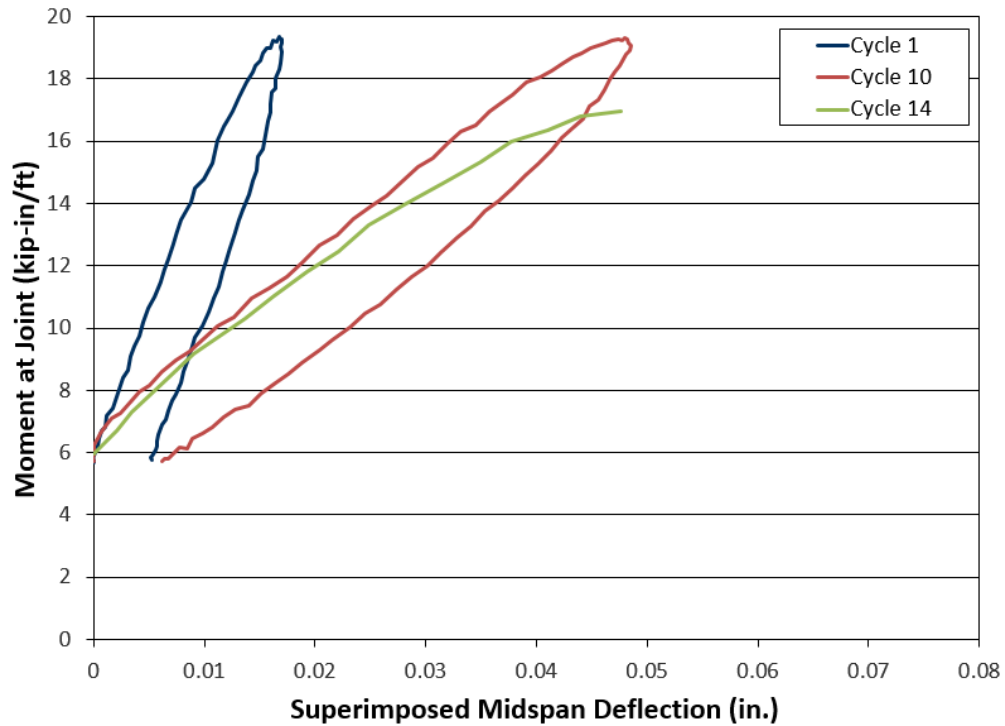
Figure 5.38 Moment at Joint versus Superimposed Midspan Deflection (U-NEG-F)

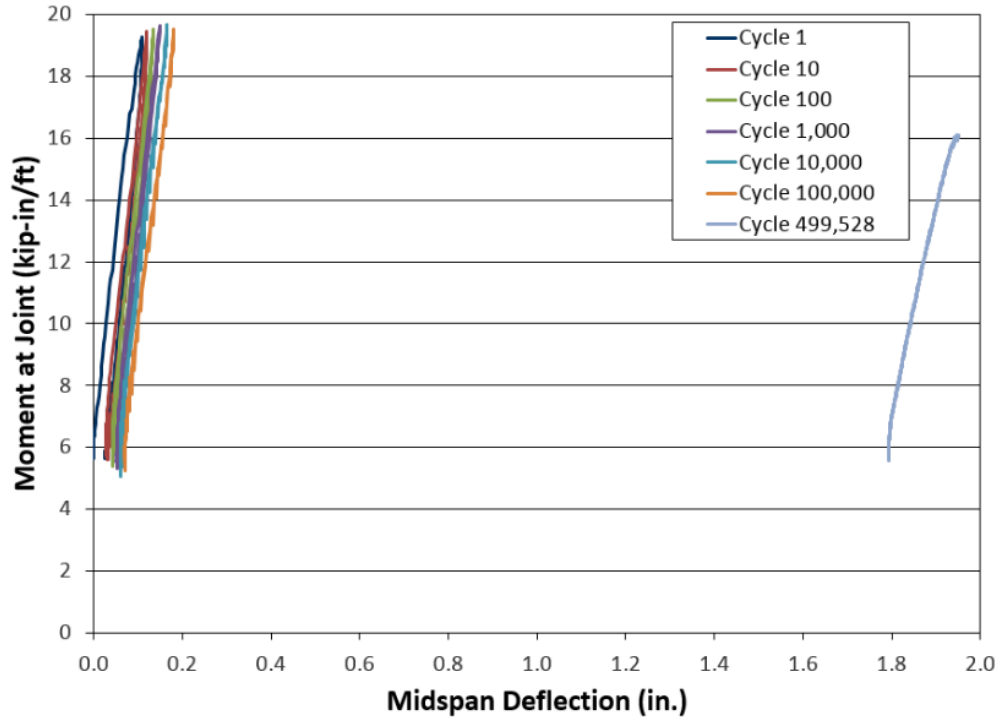
Figure 5.41 Moment at Joint versus Midspan Deflection (R-NEG-F)

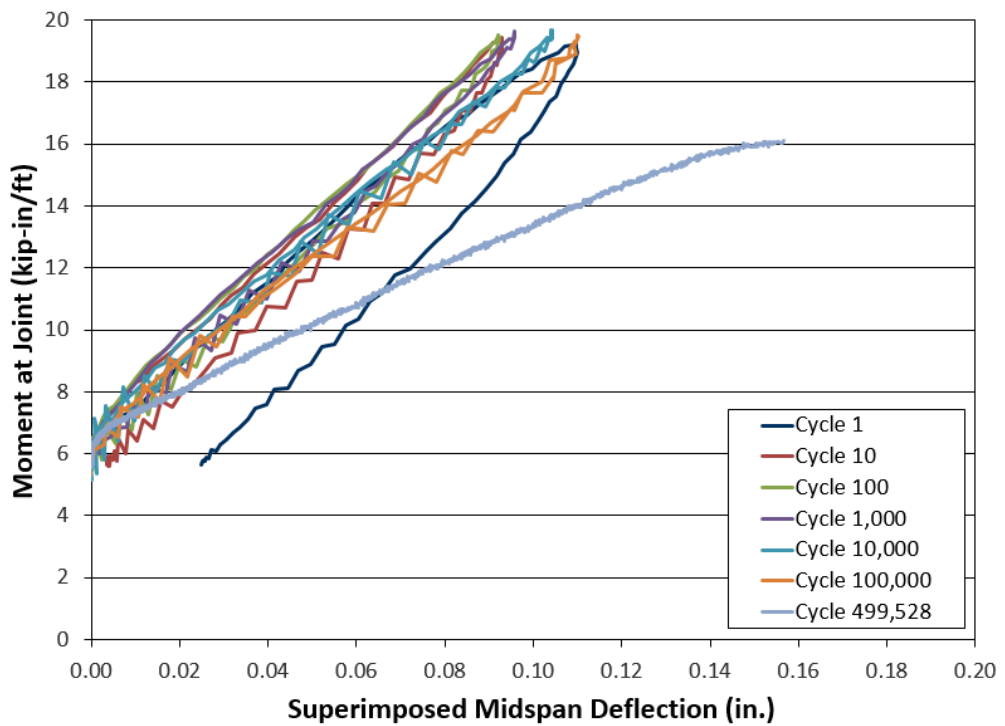
Figure 5.42 Moment at Joint versus Superimposed Midspan Deflection (R-NEG-F)

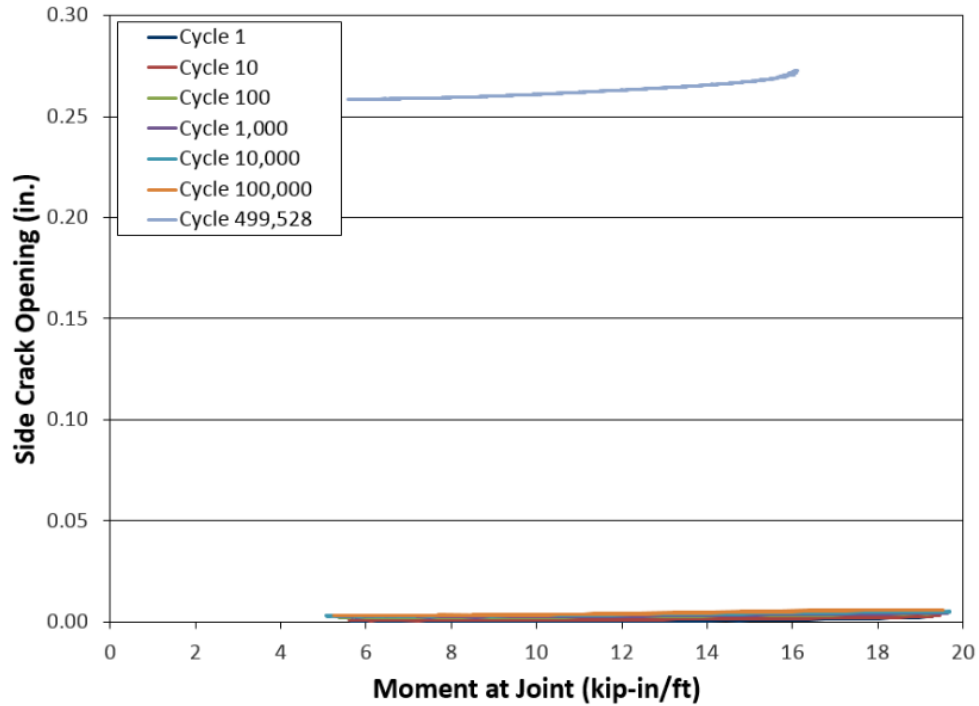
Figure 5.43 Side Crack Opening versus Moment at Joint (R-NEG-F)

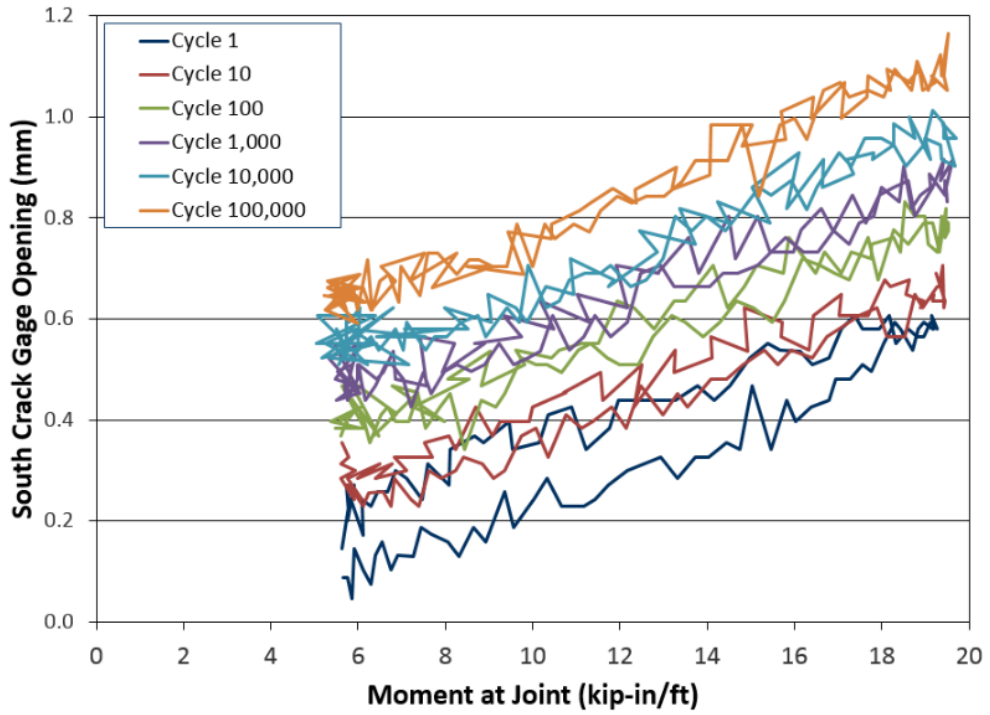
Figure 5.44 South Crack Gage Opening versus Moment at Joint (R-NEG-F)
