Research Report No. 2 for ALDOT Project 930-762

**LABORATORY TESTING OF TRANSVERSE
JOINTS FOR PRECAST-PANEL BRIDGE-DECK
REPLACEMENT SYSTEMS**

AUGUST 2020

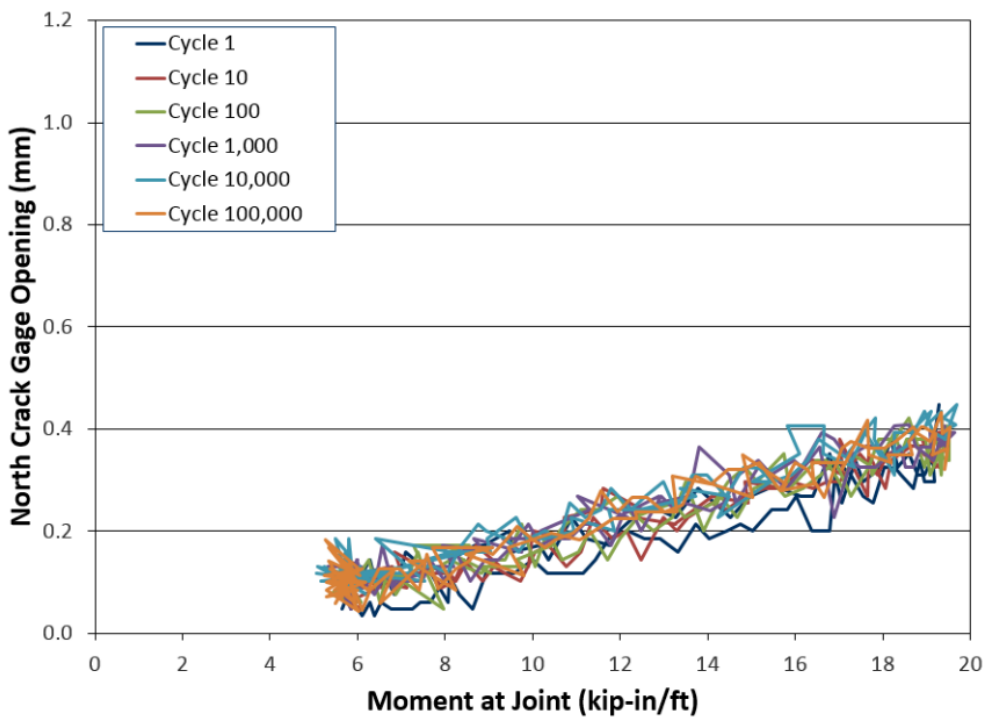
Figure 5.45 North Crack Gage Opening versus Moment at Joint (R-NEG-F)

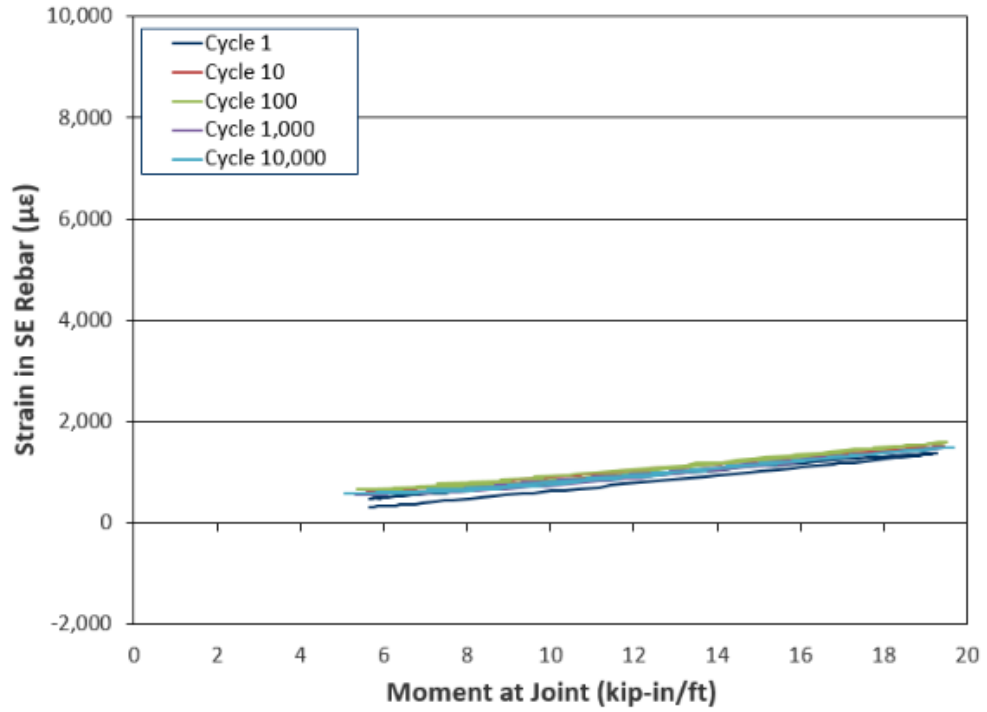
Figure 5.46 Strain in SE Reinforcing Steel versus Moment at Joint (R-NEG-F)

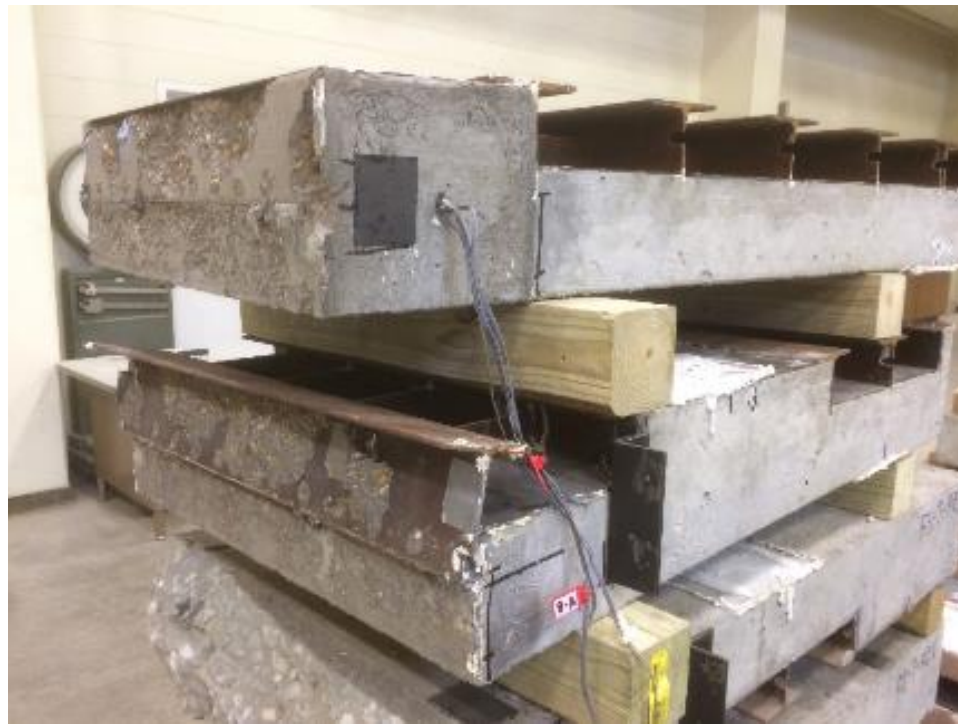
Figure 5.50 Separated (and Inverted) Deck Panels (R-NEG-F)

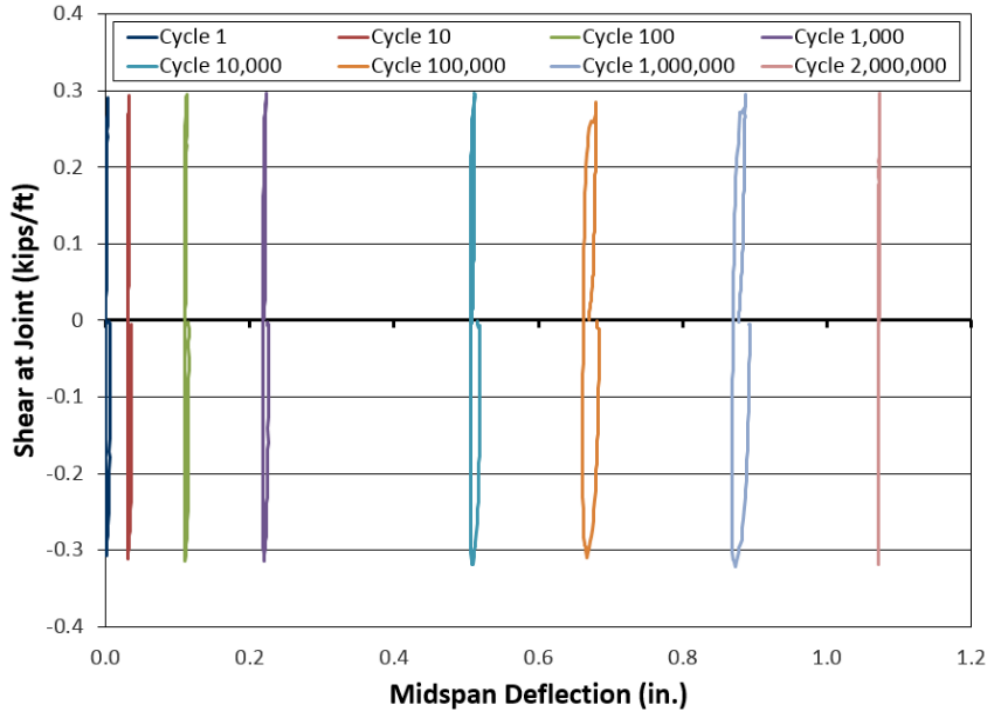
Figure 5.54 Shear at Joint versus Midspan Deflection (U-REV-F)

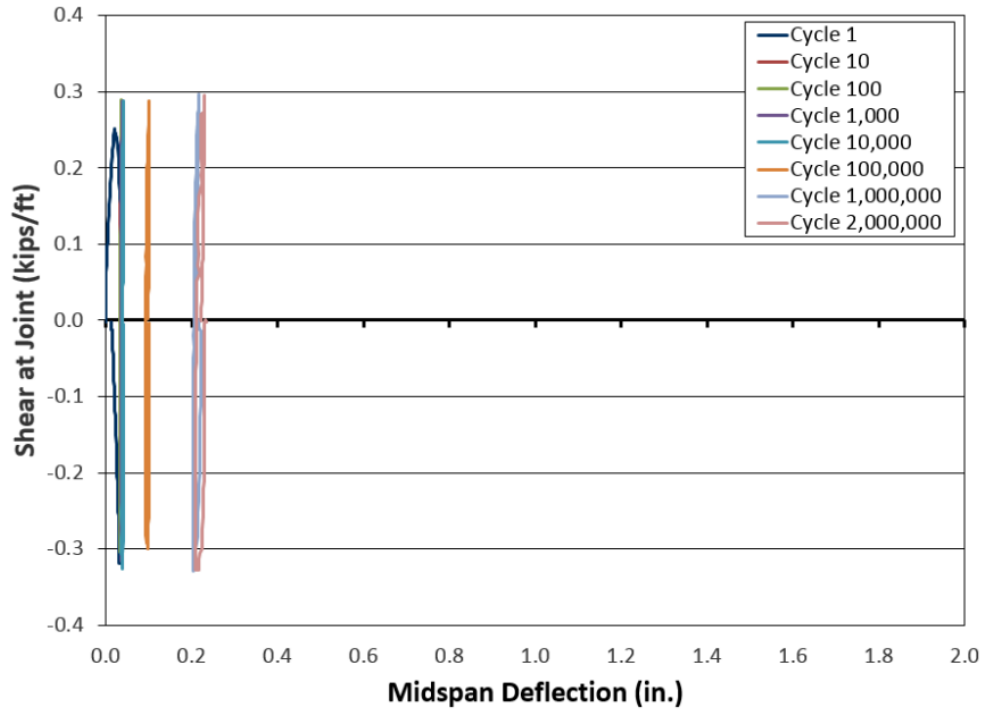
Figure 5.60 Shear at Joint versus Midspan Deflection (R-REV-F)

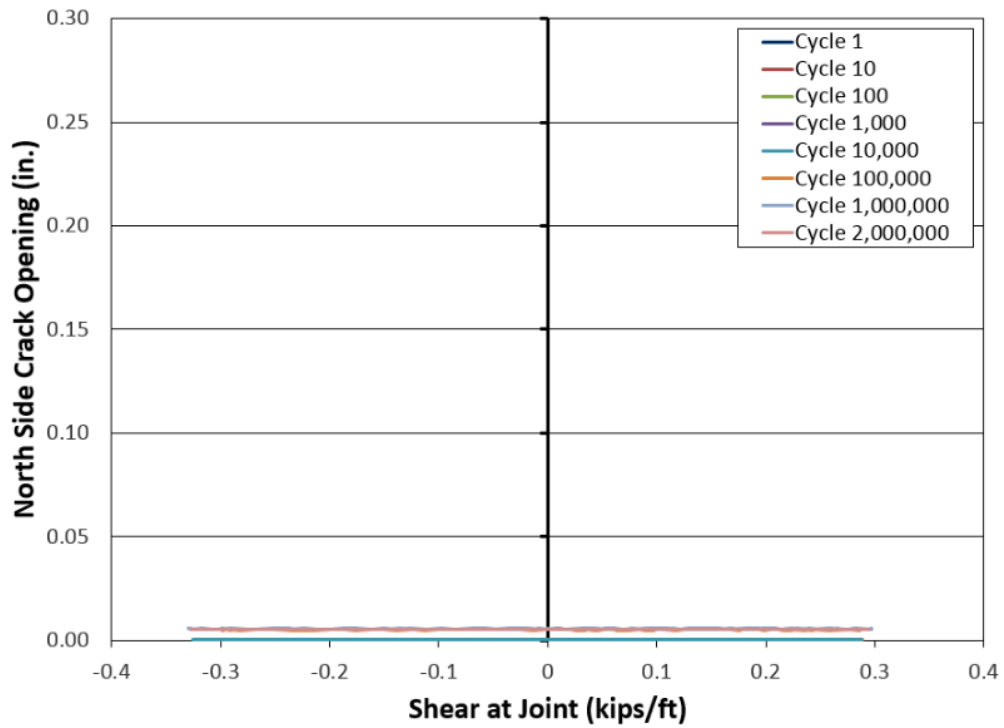
Figure 5.63 North Side Crack Opening versus Shear at Joint (R-REV-F)

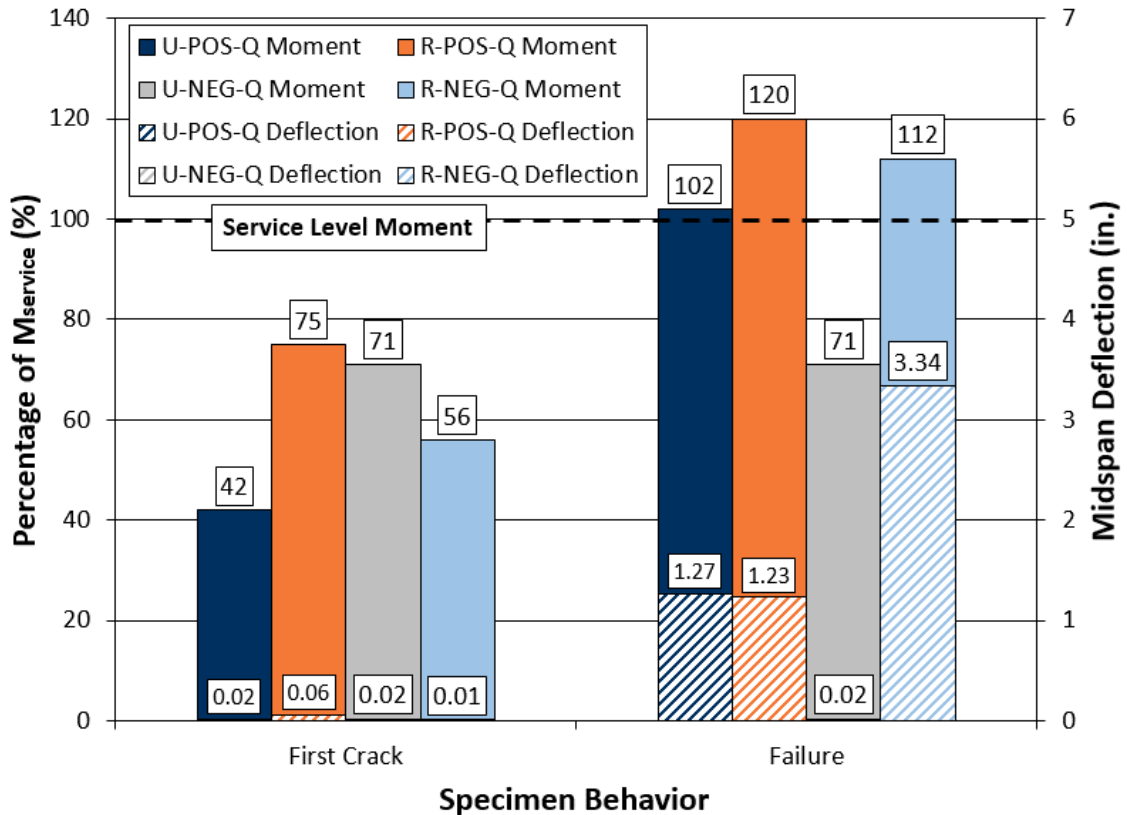
Figure 5.68 Capacities of Flexure Specimens under Quasi-Static Loading

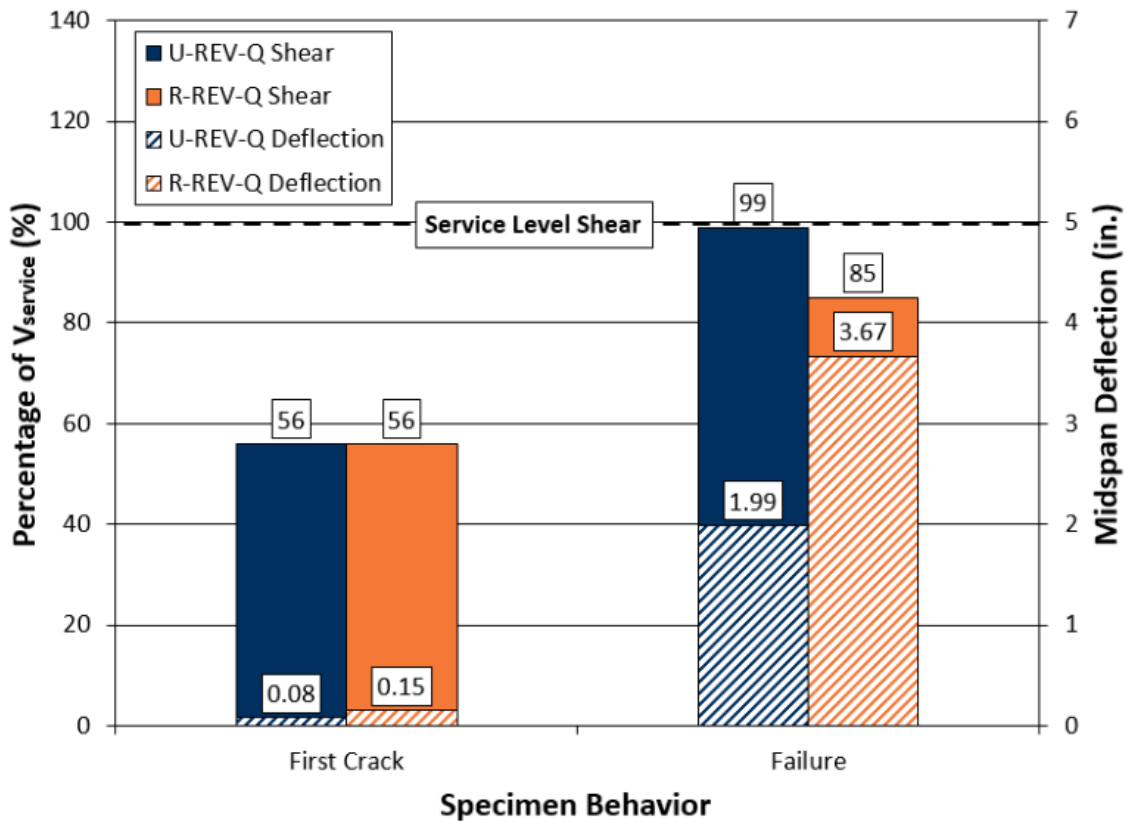
Figure 5.69 Capacities of Shear-Reversal Specimens under Quasi-Static Loading
